SUBJECT: EPA Comments on "Assessment of Dam Safety of Coal Combustion Surface
Impoundments: City of San Antonio, JT Deely Power Plant, San Antonio, TX

Raba Kistner Consultants Inc. (RKCI) is pleased to submit the report of our Geotechnical Engineering Study for the above-referenced project. This study was performed in accordance with **RKCI** Proposal No. PSA12-168-00 (3rd Revision), dated October 4, 2012. The purpose of this study was to drill borings within the existing ash pond berms, to perform laboratory testing to classify and characterize subsurface conditions, and to prepare an engineering report presenting slope stability analyses for the existing berms.

Raba Kistner Consultants Inc. (RKCI) has completed the authorized subsurface exploration and slope stability analyses for the existing ash pond berms at the Calaveras Lake Power Plant in San Antonio, Texas. This report briefly describes the procedures utilized during this study and presents our findings along with our recommendations for maintaining the existing ash pond berms.

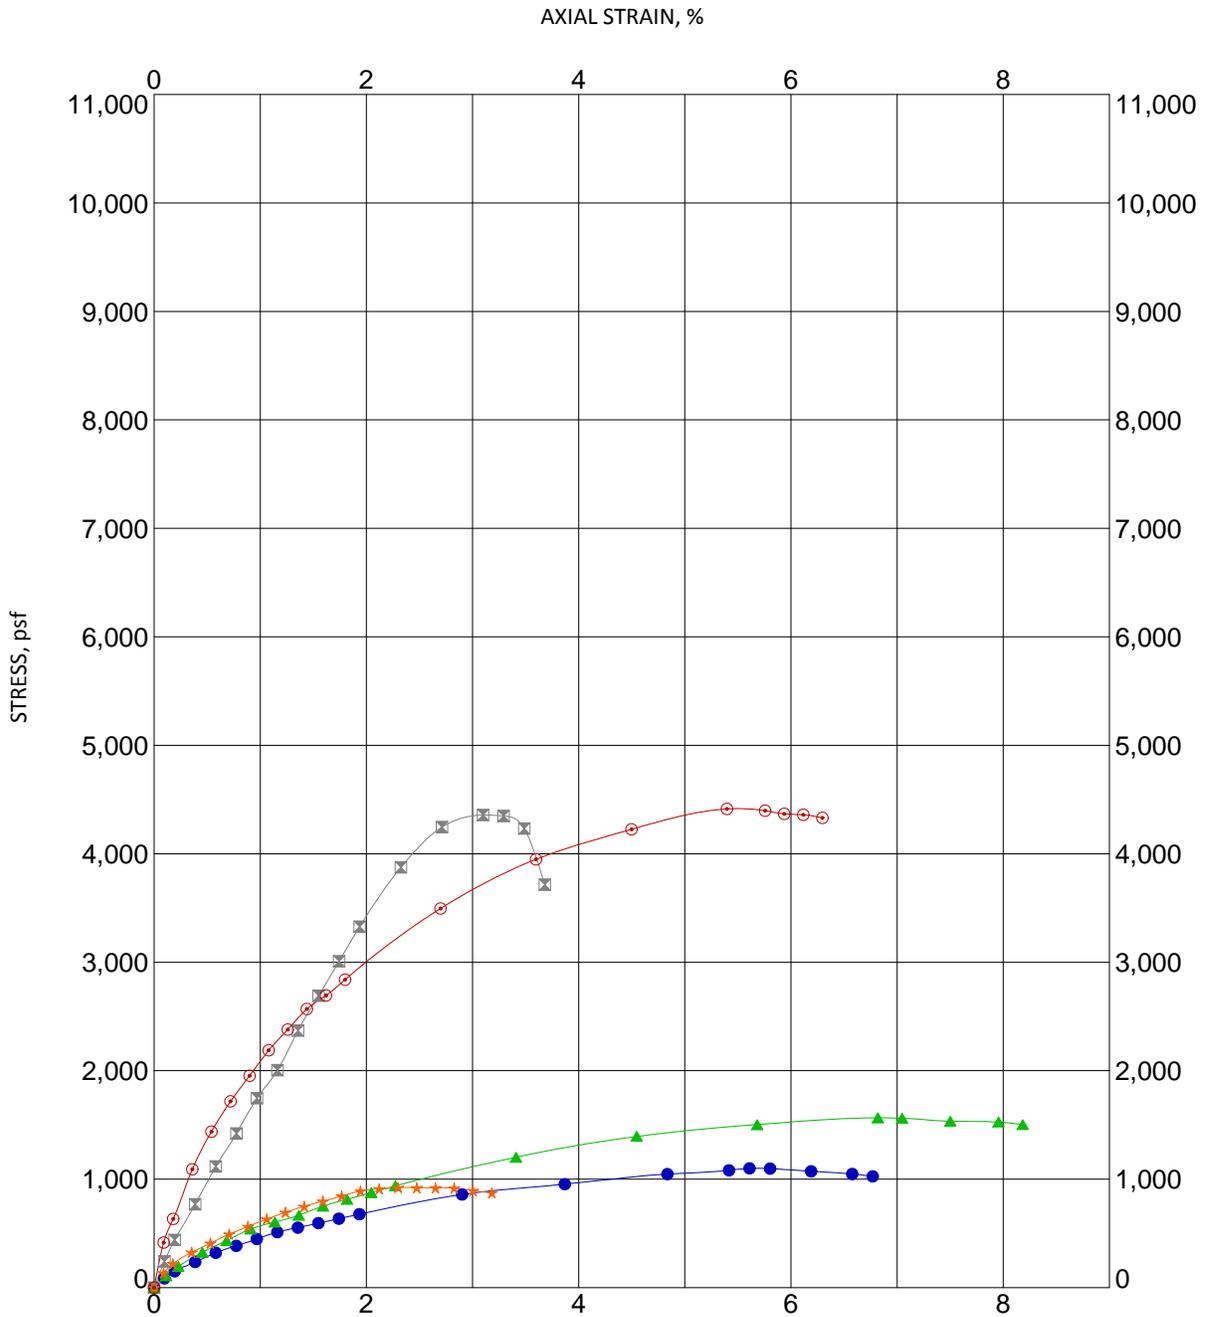
FIGURE B-2

Specimen Identification	Classification	Shear Str. (tsf)	Failure Strain (%)	PI	Dry Unit Weight (pcf)	w (%)
● B-1 4 ft		0.3	5.6	16	106.0	17.7
⊠ B-1 6 ft		1.1	3.1		109.9	15.4
▲ B-1 8 ft		0.4	6.8		111.8	13.2
★ B-10 13 ft		0.2	2.3		97.4	24.5
⊙ B-14 6 ft		1.1	5.4		117.9	13.6

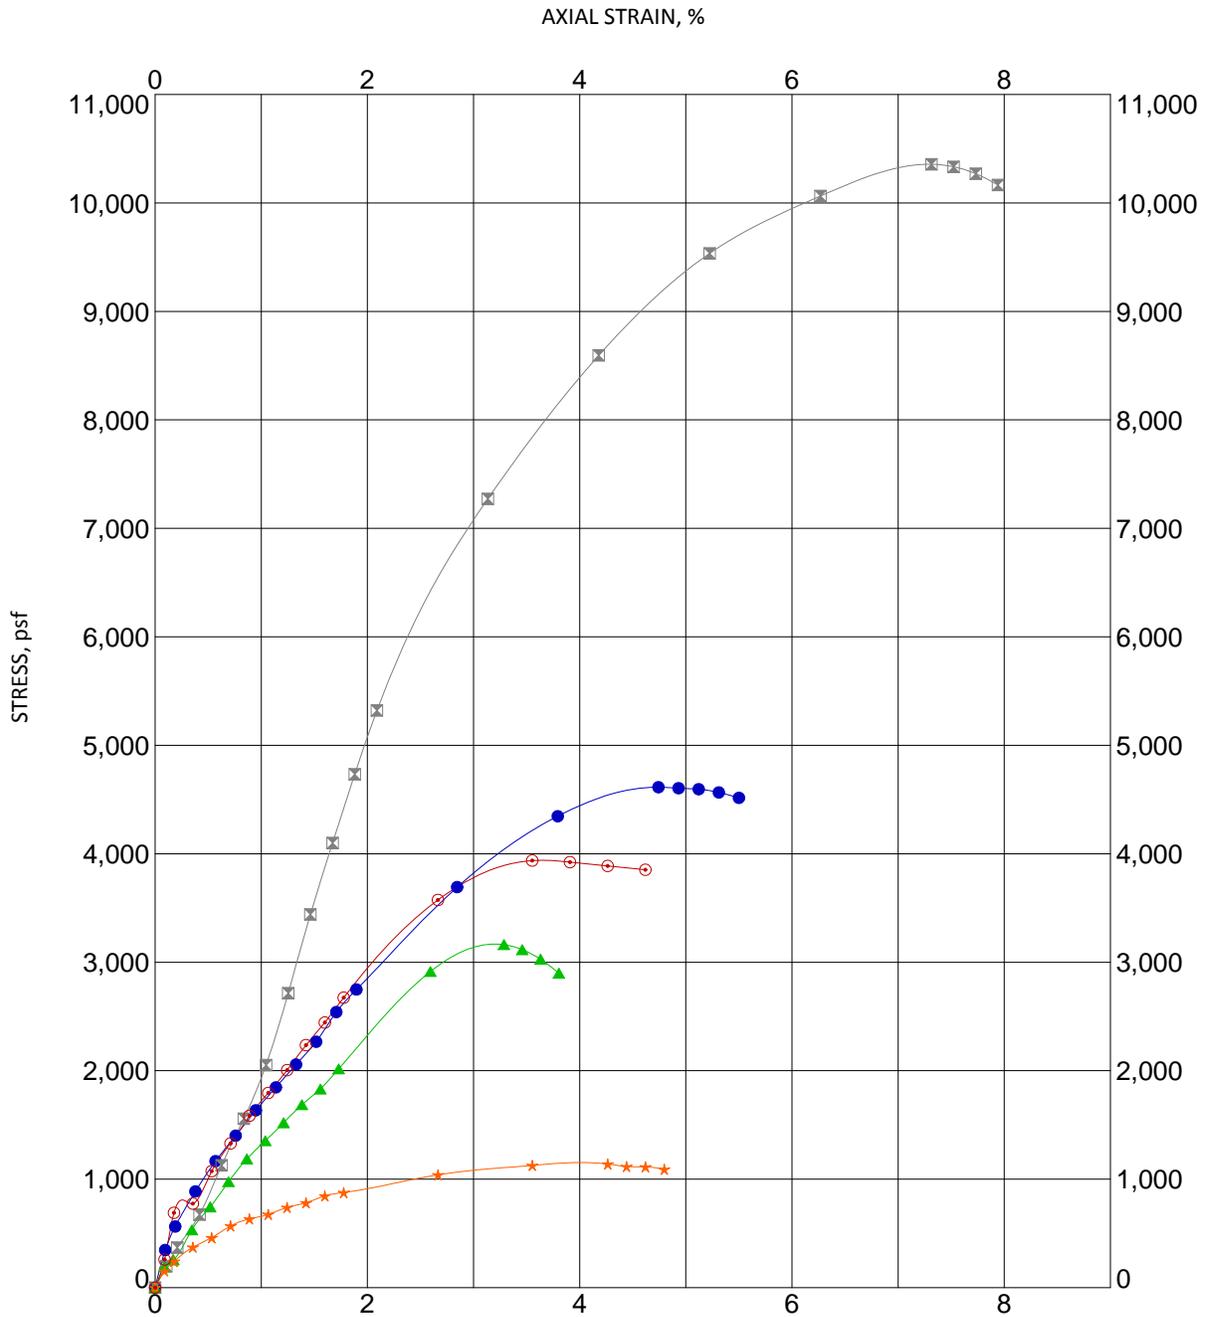
FIGURE B-3

Specimen Identification	Classification	Shear Str. (tsf)	Failure Strain (%)	PI	Dry Unit Weight (pcf)	w (%)
● B-14 8 ft		1.2	4.7		116.9	14.7
⊠ B-2 2 ft		2.6	7.3		119.3	10.9
▲ B-2 4 ft		0.8	3.3	15	104.0	16.6
★ B-2 6 ft		0.3	4.3		102.1	19.0
⊙ B-2 8 ft		1.0	3.6		110.3	16.9

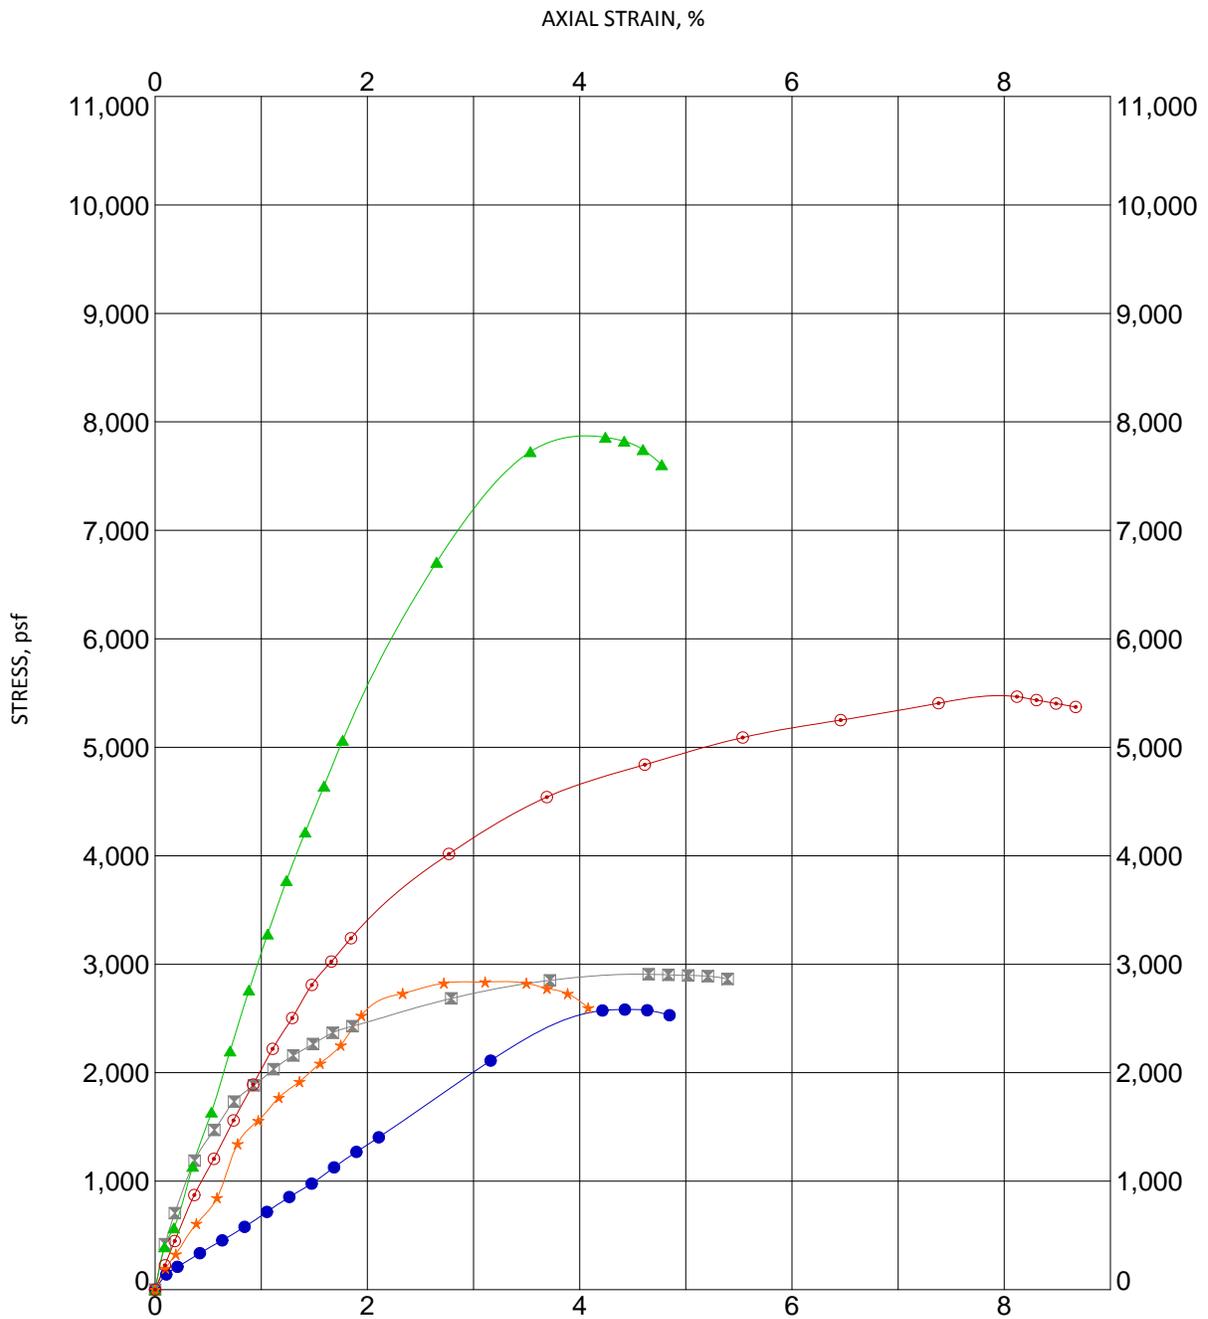
FIGURE B-4

Specimen Identification	Classification	Shear Str. (tsf)	Failure Strain (%)	PI	Dry Unit Weight (pcf)	w (%)
● B-2 18 ft		0.6	4.4		100.8	13.0
☒ B-3 13 ft		0.7	4.7	30	112.2	17.6
▲ B-4 6 ft		2.0	4.2		113.1	14.3
★ B-4 8 ft		0.7	3.1		109.8	10.6
○ B-7 6 ft		1.4	8.1		115.1	15.7

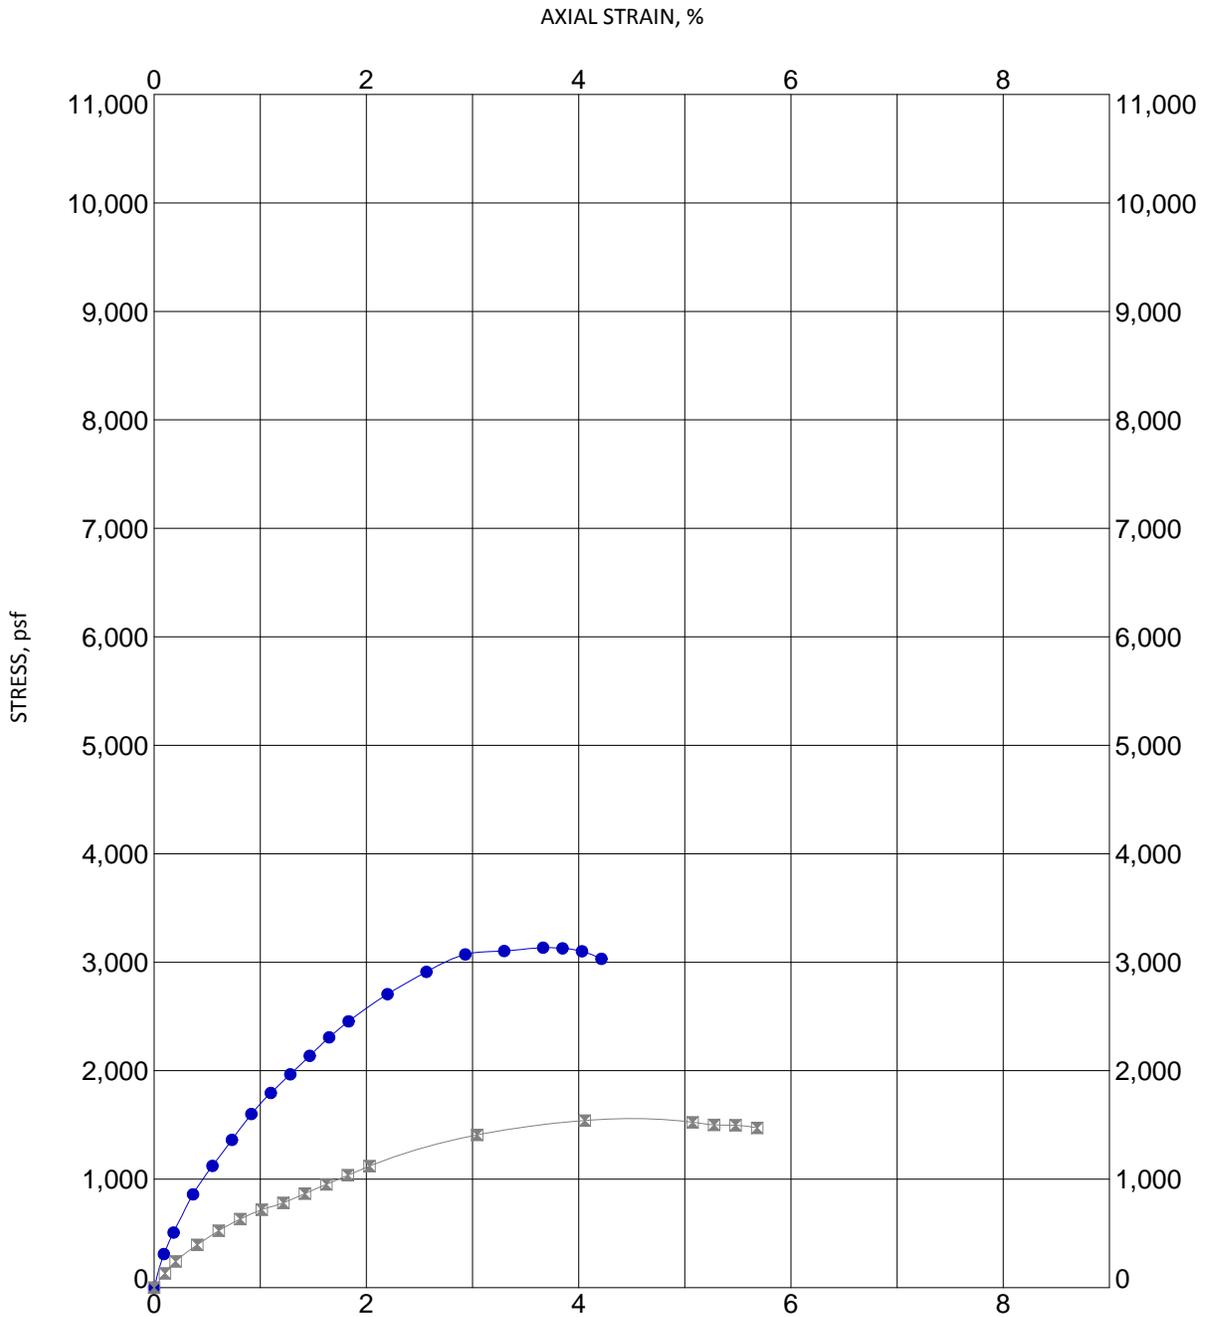
FIGURE B-5

Specimen Identification	Classification	Shear Str. (tsf)	Failure Strain (%)	PI	Dry Unit Weight (pcf)	w (%)
● B-8 6 ft		0.8	3.7		112.6	15.1
⊠ B-8 13 ft		0.4	4.1		110.8	18.1

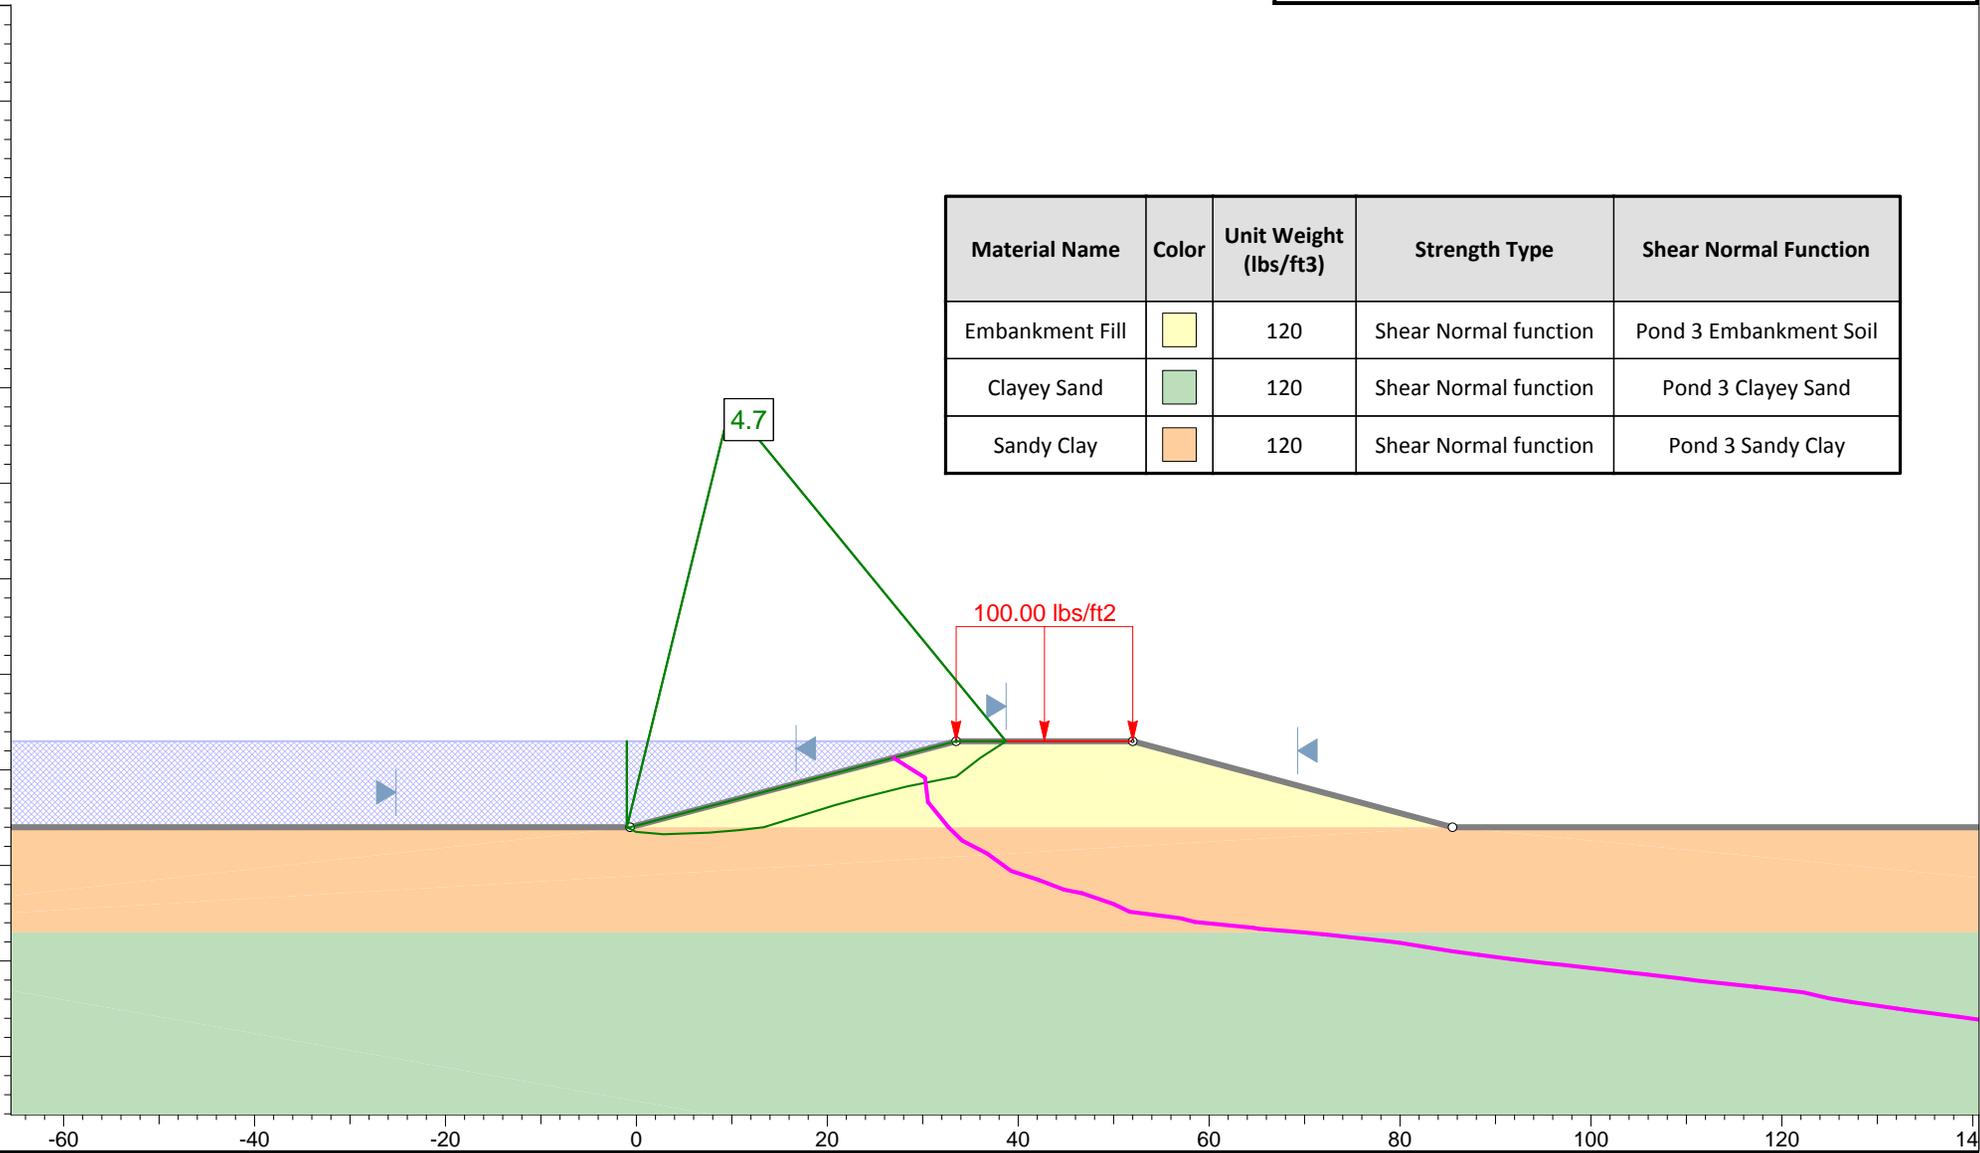
Profile "D"
Ash Pond Berms - Calaveras Lake

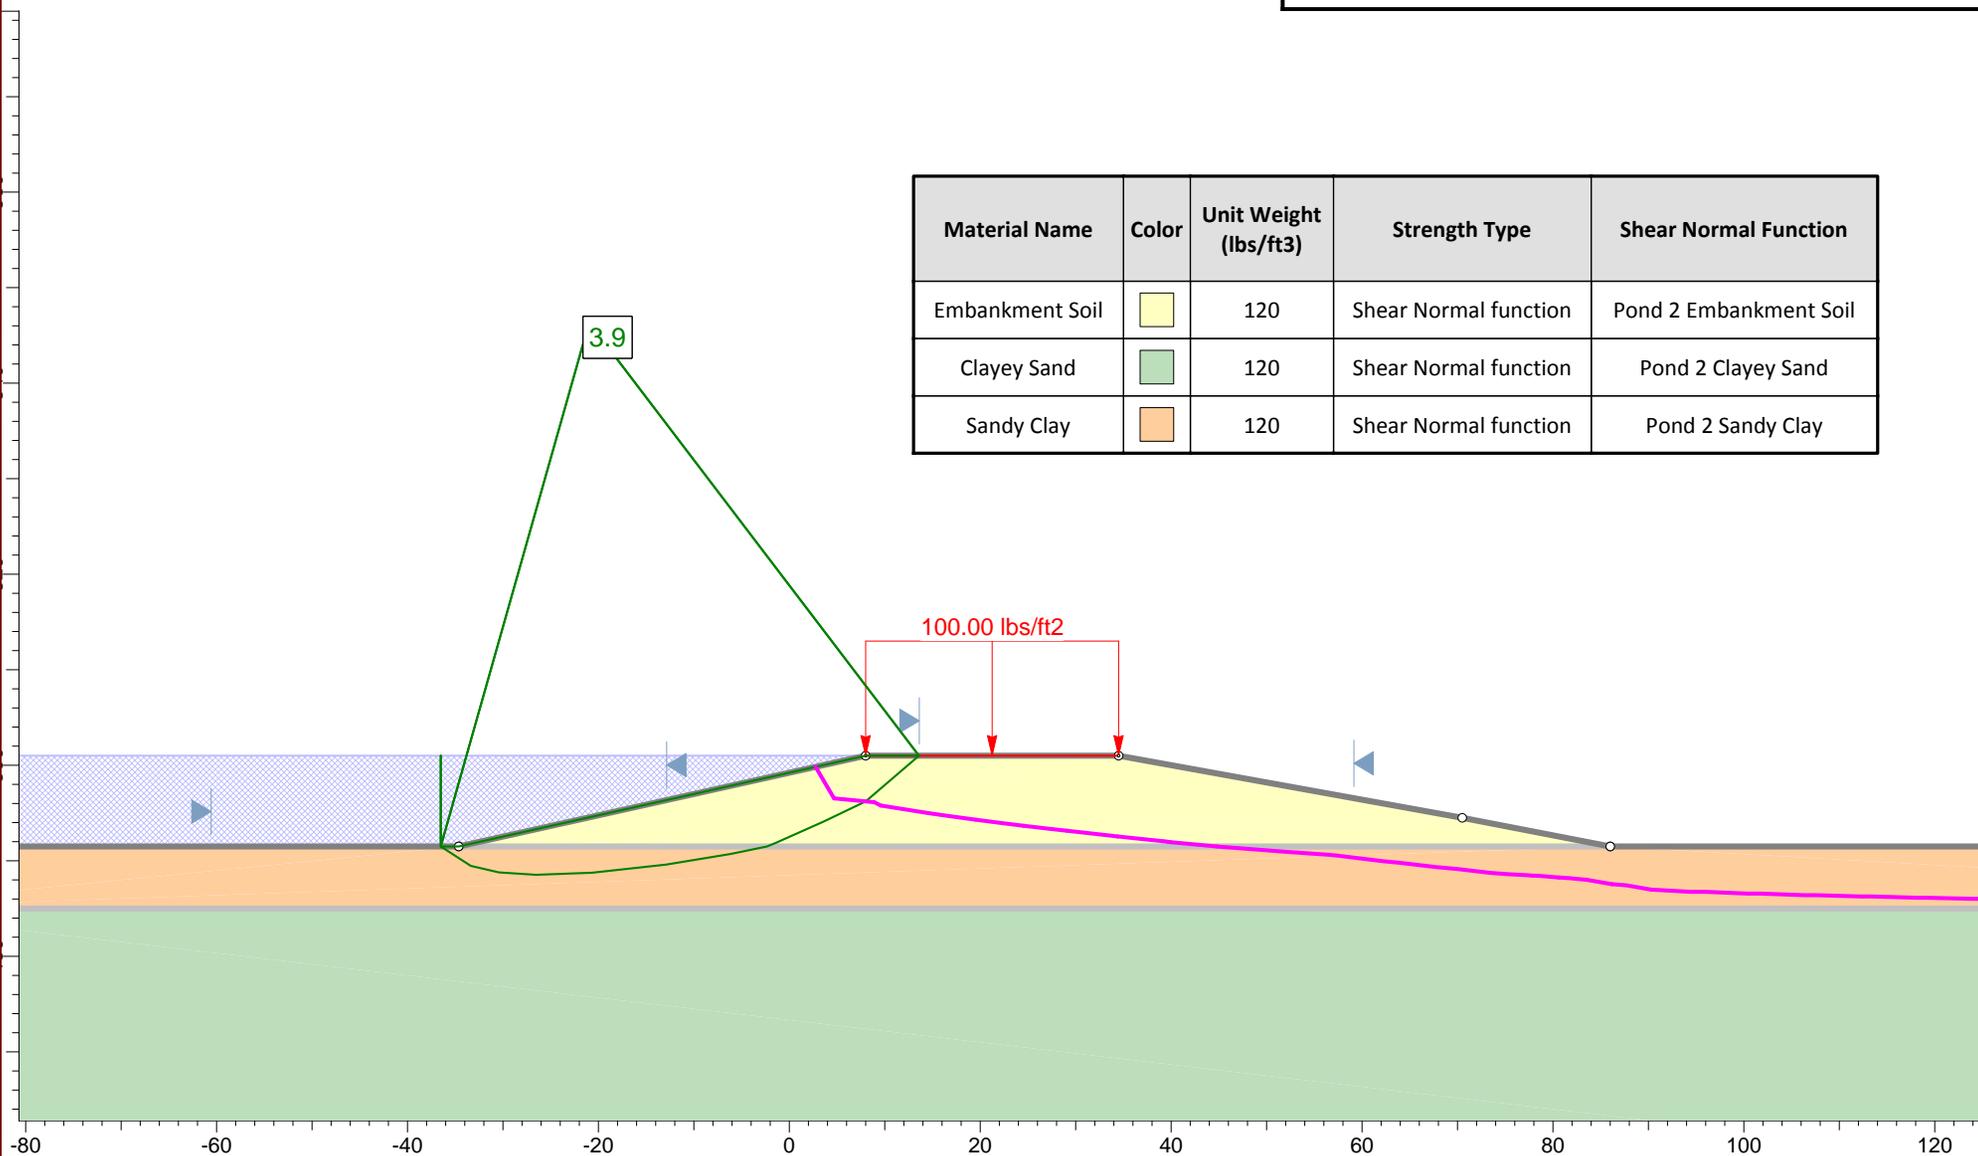
Profile "E"
Ash Pond Berms - Calaveras Lake Power Plant

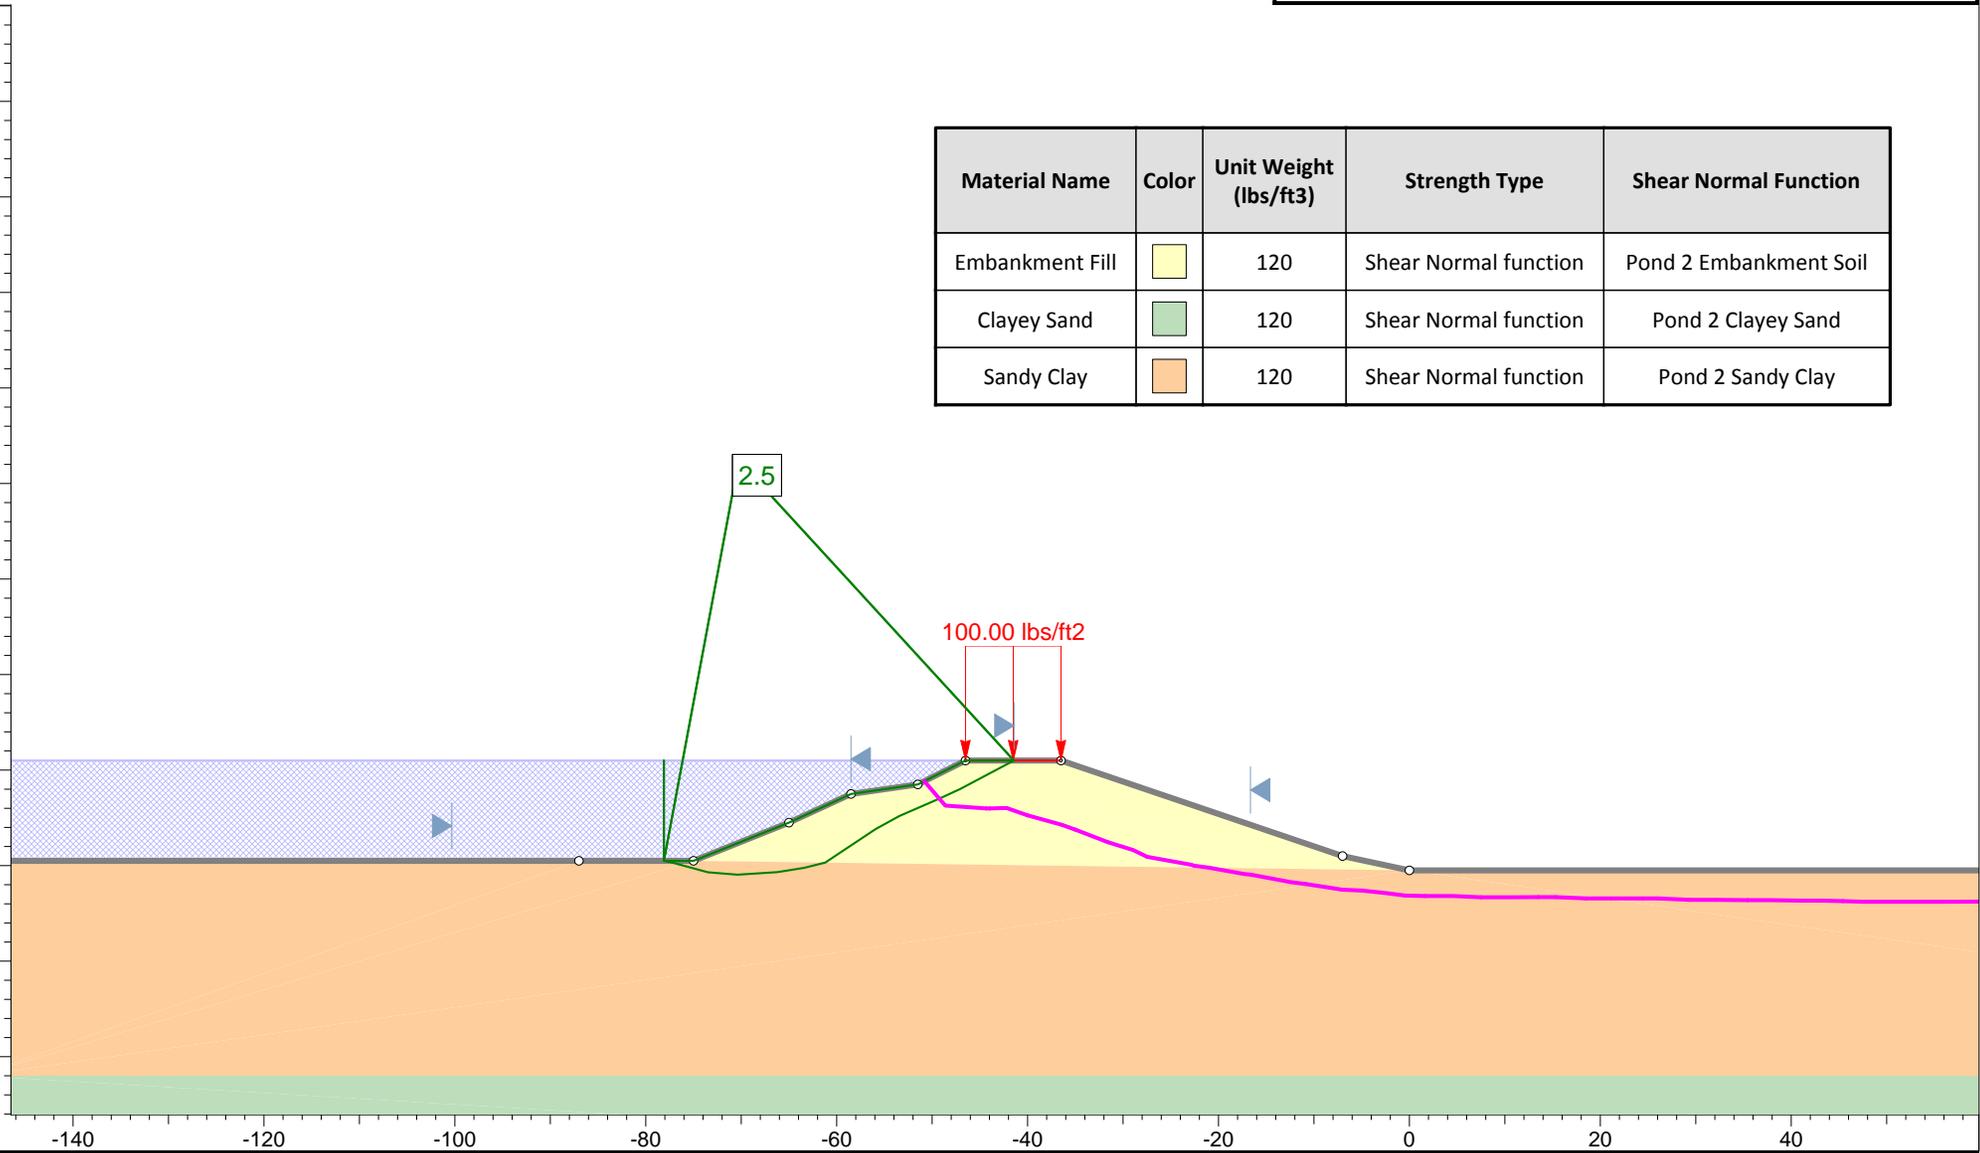
Material Name	Color	Unit Weight (lbs/ft ³)	Strength Type	Shear Normal Function
Embankment Fill	Yellow	120	Shear Normal function	Pond 2 Embankment Soil
Clayey Sand	Green	120	Shear Normal function	Pond 2 Clayey Sand
Sandy Clay	Orange	120	Shear Normal function	Pond 2 Sandy Clay

Profile "I"
Ash Pond Berms - Calaveras Lake Power Plant

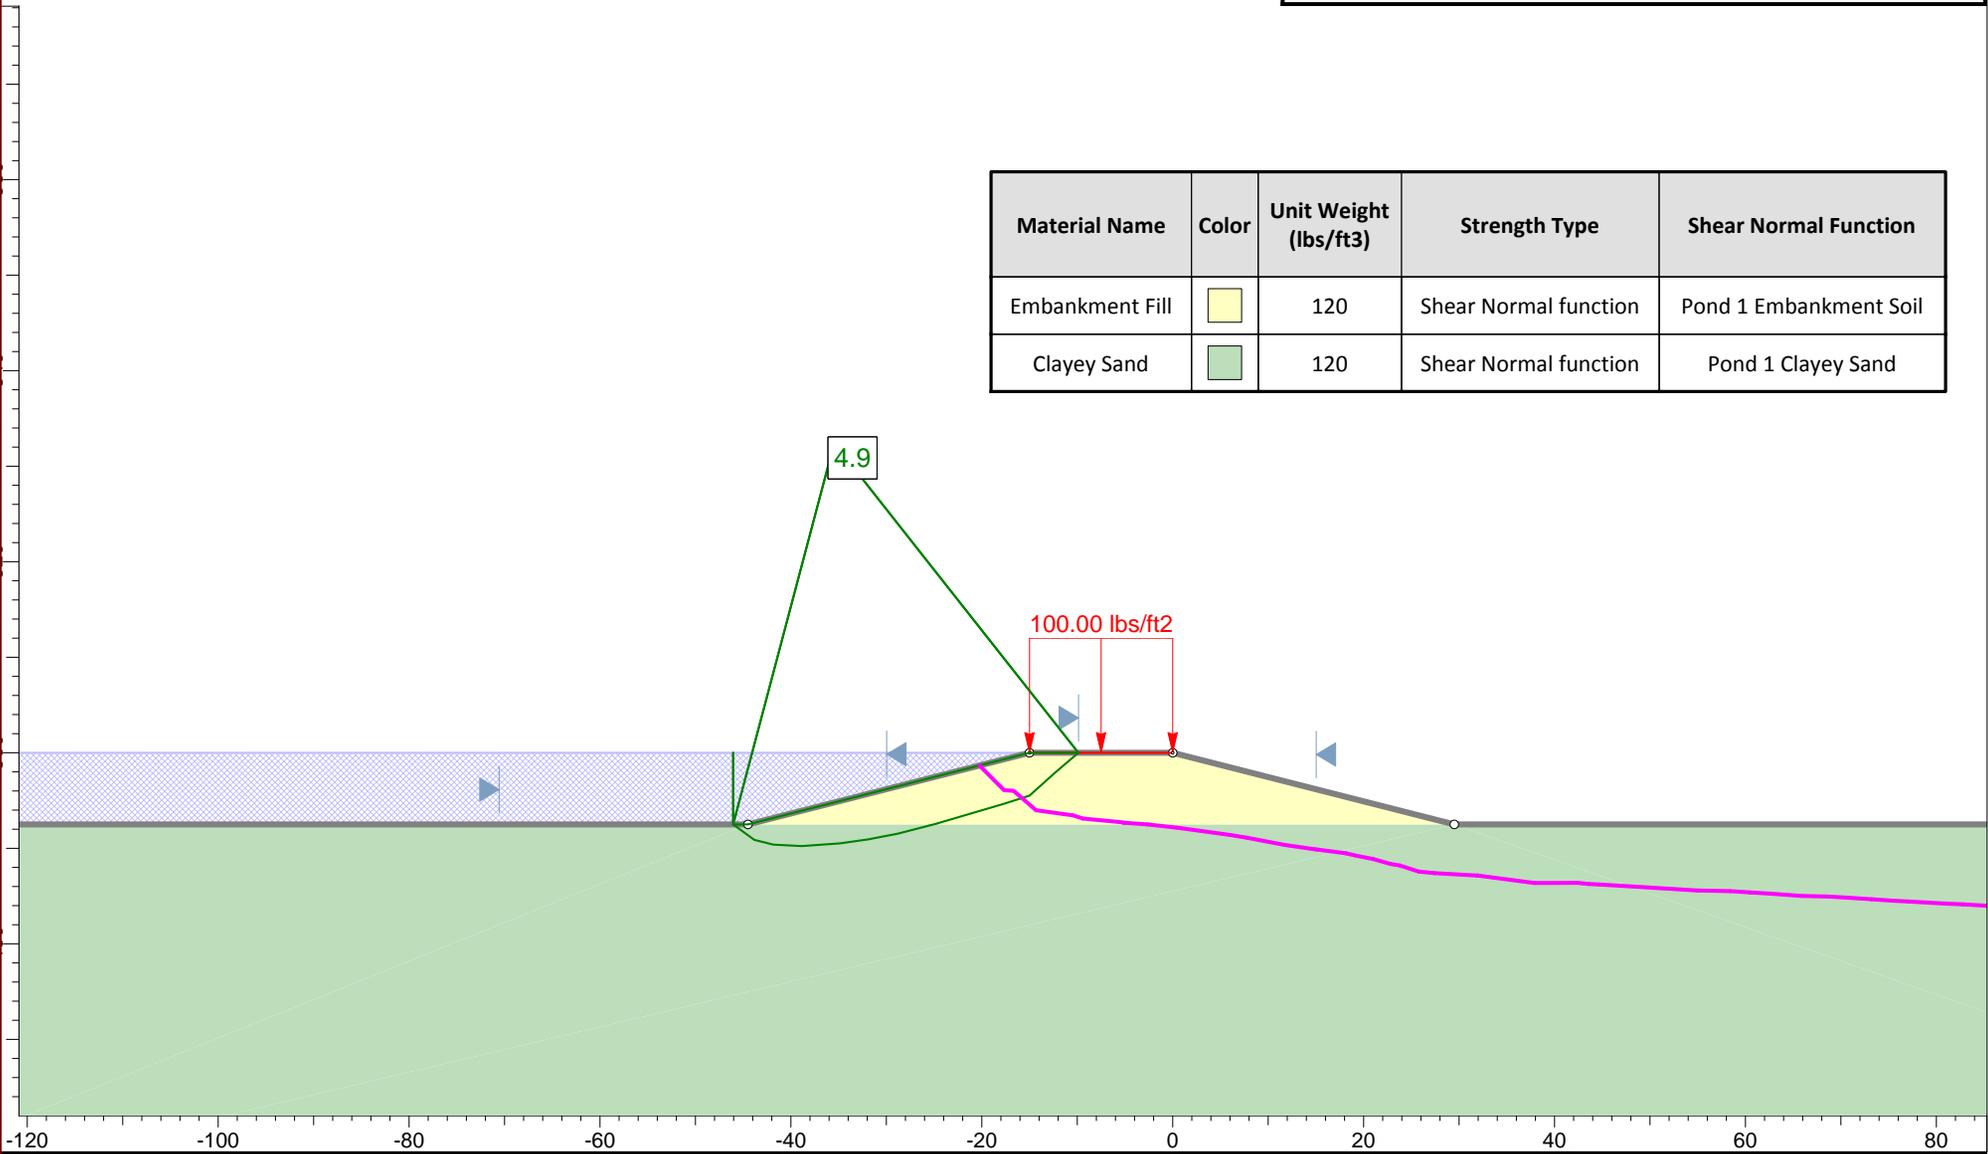
Profile "J"
Ash Pond Berms - Calaveras Lake Power Plant

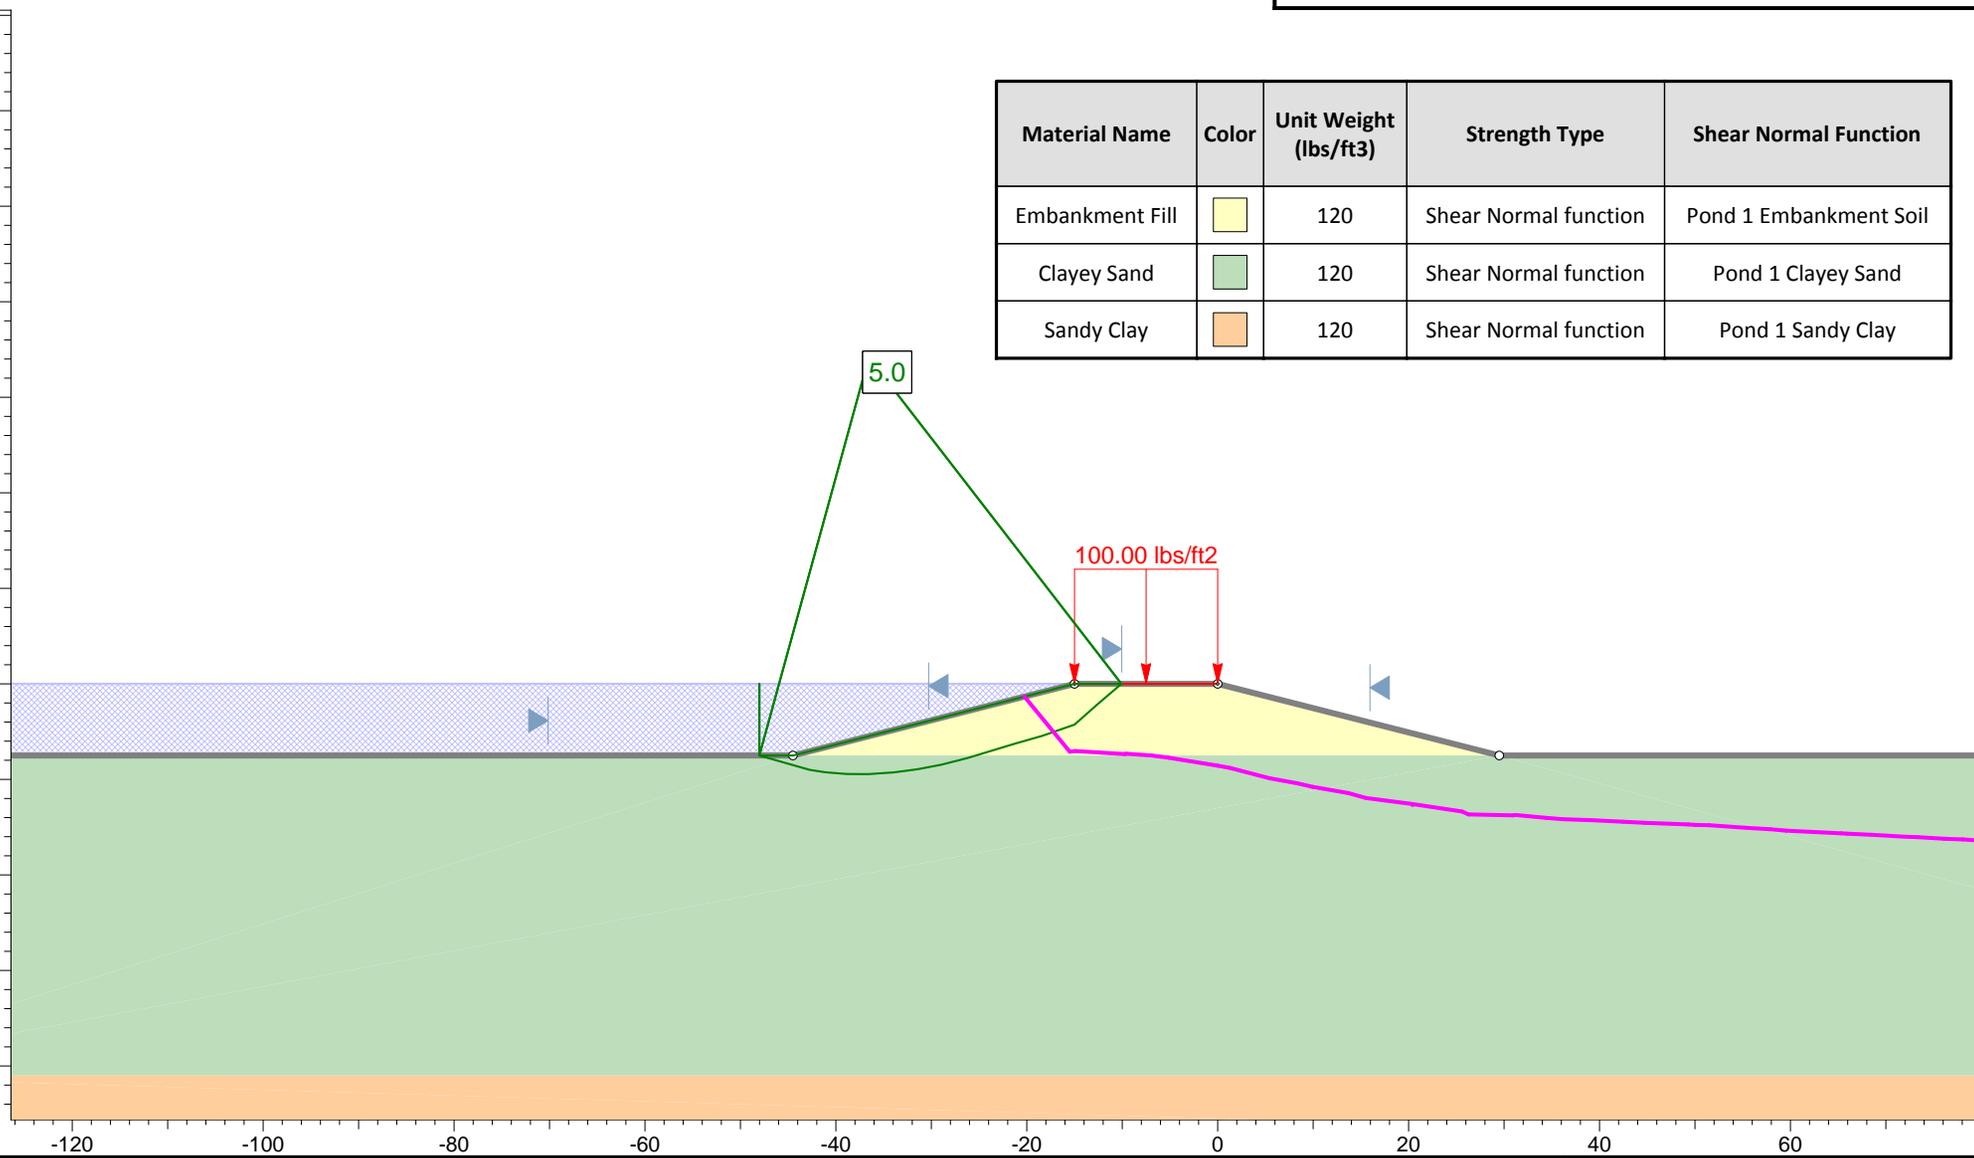
Profile "L"
Ash Pond Berms - Calaveras Lake Power Plant

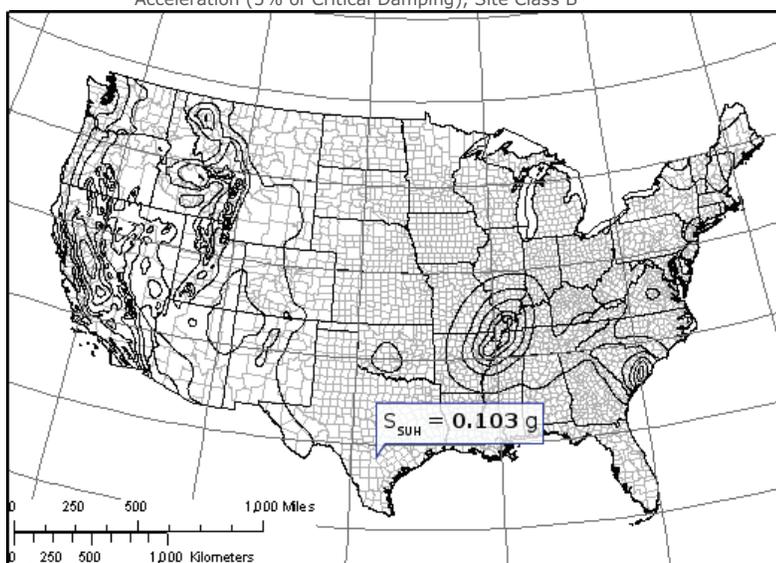
Figure 22-1: Uniform-Hazard (2% in 50-Year) Ground Motions of 0.2-Second Spectral Response Acceleration (5% of Critical Damping), Site Class B

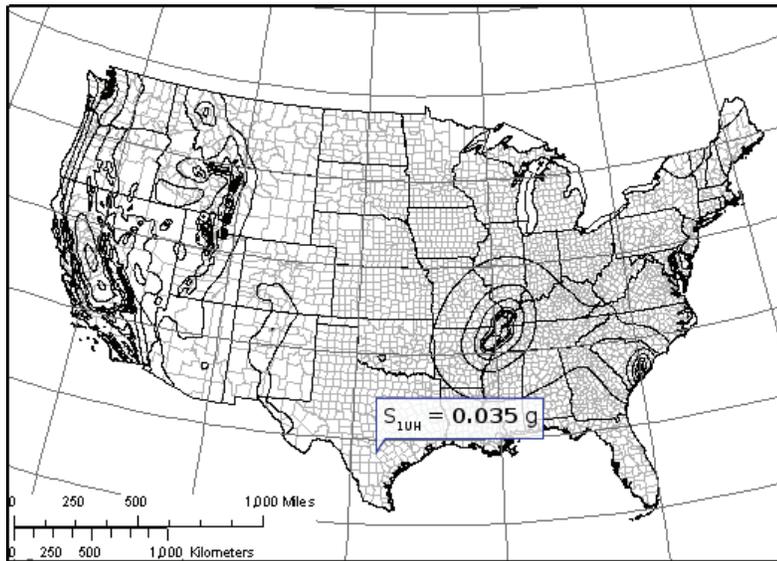
Figure 22-2: Uniform-Hazard (2% in 50-Year) Ground Motions of 1.0-Second Spectral Response Acceleration (5% of Critical Damping), Site Class B

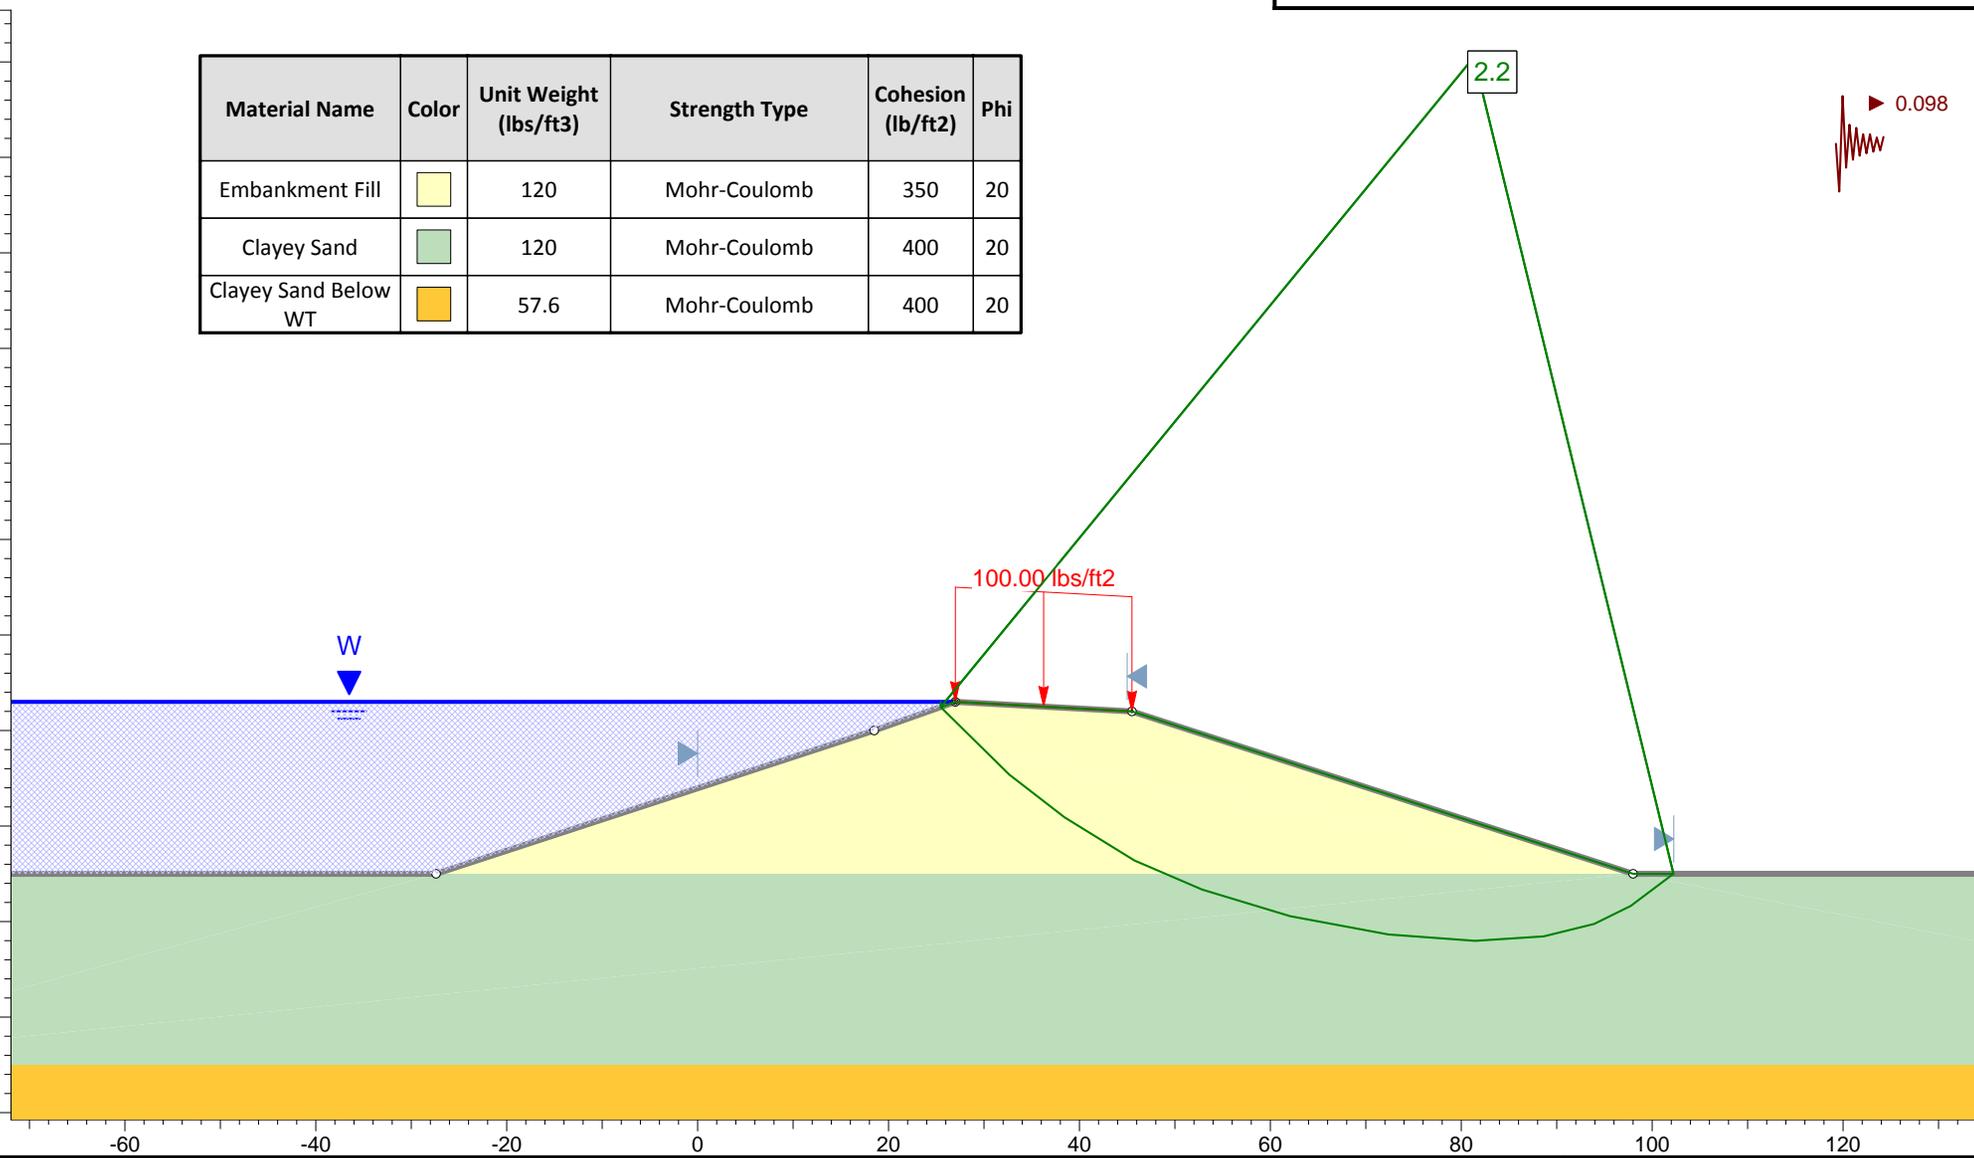
Material Name	Color	Unit Weight (lbs/ft3)	Strength Type	Cohesion (lb/ft2)	Phi
Embankment Fill	Yellow	120	Mohr-Coulomb	350	20
Clayey Sand	Green	120	Mohr-Coulomb	400	20
Clayey Sand Below WT	Orange	57.6	Mohr-Coulomb	400	20

Profile "C"
Ash Pond Berms - Spruce/Deely Generation Units
