SUBJECT: EPA Comments on "Assessment of Dam Safety of Coal Combustion Surface
Impoundments: City of San Antonio, JT Deely Power Plant, San Antonio, TX

Raba Kistner Consultants Inc. (RKCI) is pleased to submit the report of our Geotechnical Engineering Study for the above-referenced project. This study was performed in accordance with **RKCI** Proposal No. PSA12-168-00 (3rd Revision), dated October 4, 2012. The purpose of this study was to drill borings within the existing ash pond berms, to perform laboratory testing to classify and characterize subsurface conditions, and to prepare an engineering report presenting slope stability analyses for the existing berms.

Raba Kistner Consultants Inc. (RKCI) has completed the authorized subsurface exploration and slope stability analyses for the existing ash pond berms at the Calaveras Lake Power Plant in San Antonio, Texas. This report briefly describes the procedures utilized during this study and presents our findings along with our recommendations for maintaining the existing ash pond berms.

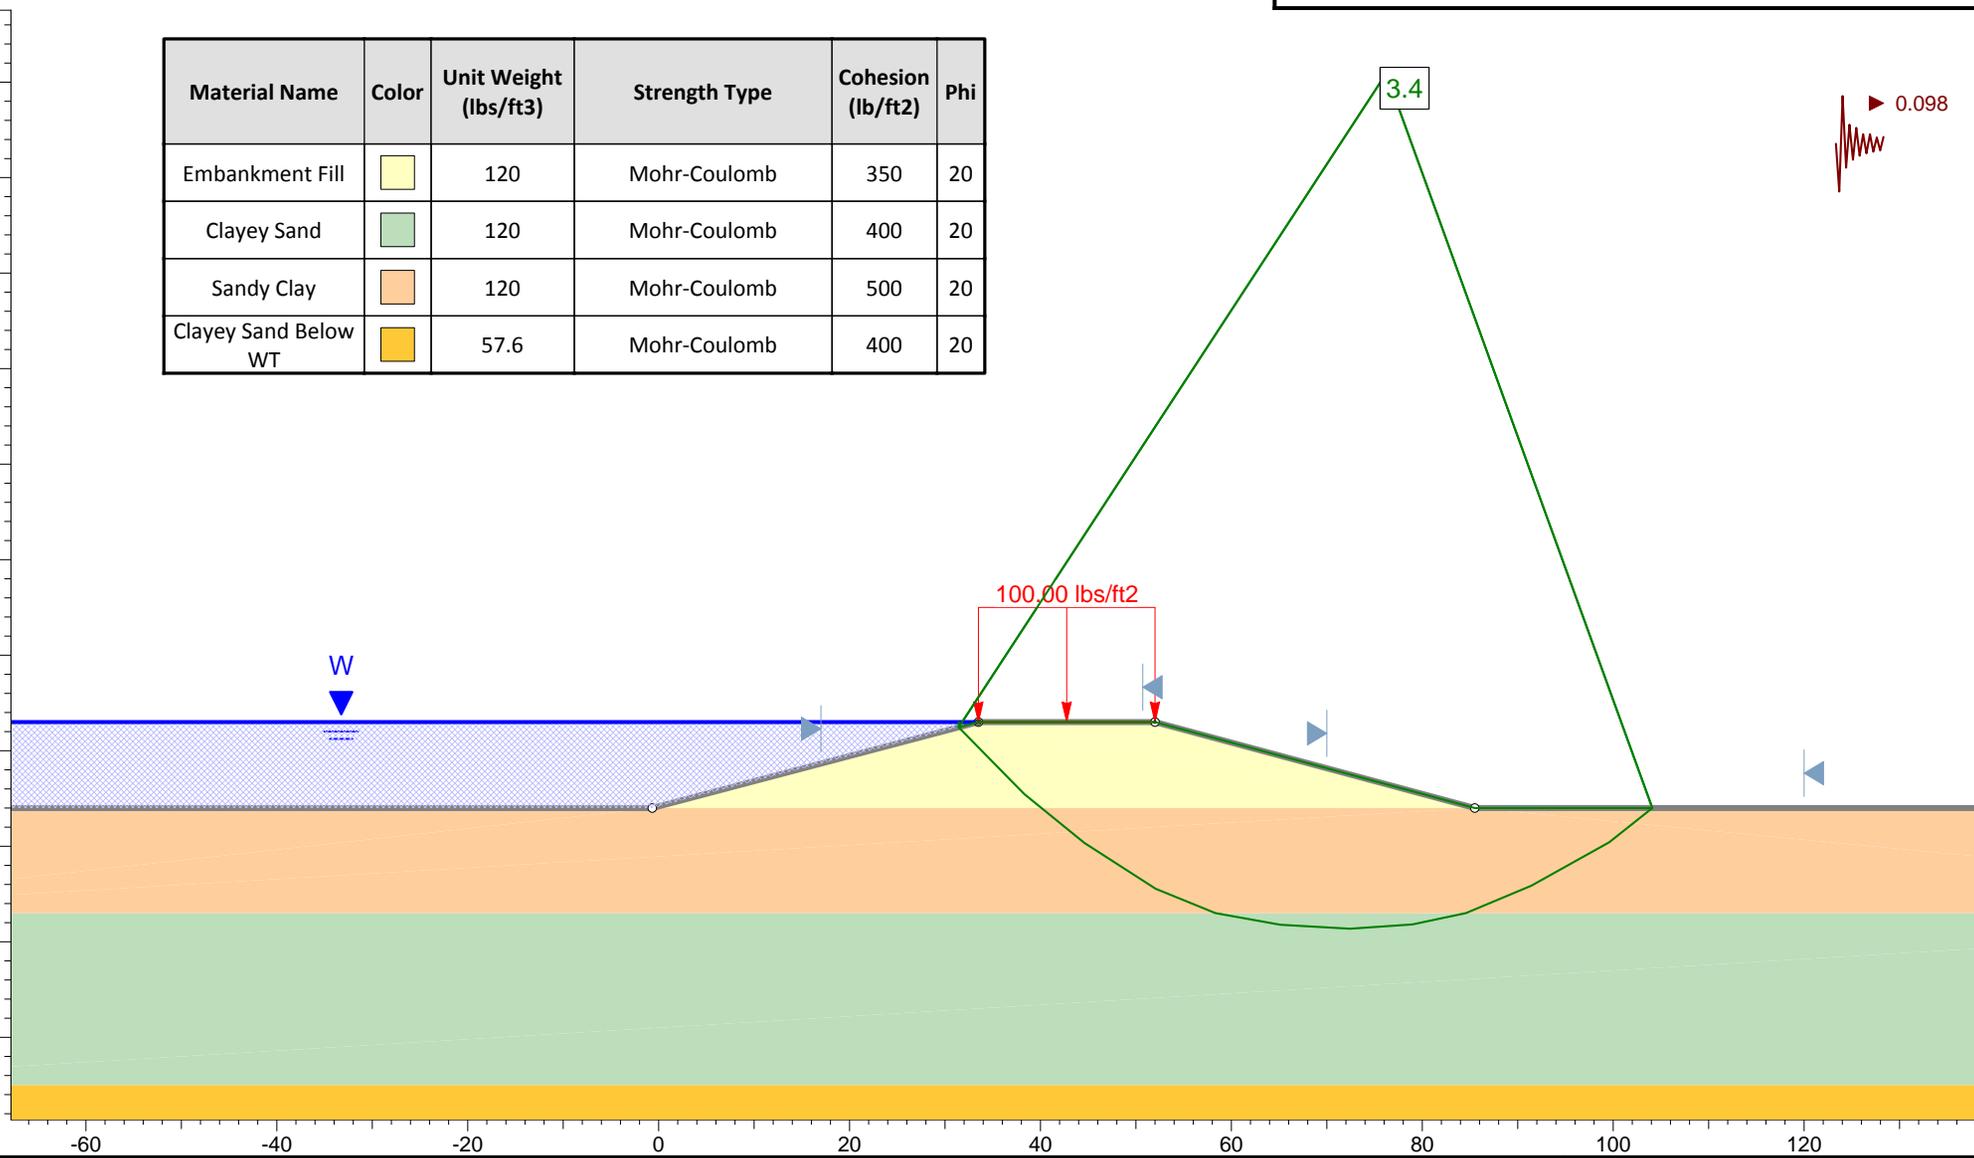
Profile "D"
Ash Pond Berms - Spruce/Deely Generation Units

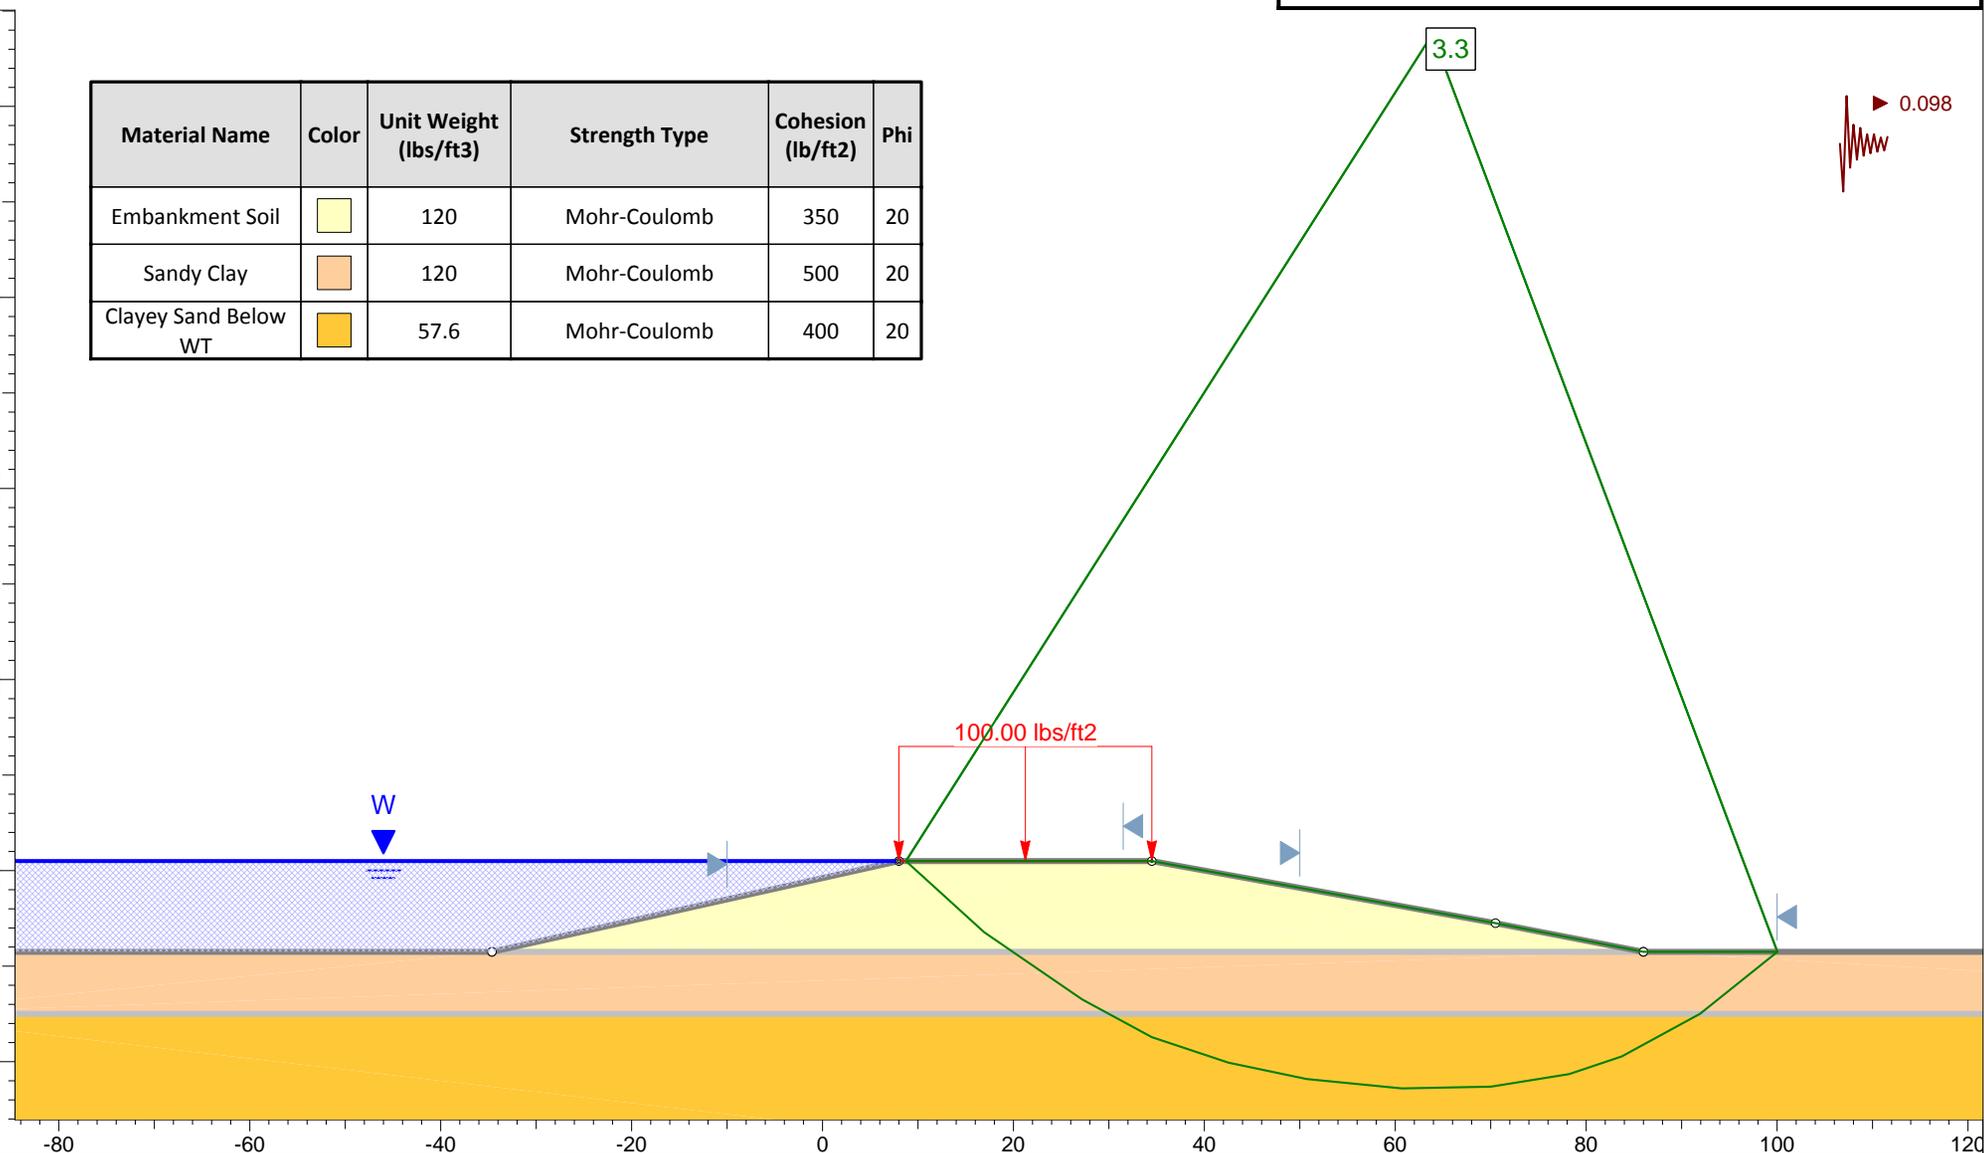
Profile "E"
Ash Pond Berms - Spruce/Deely Generation Units

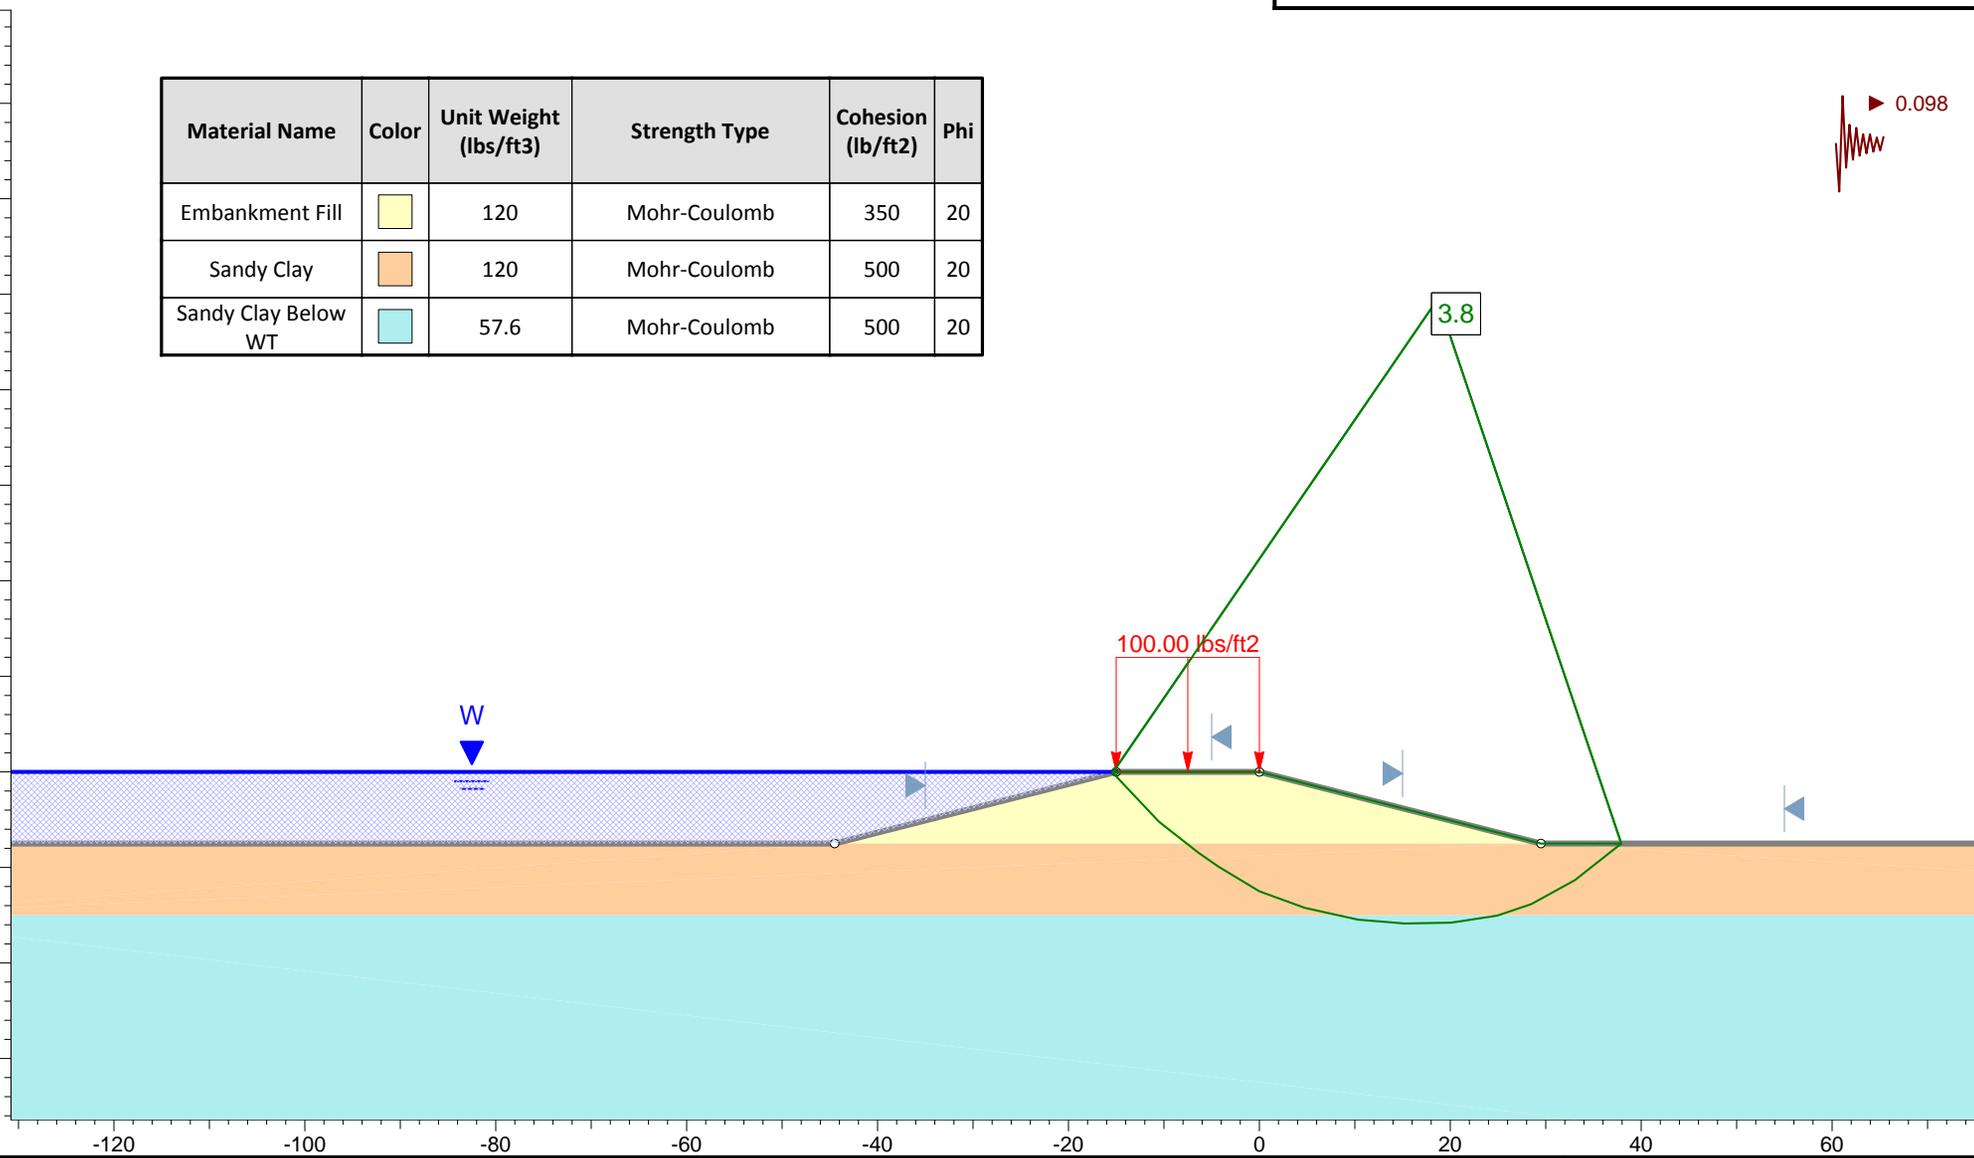
Material Name	Color	Unit Weight (lbs/ft ³)	Strength Type	Cohesion (lb/ft ²)	Phi
Embankment Fill	Yellow	120	Mohr-Coulomb	350	20
Sandy Clay	Orange	120	Mohr-Coulomb	500	20
Sandy Clay Below WT	Light Blue	57.6	Mohr-Coulomb	500	20

Profile "K"
Ash Pond Berms - Spruce/Deely Generation Units

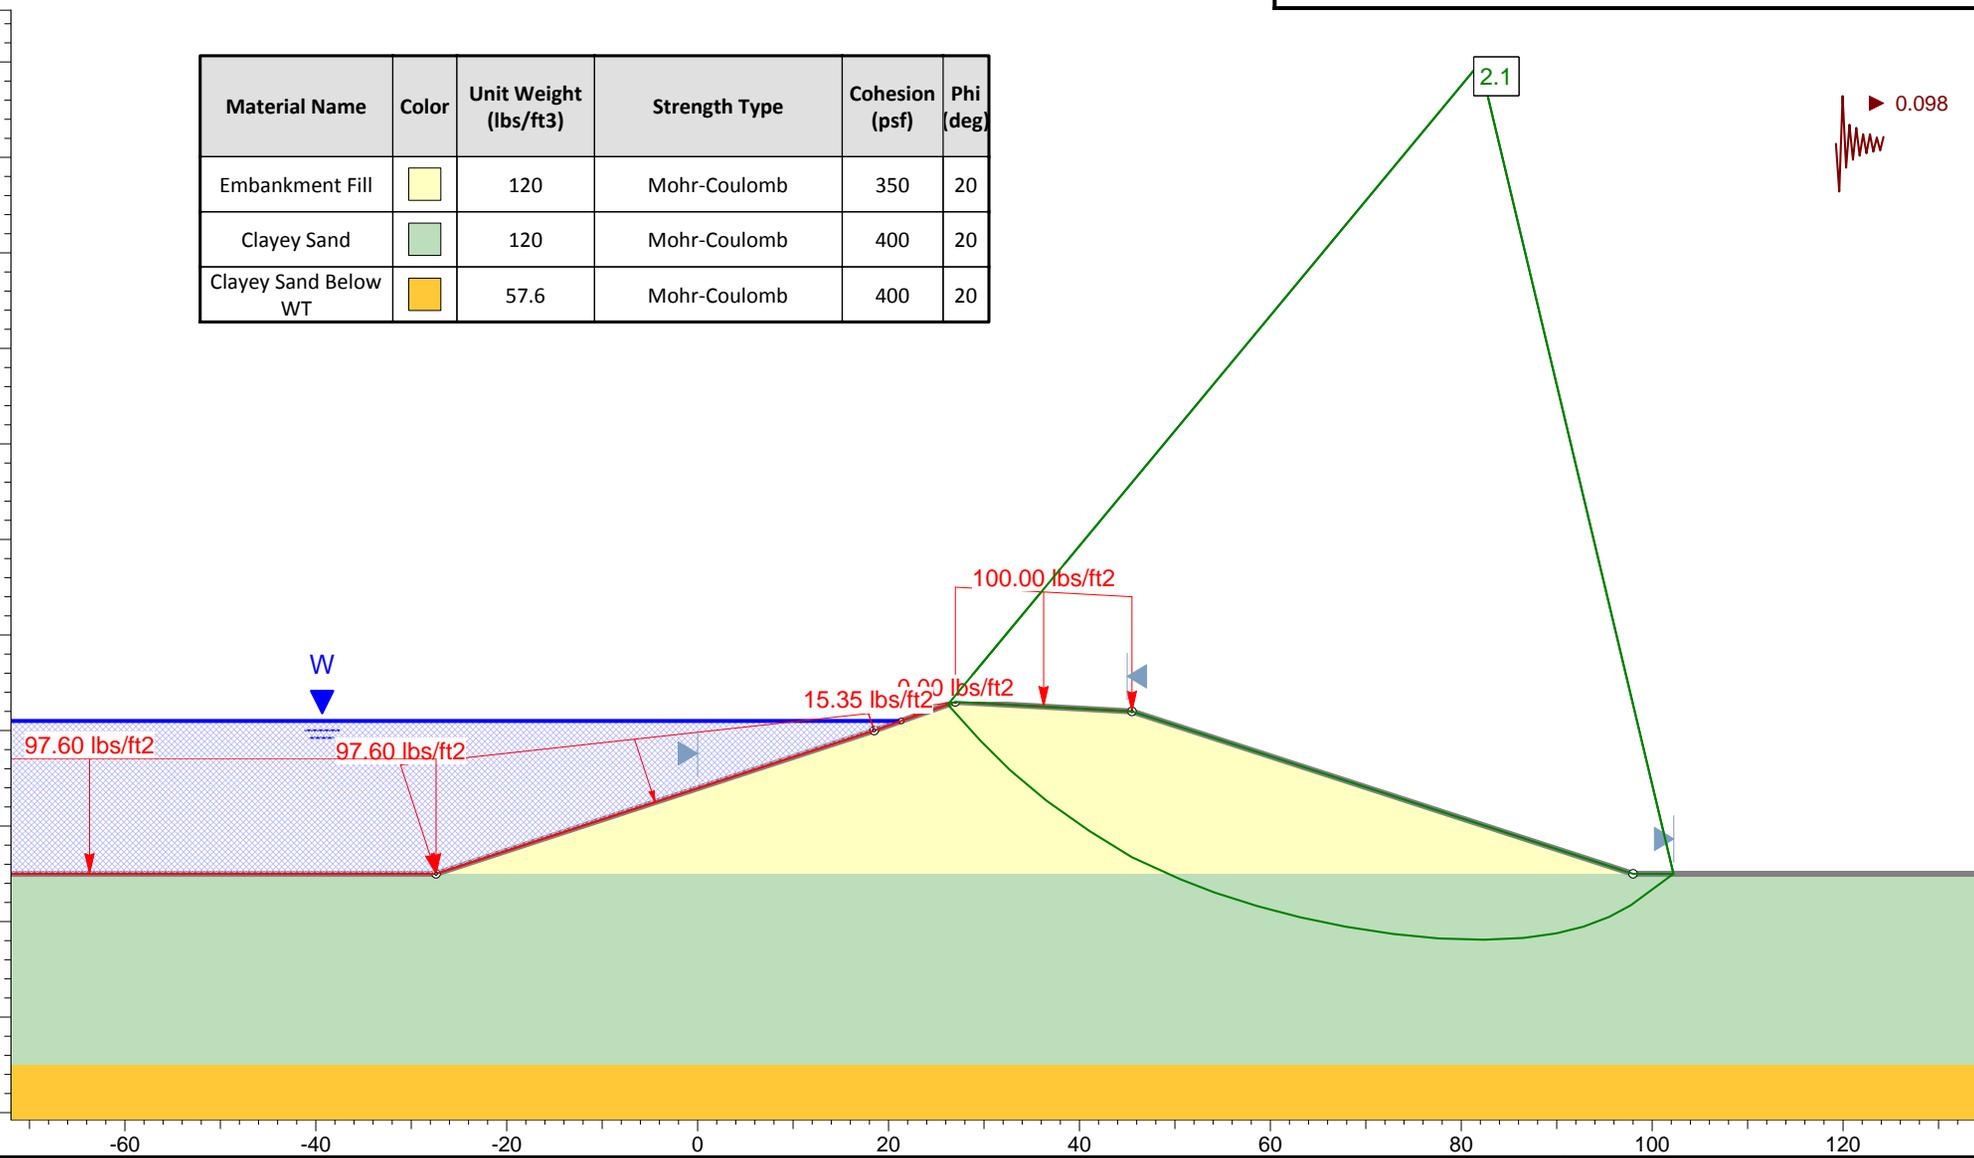
Material Name	Color	Unit Weight (lbs/ft3)	Strength Type	Cohesion (psf)	Phi (deg)
Embankment Fill	Yellow	120	Mohr-Coulomb	350	20
Clayey Sand	Green	120	Mohr-Coulomb	400	20
Clayey Sand Below WT	Orange	57.6	Mohr-Coulomb	400	20

Profile "C" - Steady State
Ash Pond Berms - Spruce/Deely Generation Units

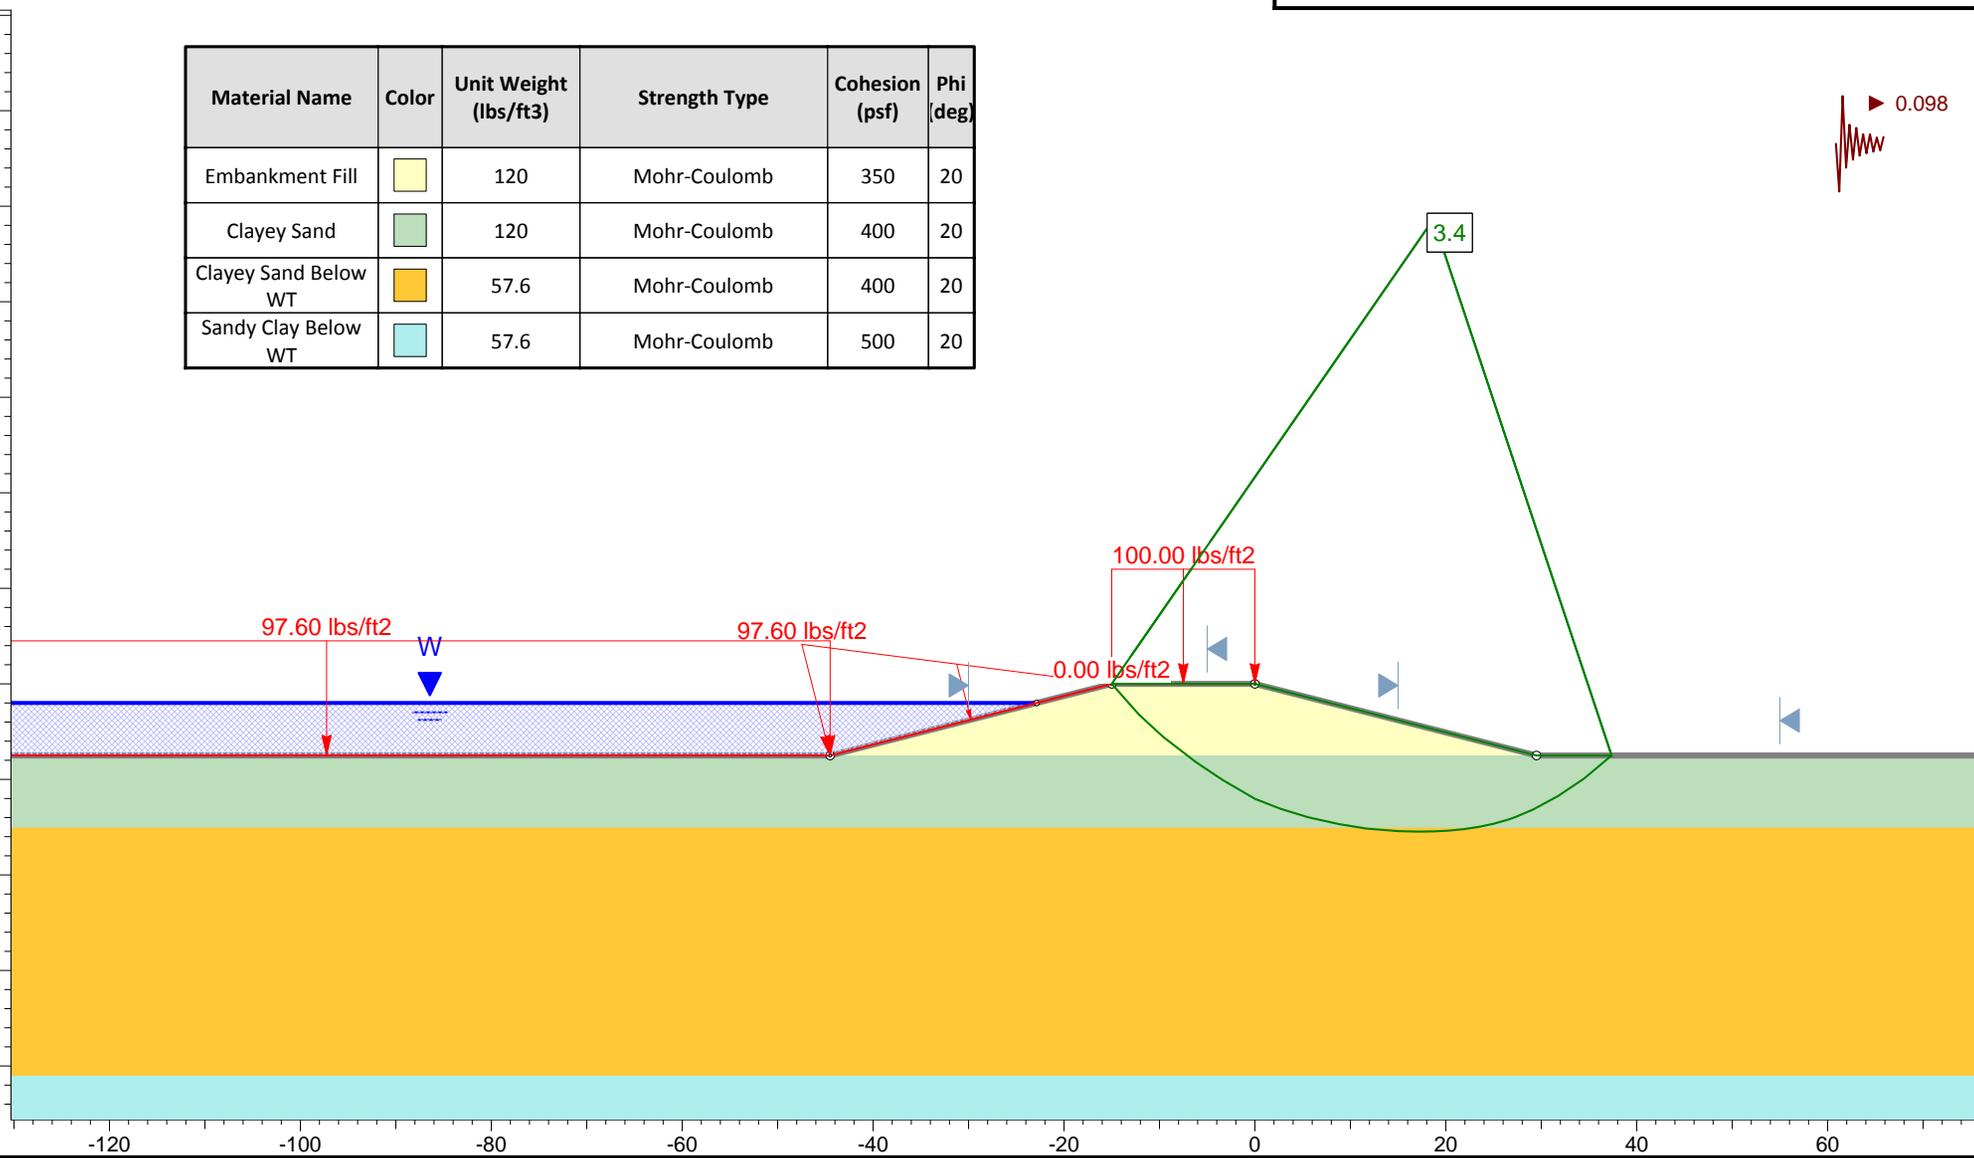
Material Name	Color	Unit Weight (lbs/ft ³)	Strength Type	Cohesion (psf)	Phi (deg)
Embankment Fill	Yellow	120	Mohr-Coulomb	350	20
Clayey Sand	Green	120	Mohr-Coulomb	400	20
Clayey Sand Below WT	Orange	57.6	Mohr-Coulomb	400	20
Sandy Clay Below WT	Light Blue	57.6	Mohr-Coulomb	500	20

Profile "L" - Steady State
Ash Pond Berms - Spruce/Deely Generation Units
