**Coal Combustion Residue Impoundment
Round 9 - Dam Assessment Report**

Plant McIntosh
Ash Dike
Georgia Power
Rincon, Georgia

Dewberry & Davis, LLC
Fairfax, Virginia

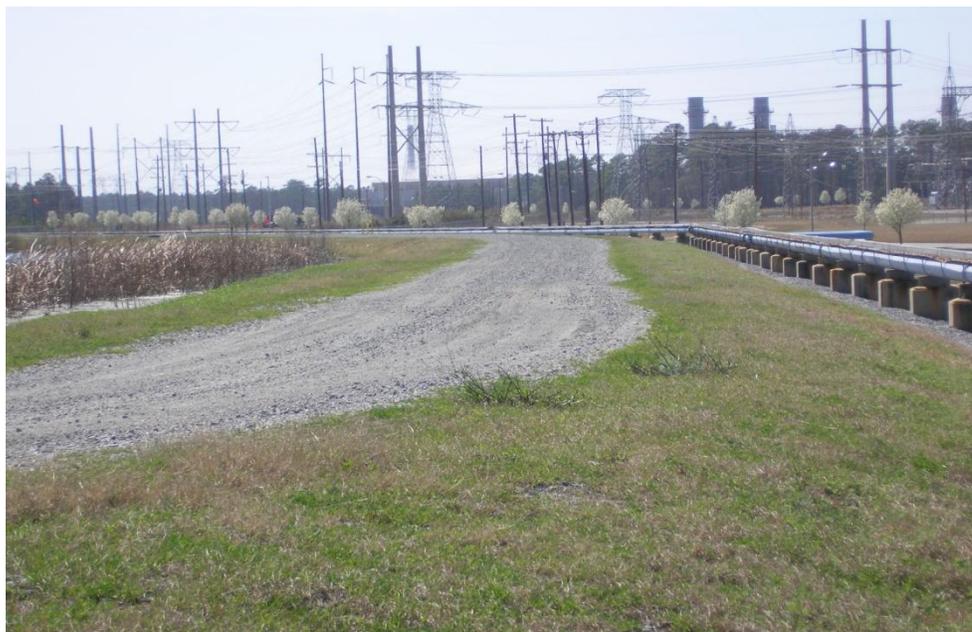
Figure 5.2.1-1 – West Embankment Crest

The crest of the west dike had a crushed stone gravel surface and had no sign of depressions, tension cracks, or other indications of shear failures. Previous inspection reports reviewed by Dewberry did not indicate issues concerning the embankment crest. Figure 5.2.1-1 shows the crest of the dike near the north groin.

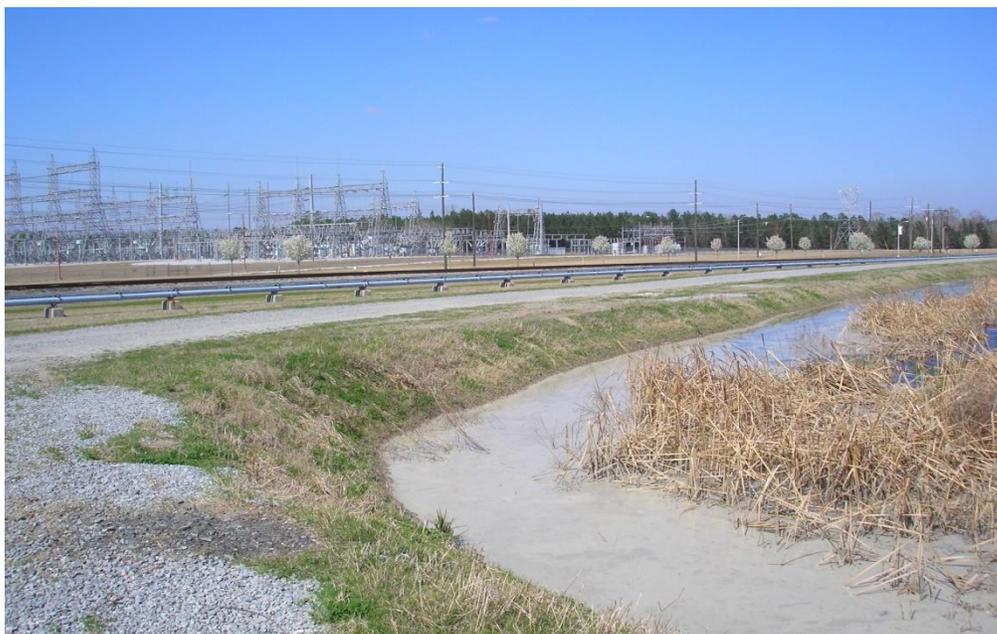
Figure 5.2.2-1 – Inside Slope of West Embankment at South Groin

The upstream/inside slope of the west embankment is grassed. There were no observed scarps, sloughs, bulging, cracks, depressions, or other indications of slope stability or significant erosion. There are a few gravel spots where erosion rills have been repaired. Figure 5.2.2-1 shows the inside slope of the west embankment.

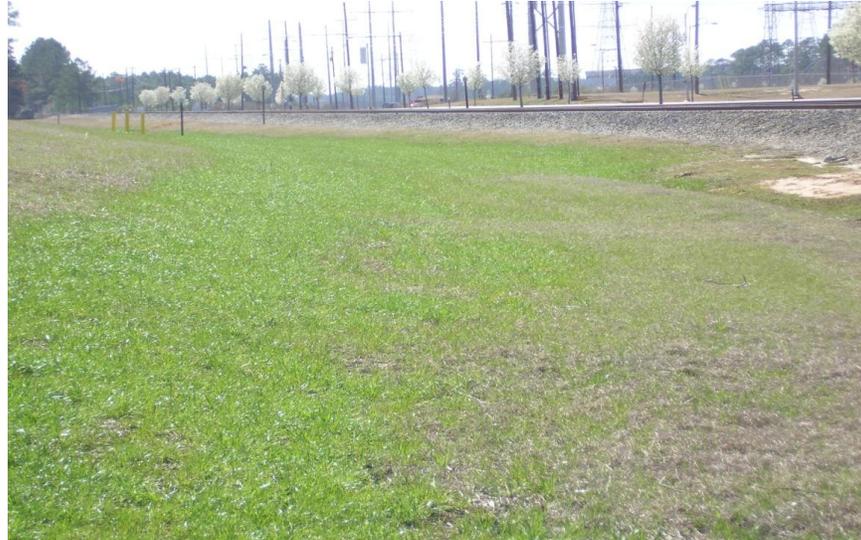
Figure 5.2.3-1 – West Embankment Outside Slope

The outside slope of the west embankment is vegetated with grass. There were no observed scarps, sloughs, bulging, cracks, depressions, or other indications of slope stability or significant erosion.

Observations of potential seepage near the toe of the west embankment in 2004 resulted in recommendations for installation of a new filter drain (See Appendix A Doc 10). The 2010 *Annual Dam Safety Inspection* report (See Appendix A Doc 11) indicated a sump and subsurface drains had been installed along a portion of the toe of the west embankment. The report recommended extending the drain systems southward to the end near the center of the embankment. Newly sowed grass along the toe of the embankment indicated the area of the extended drain system. Figure 5.2.3-1 shows the grassed outside slope of the west embankment.

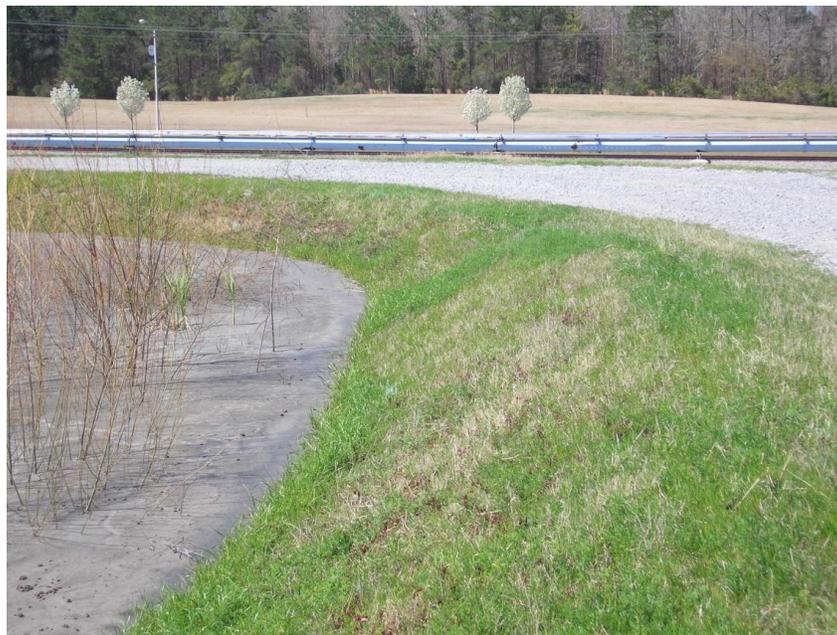
Figure 5.2.4-1 – West Embankment Inside Groin at North End

The west embankment was constructed as part of a continuous perimeter embankment without abutments. West embankment groins are vegetated with grass. No uncontrolled seepage was observed along the west embankment groins. Figure 5.2.4-1 shows the interior groin at the north end of the west embankment.

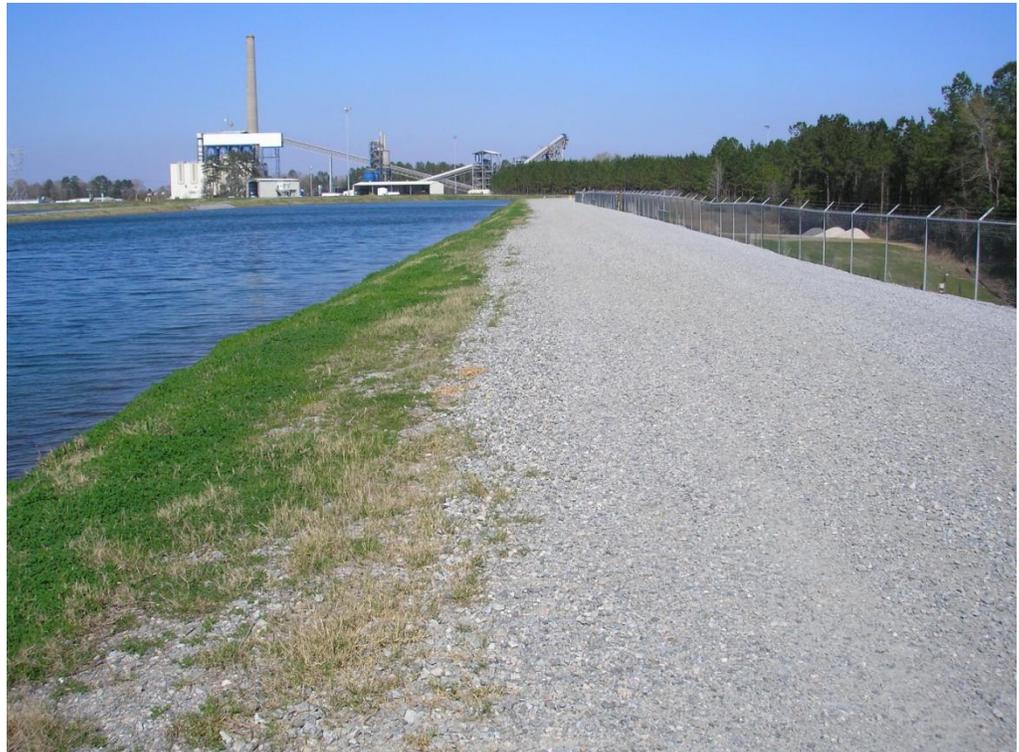
Figure 5.3.1-1 – Crest and Inside Slope of East Embankment near South End

The east embankment crest had a crushed stone surface and no sign of depressions, tension cracks, or other indications of shear failures. Previous inspection reports reviewed by Dewberry did not indicate issues concerning the embankment crest. Figure 5.3.1-1 shows the crest of the dike.

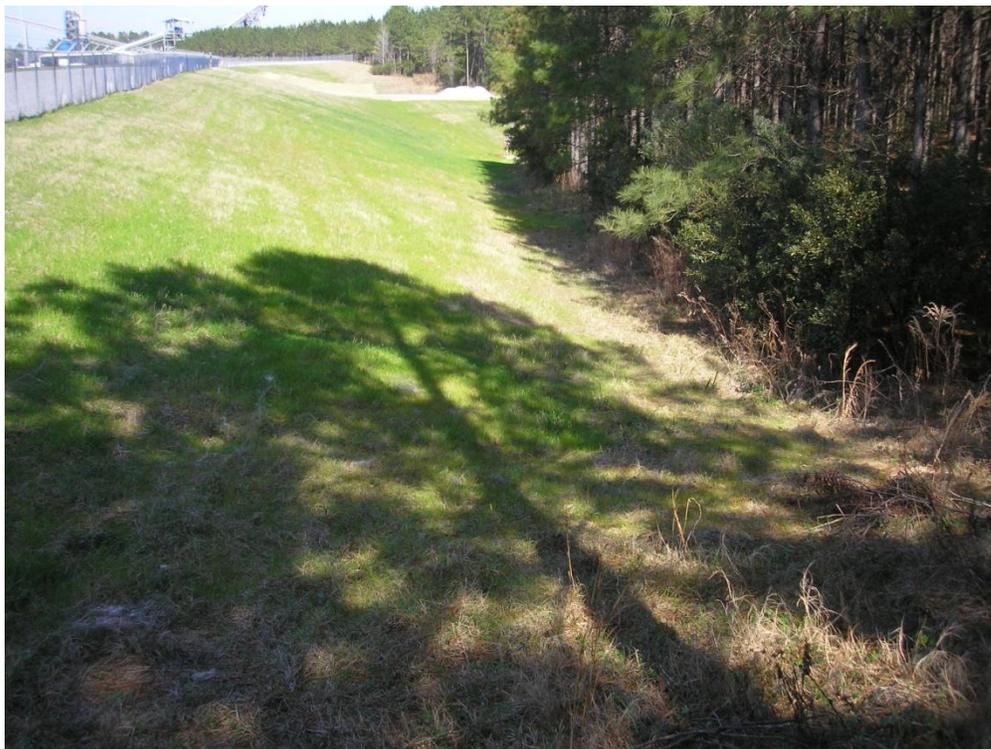
Figure 5.3.3-1 – East Embankment Outside Slope

The outside slope of the west embankment is vegetated with grass. There were no observed scarps, sloughs, bulging, cracks, depressions, or other indications of slope stability or significant erosion. Figure 5.3.3-1 shows the outside slope of the east embankment.

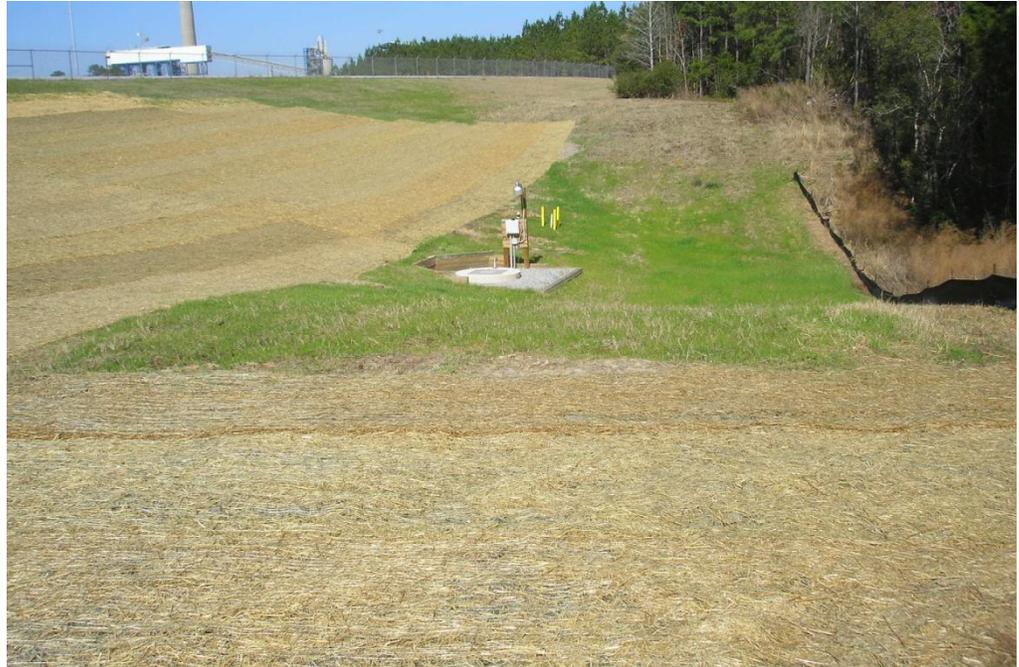
Figure 5.3.3-2 East Embankment Area of New Subsurface Drainage System

A March 2, 2011 report (See Appendix A Doc 12) indicated that plant personnel reported signs of additional seepage along the toe of the east embankment. A series of sand drains were installed and tied into the existing collection piping and sump that were part of the 2009/2010 drainage system. Figures 5.3.3-2 and 5.3.3-3 show the area of the new sand drains and north 2010 sump, respectively.

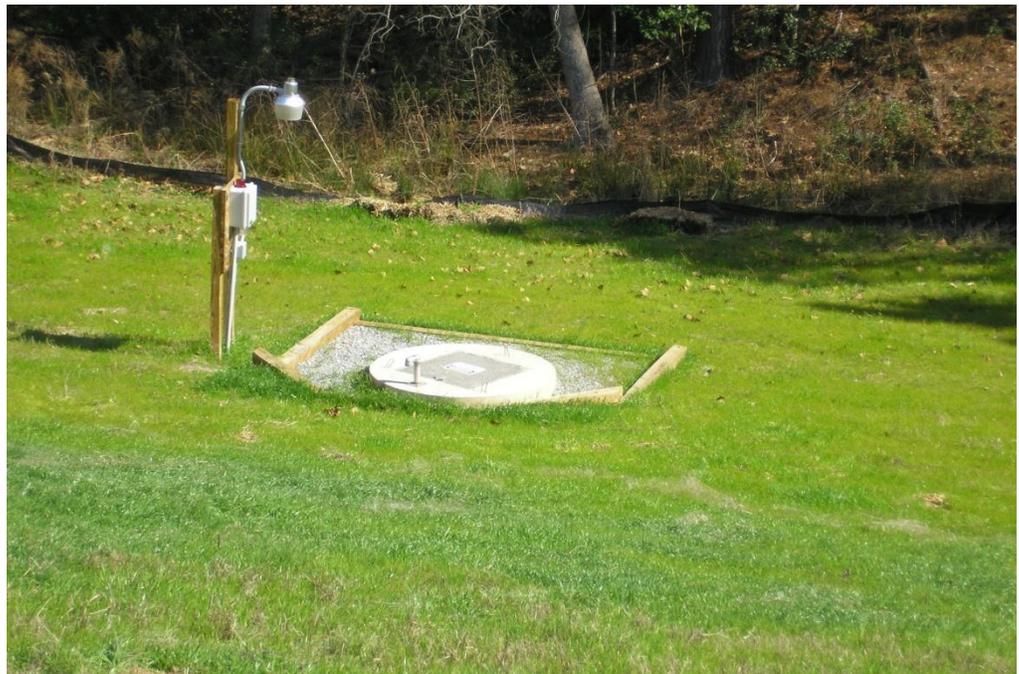
Figure 5.3.3-3 East Embankment North Drainage System Sump

Reportedly, drain flow is measured regularly and has stabilized at about 0.25 gallons per minute (gpm).

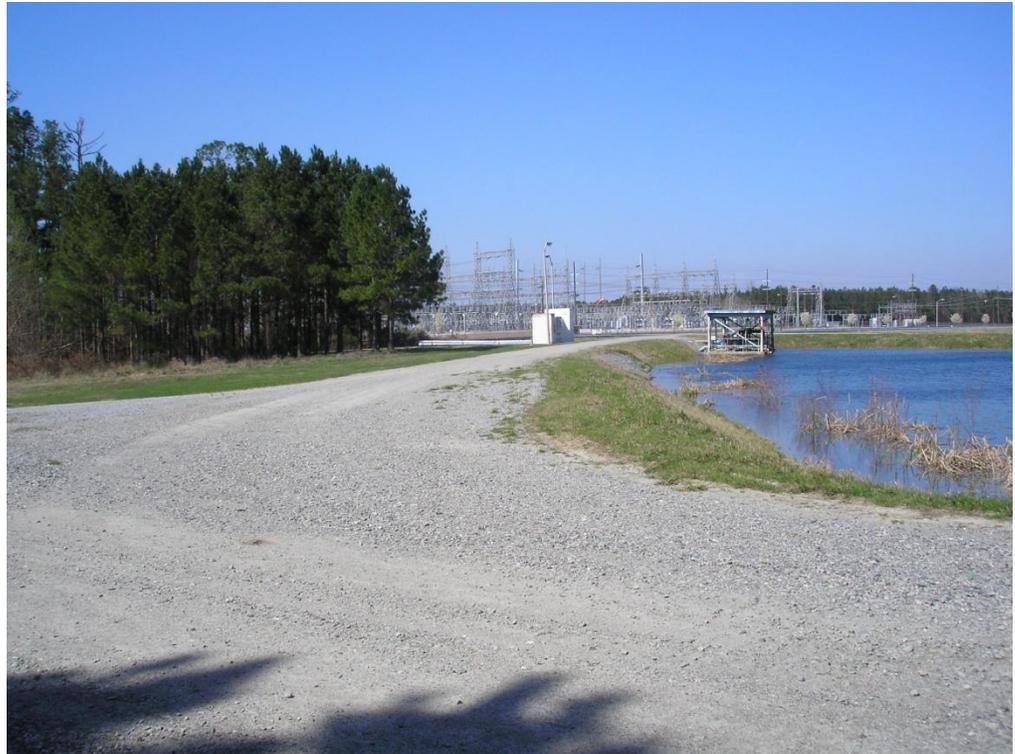
Figure 5.3.4-1 East Embankment Inside Groin at South End (East Embankment on Right Side of Photograph) and South Embankment Crest

The east embankment was constructed as part of a continuous perimeter embankment without abutments. East embankment groins are vegetated with grass. No uncontrolled seepage was observed along the west embankment groins. Figure 5.3.4-1 shows the interior groin at the south end of the east embankment.

The south embankment crest had a crushed stone surface and no sign of depressions, tension cracks, or other indications of shear failures. Previous inspection reports reviewed by Dewberry did not indicate issues concerning the embankment crest. Figure 5.3.4-1 above shows the crest of the dike.

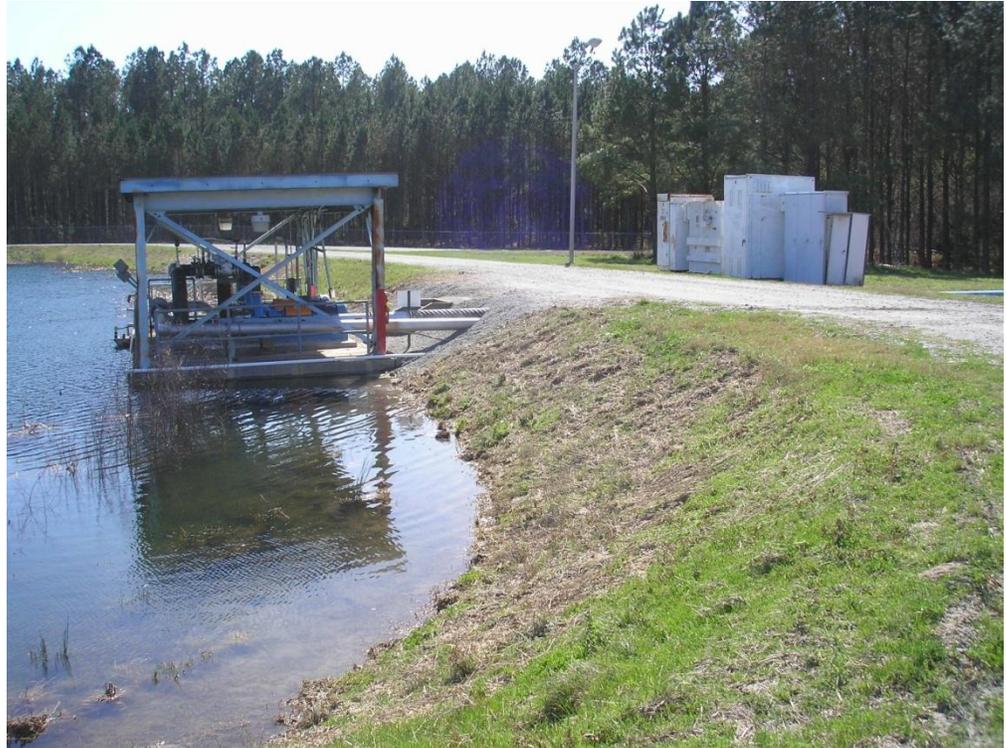
Figure 5.4.2-1: South Embankment Inside Slope

The upstream/inside slope of the south embankment is grassed. There were no observed scarps, sloughs, bulging, cracks, depressions, or other indications of slope stability or significant erosion. There are a few gravel spots where erosion rills have been repaired. Figure 5.4.2-1 shows the inside slope of the south embankment.

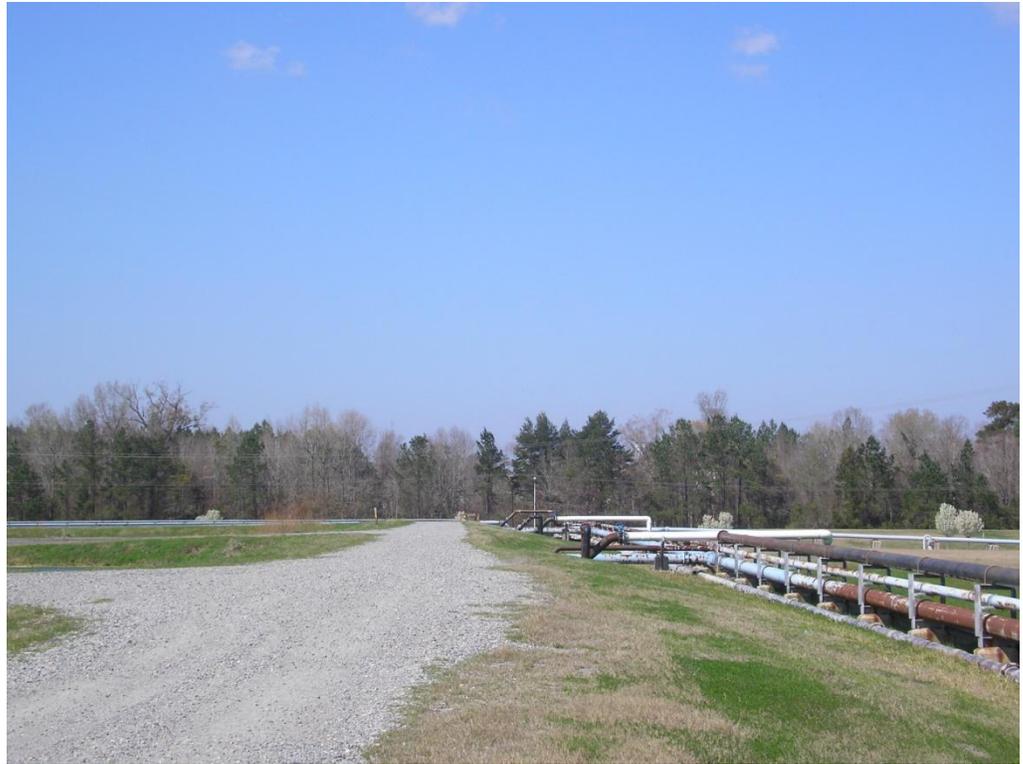
Figure 5.5.1-1 – North Embankment Crest and Outside Slope

The crest of the North Embankment was surfaced with a gravel roadway used for servicing the ponds, embankments, and piping system. No sign of depressions, tension cracks, or other indications of shear failures were observed. Figure 5.5.1-1 shows the crest, the outside slope and the adjacent sluice piping system.

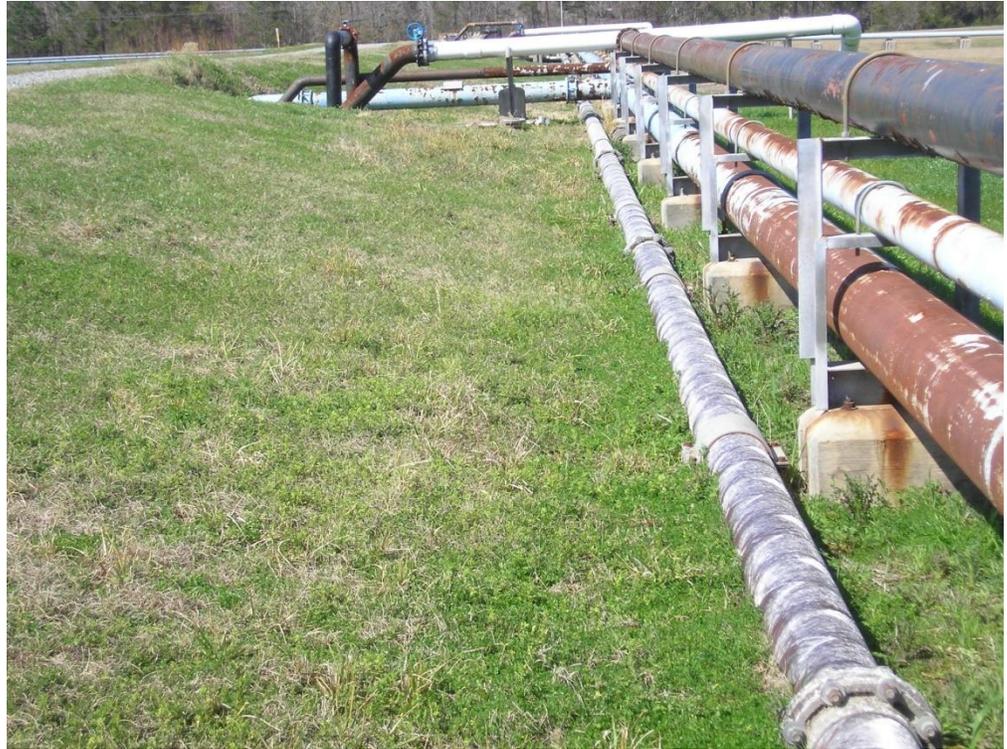
Figure 5.5.3-1 – North Embankment Outside Slope.

The downstream or outside slope of the north embankment is only a few feet high and very flat to transition to existing grade north of the impoundment. The outside slope of the north embankment is vegetated with grass. There were no observed scarps, sloughs, bulging, cracks, depressions, or other indications of slope stability or significant erosion. Figure 5.5.3-1 shows the outside slope of the north embankment.

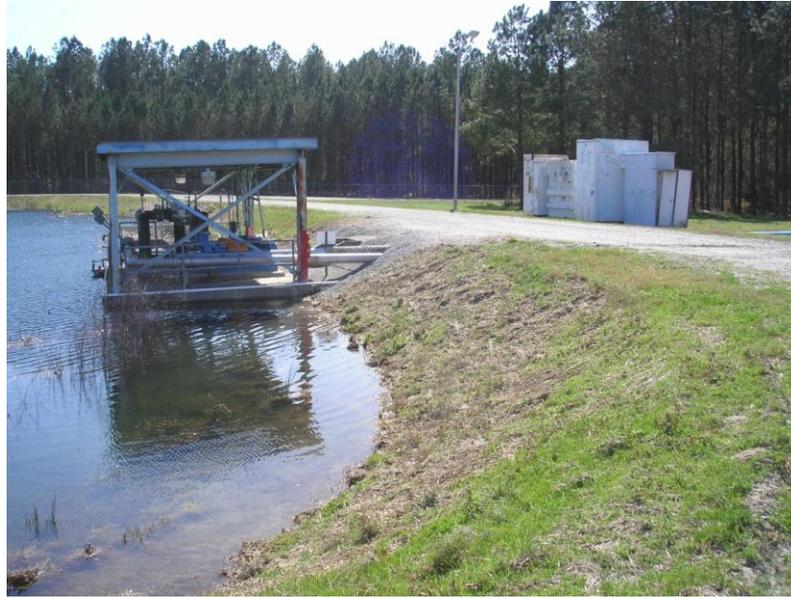
Figure 5.6.1-3 – Pumping Station to Recycle Water from CCR Impoundment Cell D to Plant.

Plant McIntosh has the capability to recycle water from the polishing pond for reuse in the plant. The pumping station for recycling/discharging is located on the west side of the polishing pond, Cell D. Photograph 5.6.1-3 shows the recycling pump station.

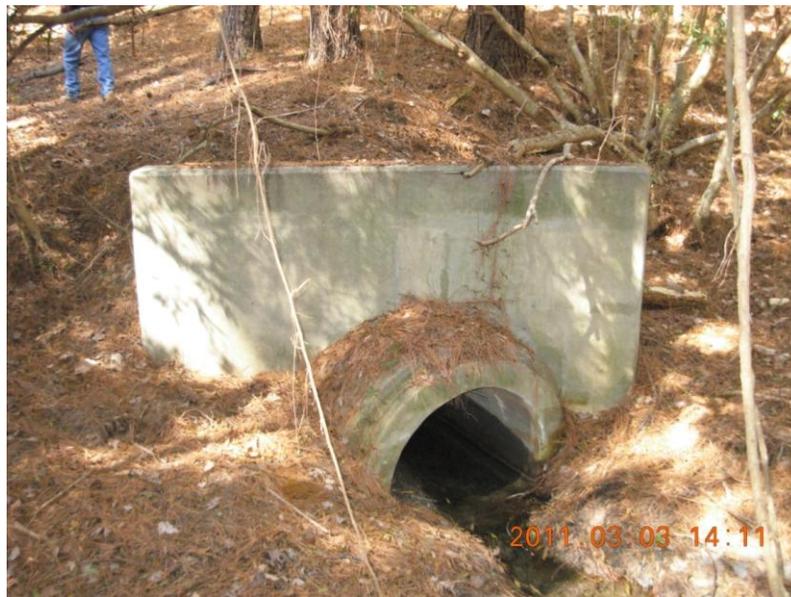
Figure 5.6.2-1 – Emergency Overflow Spillway Outlet Conduit Discharge

The emergency discharge spillway outlet conduit is 30-inch diameter concrete pipe with an invert elevation of 39.5 feet. The outlet conduit discharges to an unlined ditch that flows to a natural stream in a wooded area of the CCR impoundment. Water flowing from the outlet was clear. Figure 5.6.2-1 shows water discharge from the outlet conduit.

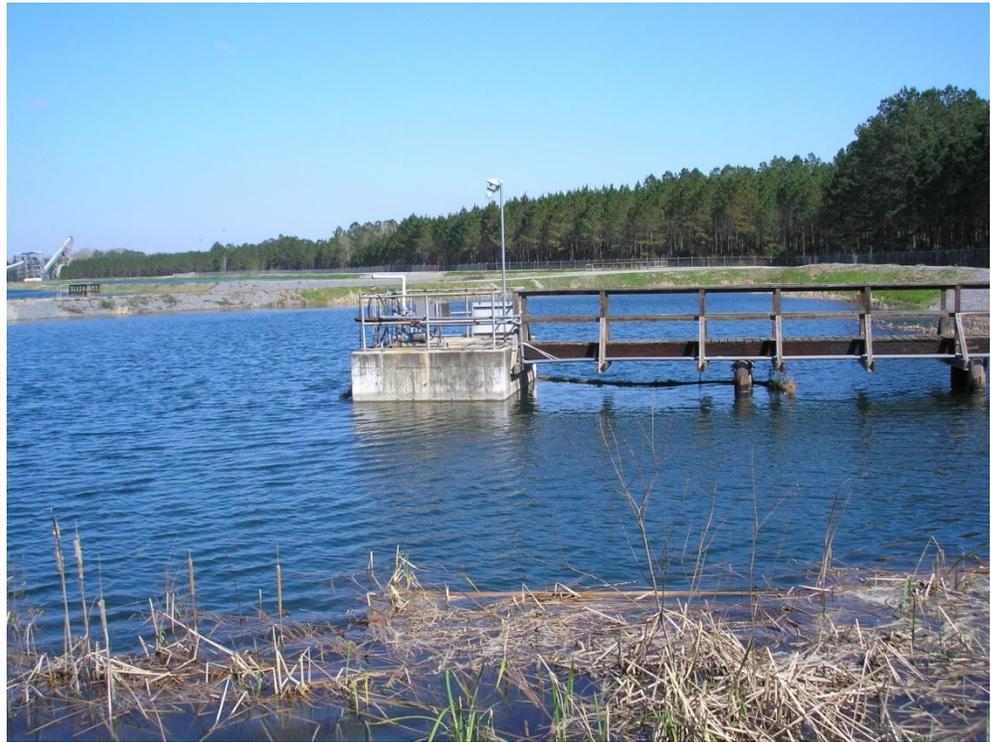
Figure 5.6.3-1 Emergency Overflow Structure.

The emergency overflow structure is a rectangular, reinforced concrete riser structure located in the southwest corner of Cell D, the polishing pond. The outlet structure has a top elevation of 62.5 feet and an invert elevation of 39.5 feet. (See Appendix A Doc 08).

Access to the overflow structure is provided by a steel framed walkway. Figure 5.6.3-1 shows the overflow structure. Figure 5.6.3-2 shows stop logs installed in the overflow structure.

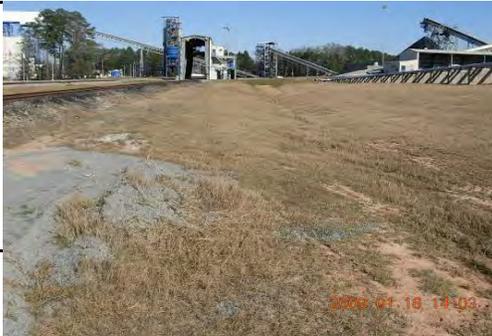
Location No. Photo No.	Description	
308 2875	Ditch between railway and ash cell A, looking northeast. There was no seepage evident at the time of this inspection. Cell A has been low for some time and was at the mark of 11 on the staff gage. When this pond level is raised this area should be monitored.

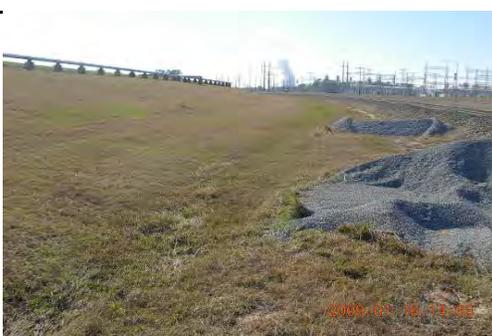
308 2876	Ditch between railway and ash cell A, looking southwest. This area was the site of seeps in 2003. pH testing of the seepage water at that time showed a very high reading, indicating that the water was coming from the ash cell. At that time stockpiles of sand, #89 stone, and #57 stone were stockpiled there to be used for an emergency filter in the event of a boil. These stockpiles should be restored.

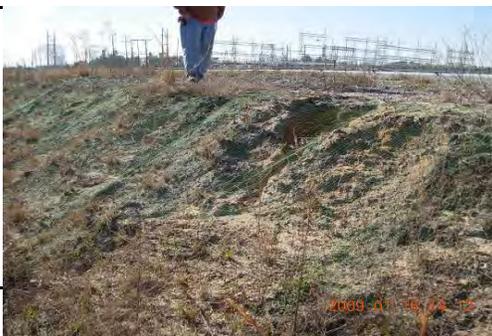
309 2877	Erosion gully at crest of ash cell A. The plastic netting indicates that some attempt to repair and regrass this area has been made. It appears that rainwater from the crest concentrates and runs down the slope at this point. Installing a plastic down drain in this location might be the best way to deal with this problem.

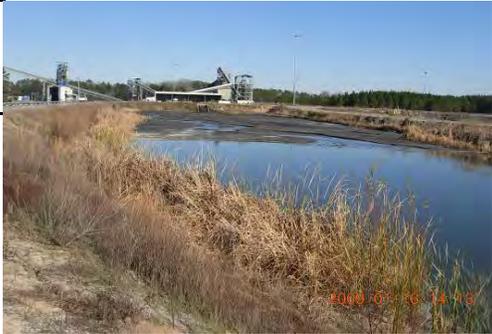
309 2879	East bank of ash cell A viewed from west bank. Erosion rills are prevalent along this area for the top 5 or 6 feet. These rills should be dressed and grassed. At locations where water concentrates and runs down the slope plastic pipe down drains could be installed, or the rills could be graveled.

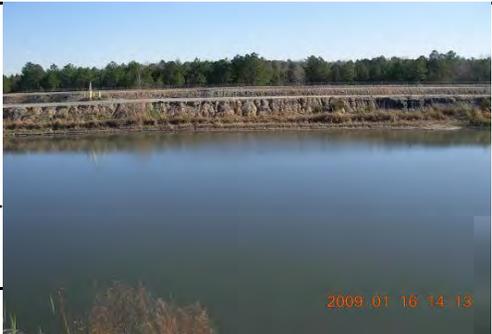
309 2880	Ash cell A looking south. Some ash bolsters were left in place during the 2005 cleanout to support the dike slopes and reduce seepage from cell B into cell A. These bolsters show up here covered with cattails.

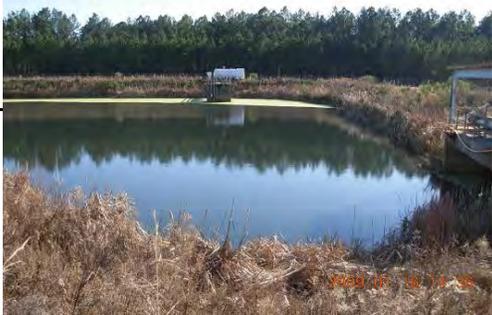
Location No. Photo No.	Description	
312 2881	D pond looking from common dike with A pond toward cell D outlet.

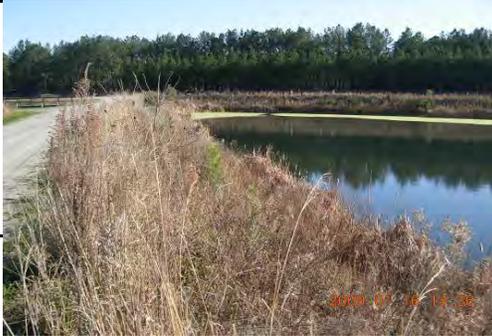
312 2882	D pond looking southeast along the common dike. The heavy cover of tall grass on the inside slope of the dike obscures the slope, making it impossible to detect erosion or other problems with the slope. The dike slopes should be cut at least twice a year.

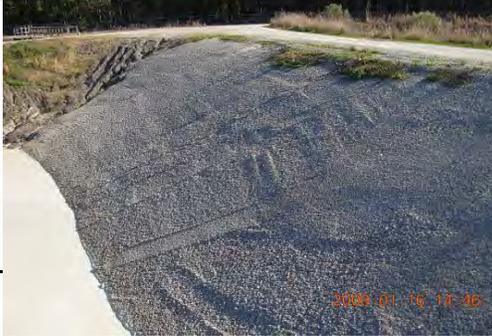
313 2885	South end of ash cell B viewed from outlet structure. The bank has been supported with a gravel bolster. The gravel is recycled concrete. There is a significant erosion gully in the southeast corner of this cell. A plastic down drain could be installed in the gully to stop the erosion.

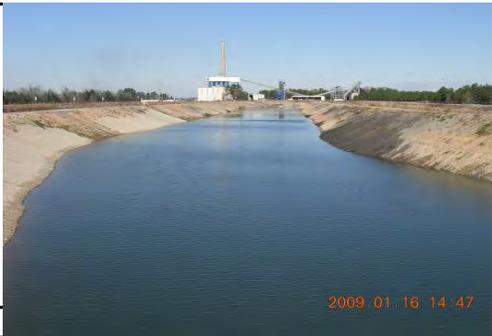
313 2886	View looking northeast up cell B from the outlet structure. Note the gravel bolsters on the left dike that were installed to support the dike and control seepage when cell B was drawn down and cell A was full.

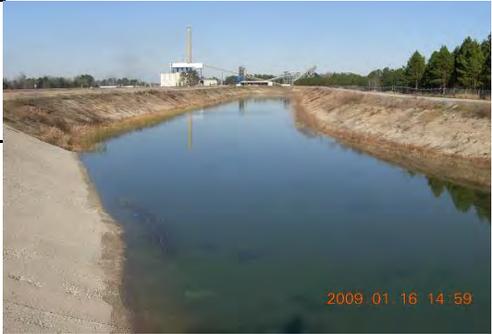
Location No. Photo No.	Description	
314 2889	View looking northeast up cell C from outlet structure. Note gravel bolster on near left dike. There are numerous erosion gullies on the right (east) dike.

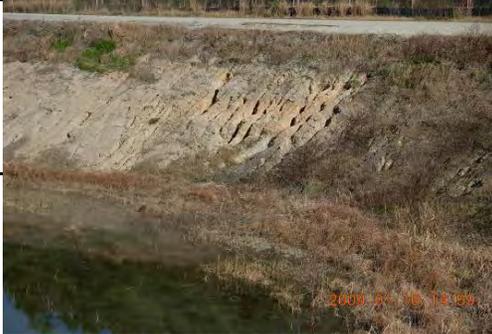
<p style="text-align: right; font-size: small;">2009.01.16 14:59</p>
314 2890	Ash cell C east dike near south end. Note erosion gullies cut into slope. These should be addressed. They could be filled with soil, graded and grassed, or filled with gravel.

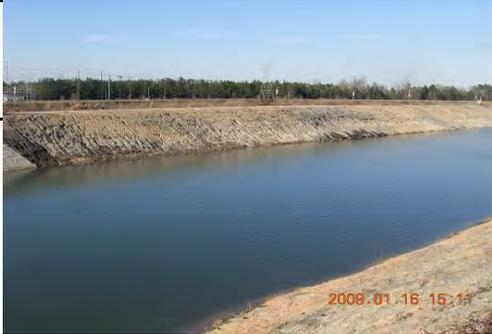
<p style="text-align: right; font-size: small;">2009.01.16 14:59</p>
315 2892	Ash cell B west dike viewed from east dike. Note erosion rills in dike. These should be addressed.

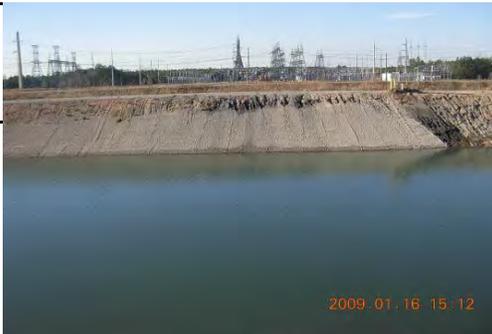
<p style="text-align: right; font-size: small;">2008.01.16 15:14</p>
315 2893	Ash cell B west dike viewed from east dike. Note erosion gravel bolster installed to support dike and control seepage.

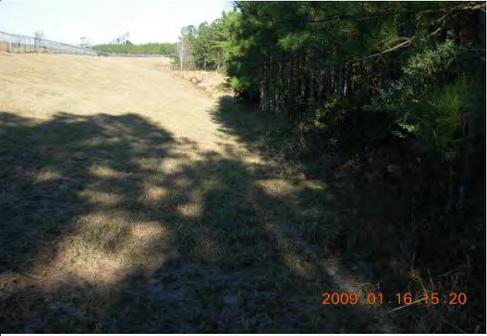
Location No. Photo No.	Description	
316 2894	Toe of cell C east dike. Note trees up to toe of slope. These trees would make it difficult to get emergency equipment in to the toe to work. The trees should be cleared a distance of 20 feet from the toe of the east dike of ash cell C. The east slope had 4" diameter trees on it until two years ago. The trees were cut off flush with the ground and the roots left in place.

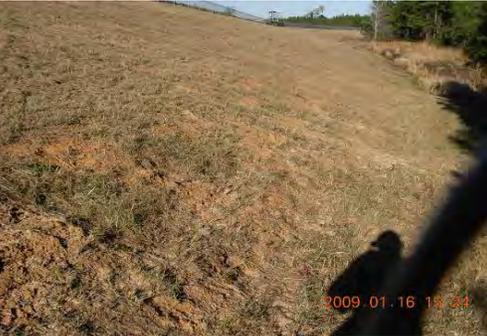
A photograph showing a wide, flat area of mowed grass. The grass is short and appears to have been cut by a mower, with some visible tire tracks. A timestamp '2009.01.16.15.34' is visible in the bottom right corner.

318-319 2896	Boggy area at toe of ash cell C east dike with plants typical of a swampy area, except this location is on a slope. This location appears to be lower in elevation than the bottom of ash cell C. Since ash cell C is almost empty and this area is still wet, there is potential for increased seepage when ash cell C is refilled. A subsurface drain should be installed in this area prior to refilling ash cell C.

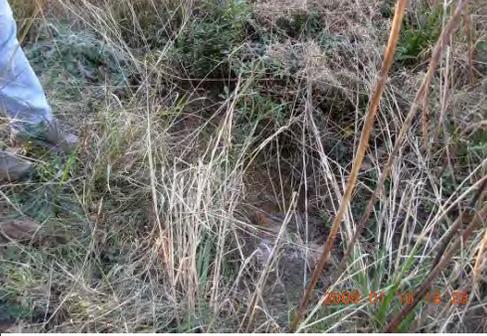
A close-up photograph of a boggy area with tall, thin grasses and some other vegetation. The ground appears to be wet and uneven. A timestamp '2009.01.16.15.39' is visible in the bottom right corner.
320 2898	Ash cell C east dike toe: Armadillo burrow. This burrow should be filled in.

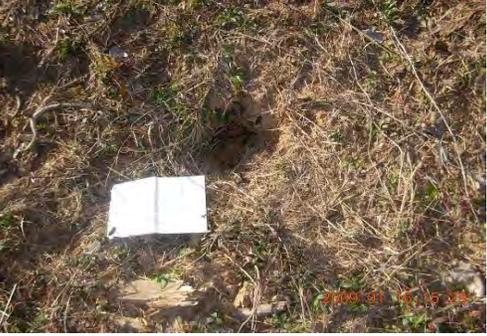
A photograph showing a hole in the ground, which is an armadillo burrow. A white piece of paper is placed on the ground next to the hole for scale. The surrounding area is covered with dry grass and twigs. A timestamp '2009.01.16.15.43' is visible in the bottom right corner.

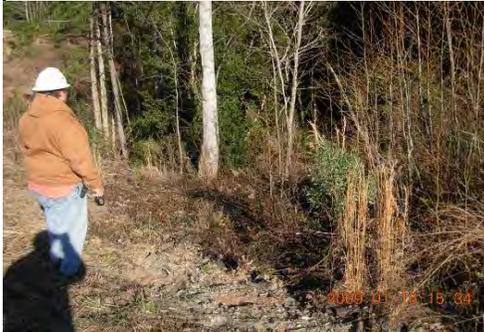
Location No. Photo No.	Description	
321 2900	Ash cell C east dike toe, maximum section. The ground in this area is dry. There are no water-loving plants. This would indicate little or no seepage in this area. The trees here grow right up to the toe. It would be desirable to have a 20 foot wide lane cleared along the toe for emergency equipment access. It would also be good to have a pocket cleared for an emergency gravel stockpile.

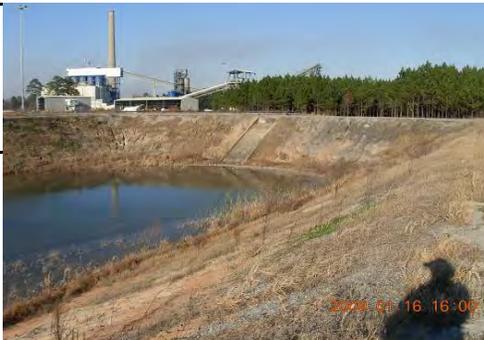
321	Ash cell C east dike toe: Animal burrow. This burrow should be filled in.	No photo.
322 2901	Ash cell C north end. Note erosion rills on interior slope of dike. These rills should be addressed. Filling them with gravel would be one way to do it.

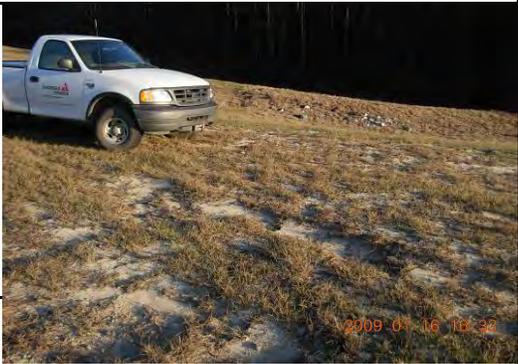
Location No. Photo No.	Description	
324 2902	Closed monofill: 'The surface of the closed landfill has a decent cover of grass for the most part, but there is a need for some gravel on the driving lanes. A general application of seed and fertilizer would be a good investment.

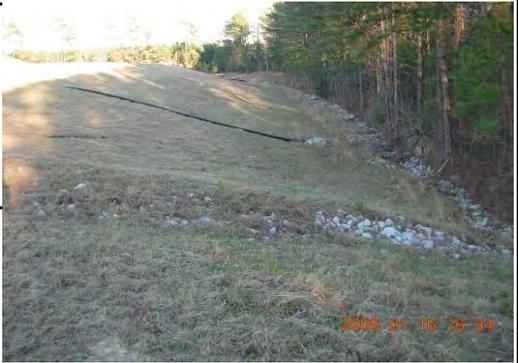
324 2903	There was some minor scalping from the mowers noted. It would be worthwhile to caution the mowing crew and to review the suitability of the mowing equipment and techniques to this task.

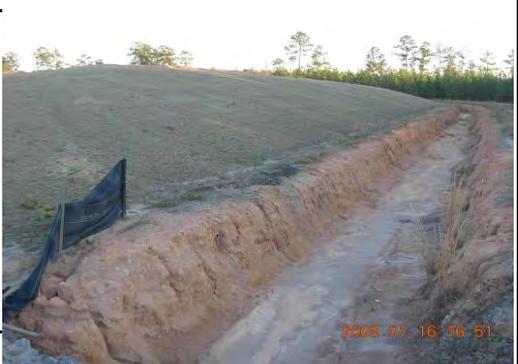
326 2904	The drainage ditches around the perimeter of the ash stack have been cut with vertical sides. This has lead to erosion and makes maintaining the ditch impossible. These ditches were designed with 2:1 side slopes. The present configuration could eventually lead to erosion that will expose ash. The ditches need to be regraded to the design configuration and grassed.

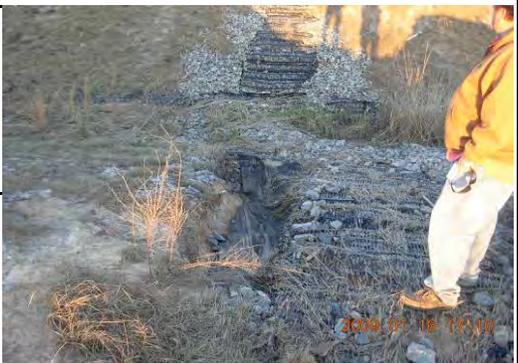
327 2909	Runoff has cut gullies on either side of the gravel/geogrid mattress where the perimeter ditches meet. This gully should be built up with Type III riprap bedded on #57 stone and choked with #57 stone.

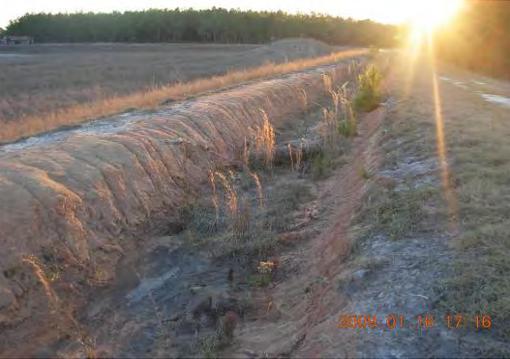
Location No. Photo No.	Description	
327 2910	Ditch near outlet. The ditch sides are near vertical. This configuration is not that shown on the design drawings. Side slopes this steep cannot be maintained and will erode. The ditch needs to be regraded. The pine trees in the ditch need to be cut down.

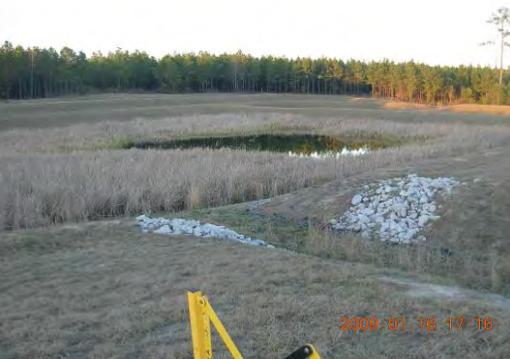
<p style="text-align: right; font-size: small;">2009-01-16 17:16</p>
327 2912	Detention pond. The dikes around this area appear to be in good shape.

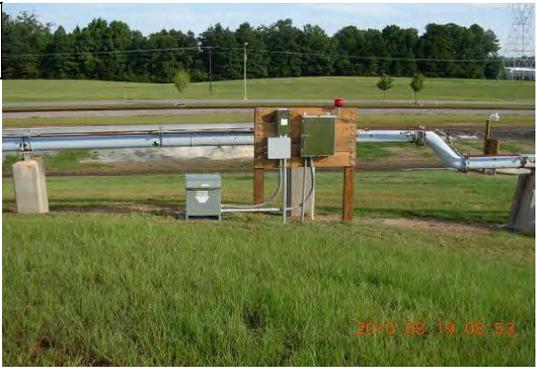
Photo No.	Description	Photo
4086	Control panel for A dike sump.

A photograph showing an electrical control panel mounted on a wooden structure in an open field. In the background, there are large concrete structures and pipes, likely part of a dam or water treatment facility. The date stamp in the bottom right corner reads "2010.08.19.08.53".
4088	Stockpiles of granular materials along toe of A dike.

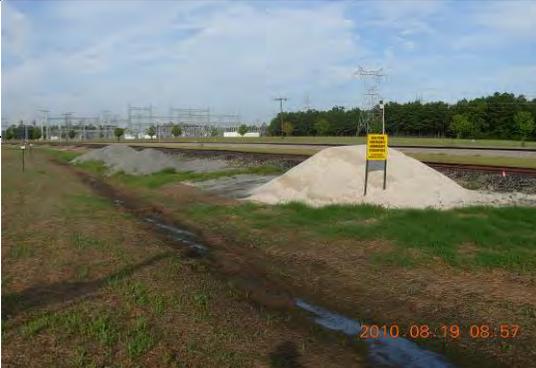
A photograph showing several large, conical stockpiles of light-colored granular material (likely sand or gravel) situated along the toe of a dike. The area is grassy with some dirt paths. In the background, there are power lines and structures. The date stamp in the bottom right corner reads "2010.08.19.08.57".
4090	Sump at toe of A dike

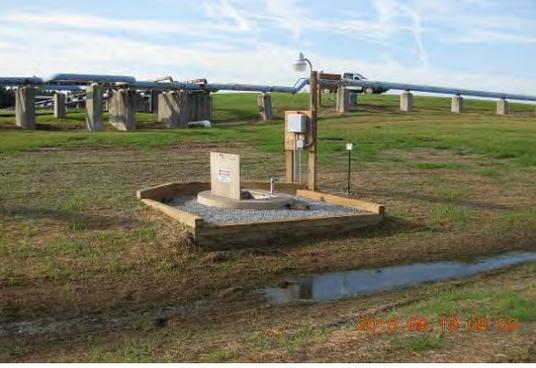
A photograph showing a concrete sump structure located at the toe of a dike. The sump is surrounded by a concrete curb and has a small amount of water inside. The background shows the same industrial site with pipes and structures. The date stamp in the bottom right corner reads "2010.08.19.09.00".

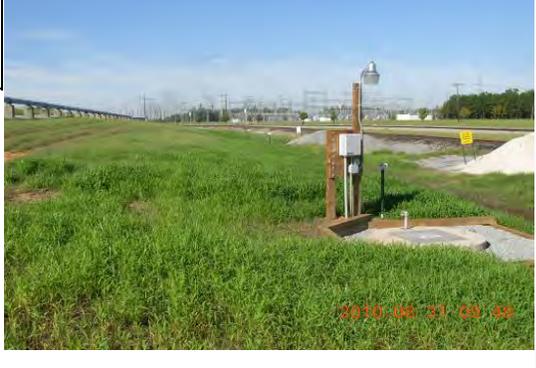
4156	Follow-up photo: Same location as above on 8/31/2010 showing excellent stand of grass cover.

A follow-up photograph of the same sump location as in photo 4090, taken on August 31, 2010. The area around the sump is now covered with a thick, healthy stand of green grass, indicating significant vegetation growth since the previous inspection. The date stamp in the bottom right corner reads "2010.08.31.09.42".

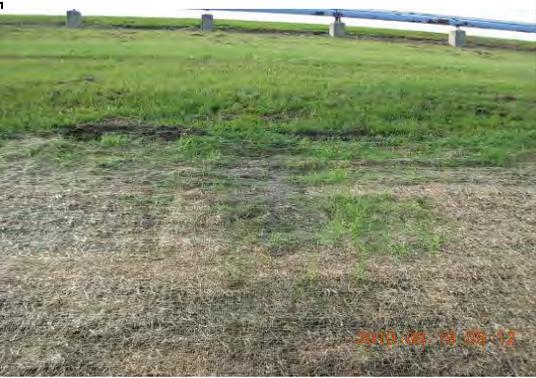
Photo No.	Description	Photo
4091	Seep area at toe of A dike, near north end. This is in an area where there have been seeps in the past.

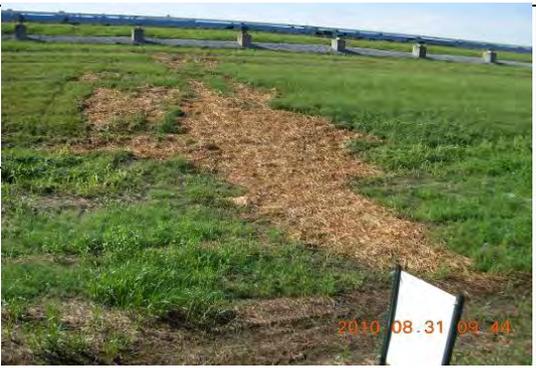
4154	Follow-up photo 8/31/2010: Same area as above after installation of sand drain to tie seep into sand/pipe drain leading to sump. Note addition of gravel under pipe to combat erosion.

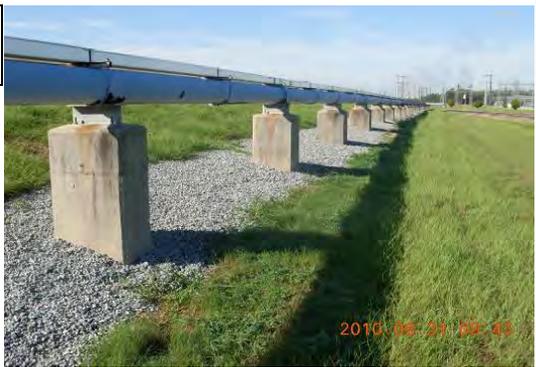
4153	Follow-up photo 8/31/2010: Note addition of gravel under pipe to combat erosion.

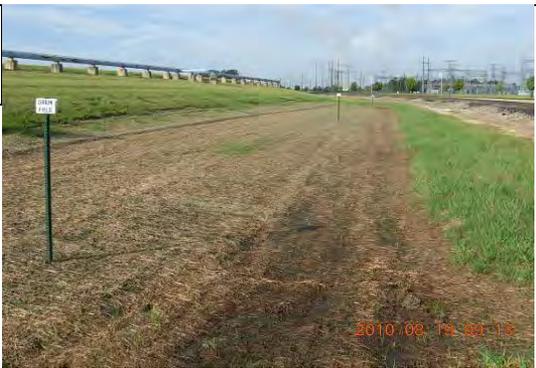
4092	View to southwest along alignment of sand/pipe drain leading to sump.

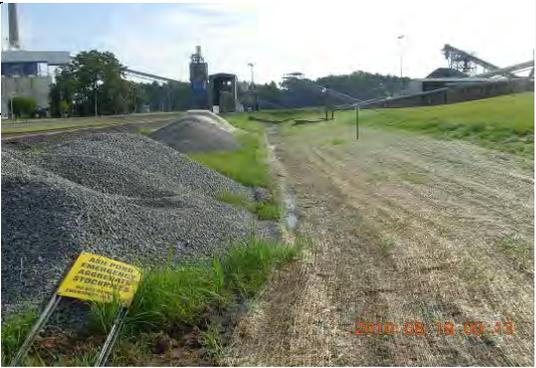
Photo No.	Description	Photo
4093	View looking northeast along toe of A dike showing granular stockpiles, sump, and alignment of sump sand/pipe drain.

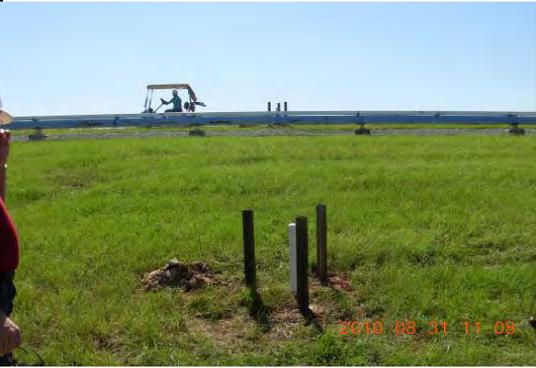
4168	Follow-up photo on 8/31/2010: Newly installed piezometers on crest and toe of A dike.

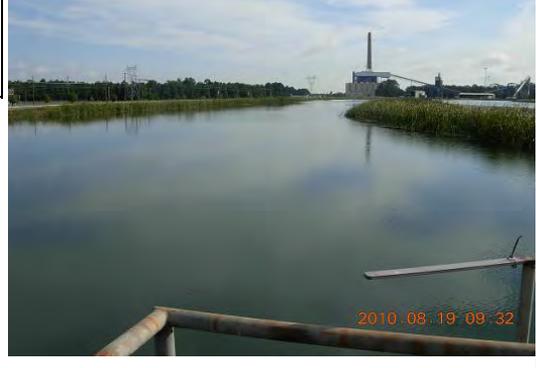
4094	Looking northeast toward plant from west end of cell A.

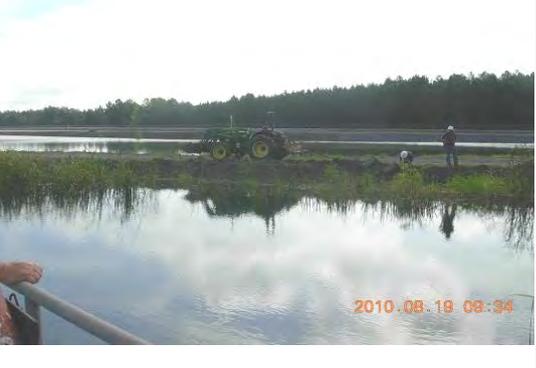
4095	Contractor dressing interior slopes of A cell.

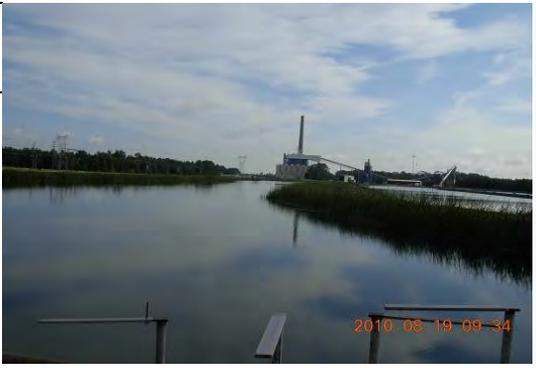
Photo No.	Description	Photo
4096	View from west end of B cell looking northeast toward plant.

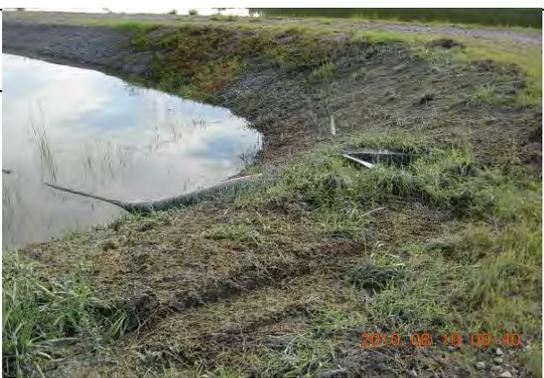
4097	Interior slope of south corner of B cell. Note plastic pipe downdrain installed to address erosion problems.

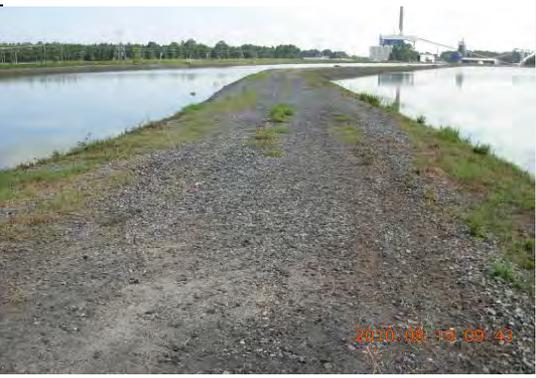
4098	BC dike looking from northeast from south end of dike. Gravel has been added to the crest to address past rutting issues. This repair has been successful.

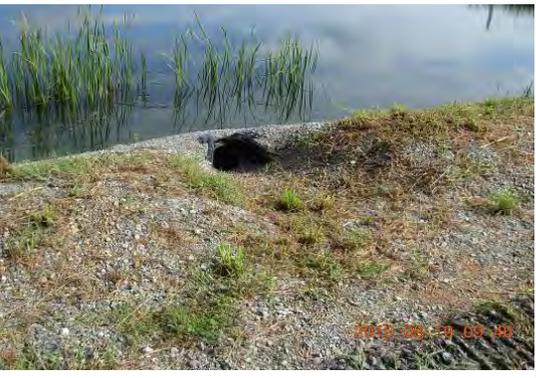
4099	Downdrain installed to deal with concentrated runoff from crest road gullying slope of BC dike. This repair has been successful.

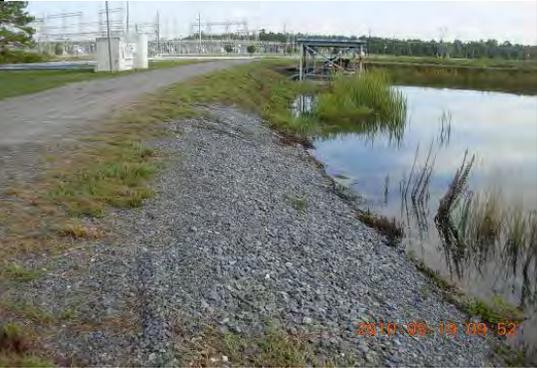
Photo No.	Description	Photo
4100	West interior slope of D cell: gravel bolster installed to address past sluffing of the interior slope. This repair has been successful.

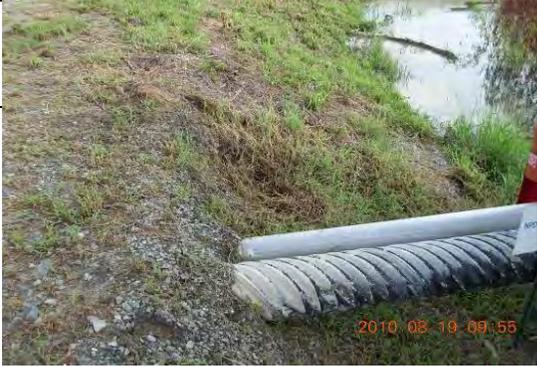
4101	D cell interior slope at north end of pumping station: oversteepened slope.

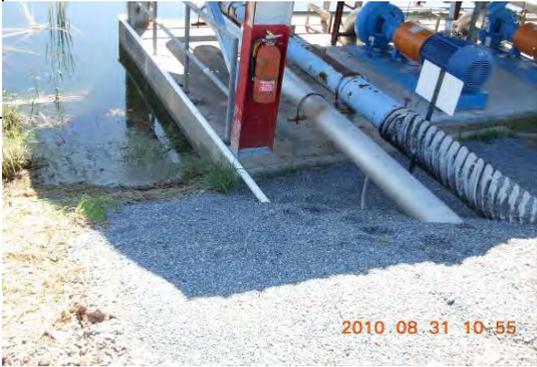
4165	Follow-up photo on 8/31/2010: Gravel has been added to the oversteepened slope noted above.

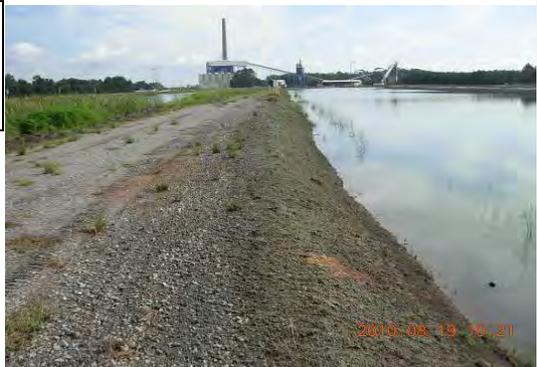
4102	AB dike looking northeast from south end. Note recently dressed and hydro-seeded slope.
