**Coal Combustion Residue Impoundment
Round 9 - Dam Assessment Report**

Plant McIntosh
Ash Dike
Georgia Power
Rincon, Georgia

Dewberry & Davis, LLC
Fairfax, Virginia

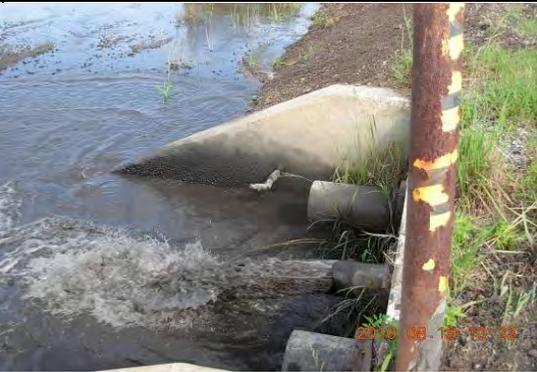
Photo No.	Description	Photo
4105	Newly installed sump discharge in headwall of A cell ash discharge.

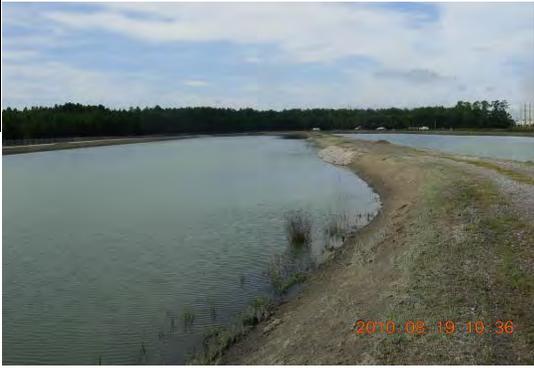
4106	AB dike looking southwest from east third of dike. Note freshly dressed and hydro-seeded slope. Note top of gravel bolsters installed in the past to deal with sluffing.

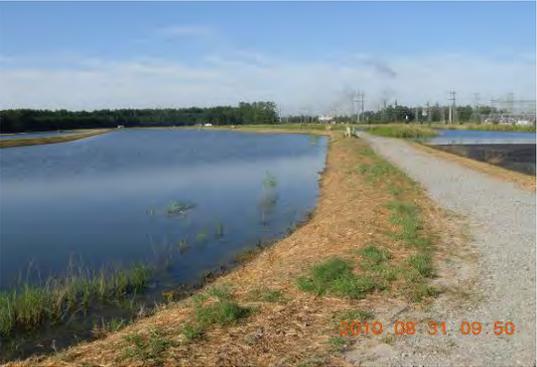
4158	Follow-up photo on 8/31/2010: Same location as above showing mulch and emergence of some grass.

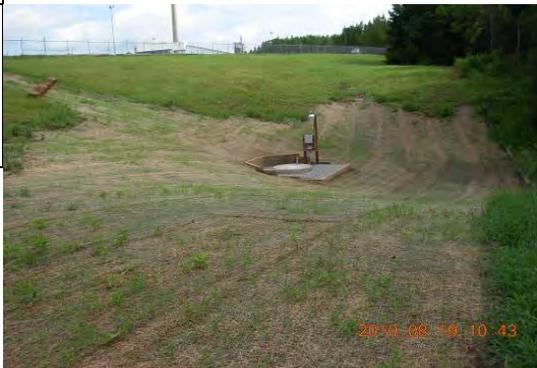
4107	Area of northern sump at toe of C dike. The area is very nicely dressed up. This was a very neat job; the area was seeded and matted. The drain was seeping into the sump at a rapid drip.

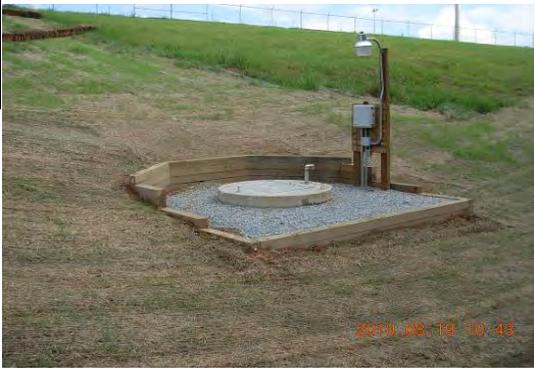
Photo No.	Description	Photo
4108	Closer view of sump described above.

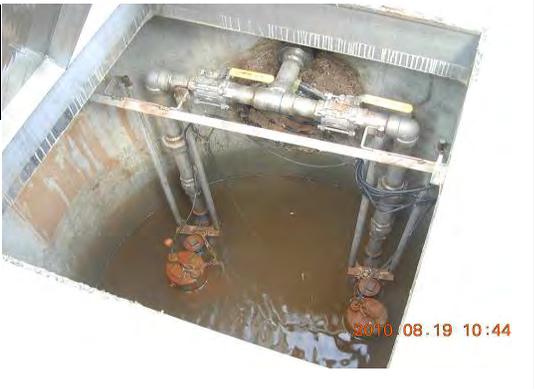
4109	Interior of sump.

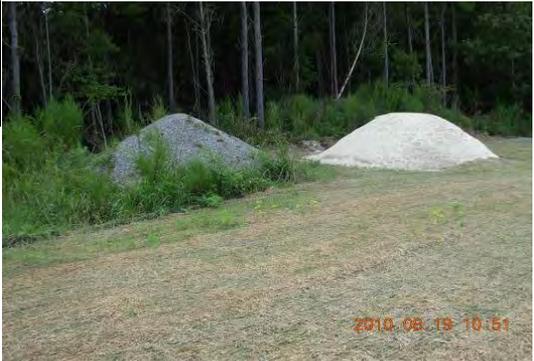
4110	Granular material stockpiles at toe of C dike. The quantities are adequate and the material is in good shape.

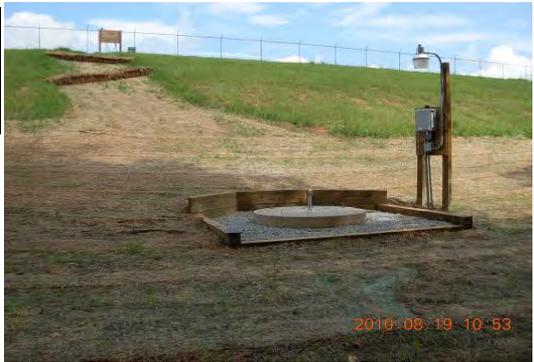
4111	Sump at south end of C dike. Trace of matting up slope indicates path of return line. This is a very neat job also.

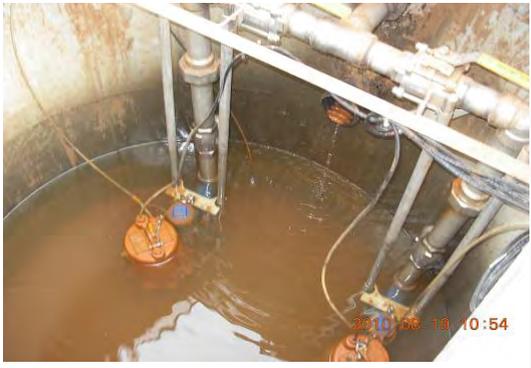
Photo No.	Description	Photo
4112	Interior of south sump at toe of C dike. Note small stream of water entering sump from drain. Also note iron oxide deposition in drain and in sump.

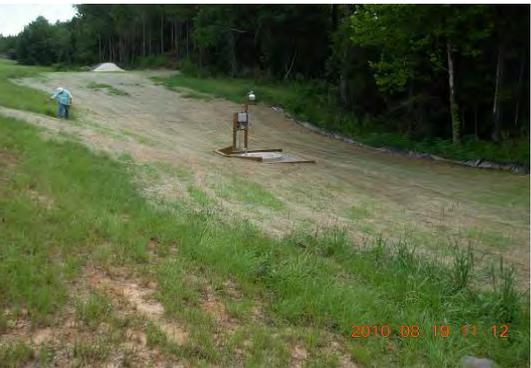
4113	Sump at south end of C dike. Some additional work is needed to address poor grass cover on slopes.

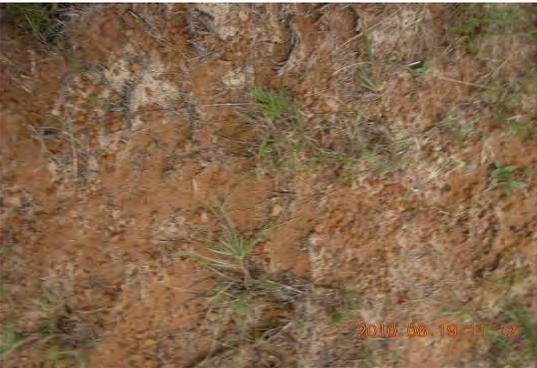
4114	There was not sign of the boils previously noted in the area of the new toe drain (which discharges to the sump) along the toe of C dike in its southern section.

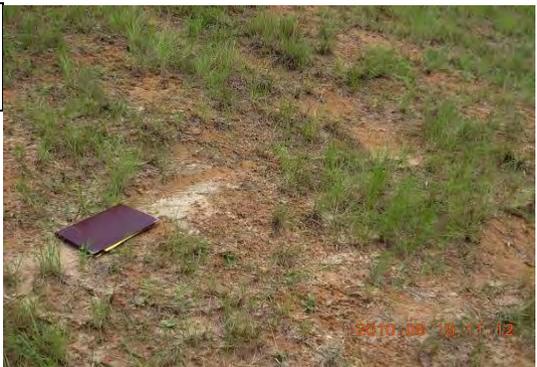
4115	Bare spots on slope of C dike. The grass is thin. The area should be tilled, seeded, fertilized and mulched.

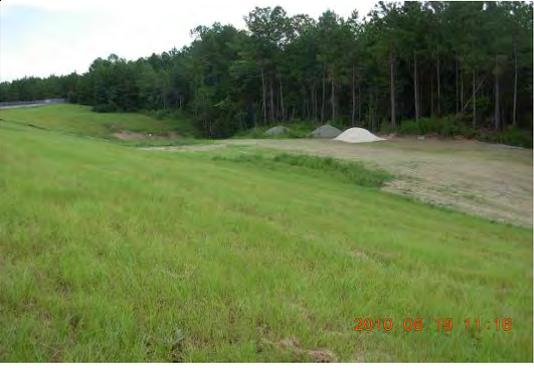
Photo No.	Description	Photo
4116	View of saddle between two low areas at the toe of C dike showing granular material stockpiles. Also note matting from cleanup after installation of sumps.

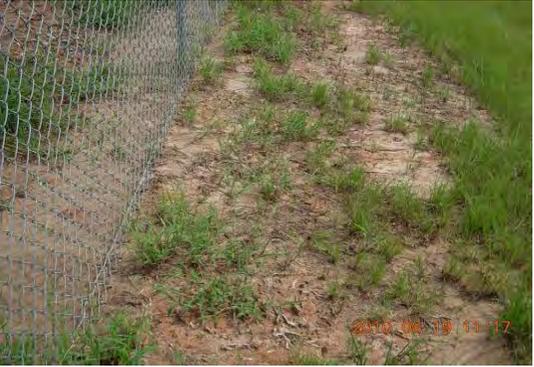
4117	Top of exterior slope of C dike near top showing bare earth and thin grass cover.

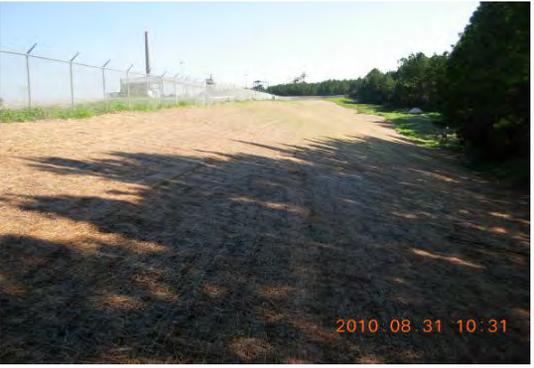
4162	Follow-up photo on 8/31/2010: C dike downstream slope. Area has been tilled, hydroseeded and matted. Grass is emerging. Covers areas depicted by previous photos 4113 - 4117.

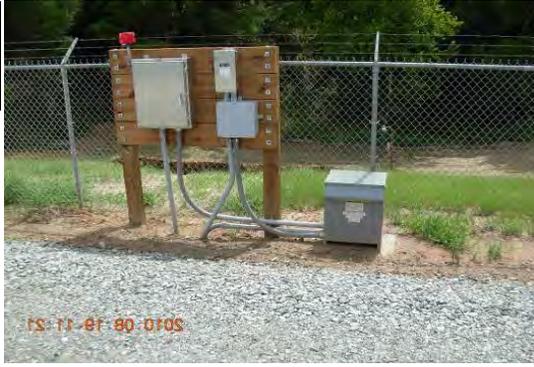
4118	Control panel for sumps at toe of C dike. Note red light for alarm.

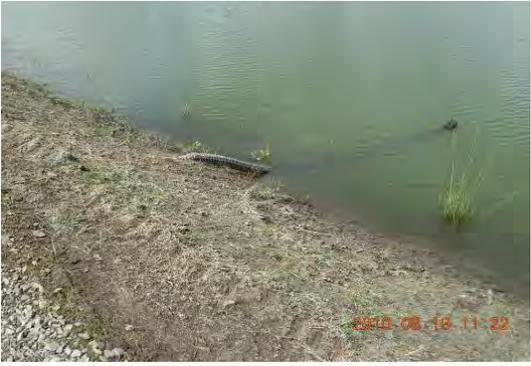
Photo No.	Description	Photo
4119	Sump outfall into C cell. Note that 2" HDPE pipe discharges into 4" corrugated pipe to avoid gulying of slope.

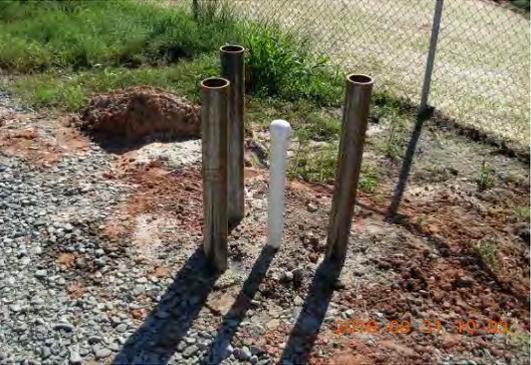
4161	Follow-up photo on 8/31/2010: New piezometer installation at top of C dike.

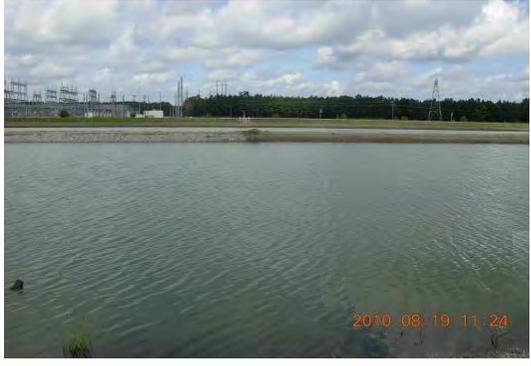
4120	View of BC dike from C dike. Note gravel bolster on left and recently dressed and seeded slope on right.

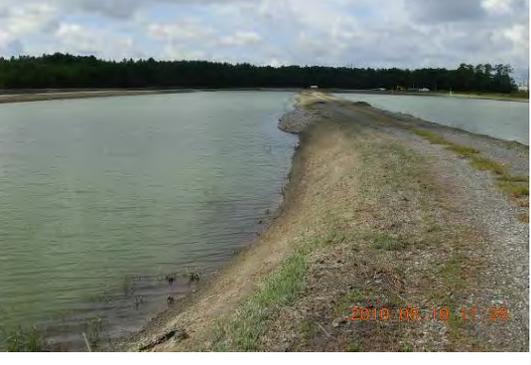
4121	BC dike looking southwest. Note recently dressed and hydro-seeded slope in the foreground and gravel bolster in the middle distance. Also, note gravel on crest.

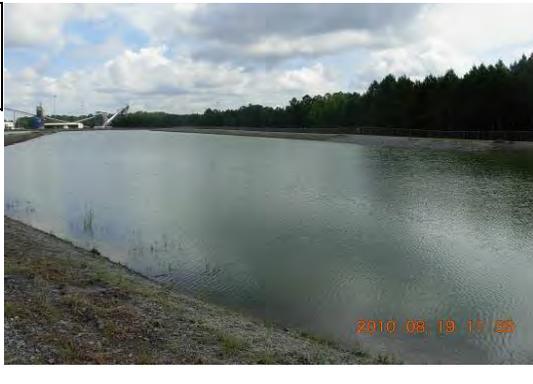
Photo No.	Description	Photo
4122	C dike viewed from BC dike. Note gravel bolsters and recently dressed and grassed slopes.
