Use of Nano- and Micro-Scale Zero Valent Iron at Navy Sites: A Case Study

Nancy E. Ruiz, Ph.D.

Naval Facilities Engineering Service Center

US EPA Workshop on Nanotechnology for Site Remediation

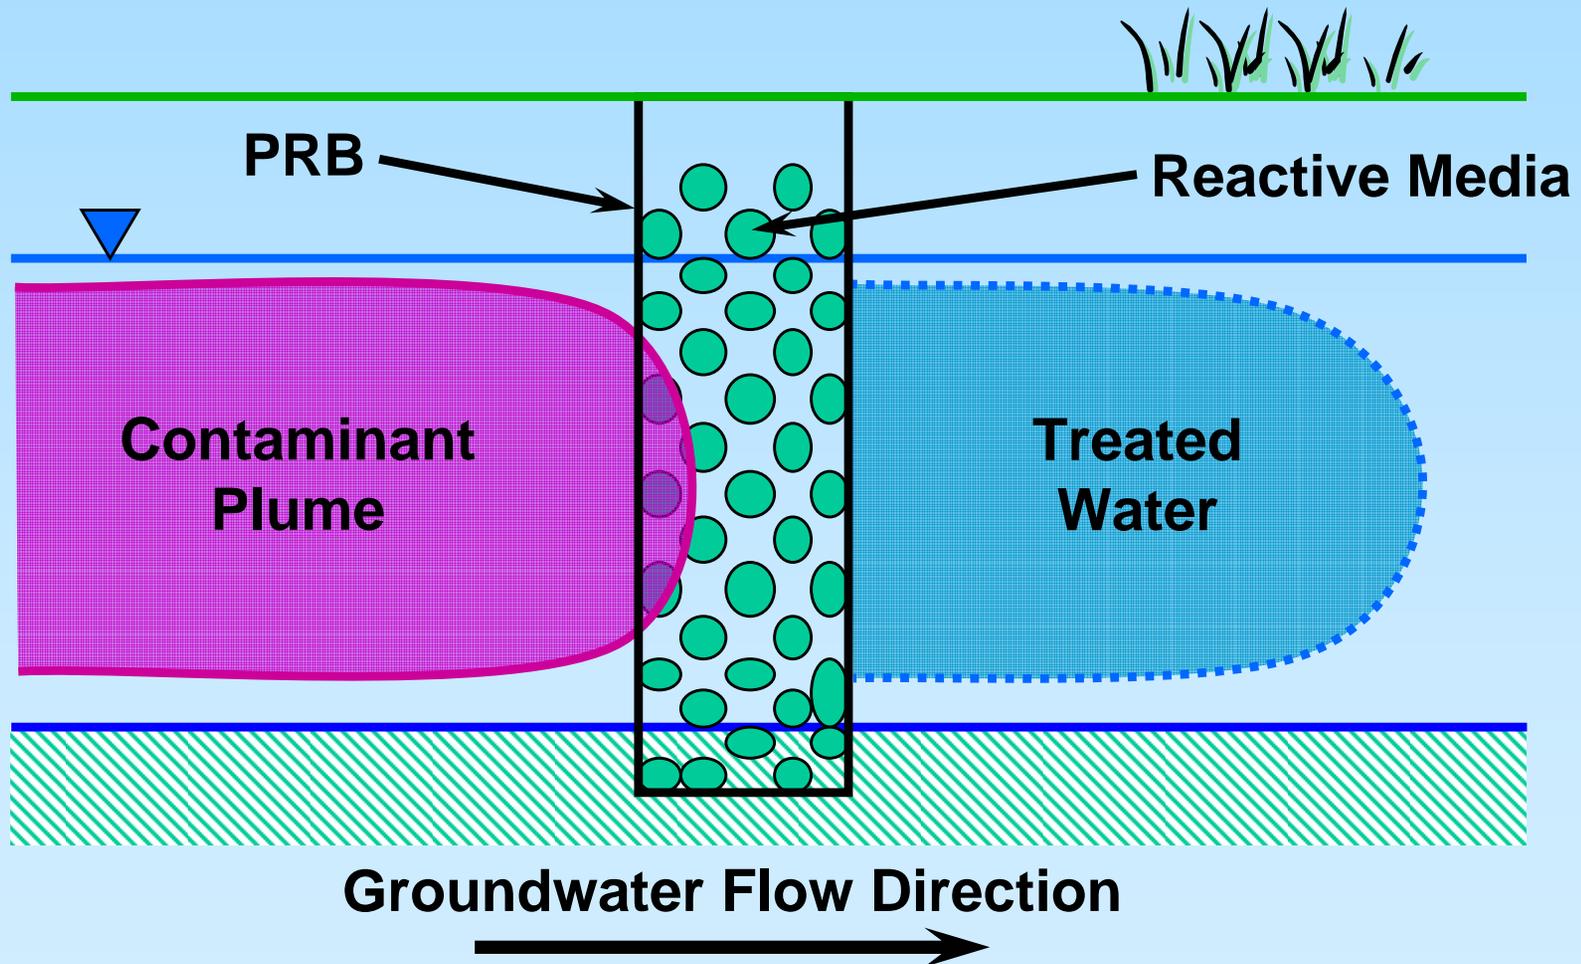
Use of ZVI in Permeable Reactive Barriers (PRBs)

**Passive Treatment,
No Aboveground Structures**

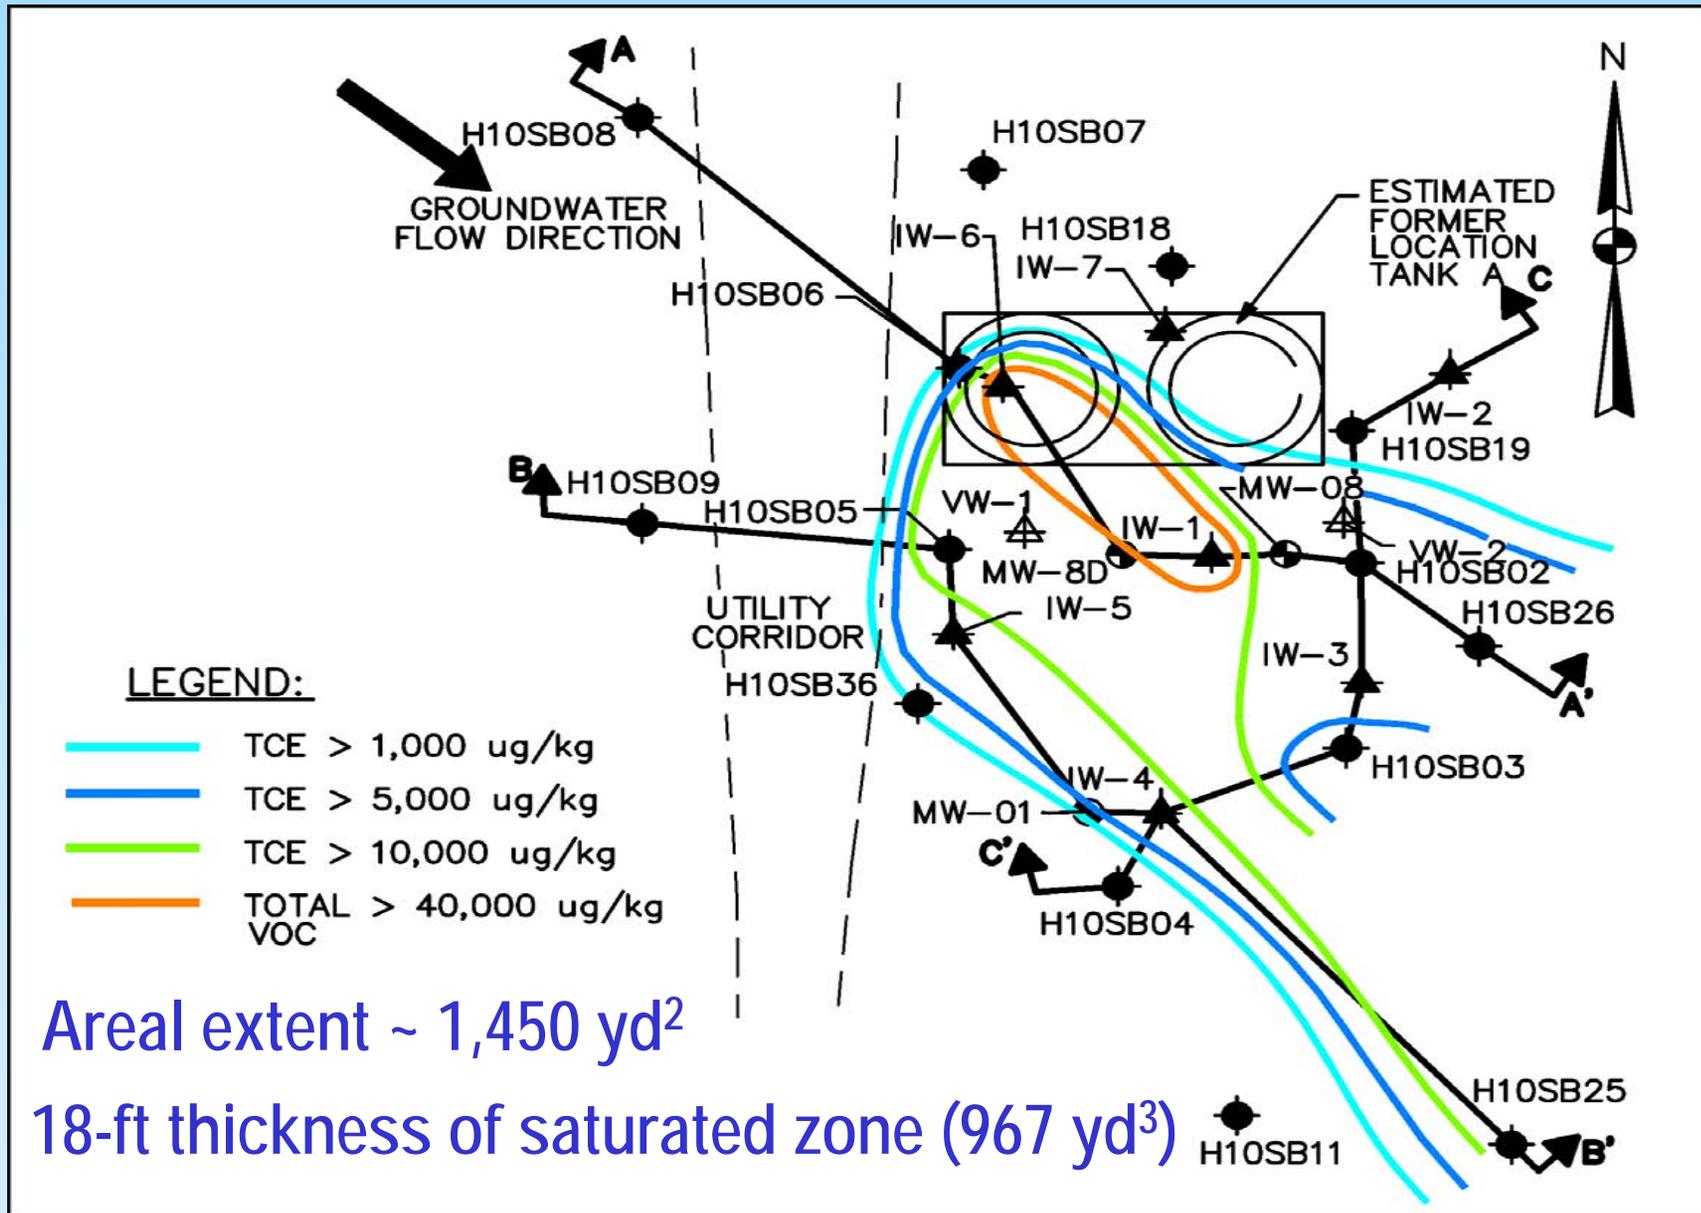
Extent of Contamination

CVOC mass estimates 42 to 125 lb

- PCE – 4,360 $\mu\text{g}/\text{kg}$
- TCE – 60,100 $\mu\text{g}/\text{kg}$
- 1,1,1-TCA – 25,300 $\mu\text{g}/\text{kg}$

- PCE – 210 $\mu\text{g}/\text{L}$
- TCE – 26,000 $\mu\text{g}/\text{L}$
- 1,1,1-TCA – 8,400 $\mu\text{g}/\text{L}$
- *cis*-1,2-DCE – 6,700 $\mu\text{g}/\text{L}$

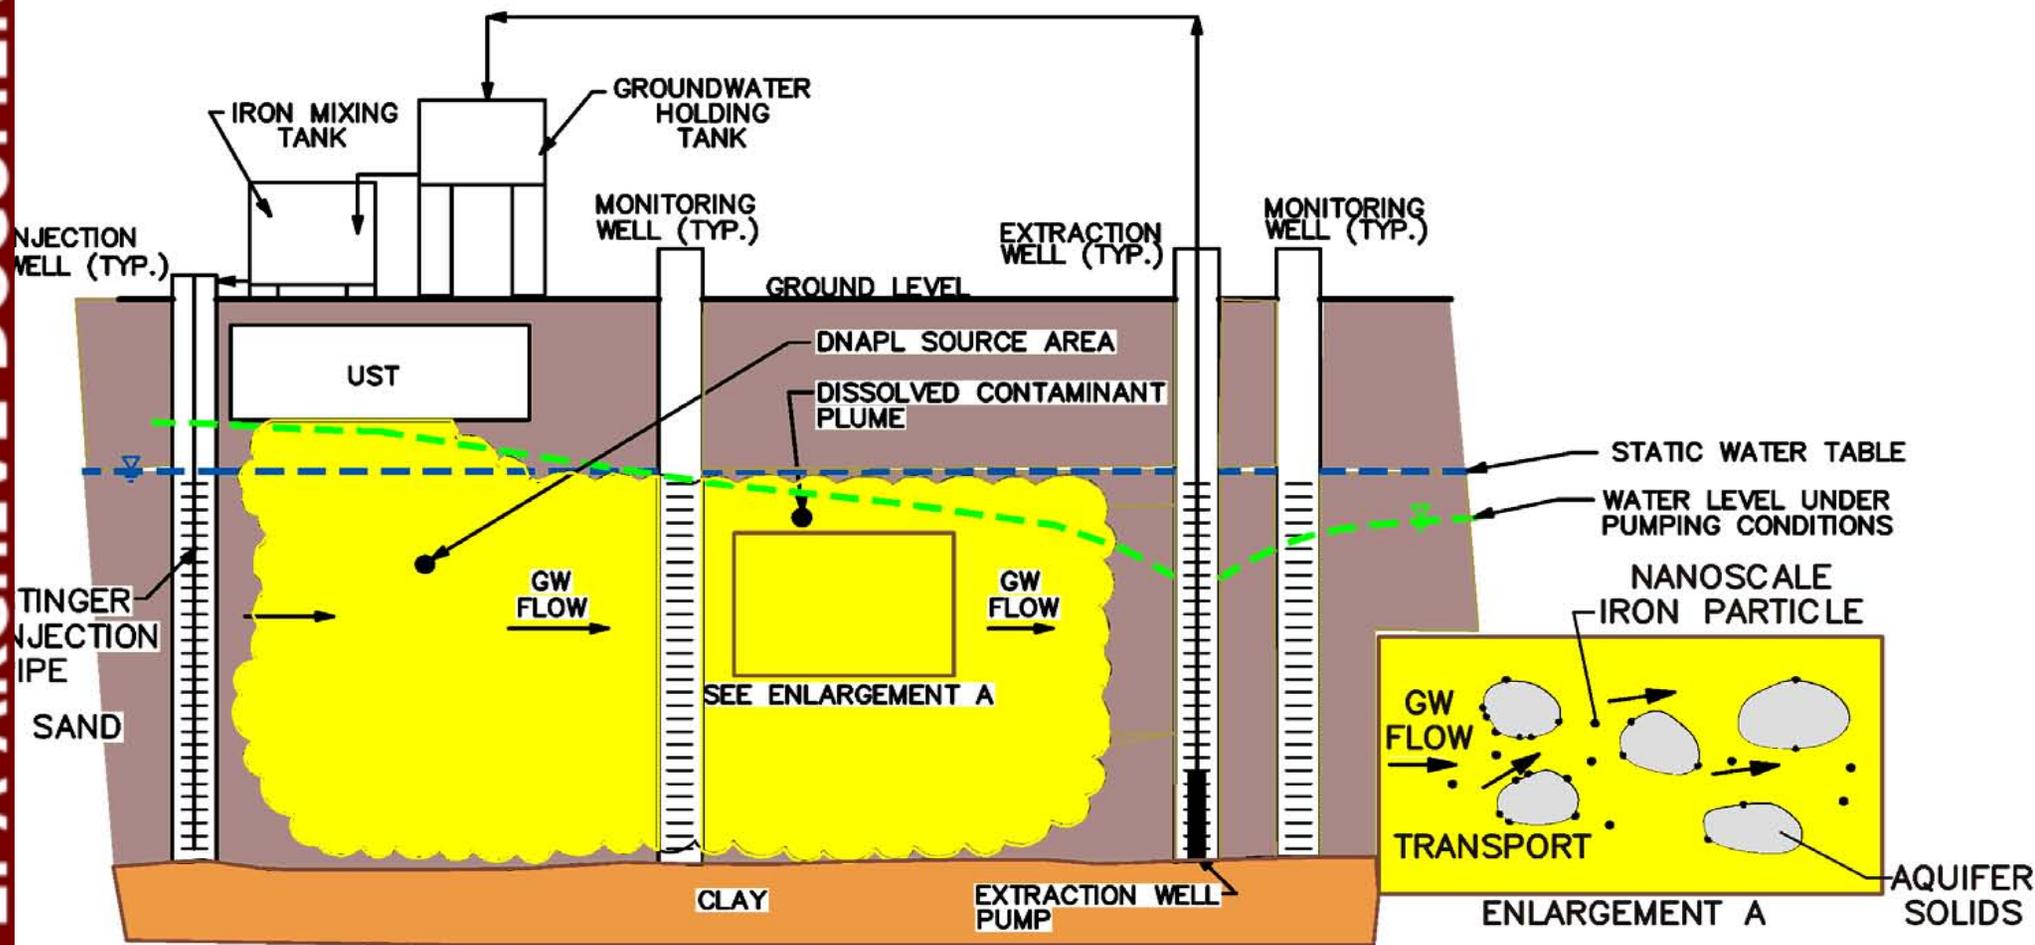
Technology Implementation

300 lb BNP (99.9 % Fe, 0.1 % Pd and polymer support)

Gravity Feed, 10 injection points

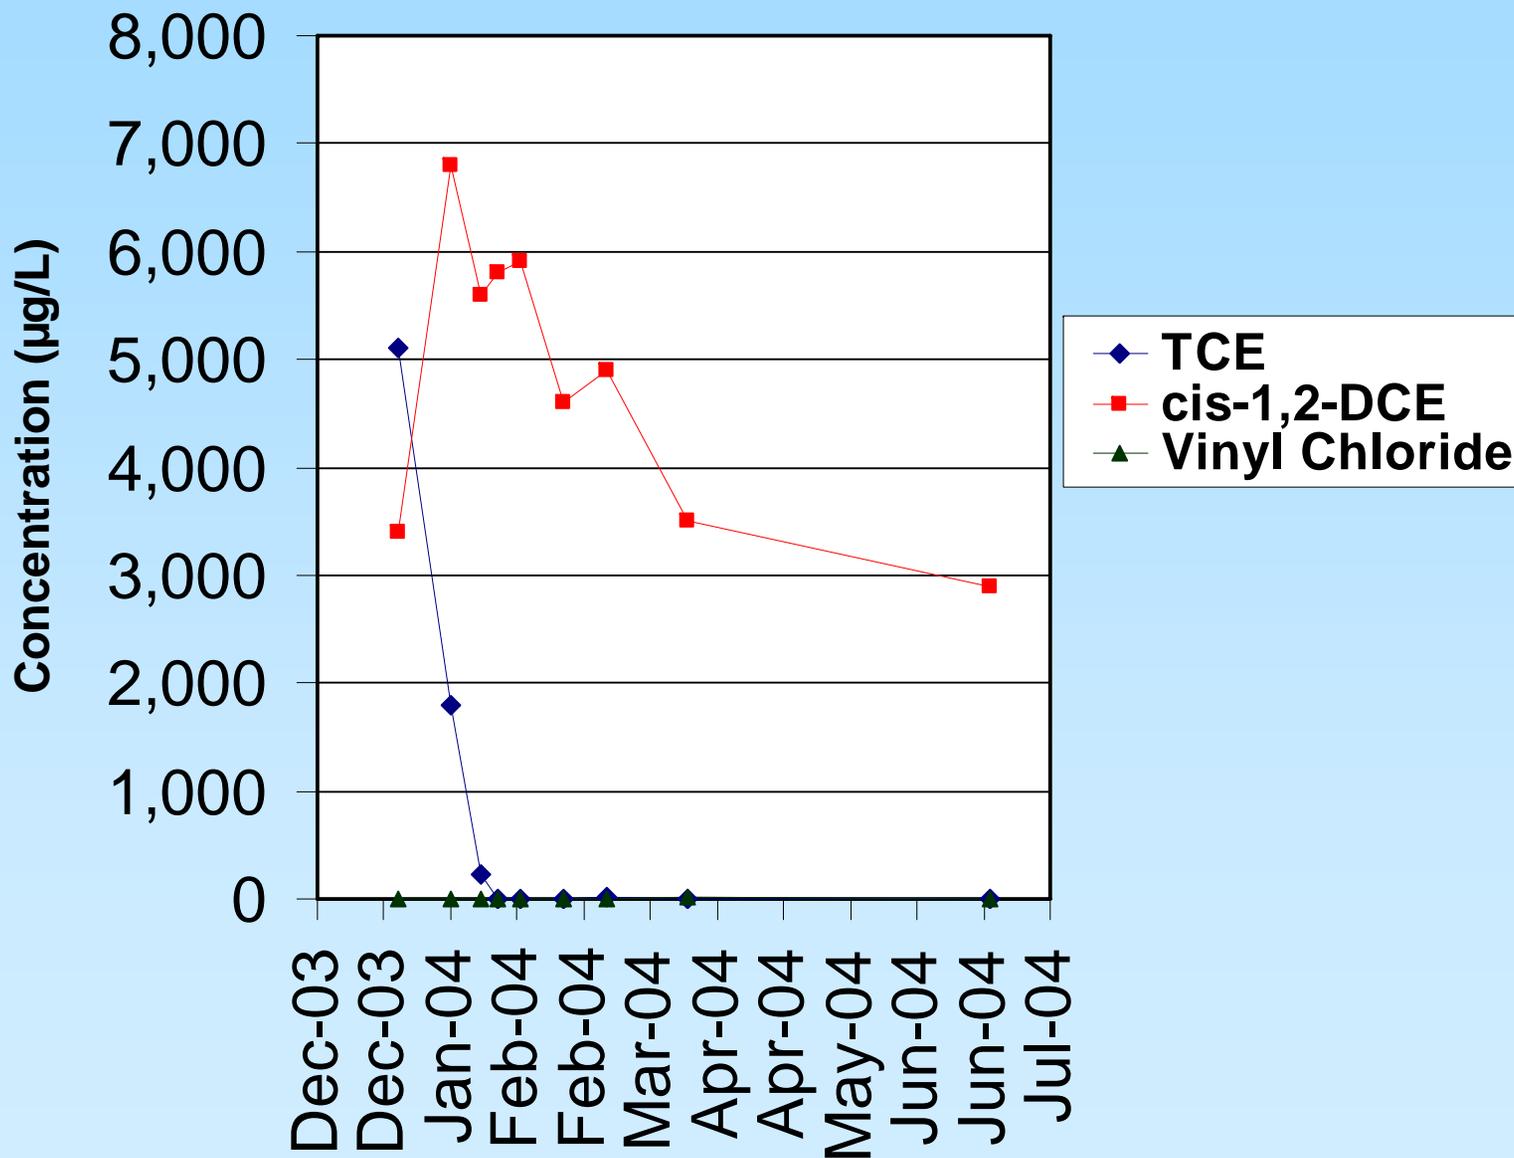
Concentrations in Source Zone Well H10MW37

- Good reduction in dissolved TCE levels
- Nitrate, sulfate reduction
- Ethene, ethane formation
- Significant increase in DCE levels, indicating biodegradation
- Not observed (signs of strong enough reducing conditions to generate abiotic reduction)
 - ORP levels well below -200 mV (-400 to -750 mV common in iron barriers)
 - pH of 8 or higher (pH of 10 or 11 observed in iron barriers)
 - Decrease in alkalinity, Ca, Mg

- NZVI significantly reduced dissolved TCE levels
- Avoid NZVI contact with oxygen (or other oxidized species) during storage or mixing to avoid deactivation
- Determine Fe mass based on Fe/groundwater ratio, rather than Fe/Contaminant ratio
 - ORP < -200 mV required in target treatment volume
- Identify and address long-term performance goals

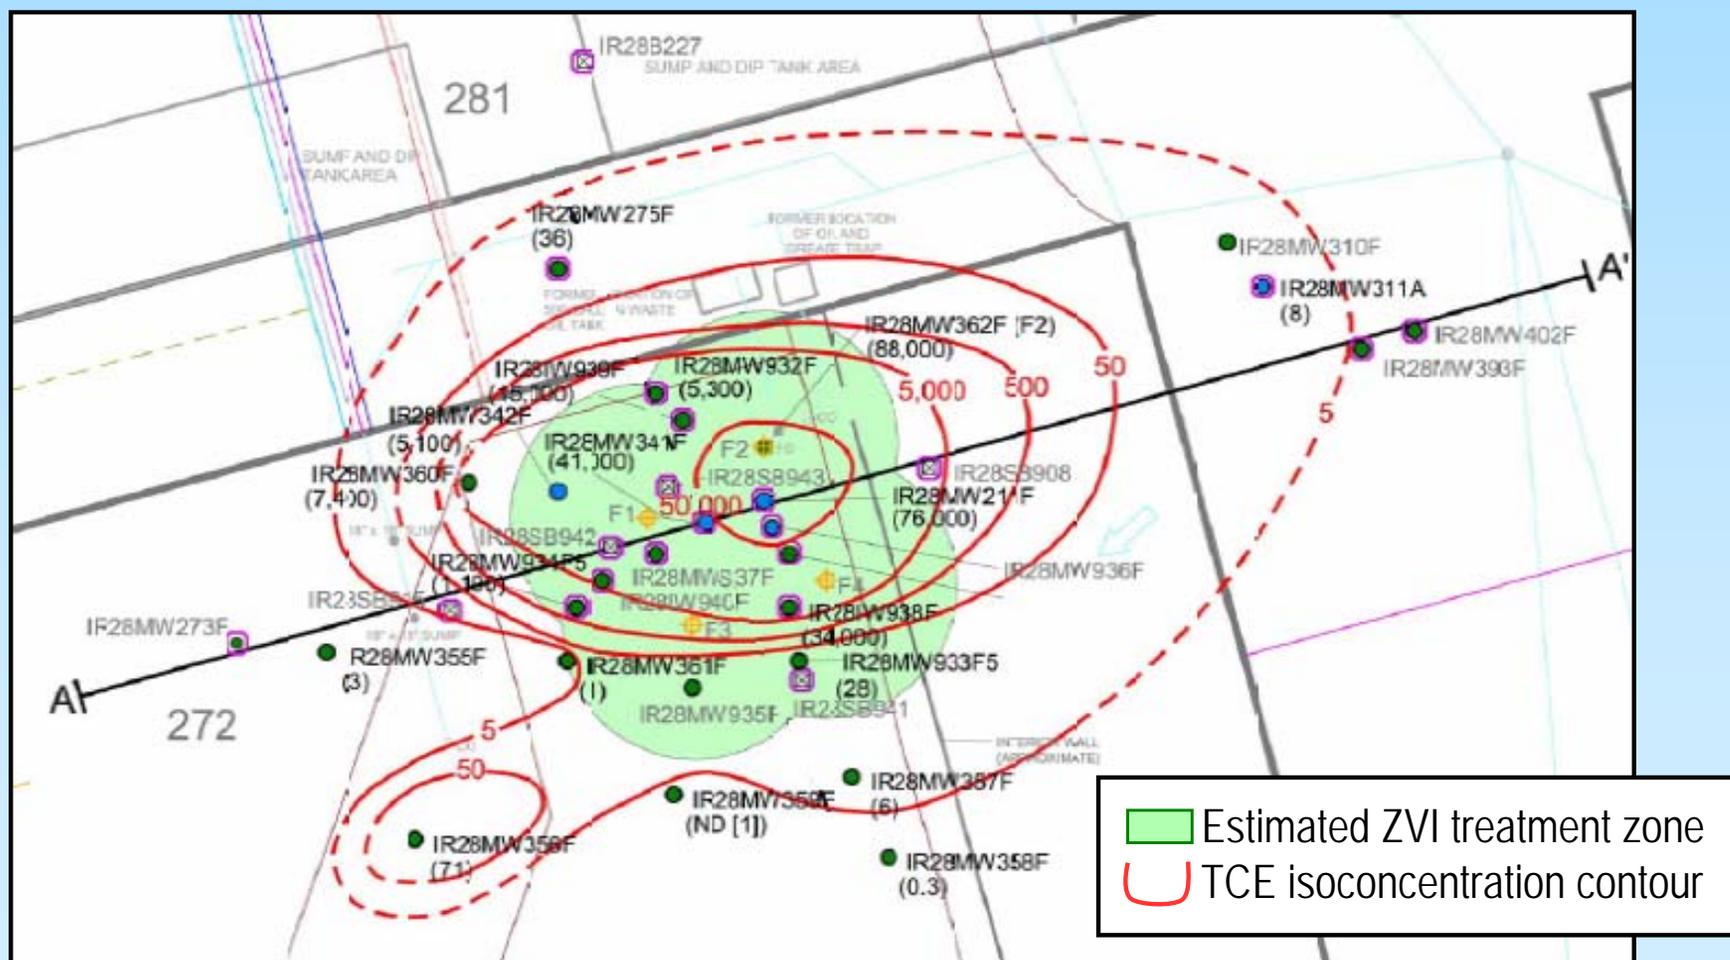
Site Conditions – Contaminant Levels/Extent of Contamination

- Areal extent of treatment area 900 ft²
- Thickness of the subsurface treatment zone 22 ft (730 yd³)

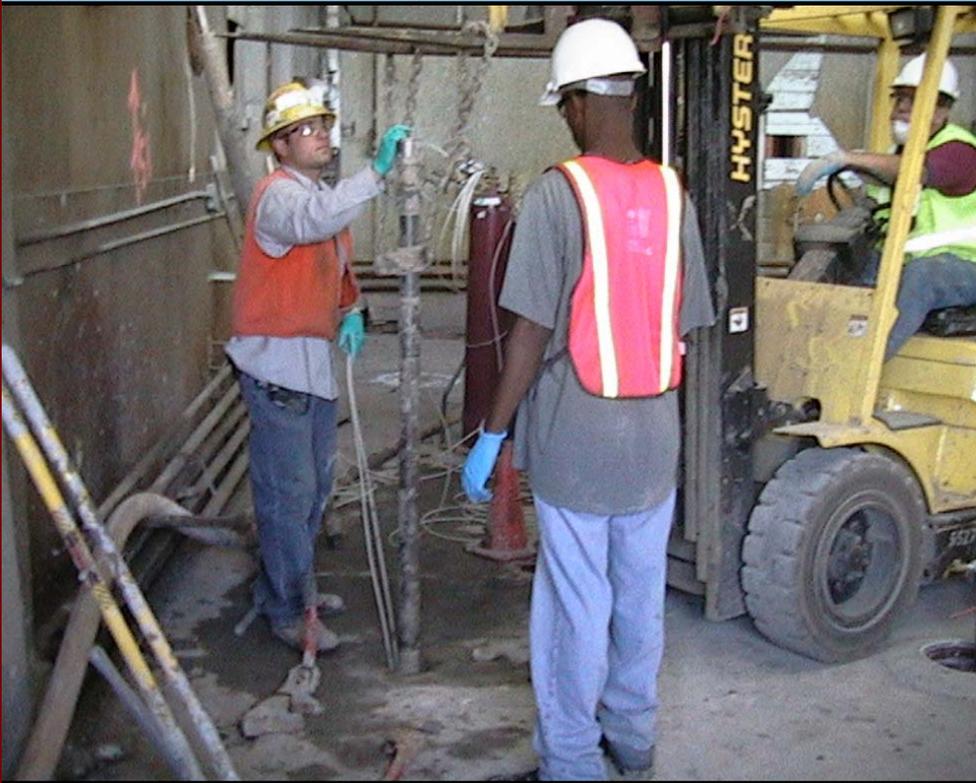
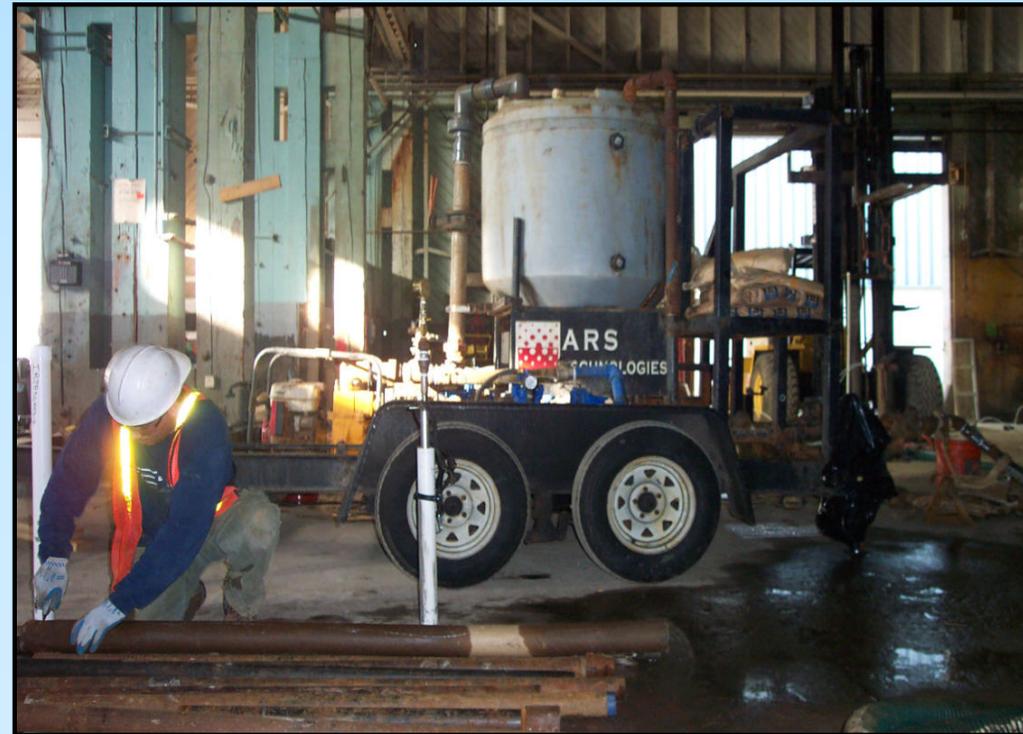
Technology Implementation (cont.)

30 to 10 ft bgs in 3-ft intervals
Nitrogen gas delivery
55 to 230 psig
1 kg Feroxsm /Gal tap water

16,000 lb microscale ZVI

Fe/CVOC: ~1,100

Fe/Soil: ~0.008

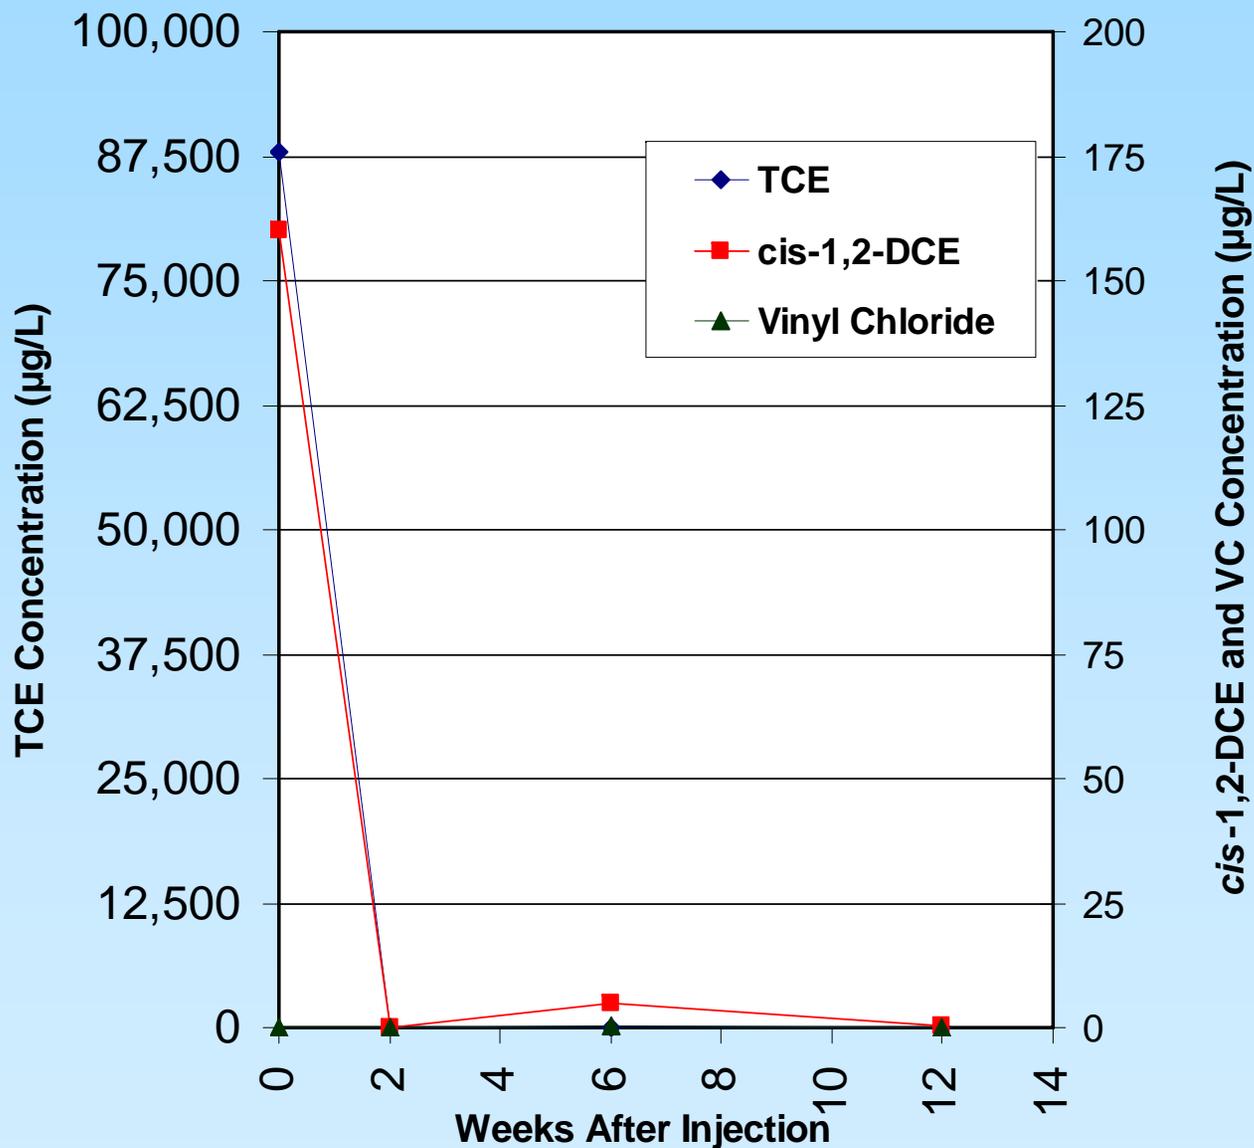
Concentrations in Monitoring Well IR28MW362F

- ~99.2% of TCE in treatment zone reduced to ethane and Cl
 - pre-injection mean 27,000 mg/L
 - post-injection mean 220 mg/L
- Significant decrease in PCE, *cis*-1,2-DCE, VC, chloroform, and carbon tetrachloride (92.6% to 99.4% reduction)
- No significant increase in TCE byproducts (DCE, VC)
- ORP significantly below -200 mV (< -400 mV in some wells)
- pH increased 1 to 2 units
