## Valzinco Mine Orphaned Land Project: Mine Site Reclamation Reduces Impacts of Acid Mine Drainage Knights Branch, VA

### WATERBODY IMPROVED

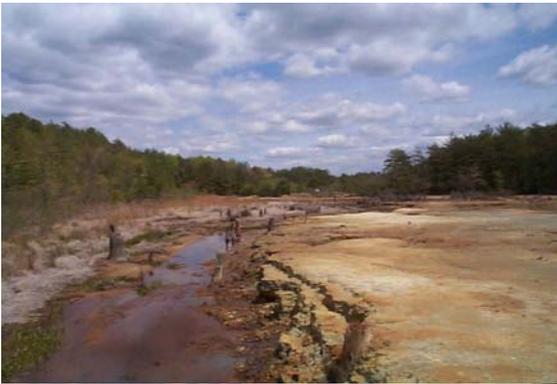
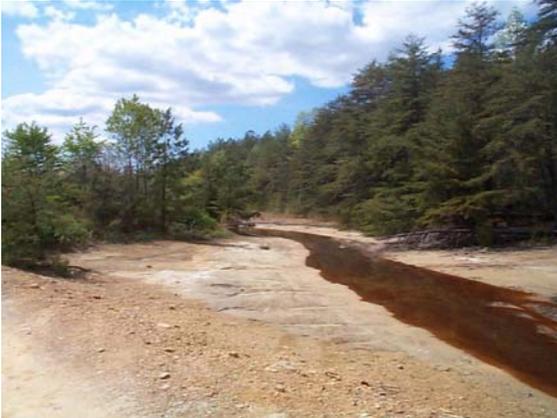
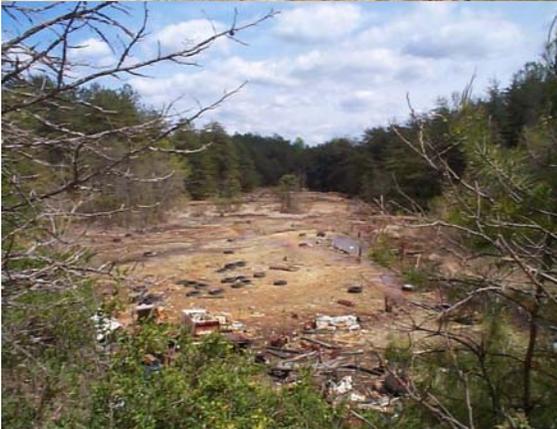
Before Reclamation

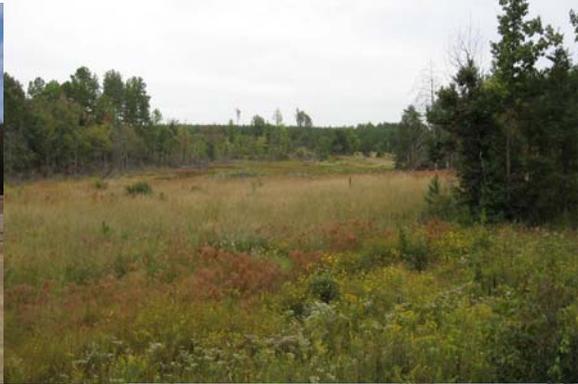
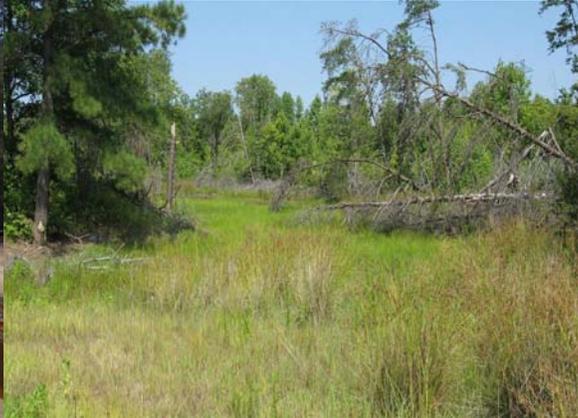
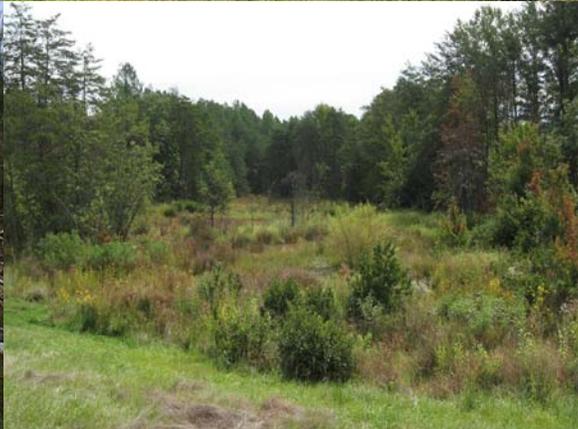
After Reclamation
