US EPA ARCHIVE DOCUMENT

figure 2.1
 5/25/2010 DIAL TESTING
 LOCATION 1 LINE OF SITE
 TONAWANDA COKE CORP.
 Tonawanda, New York

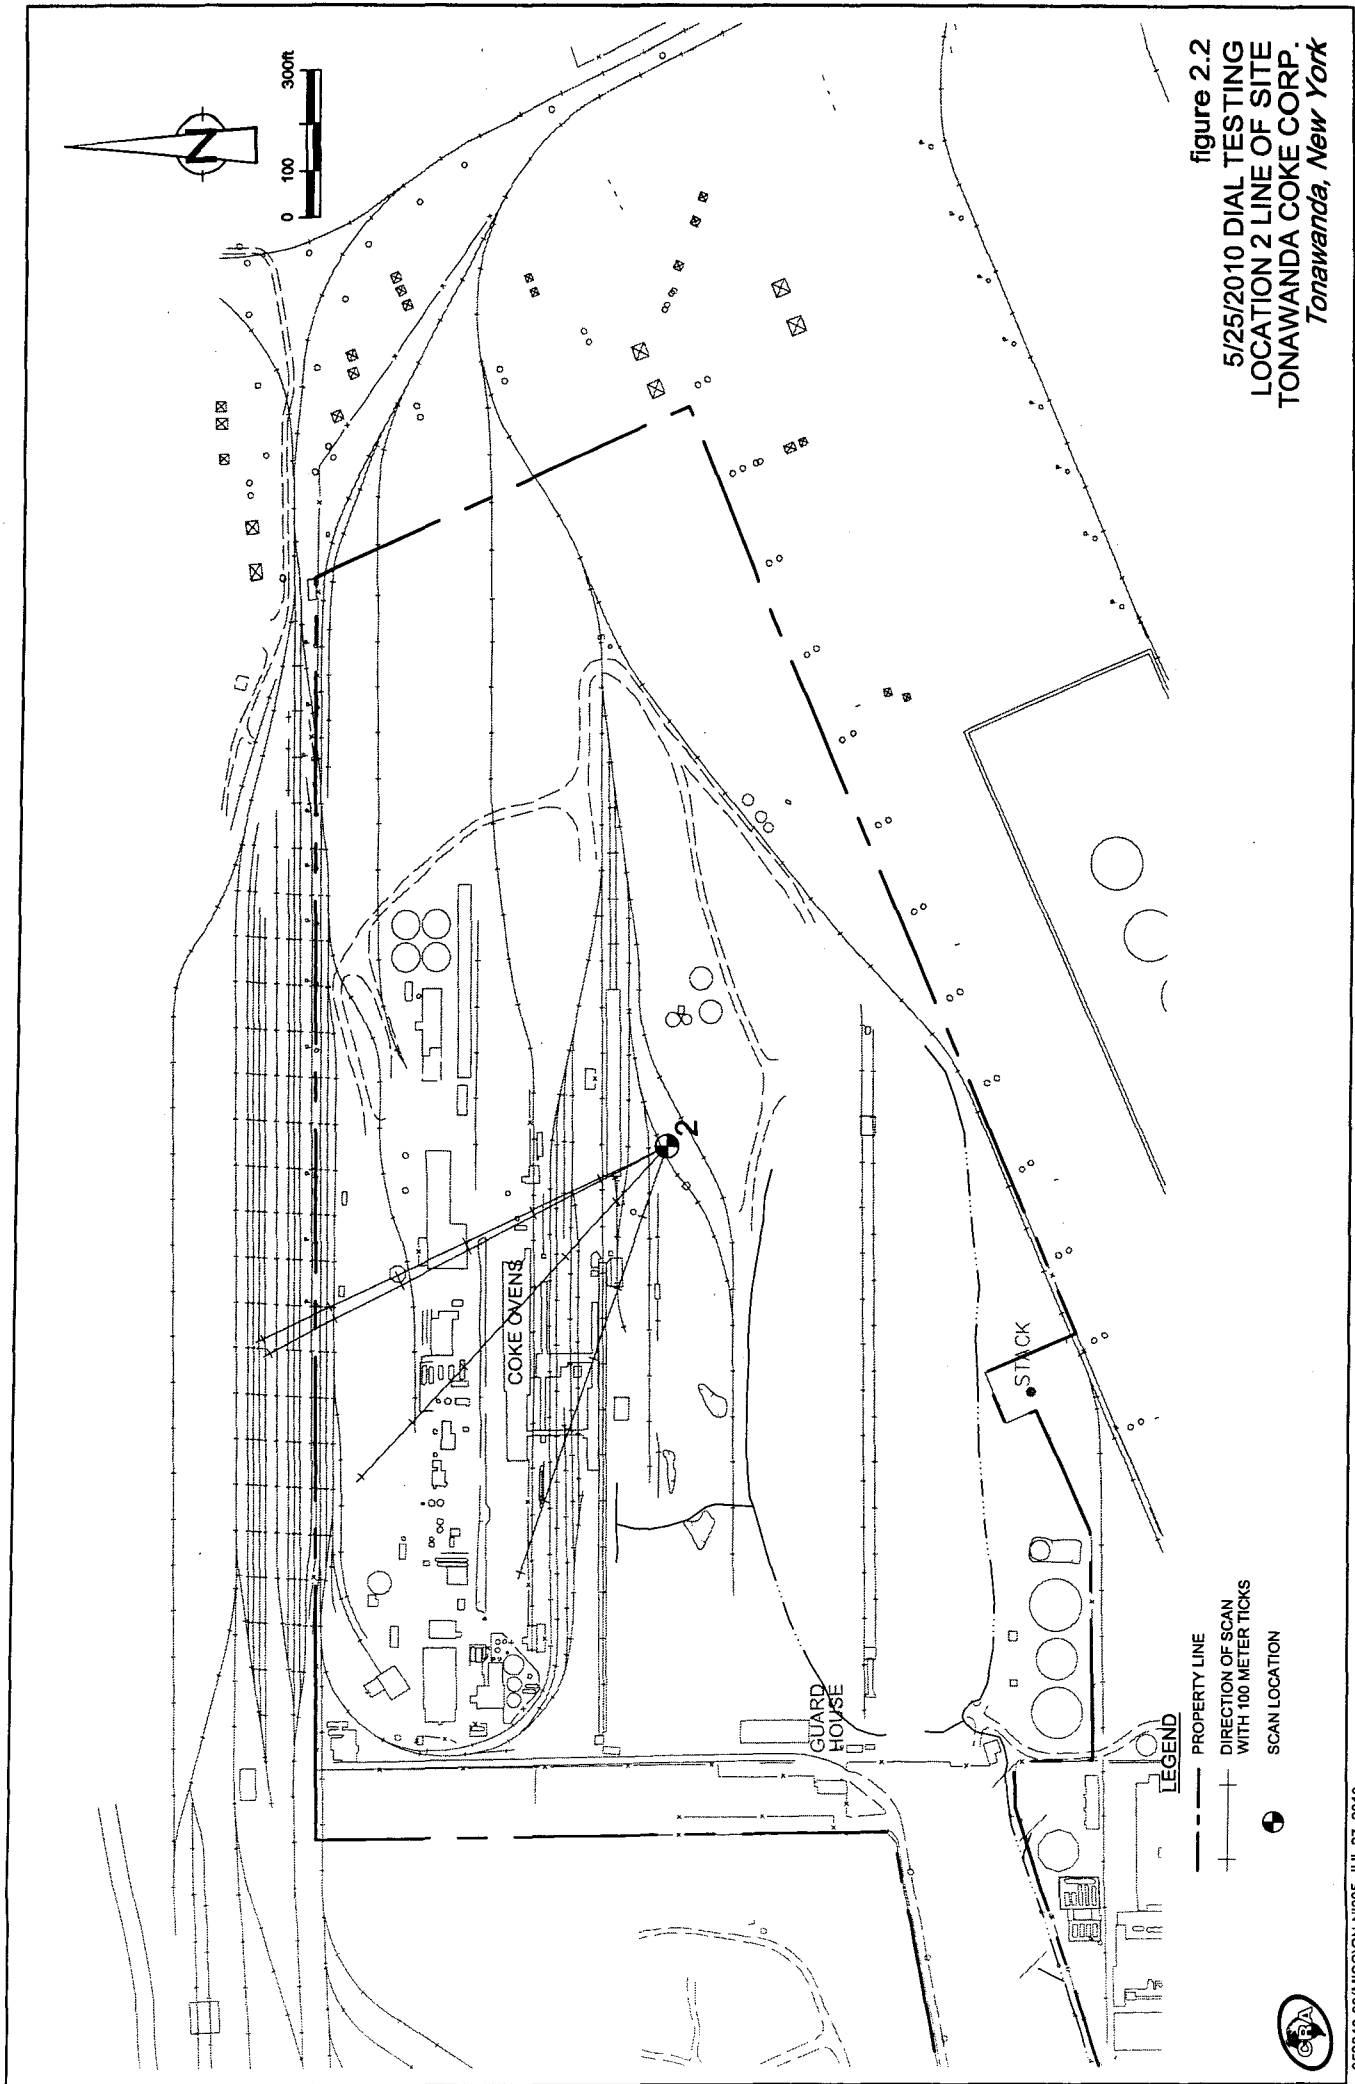
figure 2.2
5/25/2010 DIAL TESTING
LOCATION 2 LINE OF SITE
TONAWANDA COKE CORP.
Tonawanda, New York

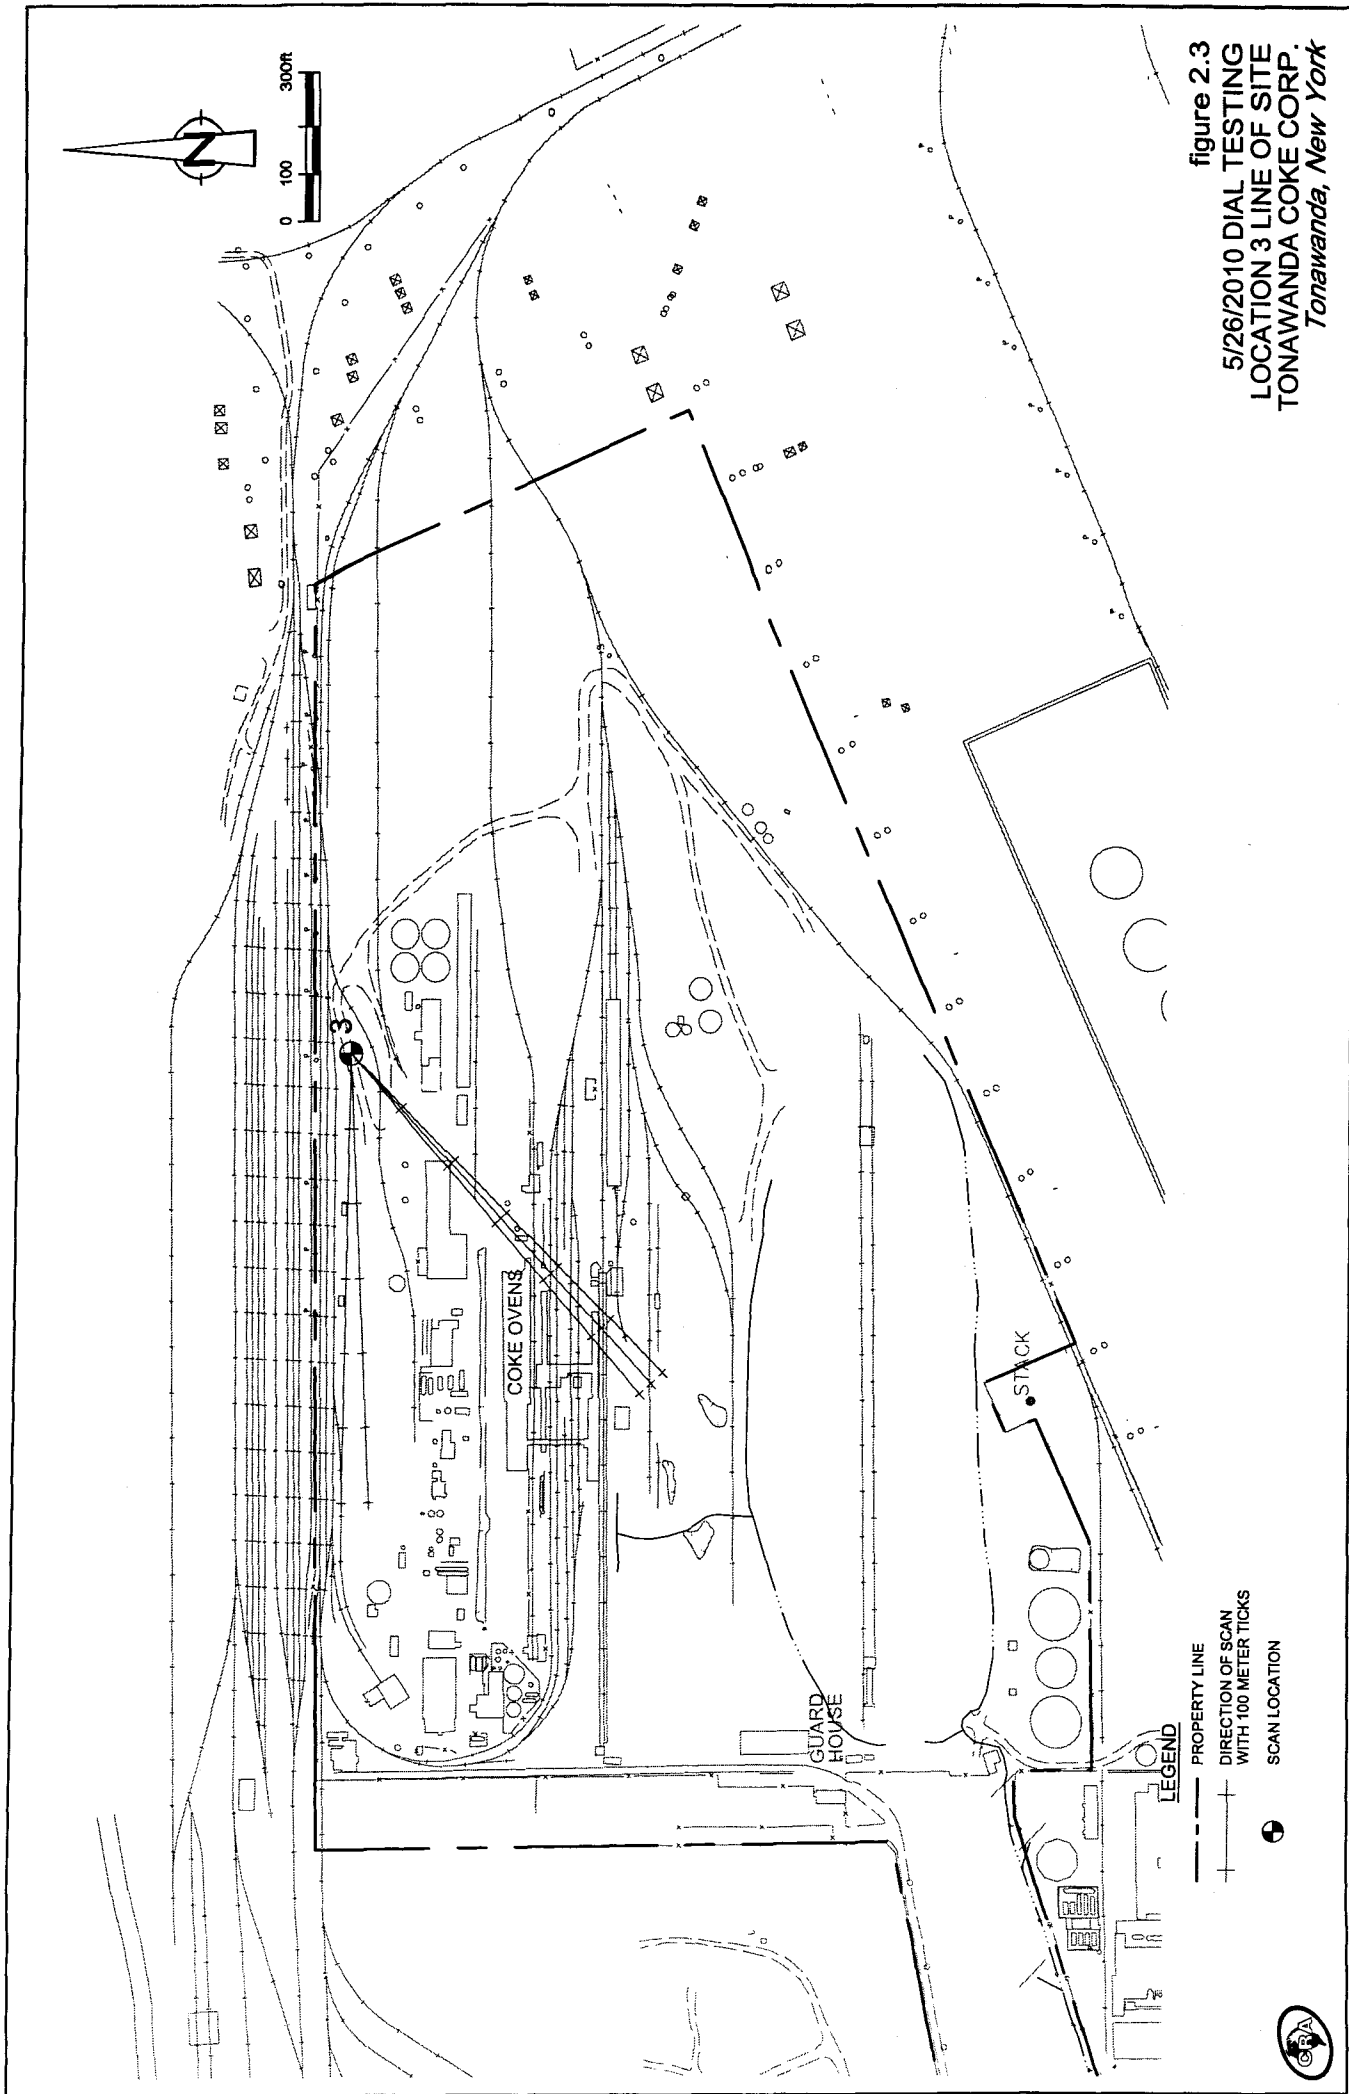
figure 2.3
5/26/2010 DIAL TESTING
LOCATION 3 LINE OF SITE
TONAWANDA COKE CORP.
Tonawanda, New York

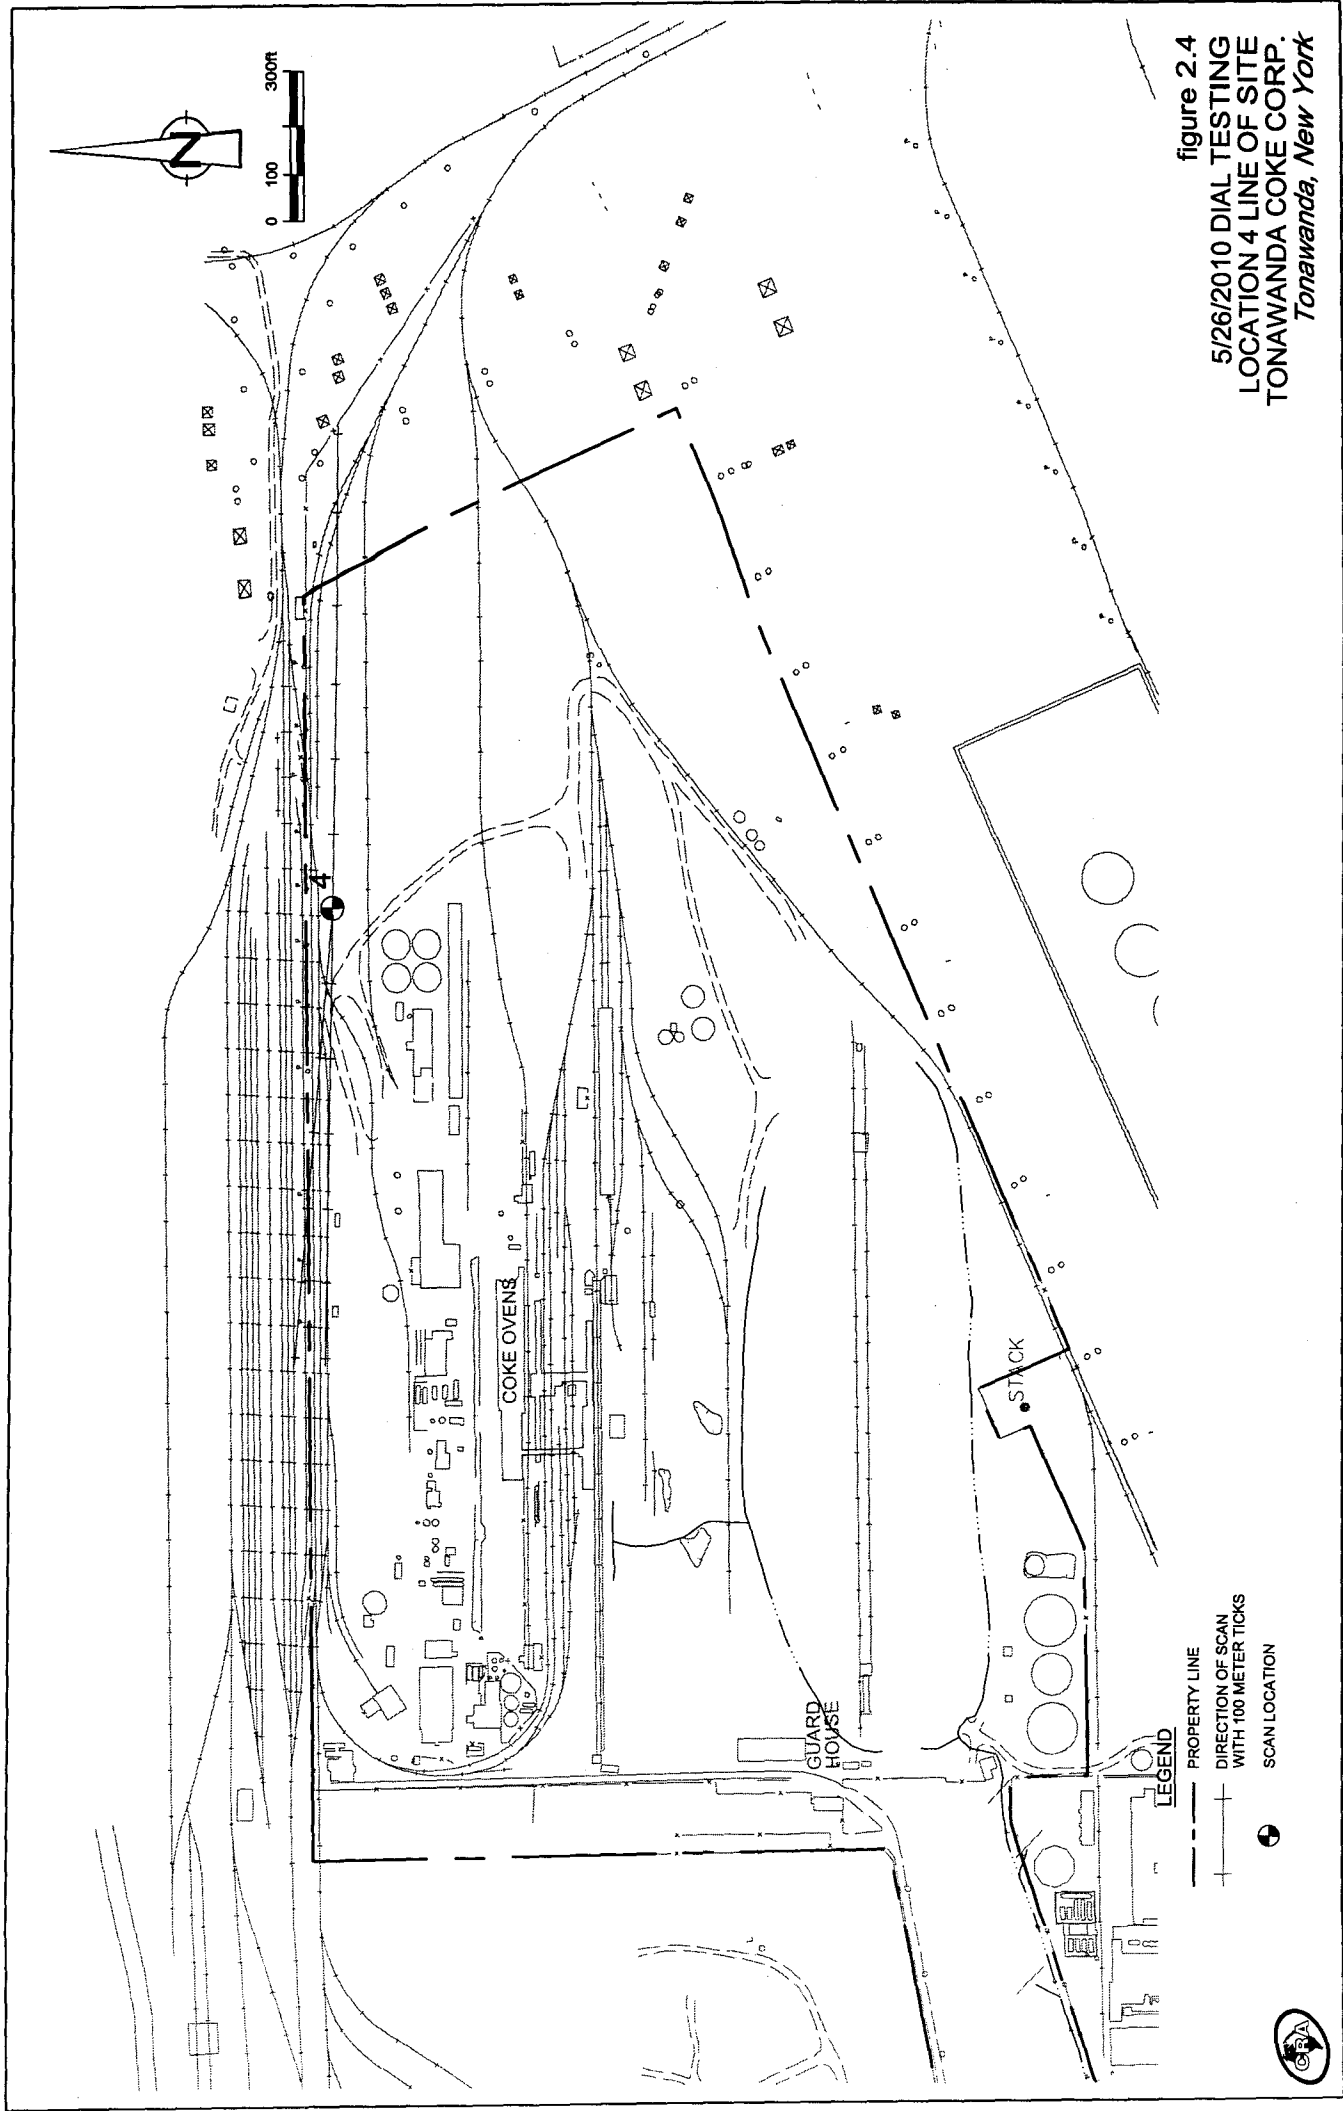
figure 2.4
5/26/2010 DIAL TESTING
LOCATION 4 LINE OF SITE
TONAWANDA COKE CORP.
Tonawanda, New York

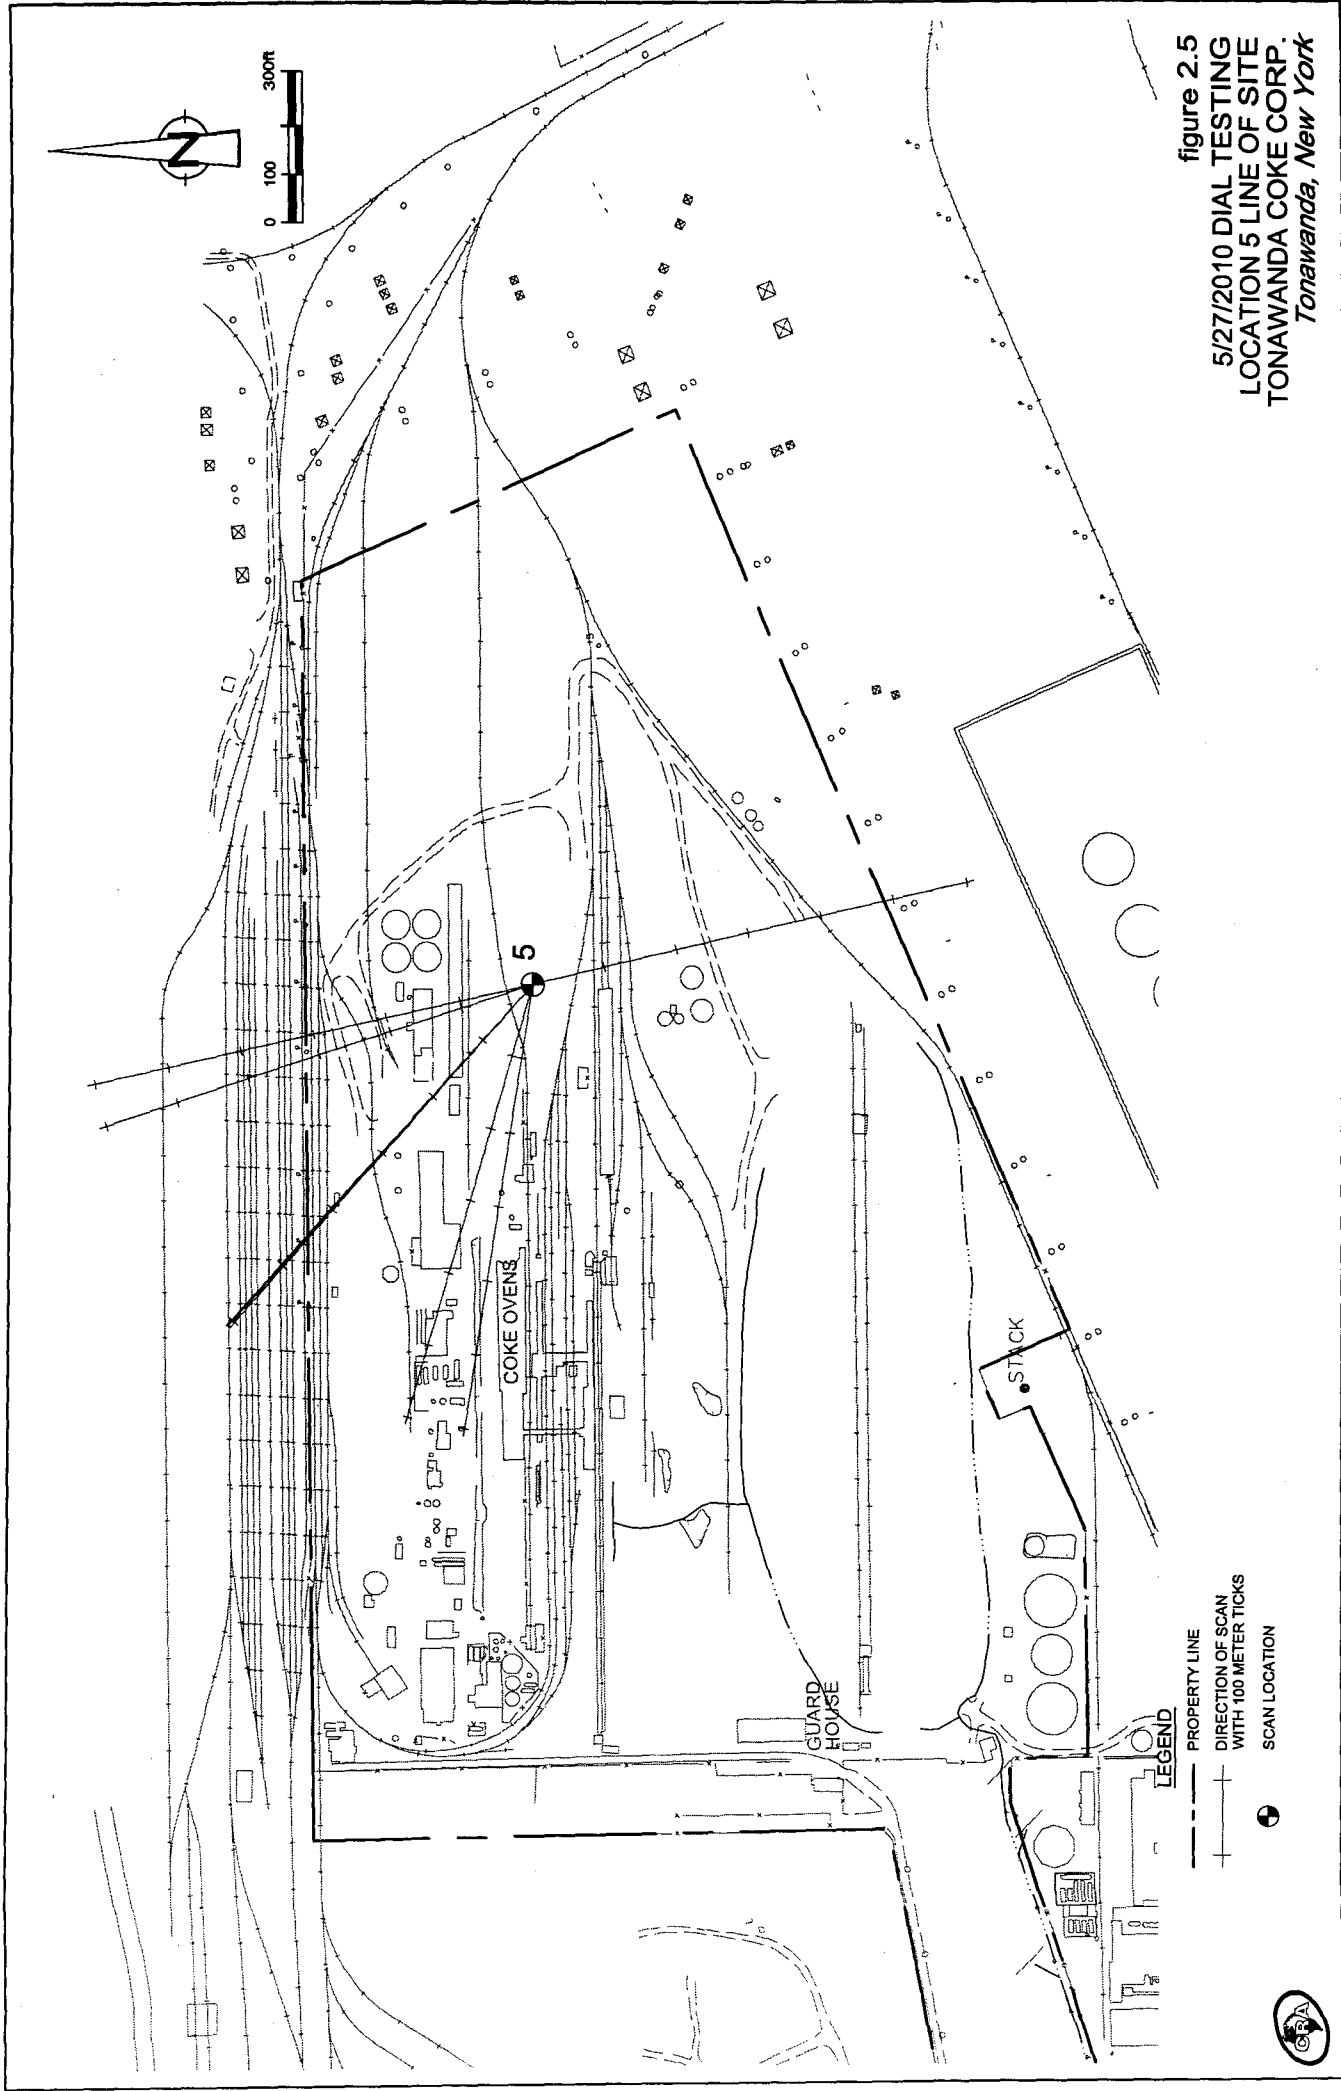
figure 2.5
5/27/2010 DIAL TESTING
LOCATION 5 LINE OF SITE
TONAWANDA COKE CORP.
Tonawanda, New York

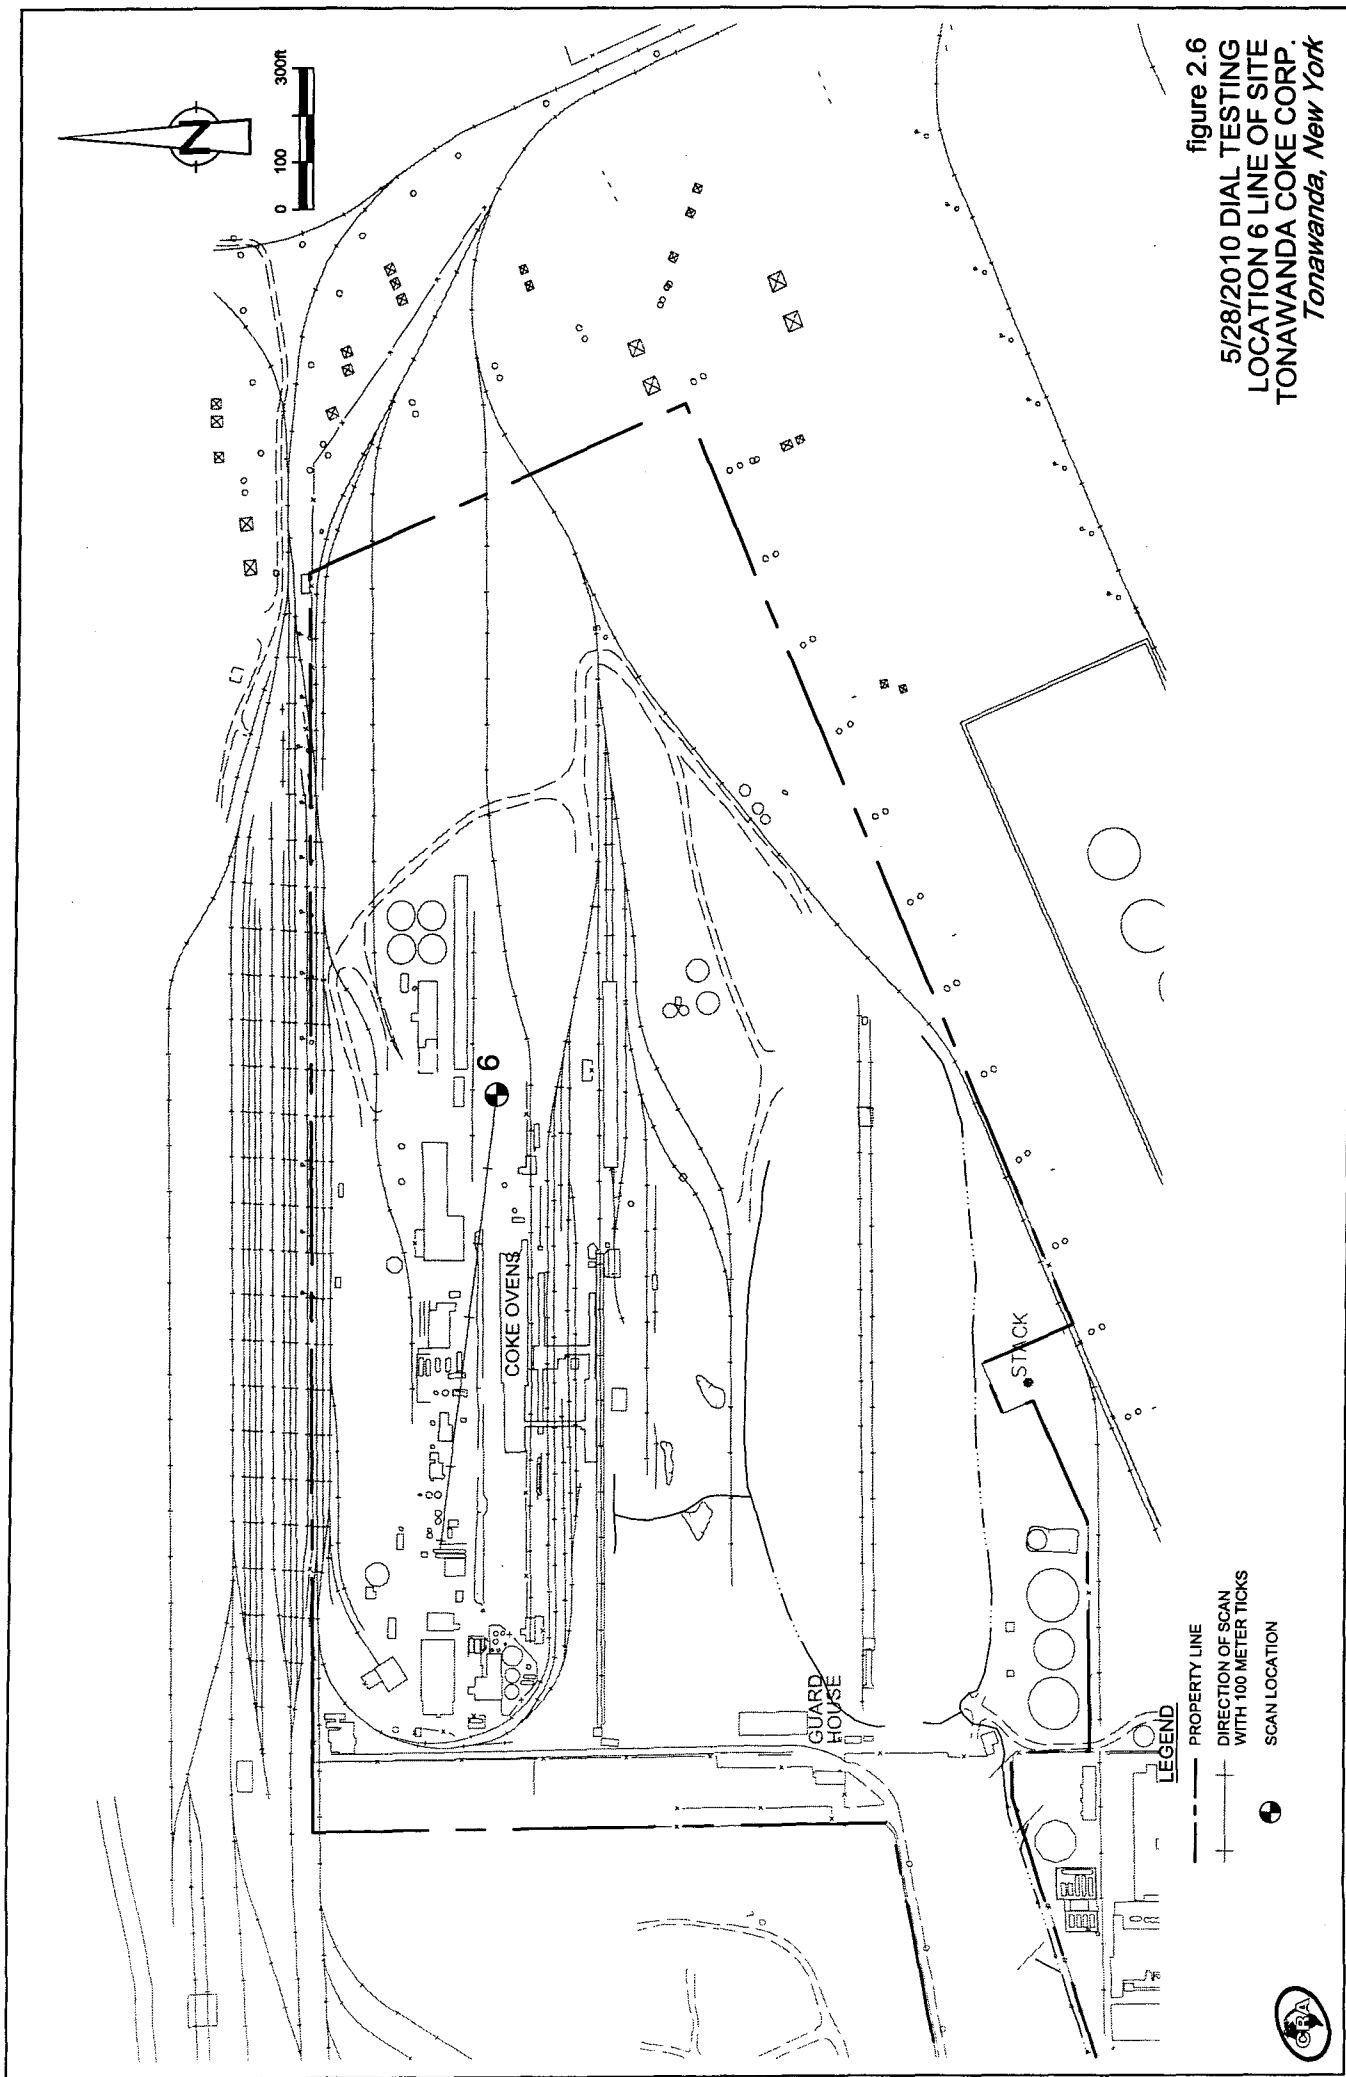
figure 2.6
5/28/2010 DIAL TESTING
LOCATION 6 LINE OF SITE
TONAWANDA COKE CORP.
Tonawanda, New York

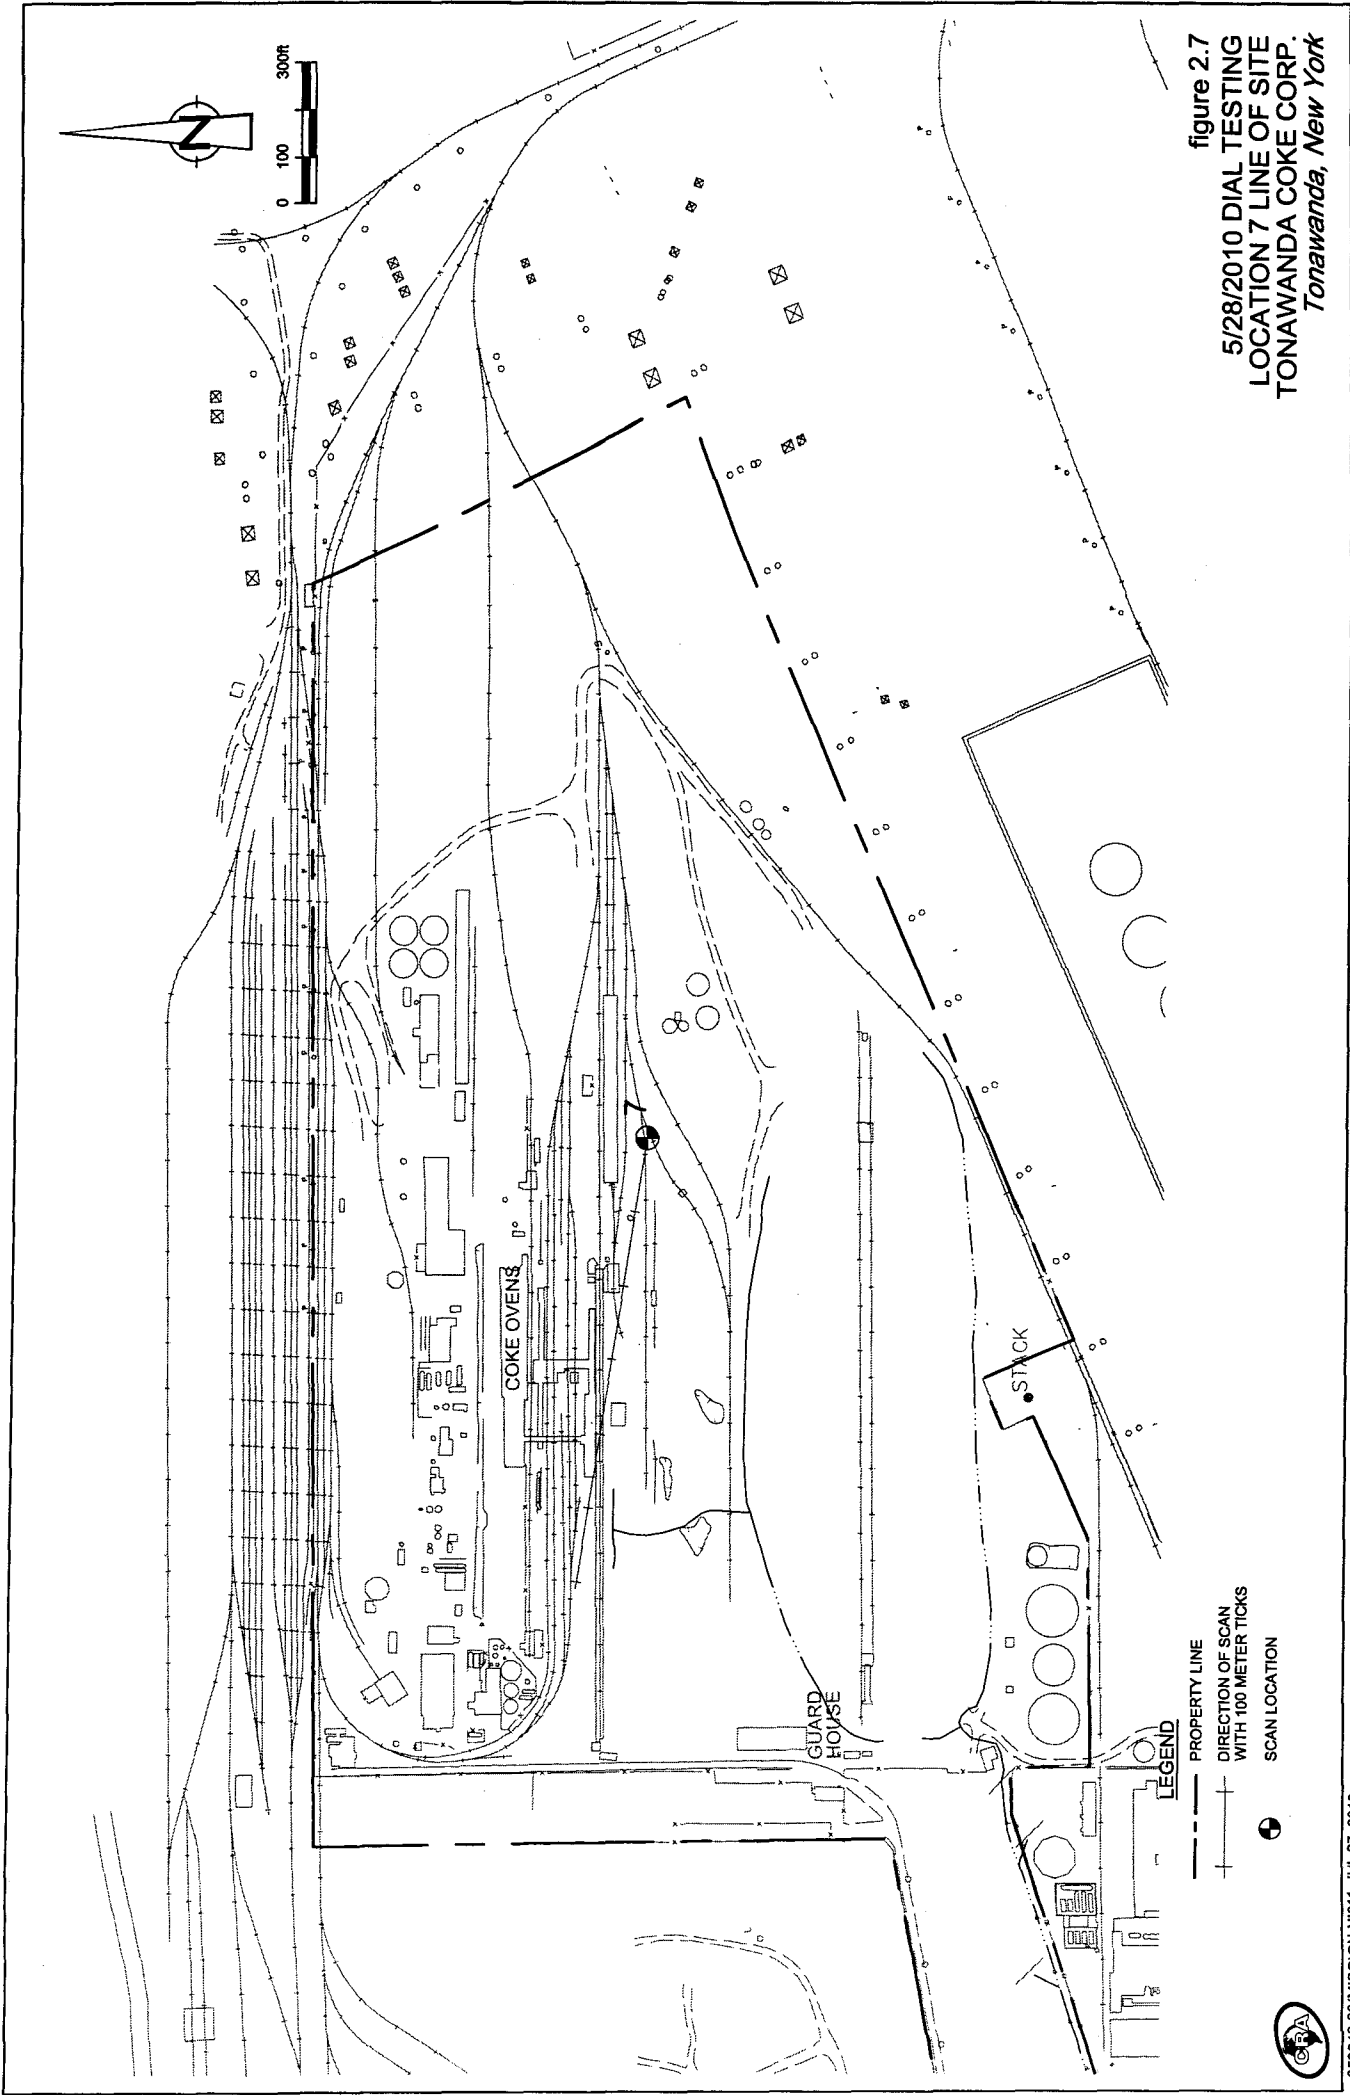
figure 2.7
5/28/2010 DIAL TESTING
LOCATION 7 LINE OF SITE
TONAWANDA COKE CORP.
Tonawanda, New York

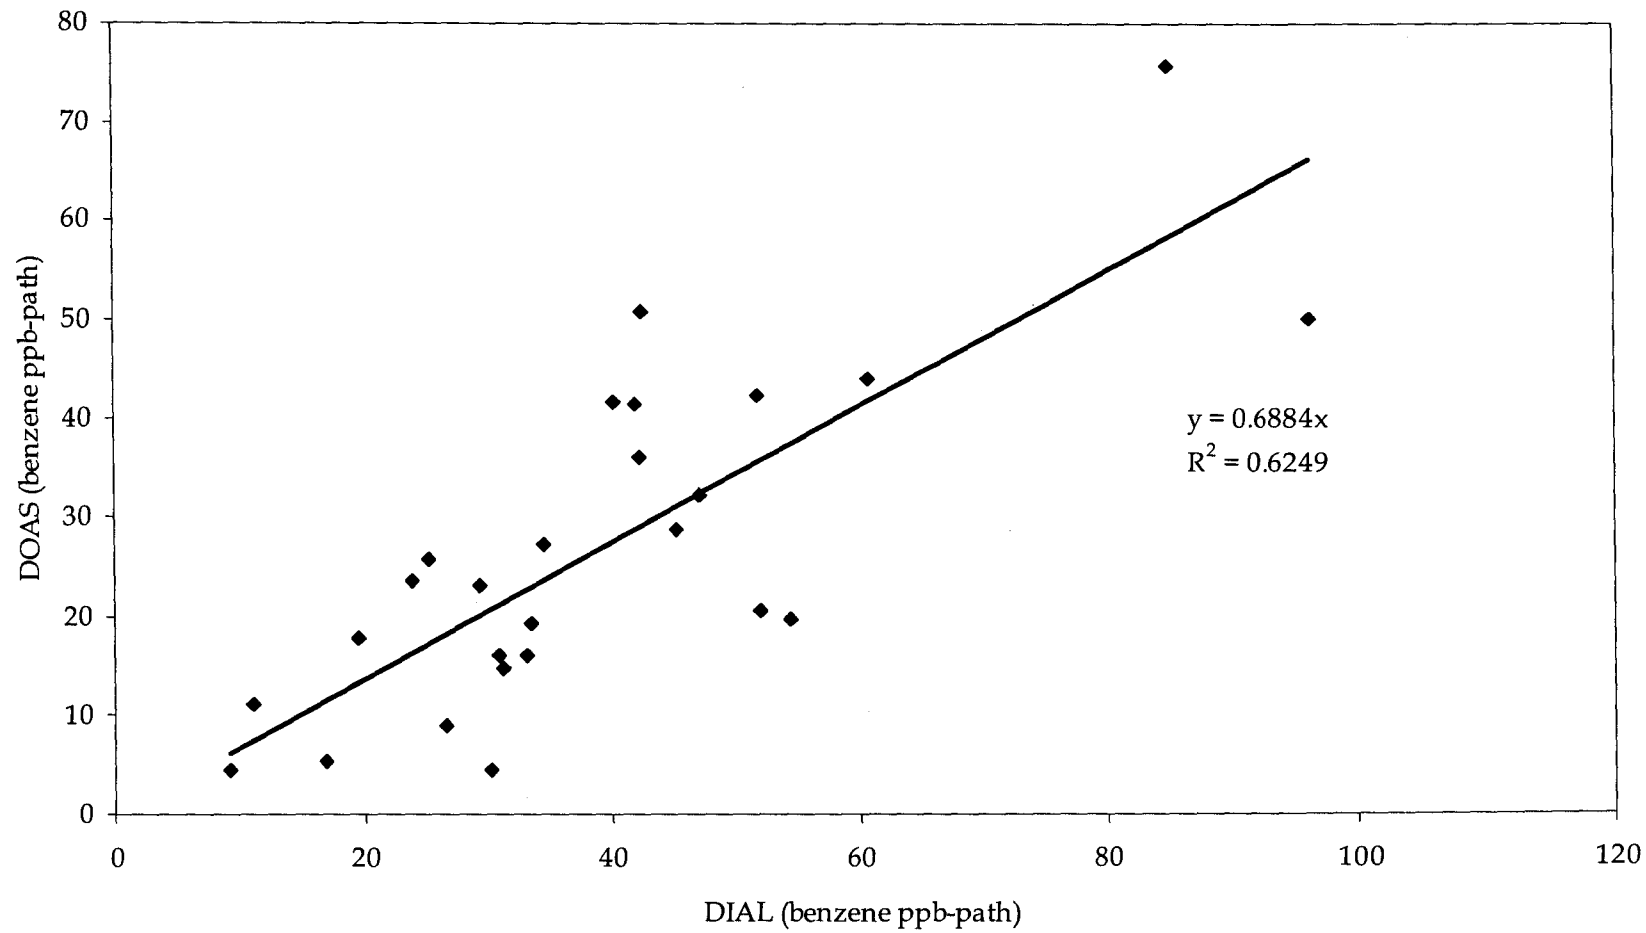
figure 4.1

COMPARISON OF DIAL TO DOAS
MAY 26, 2010 12:00-12:49
TONAWANDA COKE CORP.
Tonawanda, New York
