Vapor Intrusion Interim Measures Quarterly Report No. 1

Chamberlain Manufacturing Corporation

Former Facility at

550 Esther Street

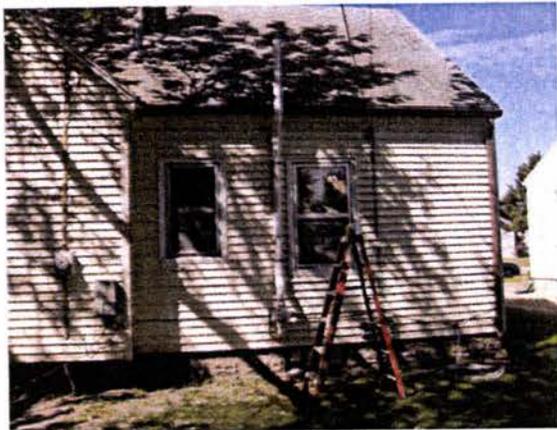
Photo #3 Residence No. 22 – Exhaust fan and stack

Due to the spacing of windows, the exhaust stack could not be located more than ten feet from openings into conditioned spaces; however, the stack was approximately centered between windows and extended approximately three feet above the eave. Extension of the stack beyond three feet would have increased the unsupported length excessively resulting in a possible hazard to the system operation or to occupants of the site.

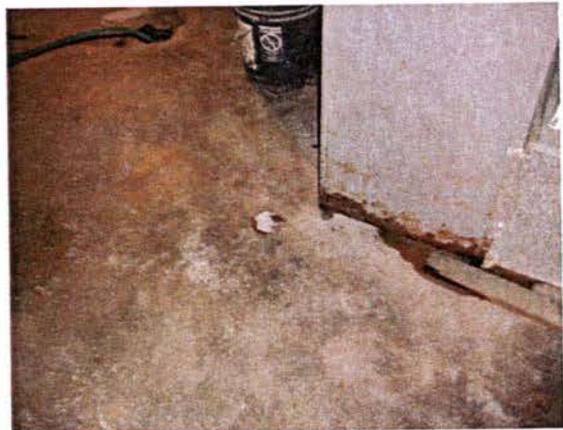
An approximate 1-inch diameter hole was observed in the floor slab. The hole was sealed with caulking.

Photo #4 Residence No. 22 – Patched hole in floor

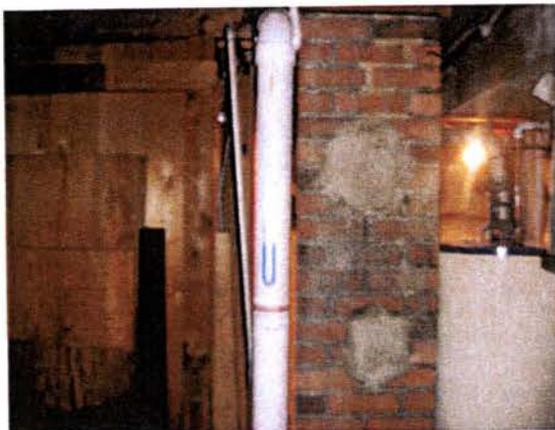
Photo #5 Residence No. 28 – Extraction point with manometer

A vapor mitigation system was installed at Residence No. 28 on September 13 and September 14, 2011. Based on the size of the Residence (approximately 730 square feet), a finished basement area that limited access, and sandy soils, Crystal determined that one extraction point would be adequate. The extraction point was installed near the center of the Residence based on observation of site conditions. A single hole was cored for the extraction point. A second hole, intended for diagnostic testing, was not cored in the floor to avoid creating a potential migration pathway for future vapors. As such, diagnostic testing was not completed.

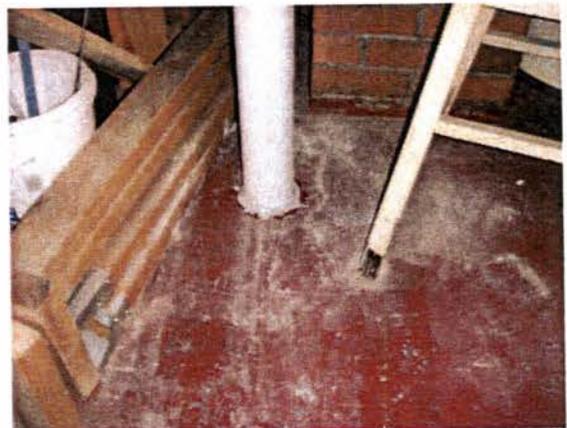
Photo #6 Residence No. 28 – Sealed extraction point

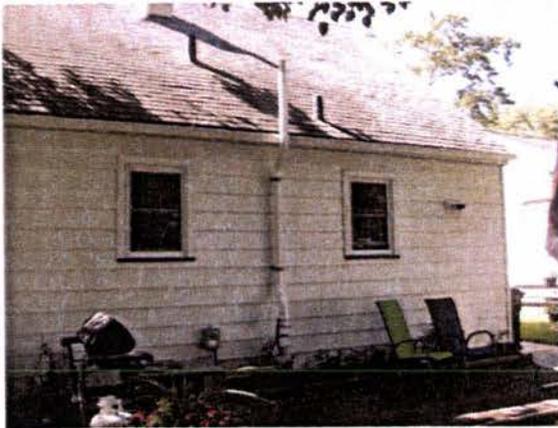
Photo #7 Residence No. 28 – Exhaust fan and stack

Due to the spacing of windows, the exhaust stack could not be located more than ten feet from openings into conditioned spaces; however, the stack was approximately centered between windows and extended approximately three feet above the eave. Further extension of the stack was not possible.

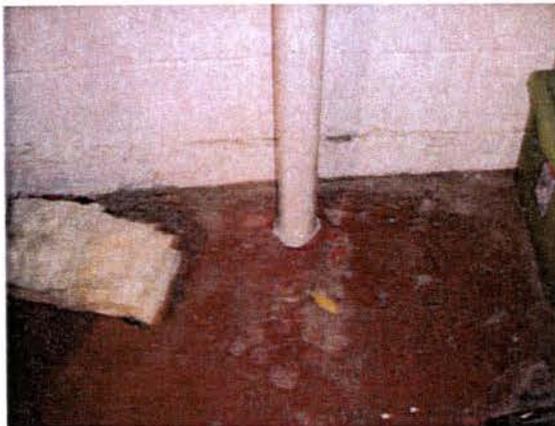
Photo #9 Residence No. 37 – Sealed extraction point

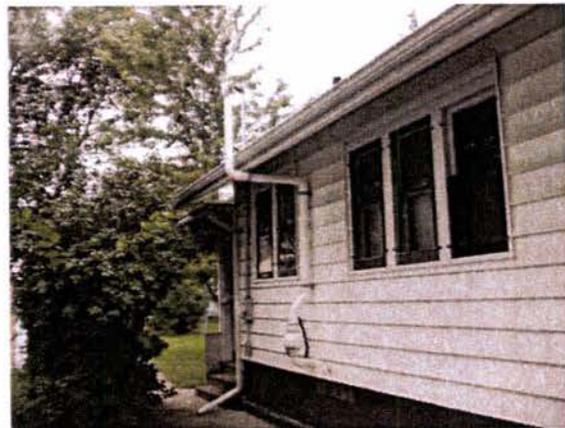
Photo #10 Residence No. 37 – Exhaust fan and stack

Due to the spacing of windows, the exhaust stack could not be located more than ten feet from openings into conditioned spaces; however, the stack was approximately centered between windows and extended approximately three feet above the eave. Extension of the stack beyond three feet would have increased the unsupported length excessively resulting in a possible hazard to the system operation or to occupants of the site.

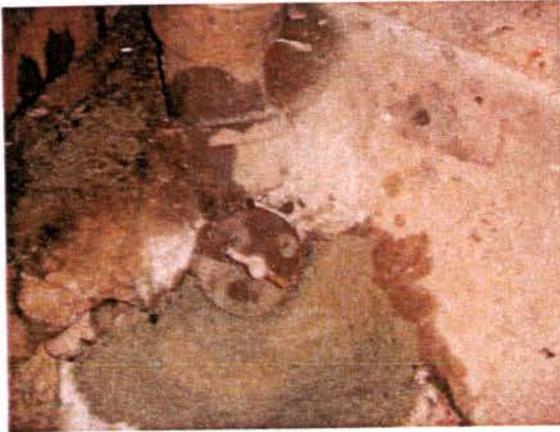
Broken concrete was observed around a sanitary sewer cleanout. The broken concrete was removed and the floor was patched with new concrete. A crawl space was sealed by covering the ground with plastic sheeting and sealing the plastic to the foundation walls. The floor of the crawl space was near ground level and well above the basement floor level. Due to Crystal's concerns about possible short-circuiting of exterior air and resulting decreased system performance, an extraction point was not installed in the crawl space.

Photo #13 Residence No. 38 – Patched floor at cleanout

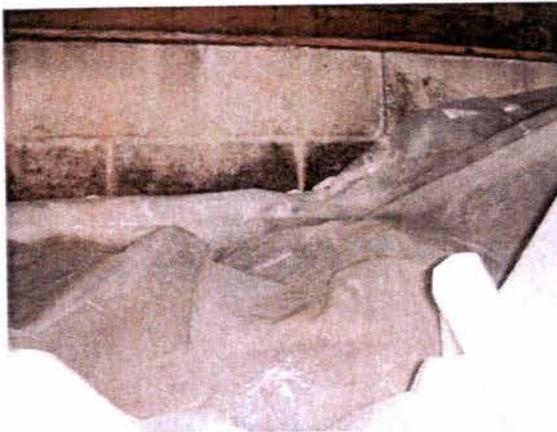
Photo #15 Residence No. 38 – Sealed crawl space

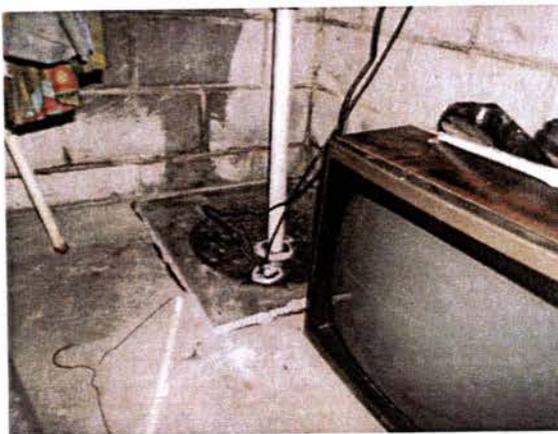
Photo #17 Residence No. 45 – Sealed sump pump cover

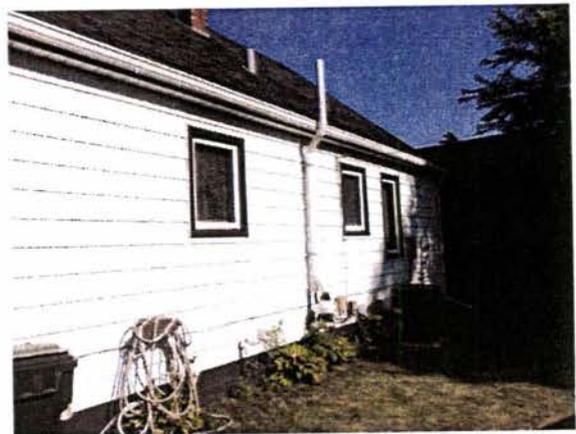
Photo #18 Residence No. 45 – Exhaust fan and stack

Due to the spacing of windows, the exhaust stack could not be located more than ten feet from openings into conditioned spaces; however, the stack was approximately centered between windows and extended approximately three feet above the eave. Extension of the stack beyond three feet would have increased the unsupported length excessively resulting in a possible hazard to the system operation or to occupants of the site.

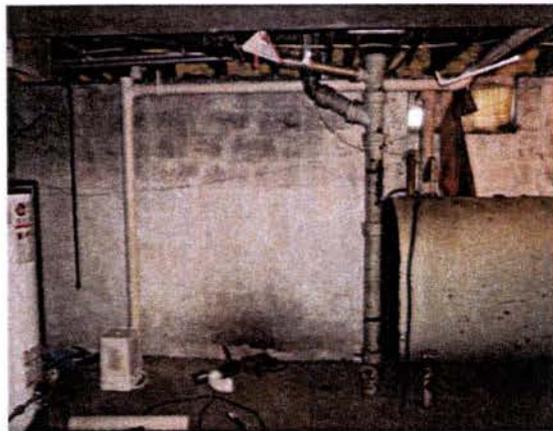
Photo #21 Residence No. 46 – Extraction point and piping

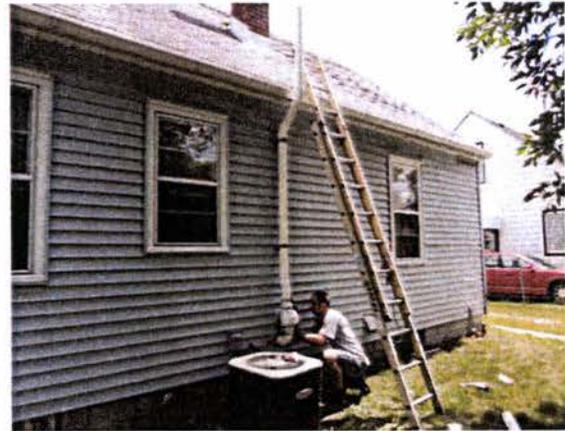
Photo #22 Residence No. 46 – Exhaust fan and stack

Due to the spacing of windows, the exhaust stack could not be located more than ten feet from openings into conditioned spaces; however, the stack was approximately centered between windows and extended approximately three feet above the eave. Extension of the stack beyond three feet would have increased the unsupported length excessively resulting in a possible hazard to the system operation or to occupants of the site.

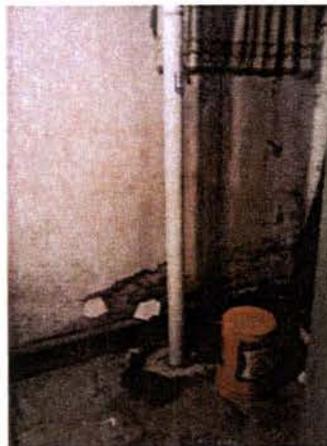
Photo #23 Residence No. 46 – Extraction point and manometer

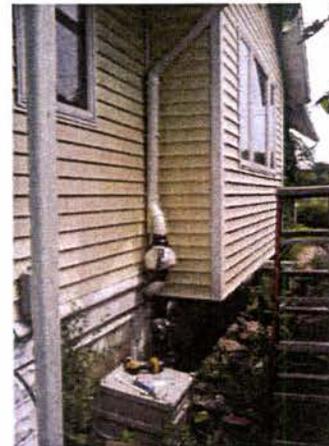
Photo #24 Residence No. 48 – Exhaust fan and stack

Due to the spacing of windows, the exhaust stack could not be located more than ten feet from openings into conditioned spaces; however, the stack was approximately centered between windows and extended approximately three feet above the eave. Extension of the stack beyond three feet would have increased the unsupported length excessively resulting in a possible hazard to the system operation or to occupants of the site.
