West Lake Update

March 24, 2016

EPA Releases First Round of Comprehensive Phase 1 Investigation Information

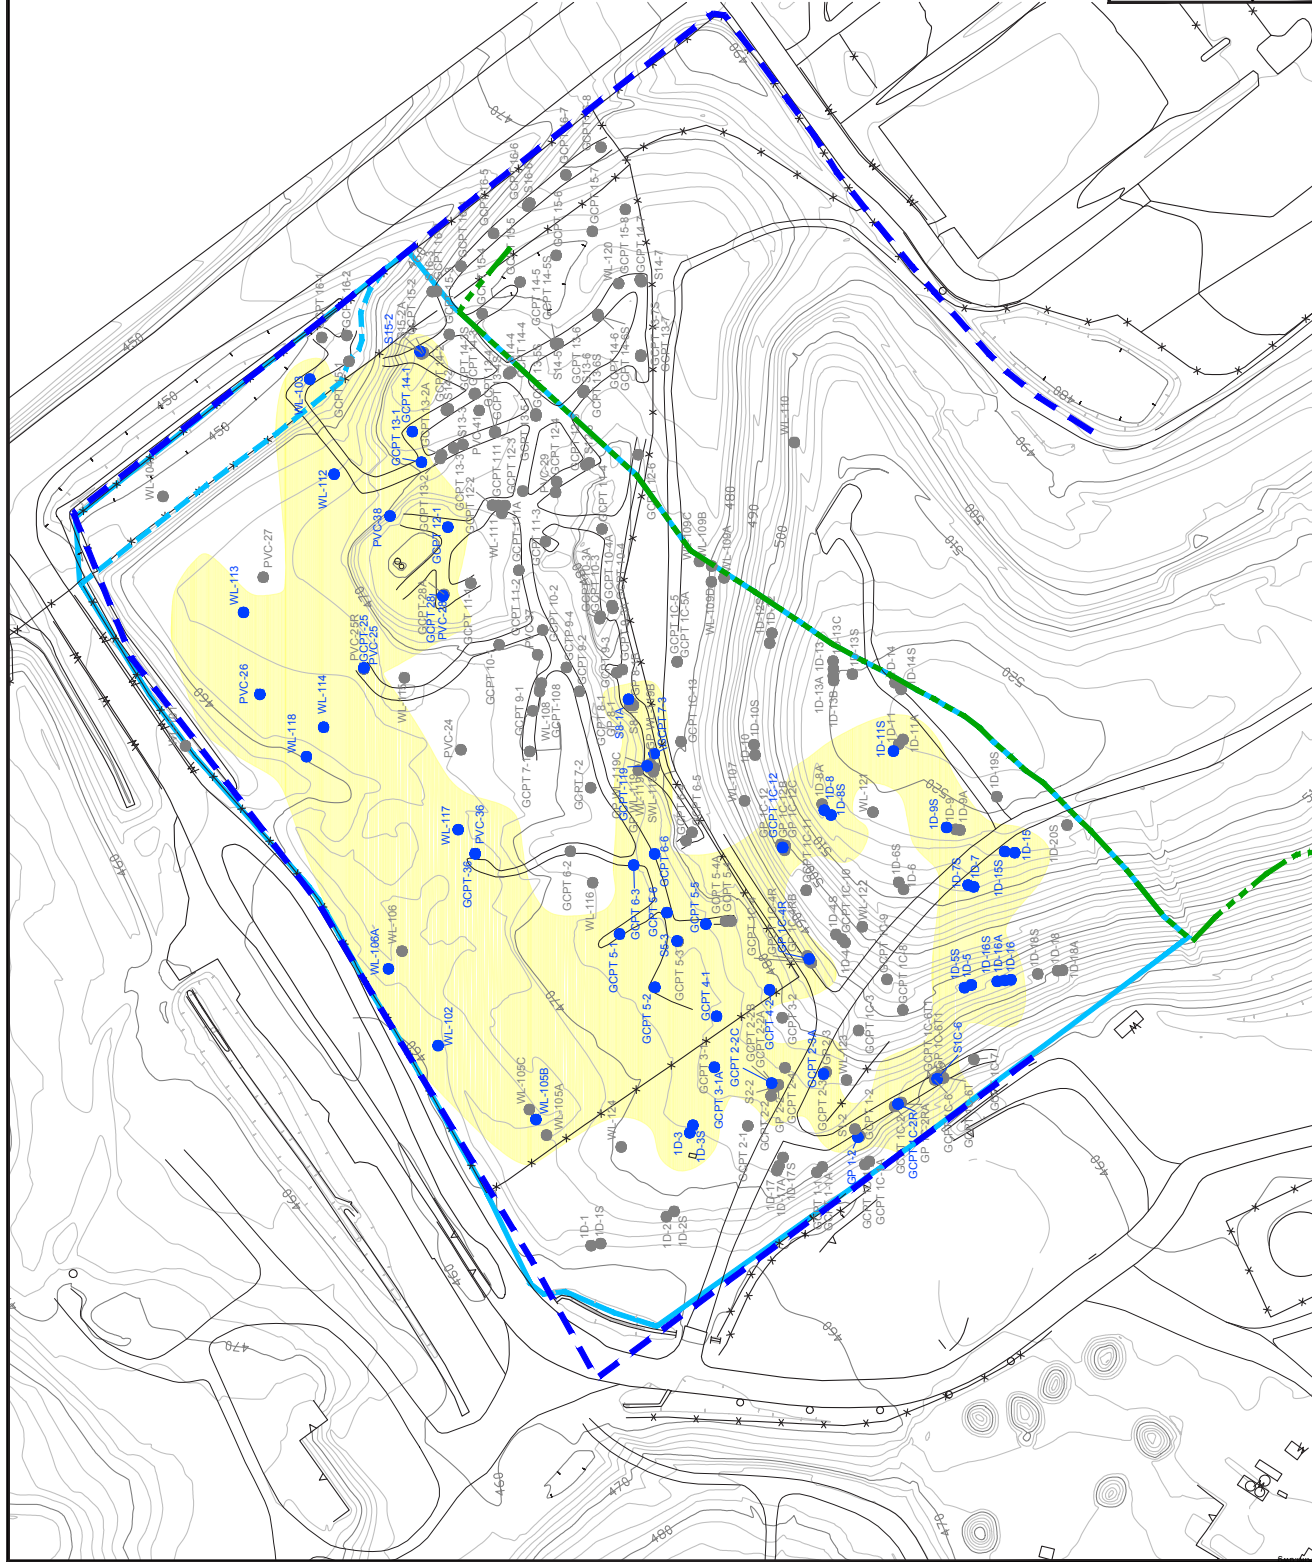
Figure 15
Extent of Radiologically-Impacted Material in Area 1
 West Lake Landfill Superfund Site

The Extent of RIM map depicts areas of RIM based on sampling points included in the Phase 1 Investigation and from historical site investigations. The Phase 1 investigation was conducted to determine the extent of RIM in Operable Unit

1 (OU-1), Area 1 of the West Lake Landfill. To accomplish the Phase 1 objective, contractors for the responsible parties under EPA oversight collected more than 120 soil samples from 110 borings and conducted gamma scans from across Area 1, to determine areas with RIM present. The soil samples were then analyzed in a certified laboratory to ensure the scientific accuracy and integrity of the data. The Phase 1 investigation identified RIM in areas of the landfill not identified during previous site investigations as shown on the Extent of RIM map. The Phase 1 investigation also determined that RIM was not present in certain areas previously presumed to contain RIM.

The Phase 1 data indicate that RIM has been identified further south and beneath a portion of the Bridgeton landfill known as the "Muffin Top". However, on-site monitoring from temperature monitoring probes, gas extraction wells, and landfill subsidence, indicate that the SSE remains in the South Quarry, hundreds of feet from the RIM and that there is no rapid movement of the SSE towards the North Quarry or the RIM in OU-1. The SSE is monitored and managed under the regulatory authority of the Missouri Department of Natural Resources. All information related to oversight and monitoring of the Bridgeton Landfill is posted on their website (<http://dnr.mo.gov/bridgeton/>). In December, EPA announced
