Purpose: RCRA Compliance Evaluation Inspection

Facility: Siemens Water Technologies Corporation

Date of Investigation: June 22, 2009

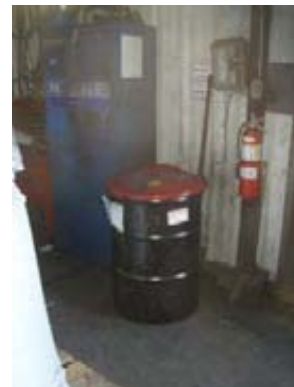
In addition to the containers of spent carbon from off-site facilities pending regeneration, the inspectors observed one 55-gallon satellite accumulation container for warehouse debris, dated 6/12/09, in this area (see photograph to the right). No potential violations were noted.

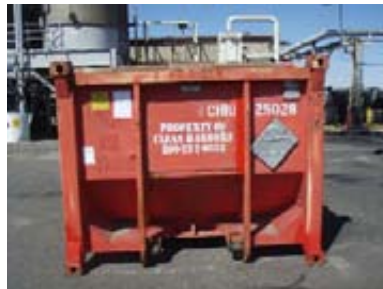
The 20-cubic yard roll-off bin was dated June 12, 2009 (see photograph to the right). No potential violations were noted.

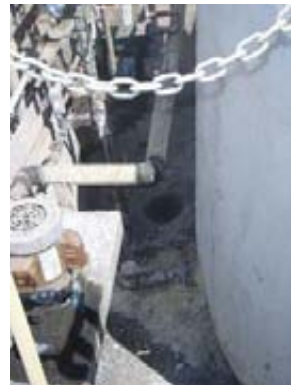
The inspectors observed some caustic residue from the product tank underneath one of the pipes (see photograph to the right). The inspectors informed the facility representative that this caustic should be cleaned up.

Findings: The inspectors observed dried caustic waste underneath a pipe next to the caustic product tank.

Subsequent to the inspection, the facility representatives provided photographs showing that this issue was resolved.

Facility Response: This area was cleaned up subsequent to the inspection.
