**Purpose:** RCRA Compliance Evaluation Inspection

**Facility:** UCSF Mission Bay  
50 Medical Center Way  
San Francisco, CA 94143

**Date of Inspection:** August 11, 2009

**Report Date:** September 22, 2009

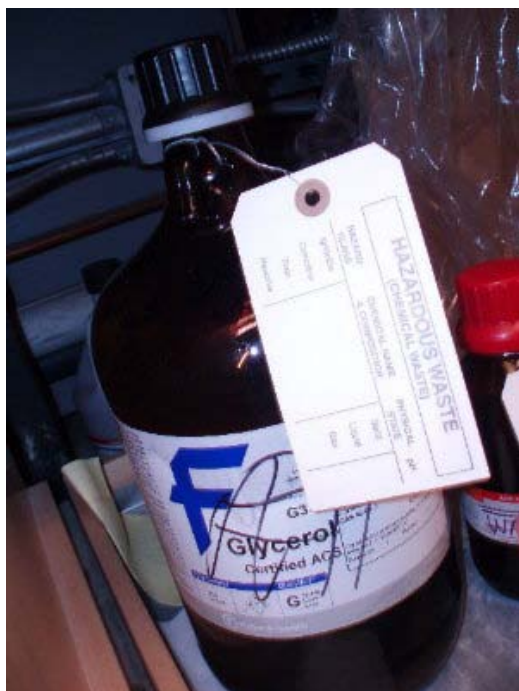
- The pre-printed facility hazardous waste labels lack a space for the physical state of the waste (solid or liquid?) as is required under CCR Title 22 §66262.34(f)(3)(A);
- One brown bottle under the fume hood had a hazardous waste label that was not filled out (Photo 1);

**Photo 1: bottle with label not filled out**

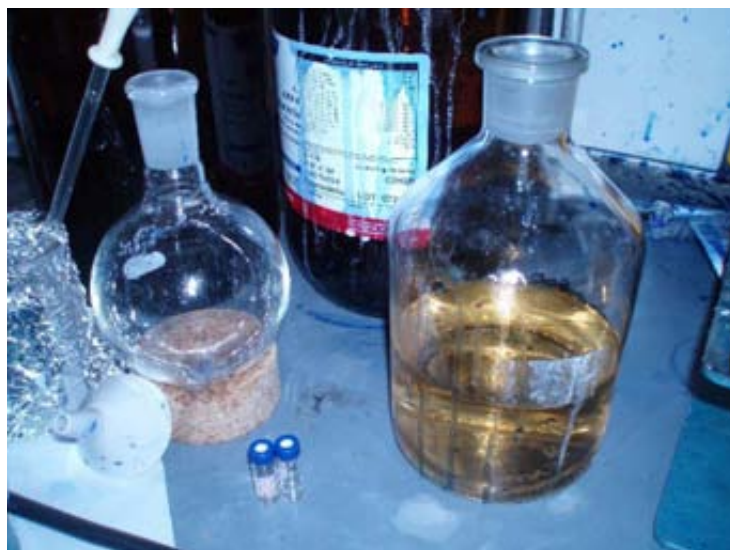
- There was an open, unlabeled container of a yellow/brown liquid under the lab fume hood (Photo 2). The lab manager could not identify the container's contents;

**Photo 2: open, unlabeled, unidentified container of yellow/brown liquid under lab's fume hood**

- Ortiz Lab: container of yellow/brown liquid under fume hood was open;
- James Lab: one Styrofoam container of hazardous waste was open;
- Frankel Lab: one container of phenol waste was open;
- Nichol Lab: one 7-gallon container of discarded ethidium bromide was open (corrected);
- Nichol Lab: one box of contaminated PPE was open.

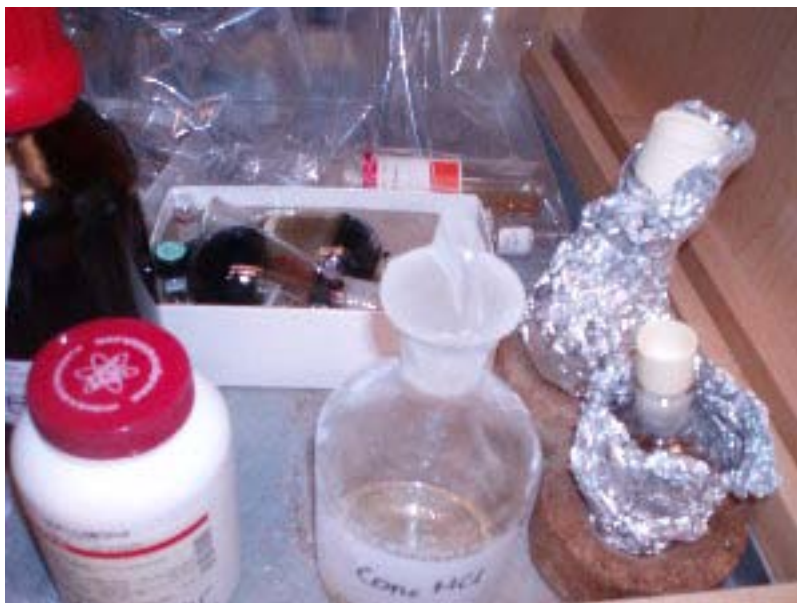
- A number of small, unlabeled bottles and vials were stored under the fume hood (Photo 3). At the time of the inspection, that lab manager could not confirm whether or not these contained hazardous wastes;

**Photo 3: unlabeled containers under the fume hood**

<ul style="list-style-type: none"> <li>- James Lab: assorted vials of hazardous waste were unlabeled;</li> <li>- James Lab: two bags of contaminated PPE were unlabeled;</li> <li>- Frankel Lab: one container of phenol waste was unlabeled;</li> <li>- Frankel Lab: assorted small containers of hazardous waste were unlabeled;</li> <li>- Nichol Lab: one box of contaminated PPE was unlabeled.</li> </ul> <p><u>Helen Diller Hall</u></p> <ul style="list-style-type: none"> <li>- McMahon Lab: one 1-gallon container of xylene waste was unlabeled;</li> <li>- McMahon Lab: one 1-gallon container identified as “FA waste” was unlabeled;</li> <li>- Long-Cheng Li Lab: six 1-pint containers of discarded phenol chloroform were unlabeled;</li> <li>- Wiencke Lab: two bottles of discarded potassium hydroxide were unlabeled.</li> </ul>
<p><b>Failure To Make A Hazardous Waste Determination</b></p> <p><b>Title 22 §66262.11 (40 CFR §262.11)</b></p>	<p><b>A person who generates a solid waste must determine if that waste is a hazardous waste.</b></p> <p>The facility failed to make a hazardous waste determination on the following wastes:</p> <p><u>Genetech Building</u></p> <ul style="list-style-type: none"> <li>- Ortiz Lab: container of yellow/brown liquid under fume hood;</li> <li>- Ortiz Lab: assorted small bottles under fume hood;</li> <li>- Ortiz Lab: 1-gallon container of HPLC effluent.</li> </ul>

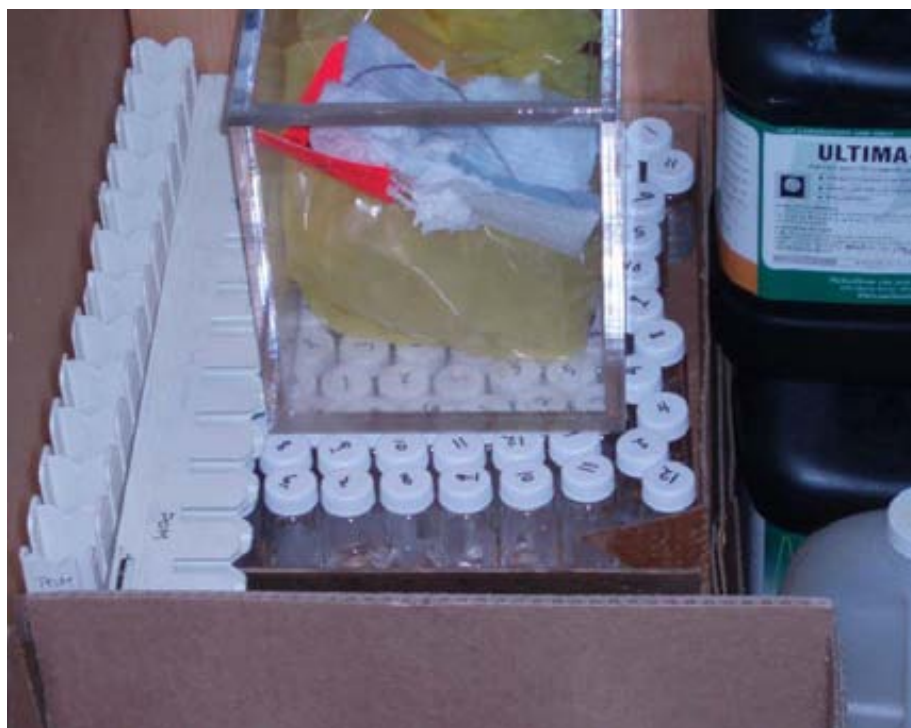
- Unlabeled discarded scintillation vials, partially filled with liquid (Photo 4). Discarded scintillation liquid is a mixed waste (both hazardous and radioactive);

**Photo 4: unlabeled, discarded scintillation vials still containing scintillation liquid**

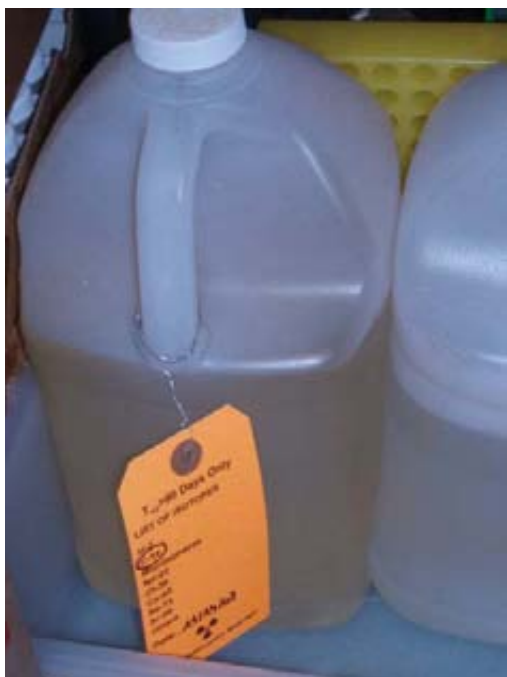
- Unlabeled HPLC effluent in a gallon container (Photo 5). The lab manager did not know at the time of the inspection whether or not this waste was hazardous.

**Photo 5: unlabeled, 1-gallon container of HPLC effluent**

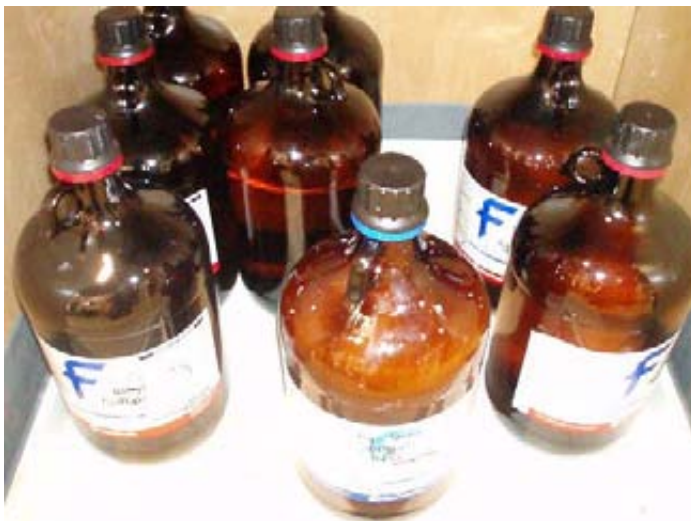
The inspectors noted eight unlabeled 1-gallon bottles of spent solvent (Photo 6), in violation of CCR Title 22 §66262.34(e)(1)(C) and Title 22 §66262.34(e)(1)(E), (f)(3), which requires that satellite accumulation containers are labeled with the following information:

- The words “Hazardous Waste”;
- The initial date of waste accumulation is clearly marked and visible for inspection on each container used for accumulation of hazardous waste;
- Composition and physical state of the waste;
- The particular hazardous properties of the waste;
- The name and address of the person producing the waste.

**Photo 6: eight unlabeled 1-gallon containers of spent solvent**

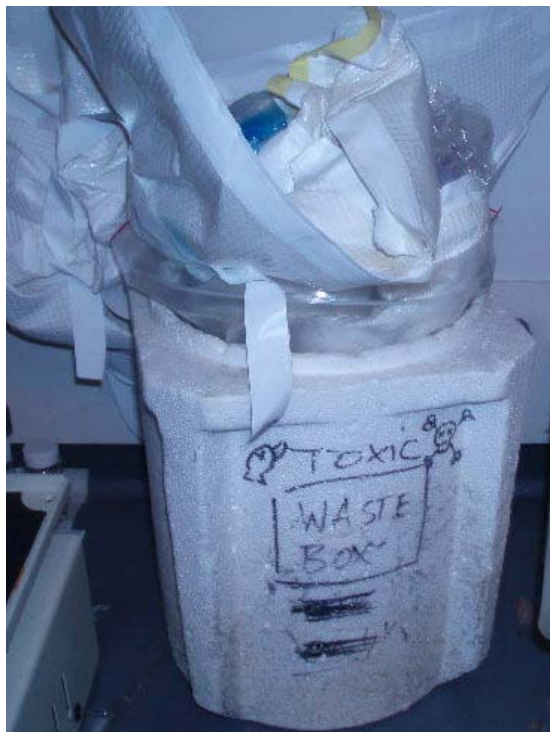
- One unlabeled and open Styrofoam container overflowing with hazardous waste (Photo 7);

**Photo 7: open, unlabeled, overflowing styrofoam hazardous waste container**

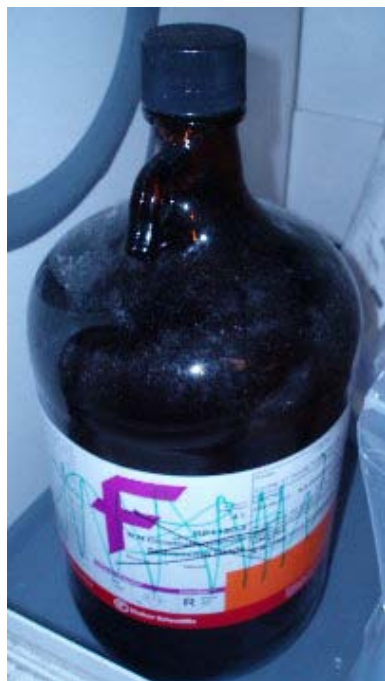
- One unlabeled 1-gallon brown bottle (Photo 8);

**Photo 8: unlabeled hazardous waste bottle**

<p><b>Satellite Accumulation Area Labeling Requirements</b></p> <p>Title 22 §66262.34(e)(1)(C); Title 22 §66262.34(e)(1)(E), (f)(3) (40 CFR §262.34(c)(1)(ii))</p>	<p><b>A generator may accumulate as much as 55 gallon of hazardous waste at or near any point of generation if each container used for onsite accumulation is labeled with the words “Hazardous Waste” and with the following information:</b></p> <ul style="list-style-type: none"> <li>- the initial date of waste accumulation is clearly marked and visible for inspection on each container used for accumulation of hazardous waste;</li> <li>- composition and physical state of the waste;</li> <li>- the particular hazardous properties of the waste;</li> <li>- the name and address of the person producing the waste.</li> </ul> <p>The following satellite accumulation area containers were either unlabeled or incompletely labeled:</p> <p><u>Genetech Building</u></p> <ul style="list-style-type: none"> <li>- Ortiz Lab: brown bottle under fume hood with label not filled out;</li> <li>- Ortiz Lab: discarded scintillation vials were unlabeled;</li> <li>- Taunton Lab: eight 1-gallon bottles of spent solvent were unlabeled;</li> <li>- Miller Lab: one 1-gallon bottle of mercury waste was unlabeled;</li> <li>- James Lab: one Styrofoam container of hazardous waste was unlabeled;</li> <li>- James Lab: one 1-gallon brown bottle of hazardous waste was unlabeled;</li> </ul>

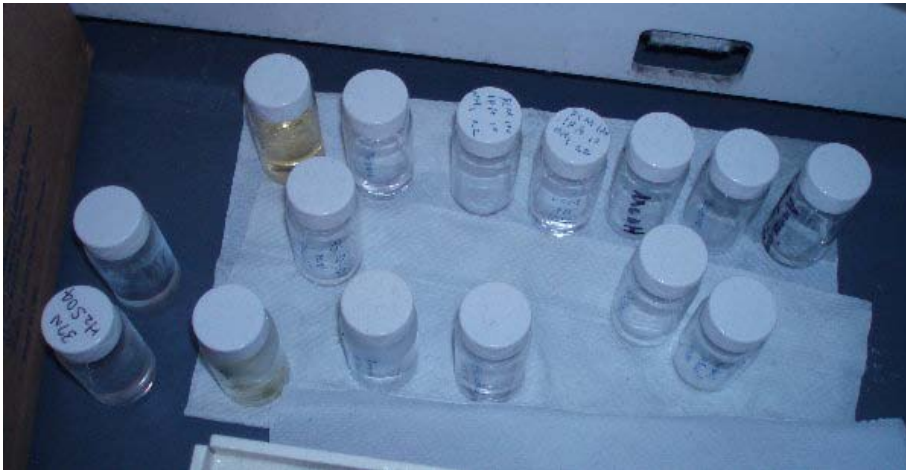
- Numerous discarded vials of hazardous waste (Photo 9);

**Photo 9: discarded vials of hazardous waste**

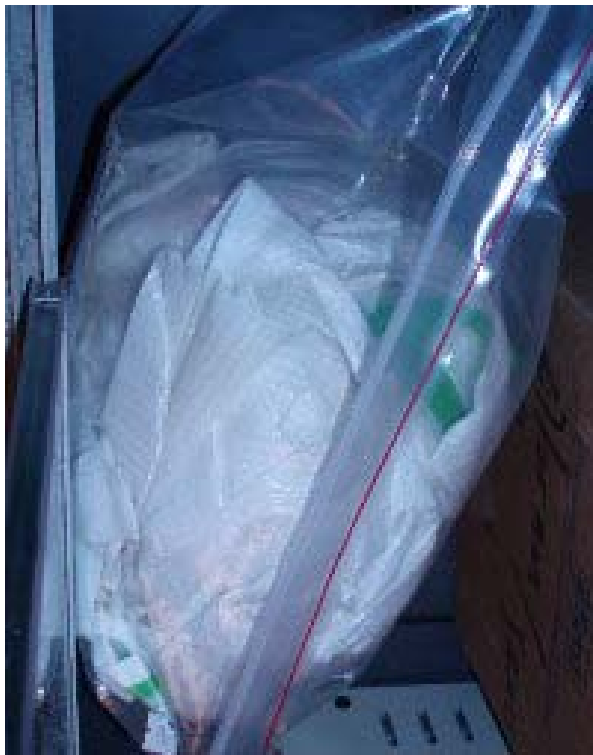
- Two unlabeled bags of contaminated personal protective equipment (PPE) (Photo 10);

**Photo 10: unlabeled bag of contaminated PPE**

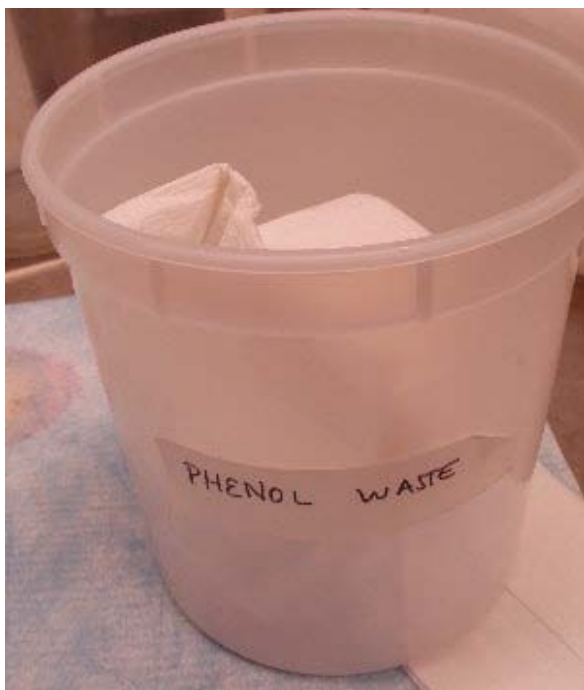
- One open container identified as “Phenol Waste” with no more labeling information (Photo 11);

**Photo 11: open, inadequately labeled container of phenol waste**

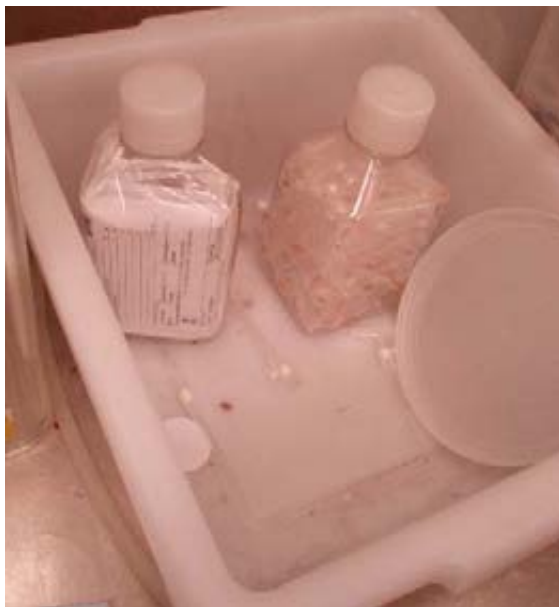
- Other small, unlabeled containers (Photo 12).

**Photo 12: unlabeled waste bottles**

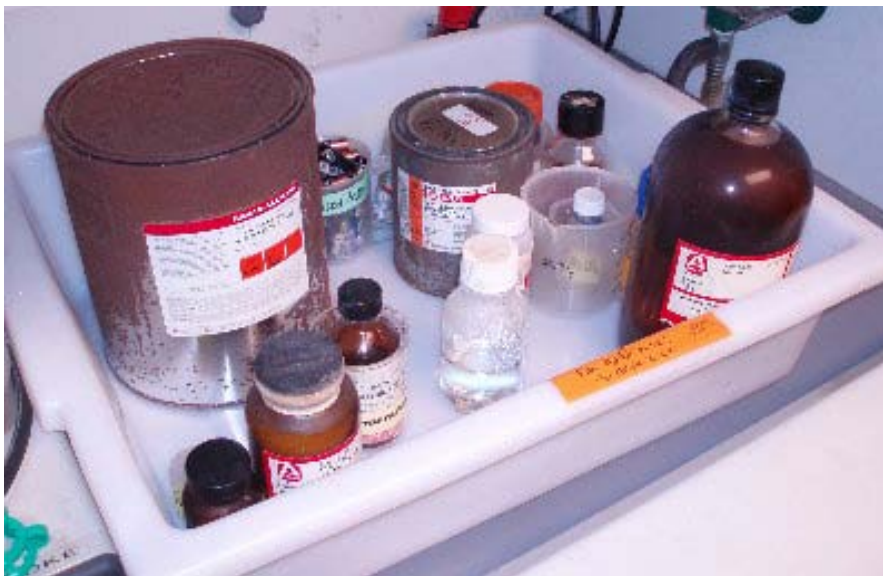
The inspectors noted one open bin containing what looked like discarded inventory. The lab manager stated that he was still in the process of making a determination of whether or not these containers were hazardous wastes (Photo 13).

**Photo 13: Discarded inventory waiting for a waste determination**

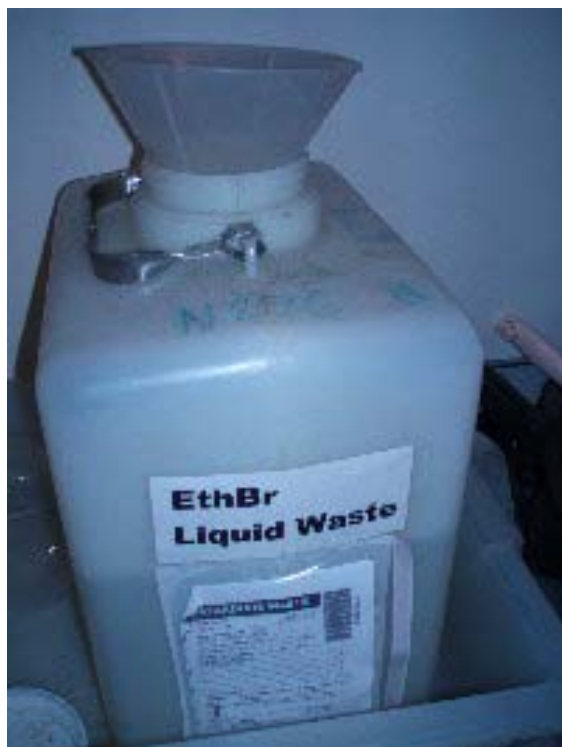
- One 7-gallon container of discarded ethidium bromide (Photo 14). The container was labeled properly, but was open at the time of the inspection, in violations of CCR Title 22 §66265.173 (this was corrected during the inspection).

**Photo 14: open container of discarded ethidium bromide**

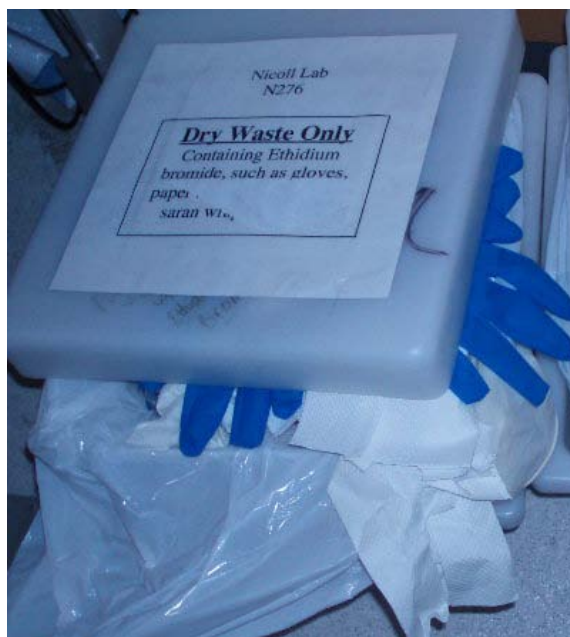
- One unlabeled, overflowing box of contaminated PPE (Photo 15).

**Photo 15: unlabeled, overflowing box of contaminated PPE**

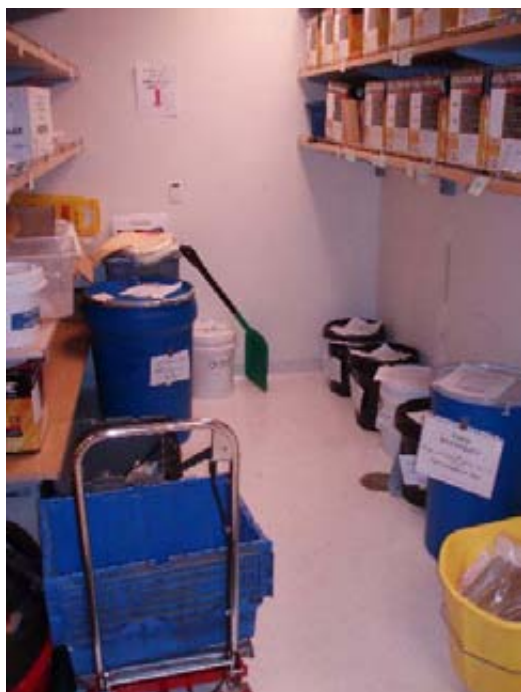
**- 90 Day Hazardous Waste Storage Area (Photo 16)**

All hazardous waste containers in this area were closed and labeled properly. A fire extinguisher and telephone were mounted on the wall. No violations were noted.

**Photo 16: Genetech hazardous waste storage area**

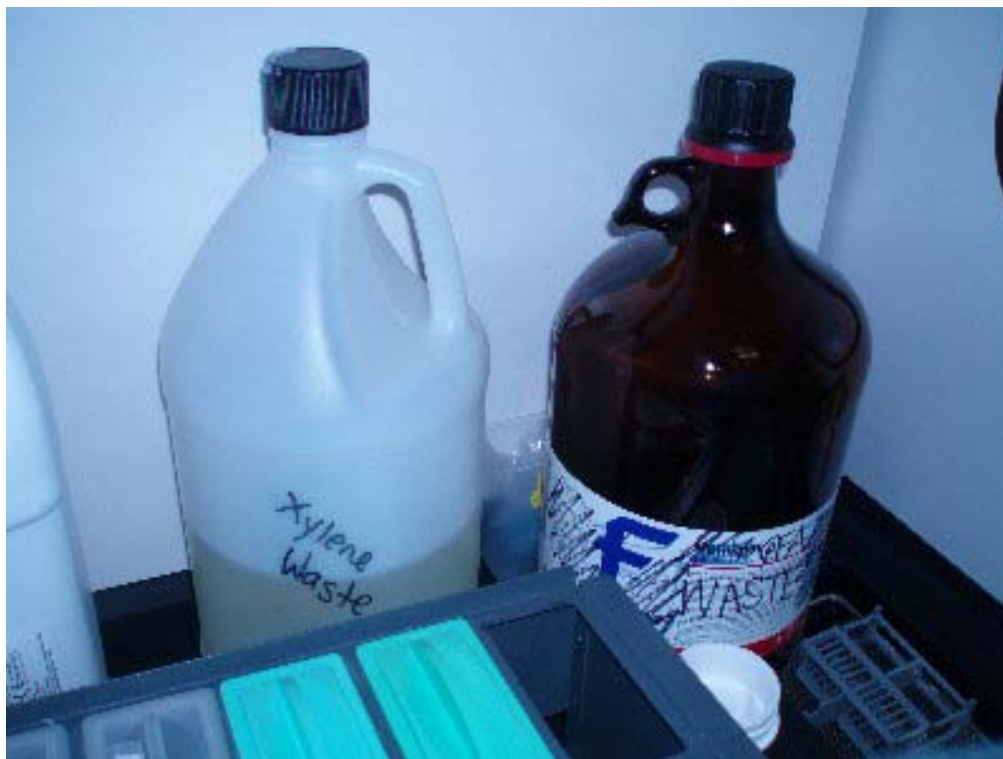
The inspectors noted that a 1-gallon container identified as “xylene waste” and a 1-gallon container identified as “FA waste” were insufficiently labeled (Photo 17).

**Photo 17: incompletely labeled containers identified as “xylene waste” and “FA waste” in the McMahon Lab.**

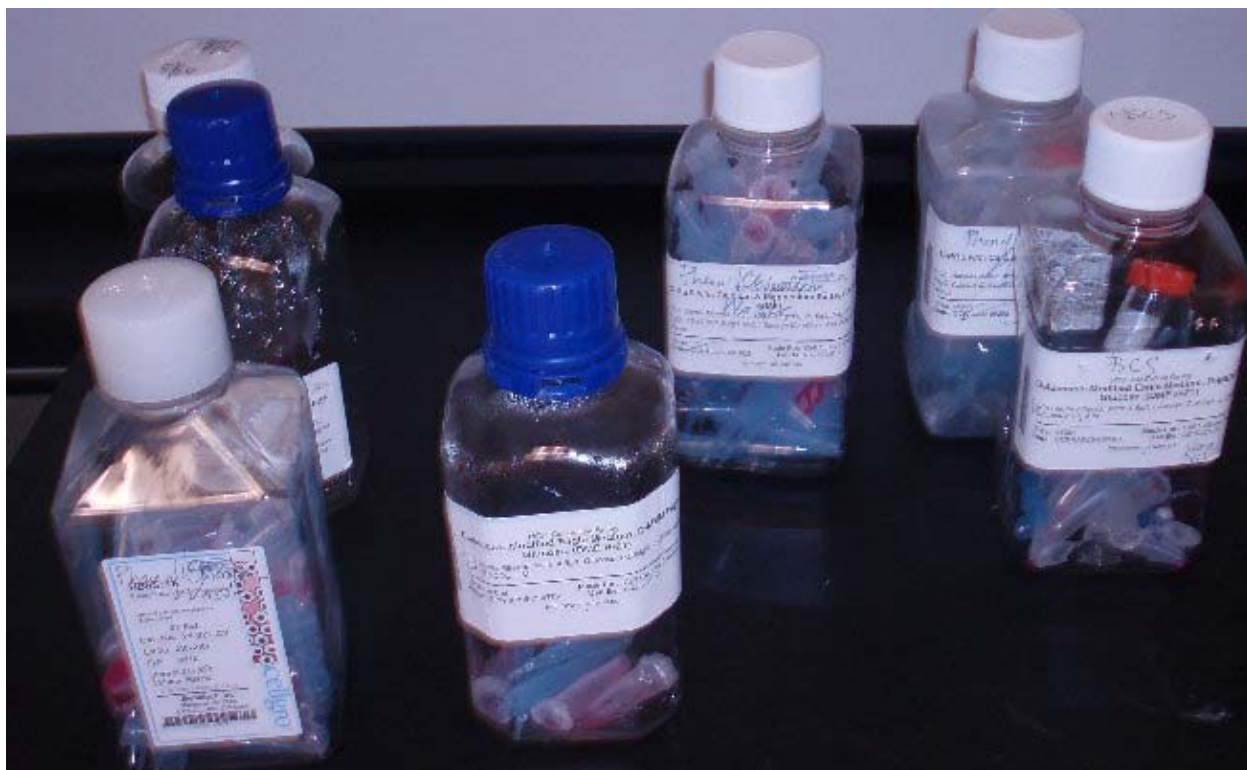
The inspectors noted that six 1-pint containers of waste phenol chloroform were not labeled (Photo 18).

**Photo 18: six unlabeled bottles of waste phenol chloroform in the Long-Cheng Li Lab**

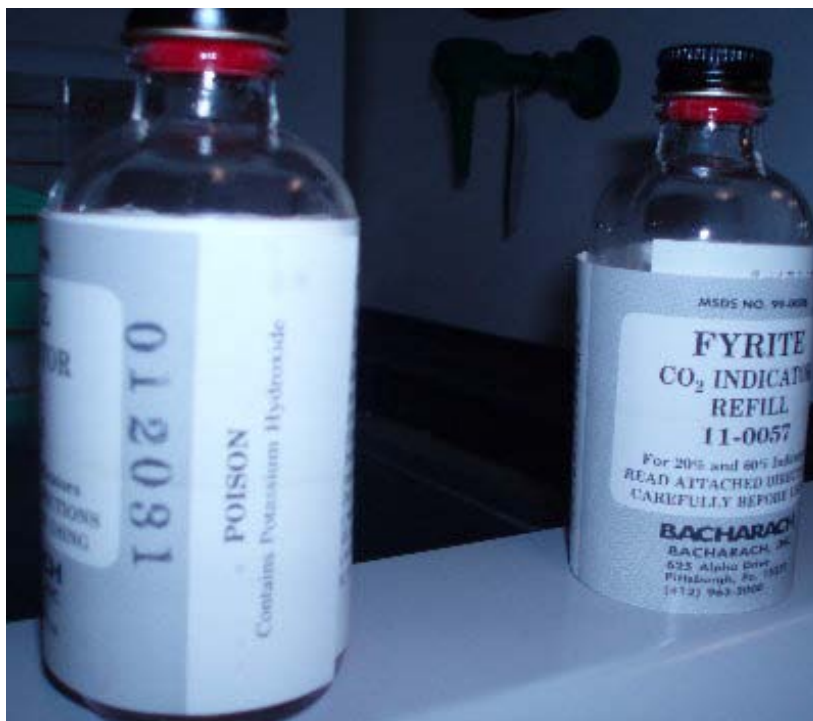
The inspectors noted two small unlabeled bottles of discarded potassium hydroxide in the lab waste bin (Photo 19).

**Photo 19: unlabeled bottles of discarded potassium hydroxide in the Wiencke Lab**
