Subject: Issuance of Findings of Violation and Order for Compliance for NPDES Permit Violations

On December 9, 2008, under the authority of the Clean Water Act (CWA), an EPA-authorized inspector and a representative of the Hawaii Department of Health (DOH) conducted a compliance inspection of Marisco Ltd.'s (Marisco's) Lil' Perris drydock and main facilities to determine Marisco's compliance with NPDES Permit No. HI0021786 and the CWA.

In the Matter of	)	
	)	
Marisco, Ltd.	)	FINDINGS OF VIOLATION
91-607 Malekole Road	)	
Kapolei, Hawaii	)	AND
	)	
Proceedings under Section 308(a) and 309(a)(3),	)	ORDER FOR COMPLAINEE
(a)(4) and (a)(5)(A) of the Clean Water Act, as	)	
amended, 33 U.S.C. Section 1318(a) and	)	Docket No. CWA-309(a)-09-014
1319(a)(3), (a)(4) and (a)(5)(A)	)

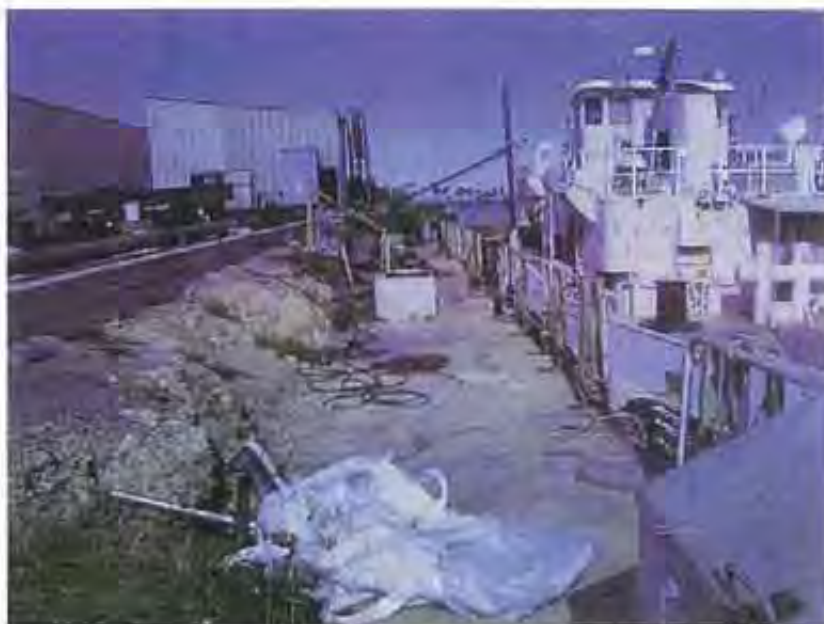
Photo 1: This photograph provides an overview of the dock, beyond the containment berm and on the edge of the water. This photograph is taken facing northwest. This area appeared to be used mostly as a walk way to the docked vessels, however observations during the inspection suggest that at a minimum, temporary or short-term storage of materials, including petroleum products, occurs at this location.

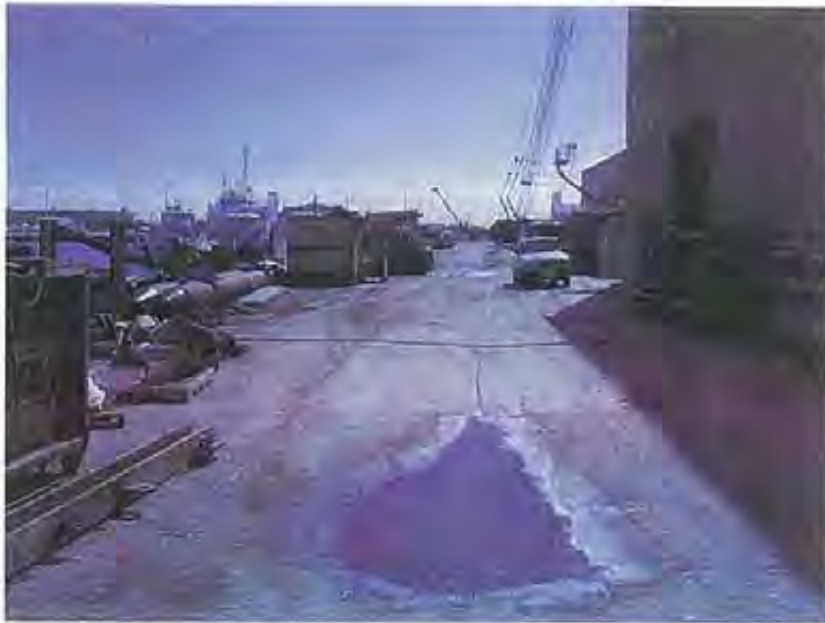
Photo 2: This photograph provides an overview of the main yard from approximately 3/4ths of the way down the southeast side. The Facility representative stated that most of the rainfall that occurs on-site is collected in the middle of the yard in three dry wells. The Facility representative was unsure of the volume of the dry wells. The gradient of the concreted area does suggest that the majority of the rainfall would drain toward the center of the main yard and into the dry wells. However, the gradient of the main yard near the bermed area was not apparent, and evidence of flow through gaps in the berm were observed during the inspection.

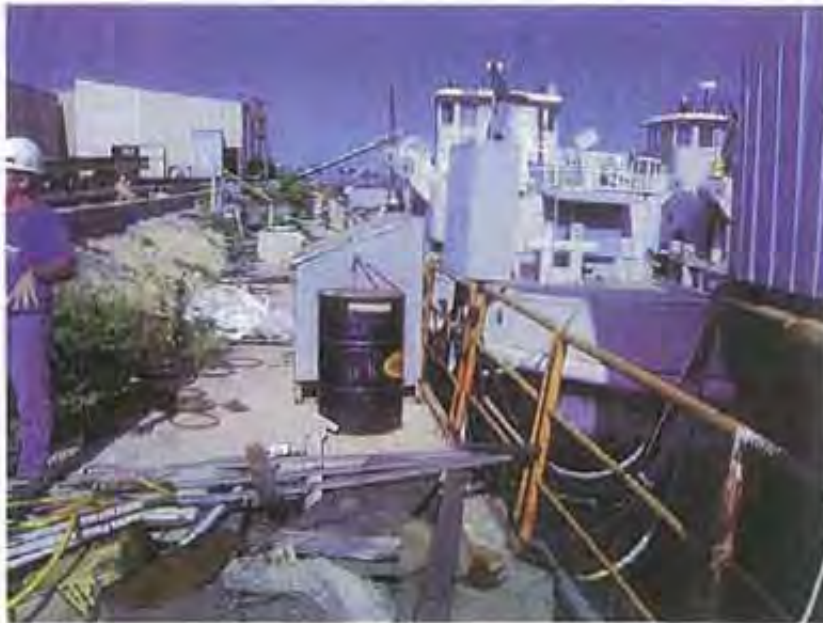
Photo 3: This photograph provides an overview of the dock, beyond the containment berm on the edge of the water, slightly further back than Photo 1. A 55-gallon drum of engine oil was observed on-site, exposed to potential rain fall, adjacent to the receiving water, and without secondary containment.

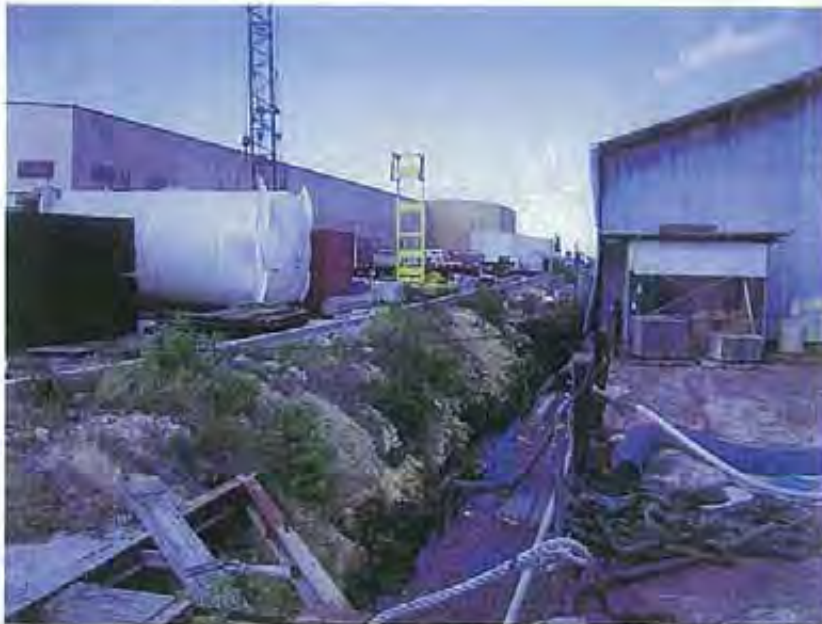
Photo 5: This photo was taken from the on-site "work barge", and depicts the drop-off from the bermed areas of the Facility directly into the receiving water. This is typical of the area referred to as "JR's Area" (area pictured above), and the portion of the main yard at the northwest end of the Facility, beyond the dockside walk way.

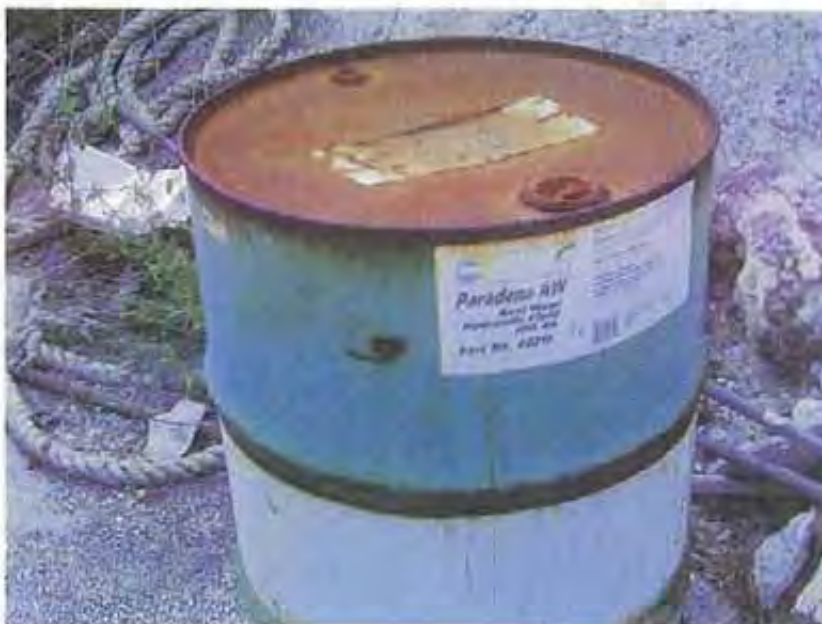
Photo 6: A 55-gallon drum of hydraulic fluid was observed on-site, adjacent to the receiving water, without secondary containment.

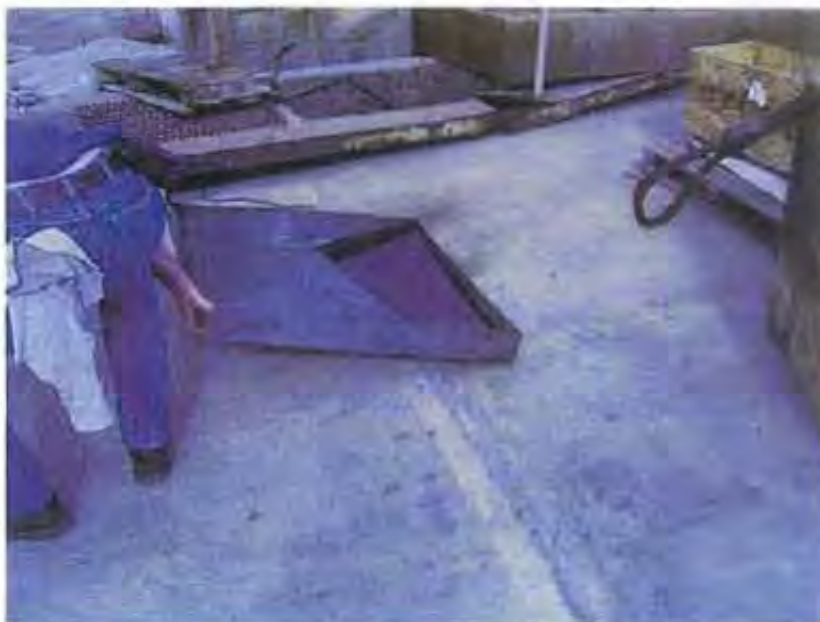
Photo 7: Unidentified liquid contained in a "make-shift" drip pan, resembling other petroleum products observed on-site, in the main yard adjacent to the berm surrounding the main yard.

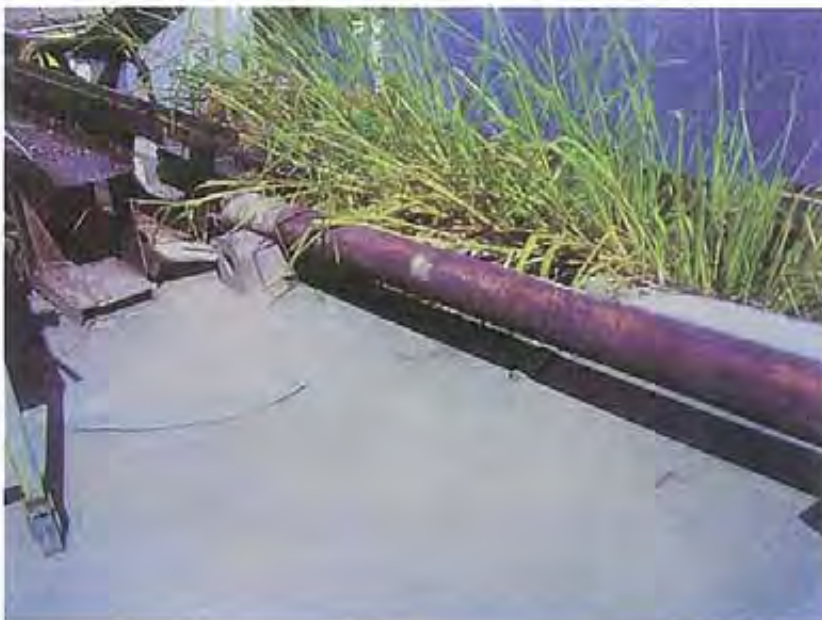
Photo 8: A break in the berm for the main yard.

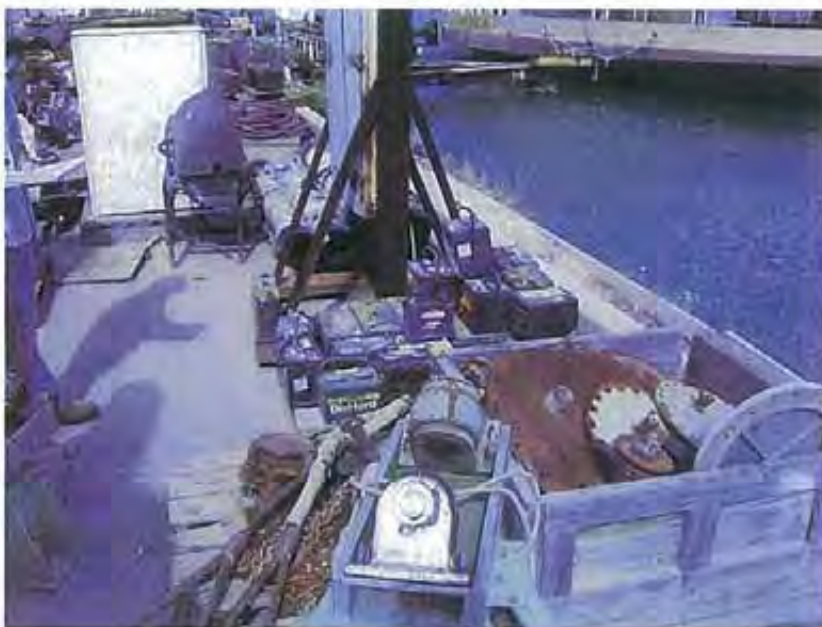
Photo 9: A pallet of used batteries stored in the main yard, adjacent to the berm around the main yard. A drainage hole in the berm was observed down gradient of this location (see Photo 9).

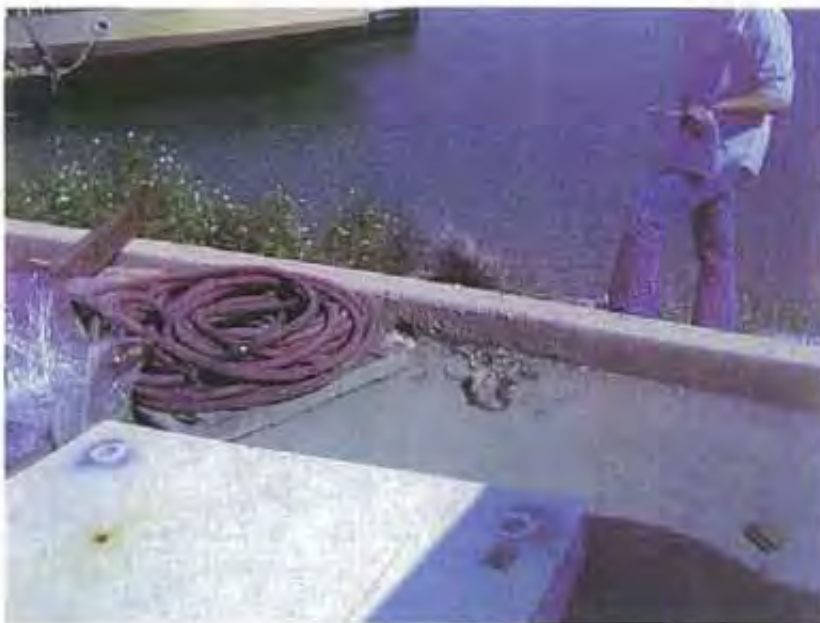
Photo 10: A drainage hole in the berm of the main yard, down gradient of the pallet of used batteries.

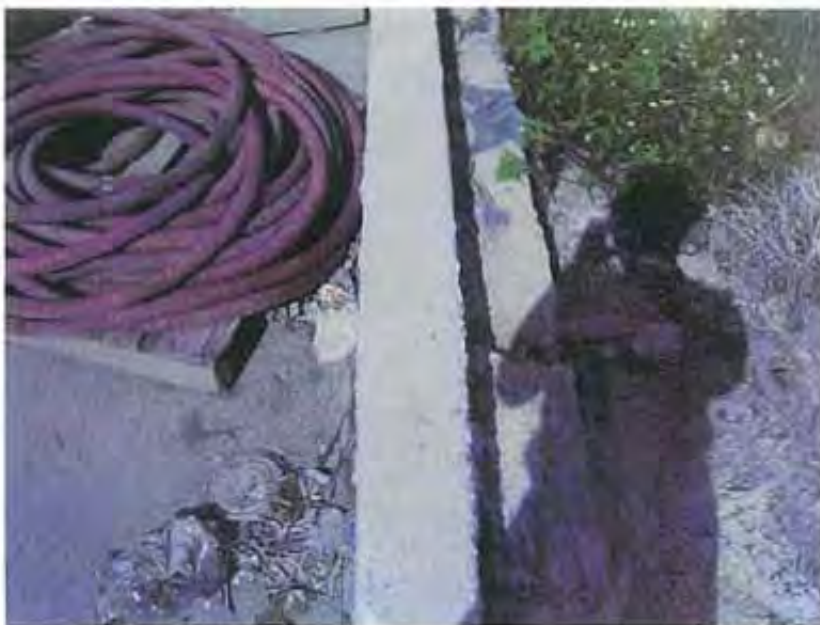
Photo 11: Debris and silt were observed around the drainage hole in the berm. Signs of erosion were observed on the water's side of the berm, indicating that discharges from this drainage hole have occurred. Flow through this discharge location would flow down the bank and directly into the receiving water.

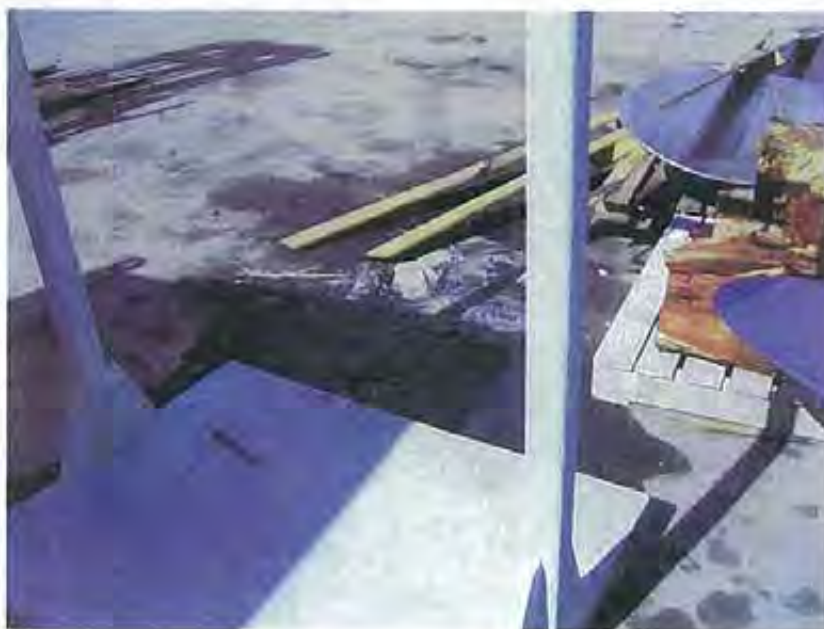
Photo 13: Signs of spillage and staining were observed in portions of the main yard.

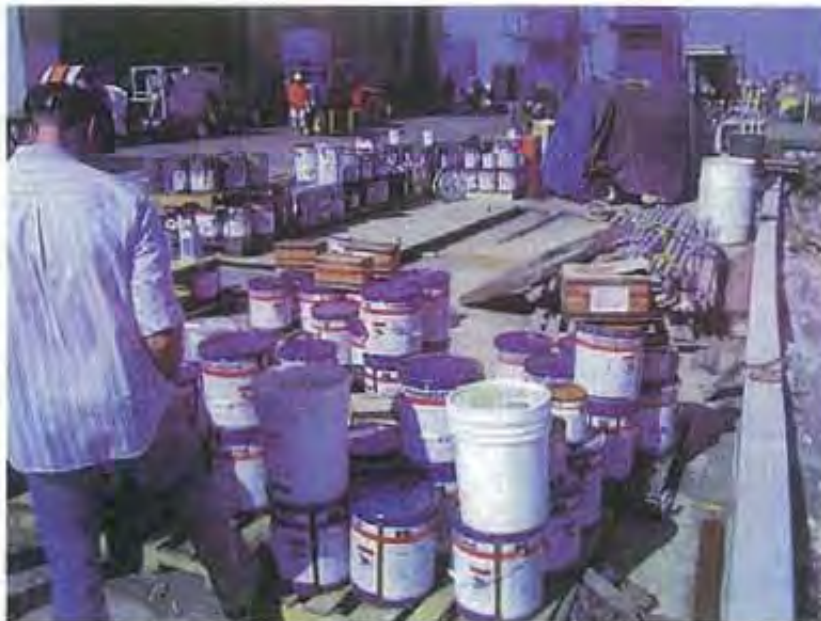
Photo 14: Large quantity of buckets of paint and paint thinner were observed in the yard, uncovered and without secondary containment. The Facility representative stated that this was a temporary measure while they cleaned out their paint storage lockers.

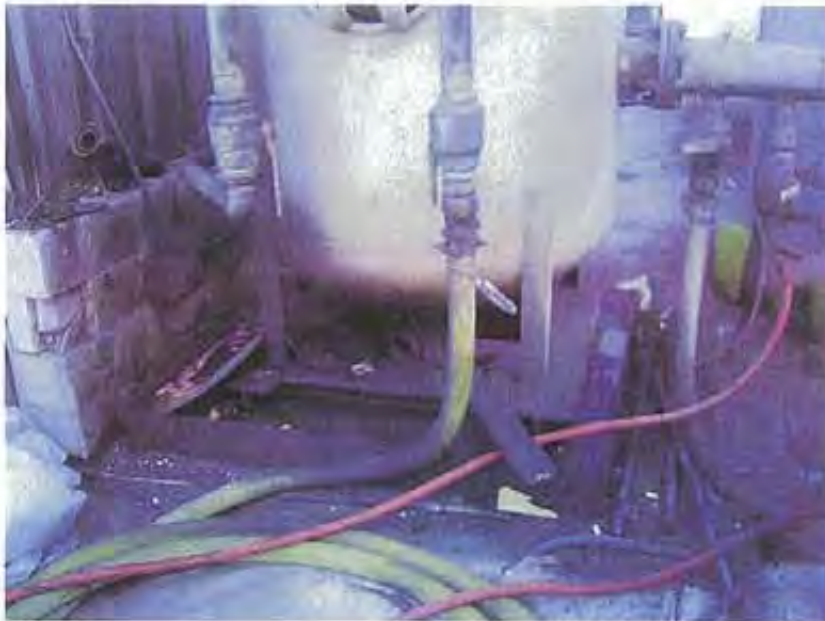
Photo 16: A drip pan for an air receiver located beside the metal working building full of a mixture of oil and condensate was observed. The drip pan was uncovered, exposed to potential rain fall, and without additional containment.

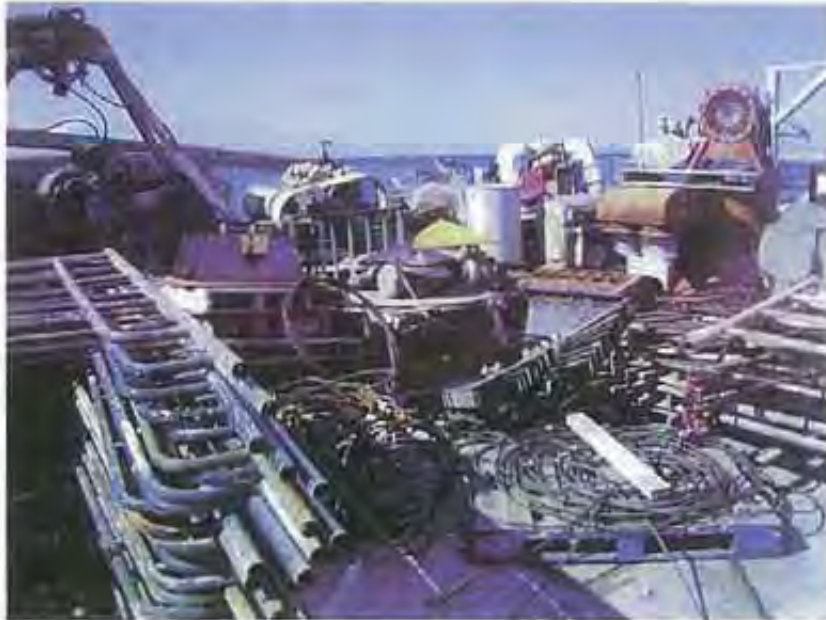
Photo 18: Material storage on the northwest end of the main yard. Engines, pumps, and other equipment were observed in this area.

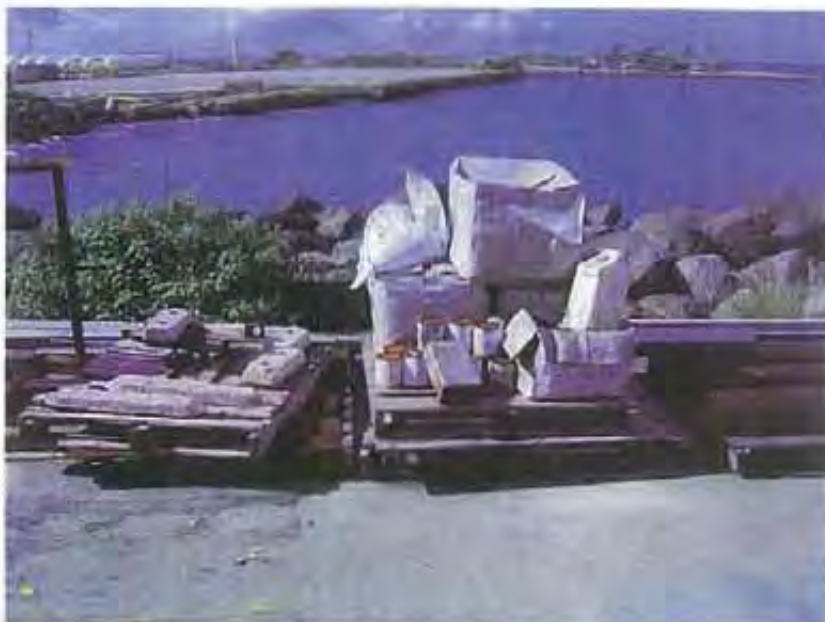
Photo 20: Additional cans of paint and zinc anodes were observed stored behind the metal working building, southwest of the main yard, exposed to potential rainfall and in the direct drainage area to a storm water outfall.

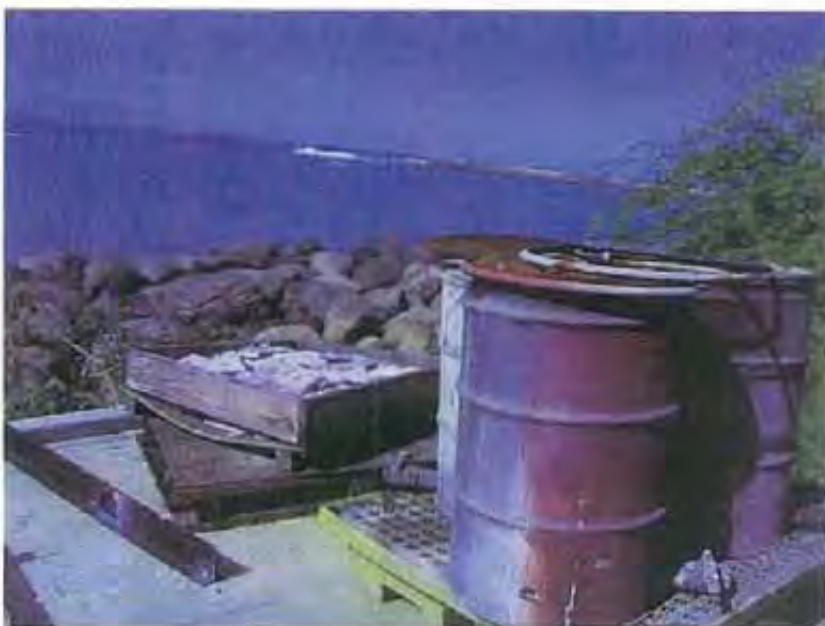
Photo 21: A wooden box of old zinc anodes were observed stored in the area behind the metal working building, exposed to potential rain fall and in the direct drainage area for a nearby storm water discharge location.

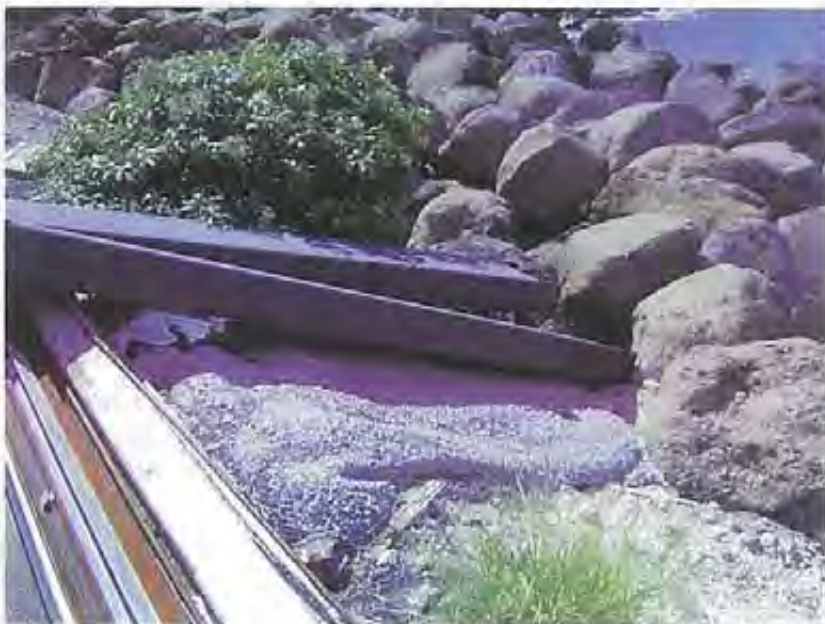
Photo 22: Evidence of concrete spillage from an on-site construction activity (possibly the construction of the concreted area itself or the berm) toward the receiving water. It is unclear if any of the concrete actually entered the receiving water. However this photo demonstrates a lack of effective best management practices utilized for the construction project by the Discharger this close to the edge of the receiving water.

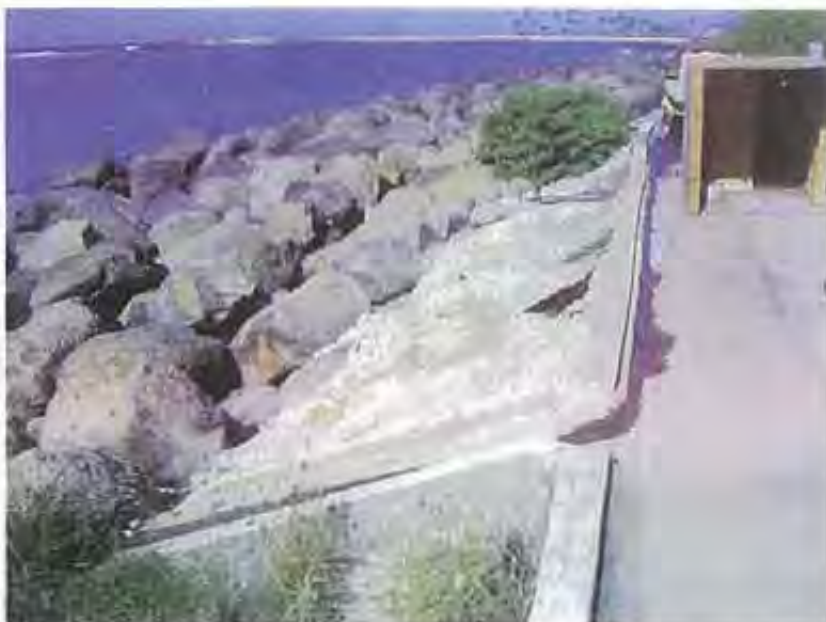
Photo 23: During the inspection, a storm water discharge location for the concrete area behind the metal working building was observed. Zinc anodes and paint cans are stored in this location. In addition, two dogs were observed chained in this area. Later in the day, a worker was observed hosing down the area toward the storm water outfall. Wash water runoff is visible discharging down the outfall.

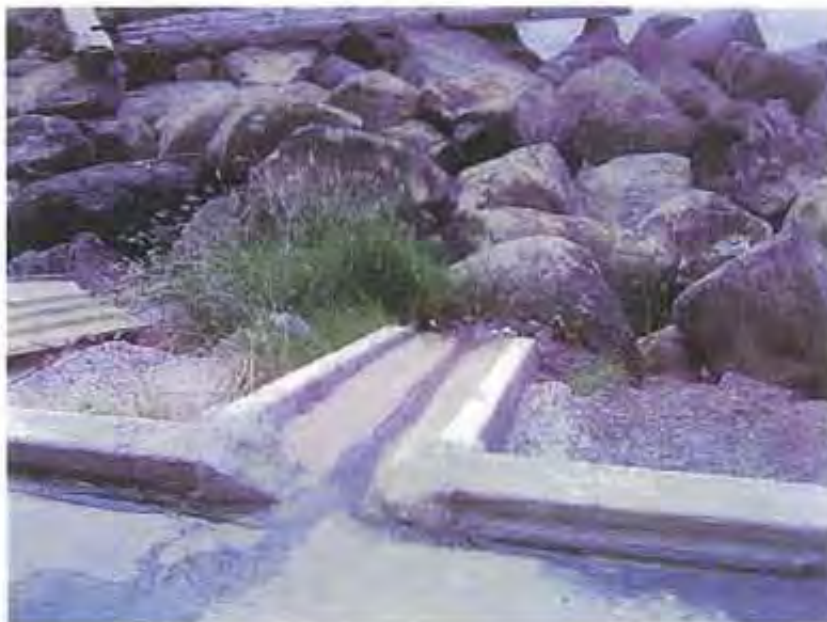
Photo 24: Another photograph of the storm water outfall for the area behind the metal working building. Wash water runoff is visible discharging down the outfall.

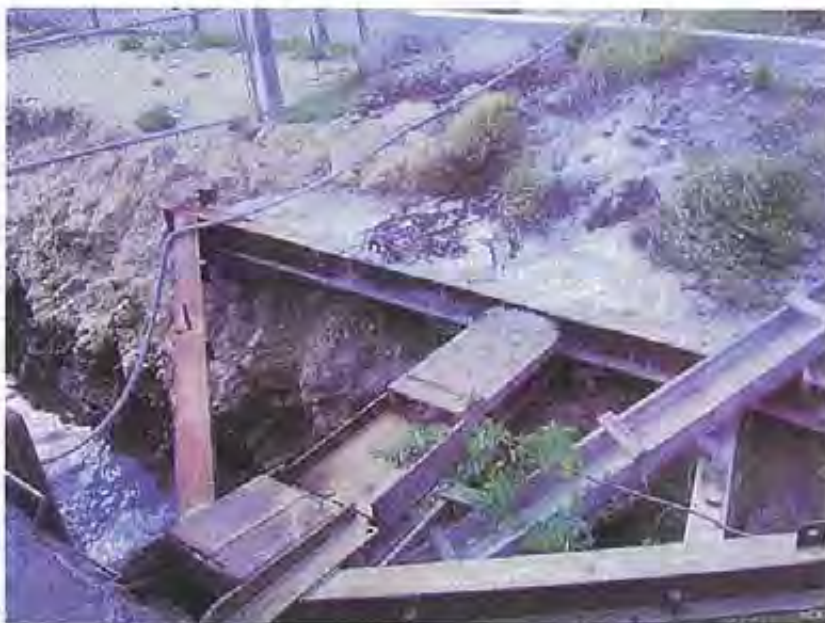
Photo 26: Evidence of concrete spillage from an on-site construction activity (possibly the construction of the concreted area itself or the berm) toward the receiving water. It is unclear if any of the concrete actually entered the receiving water, although concrete observed on the very edge of the metal frame work would indicate that it did. However this photo demonstrates a lack of effective best management practices utilized for the construction project by the Discharger this close to the edge of the receiving water.

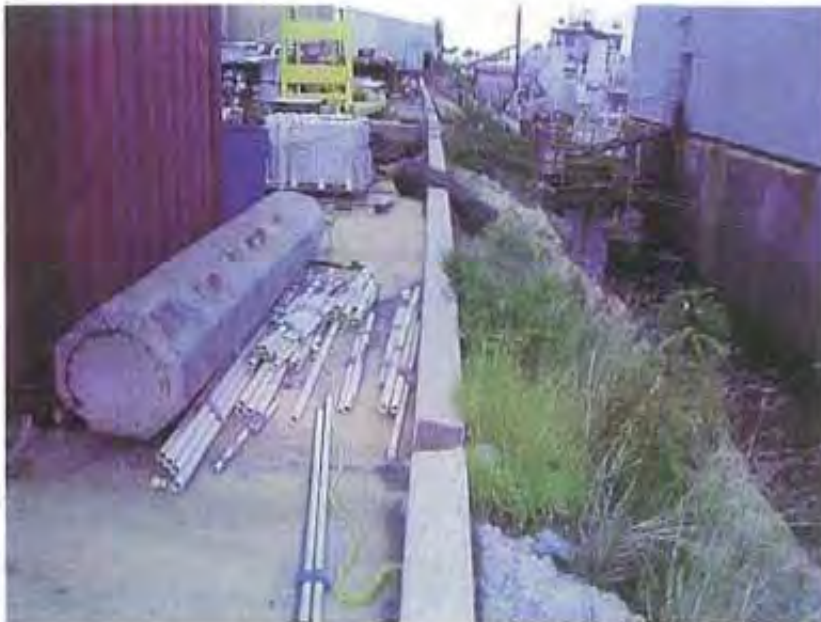
Photo 27: A gap in the berm surrounding JR's area. Discharges through this gap would flow down the bank and directly into the receiving water.

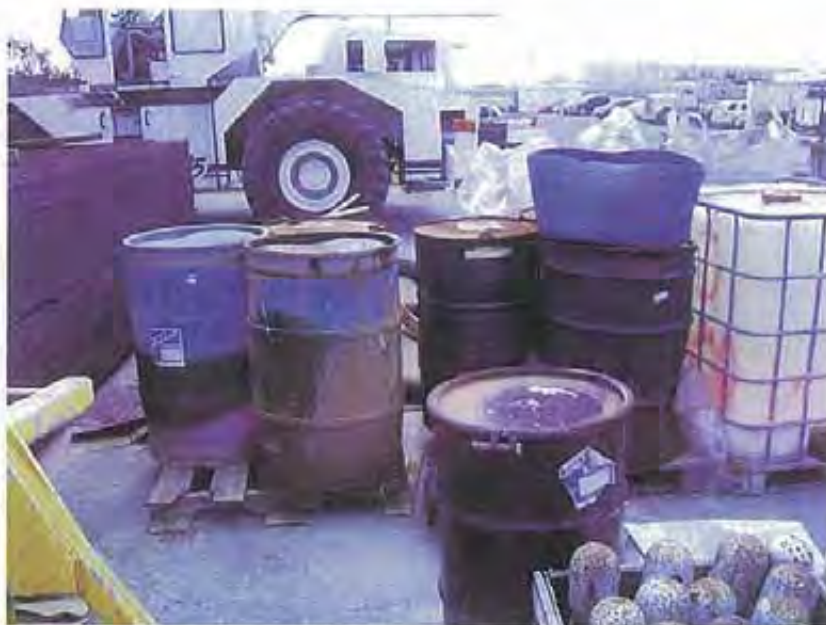
Photo 29: Three of the 55-gallon drums pictured (and labeled) above appeared to contain petroleum products, including motor oil and diesel fuel. These drums are not in a contained area, do not have secondary containment, and are exposed to potential rain fall.

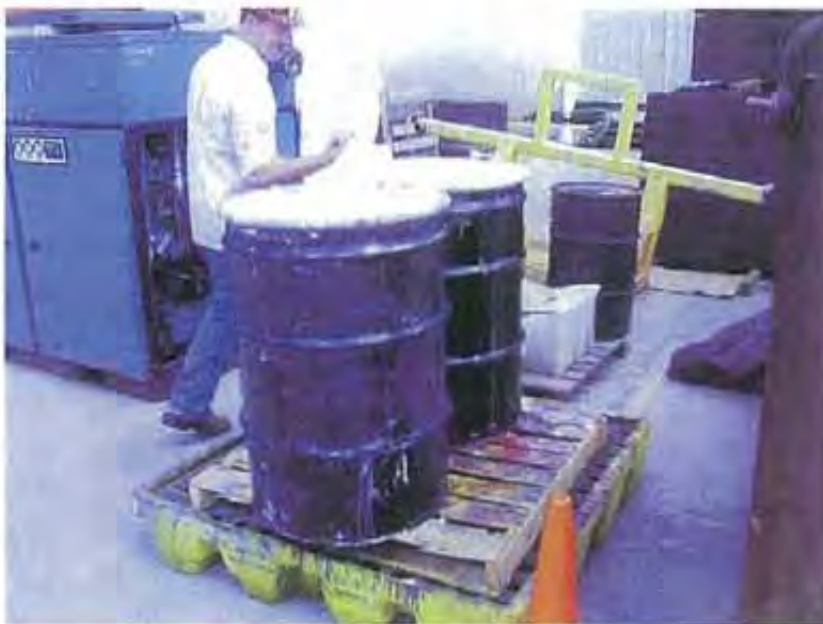
Photo 32: Two 55-gallon drums of "paint related waste" (as described by the Facility representative), which appeared to be a mixture of paint and paint thinner were stored on a secondary containment pallet, in "JR's Area", outside the designated hazardous waste storage area. The drum pictured above was opened by the Discharger at the inspector's request (as shown in Photo 31). One of the drums was hanging over the edge of the containment pallet.

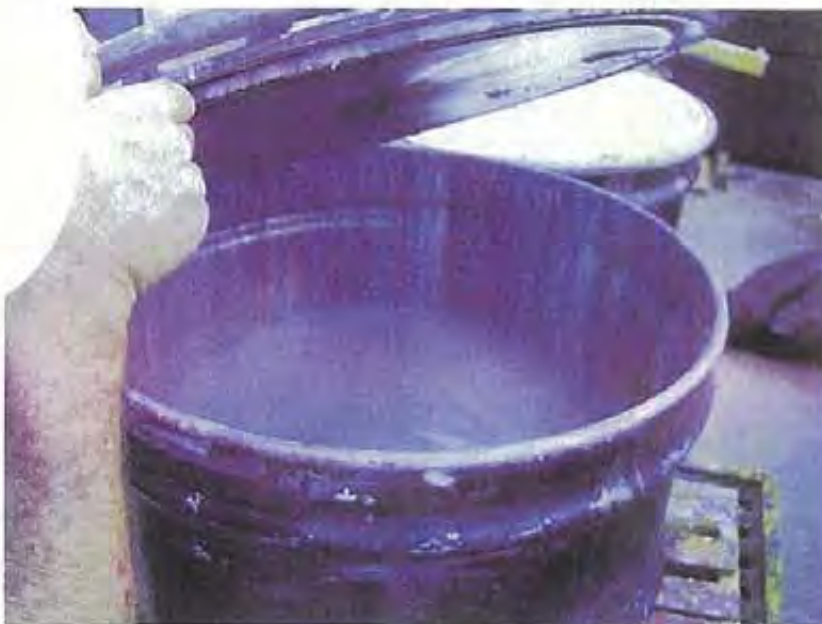
Photo 33: A photograph of the substance inside one of the two 55-gallon drums described in Photo 32. The drum pictured above was opened by the Discharger at the inspector's request.

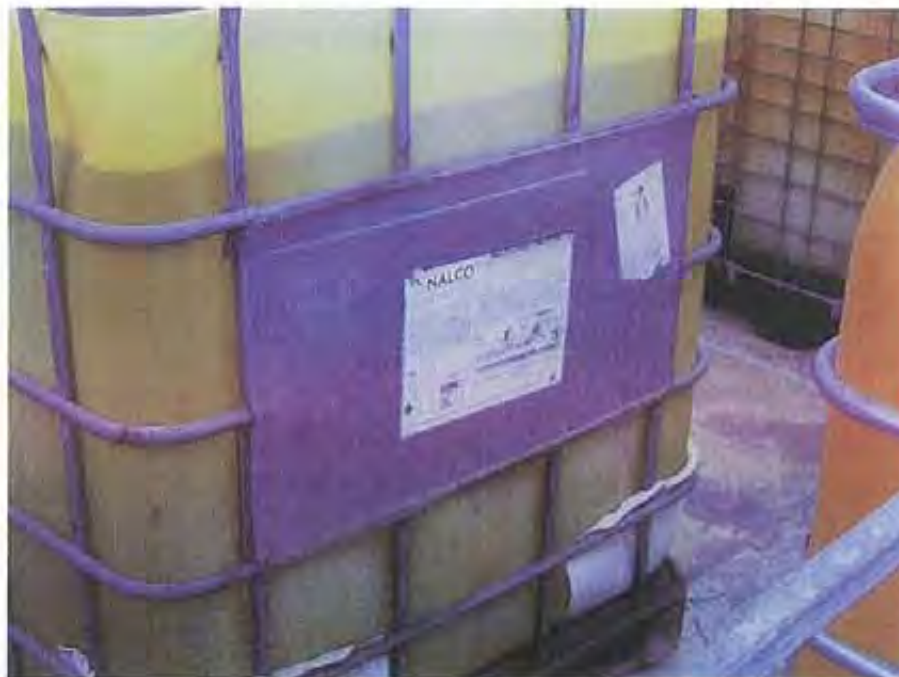
Photo 35: A tote originally used for flocculent was being used to store diesel fuel, without secondary containment. The tote was labeled as flocculent.

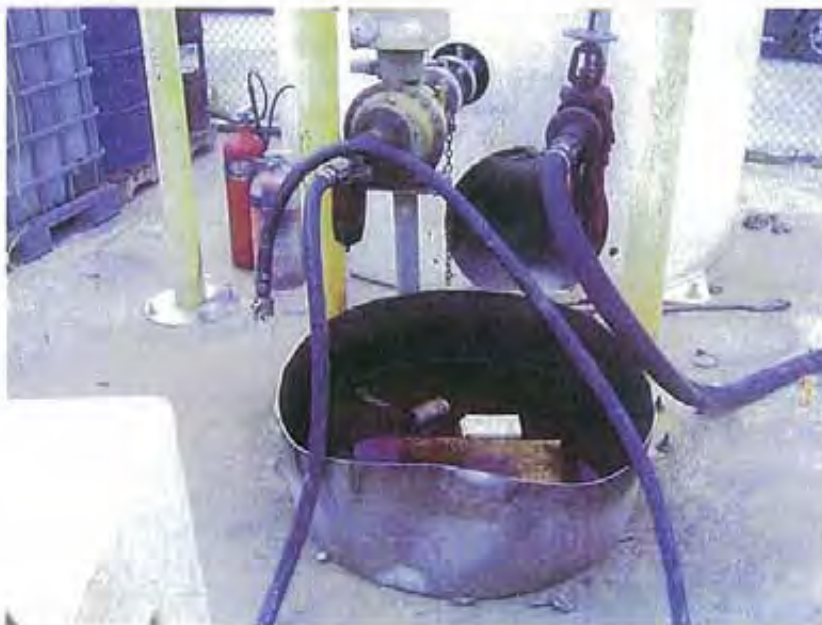
Photo 36: A drip pan for a 3,000 gallon diesel tank was observed containing diesel, open and exposed to rain fall, without secondary containment.

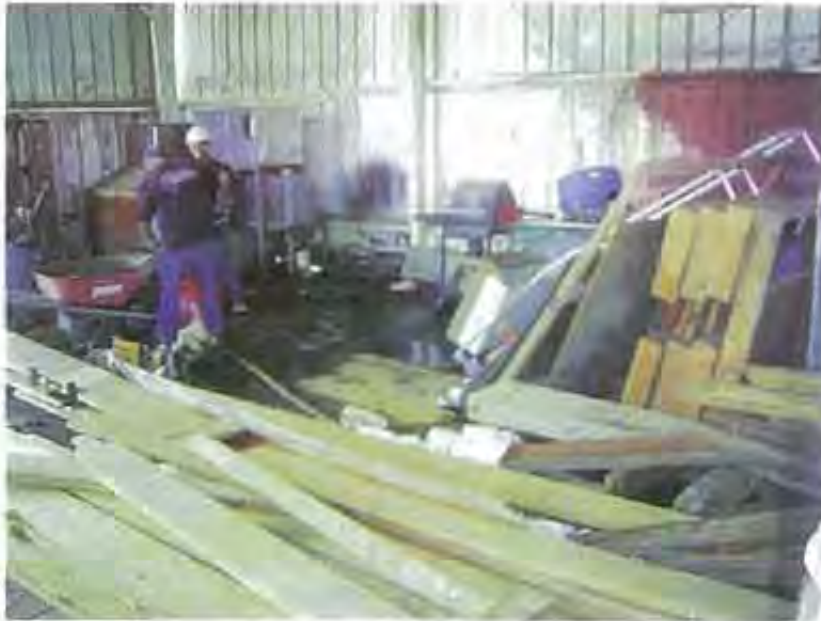
- d. Two workers were observed mixing cement on the work barge. Wet cement was observed on the ground of the work barge. Runoff from the cement mixing was observed running under the wall and down the side of the work barge into the receiving water;

Photo 37: Two workers were observed mixing cement on the work barge. Wet cement was observed on the ground of the work barge. Runoff from the cement mixing was observed running under the wall and down the side of the work barge into the receiving water, as shown in Photo No. 39.

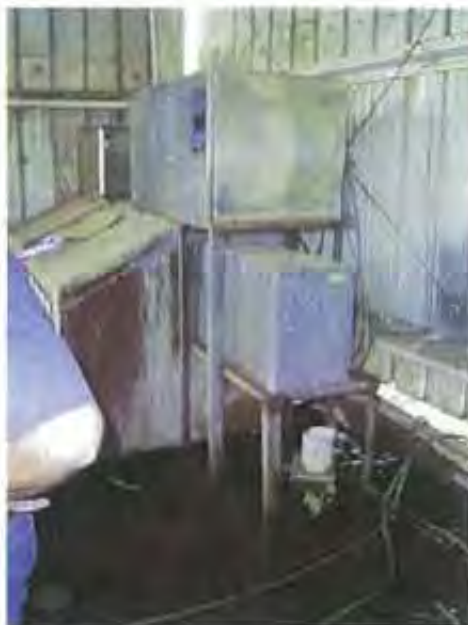
Photo 38: A closer photograph of the runoff from the cement mixing going under the wall of the work barge. Further, the Facility representative stated that condensate from the ice maker discharges under the wall and over the side of the work barge as well.

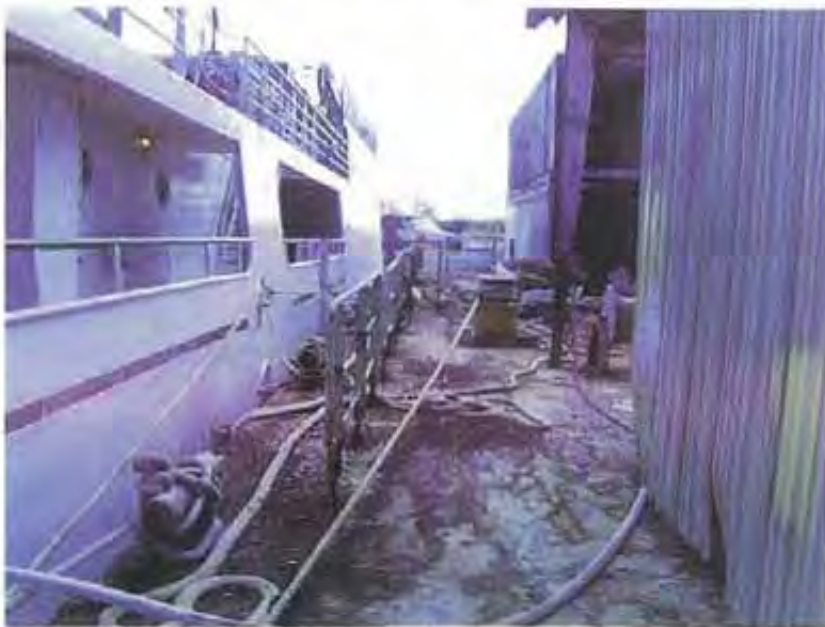
Photo 40: The floor of the work barge was covered in general debris and rust chips/dust, exposed to potential storm water runoff.

15. By APRIL 15, 2009 Marisco shall properly clean the deck of the support work barge of rust chips/dust that has a potential to discharge into Kalaeloa Barbers Point Harbor, as noted in the Inspection report, photo 40.

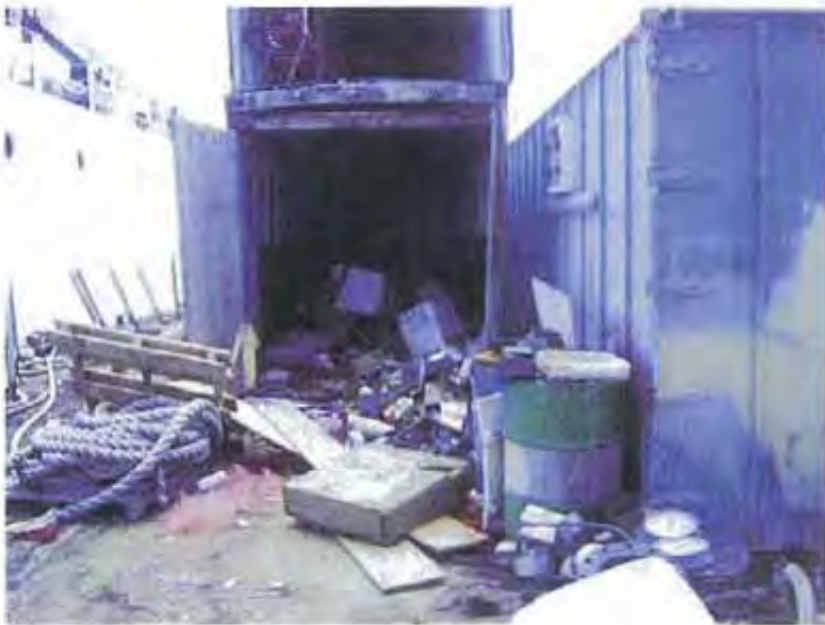
Photo 41: Debris and materials scattered on the floor of the work barge outside a storage shed. Two 55-gallon drums of oil were observed on the deck of work barge, without secondary containment.

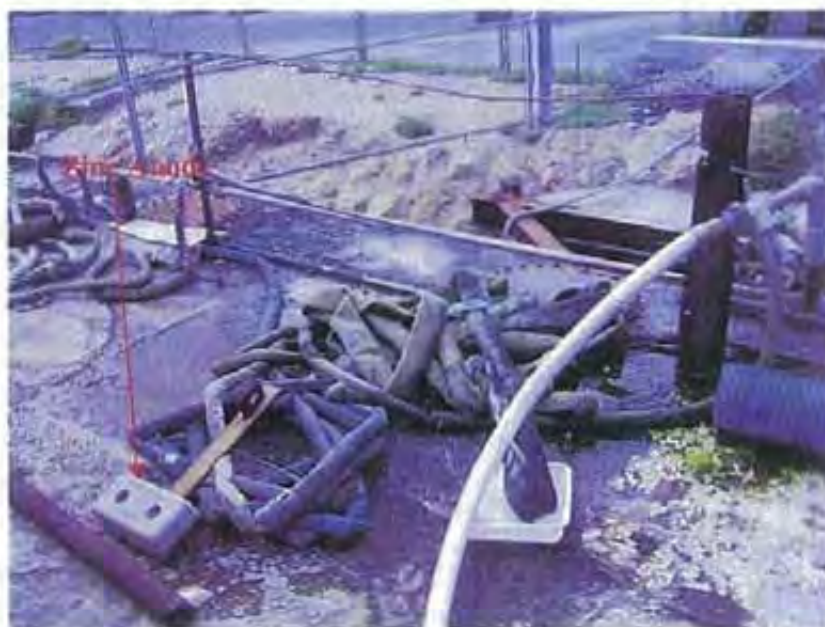
Photo 43: These water lines are used to supply the workers with potable water as they work on-board vessels. The line/hose hook ups were observed leaking and draining over the edge of the work barge. Also pictured above is a zinc anode on the deck of the work barge, near the draining water.

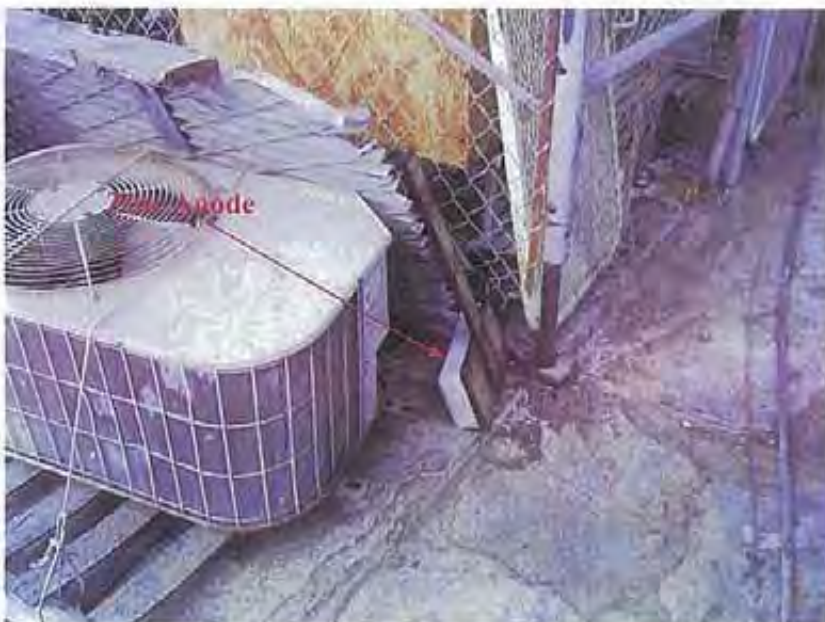
Photo 46: Another zinc anode observed on the deck of the work barge, exposed to potential storm water runoff.

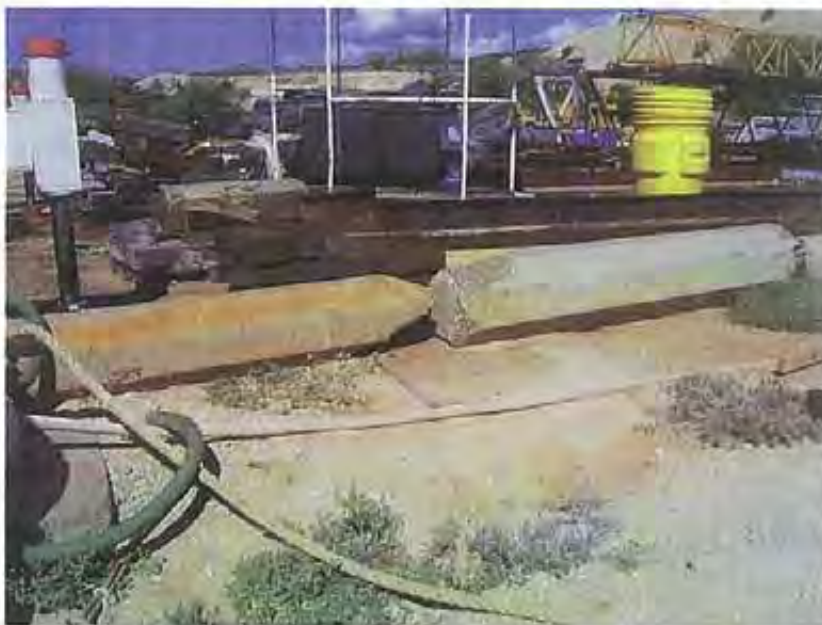
Photo 48: The shore side staging area for the Lil' Perris dry dock has a berm built from cement pillars. Plastic sheeting has been laid down against the pillars and covered with dirt, however the plastic sheeting has torn away in most areas and gaps are prevalent along the entire berm.

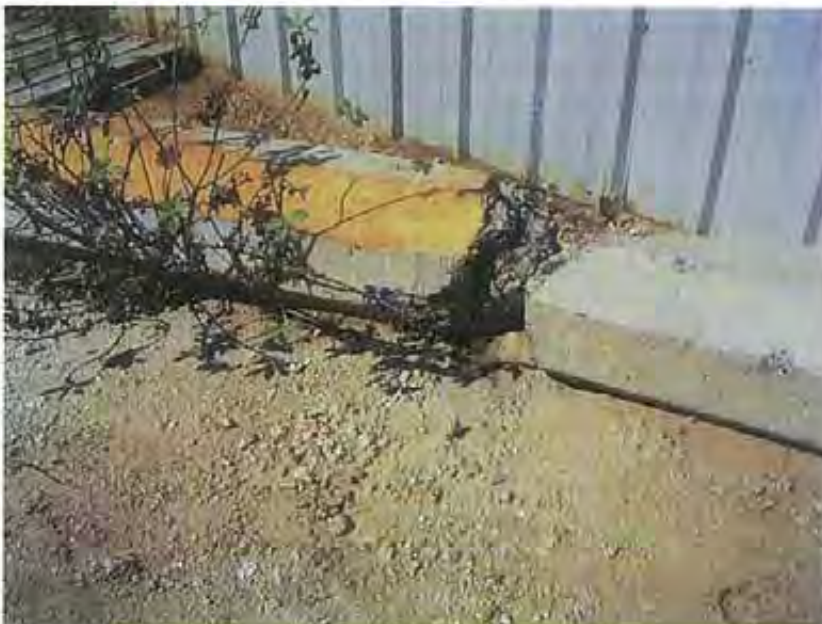
Photo 49: One of the gaps in the berm surrounding the shore side staging area for the Lil' Perris dry dock.

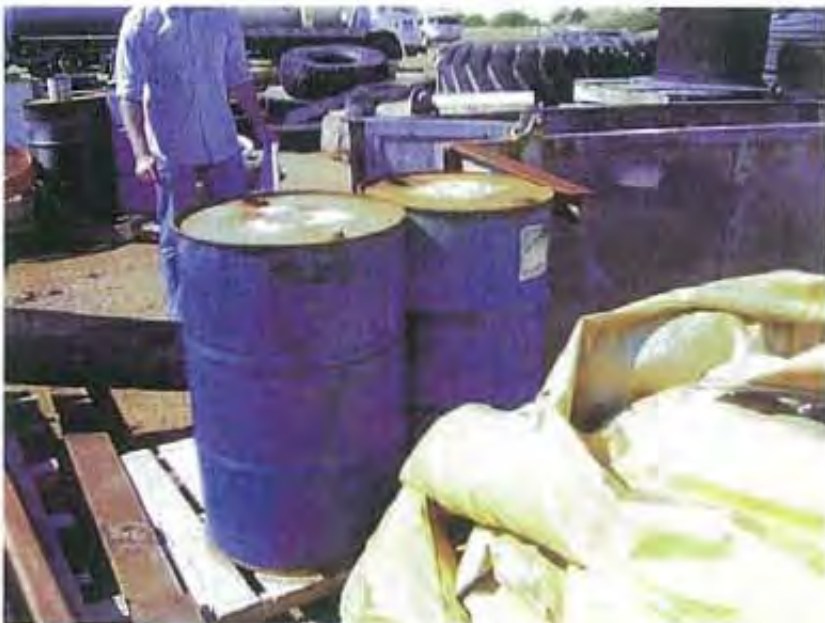
- i. Two 55-gallon drums of used oil were observed stored without secondary containment on the shore side staging area beside the dry dock, inconsistent with Part B.2.j of the permit which states, "The Permittee shall maintain land-based operations in a clean and orderly manner and implement measures to prevent pollutants from contacting storm water runoff." Further, this condition is not consistent with land-based operation BMPs of the Discharger's BMP Plan (p. 8), which states that spill pallets will be on-site and used;

Photo 51: Two 55-gallon drums of used oil were observed stored without secondary containment on the shore side staging area beside the Lil' Perris dry dock.

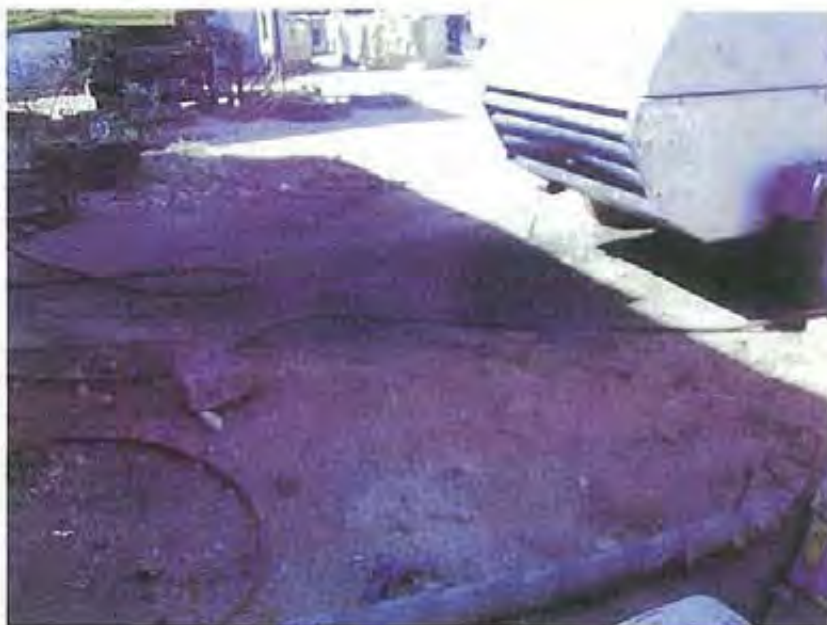
Photo 52: Staining of the ground by exhaust from an on-site air compressor.

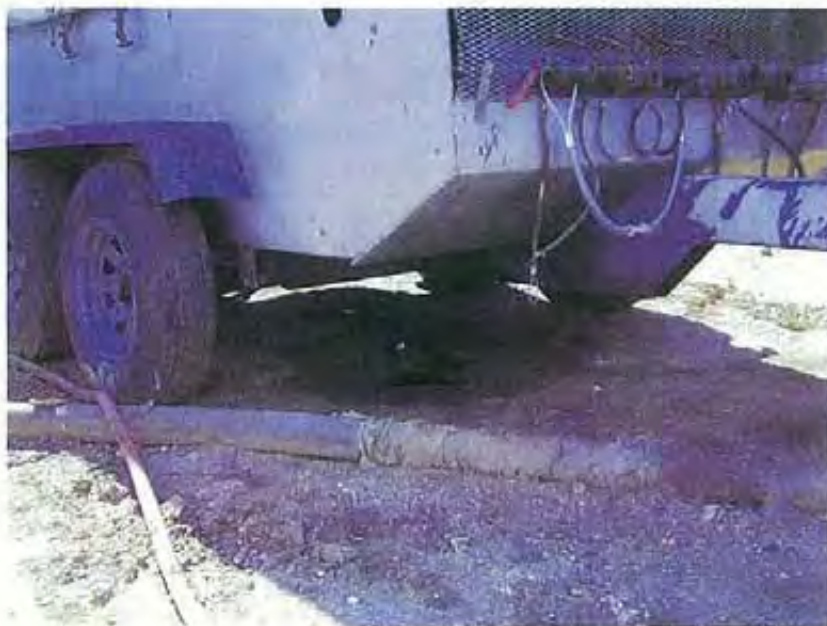
- ii. A mixture of oil and condensate was observed dripping directly on the ground from an air compressor on the shore side staging area beside the dry dock, inconsistent with Part B.2.j of the permit;

Photo 53: A mixture of oil and condensate dripping from the above pictured air compressor.

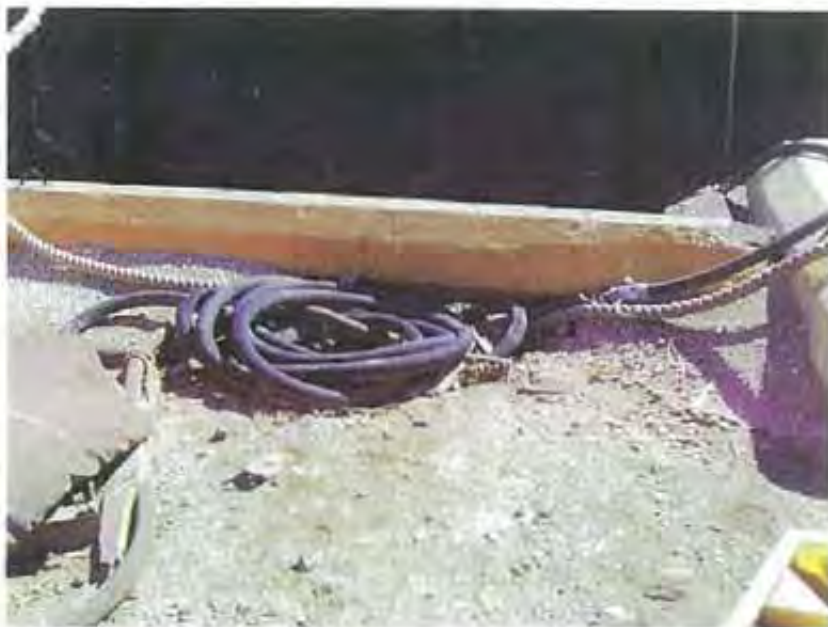
Photo 54: Another gap developed through erosion in the berm.

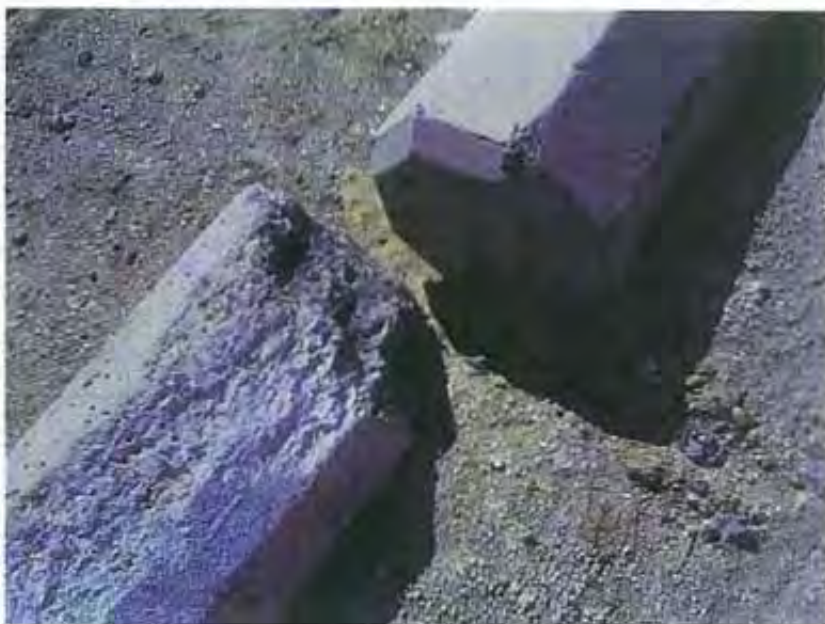
Photo 55: Another gap in the berm.
