Subject: Issuance of Findings of Violation and Order for Compliance for NPDES Permit Violations

On December 9, 2008, under the authority of the Clean Water Act (CWA), an EPA-authorized inspector and a representative of the Hawaii Department of Health (DOH) conducted a compliance inspection of Marisco Ltd.'s (Marisco's) Lil' Perris drydock and main facilities to determine Marisco's compliance with NPDES Permit No. HI0021786 and the CWA.

In the Matter of	)	
	)	
Marisco, Ltd.	)	FINDINGS OF VIOLATION
91-607 Malekole Road	)	
Kapolei, Hawaii	)	AND
	)	
Proceedings under Section 308(a) and 309(a)(3),	)	ORDER FOR COMPLAINEE
(a)(4) and (a)(5)(A) of the Clean Water Act, as	)	
amended, 33 U.S.C. Section 1318(a) and	)	Docket No. CWA-309(a)-09-014
1319(a)(3), (a)(4) and (a)(5)(A)	)

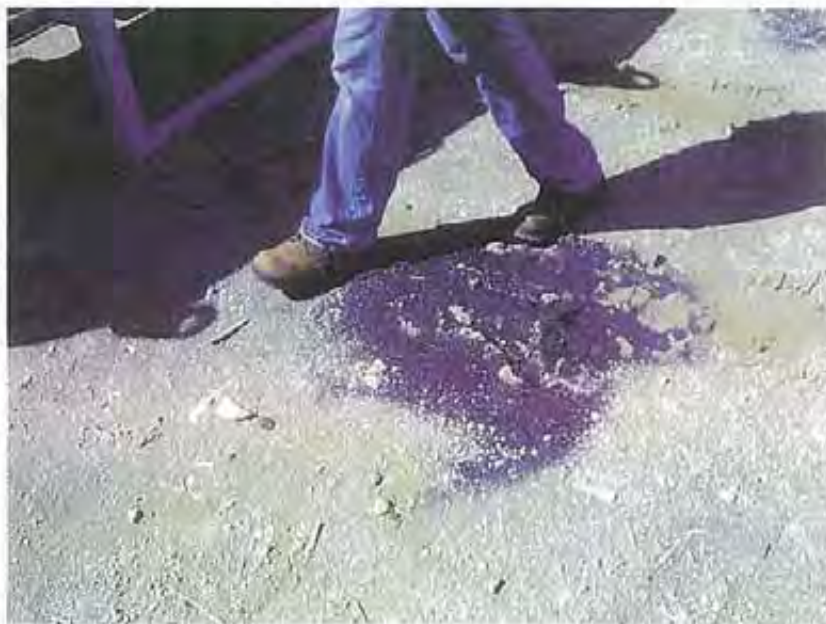
- iii. Sand blasting grit was observed spilled on the ground, shore side of the dry dock and multiple bags of fresh sand blasting grit were observed stored on-site without cover, inconsistent with Part B.2.j of the permit and with the land-based operation BMPs of the Marisco's BMP Plan, which states that sand blast grit [new or spent] will be covered; and

Photo 56: Sand blasting grit was observed on the ground, exposed to potential storm water runoff.

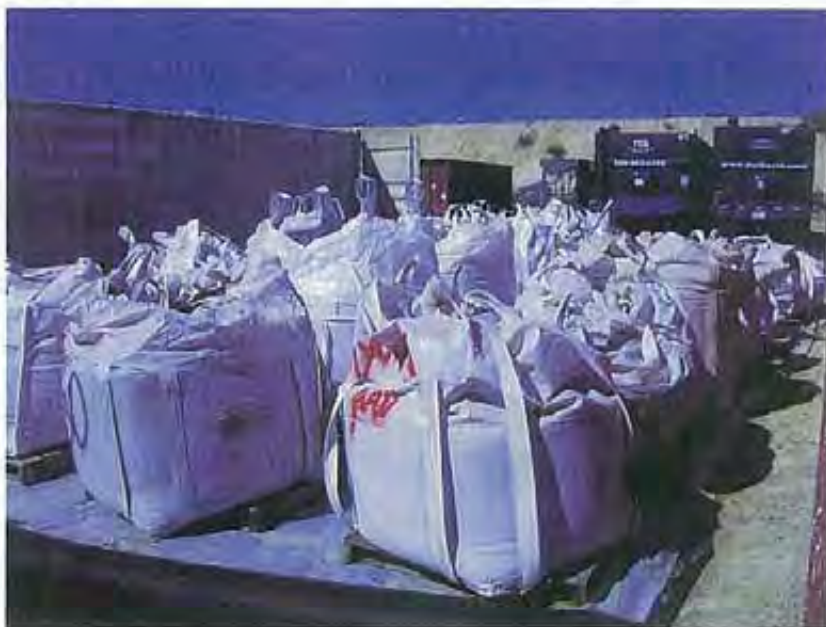
Photo 57: Sandblast grit stored on-site, un-covered.

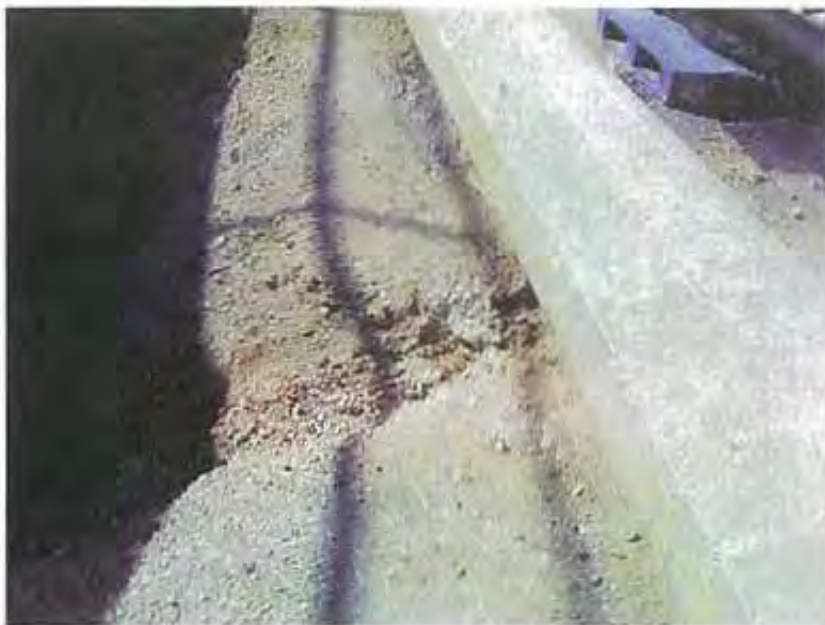
Photo 58: Another gap in the berm.

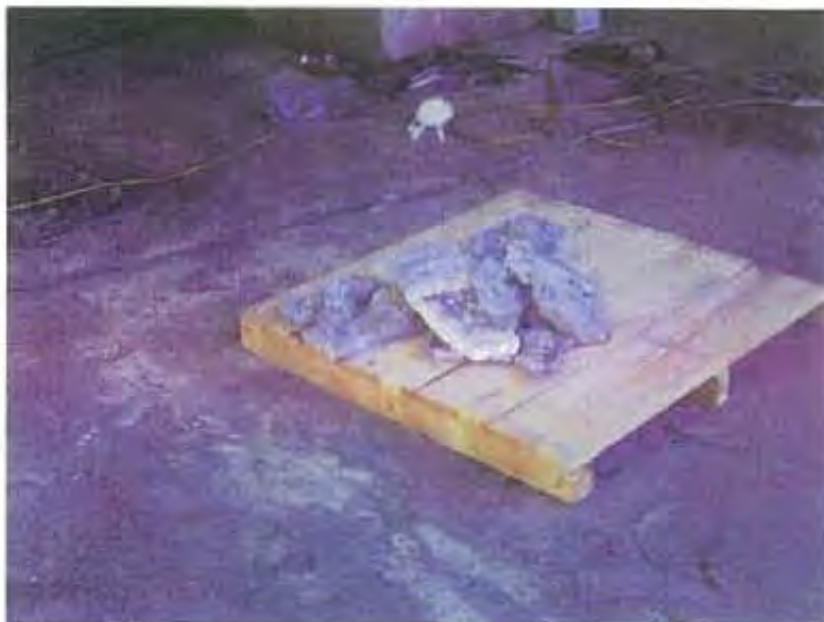
Photo 61: Zinc anodes were observed stored on the dry dock, uncovered and exposed to potential rain fall.

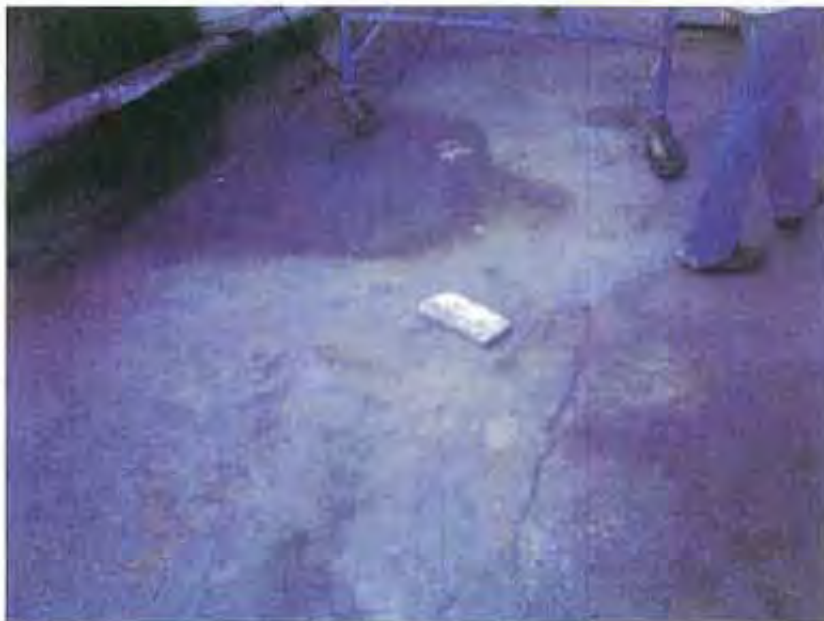
Photo 62: A zinc anode was observed on the floor of the dry dock, exposed to potential storm water runoff.
