UNITED STATES ENVIRONMENTAL PROTECTION AGENCY
REGION IX

IN THE MATTER OF:)	Docket No.: CWA 309(a)-10-024
)	
GUAM POWER AUTHORITY)	
Cabras Power Plant)	
)	FINDINGS OF VIOLATION
)	AND
)	ORDER FOR COMPLIANCE
)	
NPDES Permit No. GU0020001)	
)	Proceeding under Sections 308(a)
)	and 309(a) of the Clean Water Act
)	33 U.S.C. §§ 1318 and 1319(a)

Guam Power Authority – Cabras Power Plant (NPDES No. GU0020001) Photo Log
Inspected by: Dan Connally (PG Environmental, LLC) and Maricar Quezon (GEPA)

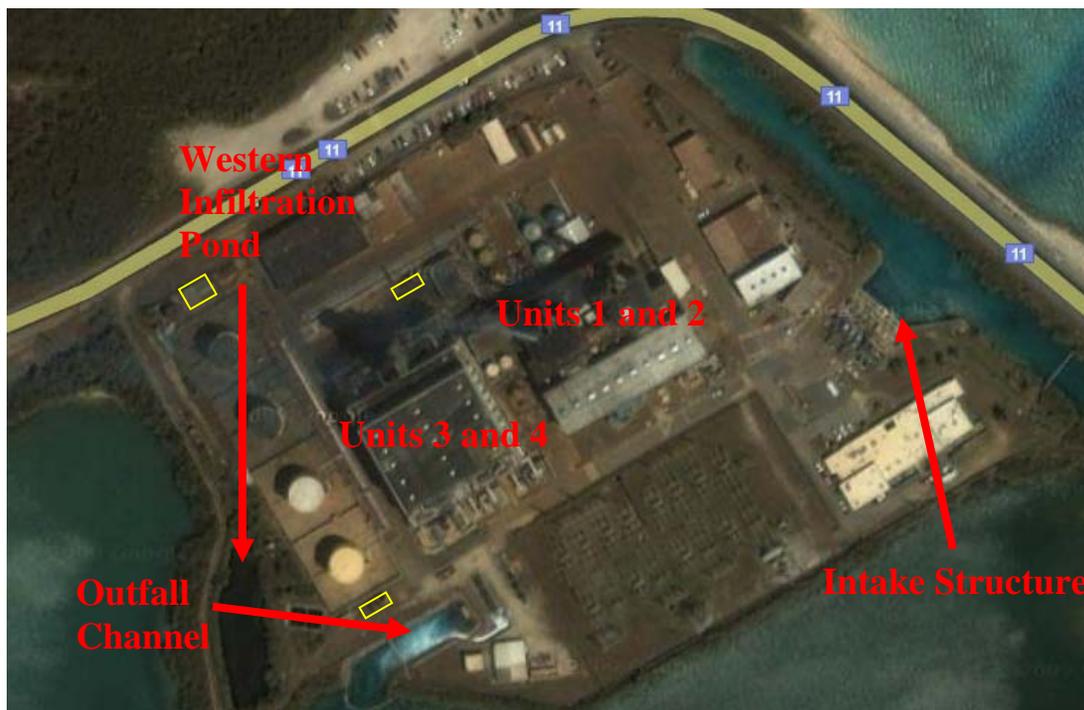
Photo 2: Overview of the Cabras Power Plant from Google Maps, with intake structure, outfall channel, western infiltration pond, and Units 1, 2, 3, and 4 identified. Oil water separators are indicated by yellow boxes, however are not labeled.

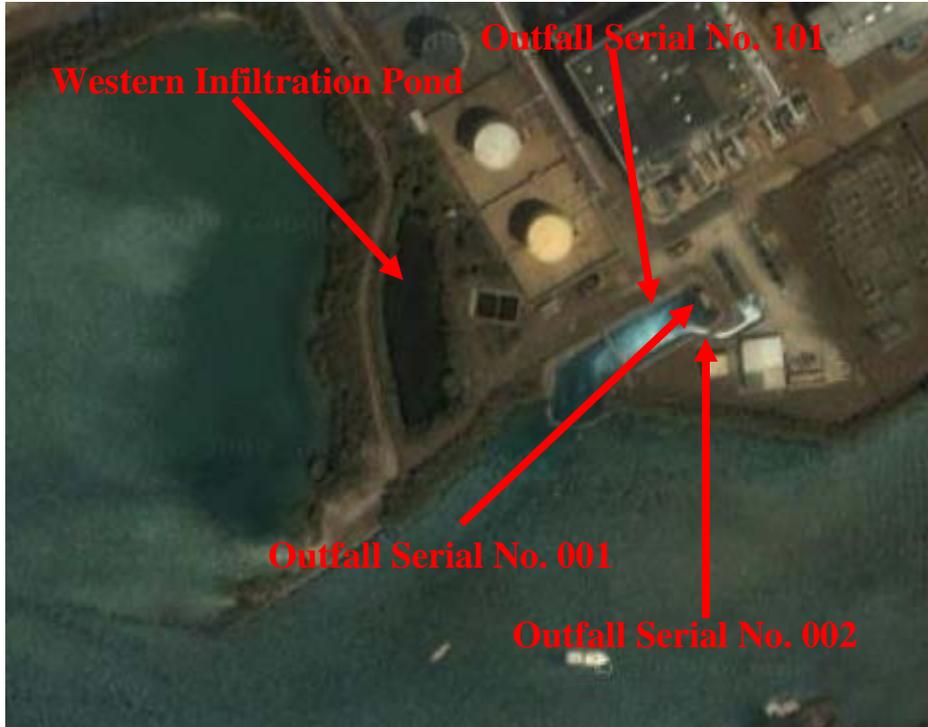
Both the eastern and western infiltration ponds were observed. The western infiltration pond is approximately 25 yards from the receiving water. Although a direct surface water discharge was not observed, it may be possible that the infiltration pond is hydraulically connected to the receiving water and that pollutants are migrating into the receiving water. Discharges to this pond include low volume wastes, process waters, and treated contact storm water.

The eastern infiltration pond is approximately 25 yards from the Piti Channel just downstream of the intake structure. It may be possible that that the infiltration pond is hydraulically connected to the receiving water and pollutants from any discharge to this infiltration pond are migrating into Piti Channel.

Photo 3: Overview of the Cabras Power Plant from Google Maps, individual outfall locations identified. Note the proximity of the infiltration pond to the receiving water. The inspector is concerned that pollutants from the infiltration pond are migrating to the receiving water.

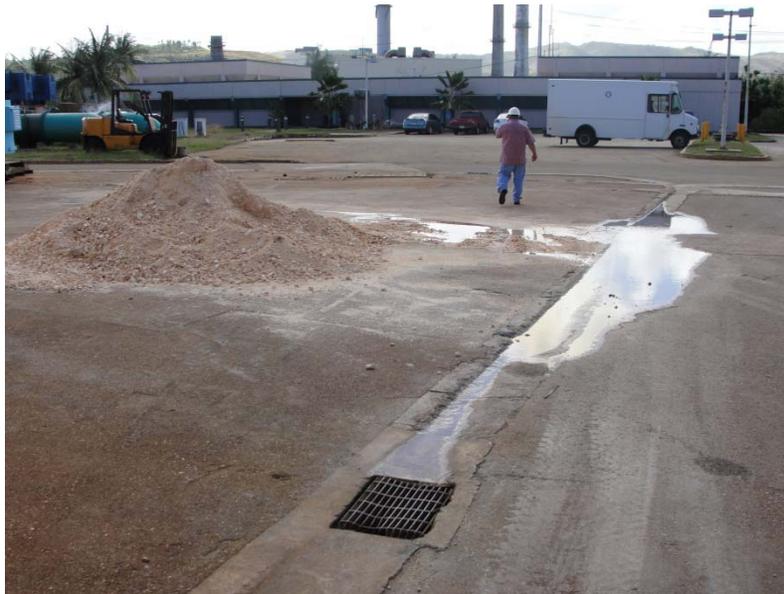
- 23) Inspectors observed that a municipal supply water line for the fire protection was ruptured and leaking on-site, through a pile of loose dirt and into a storm drain discharging to Outfall Serial No. 101. GPA is permitted to discharge only storm water through Outfall Serial No. 101. The discharge of municipal supply water through Outfall Serial No. 101 is not a permitted discharge.

A municipal supply water line for the fire protection system had ruptured and was observed leaking on-site into a storm drain that discharges to Outfall Serial No. 101. The leaking supply water was observed flowing through a pile of loose dirt, potentially accumulating sediment prior to discharging to the storm drain. A Facility representative stated that this same line break had just been repaired. The Facility representative expected the ruptured line to be fixed by the end of the week.

- 10) A municipal supply water line for the fire protection system had ruptured and was observed leaking on-site into a storm drain that discharges to Outfall Serial No. 101.

Photo 4: A pipe rupture was observed onsite, resulting in potable water discharging to the storm water collection system, which discharges to Outfall Serial No. 101.

- a) An O&M plan. The plan shall include all repairs necessary to eliminate all leaks that are described in the attached inspection report, repair the oil/water separator so that it operates as intended, and restore the treatment system equipment necessary for disposal of low-volume waste consistent with the Permit;

- a) Achieve and maintain compliance with the flow monitoring and reporting requirements of its Permit.
 - b) Complete all repairs necessary to eliminate leak of fire protection system, and bring the oil-water separator and low-volume wastewater treatment and disposal system into proper function.

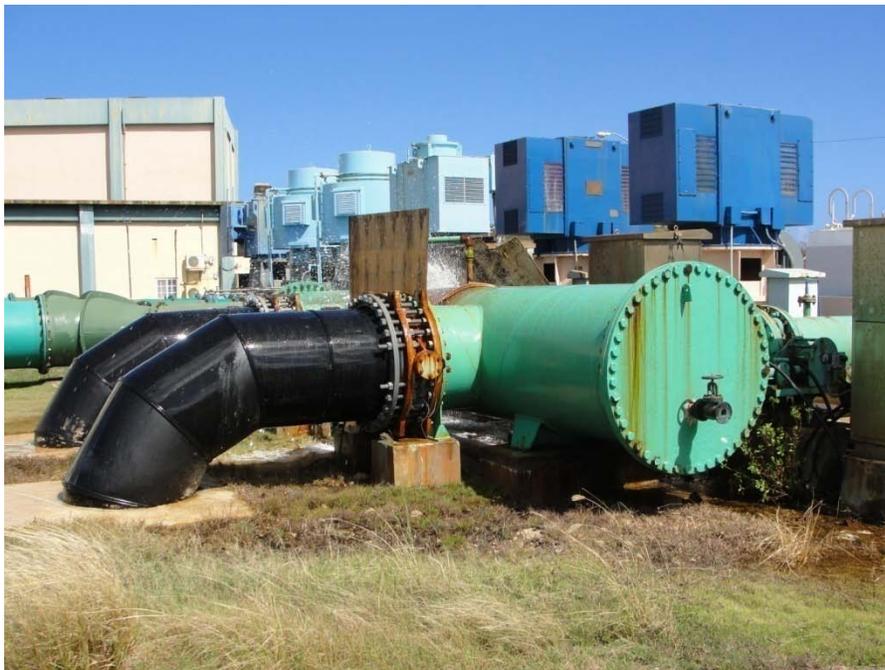
The intake manifold for Units 3 and 4 was leaking intake cooling water. The intake cooling water was draining to the eastern infiltration pond. The Discharger has not been able to shut down Units 3 and 4 to repair the manifold because Unit 2 is currently down for maintenance and they cannot reduce their generating capacity at this time. The Facility representative stated that he expected Unit 2 would be running by the following weekend and that they would be able to begin fixing the manifold for Units 3 and 4 immediately thereafter.

Photo 5: The intake manifold for Units 3 and 4 was leaking intake cooling water.

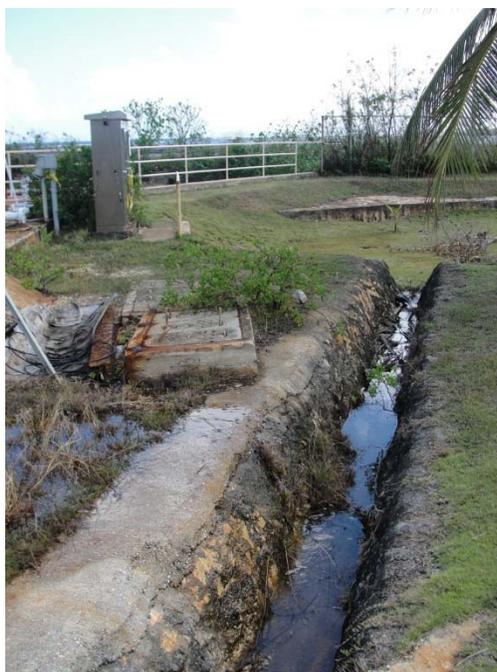
Photo 6: The intake cooling water leaking from the intake manifold was observed draining to the eastern infiltration pond, adjacent to the Piti Channel and intake structure.

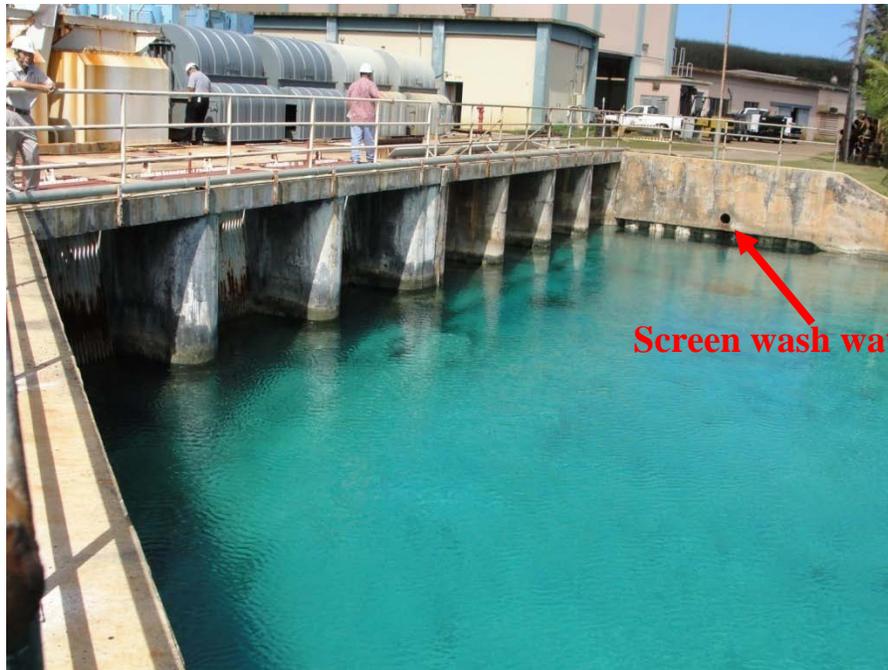
Screen wash water discharge

Photo 7: The intake structure for Units 1, 2, 3, and 4. Aquatic life, including various species of fish were observed in the vicinity of the intake structure. The screen wash water discharge location is located directly in front of the bar racks for Units 1 and 2.

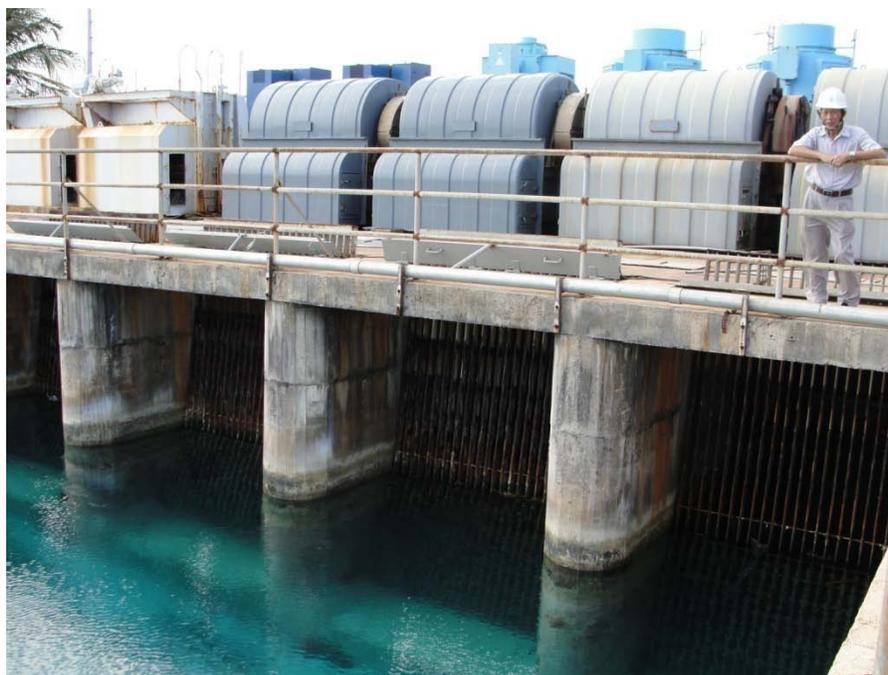
Photo 8: Close up photo of the intake structure for Units 1 and 2.

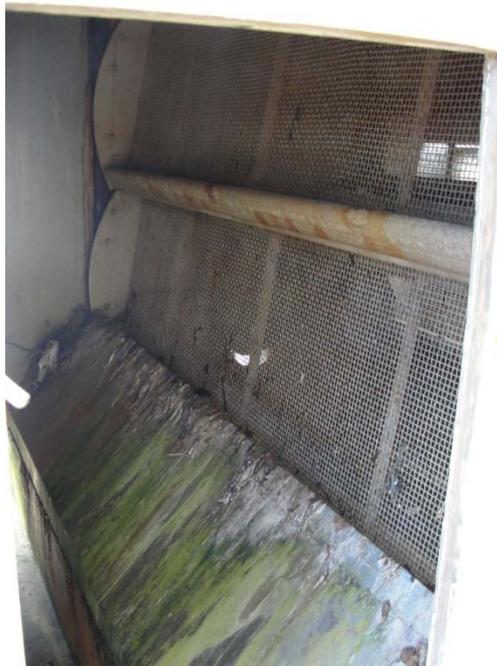
Photo 9: Mesh screen used on the traveling water screens, located just after the bar screens.

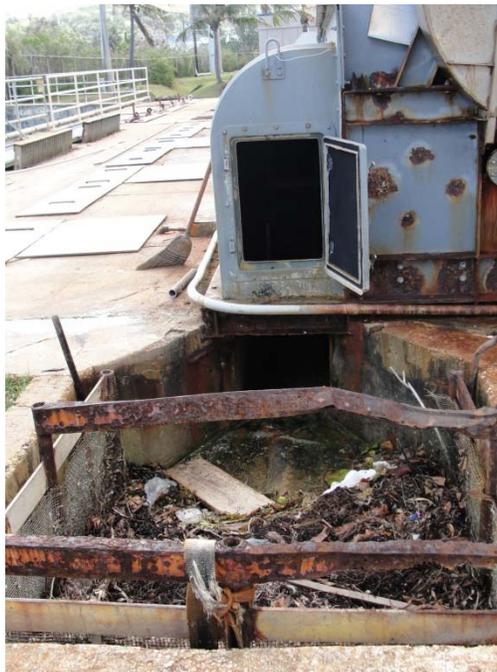
Photo 10: Traveling screen wash water trough and solids collection basin.

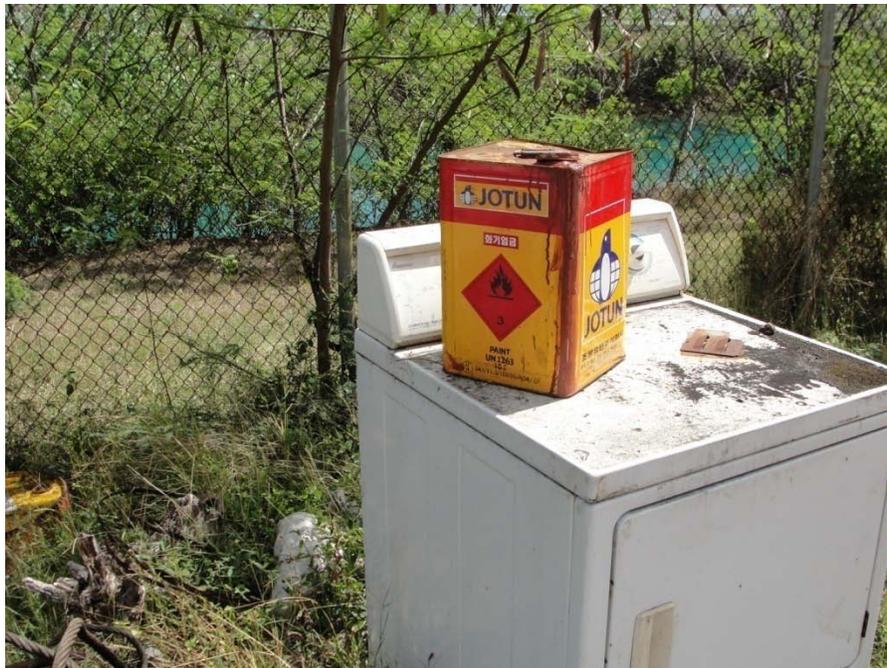
Used paint cans, a vehicle battery and other industrial debris were observed stored uncovered and uncontained behind the maintenance shop, adjacent to Piti Channel. Due to the location of this finding adjacent to Piti Channel, the inspector believes the potential for contact storm water to reach the receiving water may exist. Facility representatives stated that these materials had been present for over a month. Additional industrial debris, such as empty 55-gallon drums, packaging, floor buffer pads, tires, scrap metal, and materials with oily residue were observed in a storage yard adjacent to the discharge locations.

Photo 11: Paint observed incorrectly stored behind the maintenance shop and vulnerable to contact with storm water.

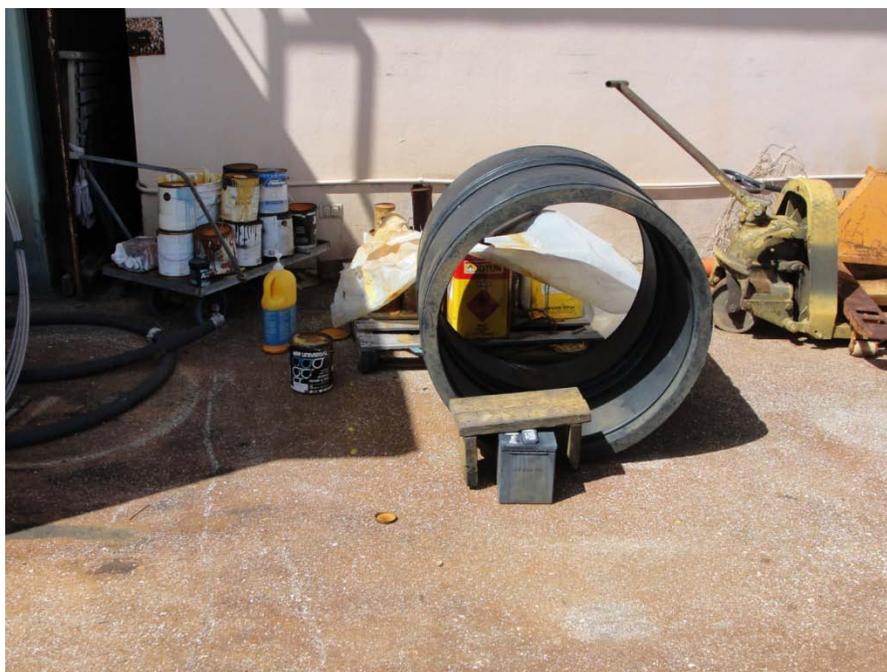
- v) hazardous wastes including used paint and batteries be properly disposed of within the guidelines of RCRA.
- d) During the March 9, 2010 inspection, the inspector observed used paint cans, a vehicle battery and other industrial debris stored uncovered and uncontained behind the maintenance shop, adjacent to Piti Channel. Due to the location, the inspector believes there is potential for storm water to reach the receiving water. Facility representatives stated that these materials had been present for over a month. Additional industrial debris, such as empty 55-gallon drums, packaging, floor buffer pads, tires, scrap metal, and materials with oily residue were observed in a storage yard adjacent to the discharge locations. Twelve full 55-gallon drums of a petroleum product ("DTE Oil Light, ISO 32") were observed stored on the south side of Units 1 and 2 without secondary containment, in the drainage area for Outfall Serial No. 101. The secondary containment around an oil tank just south of Units 1 and 2 appeared to be breached, allowing potential infiltration into the ground, or the possibility of commingling with storm water runoff that may discharge to Outfall Serial No. 101. Based on the foregoing observations made by the EPA inspector, GPA has failed to implement the BMP Plan as required in Part 13.d of the Permit.

The weekly inspection log for March 1, 2010 was reviewed during the inspection. The inspection log indicated that the area around the maintenance shop was "clean". However, on the date of the inspection, used cans of paint, a vehicle batter, and other debris were observed in this location. The Facility representative stated that this material had been at this location for "greater than a month". This is not consistent with the findings of the March 1, 2010 BMP weekly inspection log.

Photo 12: Paint, a vehicle battery, and other debris observed incorrectly stored in a location behind the maintenance shop and vulnerable to contact with storm water.

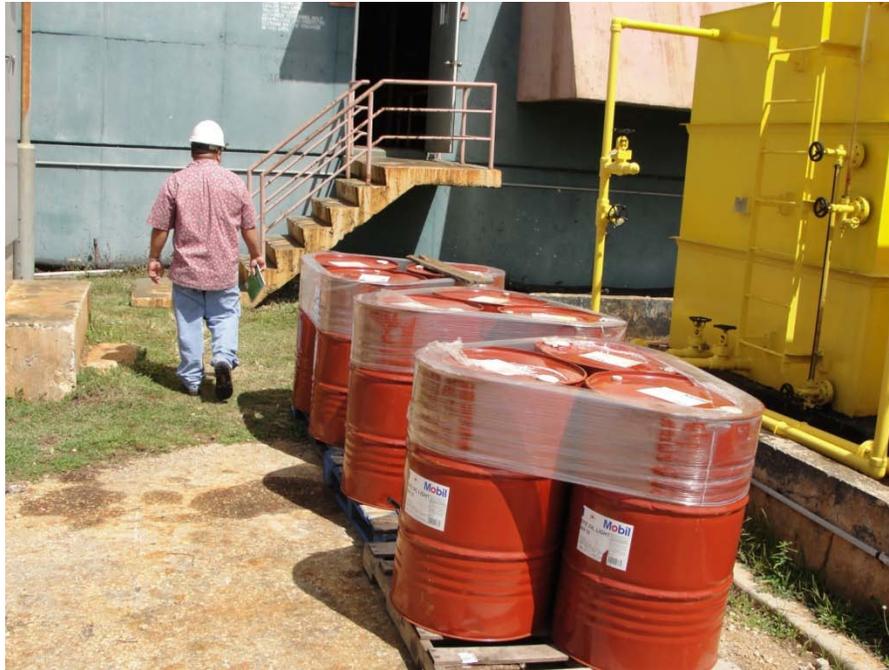
Twelve full 55-gallon drums of a petroleum product (“DTE Oil Light, ISO 32”) were observed stored on the south side of Units 1 and 2 without secondary containment, in the drainage area for Outfall Serial No. 101.

Photo 13: Twelve 55-gallon drums of a petroleum product were observed in the drainage area for Outfall Serial No. 101.

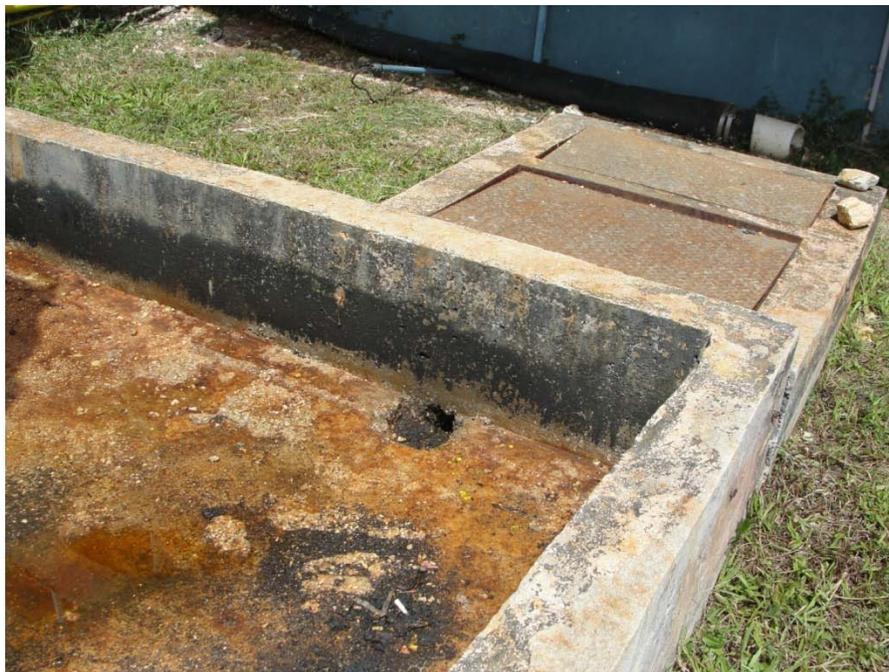
The secondary containment around an oil tank just south of Units 1 and 2 appeared to be breached, allowing potential infiltration into the ground, or possibly comingle with storm water runoff that may discharge to Outfall Serial No. 101.

Photo 14: The secondary containment for an oil tank located south of Units 1 and 2 was observed to have a constructed breach.

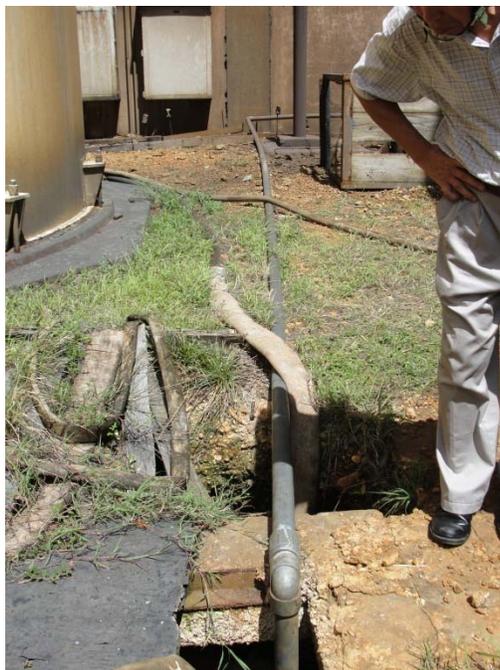
During the early morning of the inspection, two freshwater storage tanks for the Units 1 and 2 reverse osmosis system overflowed approximately 10,000 gallons into a neutralization pit. The Discharger was using hoses and pumps to pump the commingled municipal supply water and reverse osmosis brine from the neutralization pit to the Cabras 3 and 4 storm drain system, which discharges to the western infiltration pond.

Photo 15: The Discharger was observed pumping out a neutralization tank for their reverse osmosis system (due to an overflow of potable water) into Units 3 and 4 storm water drainage system, which discharges to the infiltration pond.

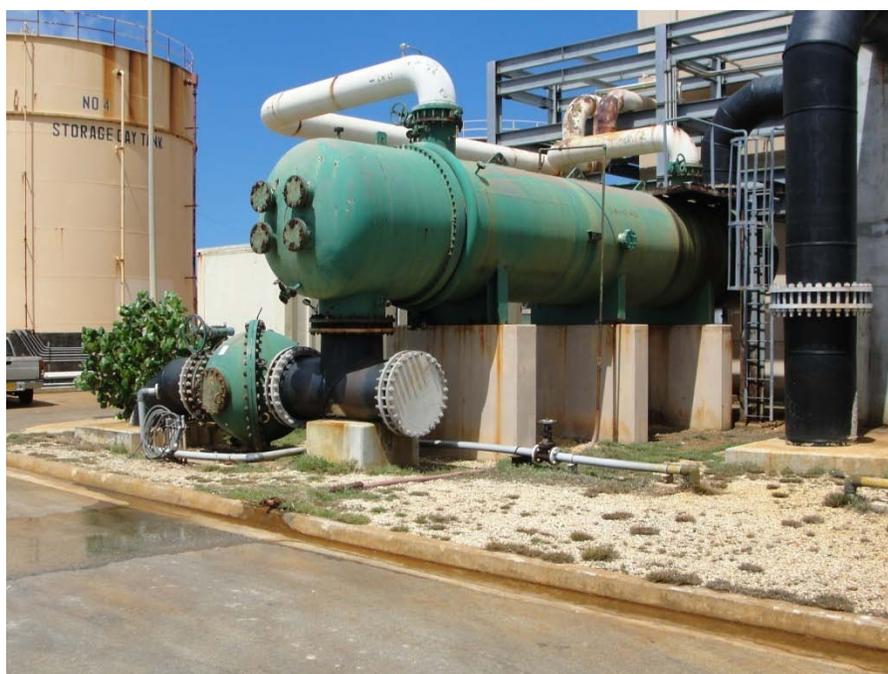
Water from the low temperature cooling system for Units 3 and 4 was observed leaking in the Cabras 3 and 4 storm drain system. Facility representatives state that this had been occurring for approximately 1 year. This wastewater is discharged to the western infiltration pond.

Photo 16: The low temperature cooling system for Units 3 and 4 was observed to be leaking. This area drains to the Units 3 and 4 drainage system, which discharges to the infiltration pond. However, during heavy rain events, this cooling water may be washed further down the service road and enter the drainage area for Outfall Serial No. 101.

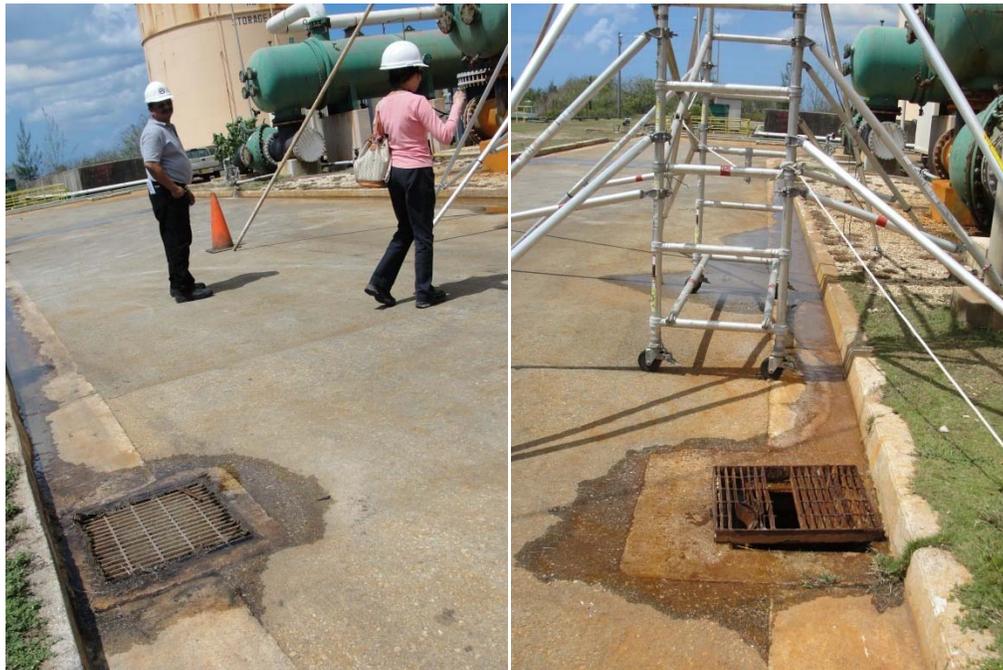
Photo 17: Low temperature cooling water from Units 3 and 4 discharged to the drainage system.

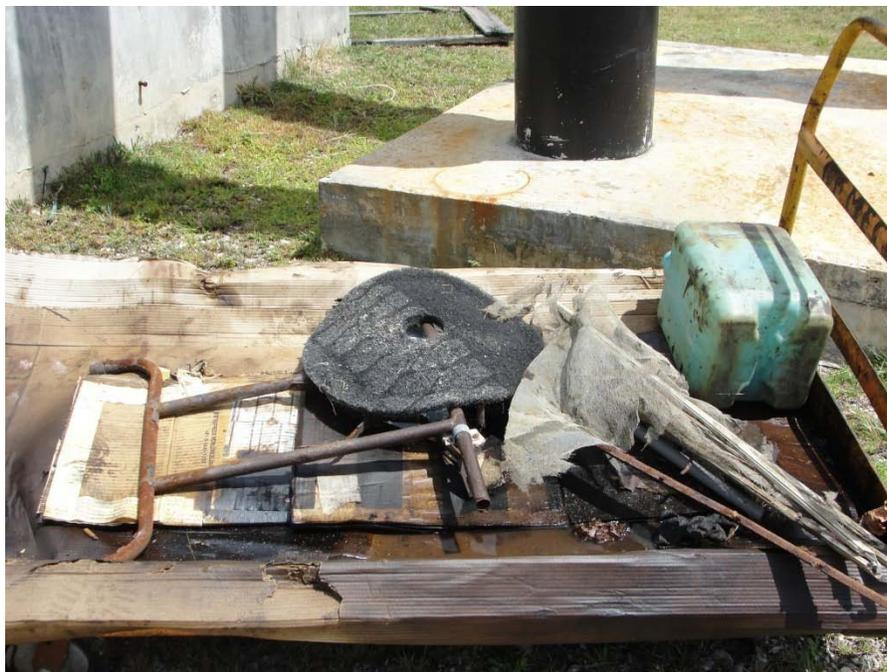
Photo 18: General debris observed stored on-site in a location which is vulnerable to contact with storm water.

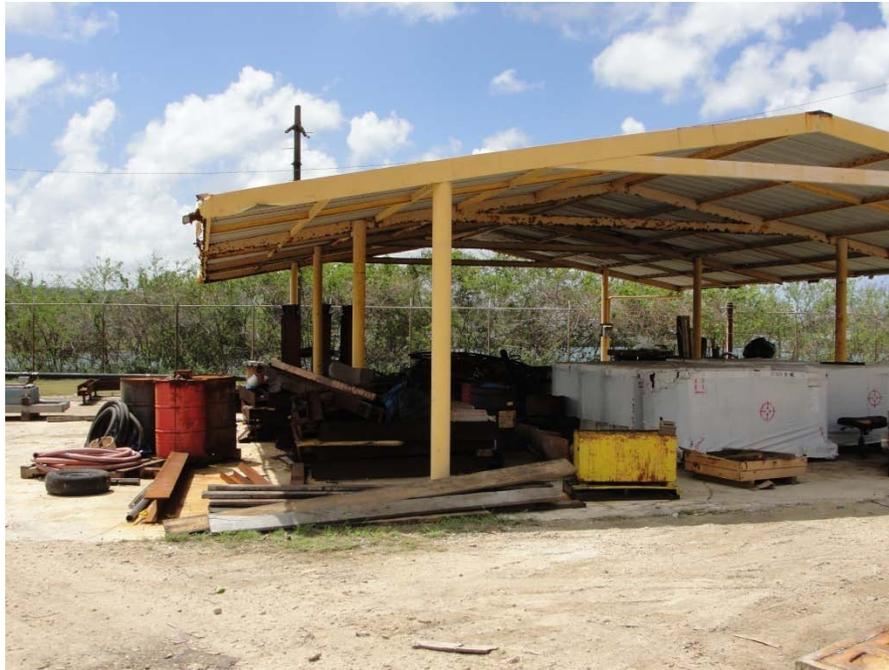
Photo 19: General debris observed stored on-site in a location that is vulnerable to contact with storm water. The items under cover appear to remain vulnerable to storm water contact via storm water flow-through.

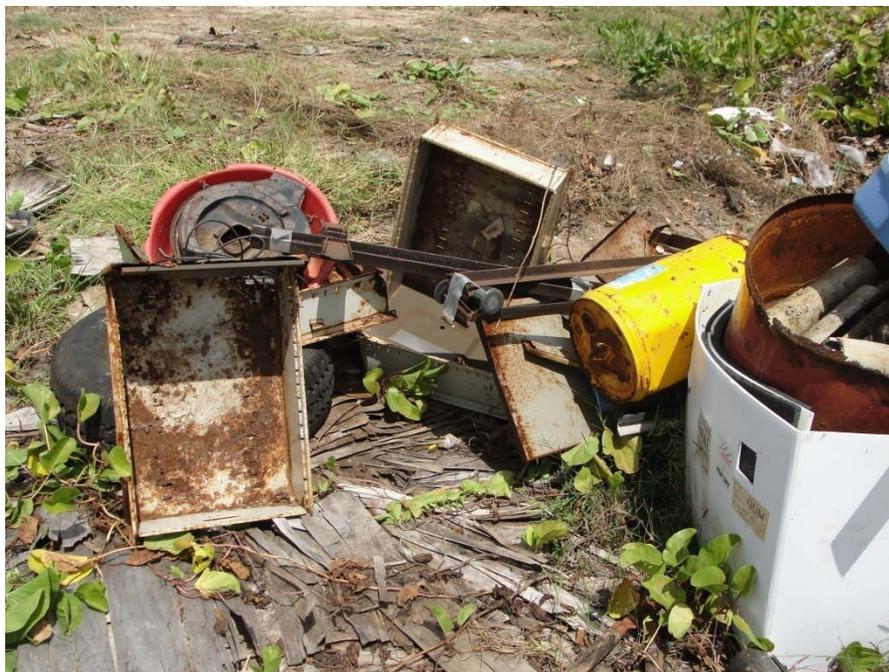
Photo 20: General debris observed stored on-site in a location vulnerable to storm water contact.

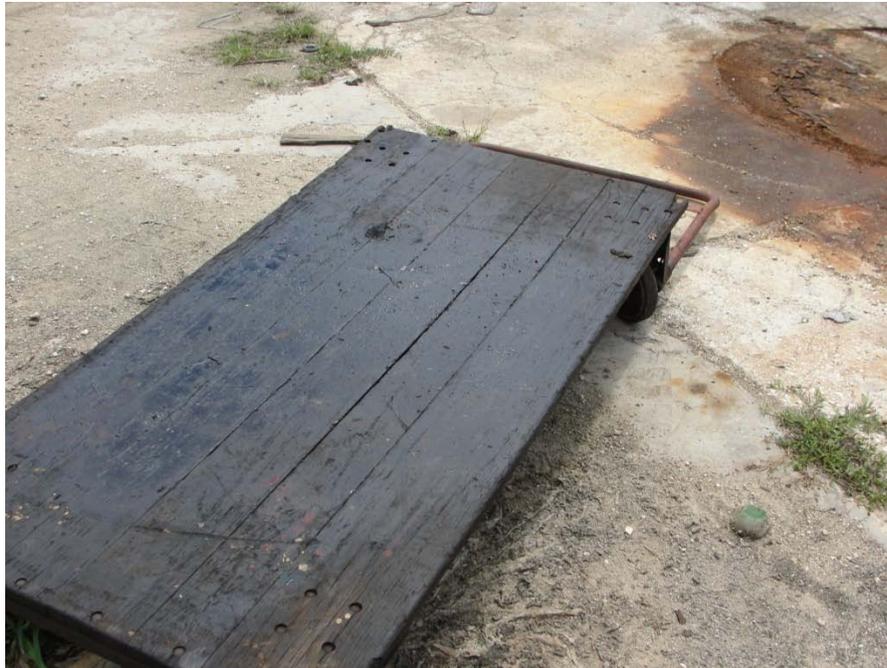
Photo 21: An oil soaked dolly, observed on-site in a location vulnerable to storm water contact.

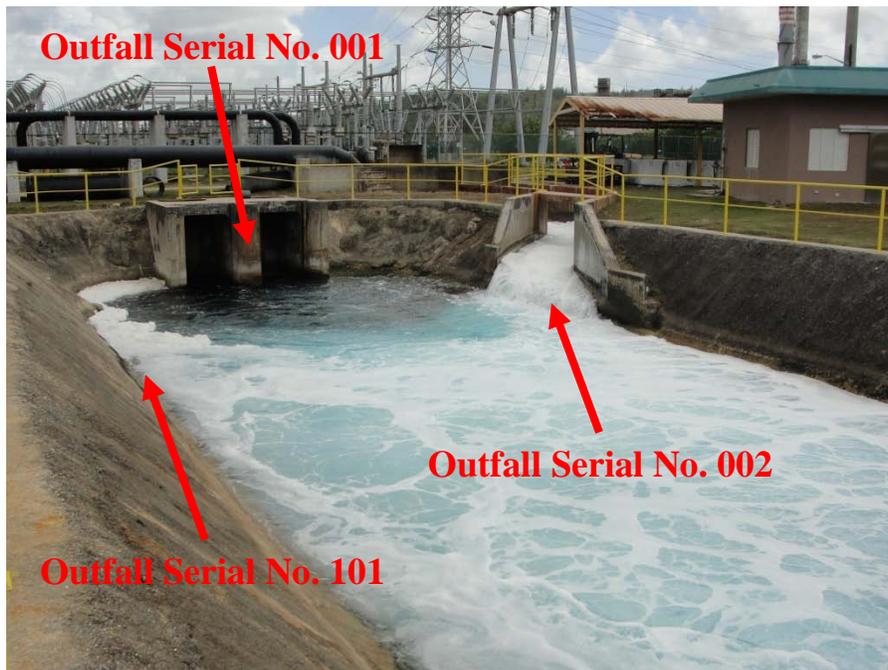
Photo 22: Outfall structure.

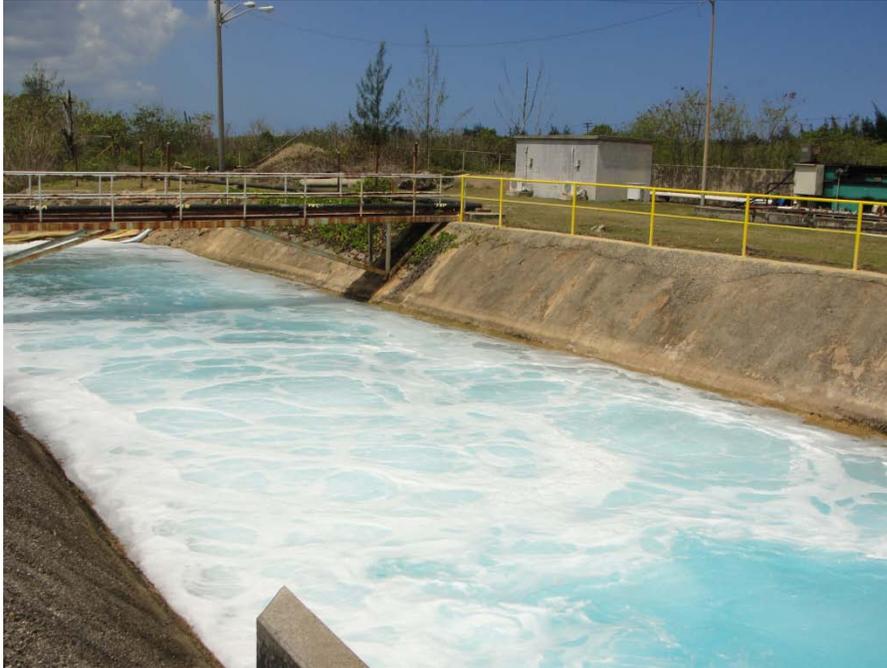
Photo 23: Outfall facing toward receiving water.

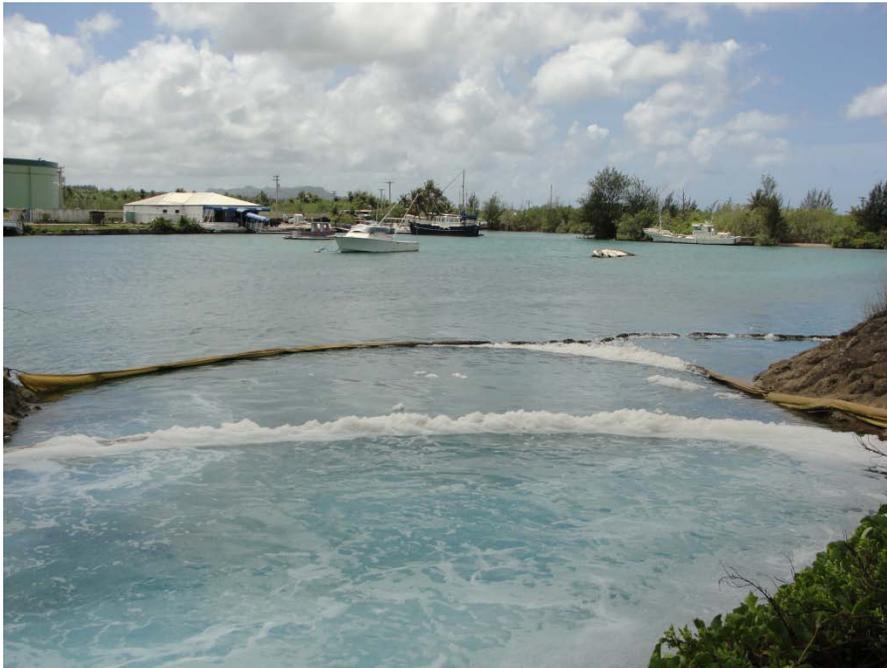
Photo 24: Receiving water at the mouth of the outfall structure.

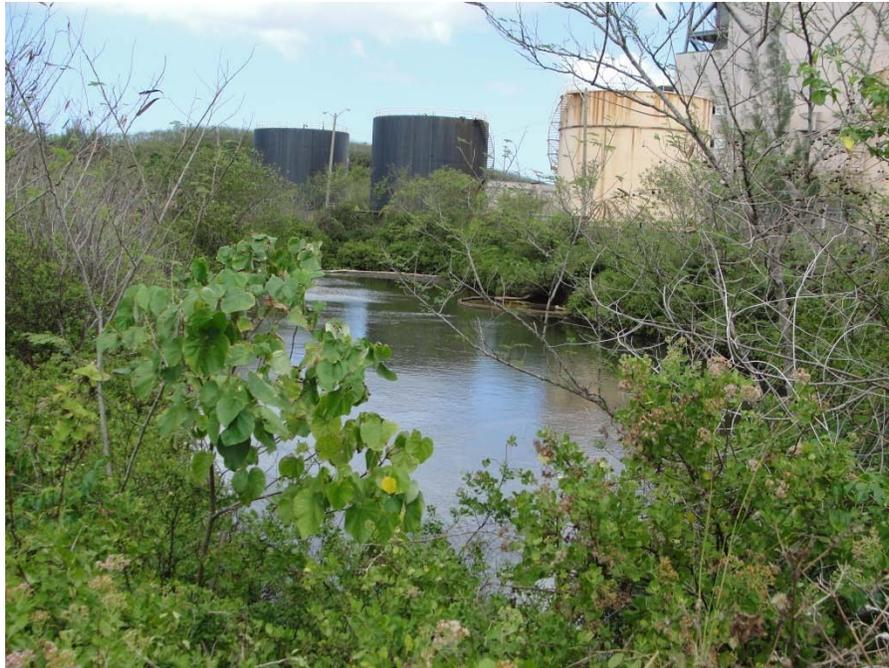
Photo 25: Western infiltration pond.

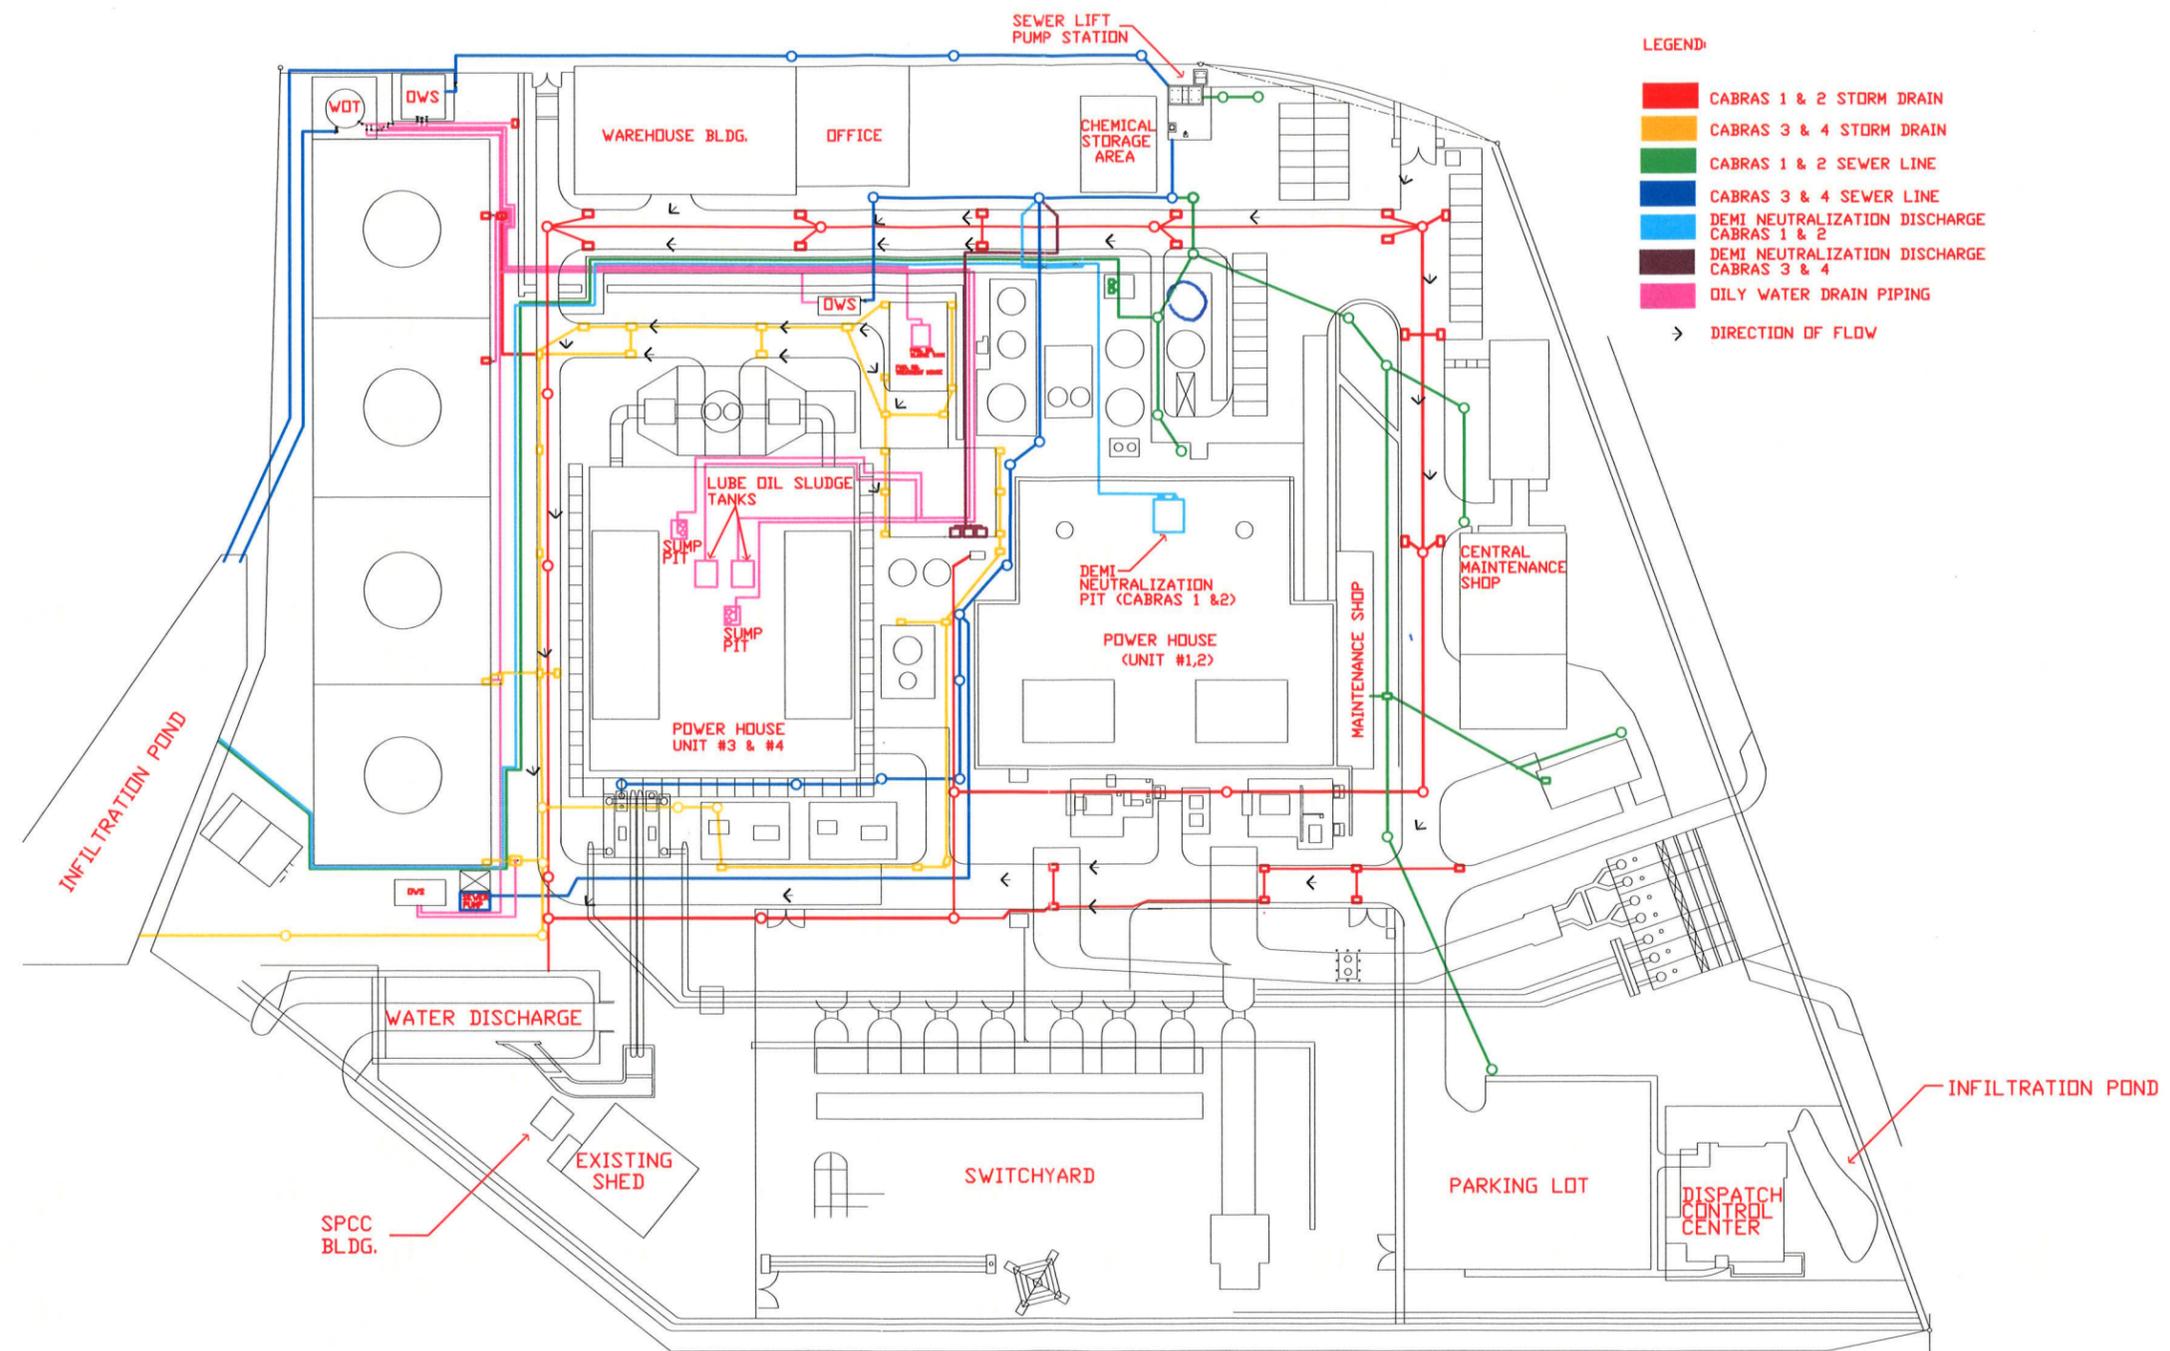
Figure 1.9-5 Power Plant Drainage Layout

The Cabras 3 and 4 storm drain system surrounds Units 3 and 4 and provides drainage for the secondary containment for two of the 420,000 gallon above ground storage tanks located on-site. The Cabras 3 and 4 storm drain system discharges directly to the western infiltration pond. However, based on the Facility Drainage Layout Diagram provided by the Discharger, there appears to be drainage route whereby the storm water could discharge to an oil/water separator and then enter the oily water drain piping system (discussed below).
