**Re: April 27 and April 30, 2009 Clean Water Act Inspection**

**NPDES COMPLIANCE EVALUATION INSPECTION**

NPDES Permittee: MYD Samoa, Inc.

Facility: Satala Shipyard  
P.O. Box 7684, Pago Pago, Tutuila Island, American Samoa  
(NPDES Permit No. AS0020026)

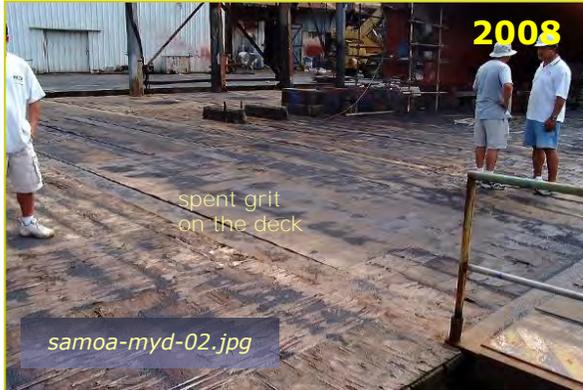
The deck consists of removable plywood and planking without perimeter curbing. Roofing felt now is added under new plywood to better fill in the gaps between the planking on the deck directly over harbor water. The dry dock has framing and rigging that allows the unfurling of portable curtains around and over the dry dock to capture painting overspray and windborne blasting debris. On the date of this inspection, MYD Samoa indicated that new curtains with grommet kits have been procured but not yet delivered to the shipyard. See Photos #1 and #2 in Section 1.6 of this report on page 9.

Photo #1: 3000-Ton Dry Dock Decking - April 2008  
Taken By: Greg V. Arthur  
Date: 04/01/08

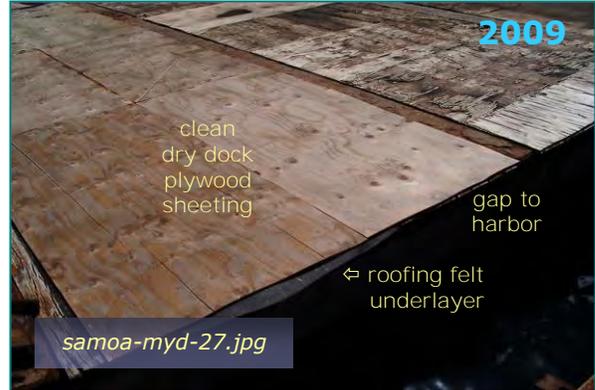
Photo #2: 3000-Ton Dry Dock Decking - April 2009  
Taken By: Greg V. Arthur  
Date: 04/27/09

Compliance Status - The dry dock was found with the gaps better sealed and the deck swept, clean, and in order. In particular, there was no blasting grit, paint debris, or overspray found on the dry dock deck or alongside on the piers. The design of the dry dock, with a split down the middle and crisscrossed with chain ways, forestalls the corrective actions advanced in the EPA Order to entirely seal the deck and direct all dry dock drainage for discharge through a controlled sample point. Nevertheless, continuous capture and removal of the solids from a curtain-shrouded and gap-sealed deck (roofing felt underlayer and temporary plastic sheeting) should prevent the loss of solids through deck gaps, over the deck edge, or entrained in storm water run-off and drainage. The EPA Order is expected to be modified to rescind the corrective actions related to controlled deck drainage. See Photos #1 and #2 on page 8.

Corrective Actions - A few remaining shortcomings have been identified following the EPA Order. First, there were no curtains available to capture drifting solids within the dry dock for removal, although MYD Samoa had them on order. Second, process-related wastewaters (*hydroblast, hose cleaning, hydrotesting*) discharge uncontrolled from the dry dock deck to the harbor beneath. Additional BMPs to correct these shortcomings and to ensure the shipyard and dry dock remain swept, clean, and in order are listed in Table 3.1 on page 17.

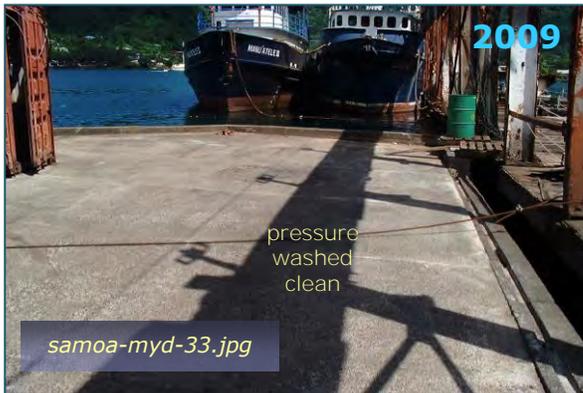
Catch Basin #1 Drainage – Catch Basin #1 includes the piers and landings around the 800-ton dry dock and two buildings. Catch Basin #1 was observed to be swept, in order, cleaned, and pressure washed, with no significant pollutant sources left exposed to contact with storm water run-off. The numerous pollutant sources observed last year were no longer found. In particular, the open storage of spent blasting grit and material debris adjacent to the 800-ton dry dock and the winch room was entirely removed. The trash piles, oily barrels, spent materials, and equipment on the landing were also removed. The pavement between the dry dock and harbor was pressure washed clean. There was curbing along the open harbor but not around the 800-ton dry dock. Catch Basin #1 drainage collects to a sump outfitted with siphon overflows to the harbor, designated as discharge point NPDES-001. No oily drainage was observed flowing into and through the discharge sump and no sheen was observed in the harbor around NPDES-001. See Photos #3, #4, #7, #8, #9, and #10 in Section 1.6 on page 10.

Photo #3: End of the Pier - April 2009  
Taken By: Greg V. Arthur  
Date: 04/27/09

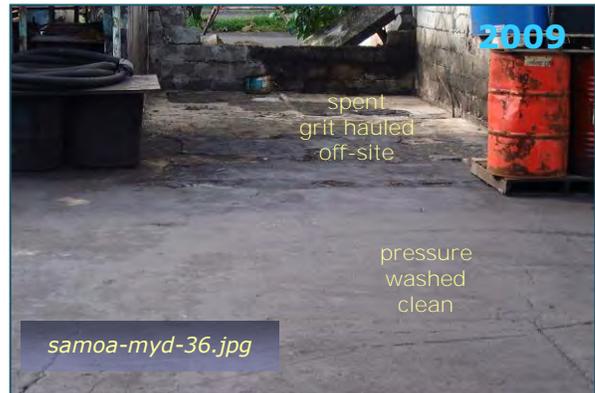
On the day of this inspection, these BMPs were observed have been effective in keeping much of the spent grit out of the harbor. In particular, (1) many of the gaps in the decking were underlain with roofing felt; (2) there was little spent grit on the deck and none on the surrounding piers; (3) there was no wet grit residue left on the deck after sweeping; and (4) the stockpile of spent grit stored next to the 800-ton dry dock was removed. However, spent grit blown to the dry dock edges would not be captured until MYD Samoa installs the new curtains. See Photos #1, #2, #4, #5, and #6 in Section 1.6 on page 9.

Photo #4: Eliminated Spent Grit Storage - April 2009  
Taken By: Greg V. Arthur  
Date: 04/27/09

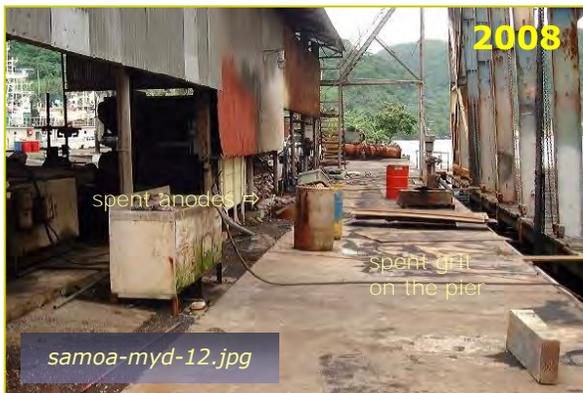
Catch Basin #3 Drainage – Catch Basin #3 includes the South Dock and the pier side landings between the fabrication and machining buildings and the 3000-ton dry dock. Catch Basin #3 was observed to be swept, in order, and cleaned, with no significant pollutant sources exposed to contact with rainfall run-off. Spent blasting grit was not found on the landings south of the dry dock. Zinc anodes, barrels, materials, scrap, and debris were no longer stored outside and around the fabrication and machining buildings. No boat repair work was being done by the ship crews on the South Dock. Most of the drainage collects to a sump outfitted with siphon overflows to a short canal leading to the harbor, and designated as discharge point NPDES-003. No sheen was observed in the canal and harbor around NPDES-003. There is curbing along the South Dock but not on the pier around the 3000-ton dry dock. Around the dry dock, the landing slants toward the open gap over the harbor between the uncurbed pier and the dry dock. See Photos #5, #6, and #12 in Section 1.6 on pages 9 and 10.

Photo #5: Catch Basin #3 - April 2008  
Taken By: Greg V. Arthur  
Date: 04/01/08

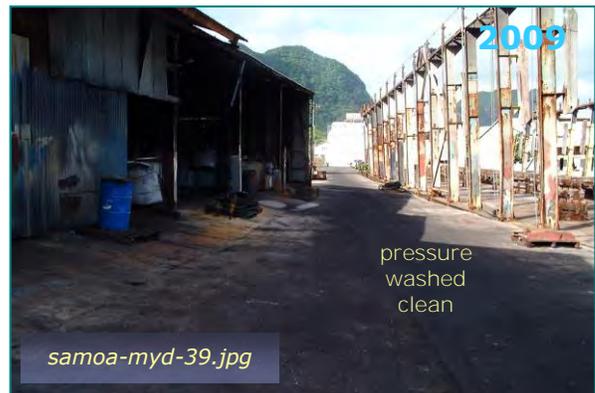
Photo #6: Catch Basin #3 - April 2009  
Taken By: Greg V. Arthur  
Date: 04/30/09

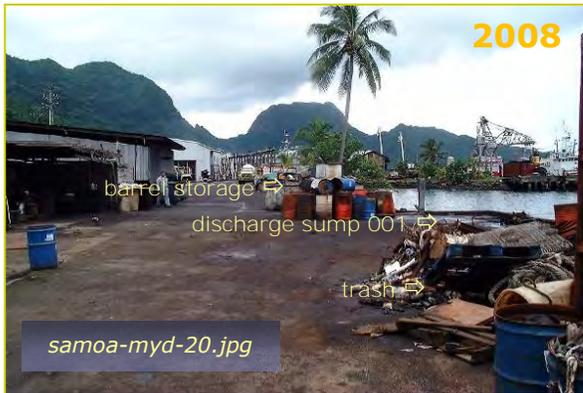
Photo #7: Catch Basin #1 – April 2008  
Taken By: Greg V. Arthur  
Date: 04/01/08

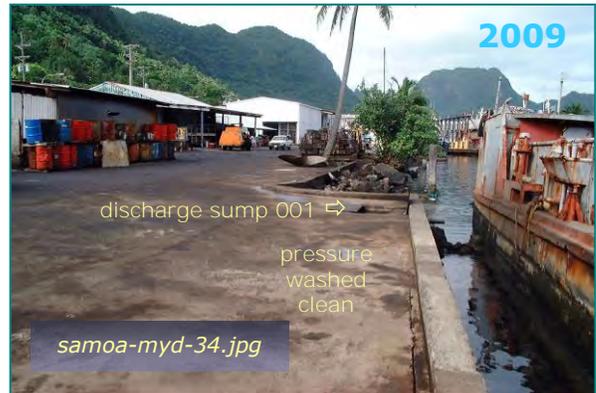
Photo #8: Catch Basin #1 – April 2009  
Taken By: Greg V. Arthur  
Date: 04/30/09

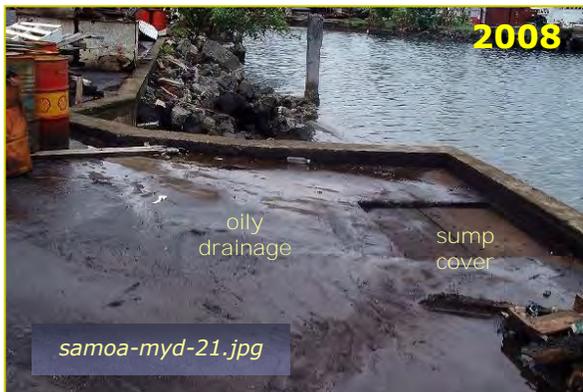
Photo #9: Discharge Sump 001 – April 2008  
Taken By: Greg V. Arthur  
Date: 04/01/08

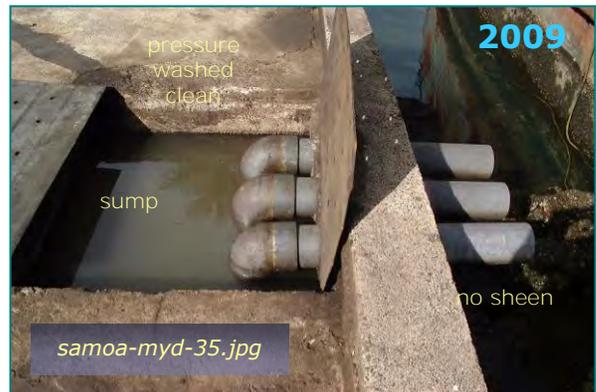
Photo #10: Discharge Sump 001 – April 2009  
Taken By: Greg V. Arthur  
Date: 04/30/09

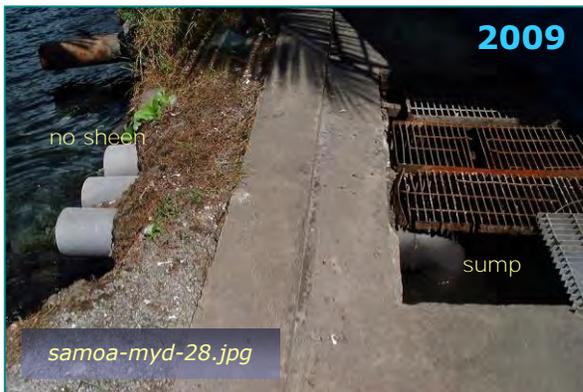
Catch Basin #2 Drainage – Catch Basin #2 encompasses buildings and pier side landings north and east of the 3000-ton dry dock. Catch Basin #2 was observed to be swept, in order, and cleaned, with no significant pollutant sources exposed to contact with rainfall run-off. Spent blasting grit was not found on the landings north of the dry dock. There is curbing along the open harbor but not on the pier around the 3000-ton dry dock. The drainage collects to a sump outfitted with siphon overflows to the harbor, designated as discharge point NPDES-002. No sheen was observed in the harbor around NPDES-002. See Photo #11 in Section 1.6 on page 10.

Photo #11: Discharge Sump 002 – April 2009  
Taken By: Greg V. Arthur  
Date: 04/27/09

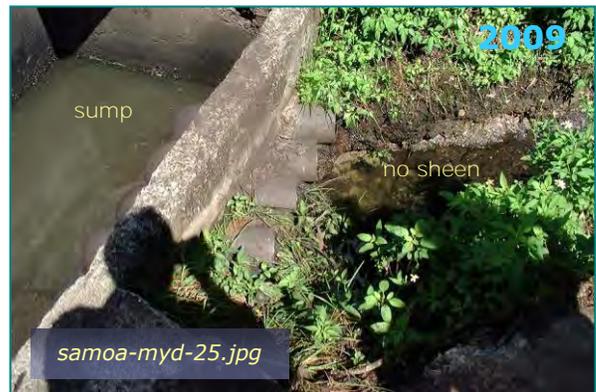
Photo #12: Discharge Sump 003 – April 2009  
Taken By: Greg V. Arthur  
Date: 04/27/09
