Impairment to Aquatic Invertebrate and Fish Assemblages caused by Heavy Metals in the Acid Rock Drainage from Ely Mine near Vershire, Vermont

USGS Water Science Center

Vermont DEC

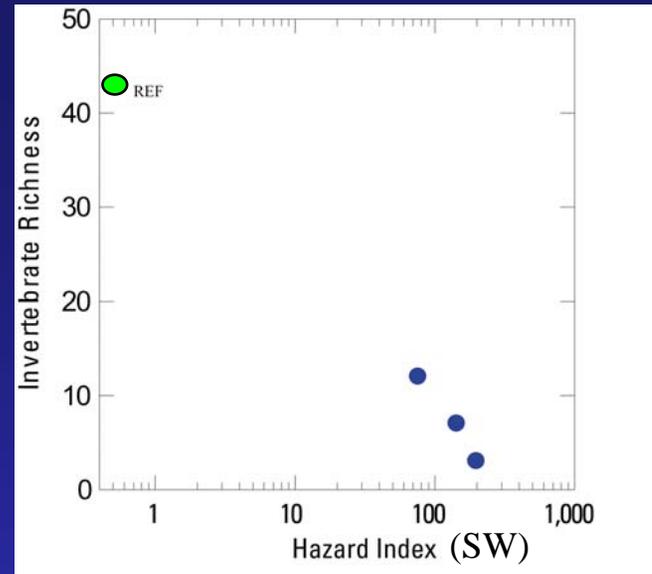
Ely Brook

Hazard Index and Richness

Macro invertebrates from riffles

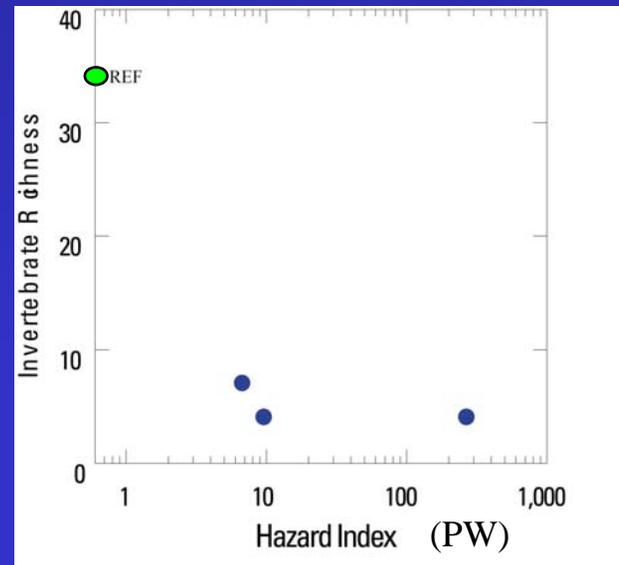
Macro invertebrates from sediment

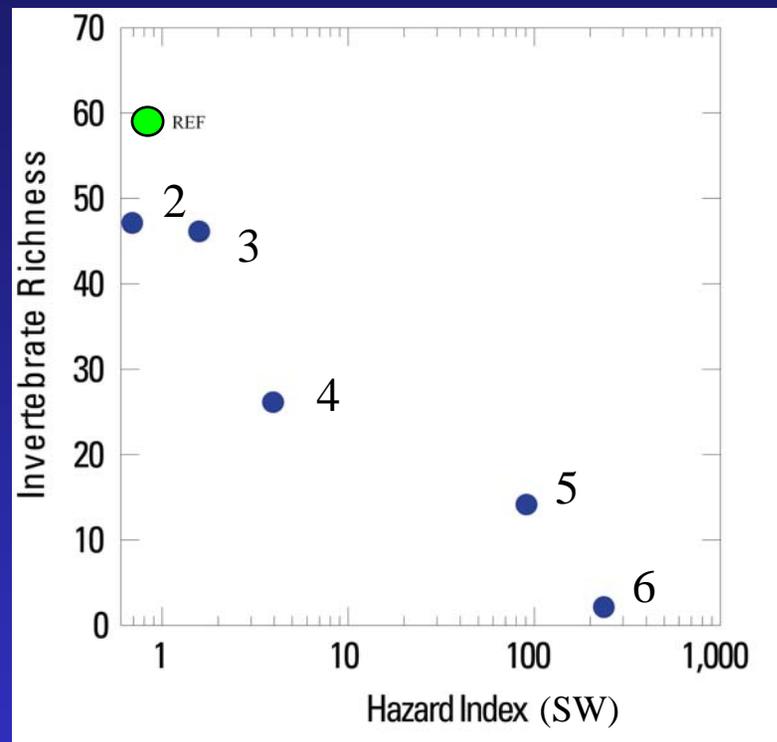
Invertebrates in littoral vegetation

Ely Ponds
Hazard Index and Richness

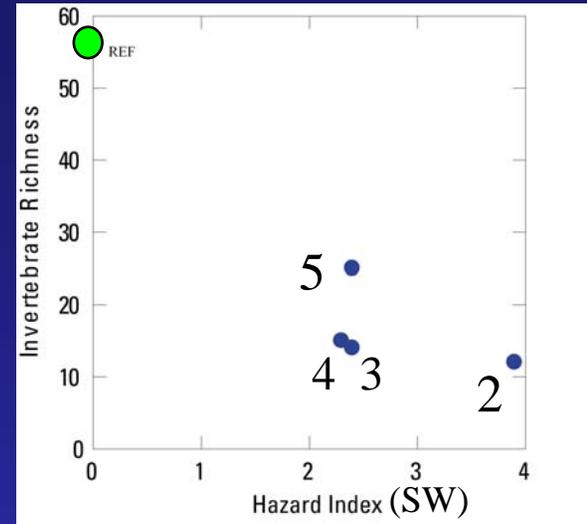
Invertebrates from riffles

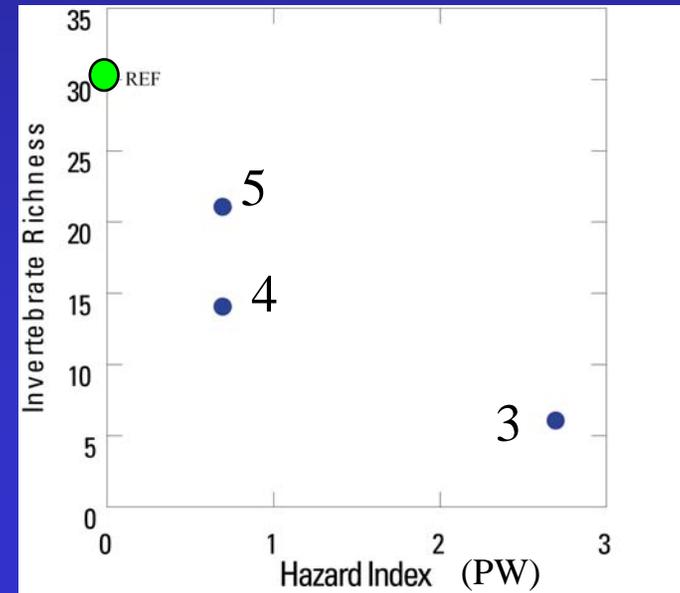
Invertebrates from sediment

Schoolhouse Brook
Hazard Index and Richness

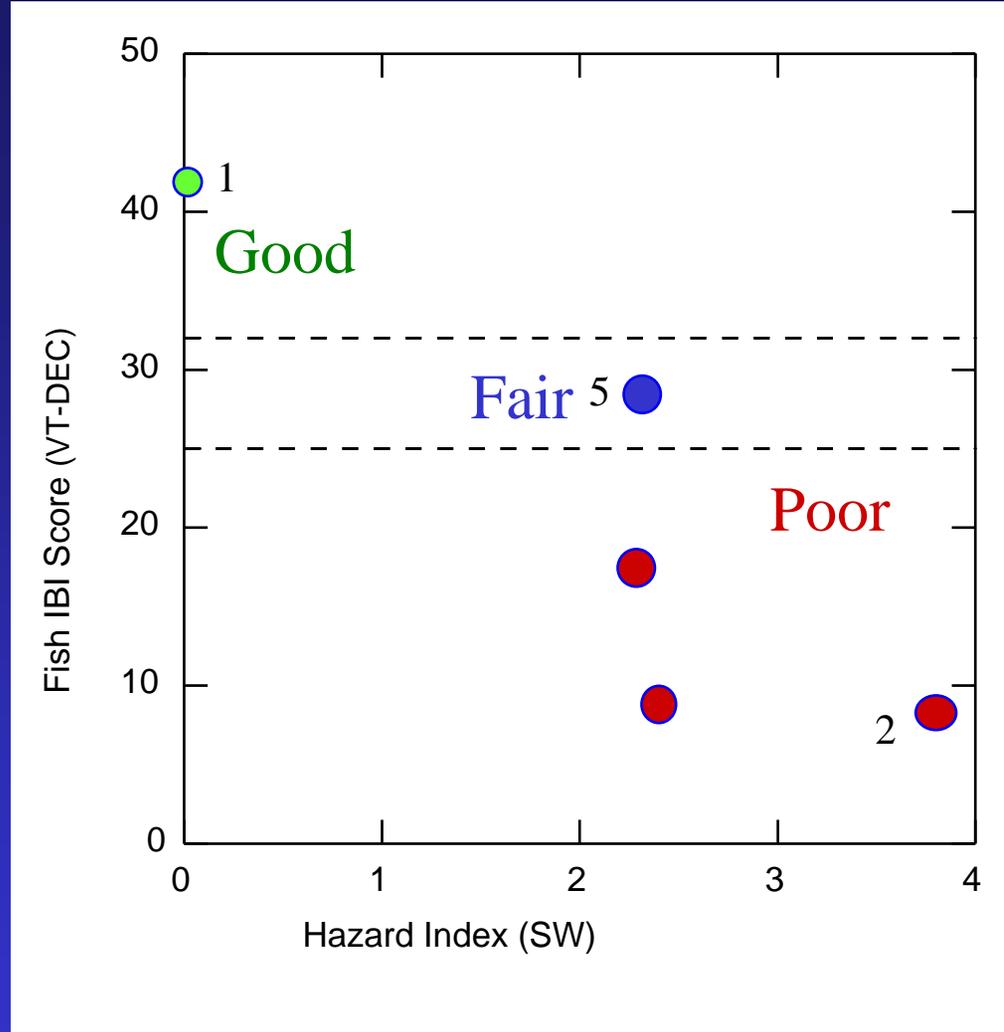
Schoolhouse Brook
Hazard Index and Fish
