How much of a buffer is needed to mitigate the change to littoral habitat from lakeshore development?

Kellie Merrell, Jeremy Deeds, Mark Mitchell, Eric Howe and Susan Warren

Vermont Agency of Natural Resources
802-241-4242
kellie.merrell@state.vt.us

18 March 2010 NEAEB, Newport, RI

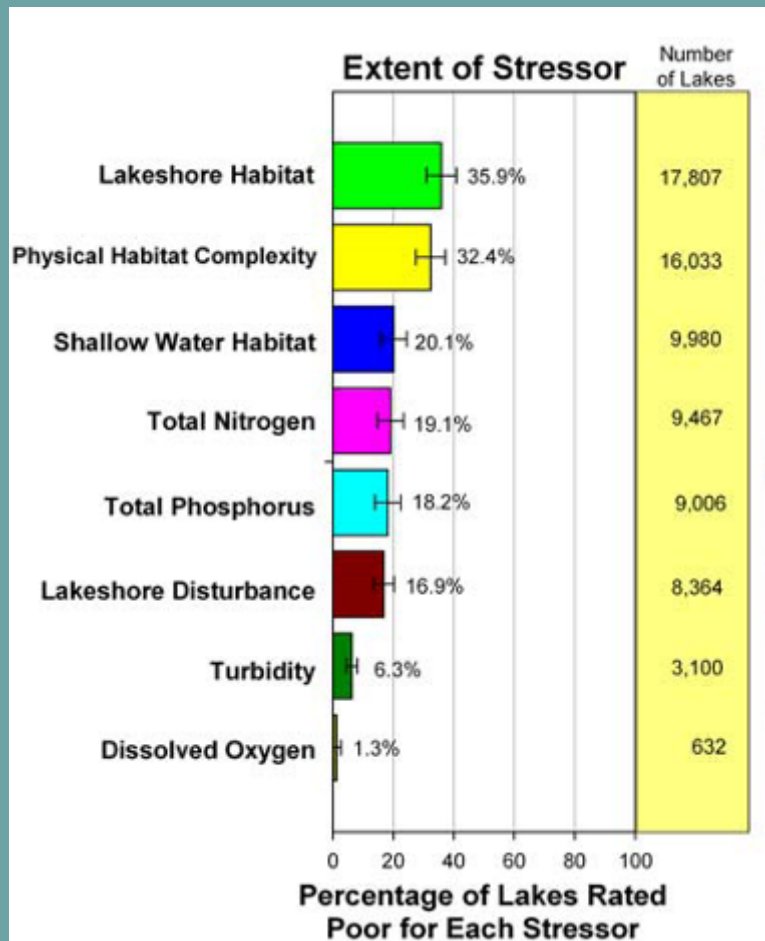
Removal of Lakeshore Vegetation 'Lakeshore Habitat' is the most widespread stressor to the nation's lakes

"Of the stressors included in the NLA, poor lakeshore habitat is the biggest problem in the nation's lakes; over one-third exhibit poor shoreline condition."

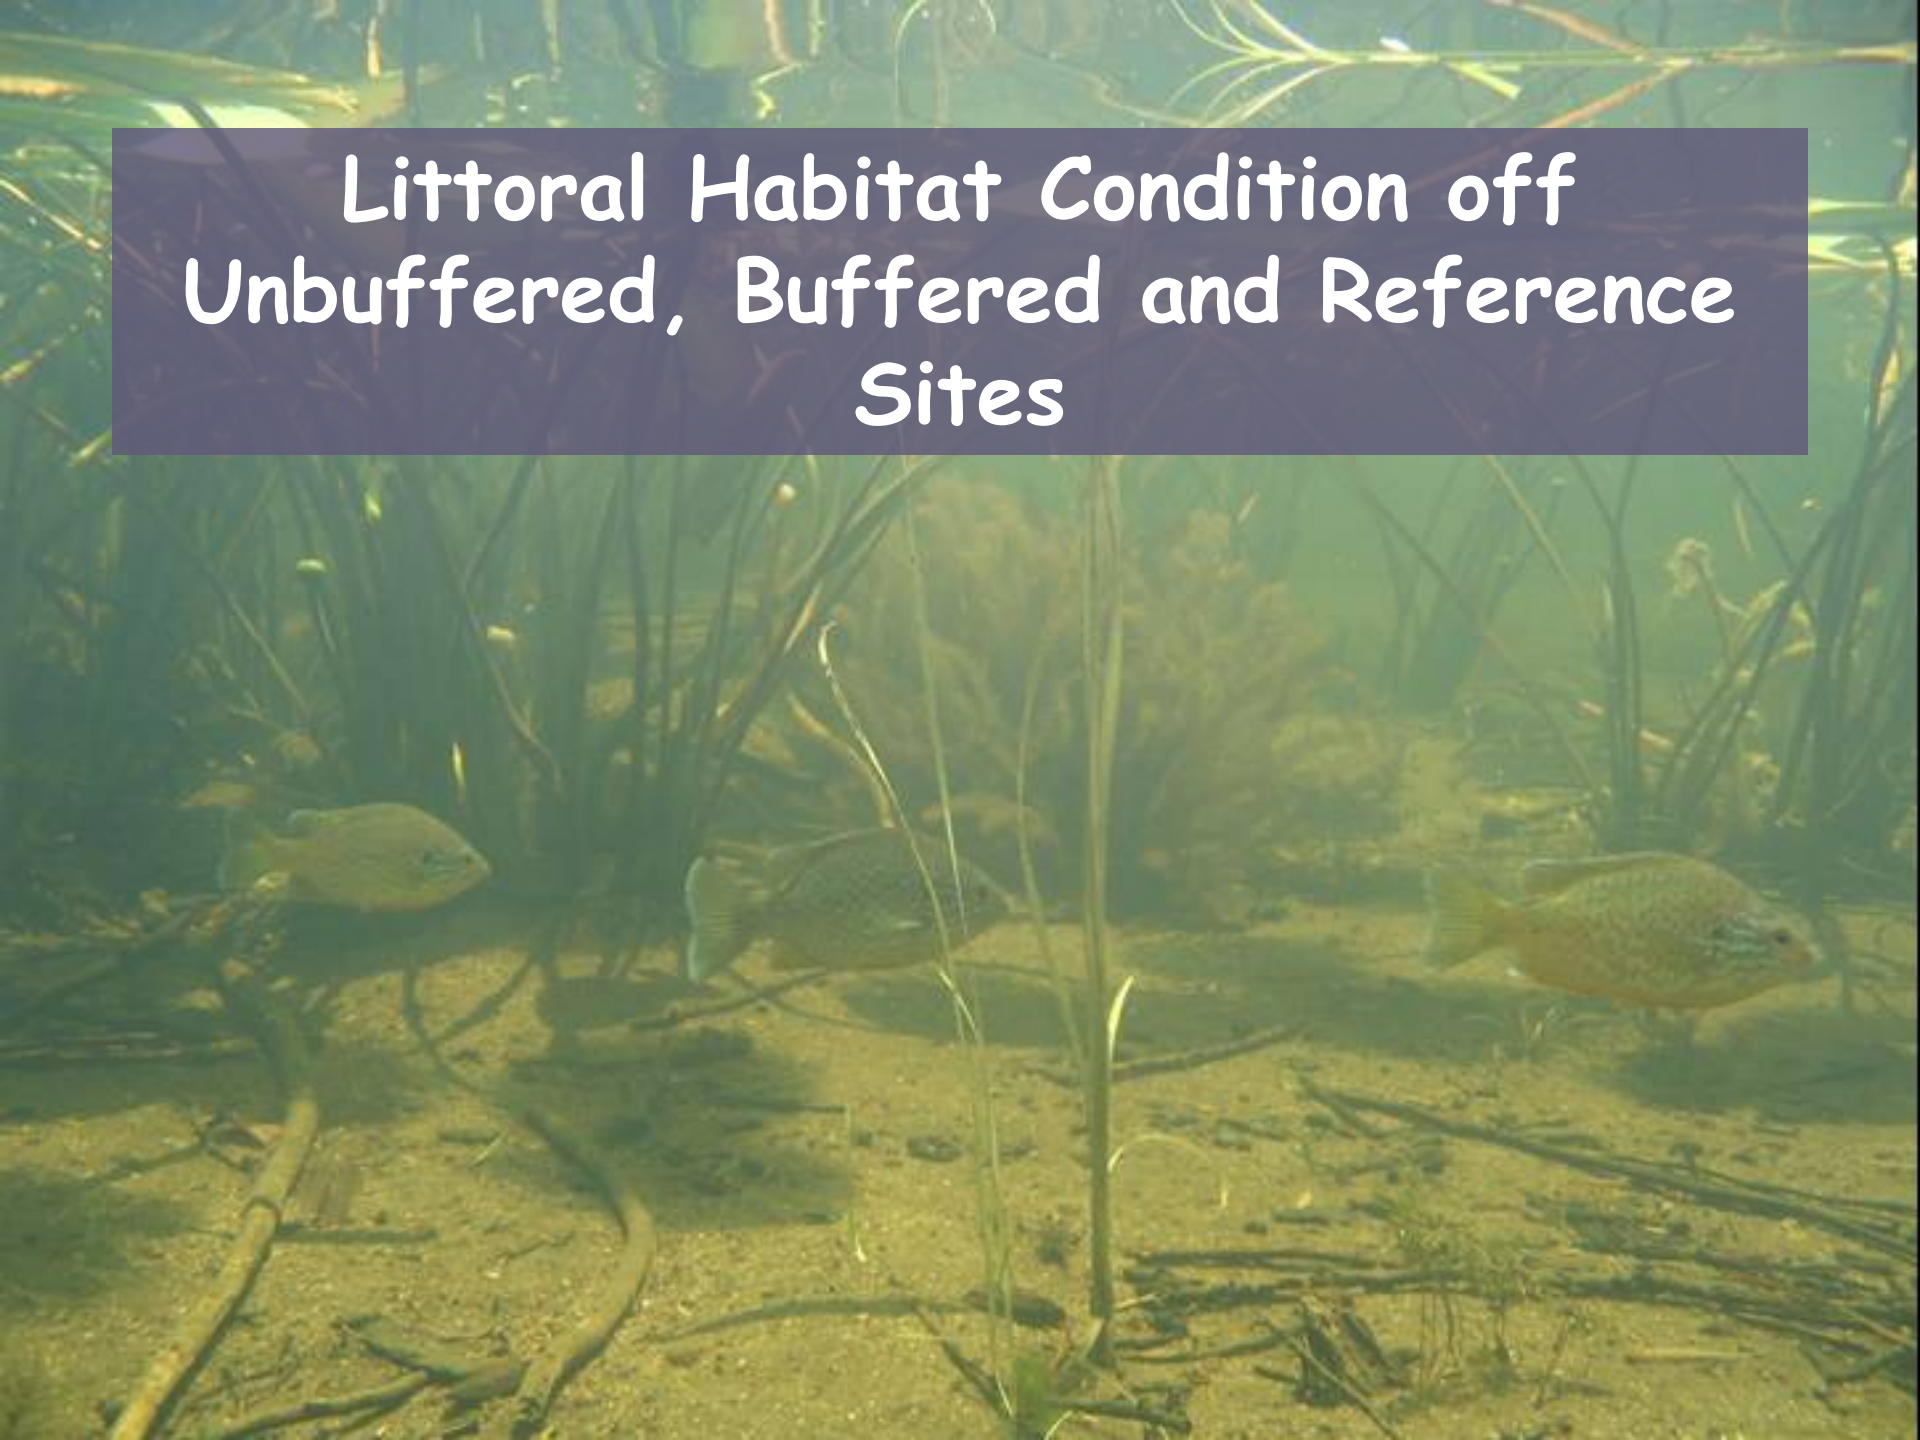
Littoral Habitat Condition off Unbuffered, Buffered and Reference Sites

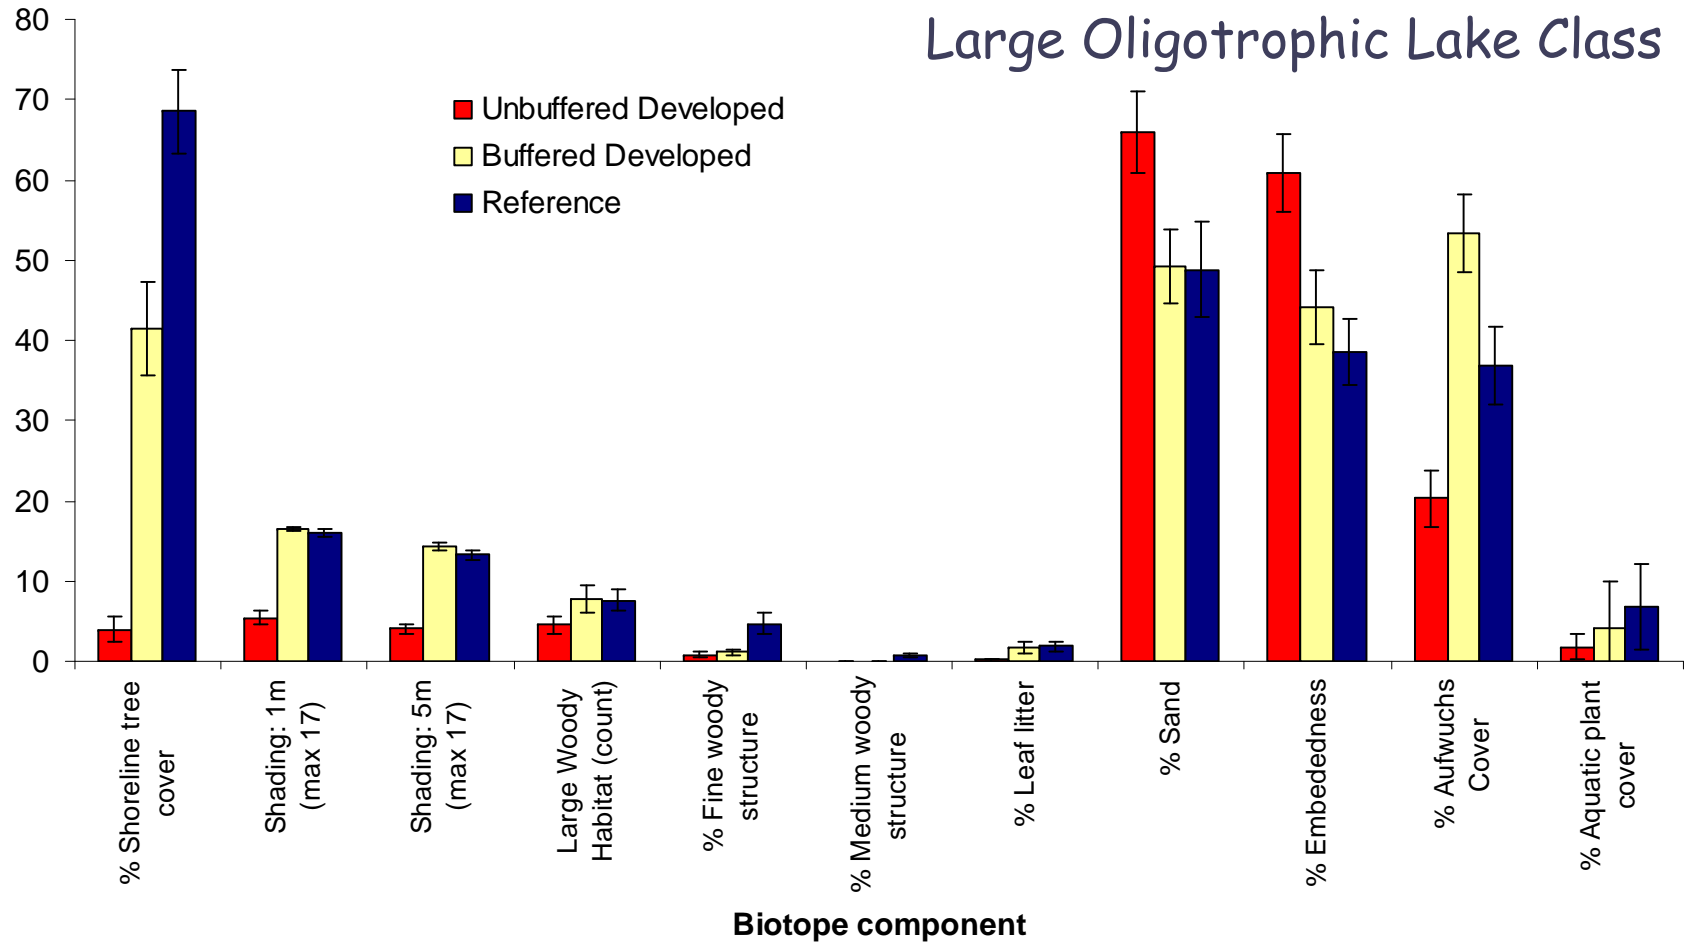
Buffered Developed Sites More Like Reference Sites

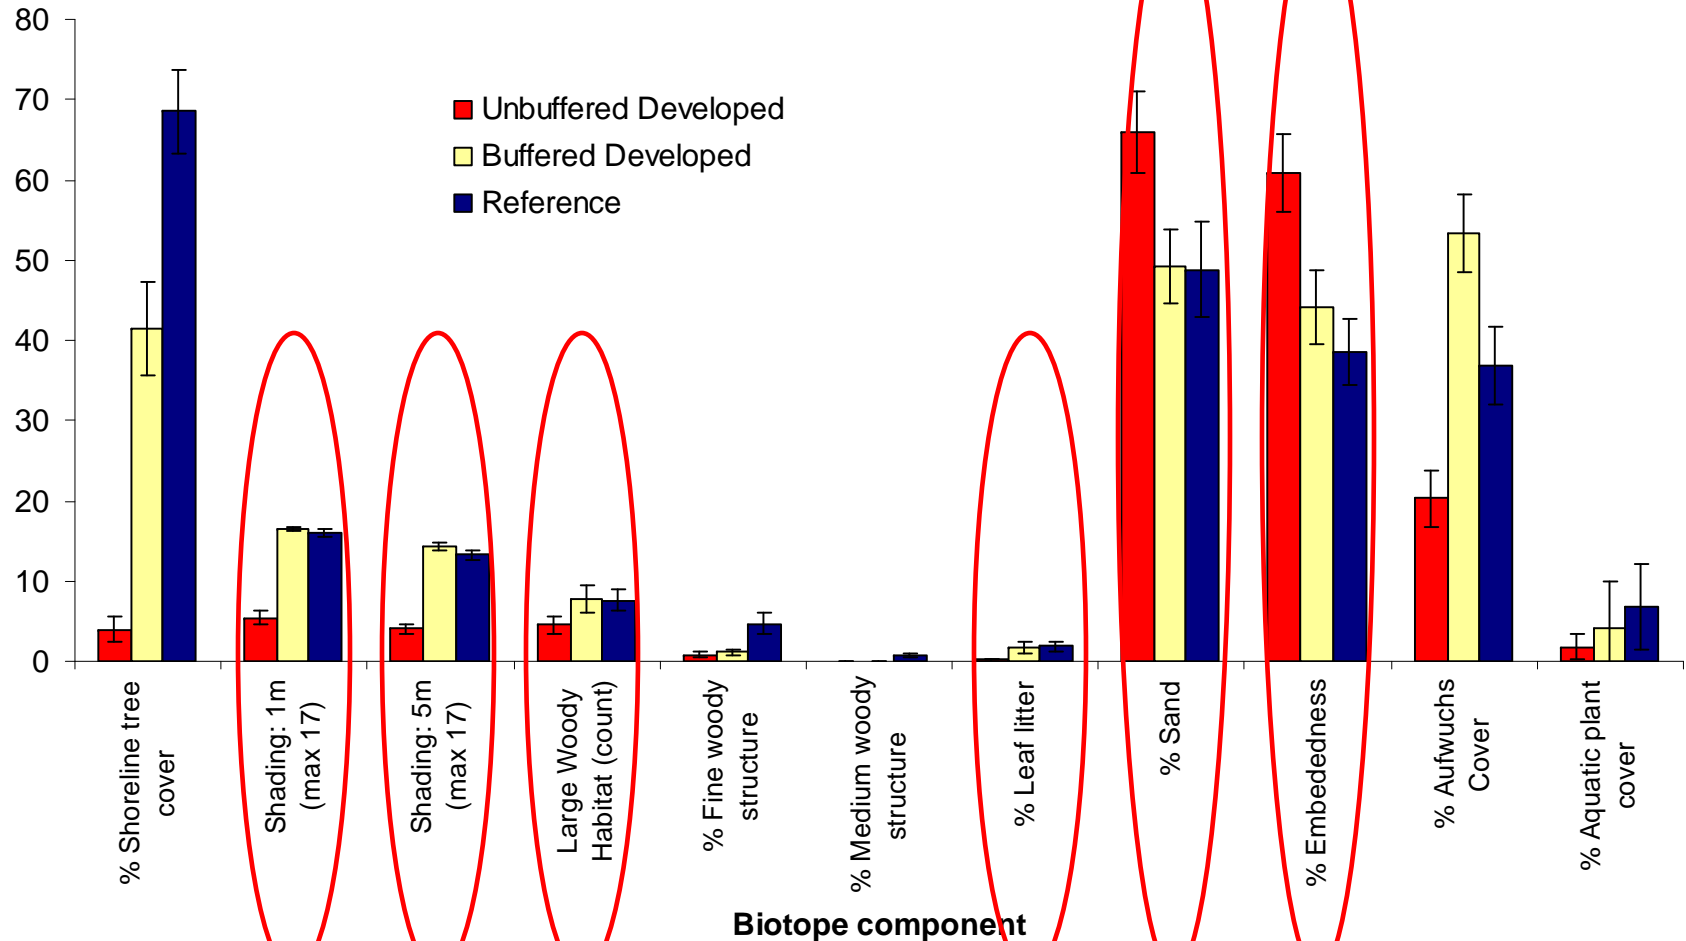
These 6 littoral habitat parameters retained their reference condition off buffered developed sites

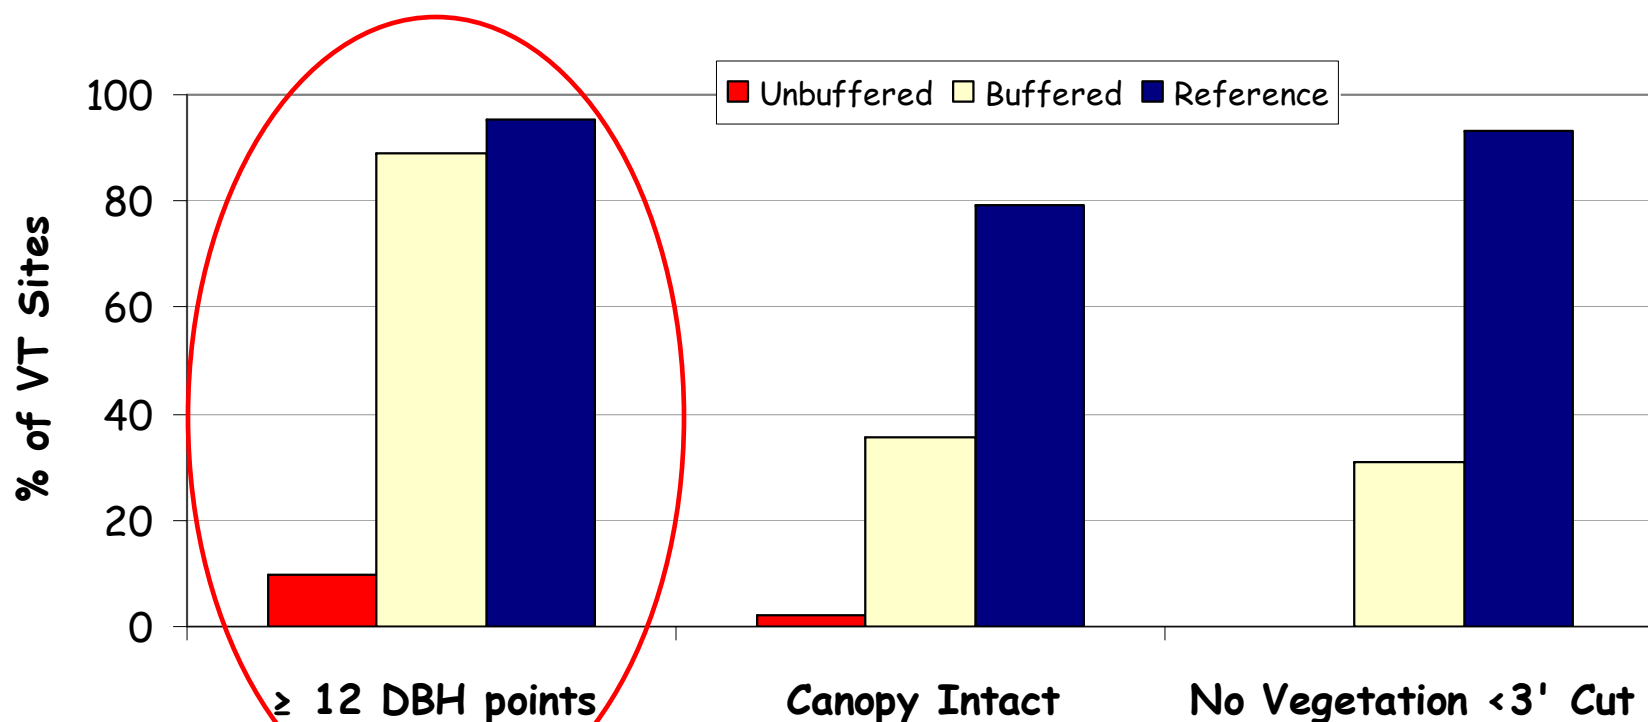
Percentage of VT Large Oligotrophic Lake Sites Meeting Maine's Shoreline Protection Act Standards

These sites met Maine's 12 point criteria in the 25'X25' plot

DBH = 2"-4" = 1 point, DBH >4"-12" = 2 points, DBH >12" = 4 points

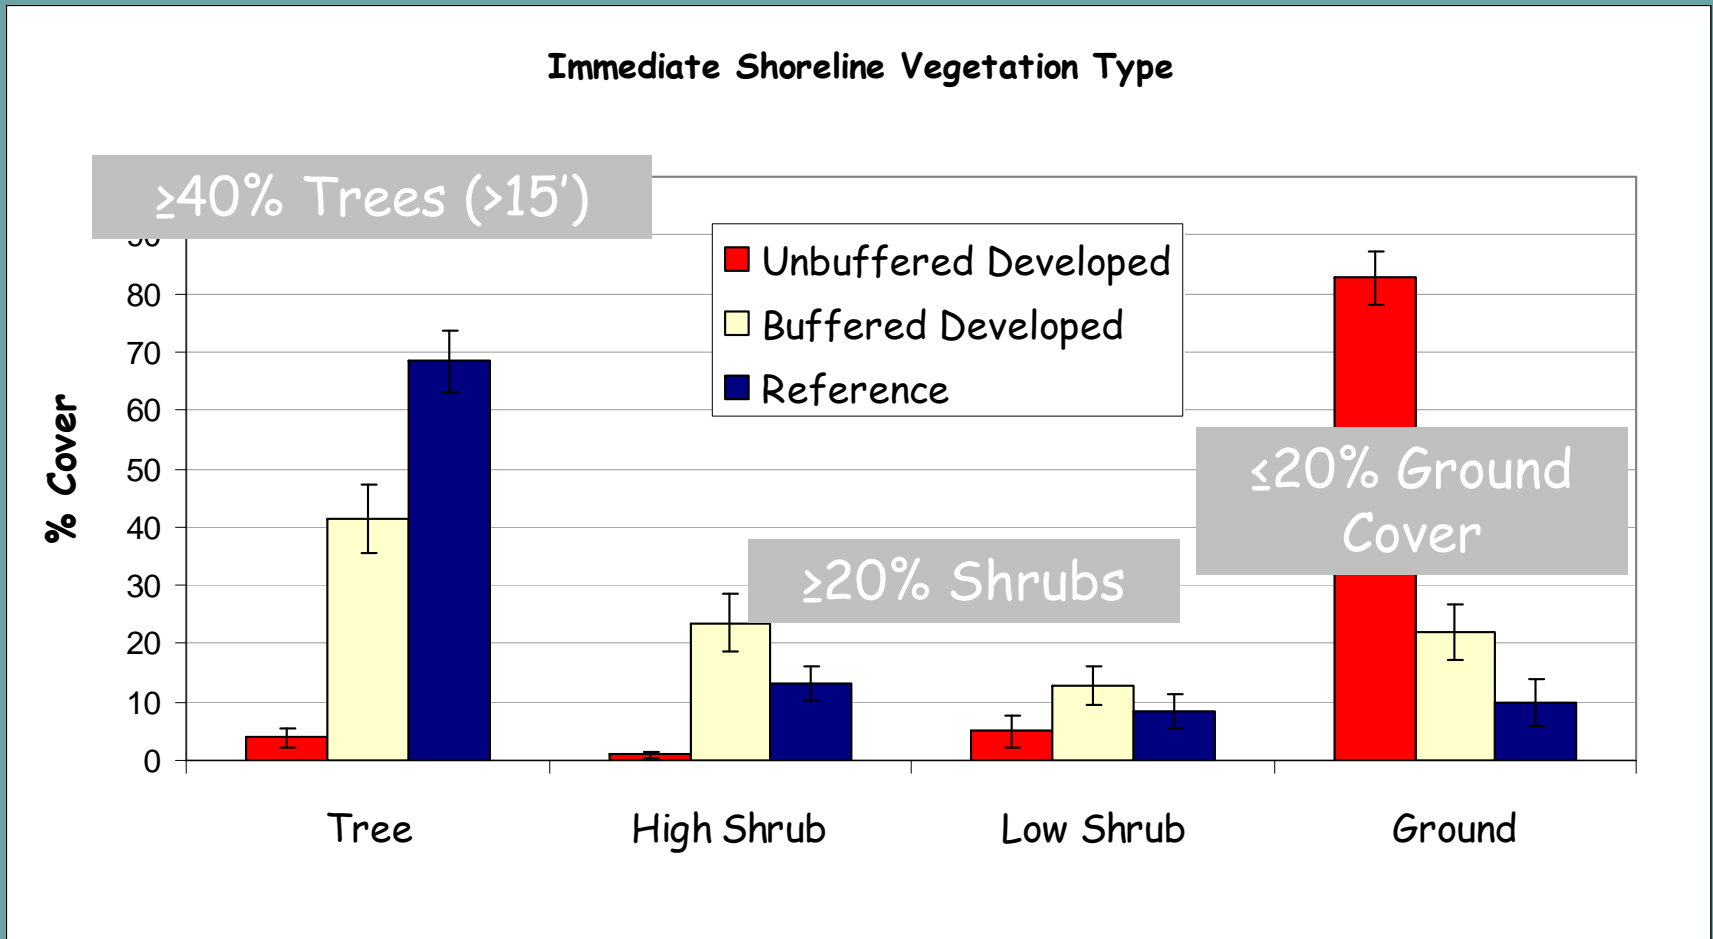
Immediate Shoreline Vegetation Viewed from Lake During Summer

IMMEDIATE SHORELINE Main features were that trees ($\geq 15'$) made up at least 40% of the vegetation, shrubs made up at least 20% and ground cover made up no more than 20%

- IMMEDIATE SHORELINE (*viewed from lake in summer*):
 - Trees ($\geq 15'$) made up at least 40% of the vegetation
 - Shrubs made up at least 20%
 - Ground cover made up no more than 20%
- The width of the intact buffer was
 - 9m (30') at it's widest
 - 7m (23') overall
 - 5m (16') at it's narrowest
- Main structures were set back an average of 20m (66')
- Closest structures were set back an average of 17.5 m (57')

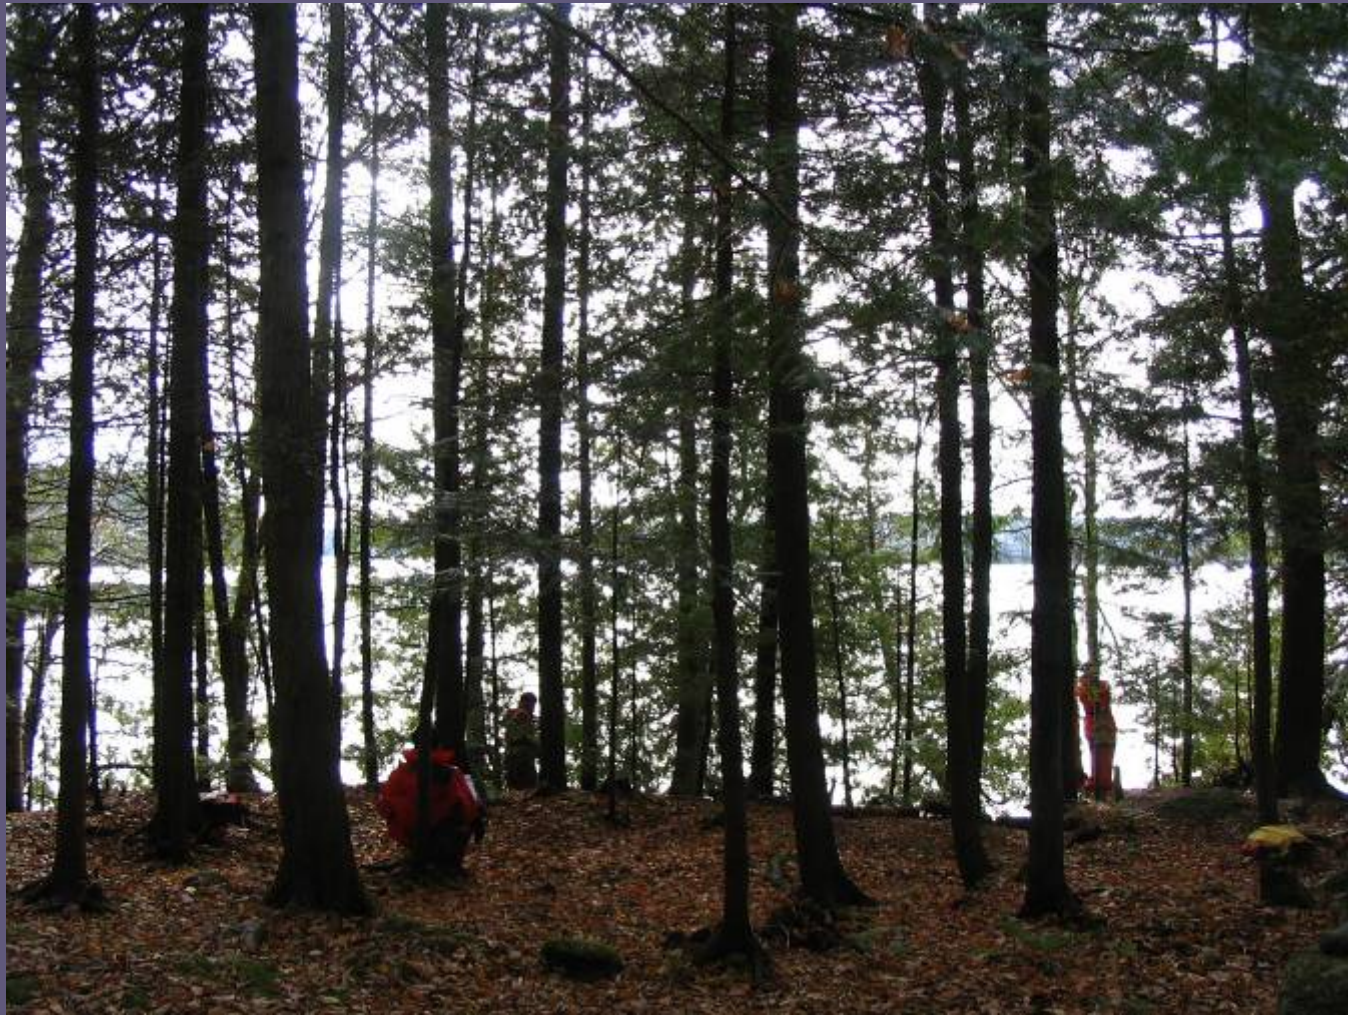
25'x25' riparian plot vegetative cover
(viewed at knee height after leaf off)

25'X25' RIPARIAN PLOT Main features were that duff and natural grasses made up 60-80%, shrubs 15%, tree trunks 10%, and lawn/flower beds less than 10%

- Duff and natural grasses/ferns made up 60-80%
 - Tree trunks 10%
 - Shrubs 15%
 - Lawn/flower beds less than 10%
- >30 saplings (<2' diam) in 25'X25' riparian plot
- <5% of the 25'X25' riparian plot was impervious
- Maintained the minimum of 12 DBH points allowed by Maine's shoreland protection act

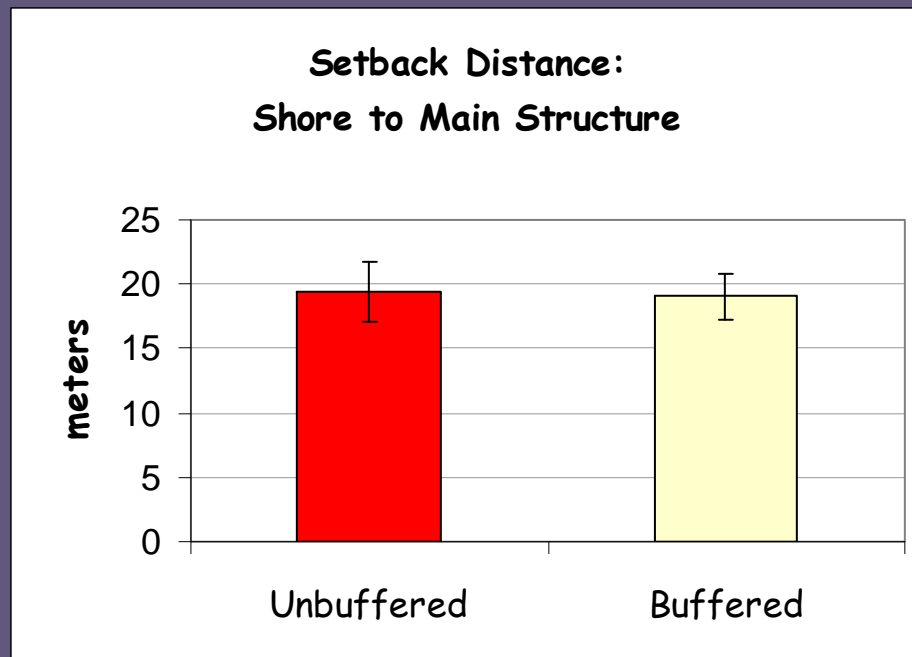
Average setback distances were the same for developed sites, whether buffered or unbuffered

~20m (66')

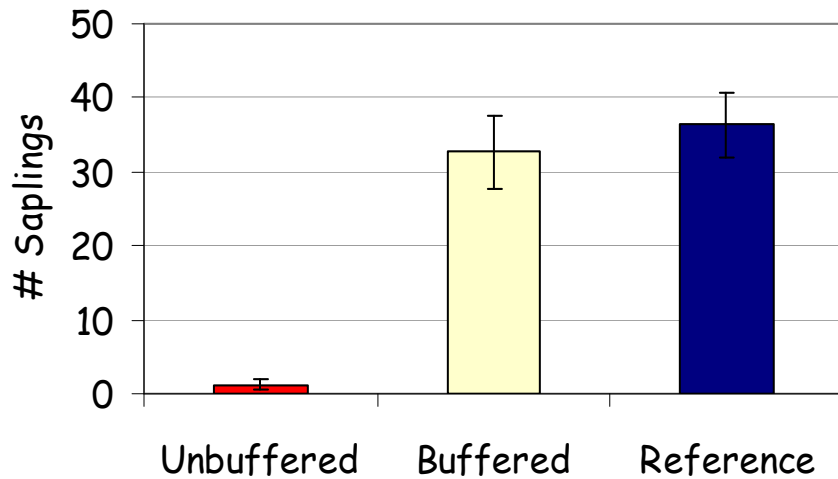
Nearshore Plot Tree Saplings

Buffered Developed Sites Had More Tree Saplings and Less Impervious Surfaces Than Unbuffered Developed Sites

>30 saplings/25'x25'
riparian plot

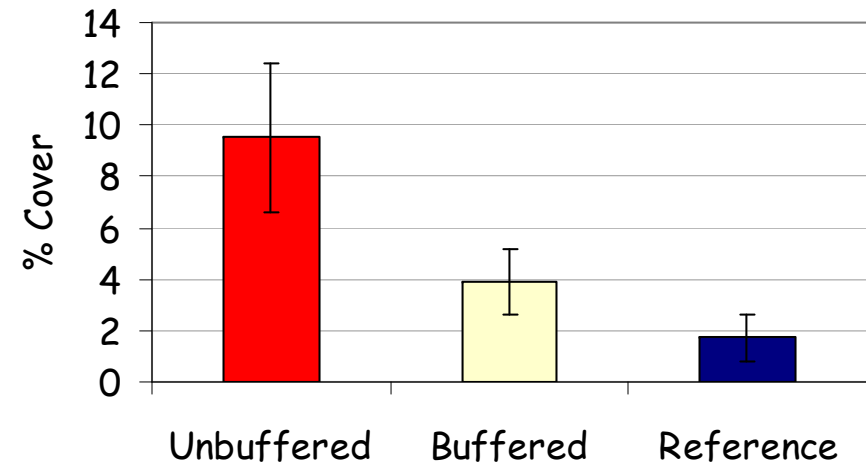
Nearshore Plot Impervious Surfaces

<5% of 25'x25' riparian
plot impervious

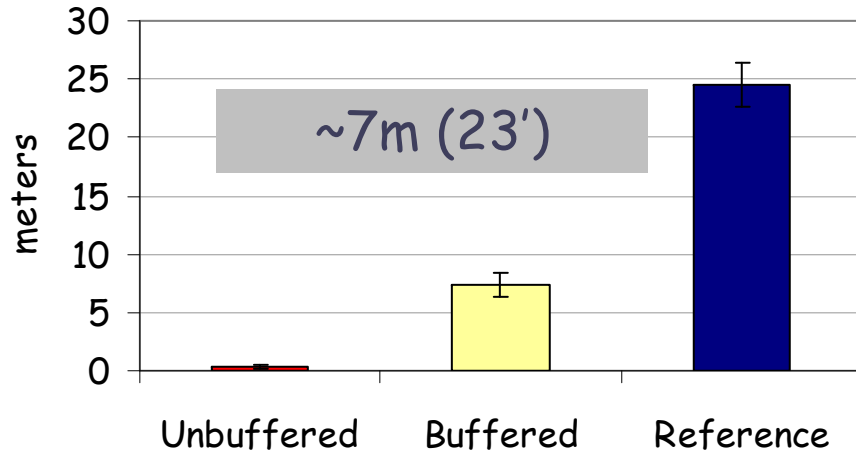
Average Width of Intact Buffer

**Maximum buffer width measured was 30.5 m (100 ft)*

**Buffered Developed Sites
Had Wider Intact
Buffers Than Unbuffered
Developed Sites**

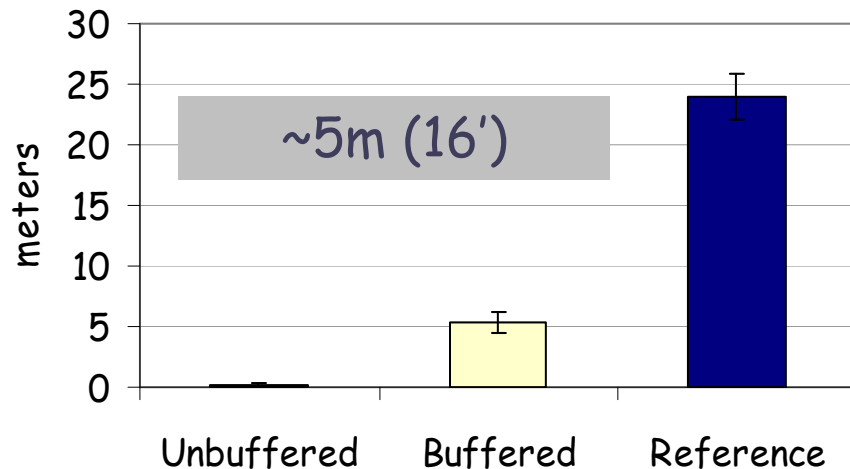
Narrowest Width of Intact Buffer

**Maximum buffer width measured was 30.5 m (100 ft)*

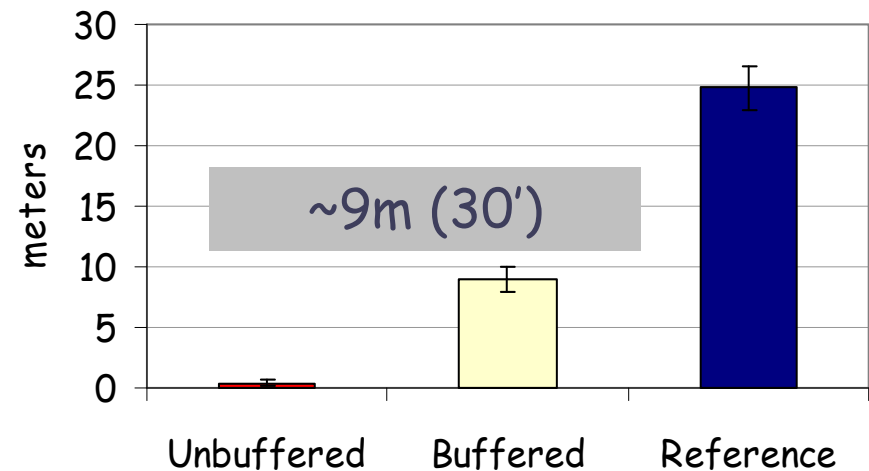
Widest Width of Intact Buffer

**Maximum buffer width measured was 30.5 m (100 ft)*

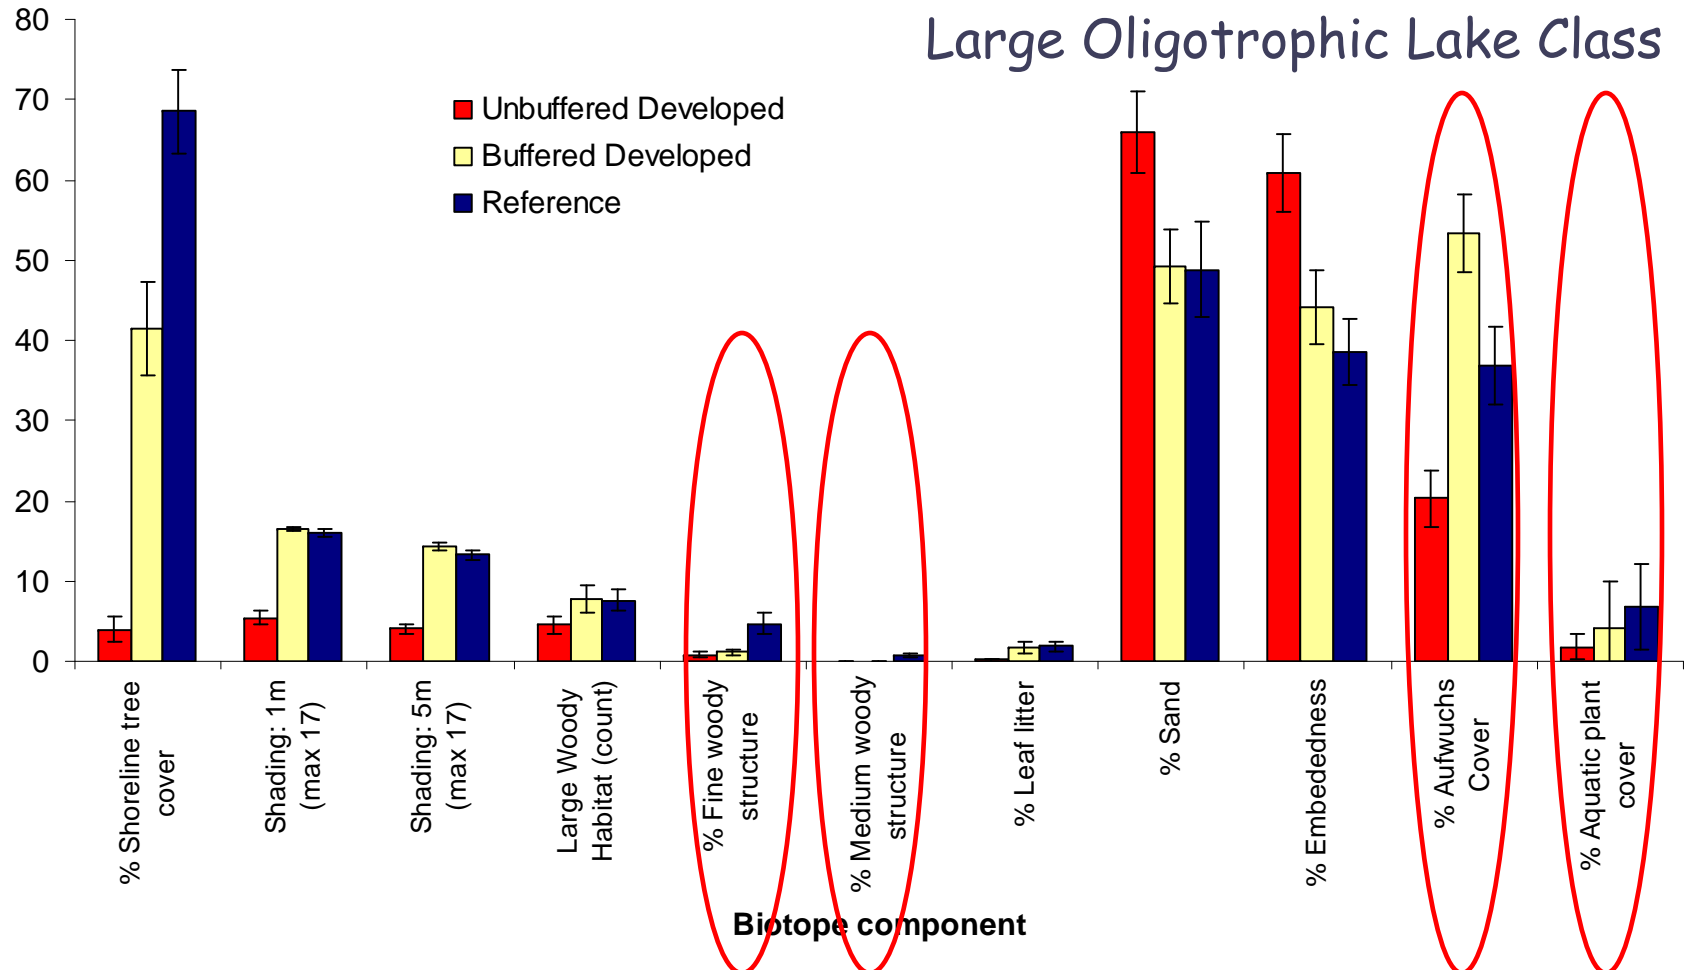
What about the 4 littoral habitat parameters that were still significantly different from reference when development was buffered?

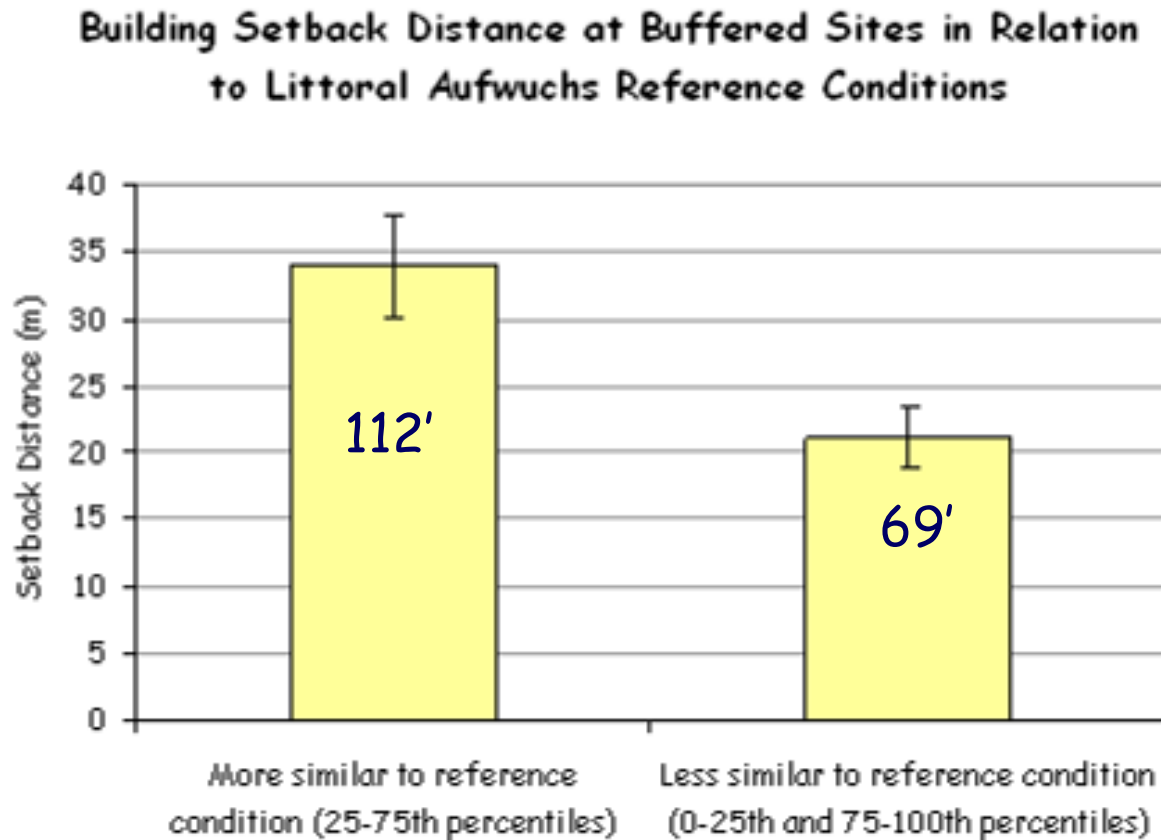
Buildings were set back further from the lake at the buffered developed sites where there was no change in aufwuchs

112'
instead of
overall
average of
66'

Nutrient runoff from the impervious roof area could be absorbed into the ground before entering the lake

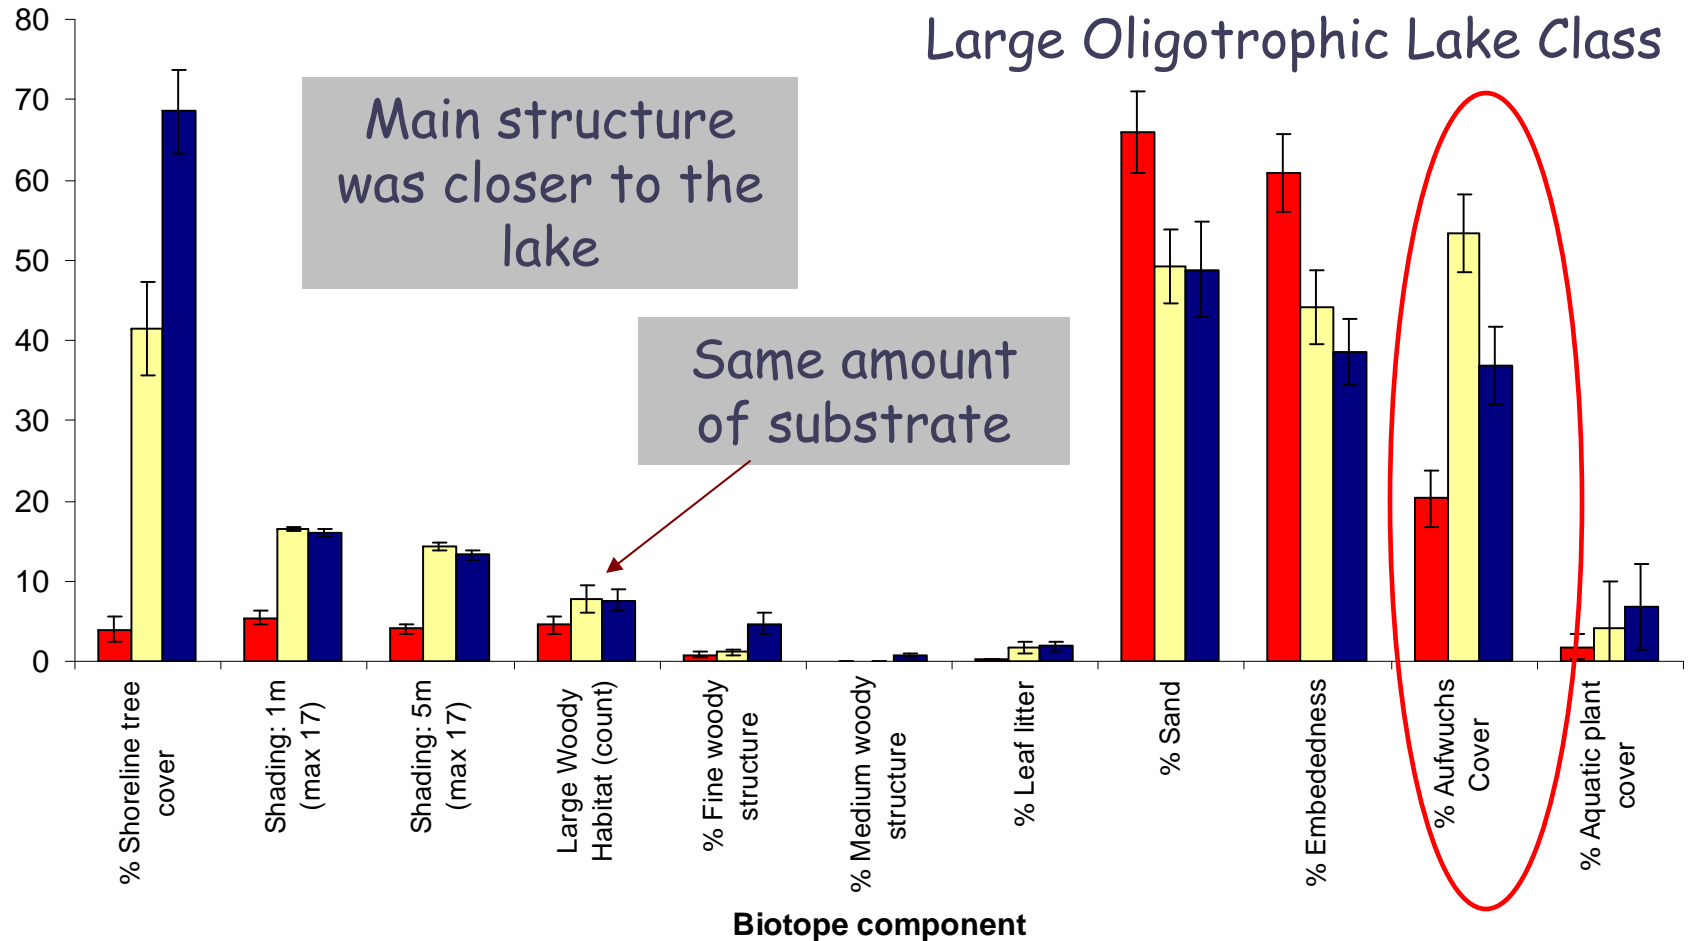
When we had included all the buffered developed sites, we had seen significantly increased aufwuchs growth

Whereas, there was no difference in mean setback distance when all the buffered developed sites were used and we saw an overall increase in mean aufwuchs from reference

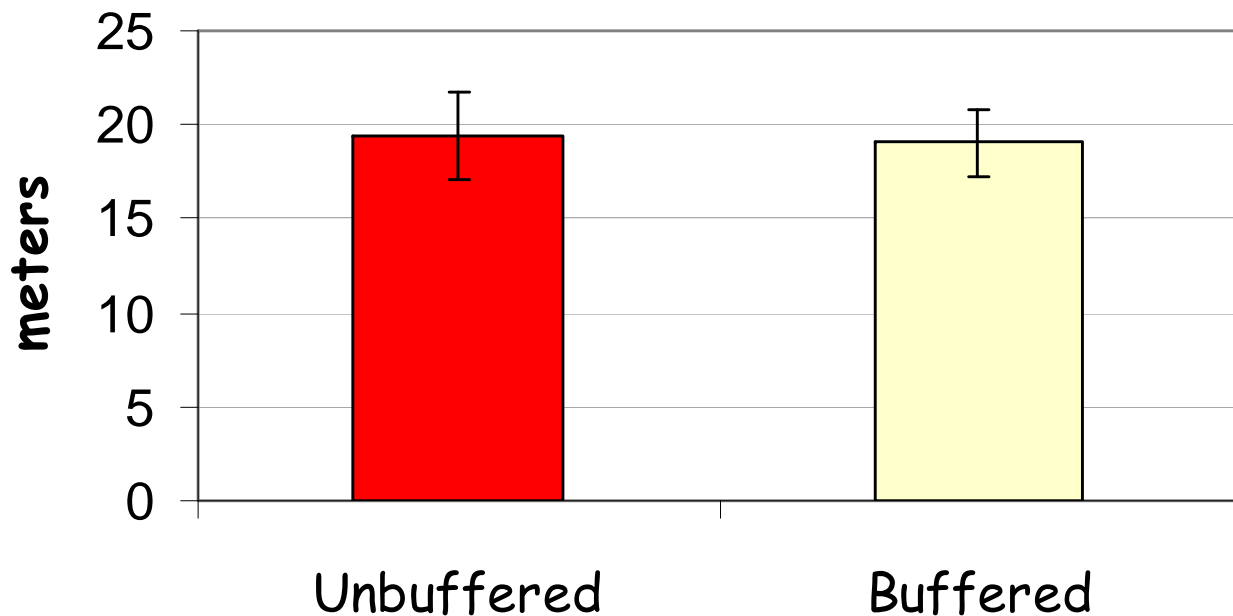
Setback Distance: Shore to Main Structure

~20m (66')

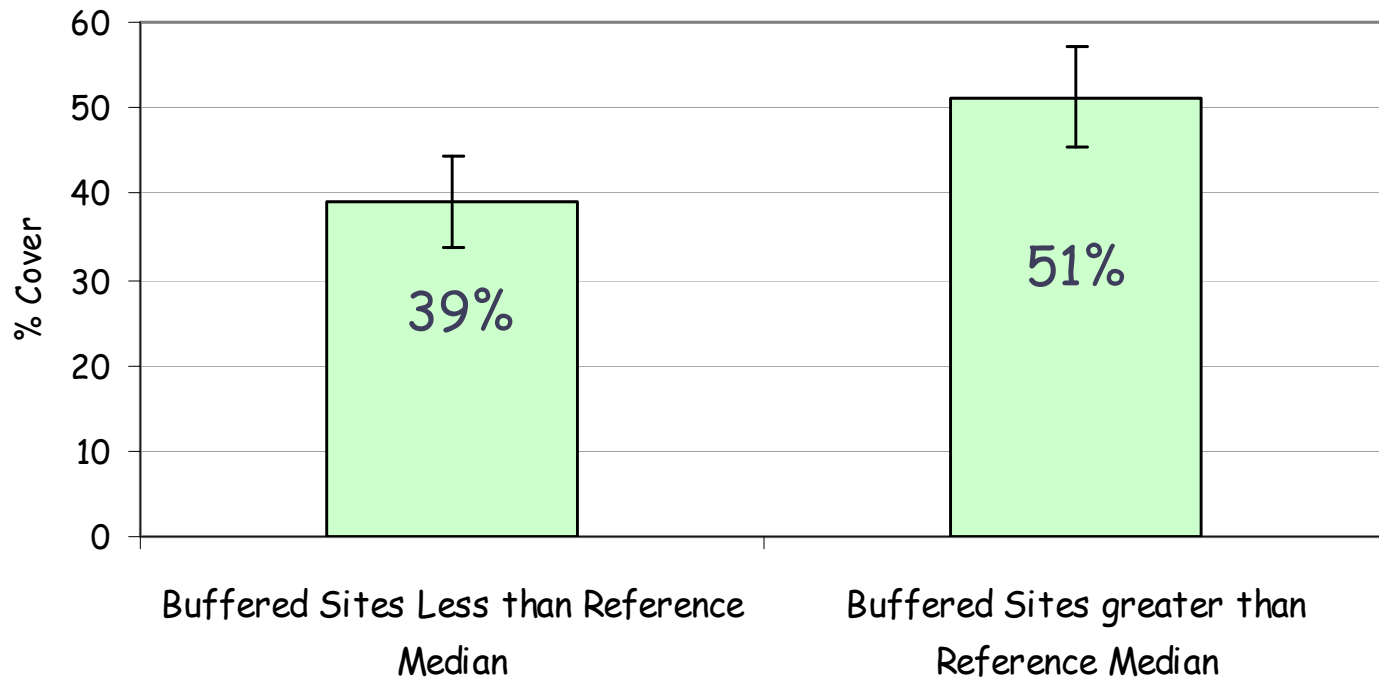
Shoreline Tree Cover at Buffered Sites in Relation to Fine Woody Structure Reference Condition

Buffered developed sites that had greater proportions of mature trees (>15') along the immediate shore, had no change in fine woody structure from reference

- Trees (>15') made up an additional 10% more of the immediate shoreline (for a total of 50%)

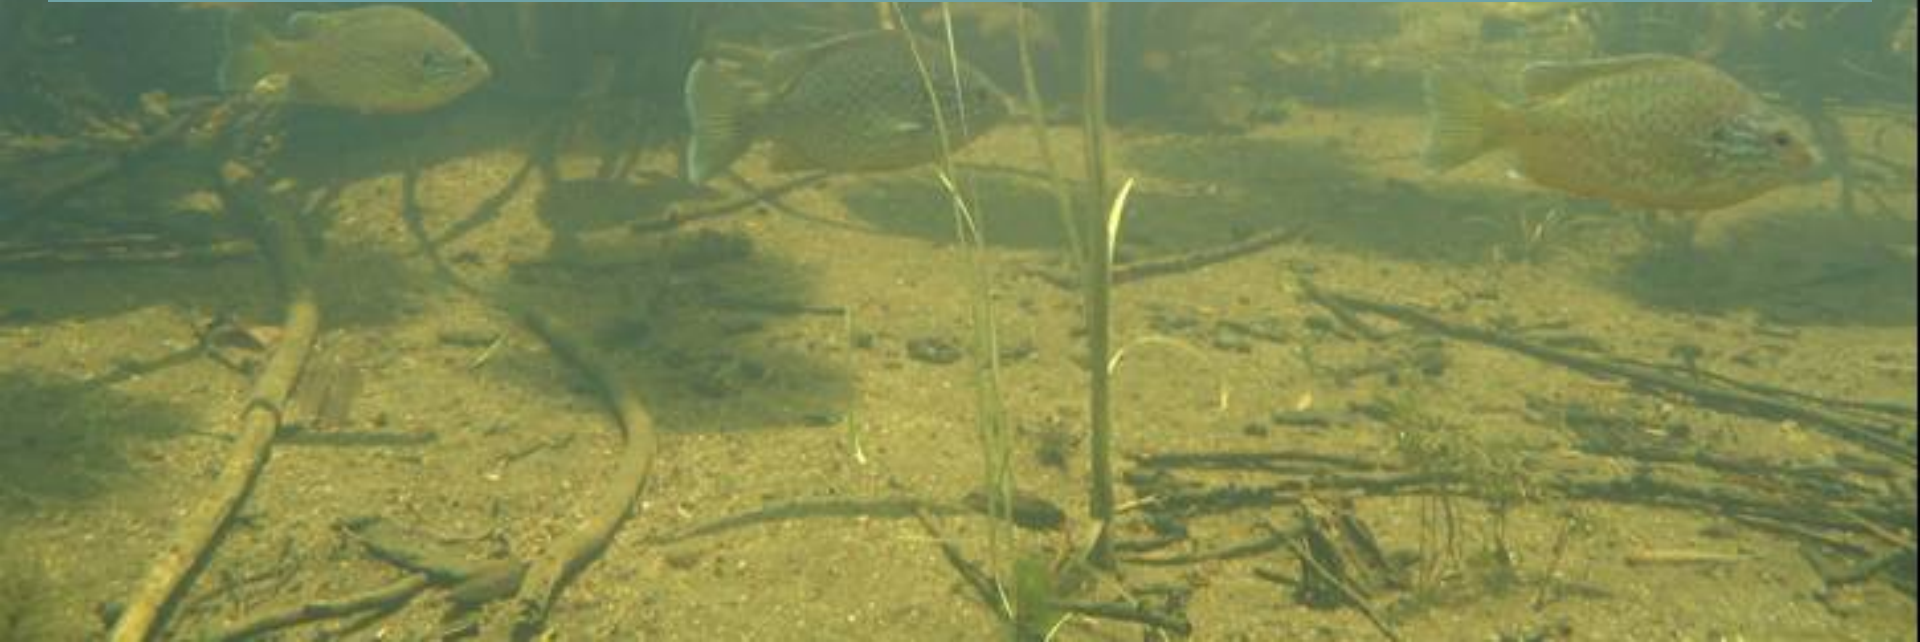
No change to aufwuchs was achieved when the lakeshore property met the additional criteria of:

- Main structures were set back an additional 14m back (34m or 112')

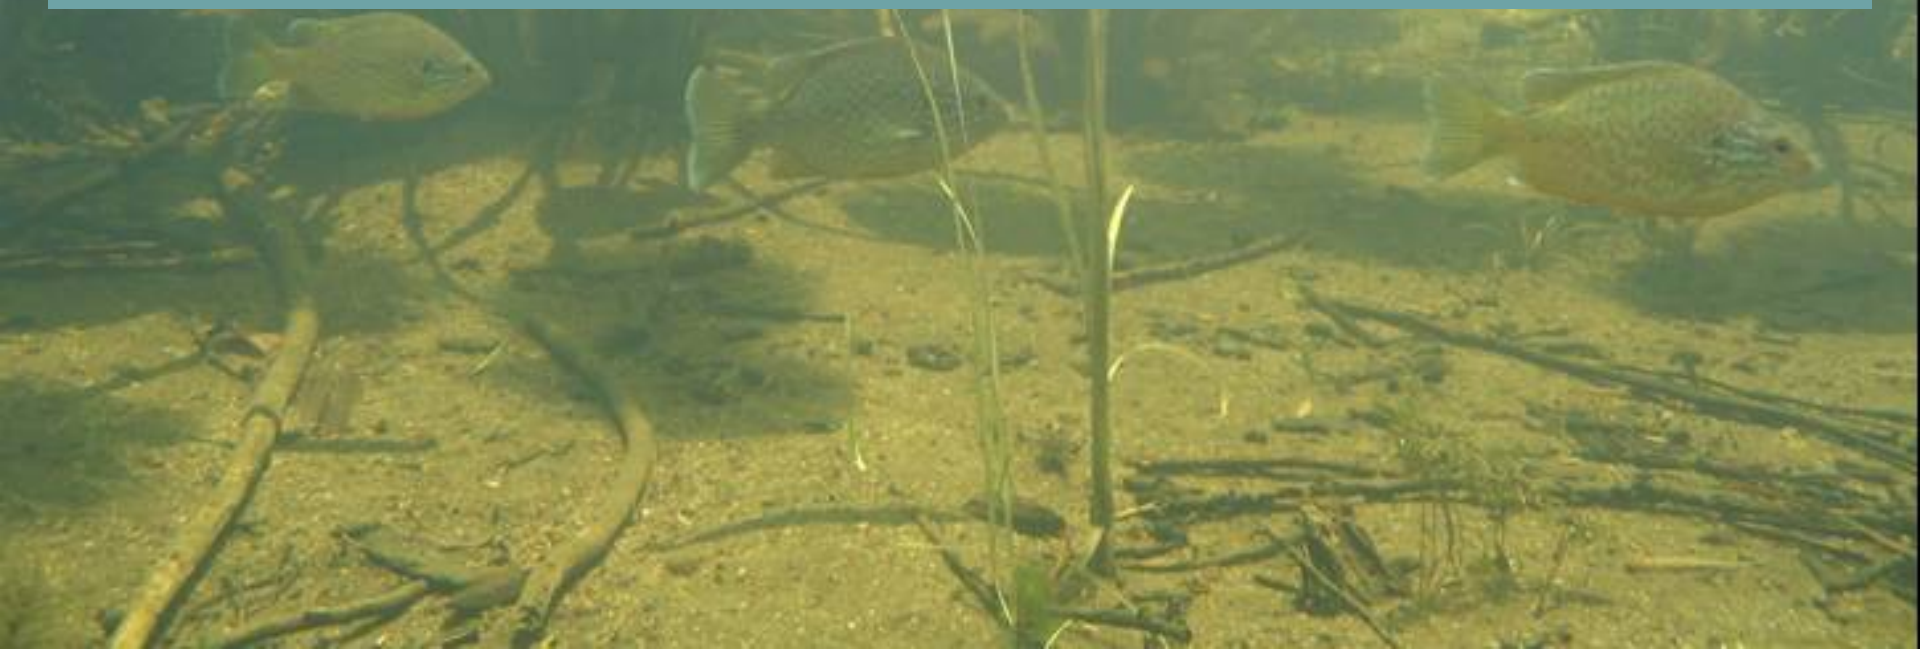
No change to fine woody structure was achieved when the lakeshore property met the additional criteria of:
