Fort Halifax Dam Removal

What happens when the water goes down?

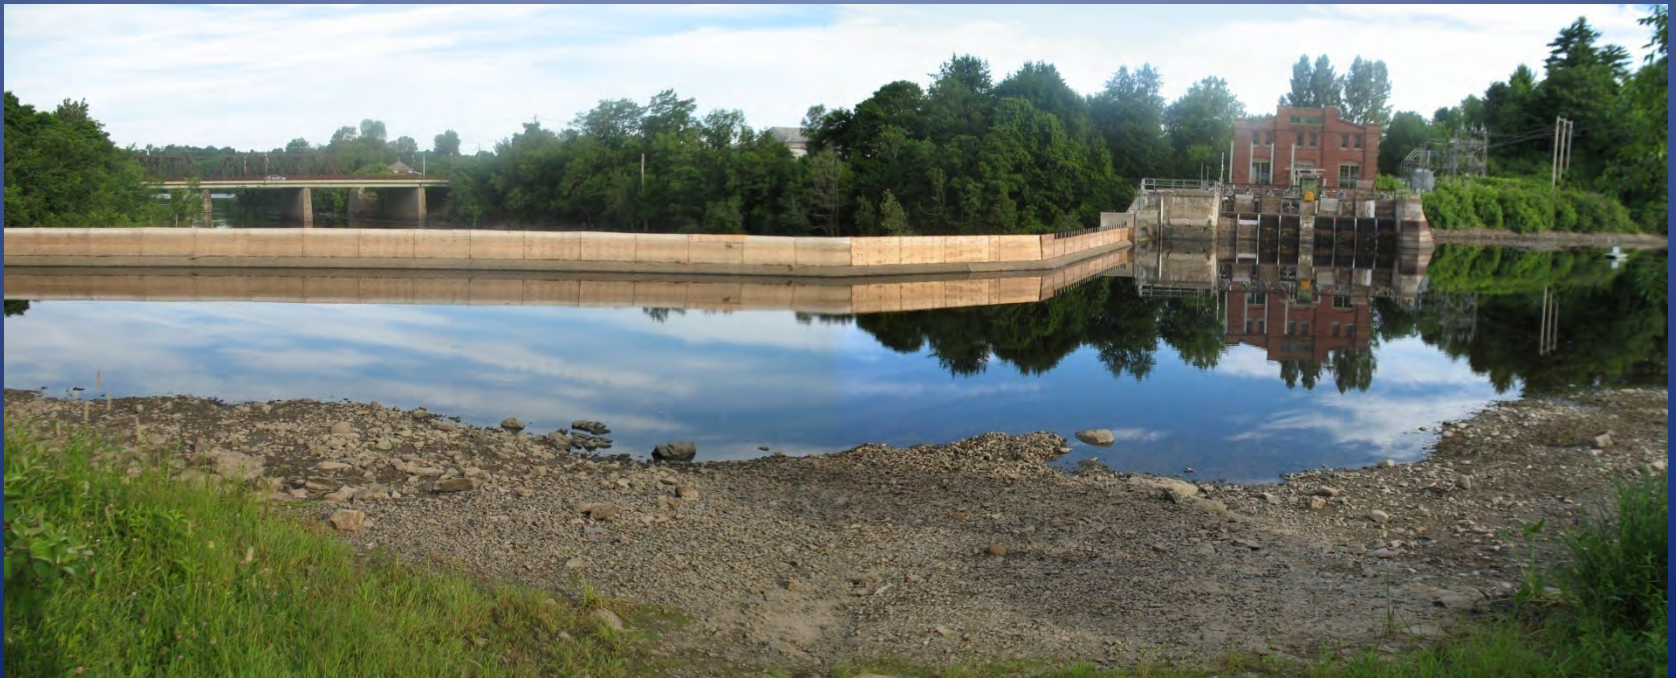
- The project took place in late July when river flows were low and after migration of anadromous fish.
- The impoundment was initially drained through the hydro units dropping the headpond 9 feet.

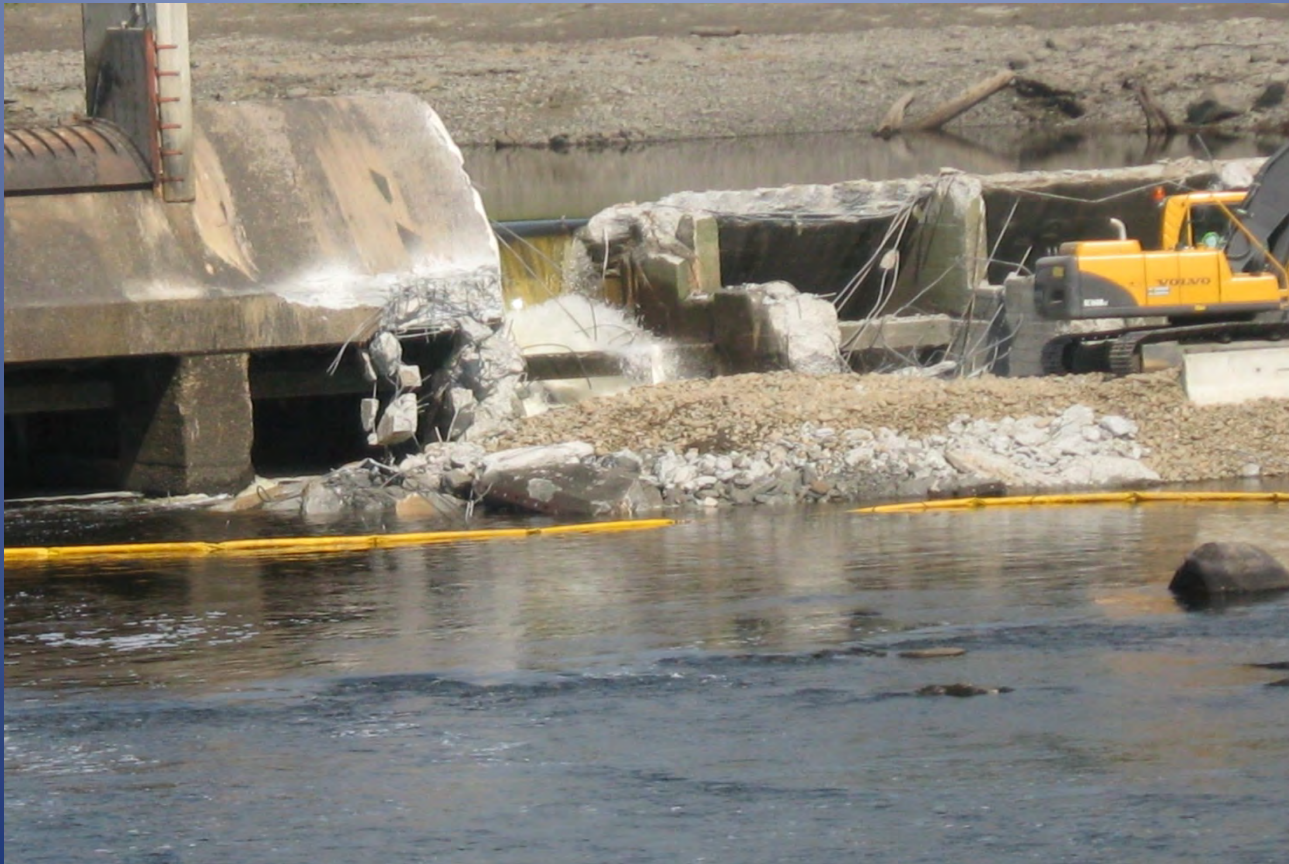
- The dam was breached by mechanical means.
- Flows were controlled, and the headpond was lowered 2 feet per day.

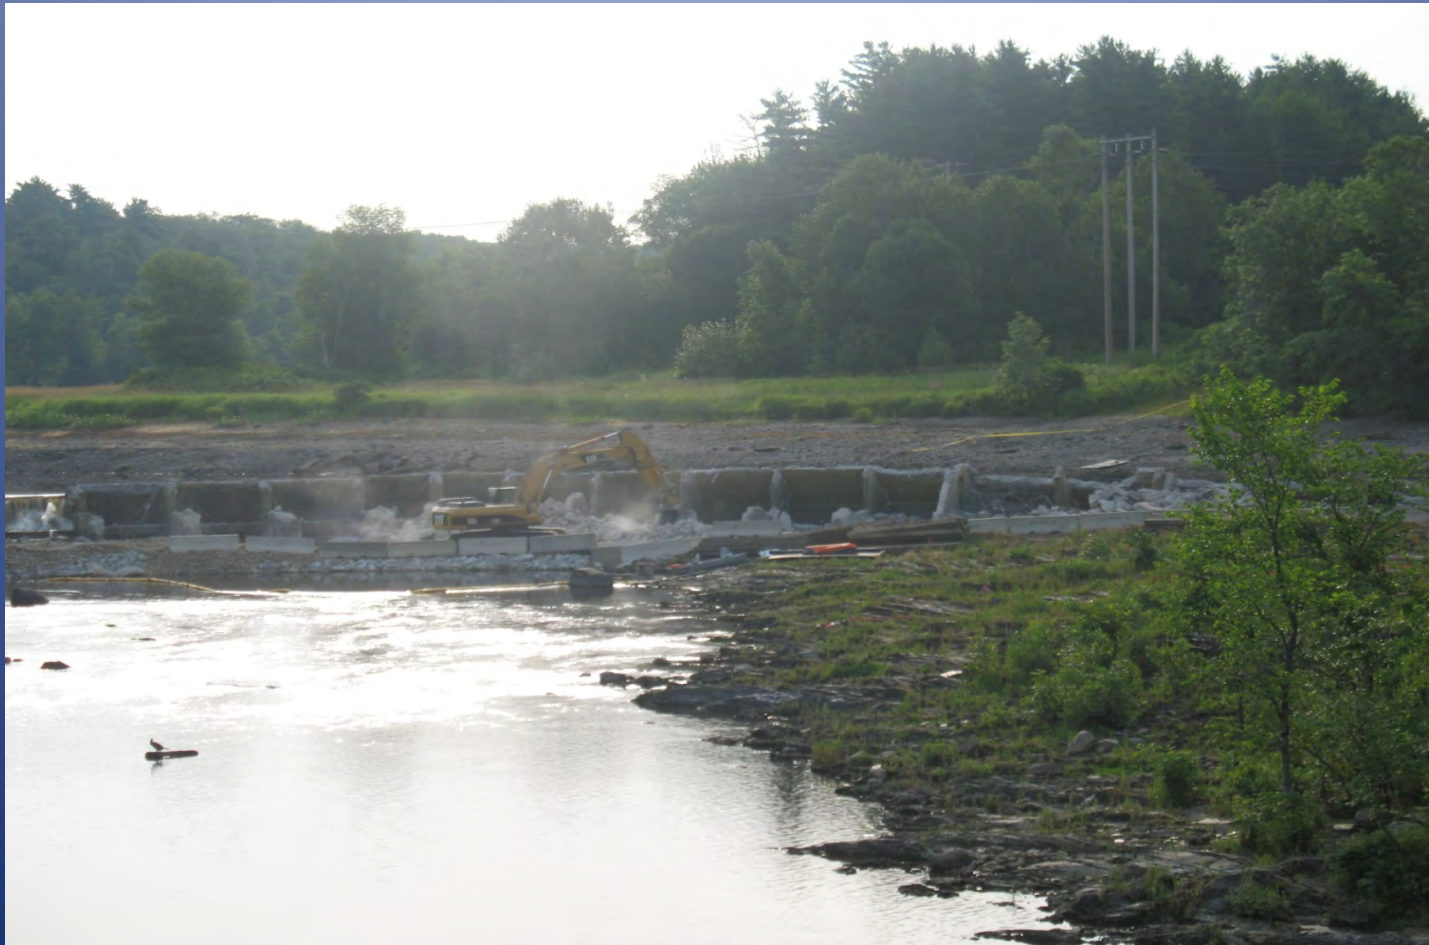
- After the initial breach, the remaining bays were removed.
- All debris was removed by September 1st in order to minimize impacts to anadromous fish.

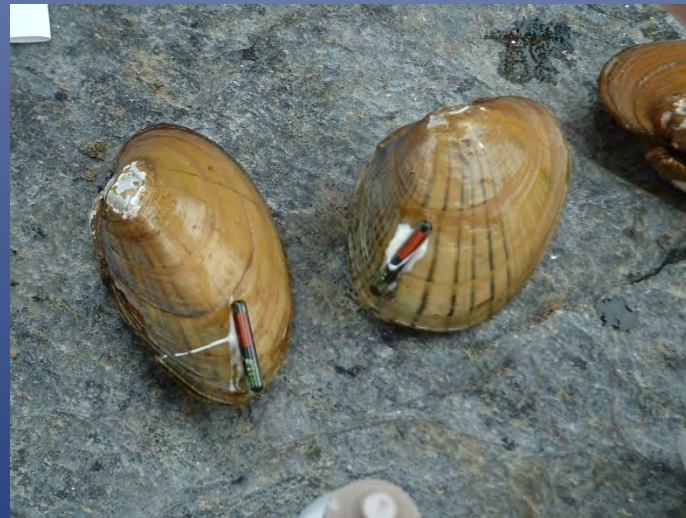
- 240 individuals were tagged using passive integrated transponder (PIT) tags.
- 120 each of yellow lampmussels (*Lampsilis cariosa*) and tidewater mucketts (*Leptodea ochracea*) were tagged, 60 control and 60 test subjects.
- A total of 12 mussels were tagged with radio tags.

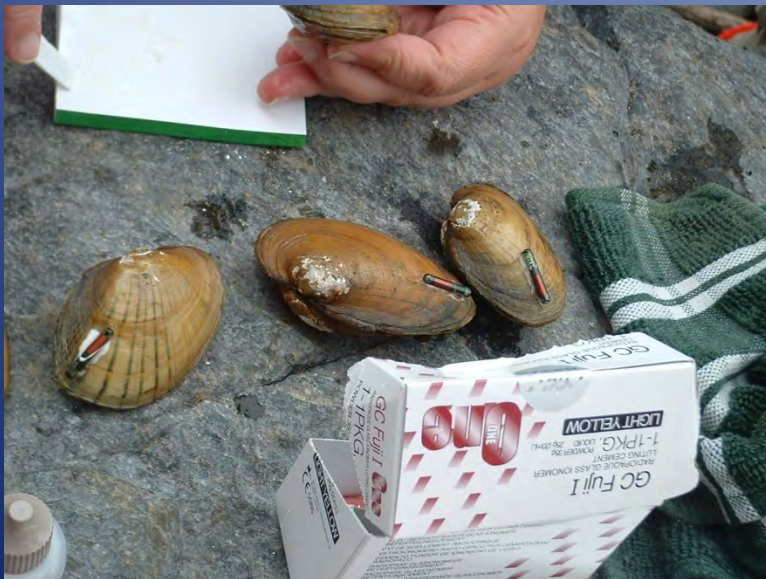
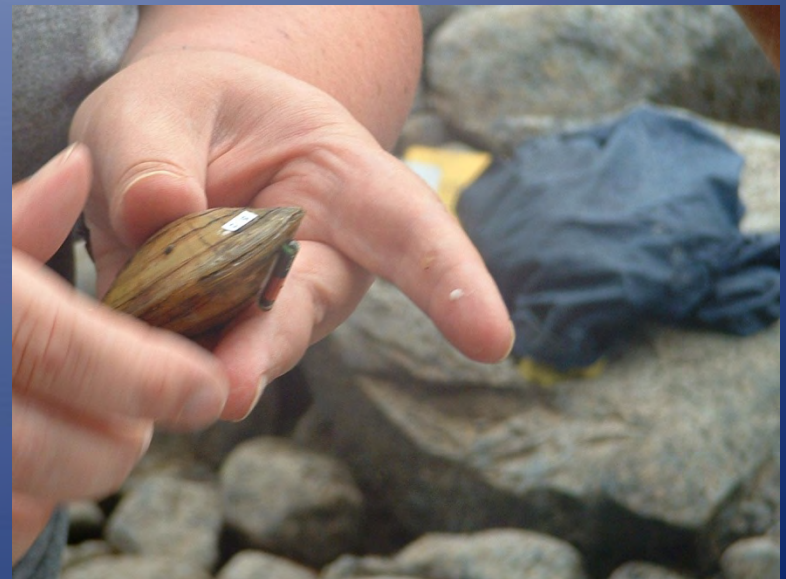
- Pit tags and radio tags were attached with dental cement.
- In addition, all mussels had a unique number attached in case the tag was damaged or lost.

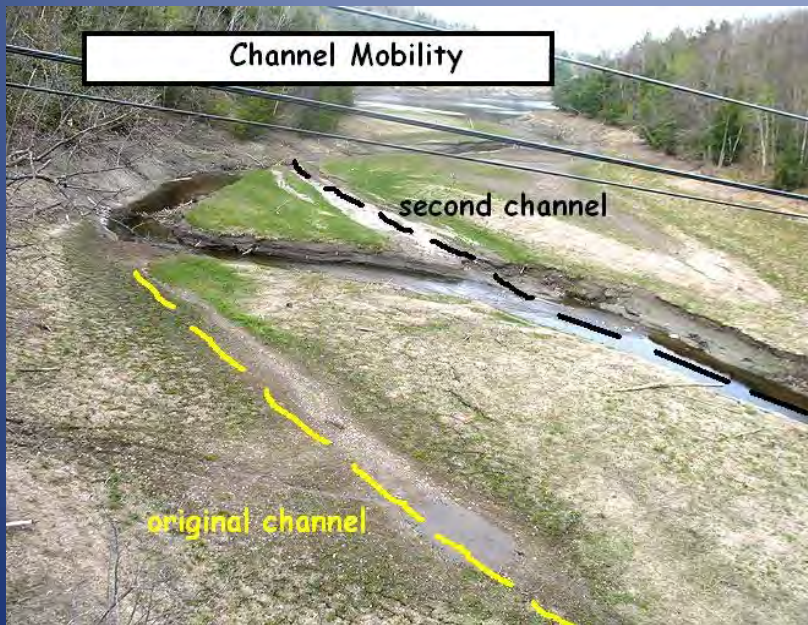
Shortly after dam removal

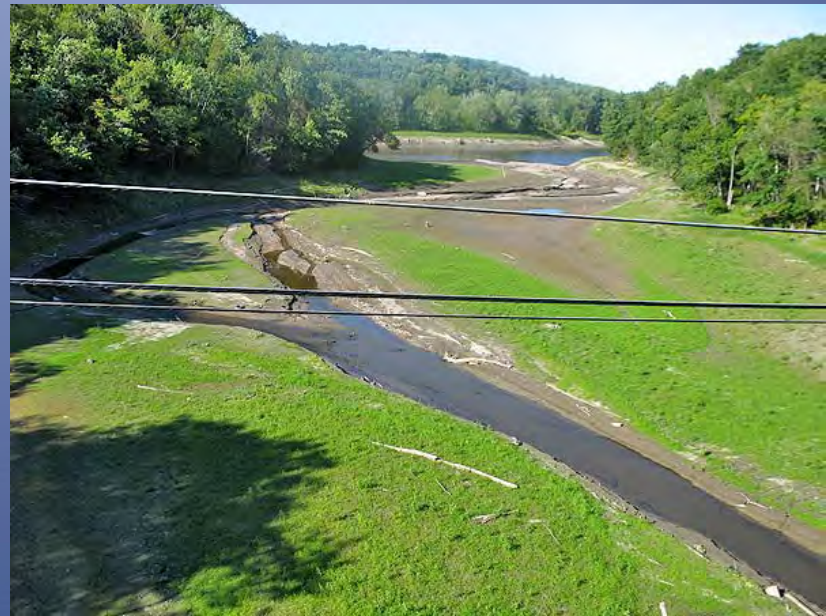
Spring 2009

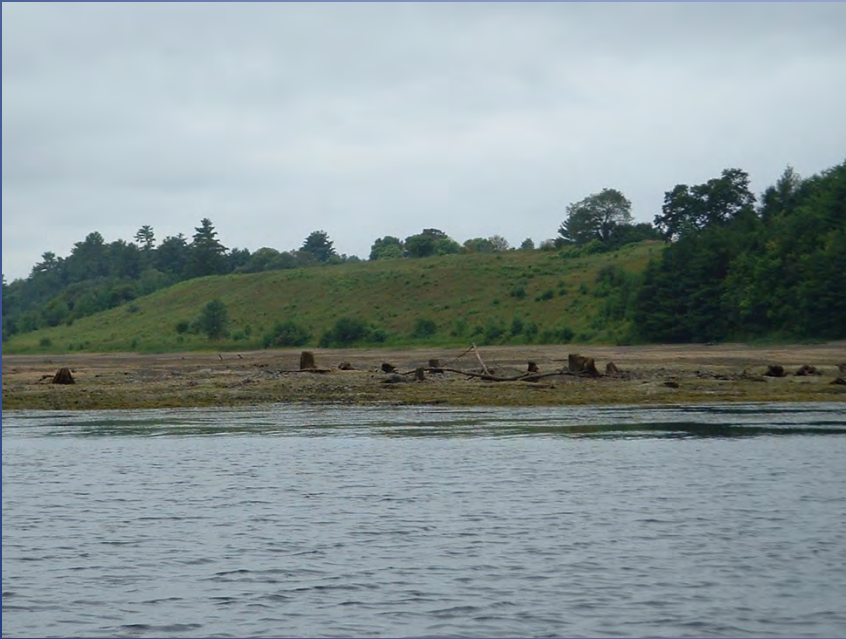
July 2008

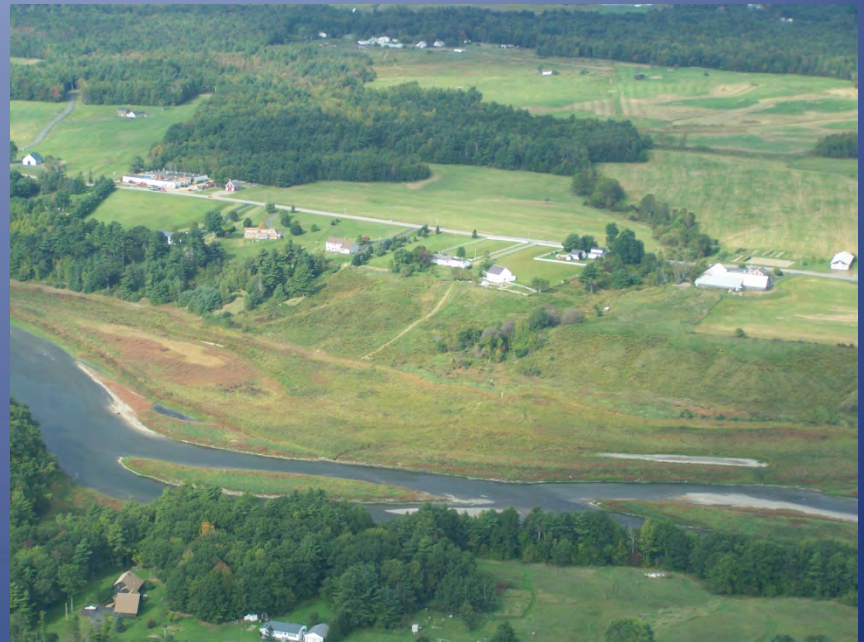
September 2009
