Lockheed Martin Technology Services  
Environmental Services REAC  
2890 Woodbridge Avenue Building 209 Annex  
Edison, NJ 08837-3679  
Telephone 732-321-4200 Facsimile 732-494-4021

DATE: 31 October 2003

SUBJECT: WATERBORNE GEOPHYSICAL SURVEYS AND SEDIMENT CORING,  
CENTERDALE MANOR SITE  
WORK ASSIGNMENT R1A00270 - TRIP REPORT

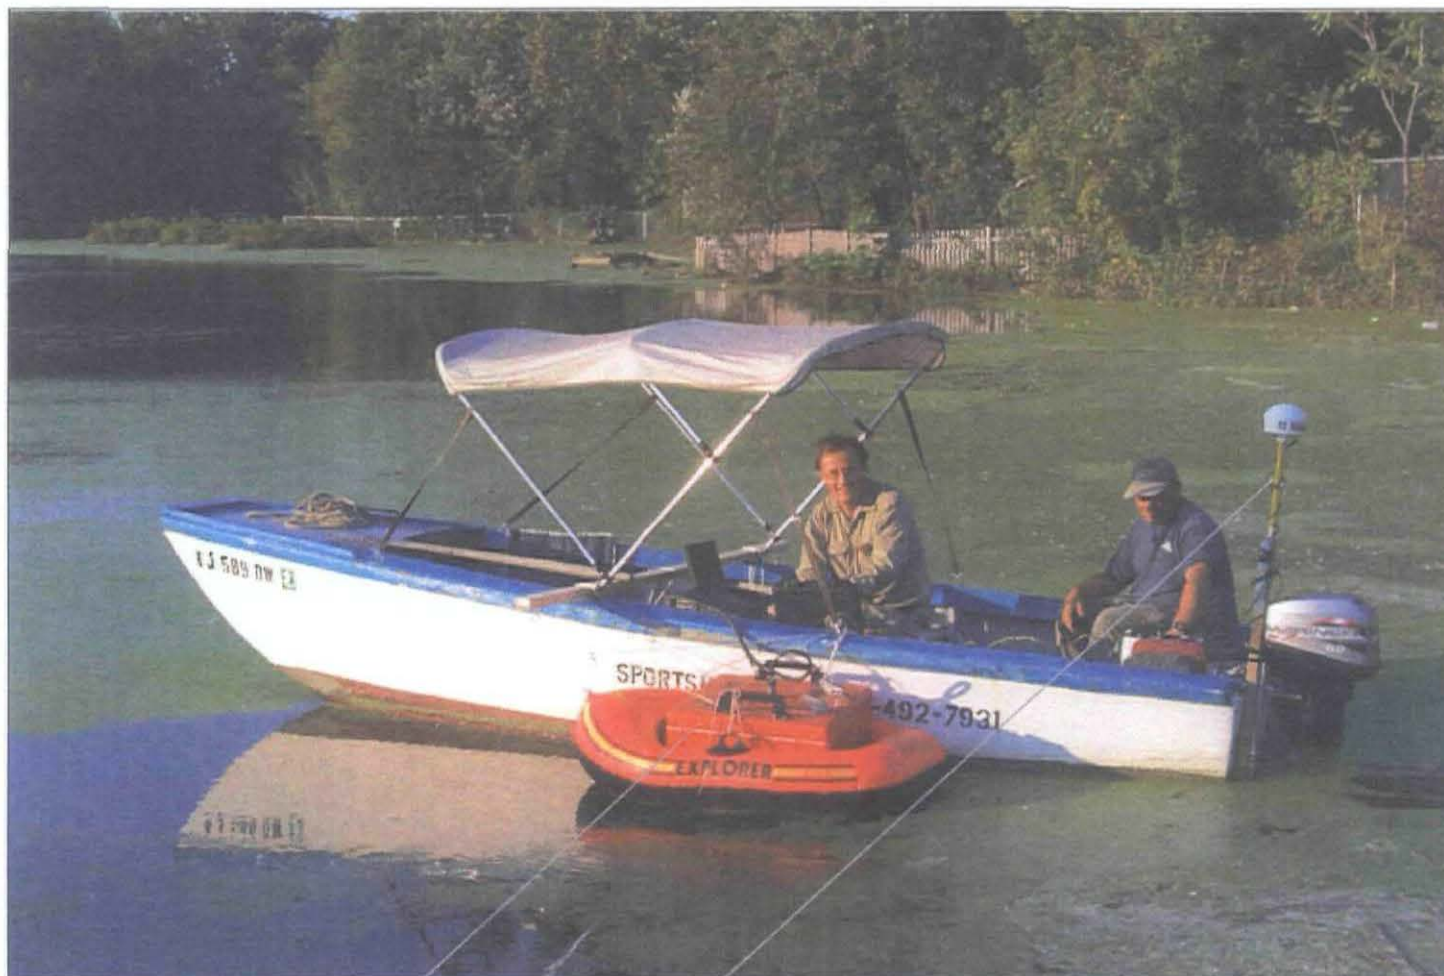
**Figure 2. Waterborne Ground Penetrating Radar**

200 MHz Ground Penetrating Radar Antennae

Global Positioning System Antenna

A 16-foot, flat-bottomed, wooden Garvey boat with a 8.0 horsepower outboard motor was used for the waterborne geophysical surveys (Figure 2). The low draft and wide beam of this boat were ideal for the surveys. Several geophysical methods were attempted initially. However, only one method appeared to be useful to map the sub-bottom sediments at this site, and was applied in all areas.

Sub-bottom profiling was attempted using a Datasonics® Chirp II system (Figure 2). The sub-bottom profiling data recorded time and amplitude of acoustic energy in a manner similar to the sidescan sonar equipment but with much greater power that was aimed directly beneath the towfish. The purpose was to penetrate soft sediments, to reflect off possible layering within, and/or to reflect off the underlying hard material. This employed a model DSP-662 transceiver and a DSP-661 processor. The system was capable of operating in two frequencies centered between 2

Ground penetrating radar (GPR) was the only geophysical method that appeared to be useful for mapping soft sediment thickness at this site (Figure 2). The GPR method used principles similar to sub-bottom profiling but with electromagnetic energy as a source. This responded to changes in electrical properties of the sediment, which were usually related to hardness and/or bulk density. It employed a GSSI® 200 megahertz (MHz) antennae deployed in a small rubber raft. A 250 nanosecond (ns) range was chosen and time varying gains were set at 10, 30, 50, 55, 60, and 65 decibels (dB). A vertical low pass filter was set at 1,000 MHz and a high pass filter was set at 125 MHz. The instrument recorded six traces per second. The usual boat speed was about 1.0 knots, which resulted in a sample interval of about eight traces per foot. A trace number was stored on the GPS console with current navigation data once per second.
