**COMPLETION OF WORK REPORT  
ENERGY REPLACEMENT OF WATERLINE  
CENTREDALE MANOR  
NORTH PROVIDENCE, RHODE ISLAND**

March 2011  
File No. 33688

Re: Completion of Work Report – Emergency Water Line Repairs  
Centerdale Manor  
2074 Smith Street  
North Providence, Rhode Island

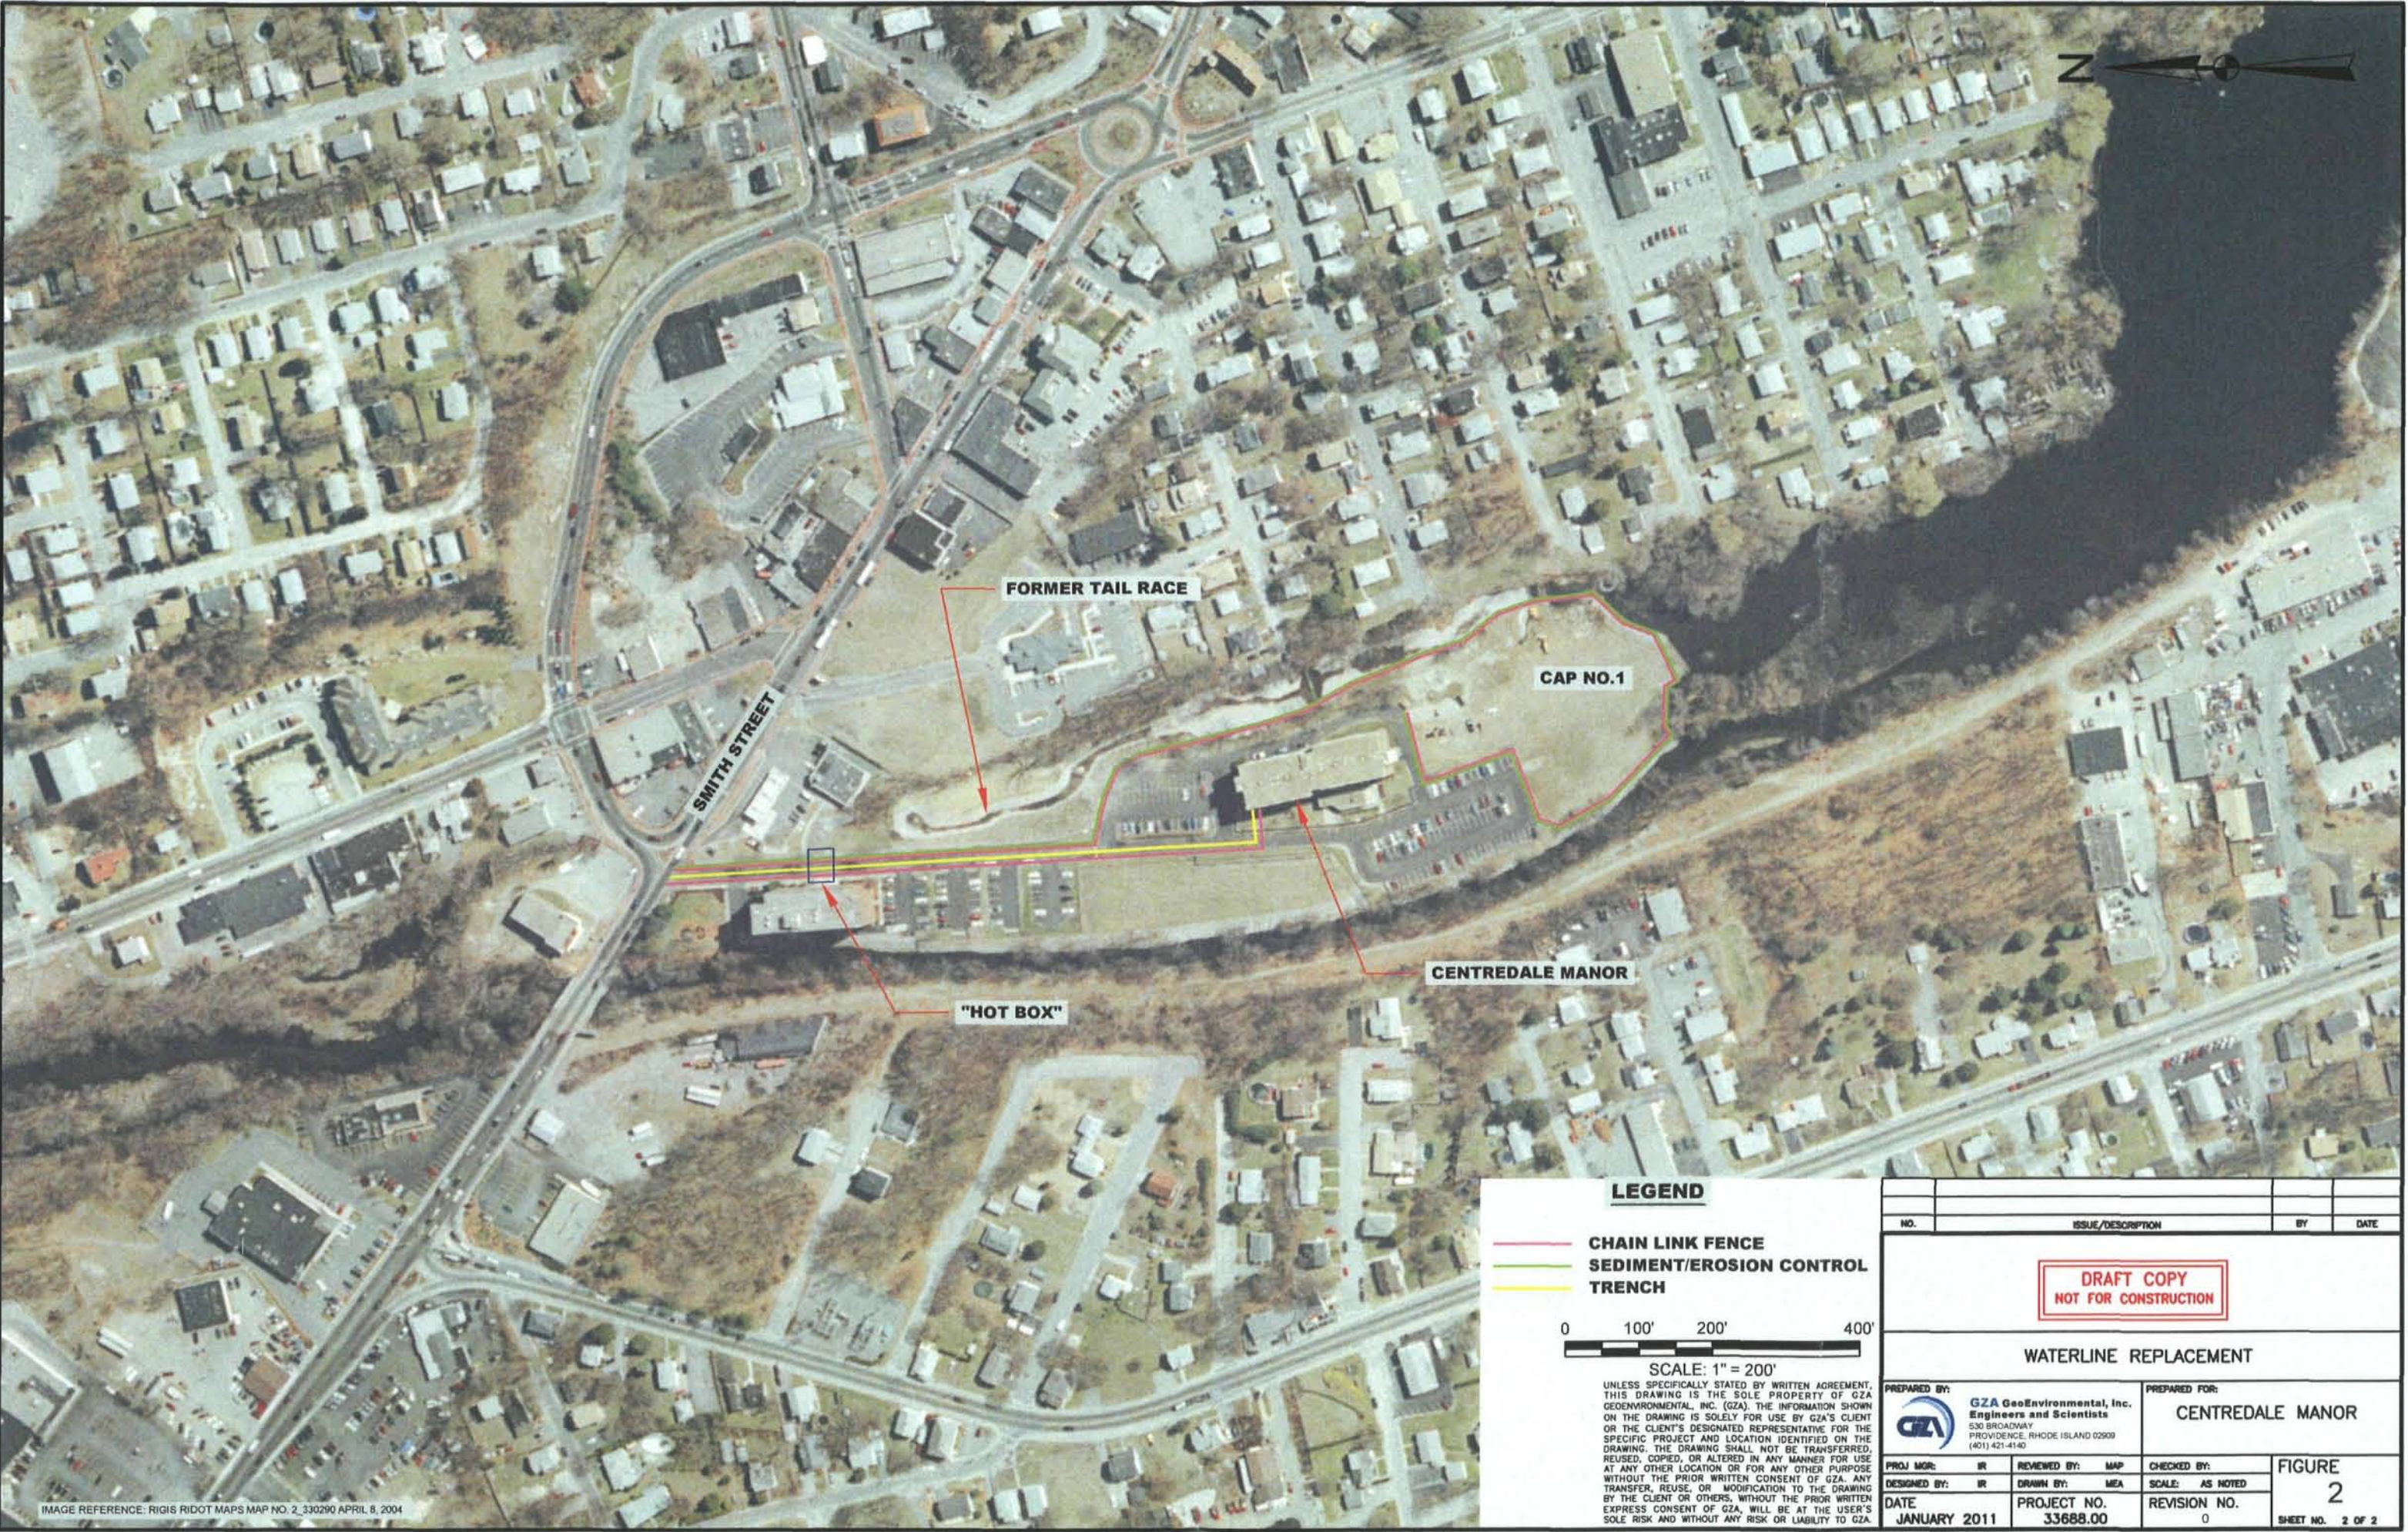
| NO. | | ISSUE/DESCRIPTION | | BY | DATE |
|---|--|---|--|---|---|
| <b>WATERLINE REPLACEMENT</b> | | | | | |

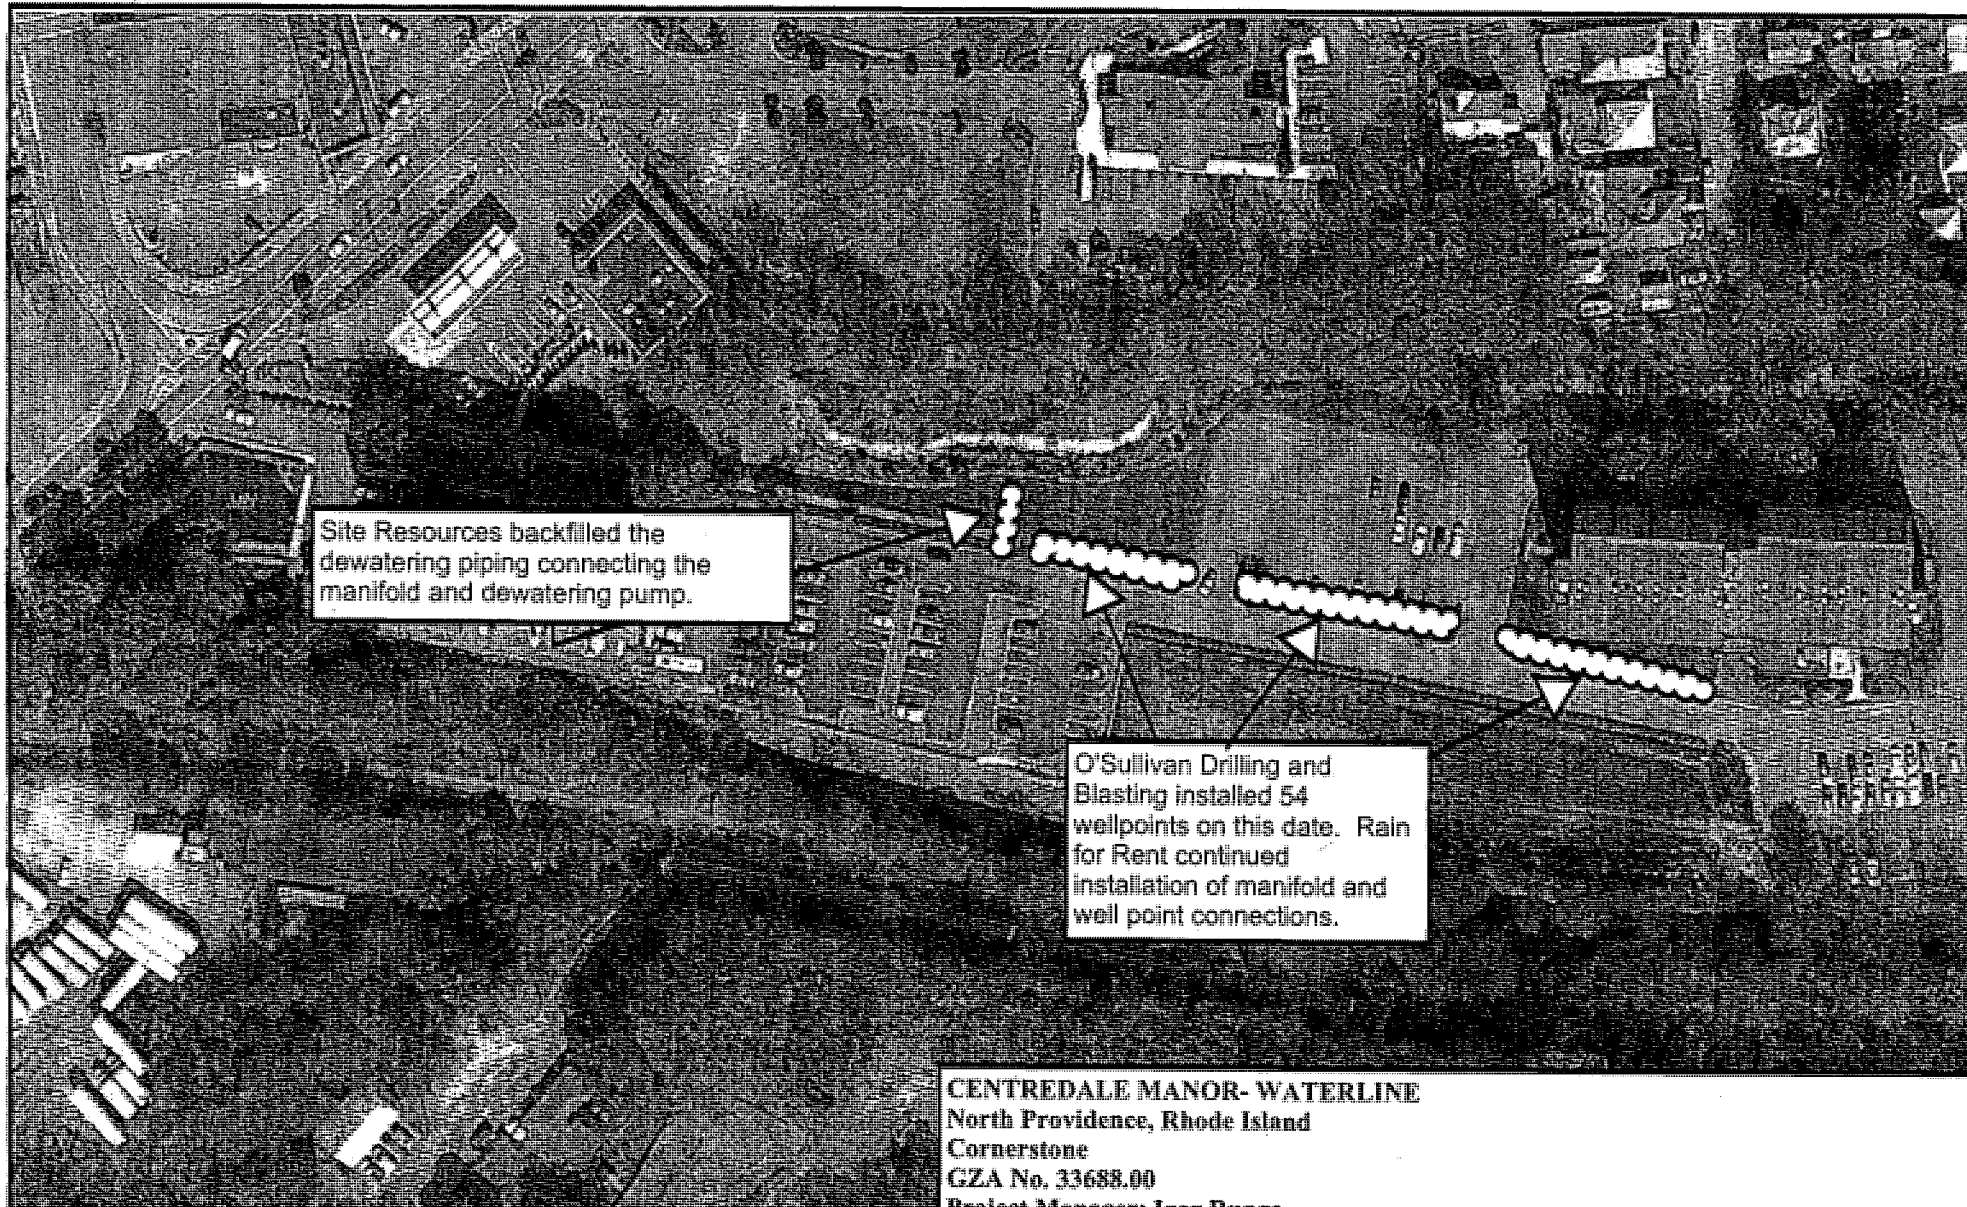
Site Resources backfilled the dewatering piping connecting the manifold and dewatering pump.

O'Sullivan Drilling and Blasting installed 54 wellpoints on this date. Rain for Rent continued installation of manifold and well point connections.

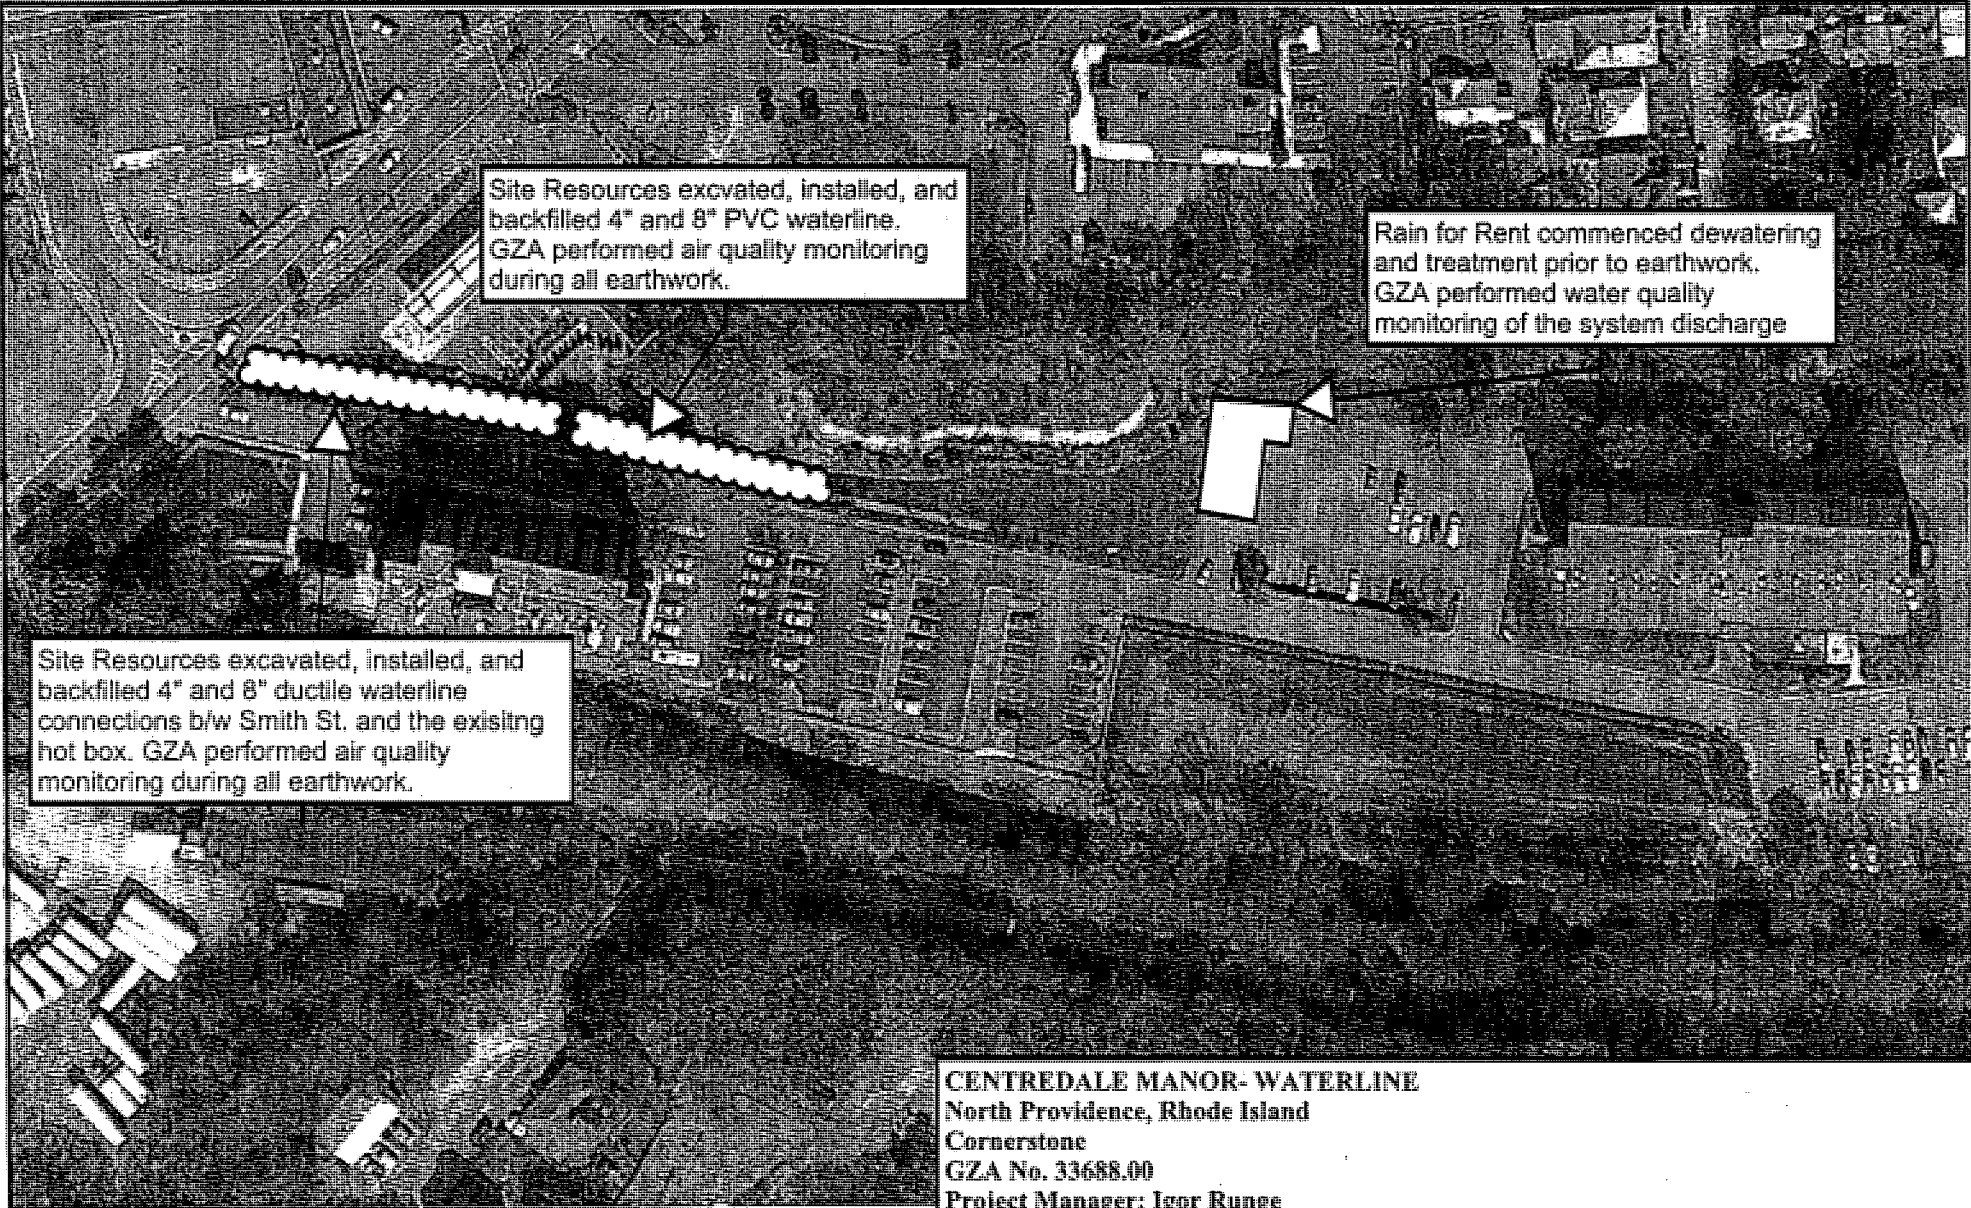
Site Resources excavated, installed, and backfilled 4" and 8" PVC waterline. GZA performed air quality monitoring during all earthwork.

Rain for Rent commenced dewatering and treatment prior to earthwork. GZA performed water quality monitoring of the system discharge

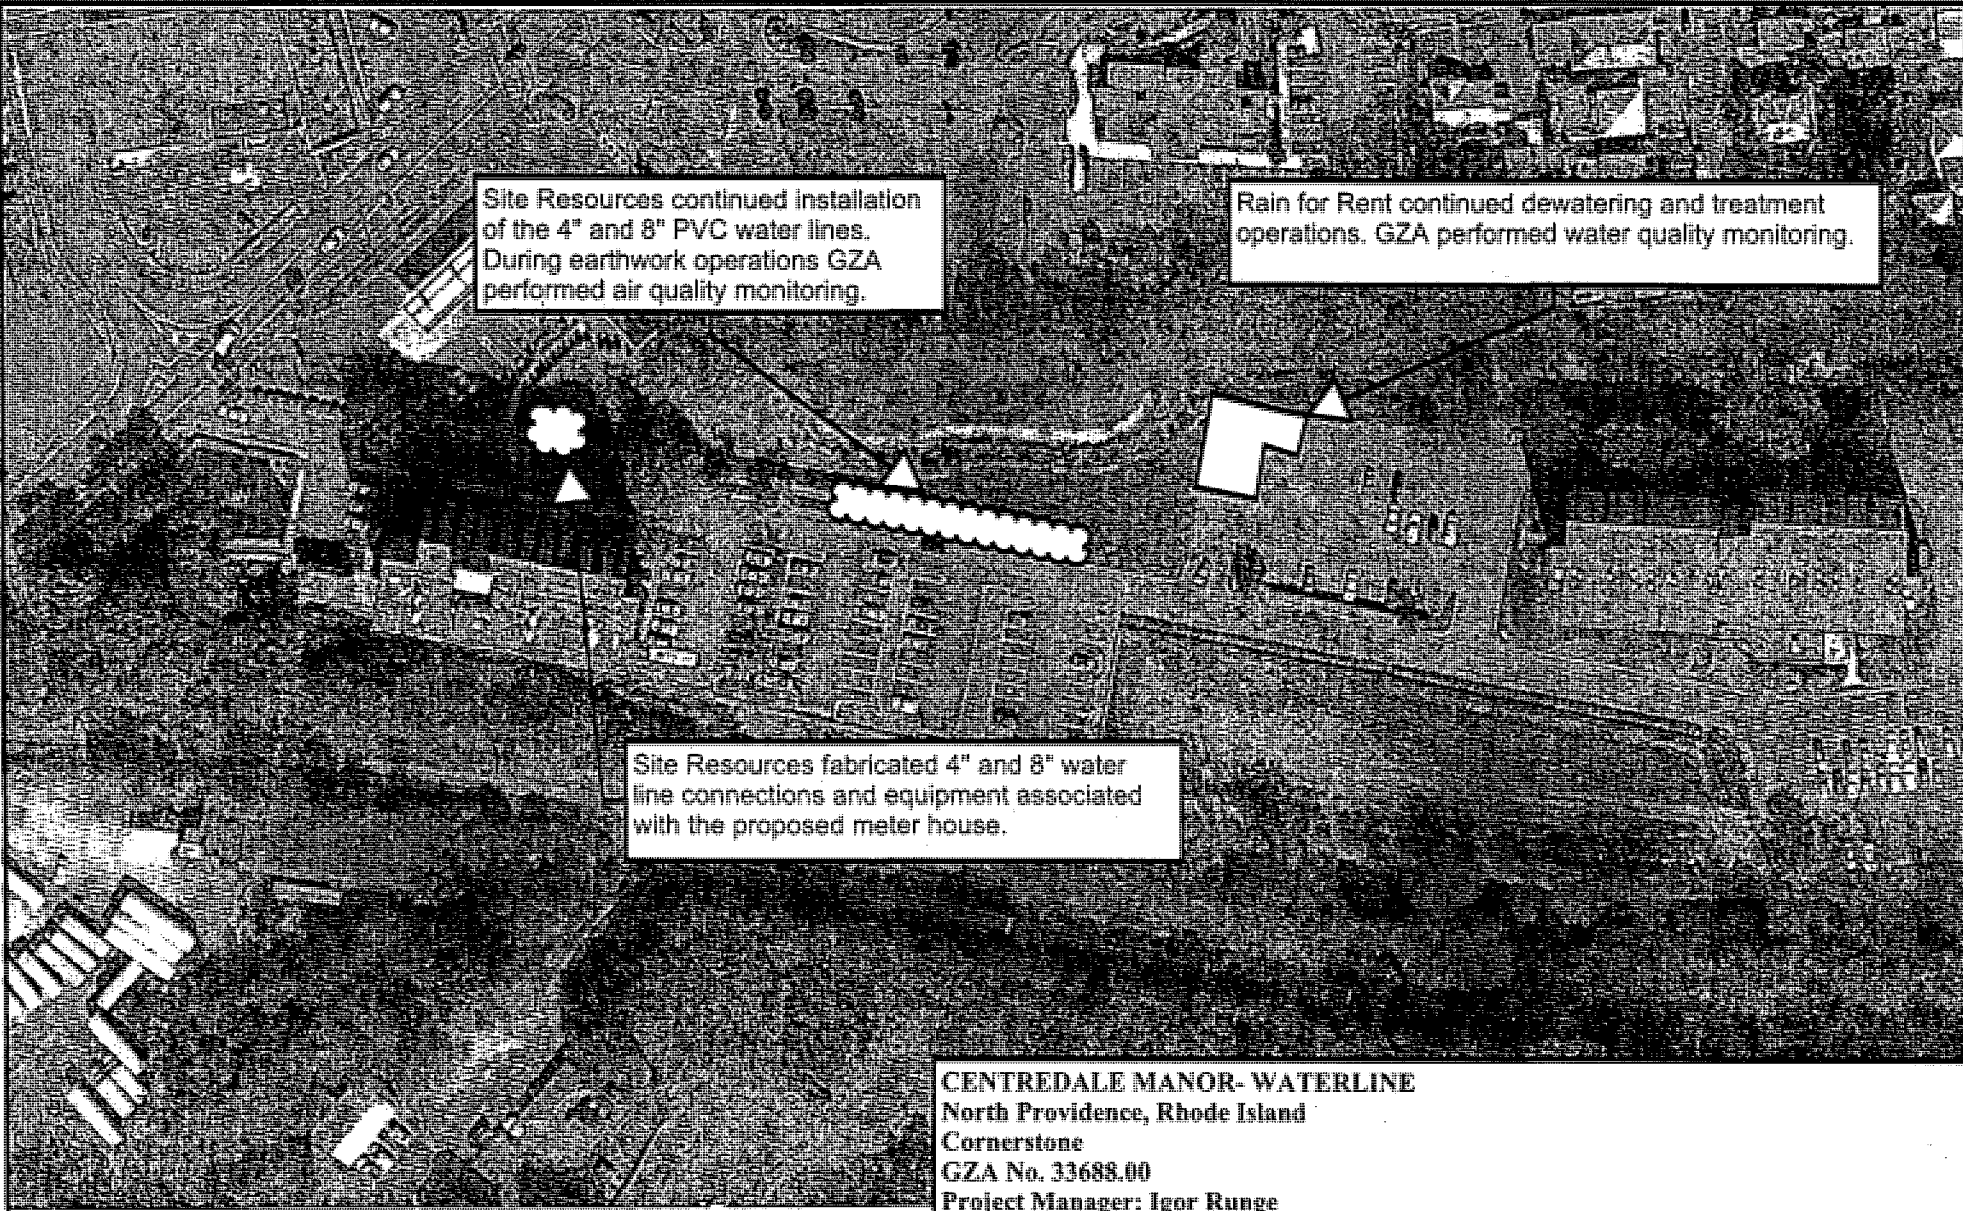
Site Resources continued installation of the 4" and 8" PVC water lines. During earthwork operations GZA performed air quality monitoring.

Rain for Rent continued dewatering and treatment operations. GZA performed water quality monitoring.

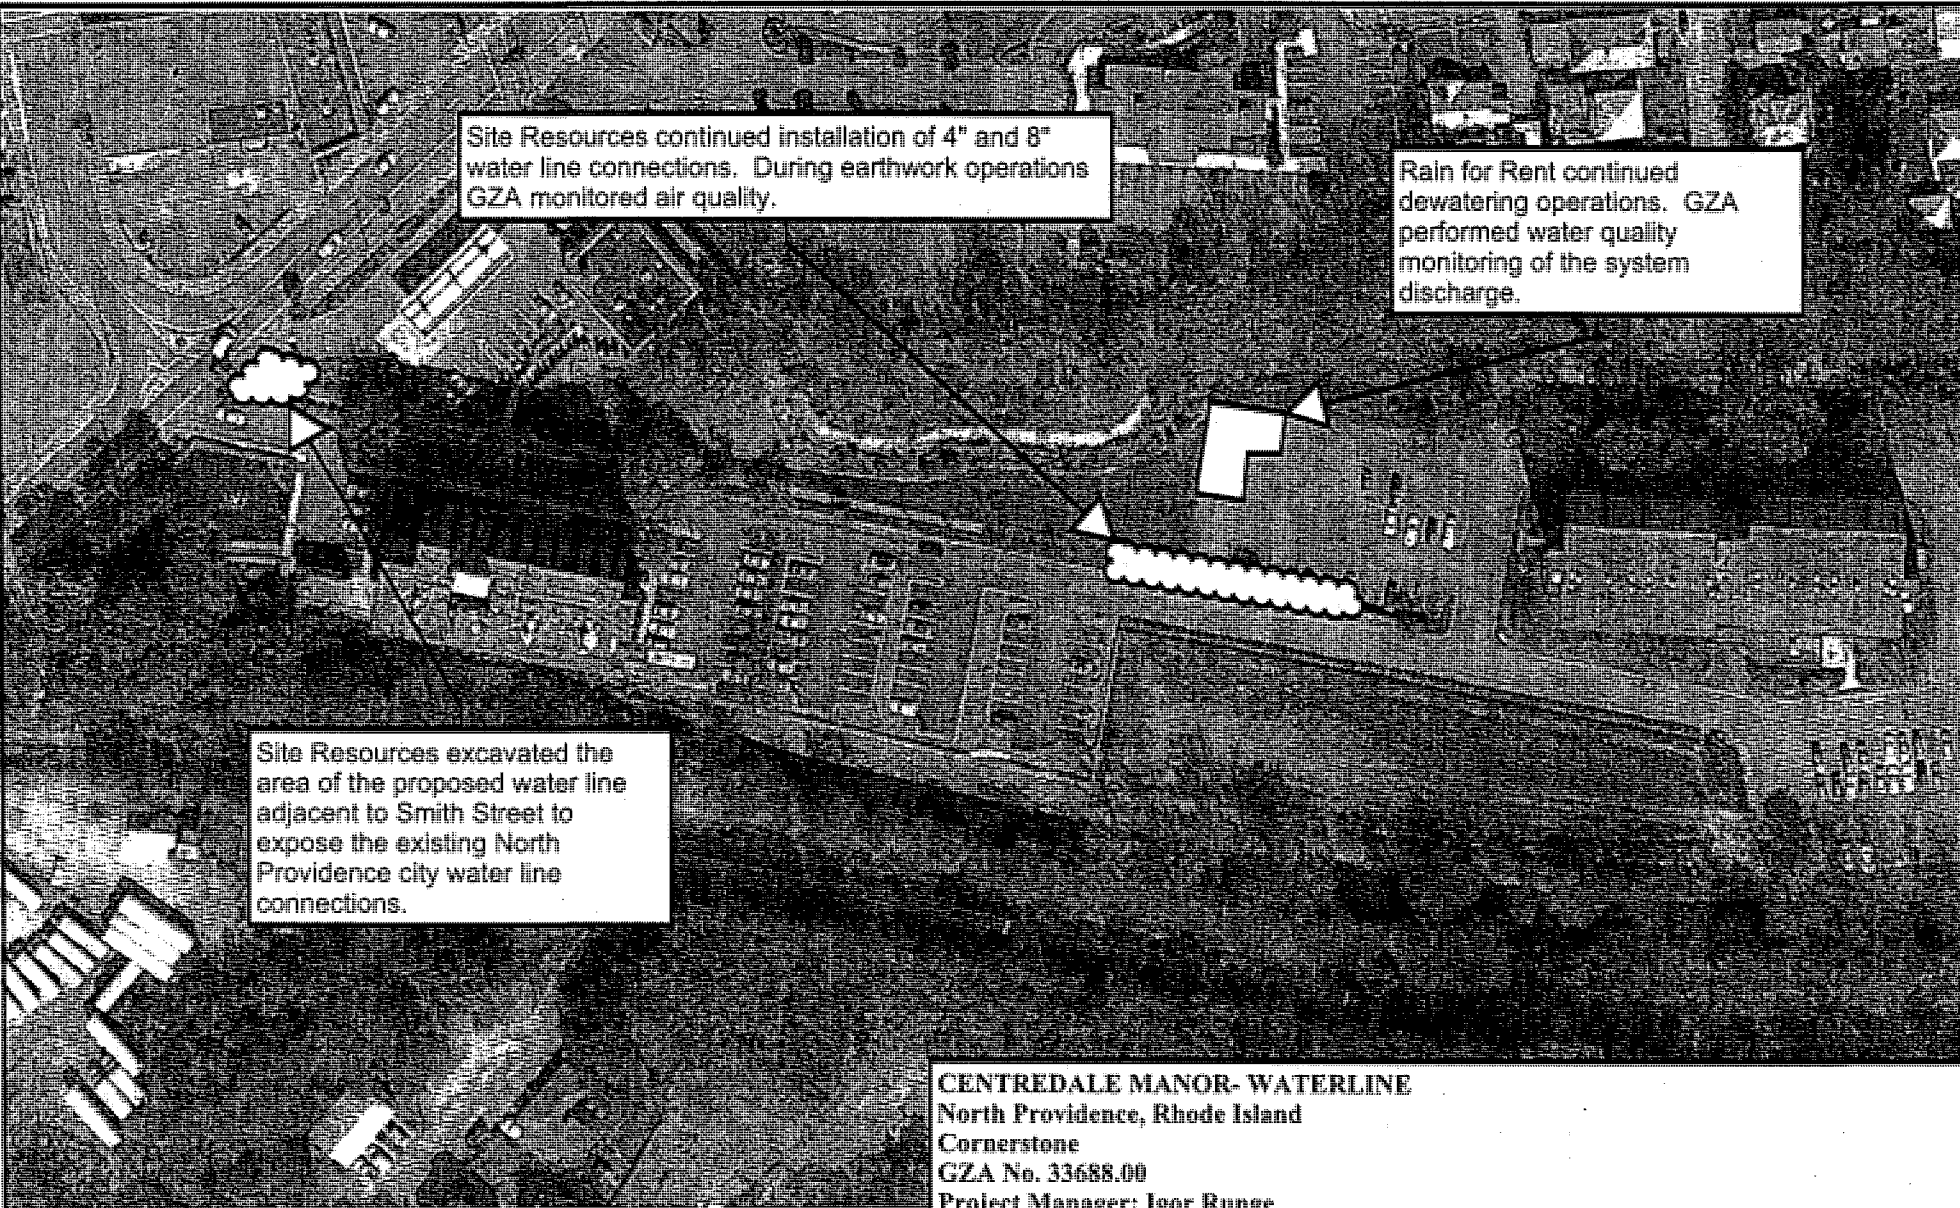
Site Resources continued installation of 4" and 8" water line connections. During earthwork operations GZA monitored air quality.

Rain for Rent continued dewatering operations. GZA performed water quality monitoring of the system discharge.

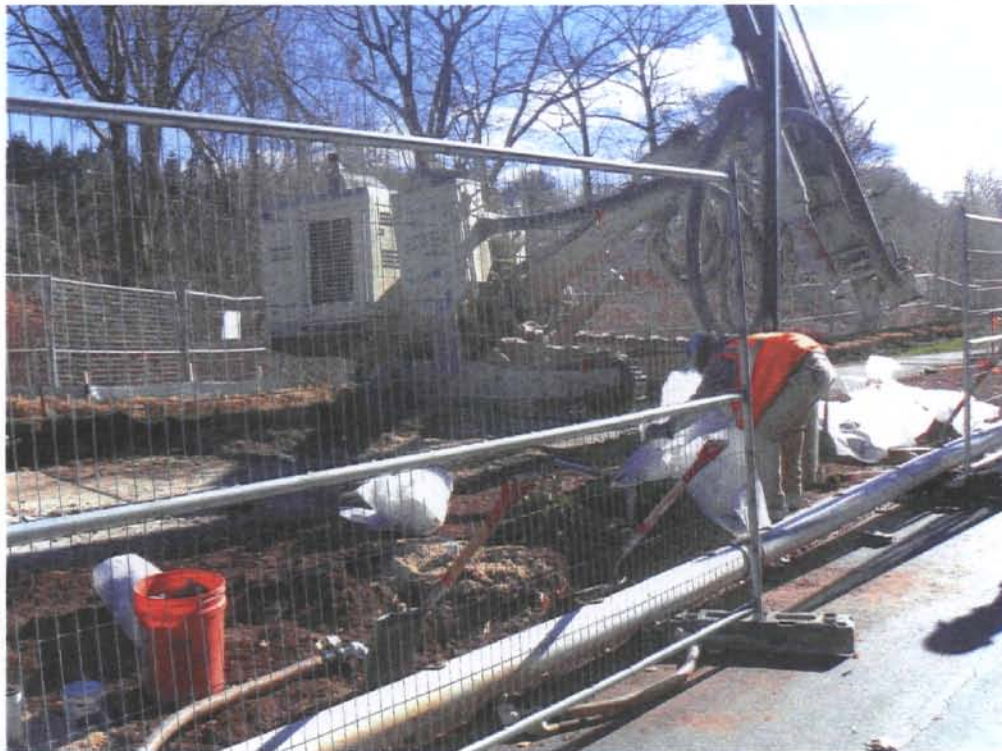
**Description:** Installation of dewatering components  
**Name:** 6Dec2010 019

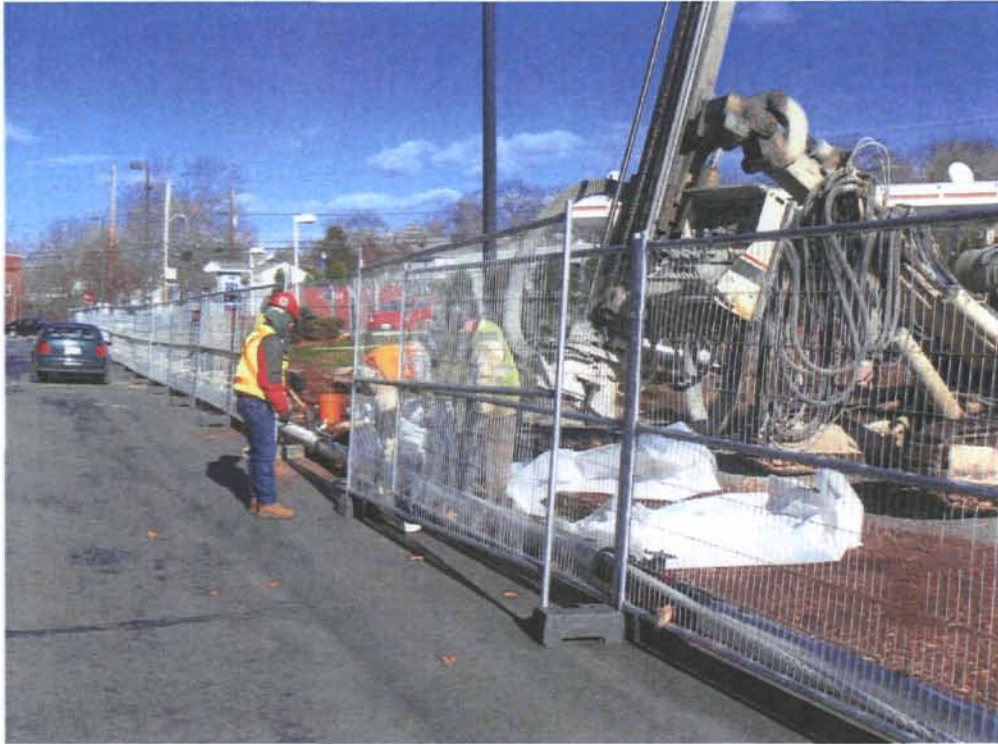
**Description:** Installation of dewatering components  
**Name:** 6Dec2010 021

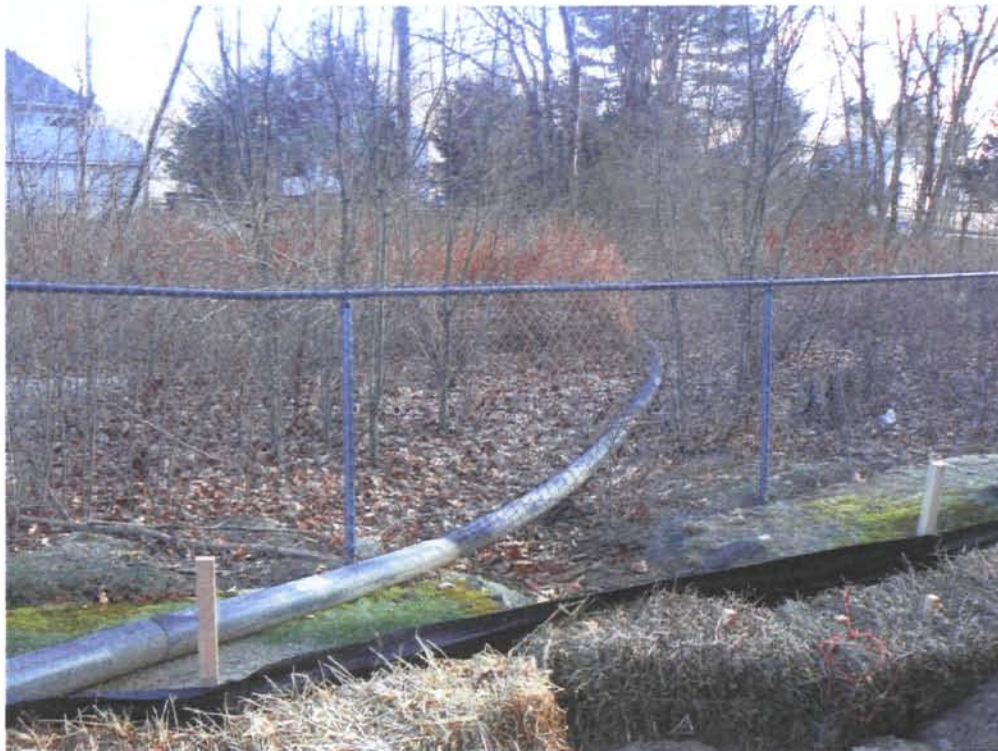
**Description:** Temporary waterline  
**Name:** 6Dec2010 013

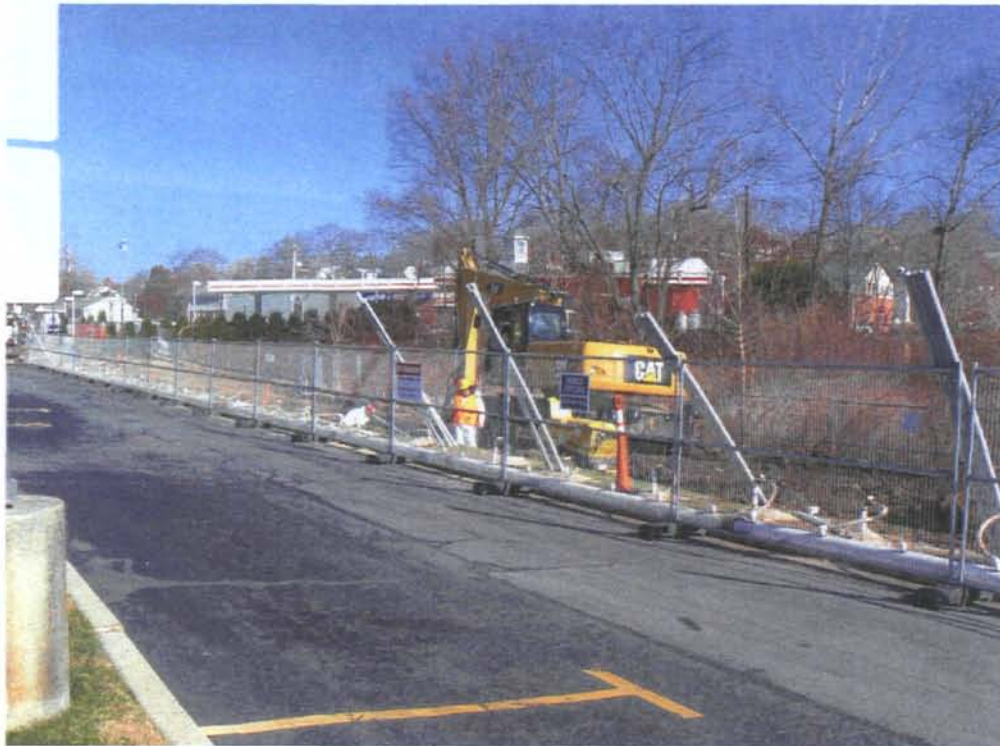
**Description:** Trench excavation  
**Name:** 11Dec2010 001

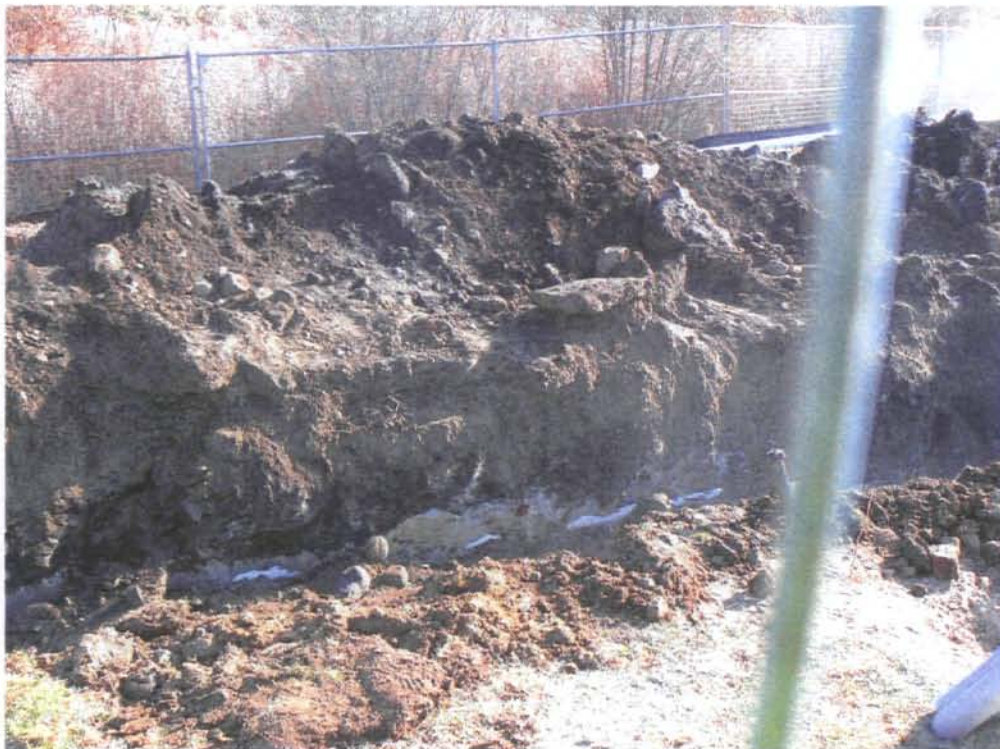
**Description:** Trench excavation  
**Name:** 11Dec2010 002

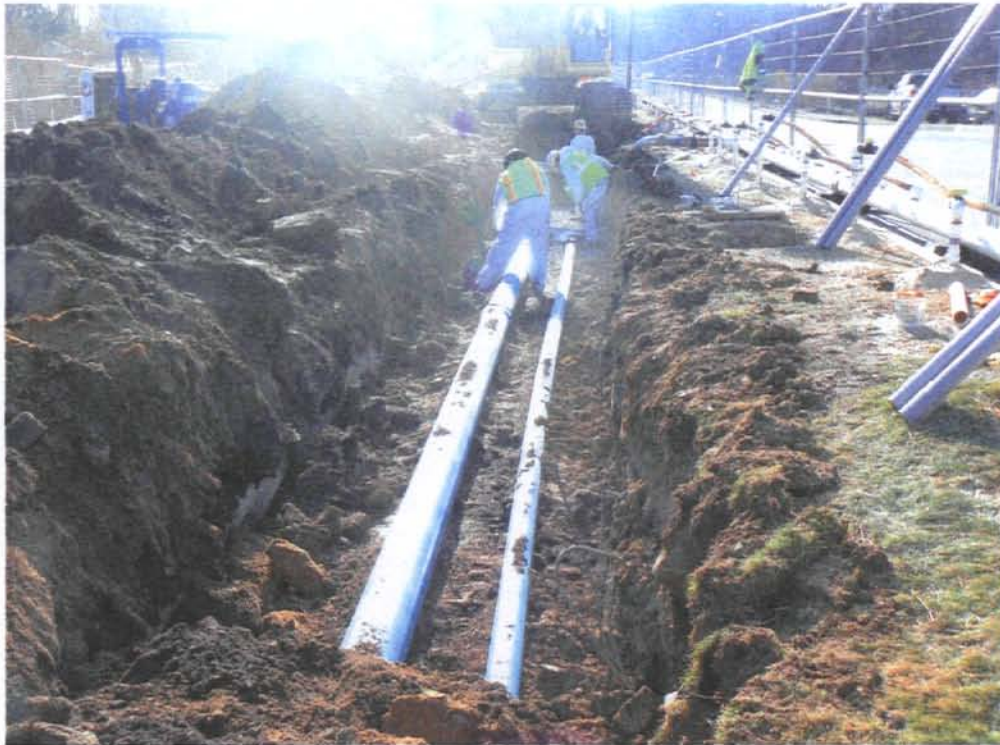
**Description:** Trench excavation  
**Name:** 11Dec2010 004

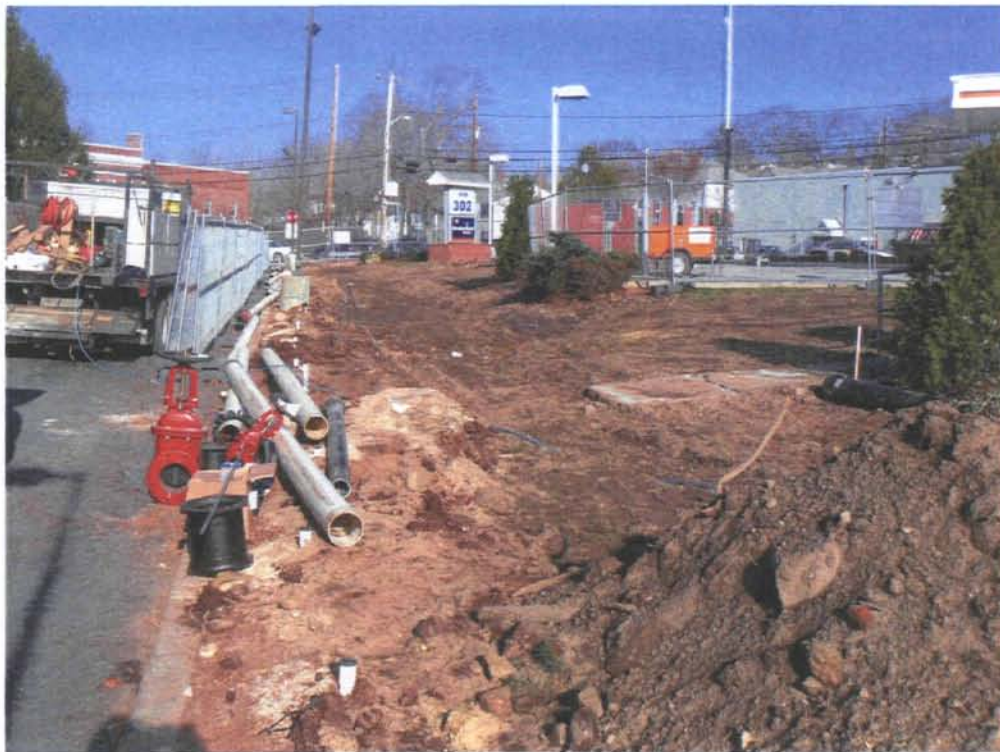
**Description:** "Hot Box" components  
**Name:** 11Dec2010 008

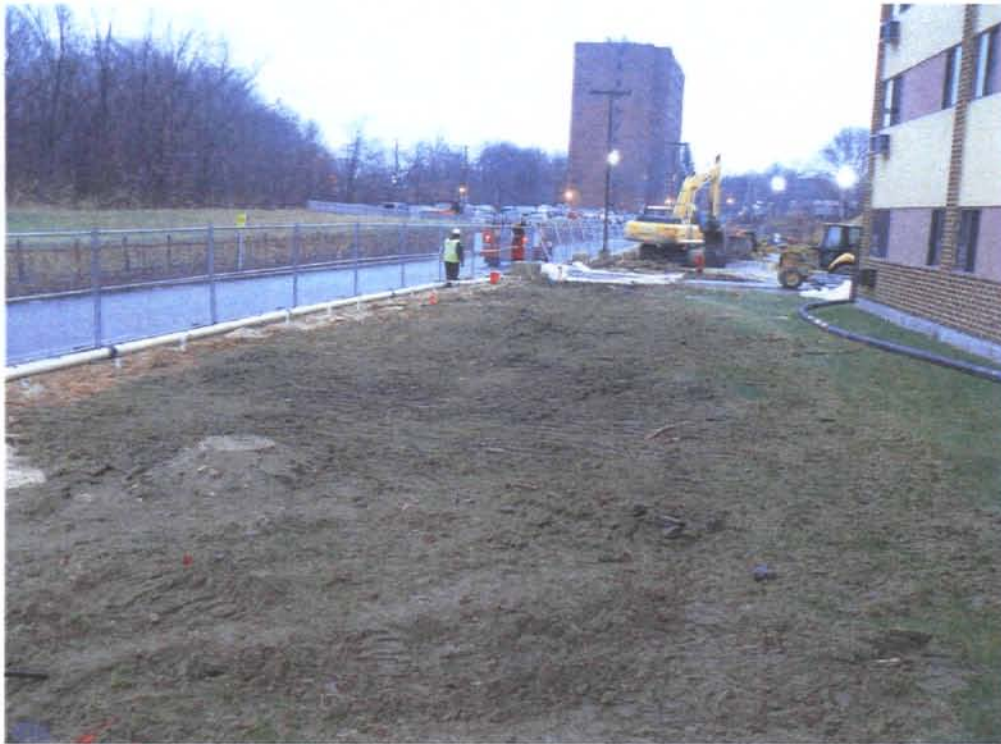
**Description:** Dewatering components near Centredale Manor building  
**Name:** 12Dec2010 001

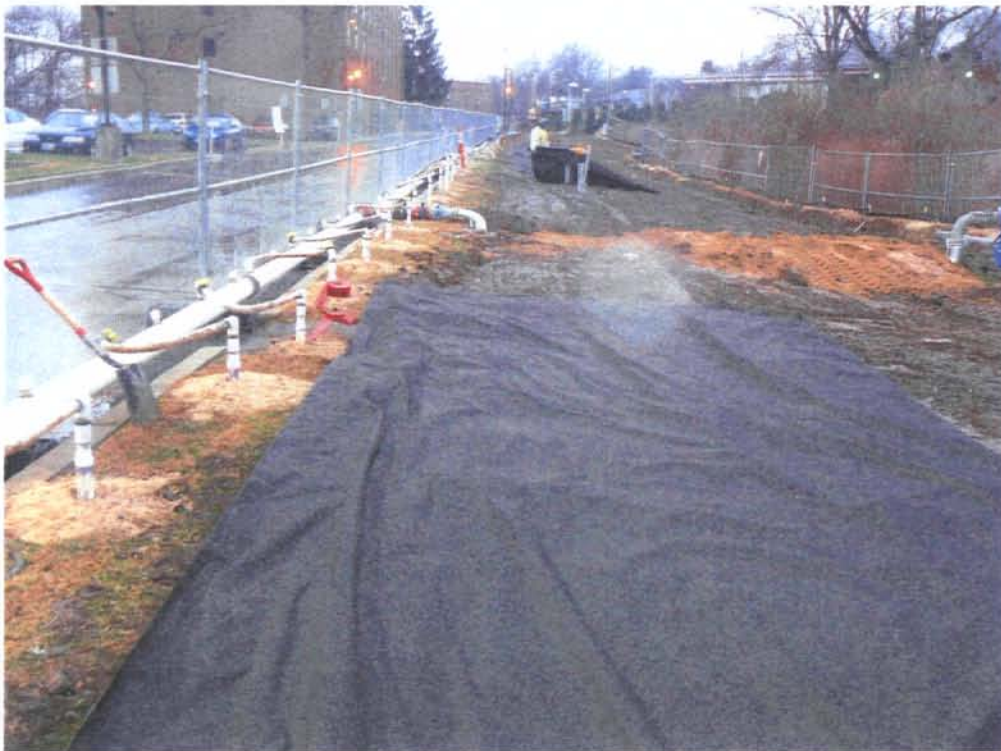
**Description:** Laying of fabric in preparation for rain  
**Name:** 12Dec2010 005

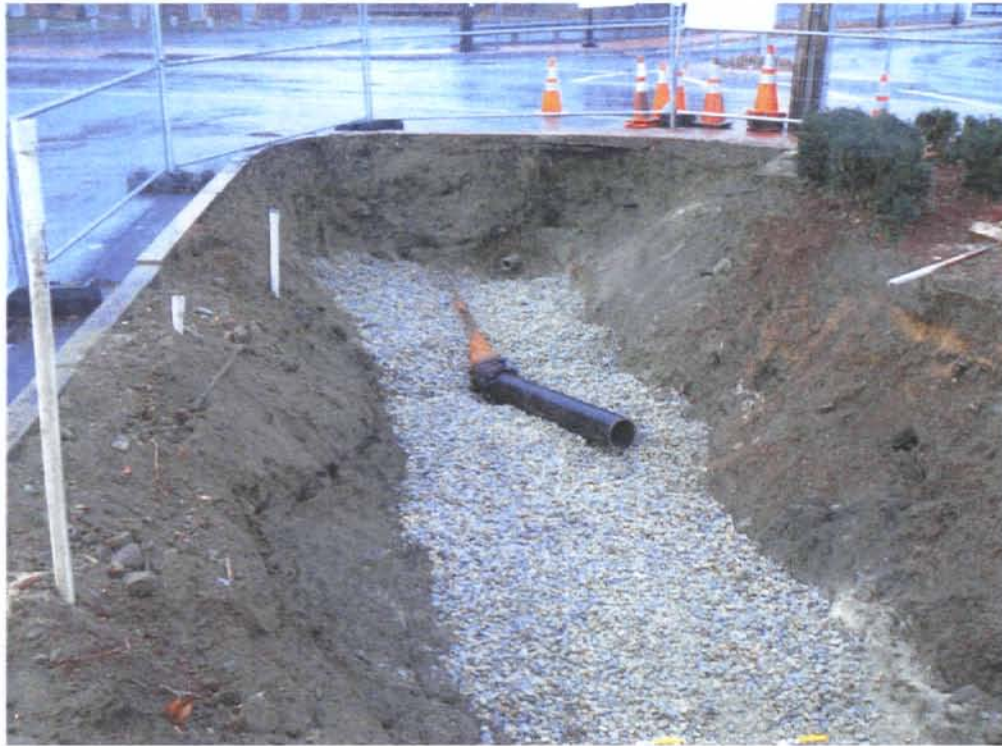
**Description:** Waterline near Smith Street  
**Name:** 12Dec2010 011

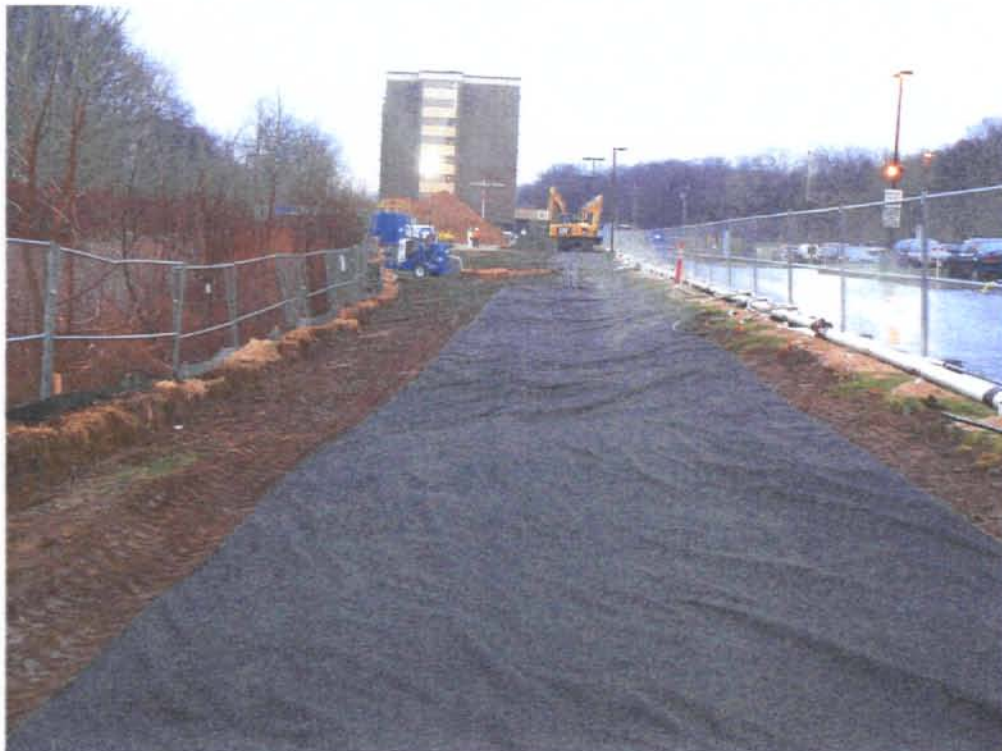
**Description:** Fabric over completed trench  
**Name:** 12Dec2010 019

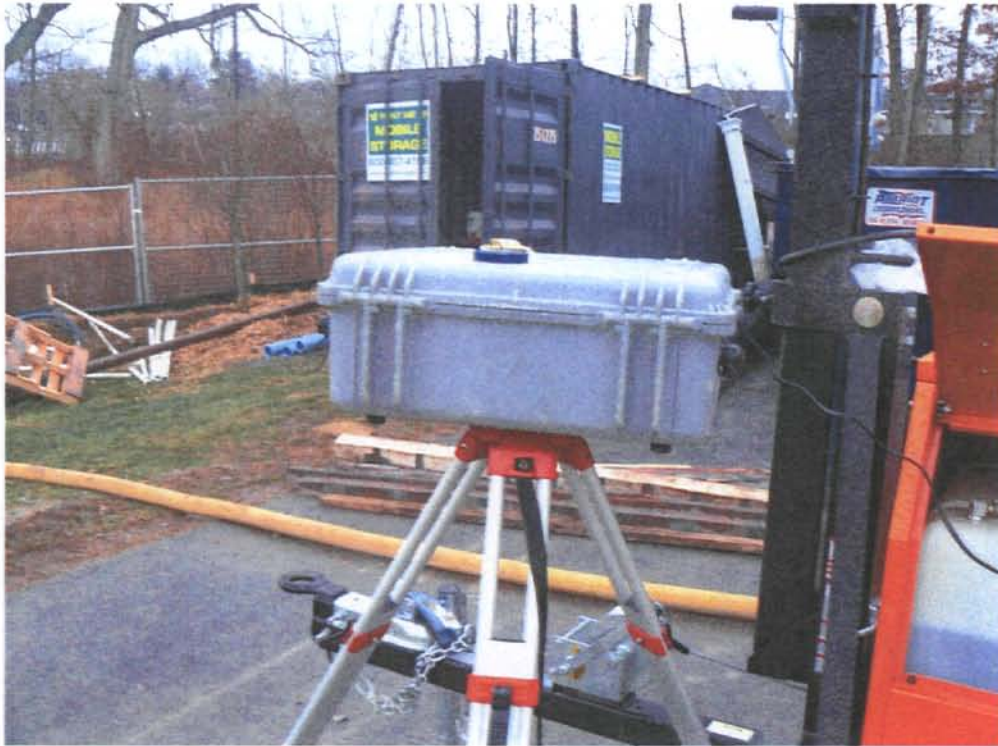
**Description:** Dust monitoring meter  
**Name:** 12Dec2010 022
