**COMPLETION OF WORK REPORT  
ENERGY REPLACEMENT OF WATERLINE  
CENTREDALE MANOR  
NORTH PROVIDENCE, RHODE ISLAND**

March 2011  
File No. 33688

Re: Completion of Work Report – Emergency Water Line Repairs  
Centerdale Manor  
2074 Smith Street  
North Providence, Rhode Island

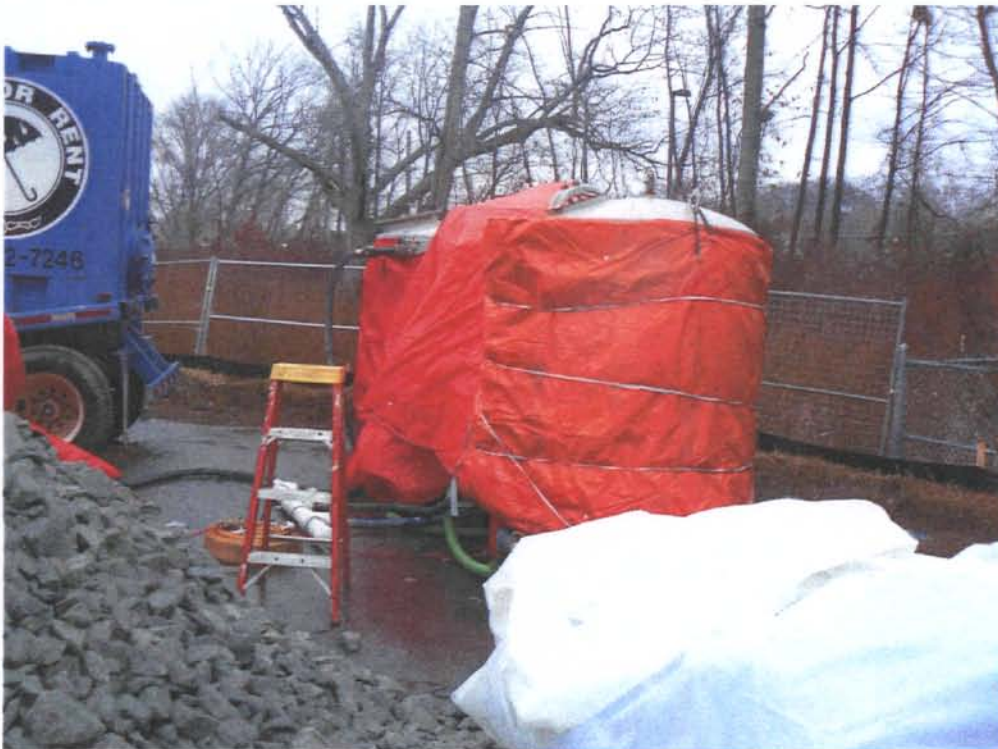
**Description:** Granular activated carbon vessels  
**Name:** 12Dec2010 026

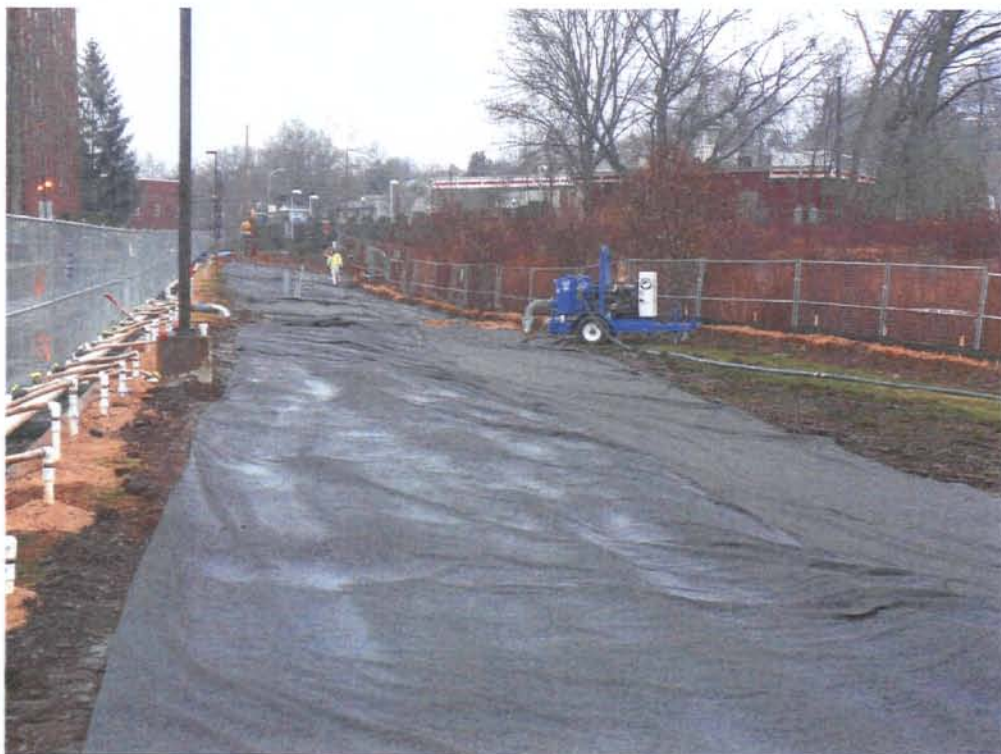
**Description:** Fabric over completed trench before rain  
**Name:** 12Dec2010 033

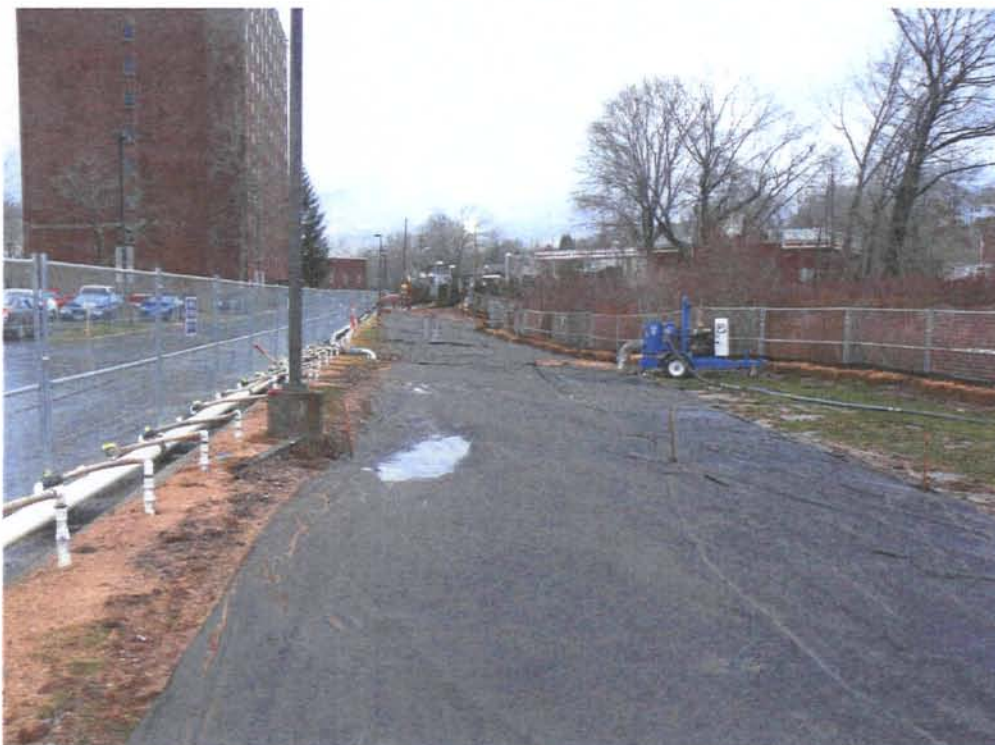
**Description:** Fabric over completed trench after rain  
**Name:** 13Dec2010 003

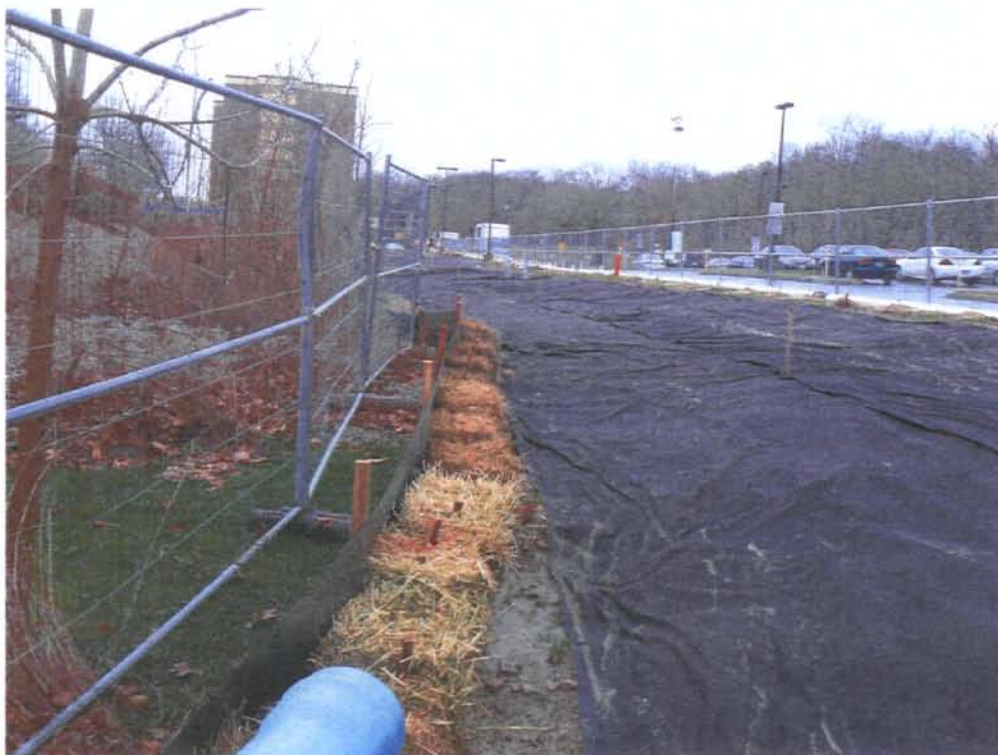
**Description:** Erosion control haybales  
**Name:** 13Dec2010 008

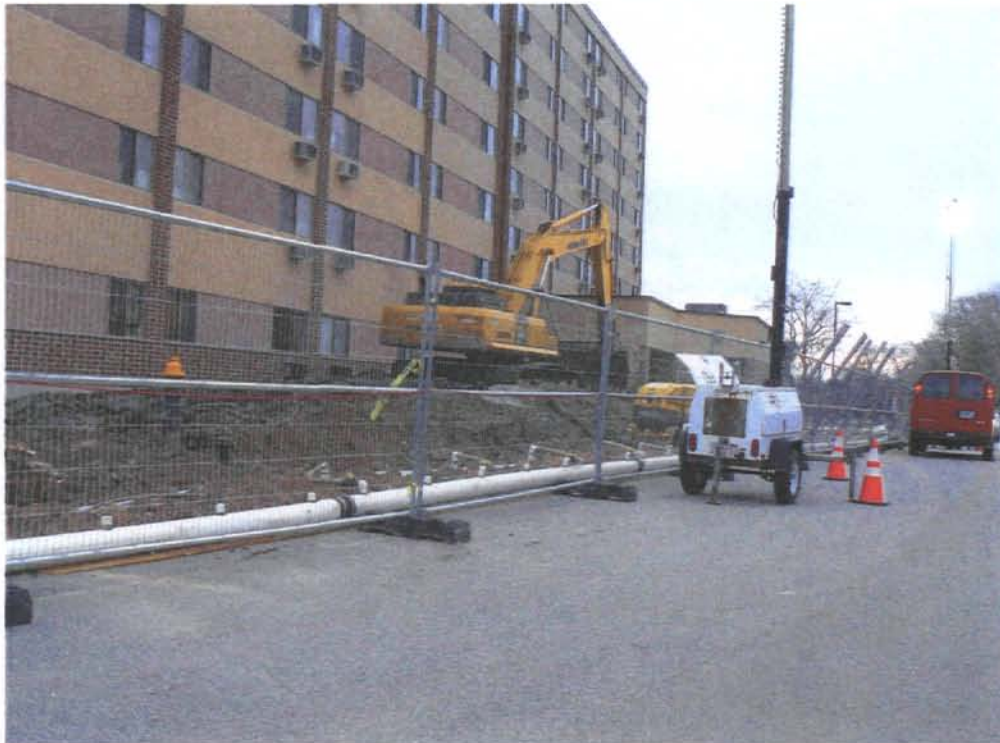
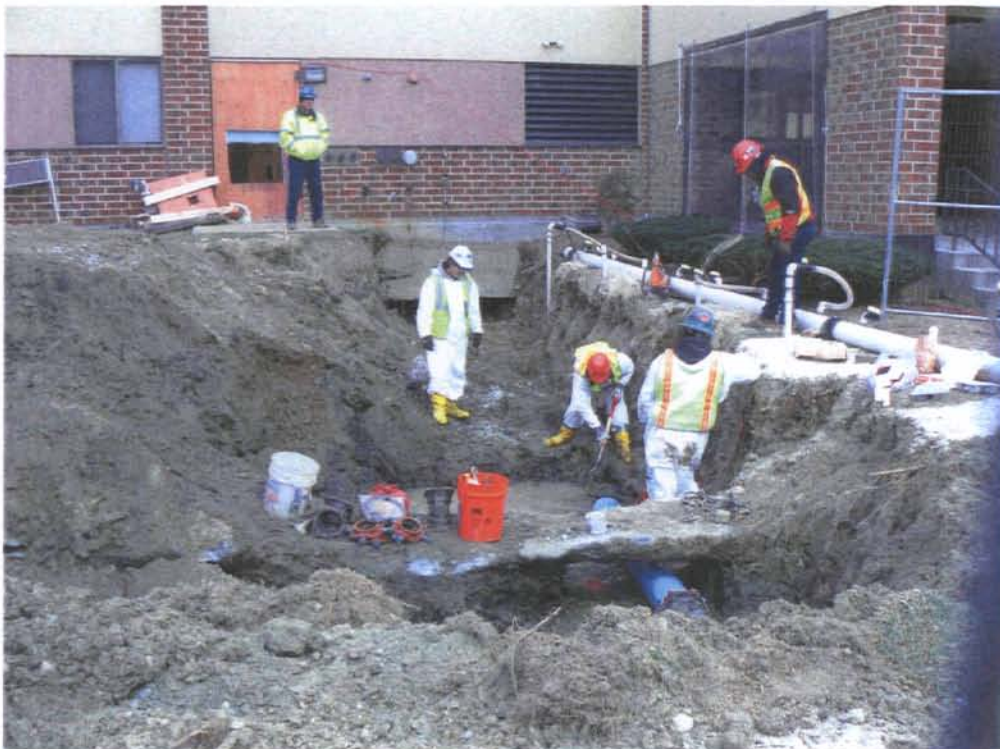
**Description:** Trenching near Manor building  
**Name:** 14Dec2010 001

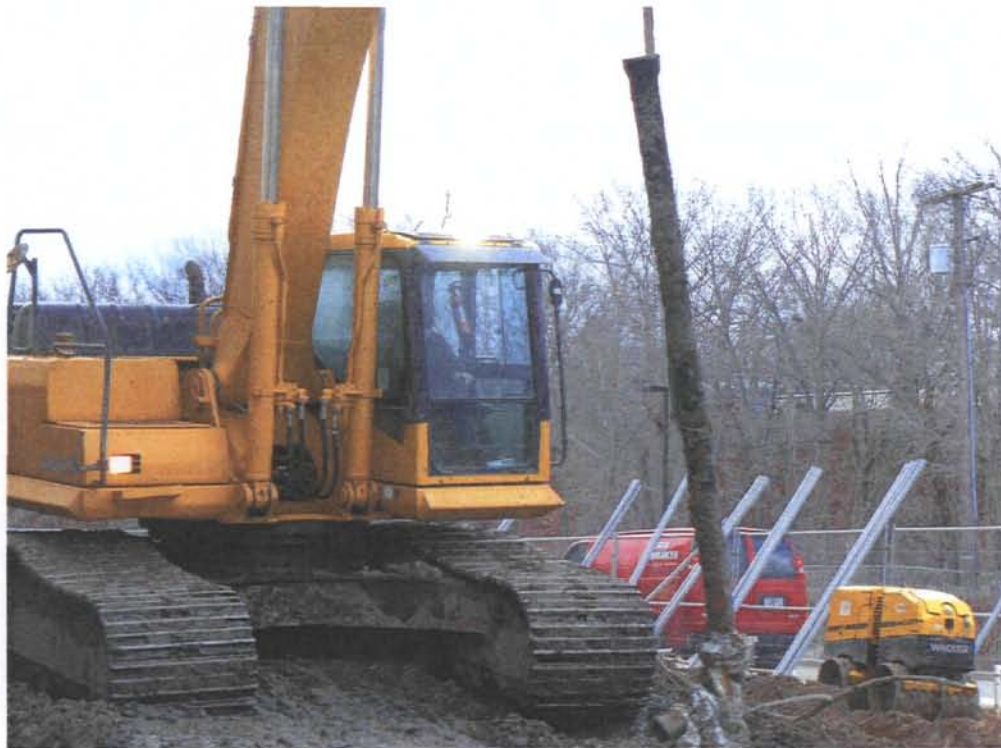
**Description:** Removal of damaged waterline  
**Name:** 14Dec2010 013

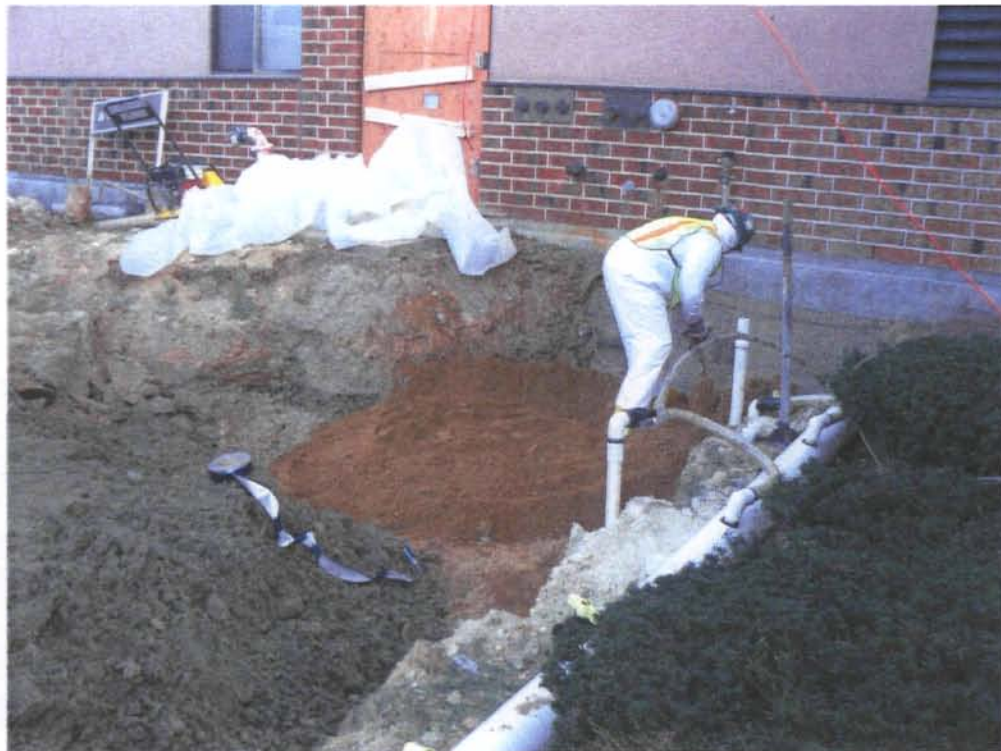
**Description:** Building connection  
**Name:** 15Dec2010 004

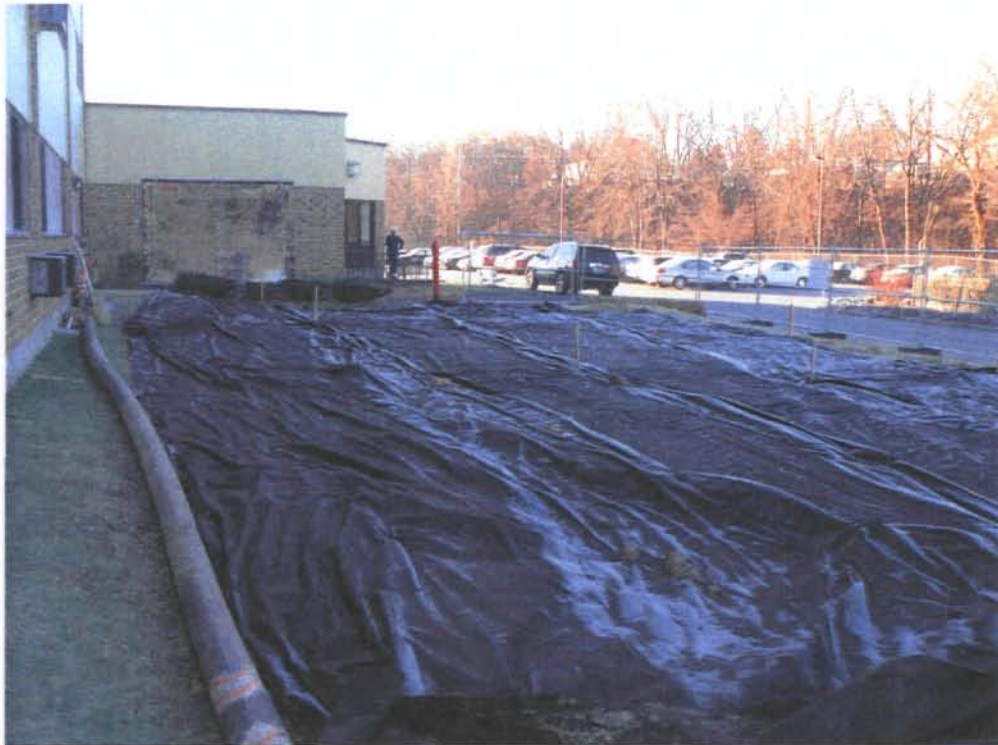
**Description:** Laying of fabric  
**Name:** 17Dec2010 003

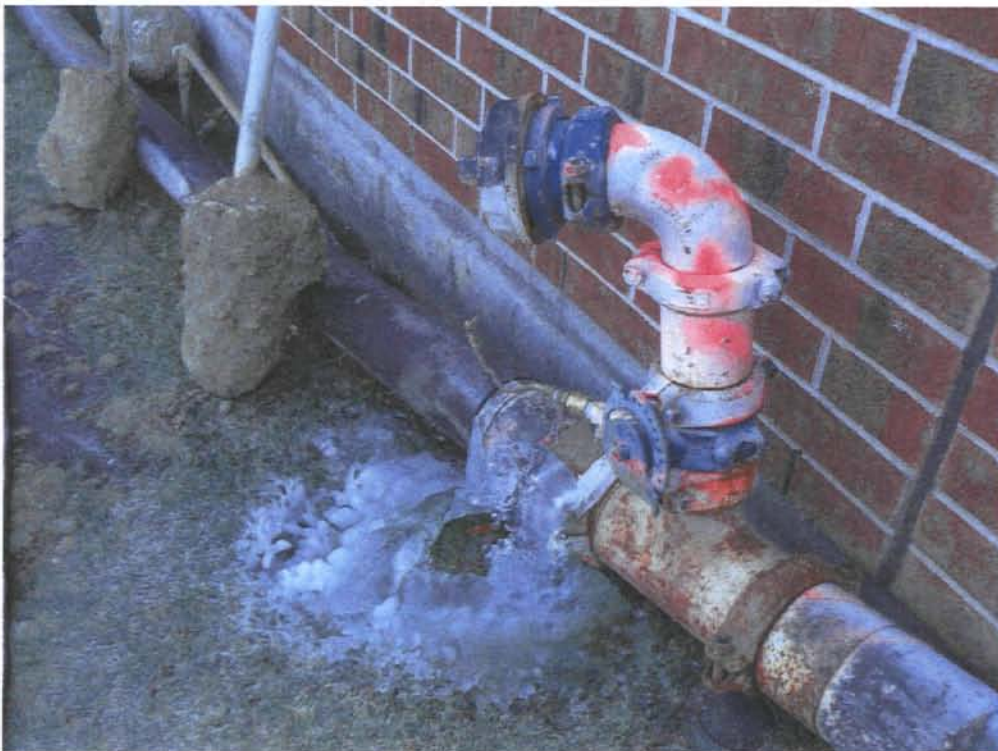
**Description:** Temporary waterline icing  
**Name:** 17Dec2010 004

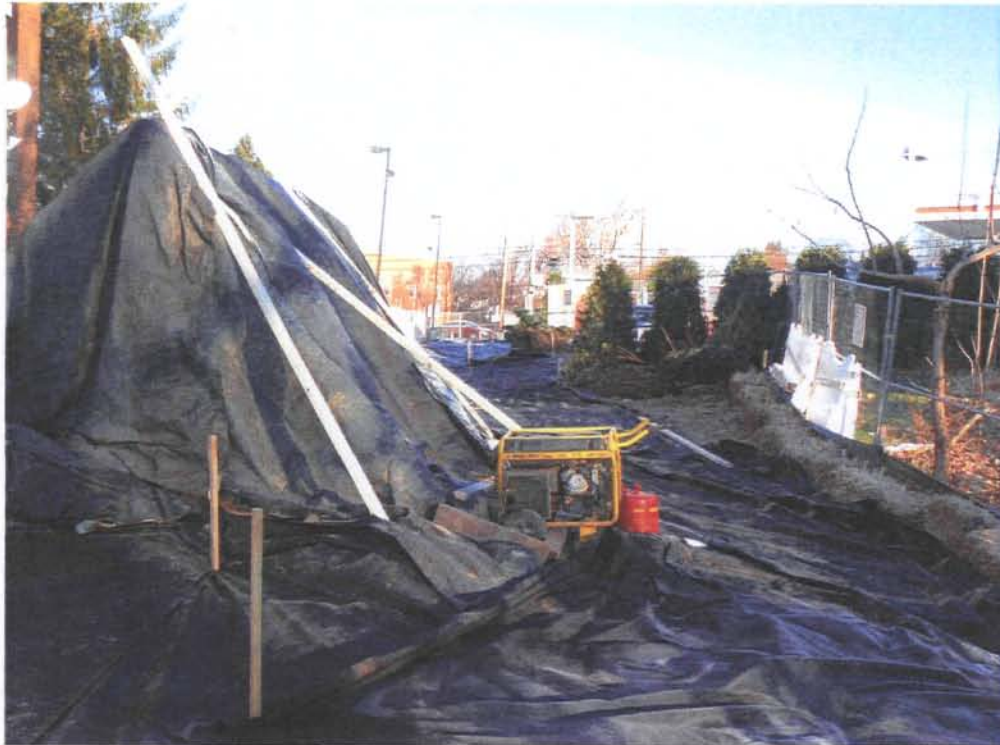
**Description:** "Hot Box" construction  
**Name:** 17Dec2010 017

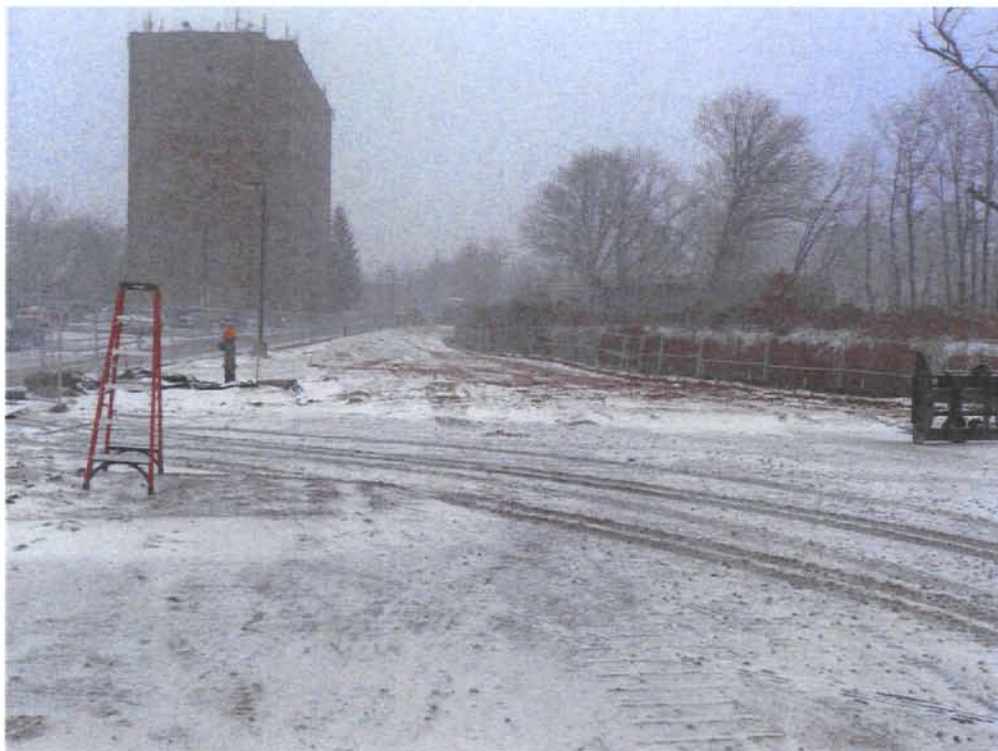
**Description:** Application of clean fill over trench  
**Name:** 21Dec2010 005

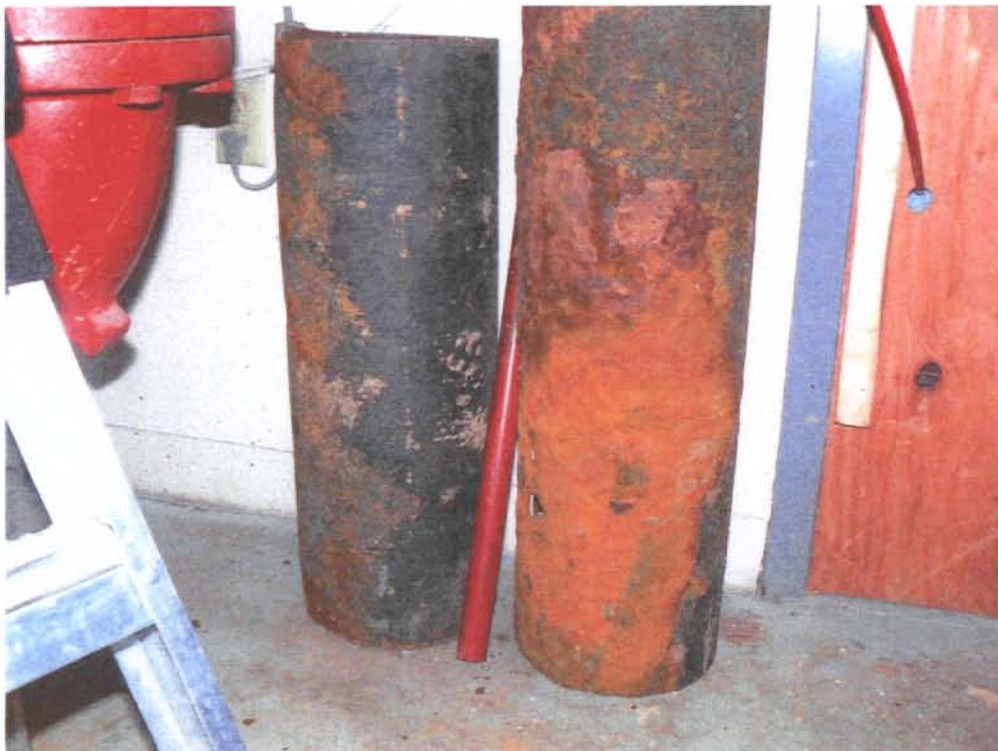
**Description:** Section of corroded waterline  
**Name:**

On or about 1 November 2010, the property owner, with the assistance of personnel from GEM Plumbing and Heating Services, Inc. (GEM), identified that the subsurface water line to the subject building was leaking. As a precaution, the residents were provided with bottled water. A subsequent test pit exploration, conducted by GEM on 15 November 2010 established that at least portions of the 8-inch cast iron pipe had been corroded. Visual observations indicated that the bottom of the pipe (at the test pit location, near the North end of the building) was severely corroded with a hole on the order of ½ inch in diameter being noted at one location, while the top and interior of the pipe were in good condition.

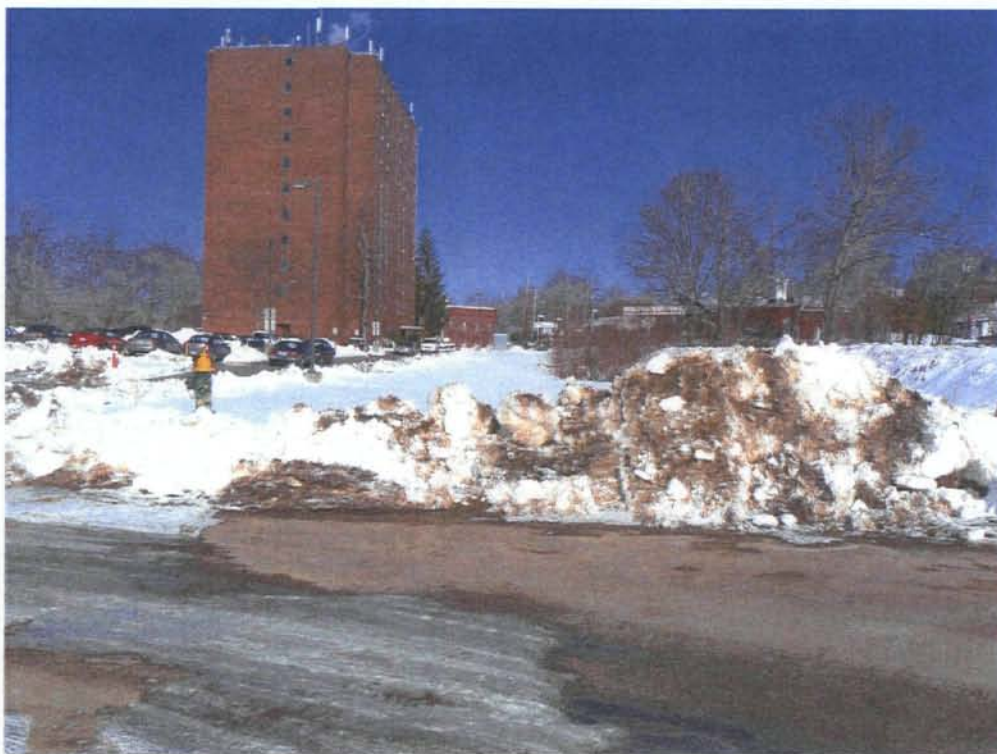
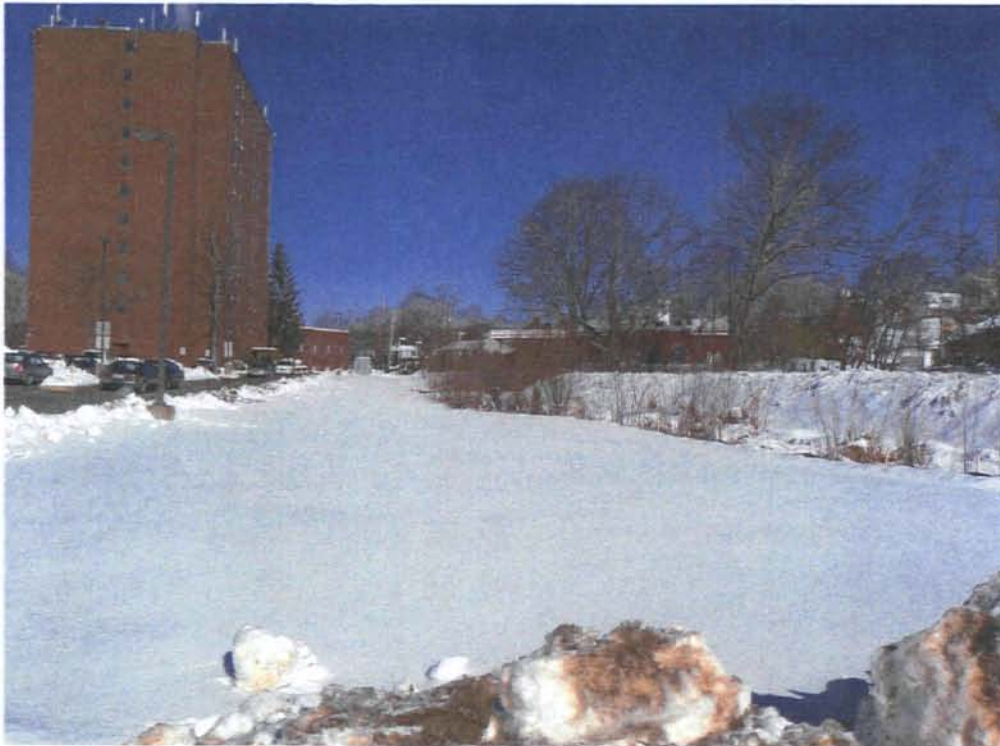
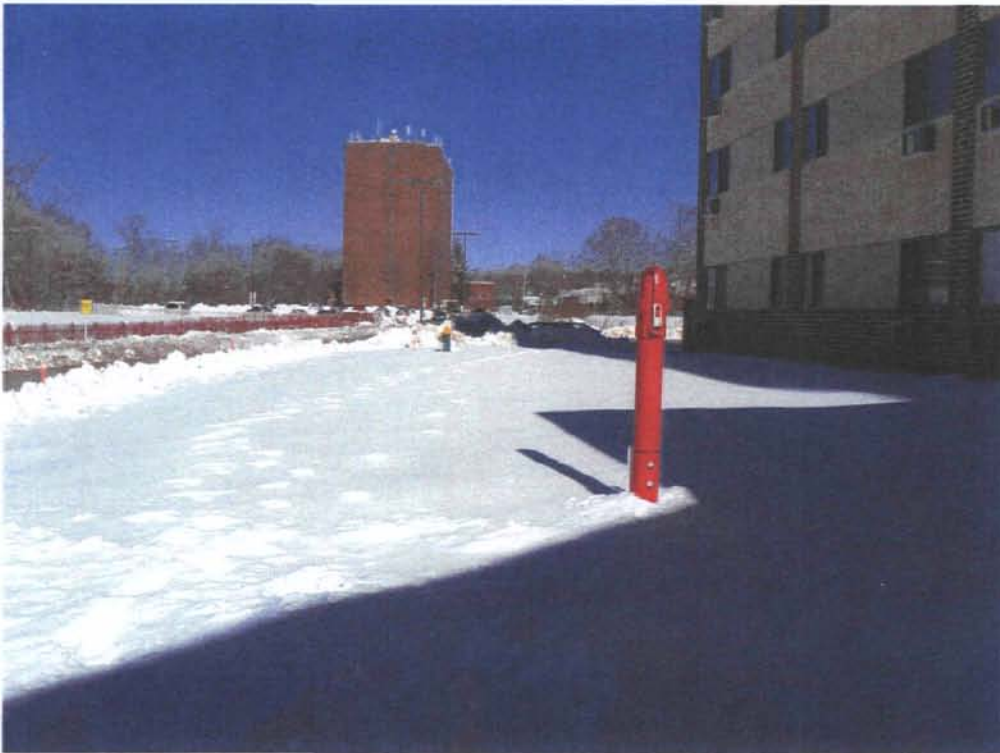
**Description:** Trench Site covered with snow  
**Name:** 17Jan2011 004

It bears noting that beginning on December 26, a series of snow storms has left a substantial covering of snow and ice at the site. Coupled with below freezing temperatures, removal of sediment and erosion control measures surrounding Cap 1 Area and final grading, top soil application, and seeding has not been possible. These activities will be completed in early spring 2011 as site and weather conditions allow.
