SUBJECT: WATERBORNE GEOPHYSICAL SURVEYS, CENTERDALE MANOR SITE  
WORK ASSIGNMENT R1A00270 - PRELIMINARY DRAFT TRIP REPORT

The objective of the field activities described in this Preliminary Draft Trip Report was to map sub-bottom sediments in two ponds at the Centerdale Manor Site in North Providence, Rhode Island. Lockheed Martin personnel were tasked by the United States Environmental Protection Agency (U.S. EPA) Environmental Response Team Center (ERTC) under the Response Engineering and Analytical Contract (REAC) to perform waterborne geophysical surveys.

This Preliminary Draft Trip Report documents the waterborne geophysical surveys performed at the Centerdale Manor Site on 1 through 10 October 2002 and 22 through 24 October 2002. However, only data from the upper, Allendale Pond have been processed to date for presentation in this report.

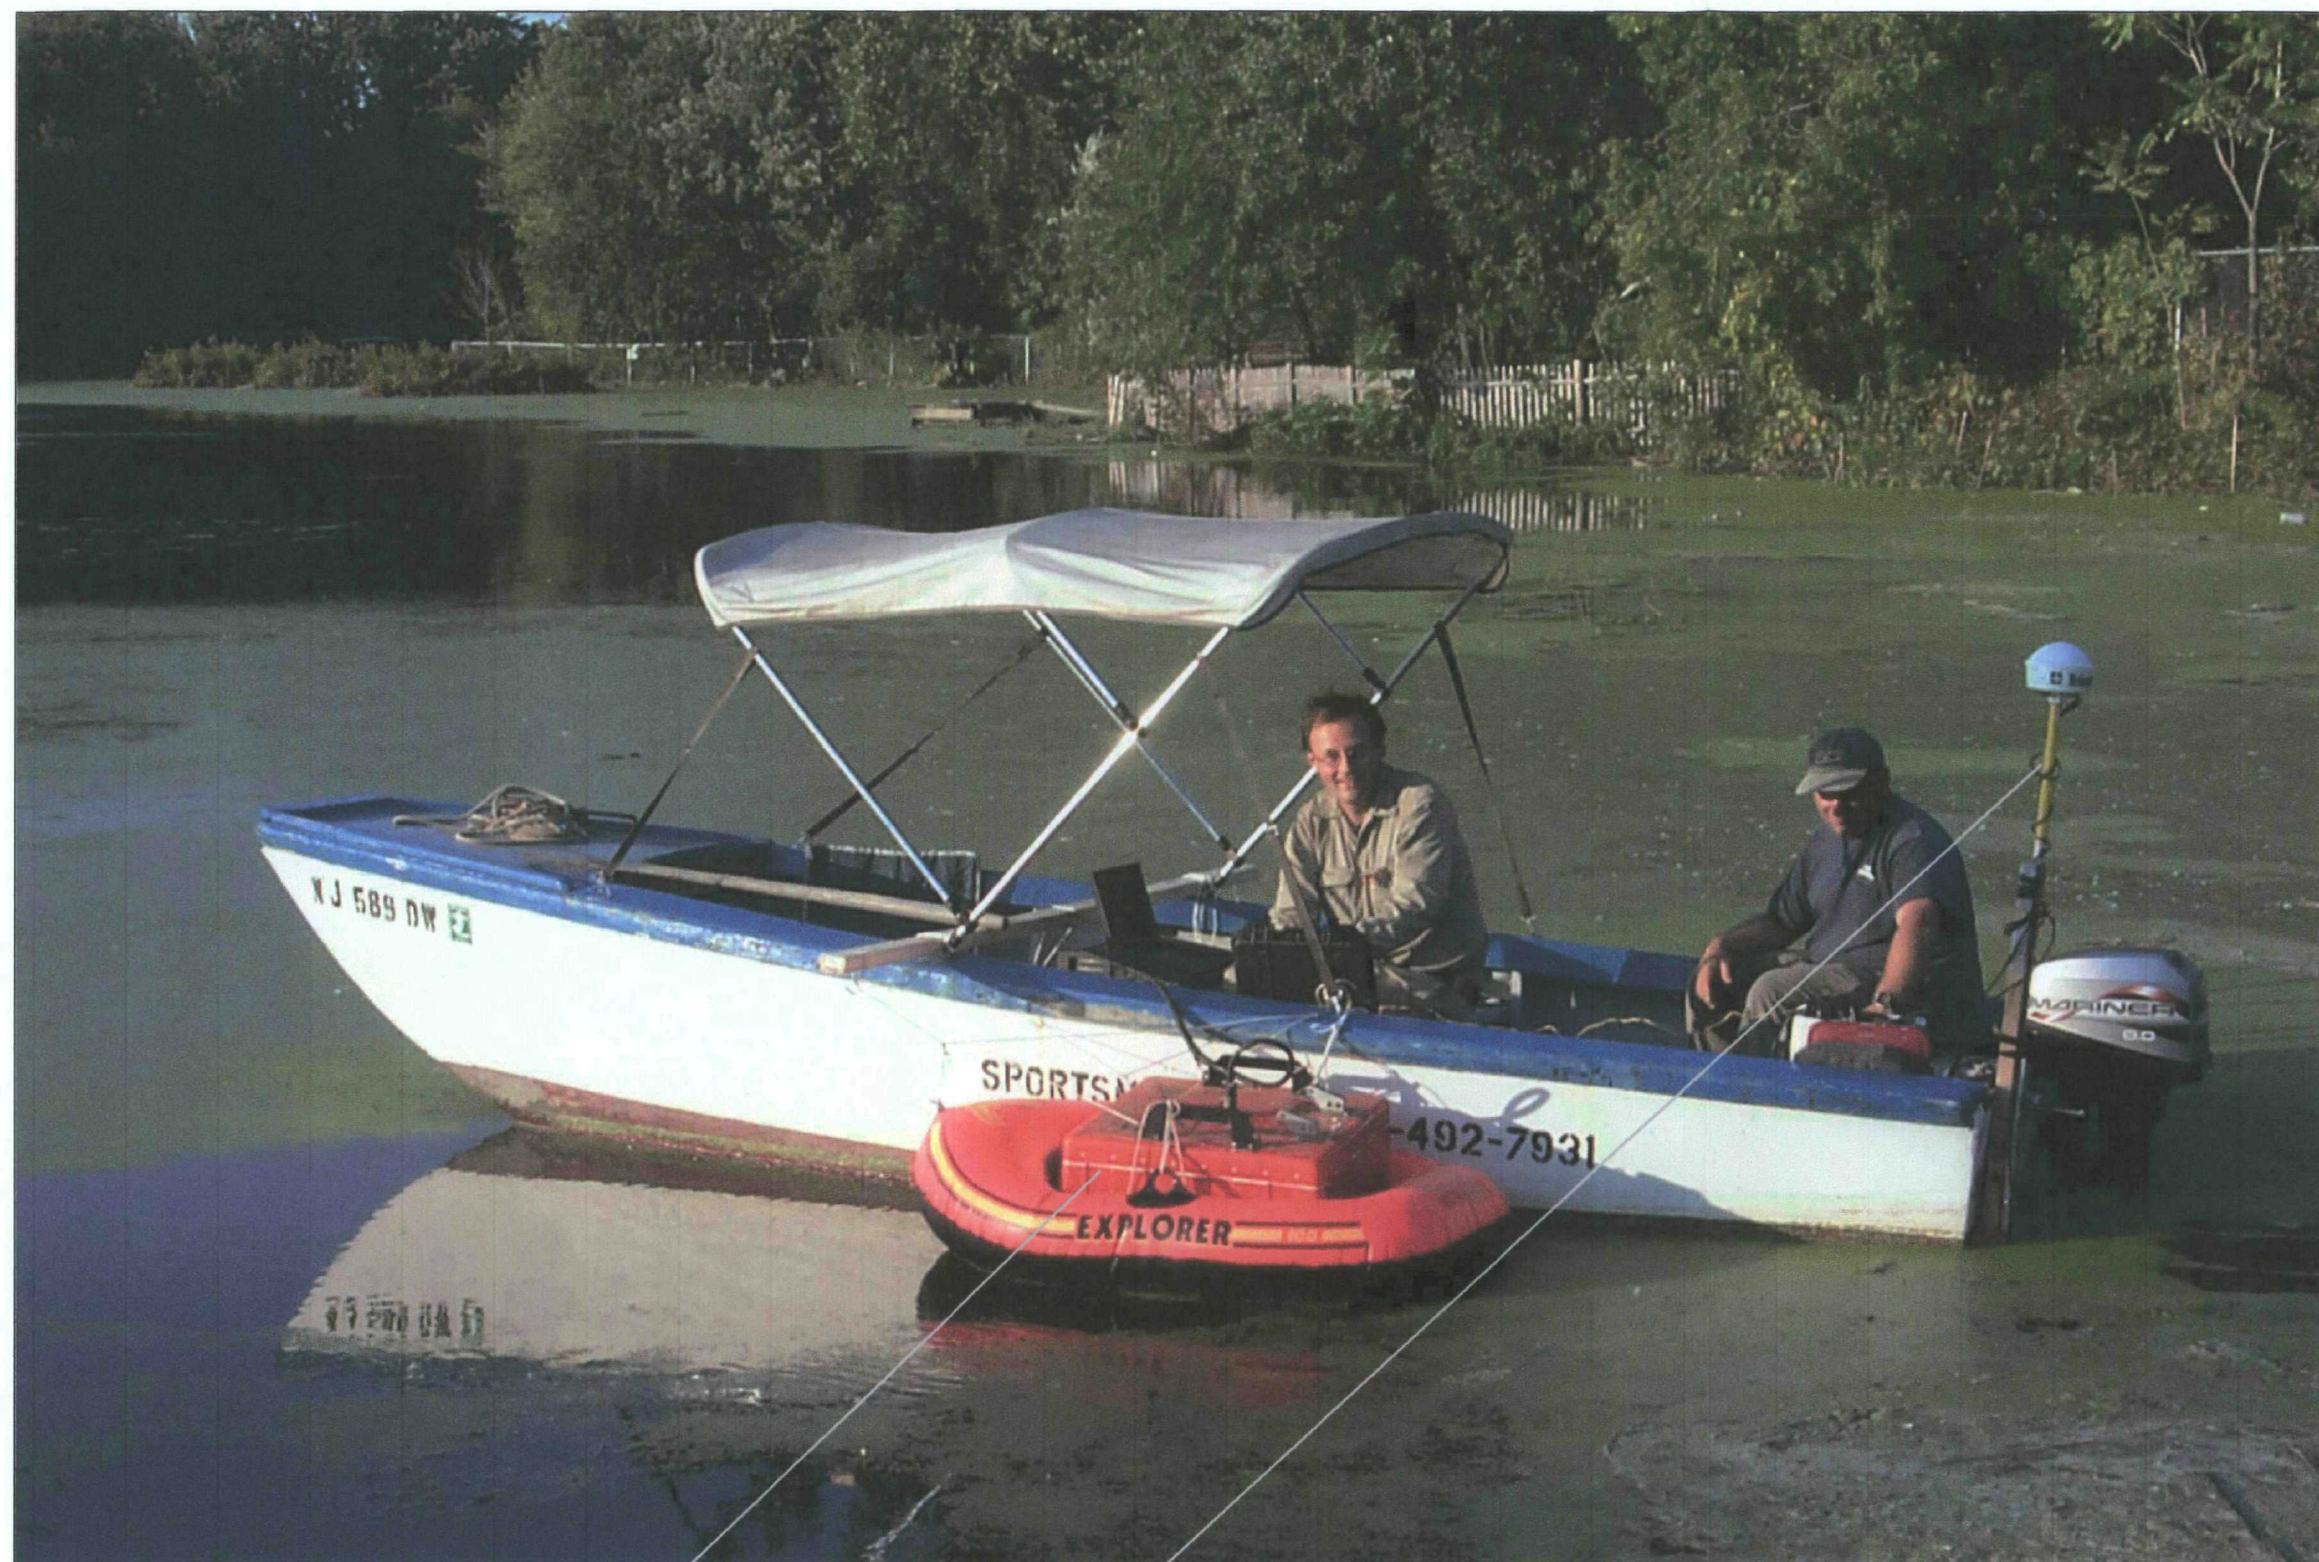
Figure 2. Waterborne Ground Penetrating Radar

A 16-foot, flat-bottomed, wooden Garvey boat with a 8.0 horsepower outboard motor was used for the waterborne geophysical surveys (Figure 2). The low draft and wide beam of the Garvey boat were ideal for the surveys.

Ground penetrating radar (GPR) was the only method that appeared to be useful at this site. It employed a GSSI® 200 megahertz (MHz) antennae deployed in a small rubber raft. A 250 nanosecond (ns) range was used and time varying gains were set at 10, 30, 50, 55, 60, and 65 decibels (dB). A vertical low pass filter was set at 1000 MHz and a high pass filter was set at 125 MHz. The instrument recorded six traces per second. The usual boat speed was about 1.0 knots, which resulted in a sample interval of about eight traces per foot. A trace number was stored on the GPS console with current navigation data once per second.

200 MHz Ground Penetrating Radar Antennae

Global Positioning System Antenna

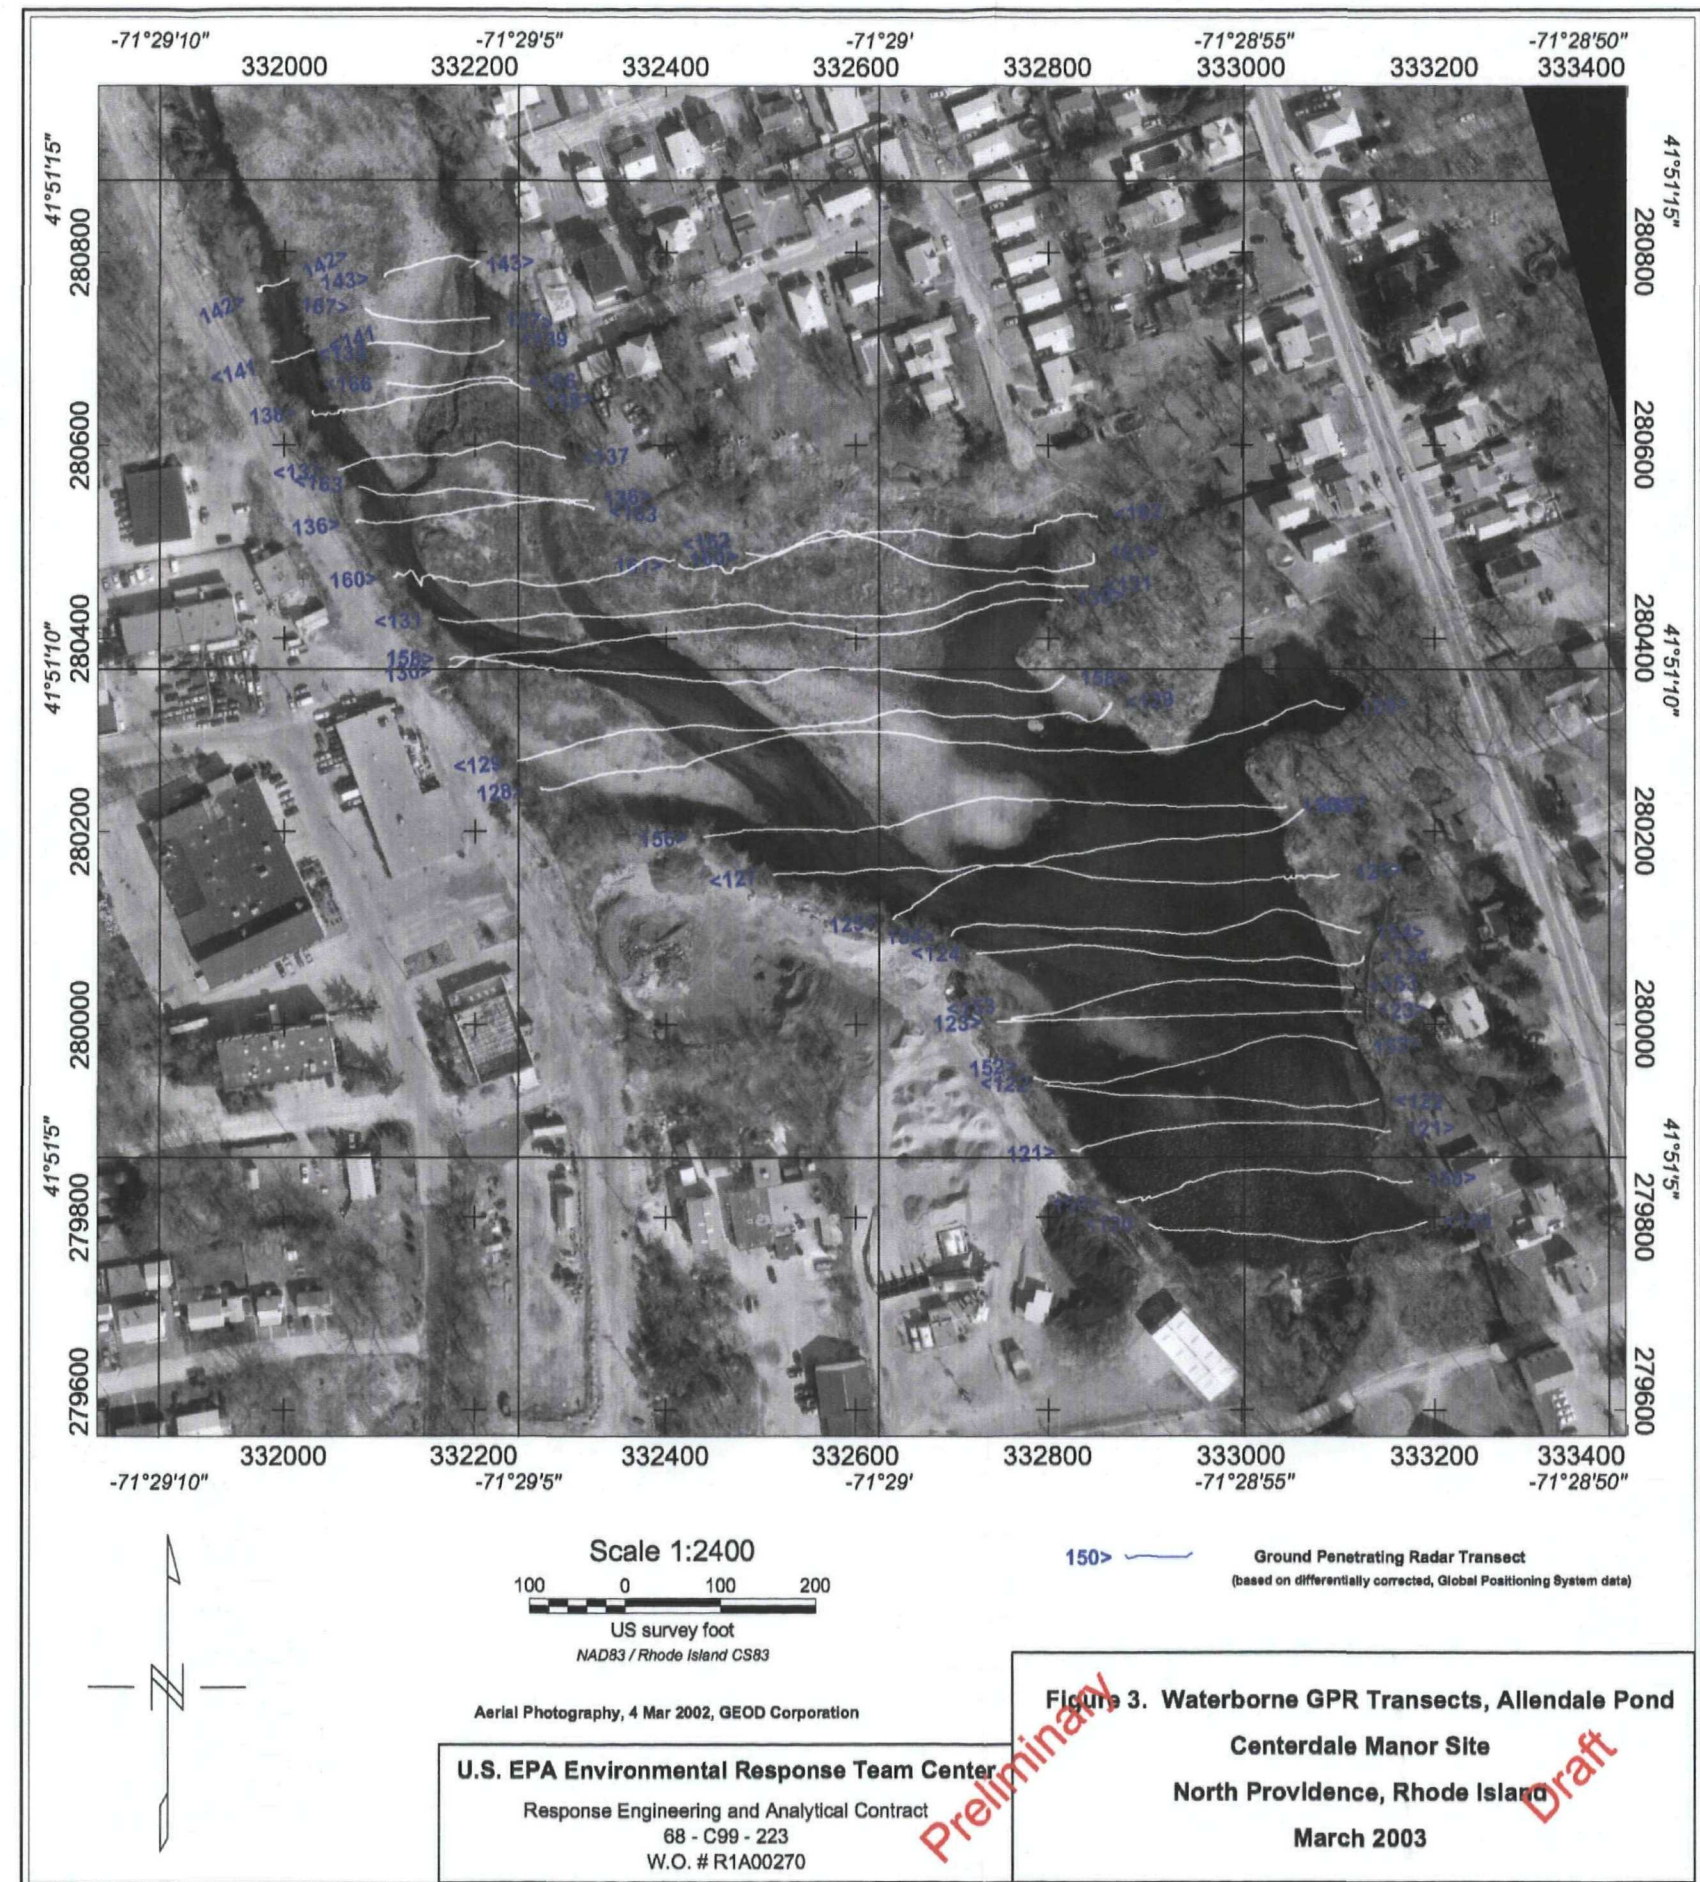
On Allendale Pond, about 2.11 linear miles of GPR data were chosen to provide the most even coverage (Figure 3). In a few places the coverage was sparse due to obstacles and difficulty navigating. The survey area covered was about 12.5 acres. This area was considerably larger than the low-water level area indicated by high resolution aerial photography. At low-water level, the main flow channel was evident down past the middle of the survey area. Several adjacent areas of either erosion or migrating point bars were evident.

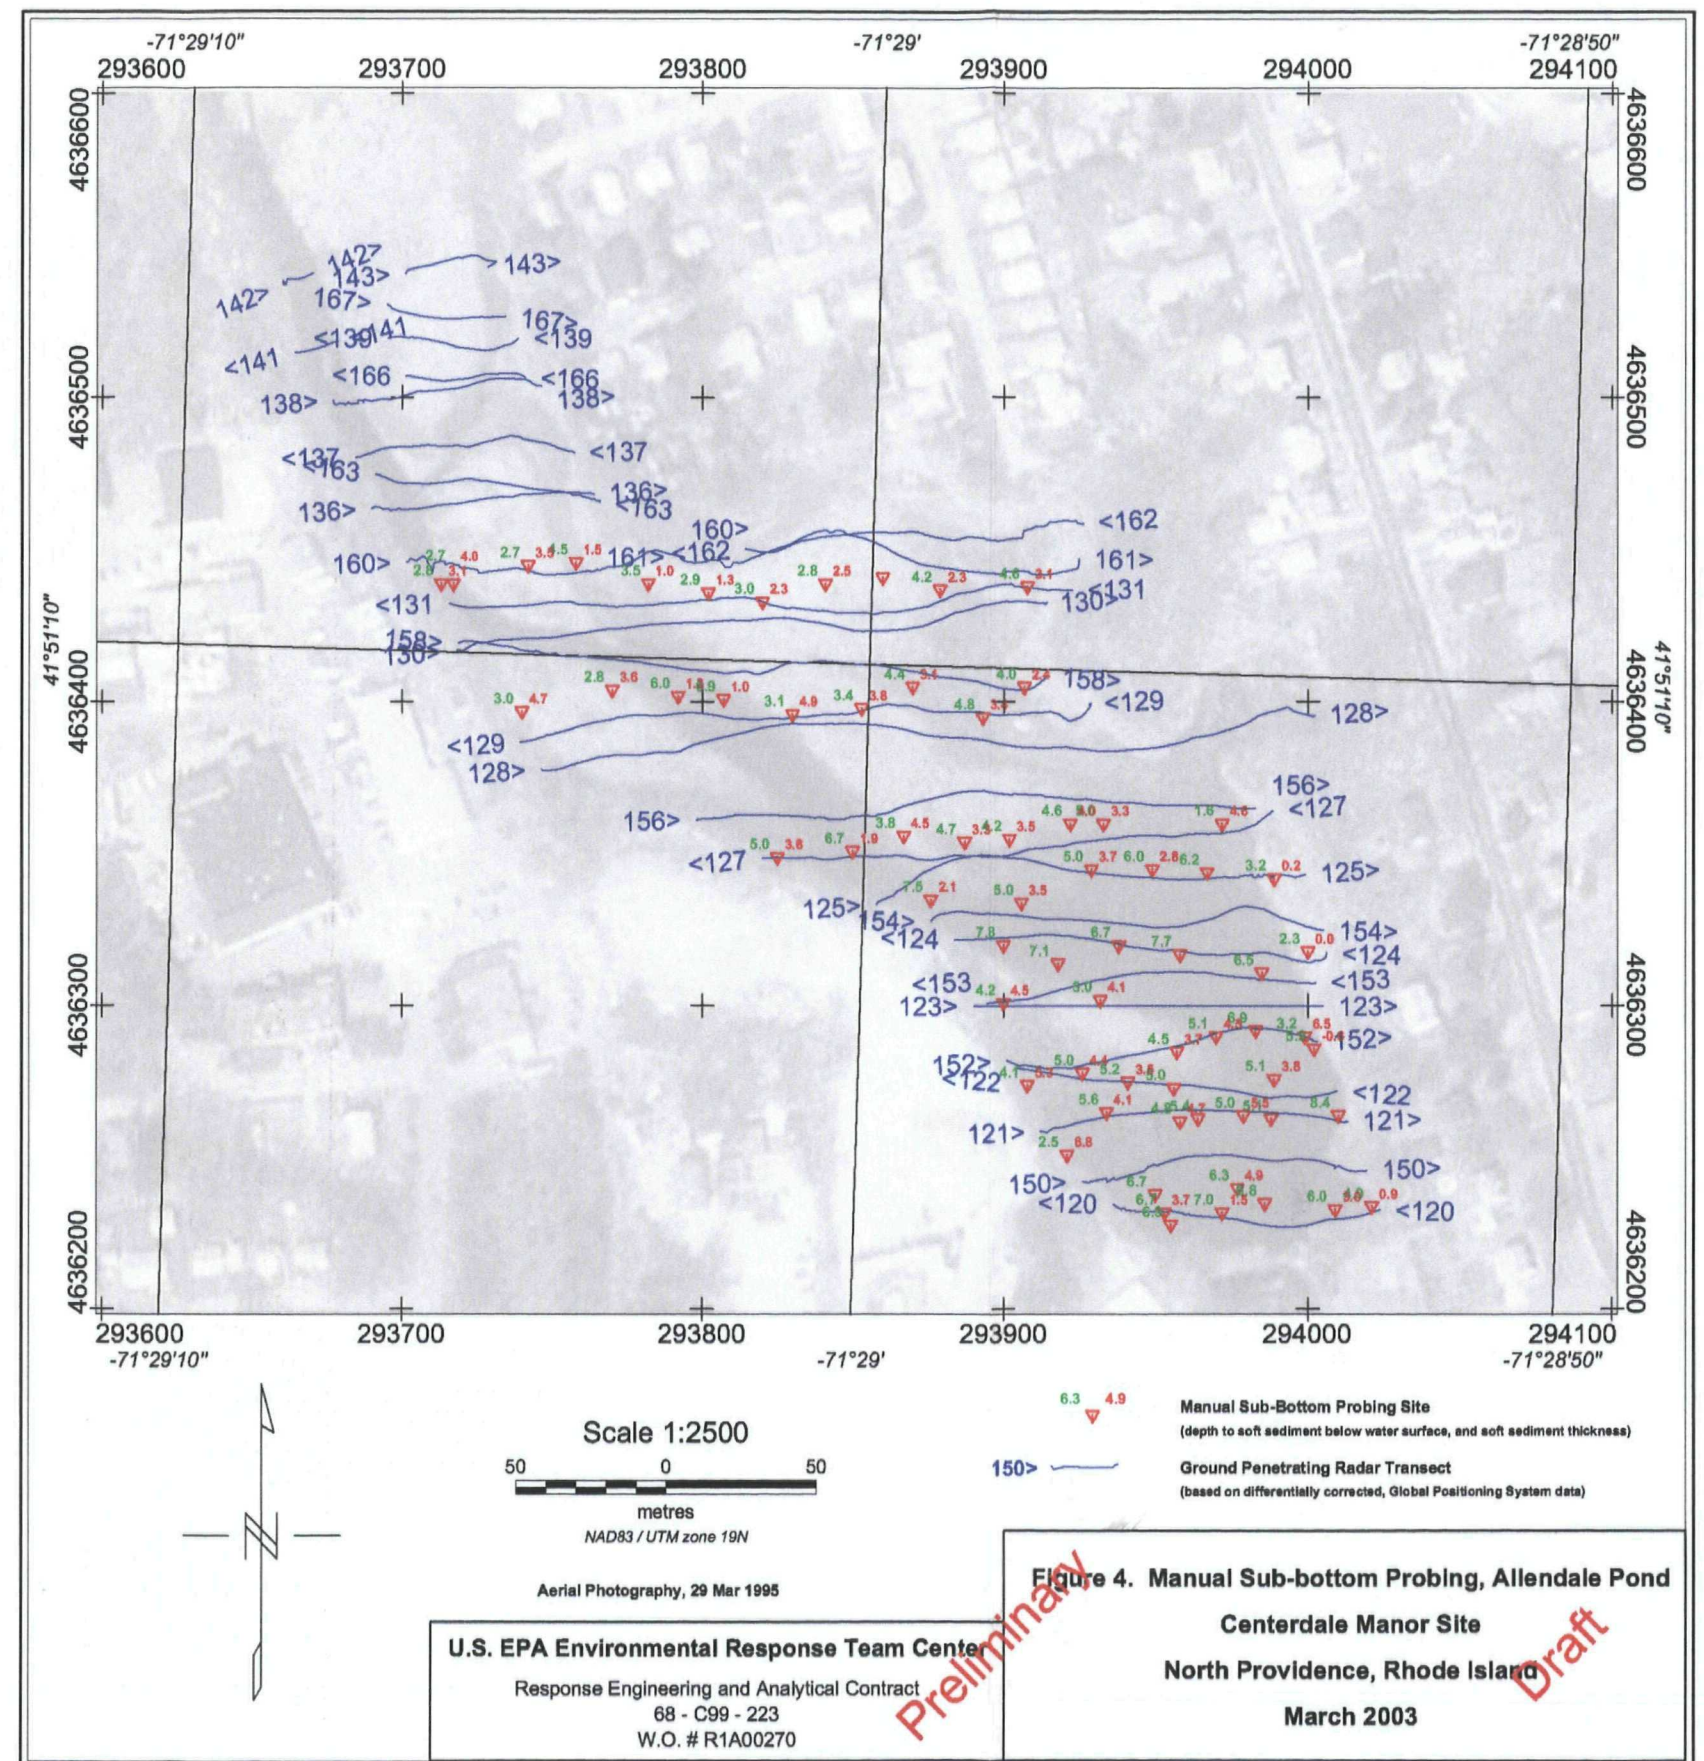
The maximum water depth probed was 8.4 feet at the southeastern part of Allendale Pond (Figure 4). The thickest soft sediment probed was 6.8 feet. Thick soft sediments were probed in many areas of the pond. A hard bottom of

gravel and coarse sand with little or no soft sediments appeared to characterize the flow channels. Apparent bedrock was observed at the east side of the pond.
