SUBJECT: WATERBORNE GEOPHYSICAL SURVEYS, CENTERDALE MANOR SITE  
WORK ASSIGNMENT R1A00270 - PRELIMINARY DRAFT TRIP REPORT

The objective of the field activities described in this Preliminary Draft Trip Report was to map sub-bottom sediments in two ponds at the Centerdale Manor Site in North Providence, Rhode Island. Lockheed Martin personnel were tasked by the United States Environmental Protection Agency (U.S. EPA) Environmental Response Team Center (ERTC) under the Response Engineering and Analytical Contract (REAC) to perform waterborne geophysical surveys.

This Preliminary Draft Trip Report documents the waterborne geophysical surveys performed at the Centerdale Manor Site on 1 through 10 October 2002 and 22 through 24 October 2002. However, only data from the upper, Allendale Pond have been processed to date for presentation in this report.

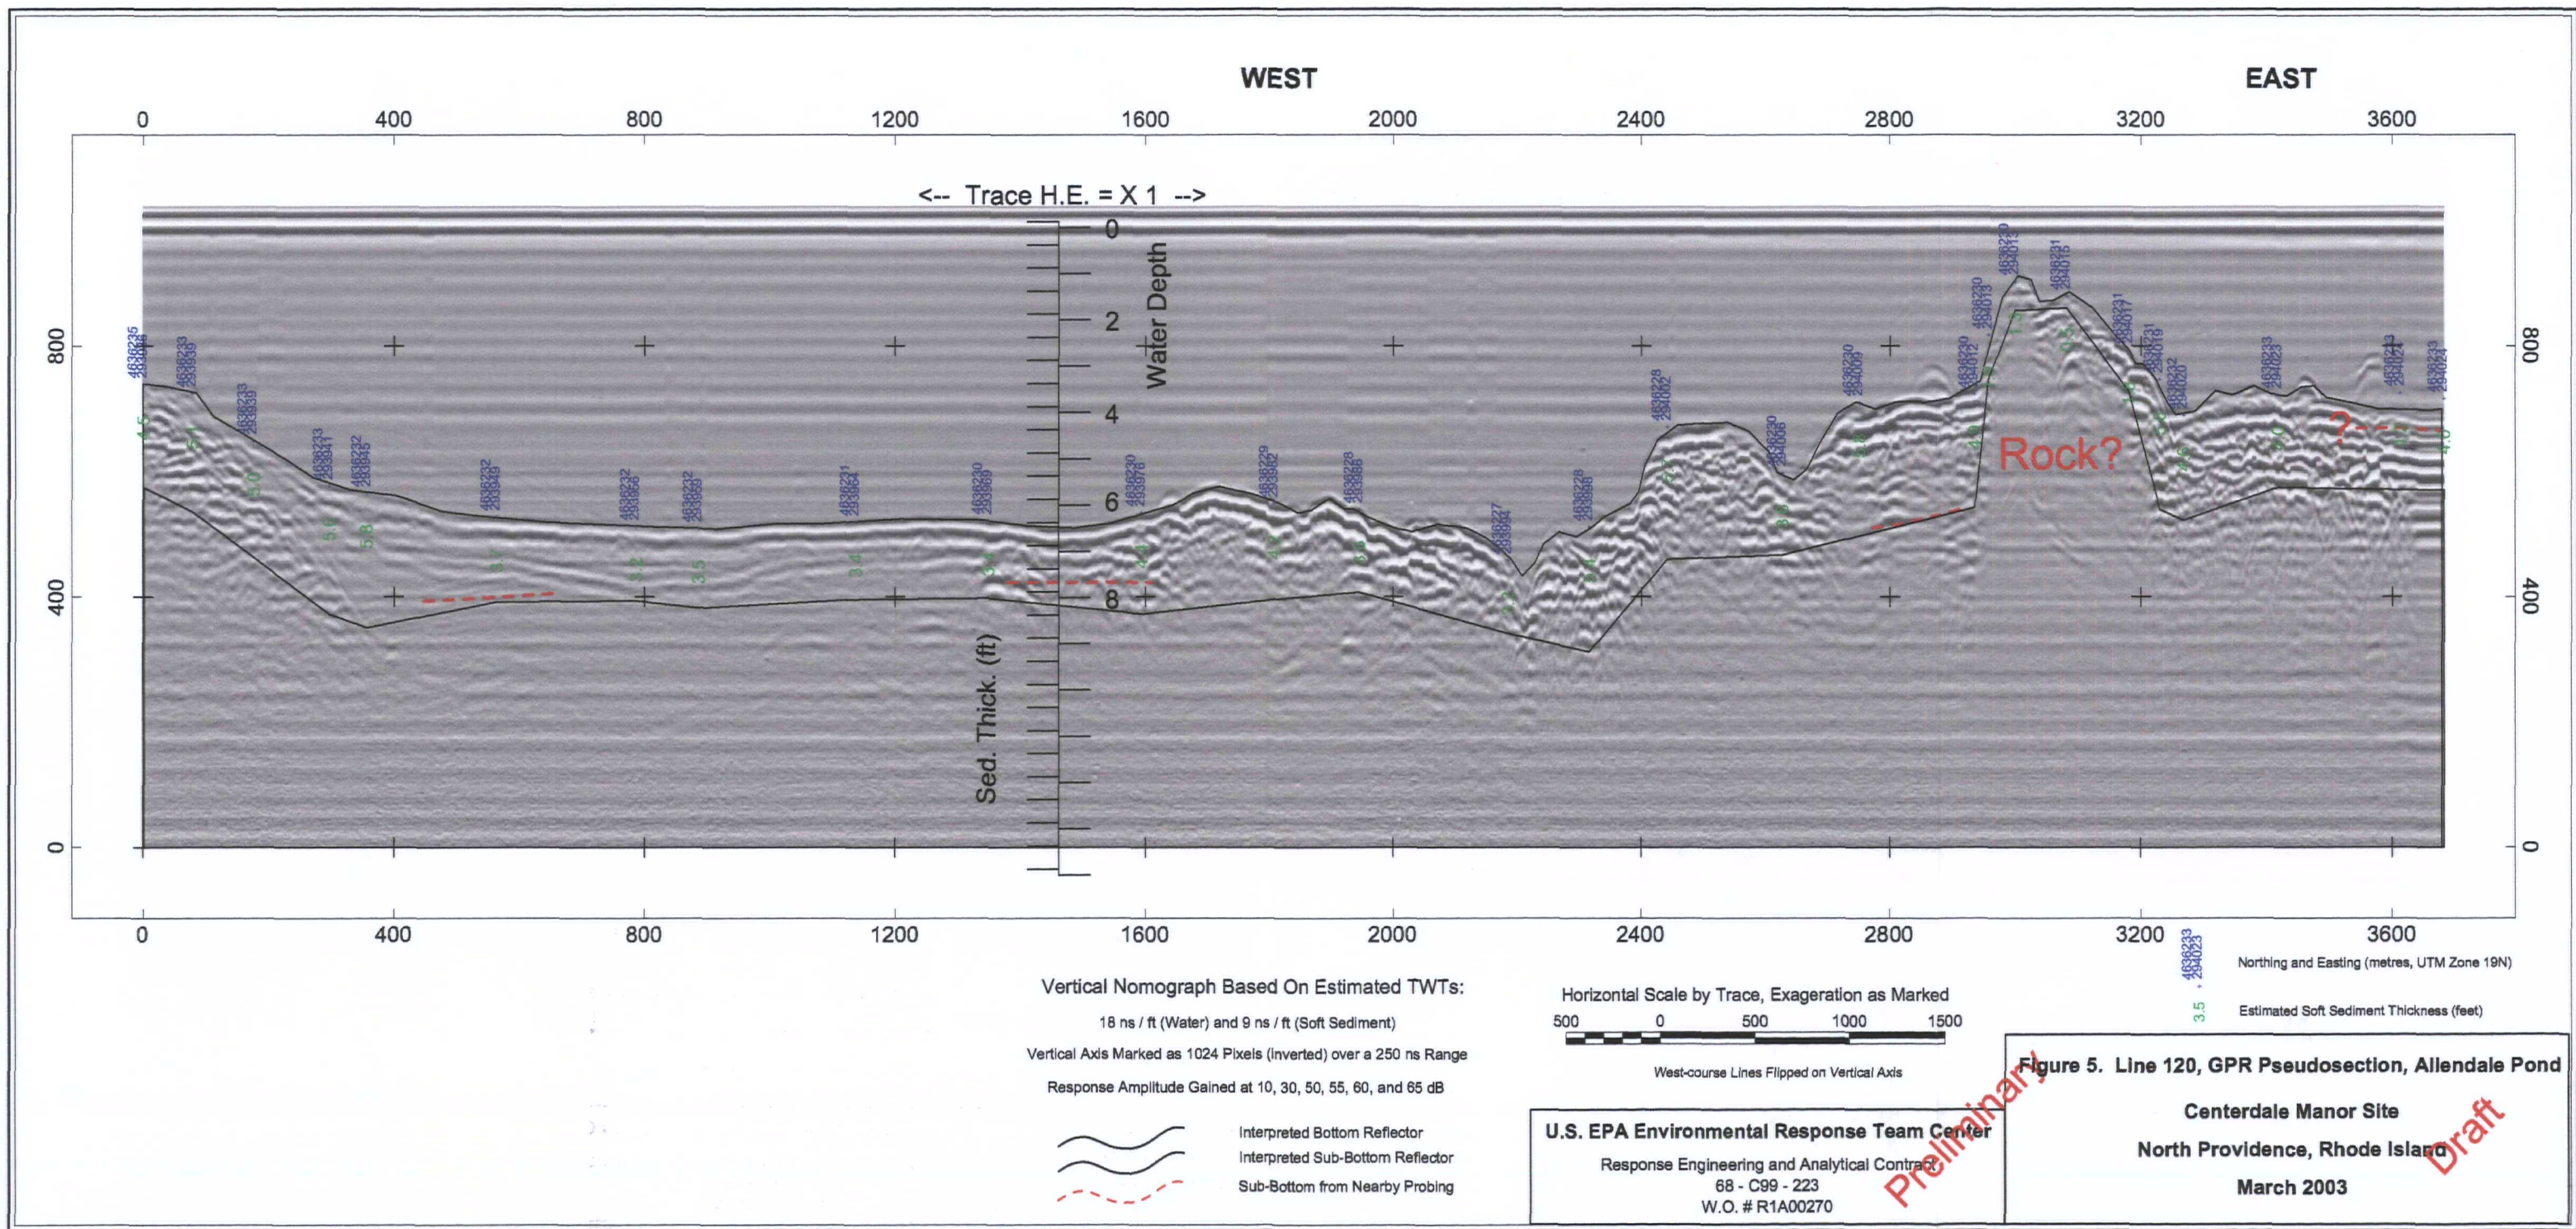
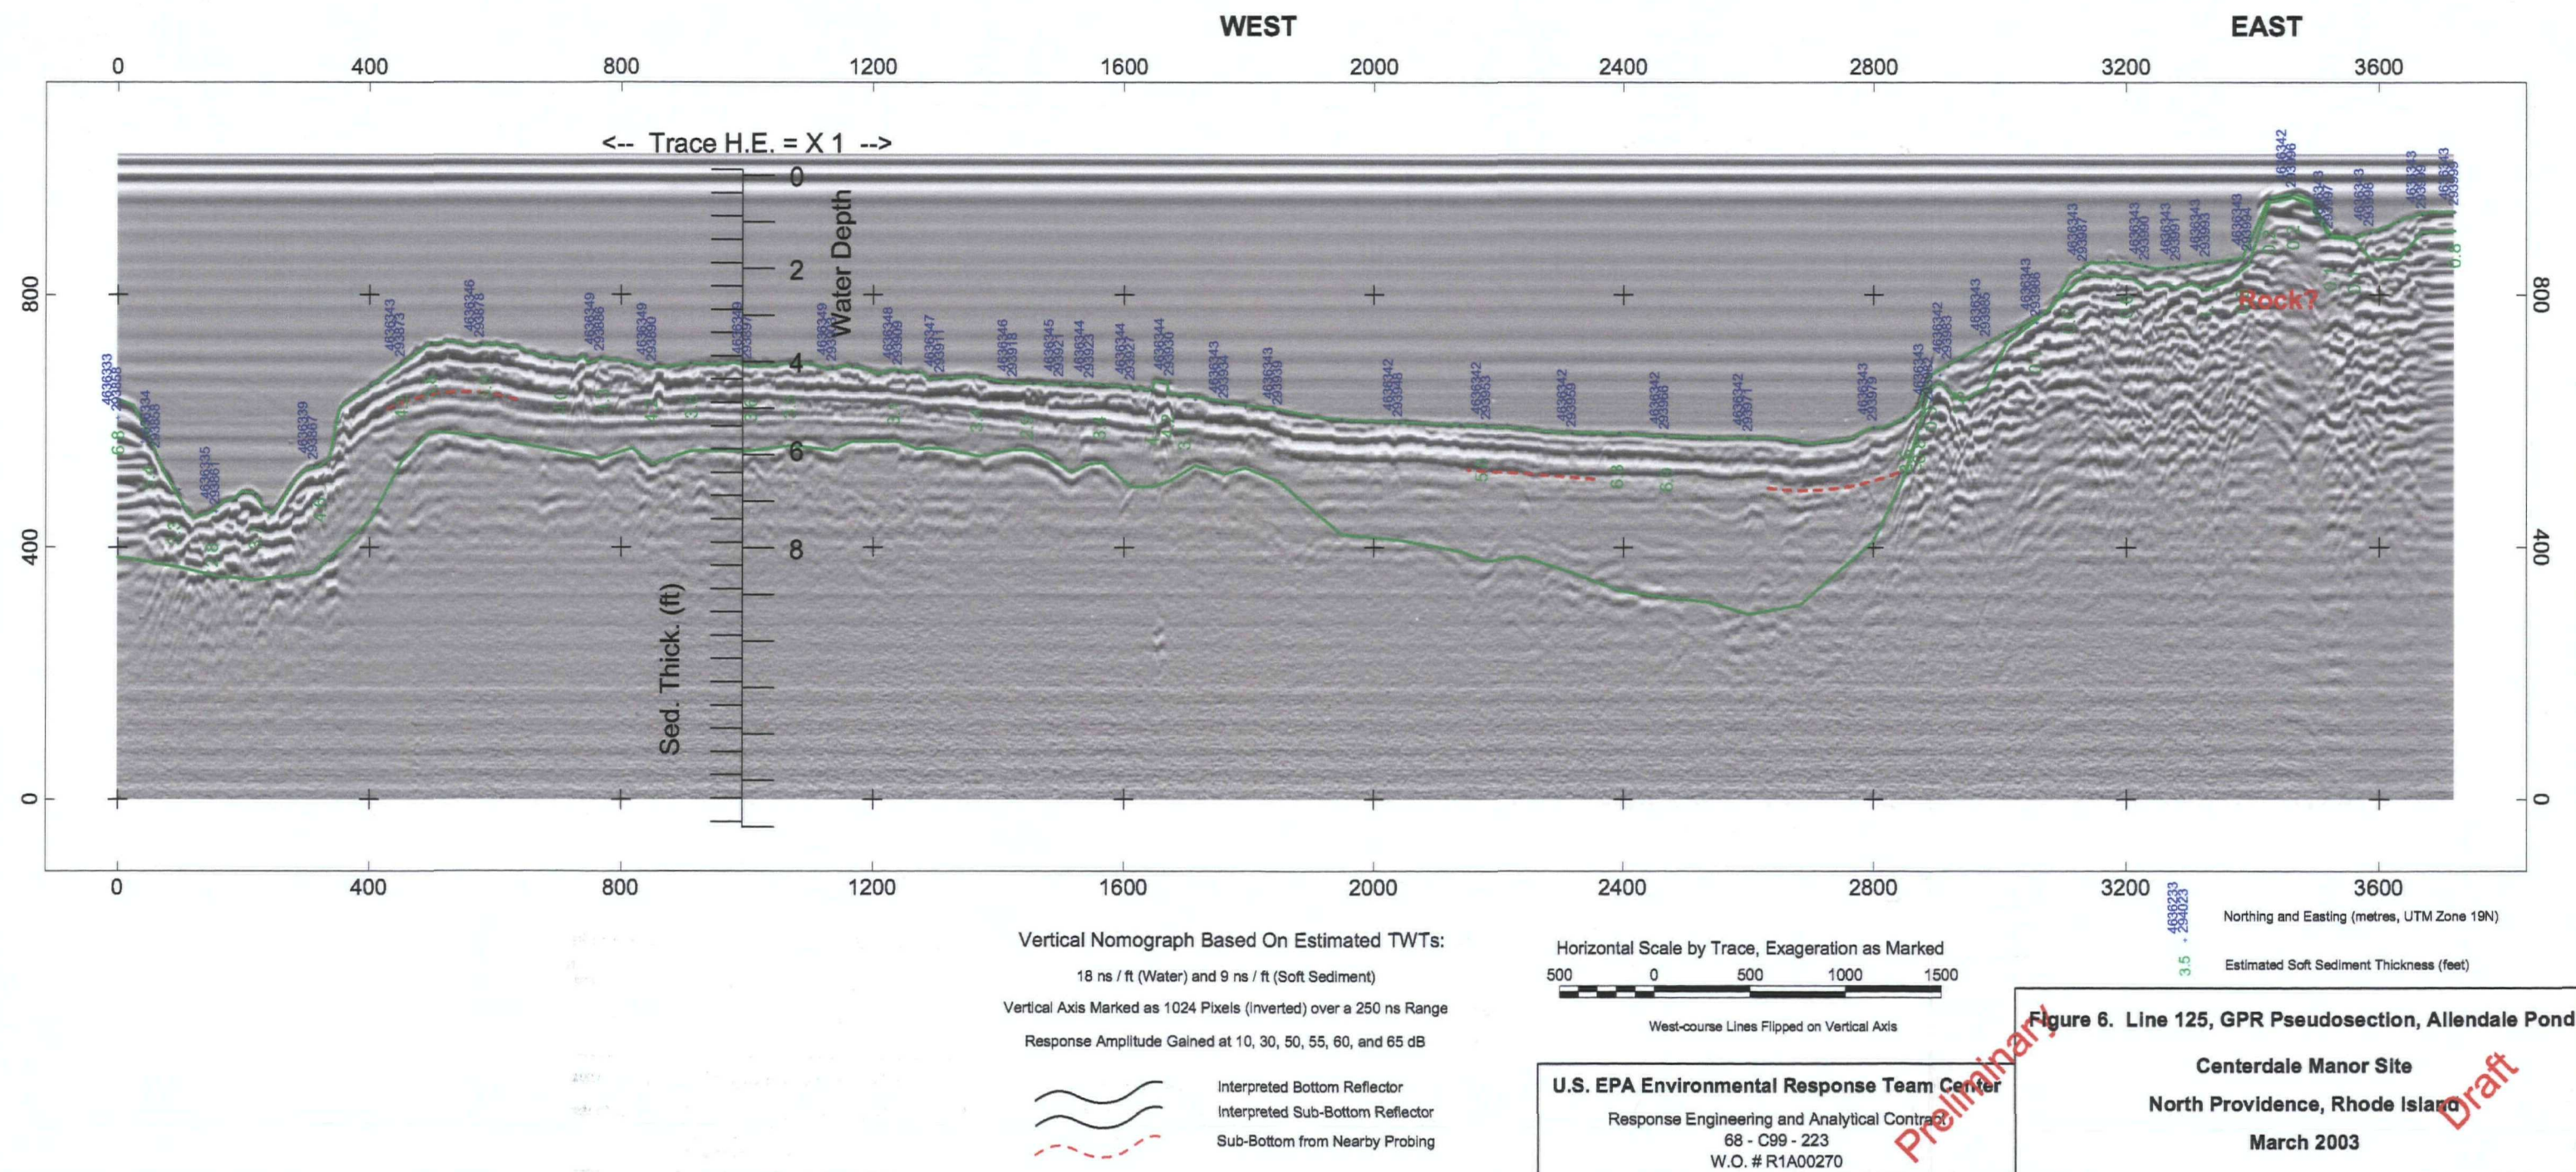
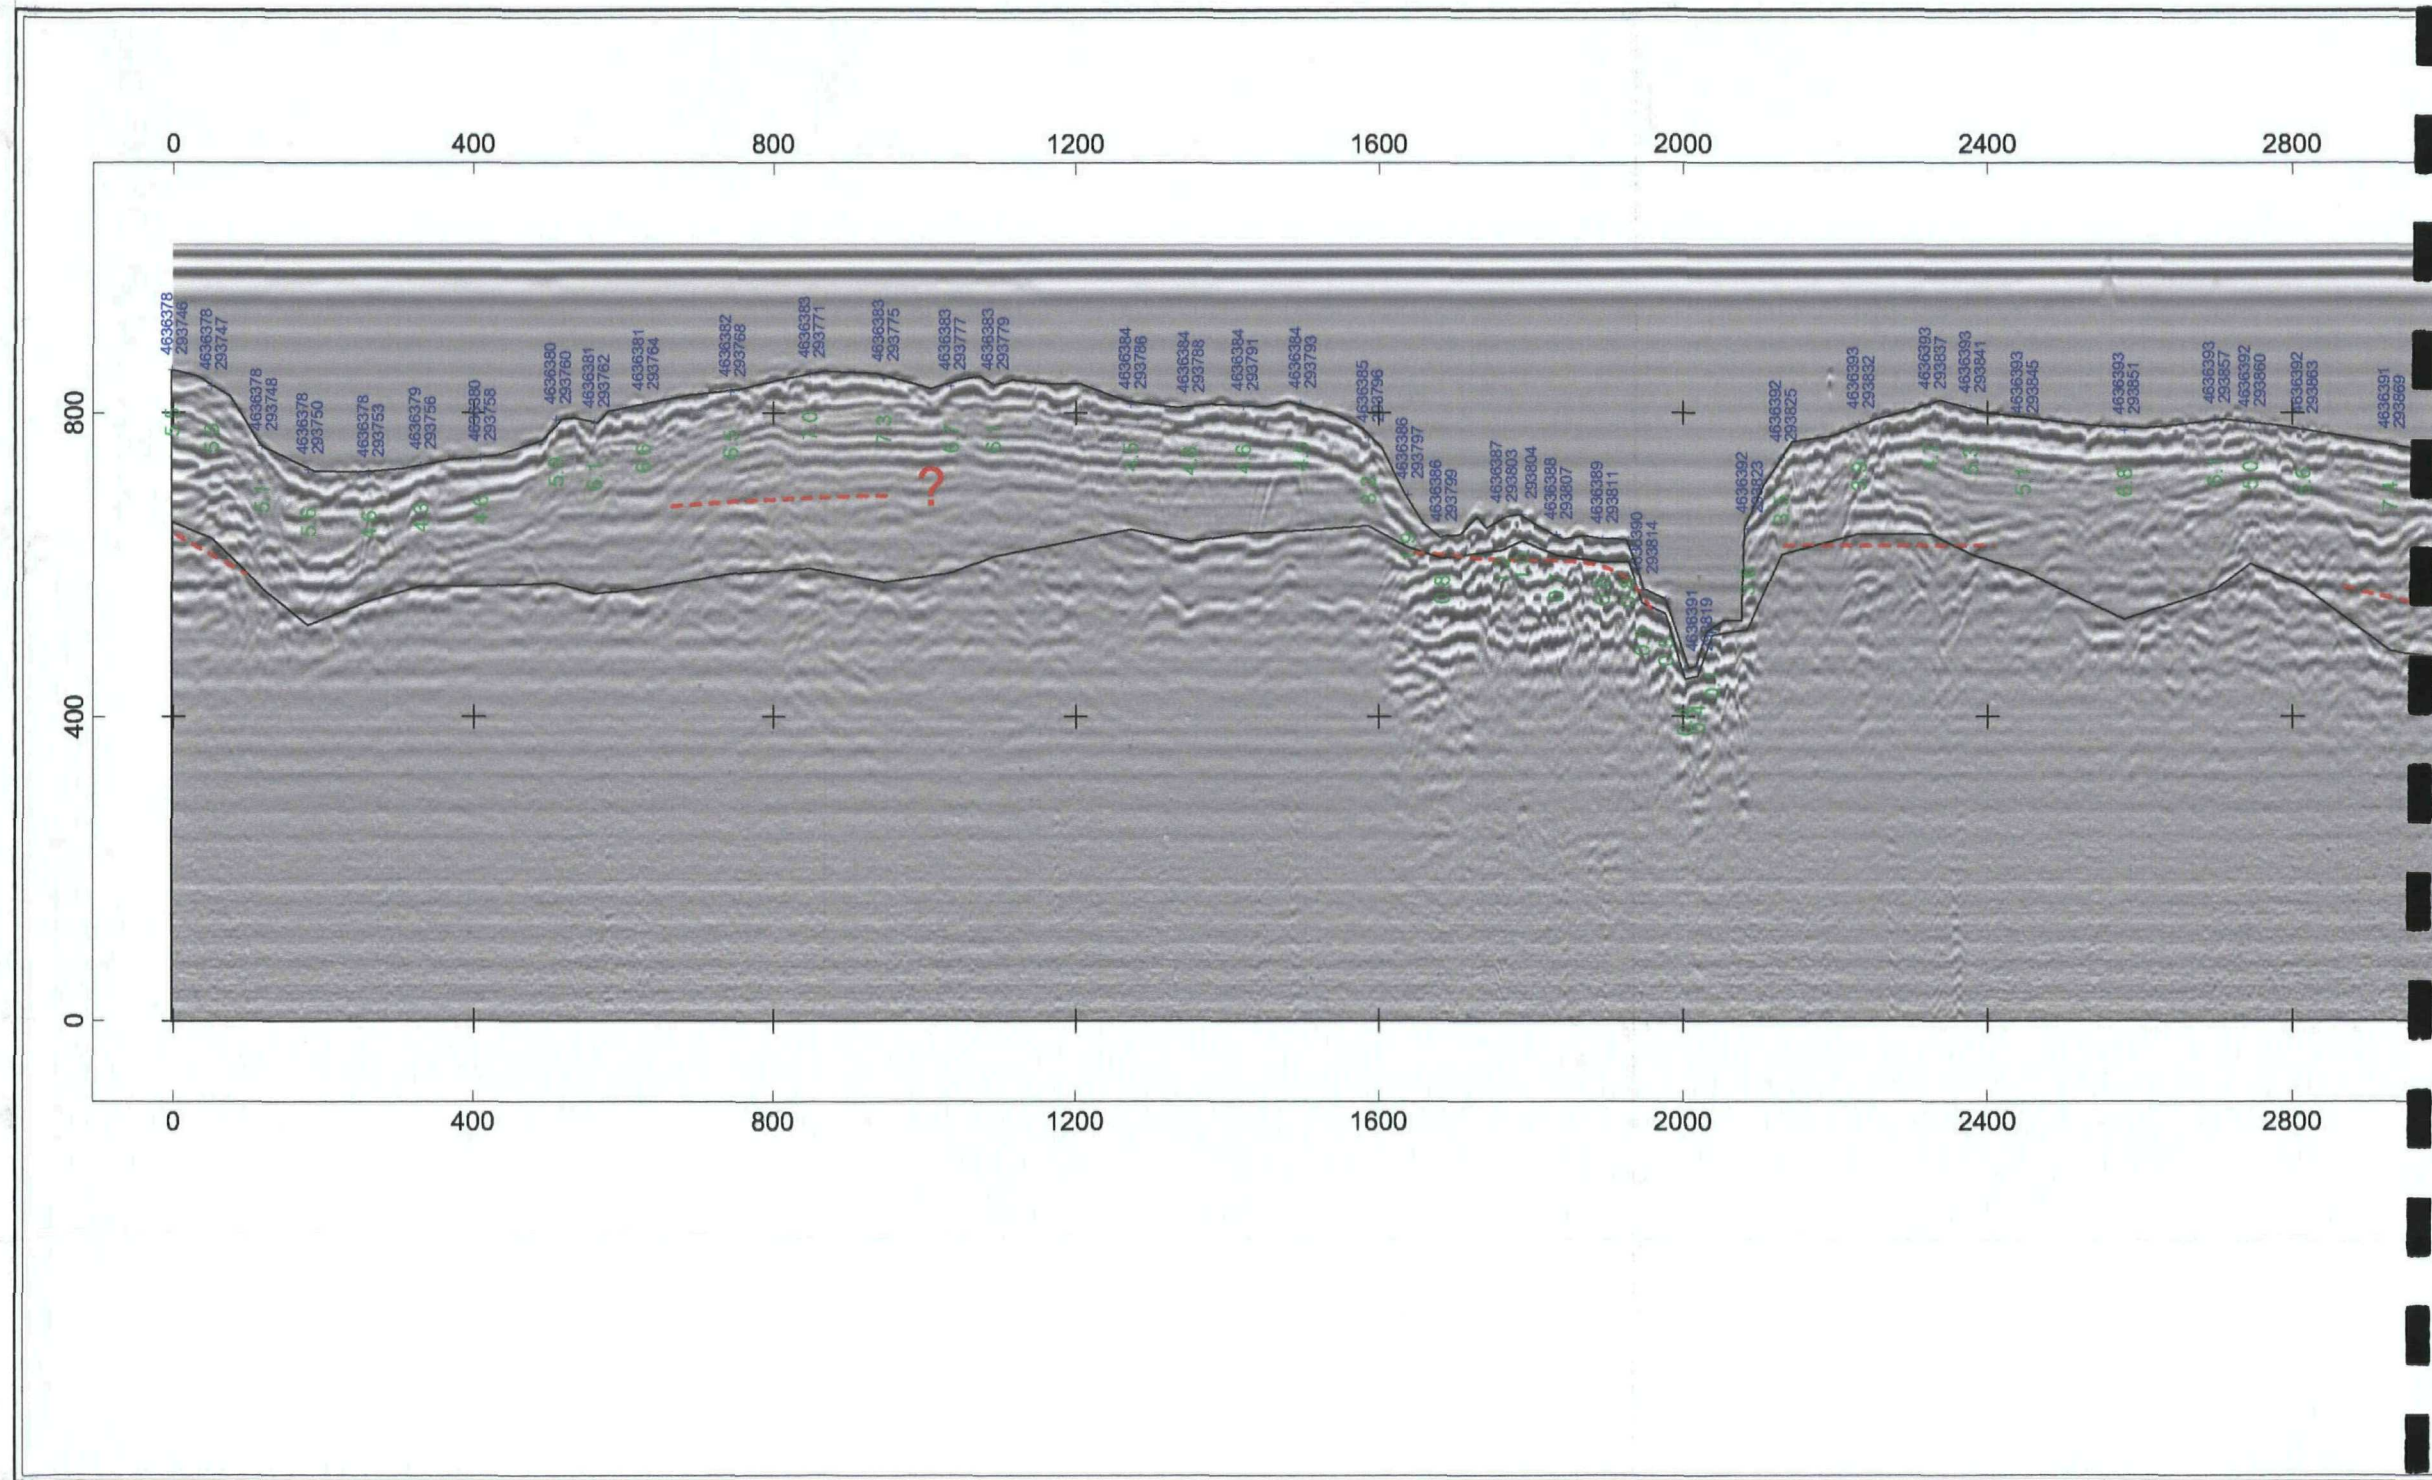
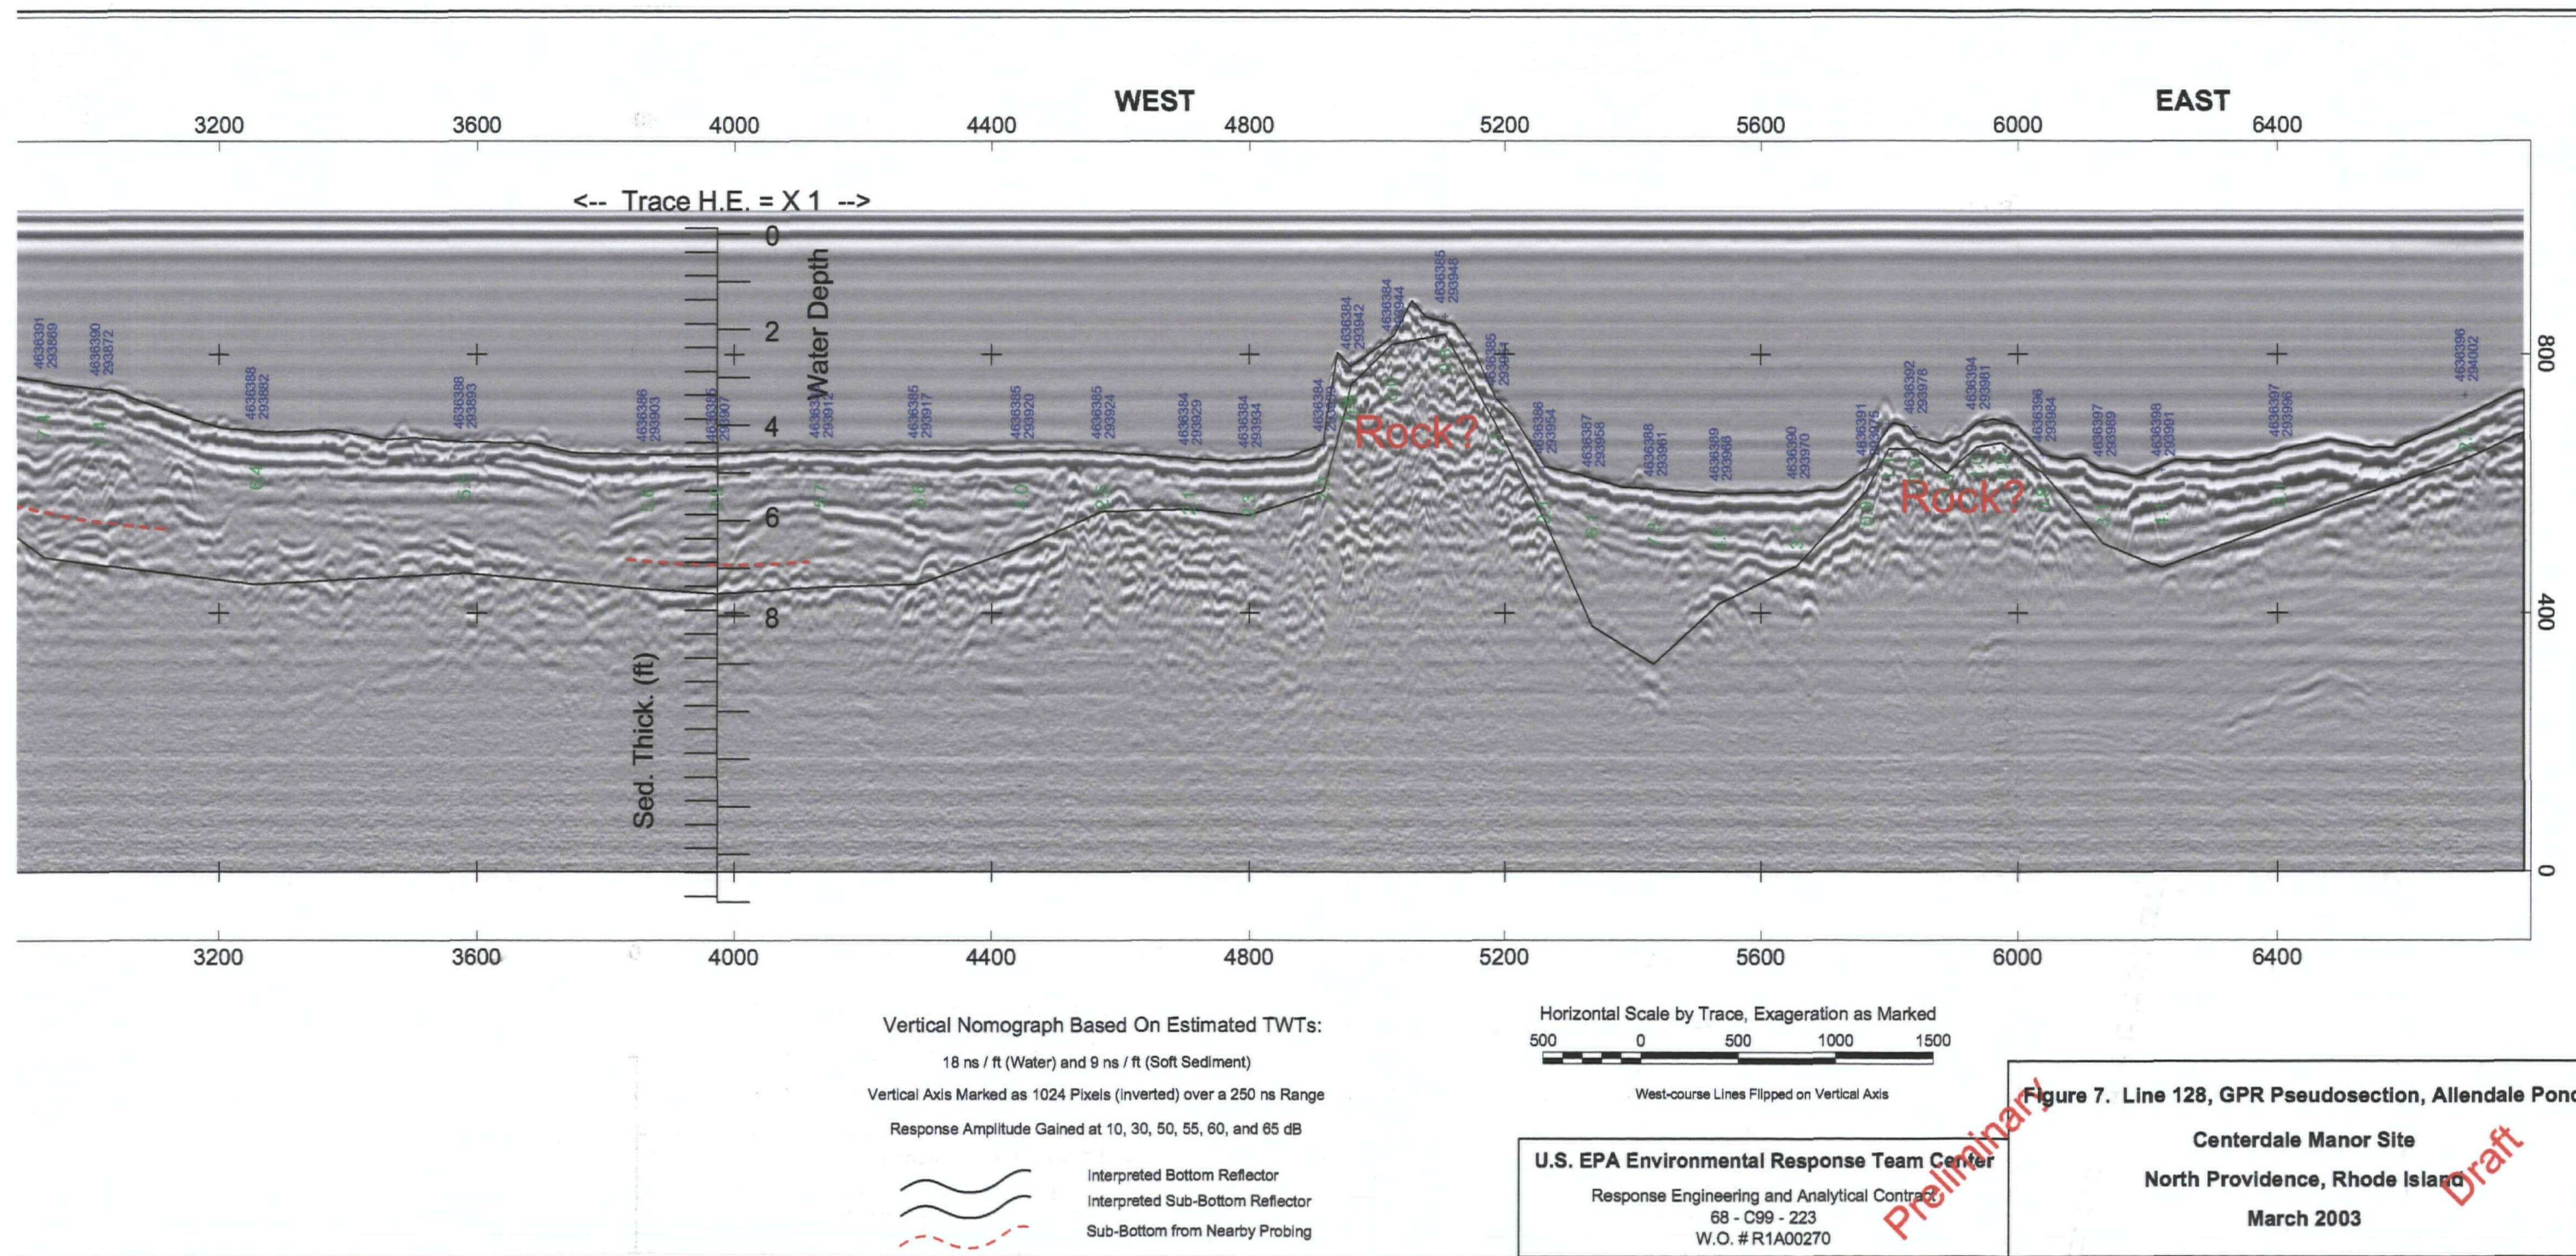
Thirty pseudosections were generated for the Allendale Pond (Appendix A, available by request). The pseudosections do not represent actual spatial relationships directly, although they may appear to graphically depict possible features of interest (eg. Figures 5, 6, 7, and 8). Such features may include pockets of soft sediment, paleo flow channels, cross bedding, pinching and thickening of certain strata, and possible chronostratigraphic relationships across many areas.

Features of interest in the pseudosections, which may require further investigation such as sediment coring, must be spatially located using the UTM coordinates posted directly above (eg. Figures 5, 6, 7, and 8). This is necessary due to variations in transect direction, and in boat speed. The latter effect was most dramatic at the beginnings of lines where the boat was slow to reach cruising speed, or where the boat became stuck, and resulted in suspiciously uniform and horizontal stratification. Small features that occur between UTM postings must be located using an interpolation between both northings and eastings. Similarly, depth and sediment thickness can be measured at any location using the nomograph provided. Due to the wide line spacing, the pseudosections appeared to indicate more detailed features than the plan view compilations.

The GPR pseudosections appeared to indicate several different depositional environments. These included migrating point bars (and associated scour channels), basin-like pools, and small isolated pockets. On some pseudosections, depositional features may represent very focused coring targets. The apparent layering may also have chronostratigraphic significance.

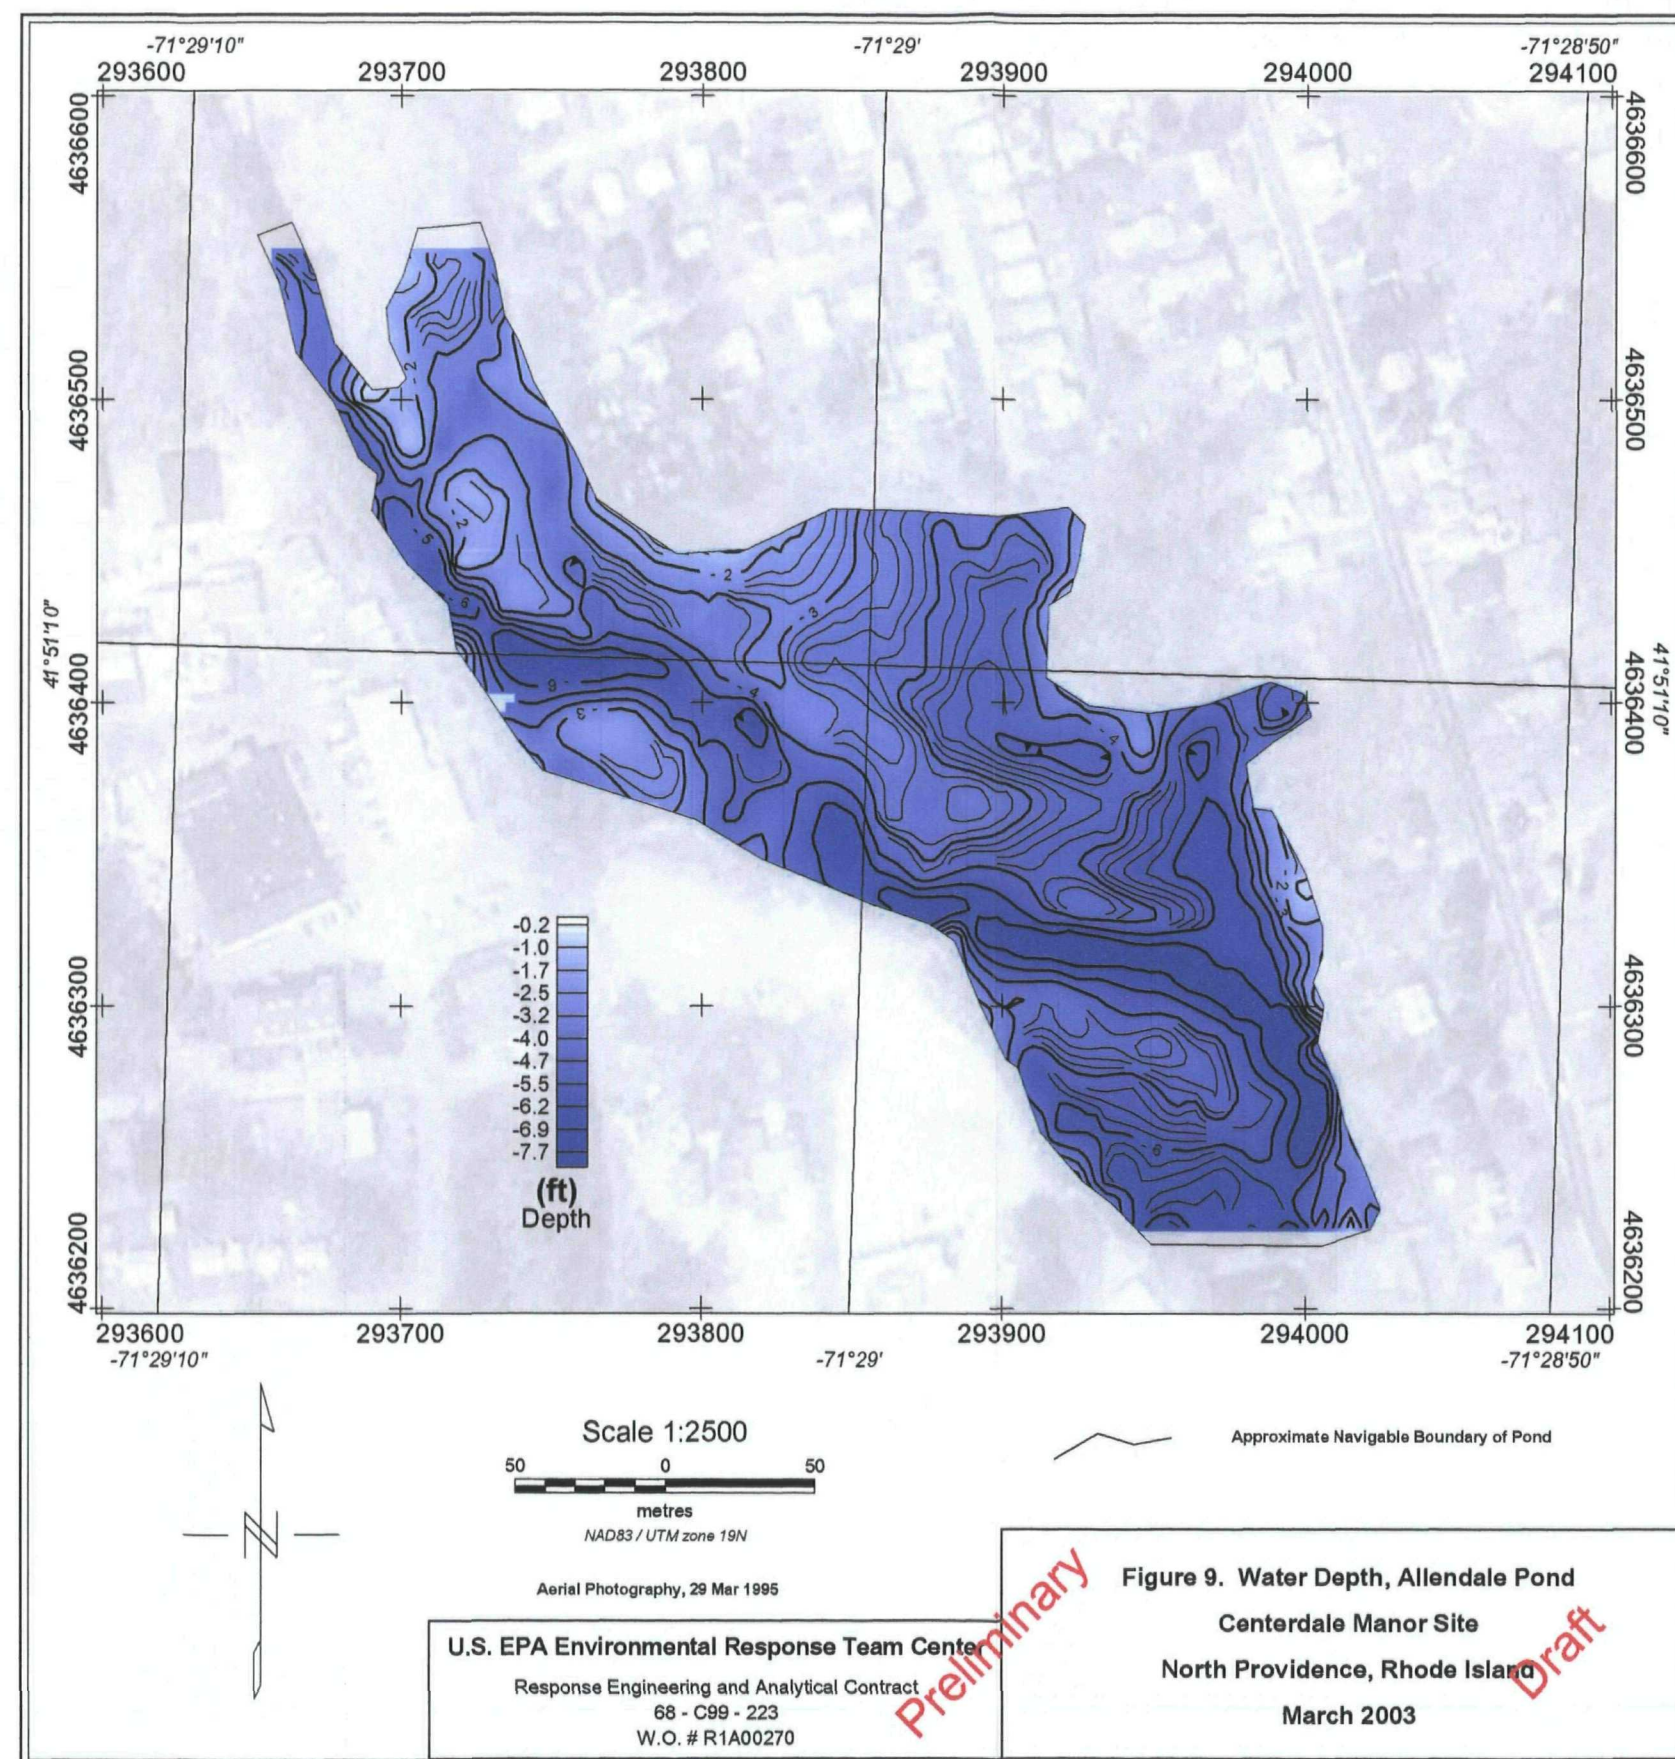
Plan view maps were compiled using interpreted water depth (Figure 9) and sediment thickness (Figure 10) at selected positions from each section. The water depth contours indicated one main flow channel that appeared to have cut into the bottom of the pond. Possible smaller tributary or paleo flow channel scars were also indicated. The sediment thickness contours indicated several areas where the greatest accumulations may have occurred. Generally, thick sediments appeared to occur away from the present flow channel, where the water depths were shallow. However, thick sediments also appear to be coincident with deep water in southern parts of the pond.

The resultant bathymetric and soft sediment thickness isopach maps appear to have large features that cross several transects. Features such as long paleochannels and large accumulations of sediment may represent general coring targets. However, unfavorable ground or hazards to coring, such as rock, may exist between the transects where no data were collected.
