RE: Phase I Environmental Site Assessment  
Town of Cumberland Tax Assessor's Map Plat 14, Lots 2 and 4 and Plat 15, Lot 1  
Cumberland, Rhode Island

**Phase I Environmental Site Assessment  
Plat 14 Lots 2 and 4, Plat 15 Lot 1  
Berkeley Commons/River Run Development  
Cumberland, Rhode Island**

June 2003  
Version: FINAL  
EA Project No. 61776.01.0001

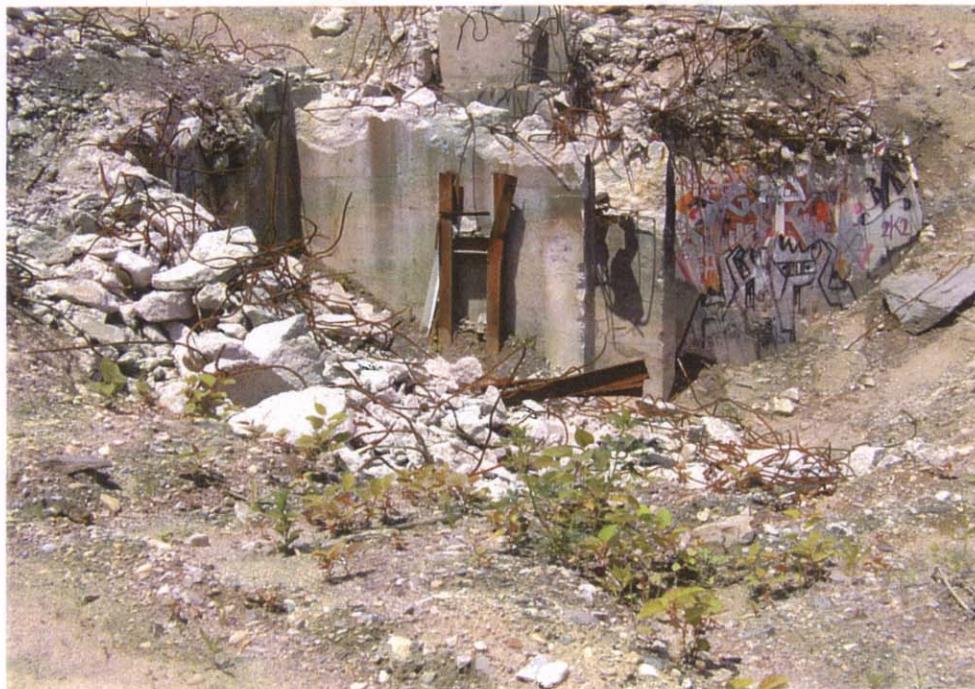
Photo 1: Remnants of the reinforced concrete material crusher foundation.

There are currently no buildings on the site. On the Plat 15 side of the development, site development was limited to a reinforced concrete base for the material crusher (Appendix A, Photo 1) and a scale house. On the Plat 14 side of the site, the Admiral Inn (since demolished) was located on the eastern site portion, abutting Mendon Road. This structure was not part of the sand and gravel operations, and the lot was transferred to the current site owner in 1993. Aerial photographs from 1939, 1951, 1965, 1972, 1972–1974, 1981, and 1992 all show no additional development on the site.

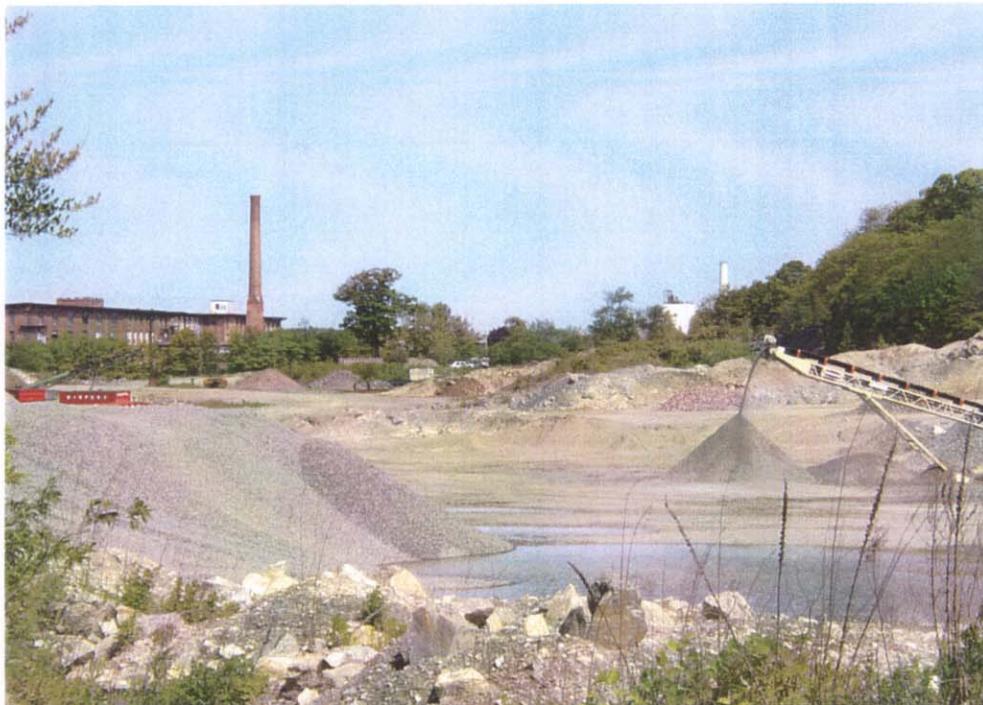
Photo 2: The sand and gravel mining operation to the southwest of the site. Industrial development along Martin Street can be seen in the background.

The site is in an area consisting primarily of residential development. Sporadic commercial development exists to the north along Mendon Road. Abutting the site to the south/southwest is a sand and gravel mining operation (Appendix A, Photo 2). Further to the north is an area of concentrated industrial development along Martin Street (Appendix A, Photo 2).

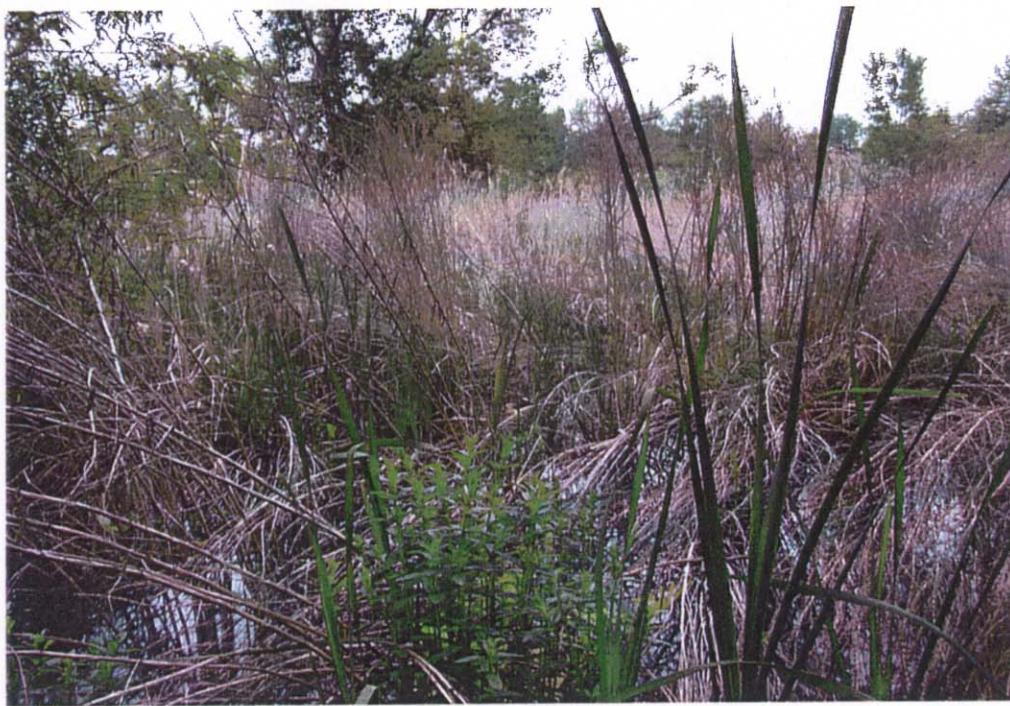
Photo 3: Vegetation in wetland south of the site.

The site is located in the Town of Cumberland, Providence County, Rhode Island. The site is located on locally variable terrain approximately 115 ft above mean sea level. According to the Federal Emergency Management Agency flood insurance rate map, the southern portion of the site is located within the 100-year flood zone. Drainage patterns in the area of the site are generally to the south and southwest, toward wetlands and New River. National Wetlands Inventory maps indicate wetlands on the site (Appendix A, Photo 3).

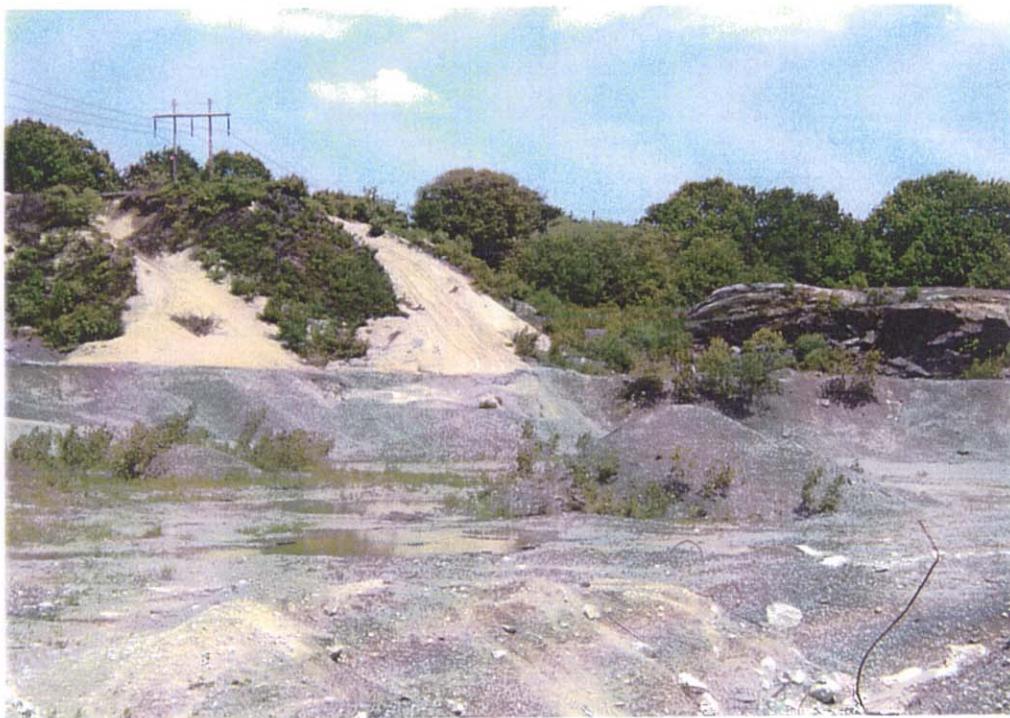
Photo 4: Topography created by sand and gravel mining operations. A bedrock outcrop can be seen on the right.

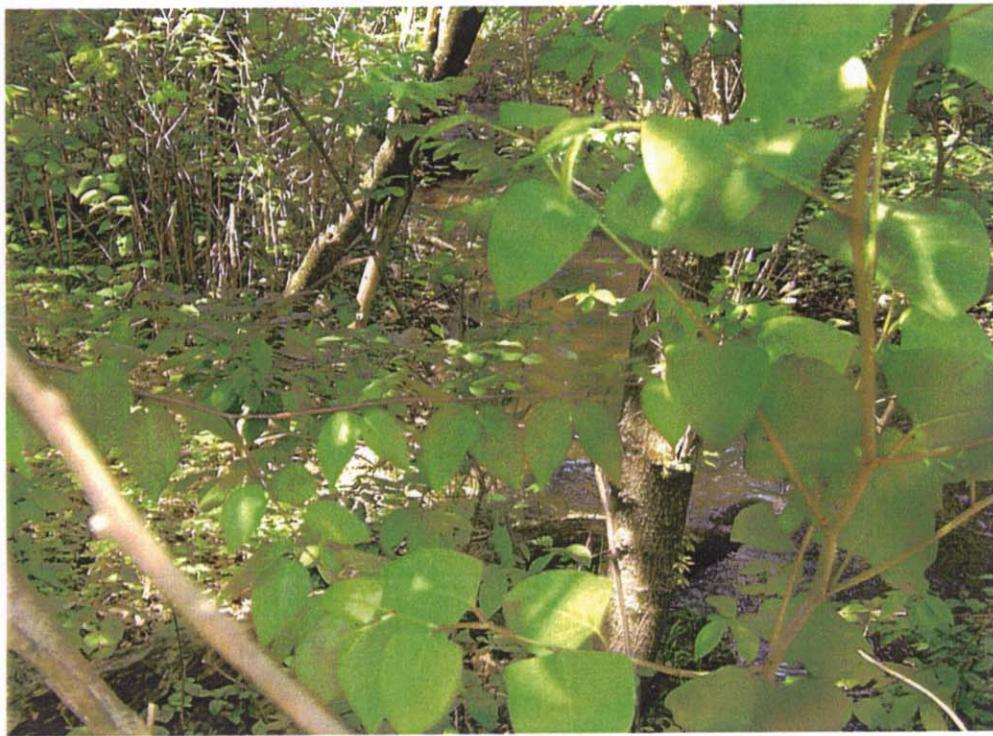
Photo 5: Monastery Brook just upstream of the culvert under the access road.

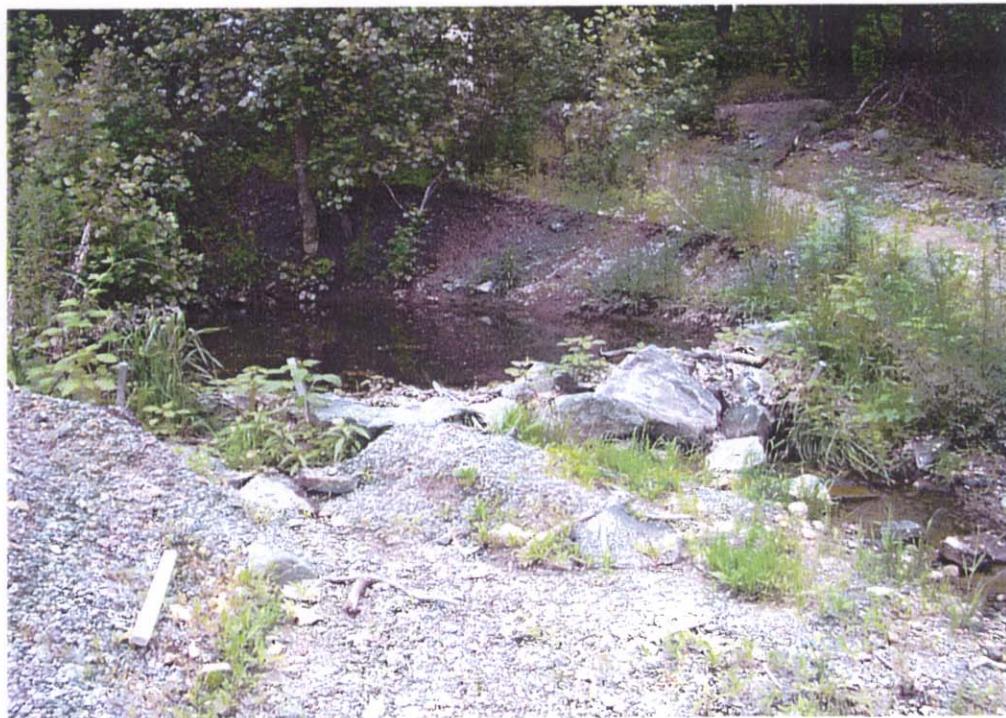
Photo 6: Retention pond for stormwater runoff from residential development to the north.

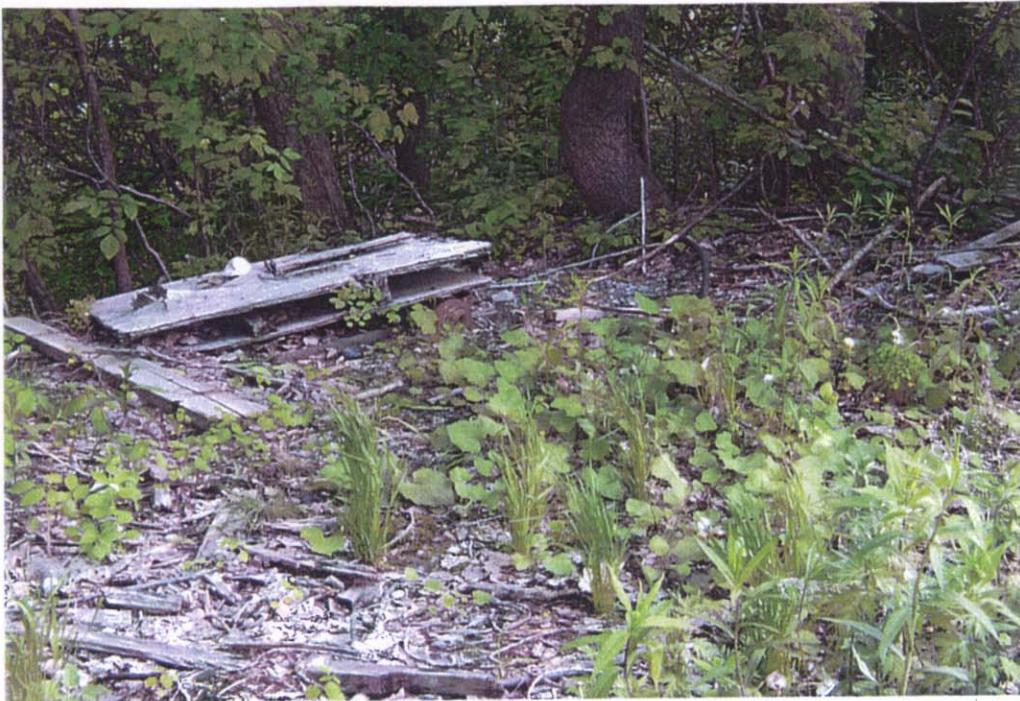
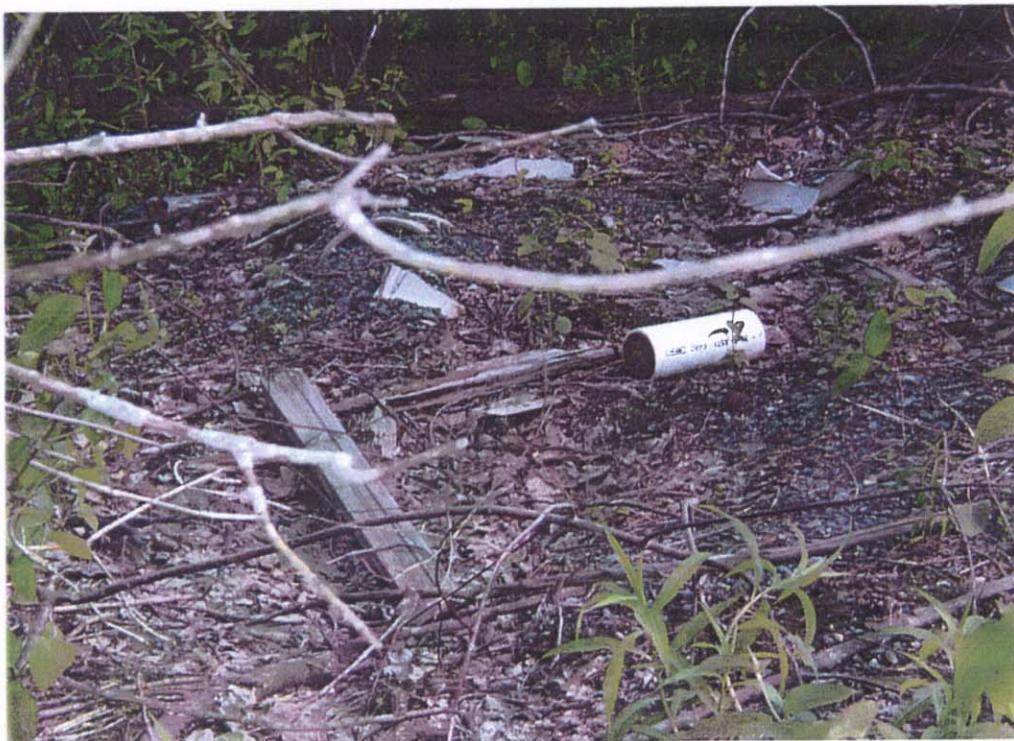
During the site inspection, isolated examples of small-scale solid waste dumping were observed at the site (Appendix A, Photos 7 and 8). No indication was found of environmental impacts from this non-hazardous waste disposal. The site representative indicated that this dumping was conducted without the knowledge or permission of the site owners.

Photos 7 and 8: Miscellaneous debris along southern edge of Plat 14.
