# FIELD INVESTIGATIONS OF UNCONTROLLED HAZARDOUS WASTE SITES

TDD # F1-8005-01E-03

**TASK REPORT TO THE ENVIRONMENTAL PROTECTION AGENCY  
CONTRACT NO. 68-01-6056**

SITE INSPECTION REPORT  
of  
JOHN J. RILEY COMPANY  
(A Division of Beatrice Foods)  
228 Salem Street  
Woburn, Massachusetts

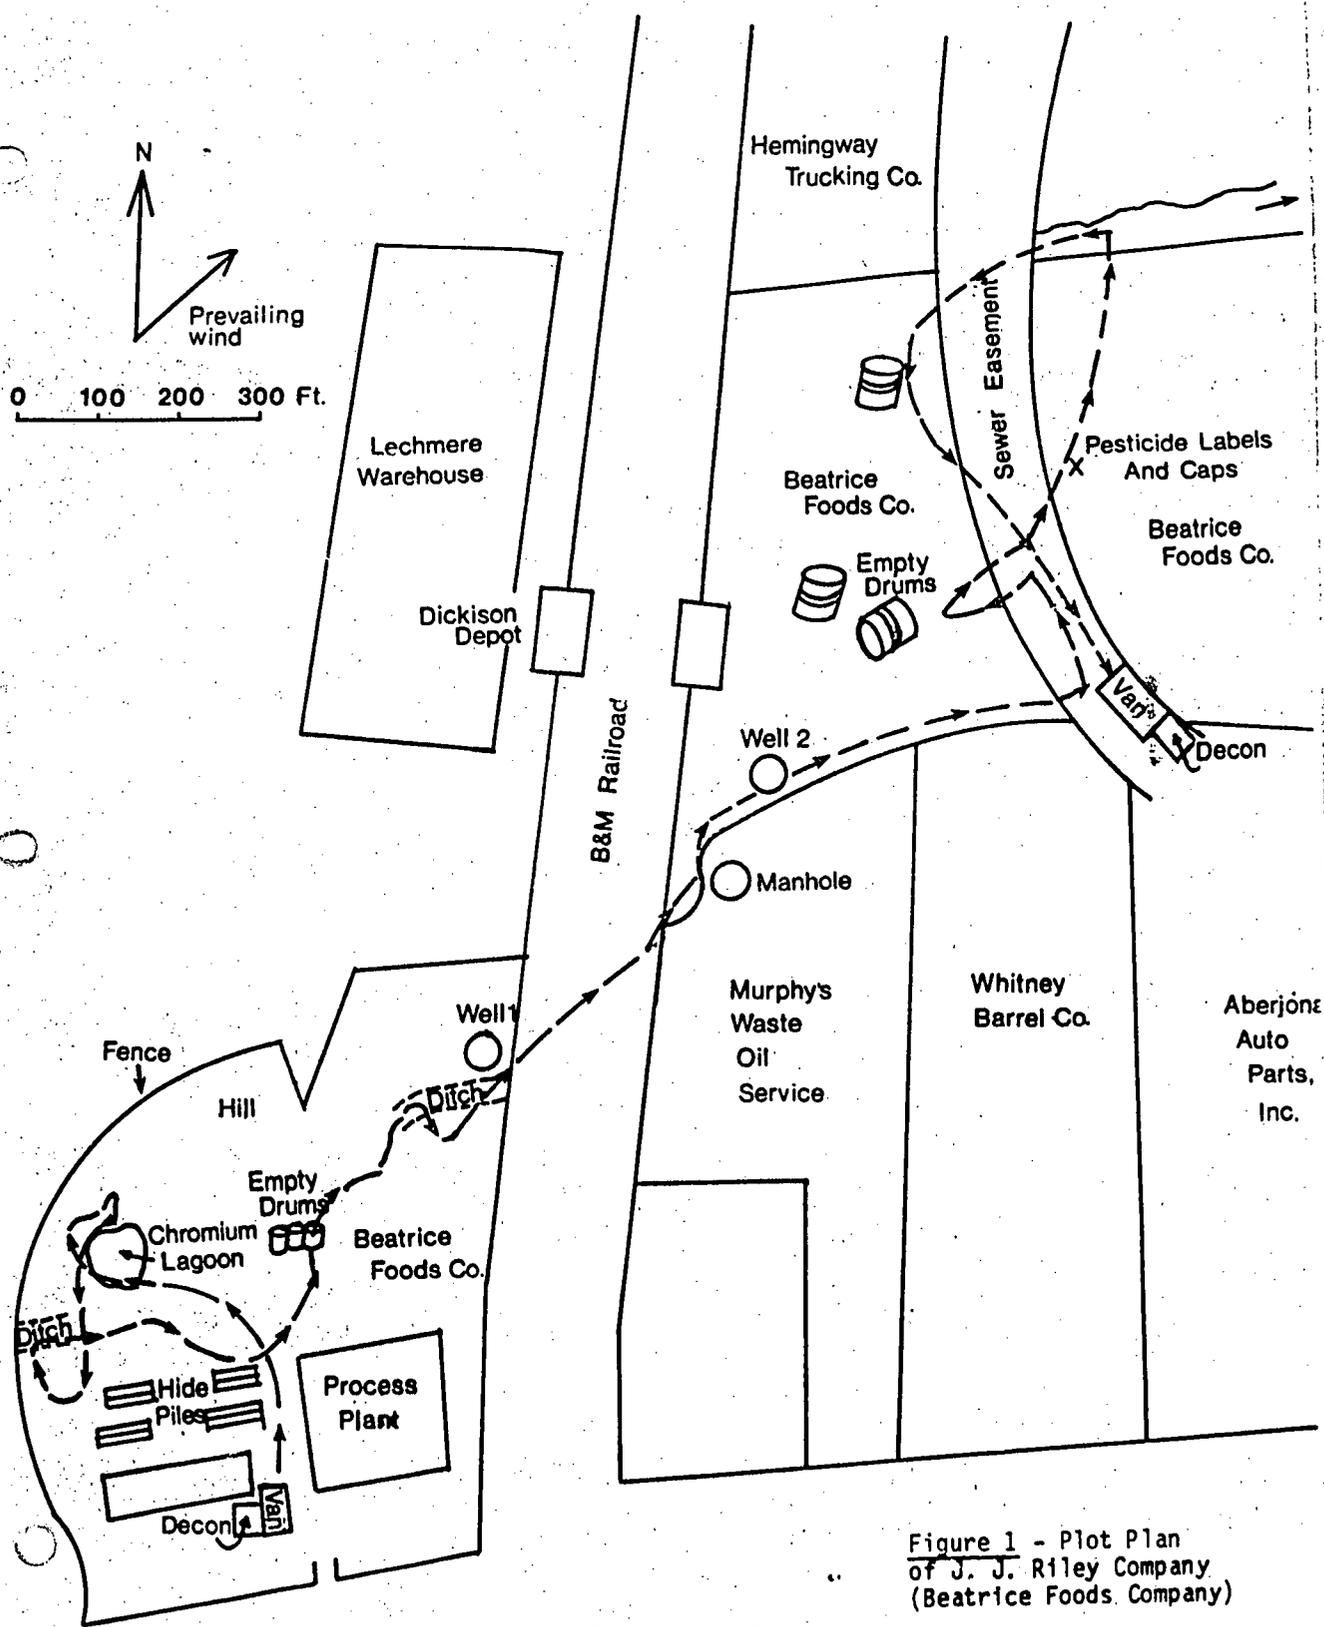
Figure 1 - Plot Plan of J. J. Riley Company (Beatrice Foods Company)

3.4.6 The following analysis of well #2 (See Figure 1) was obtained by Lori Fucarile (E & E) during an interview with Brian Kelleher, Division of Hazardous Materials, Massachusetts Department of Environmental Quality Engineering.

Figure 1 shows the location of the command post (van) and decontamination areas and the itinerary of the work party. No hot line was delineated because no "hot spots" were indicated either during the preliminary assessment or the site inspection. No logistical problems were encountered during the planning and performance of this site inspection.

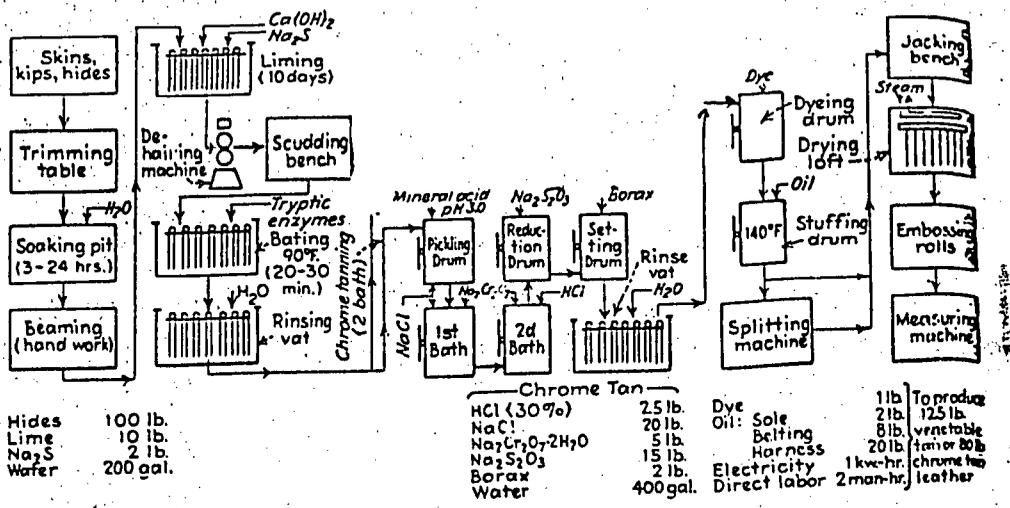
Figure 2: Flow Diagram of Chrome Tanning Process (Shreve and Brink, Chemical Process Industries, 1977)

3.2.1 Figure 2 is a flow diagram illustrating the chrome tanning process (from "Chemical Process Industries," Shreve and Brink, 1977).

3.2.2 Chrome Tanning Procedure. The following steps are involved in the chrome tanning procedure.

The skins are opened, examined, trimmed and graded. They are then water-soaked with sodium tetrasulfide and surfactants to hasten hydration. Hides may be stored after brine or salt curing and subsequently soaked and washed before using.

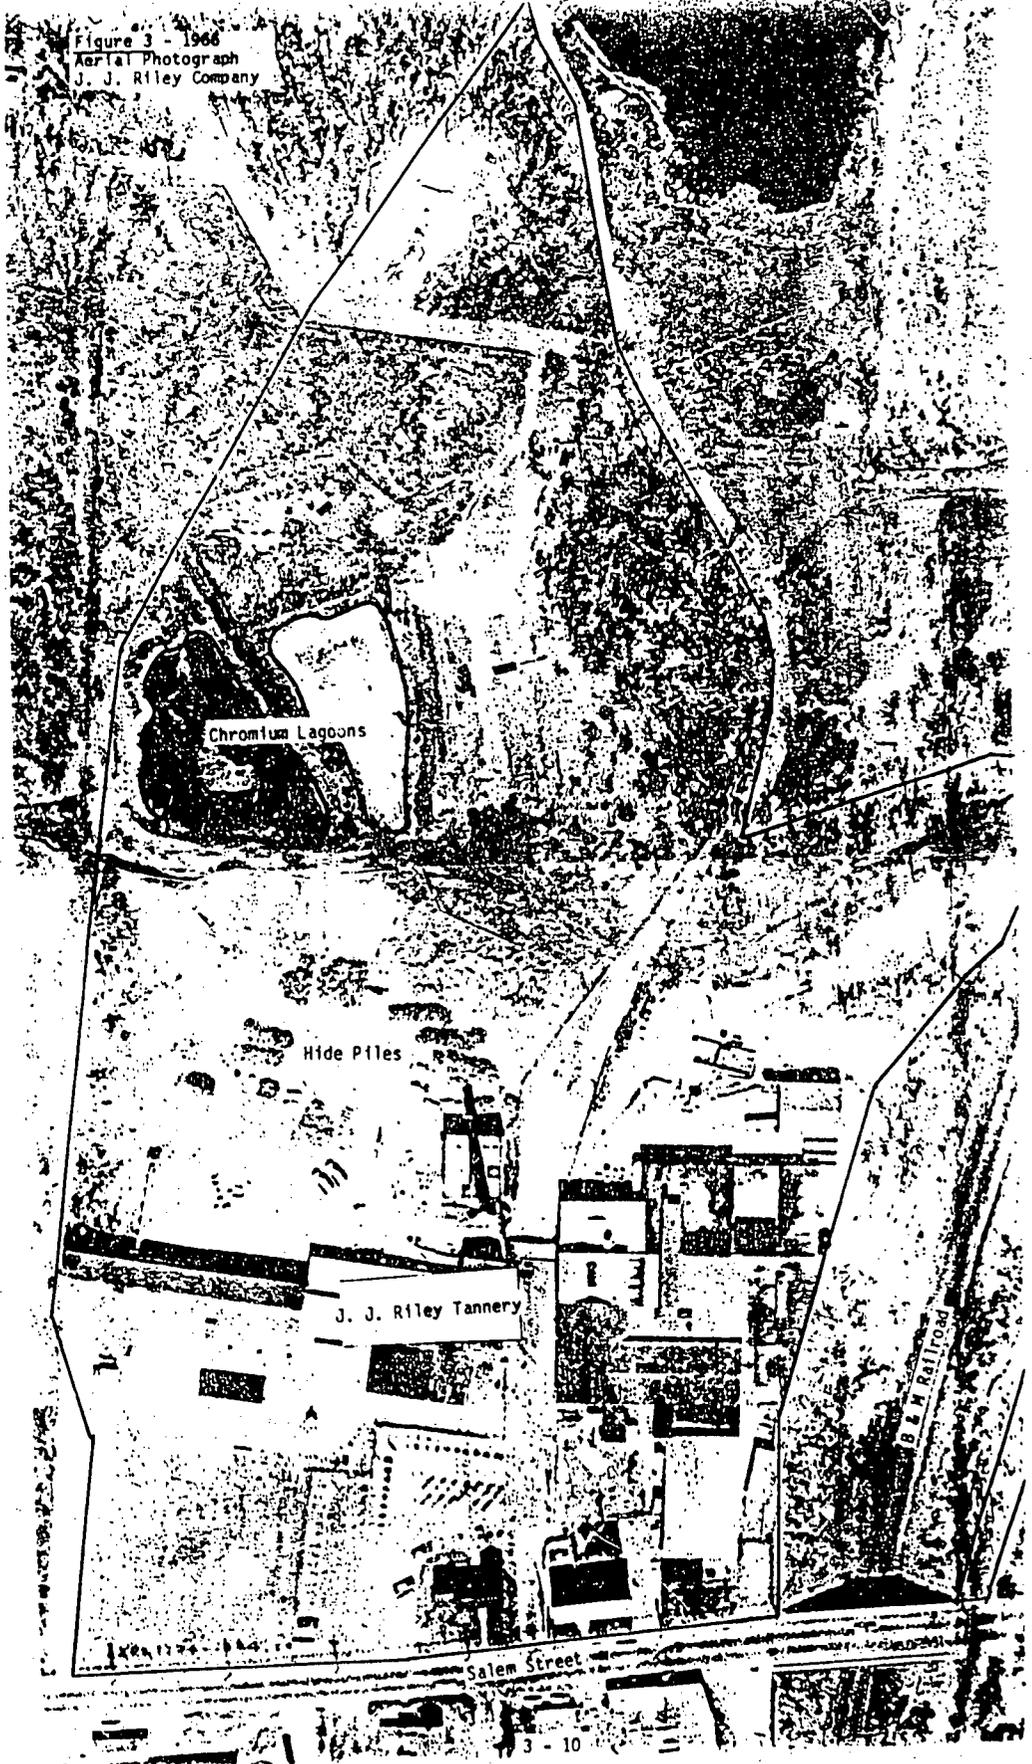
Figure 3 - 1966  
Aerial Photograph  
J. J. Riley Company

3.4.5 According to the May 13, 1980 DEQE investigation of the J. J. Riley Company, two chromium lagoons (See Figure 3) are located in a swampy area to the northwest of the paved area. At the time of the DEQE visit, the lagoons were partly covered with a "dirty, white, foamy substance of unknown origin". During this site investigation, one small four foot by seven foot area of standing water was present in the chromium lagoon area. The lagoon had a white crusted top, and the area surrounding it was densely vegetated. According to John Riley, chromium and benzidine dye wastes were dumped in the lagoons until ten years ago when use of the dyes was discontinued. The site inspection indicated no evidence of recent use of the lagoons. However, the lagoons pose a potential hazard from leaching of materials into the groundwater. Analysis of the well water samples should indicate if this has taken place.

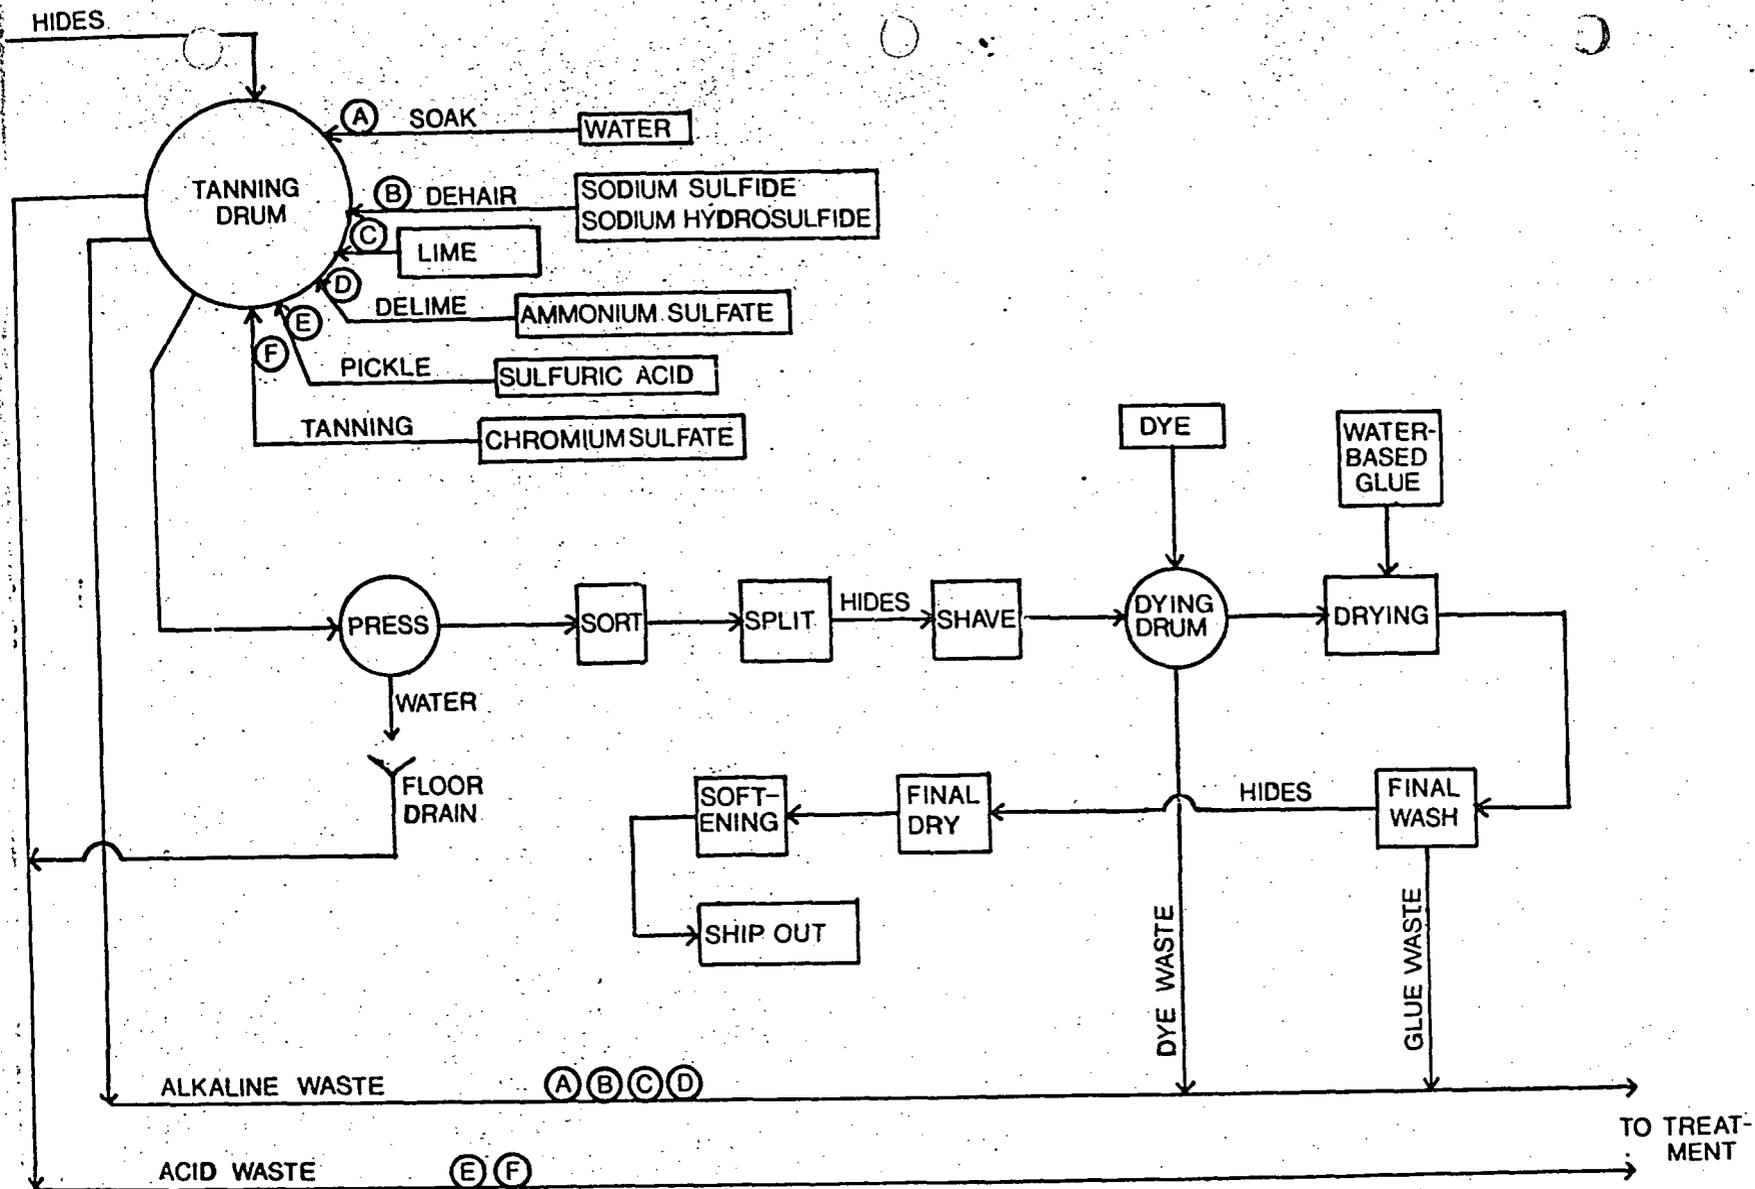
Figure 1A: Chrome Tanning Process  
 Mohawk Associates  
 Nashua, New Hampshire

Figure A1 is a flowsheet of the tanning process used by Mohawk Associates.

The cow hides brought into the tannery are prefleshed, pretanned and pregraded. Thus, there are virtually no scrap wastes from the pretanned skins. These hides are brine cured and stored.

1. The hides are soaked in water.
2. Sodium sulfide and sodium hydrosulfide are added to "burn the hair" or dehair the skins. This process water is drained and enters the alkaline wastewater stream (described later).
3. The skins are "limed" with calcium hydroxide. This process water is also drained and enters the alkaline wastewater stream.
4. The deliming procedure takes place with the addition of ammonium sulfate into the drum. This process water is drained and enters the alkaline wastewater stream.
5. The chrome tanning process begins with the "pickling" of the hides by the addition of sulfuric acid.
6. The hides are tanned with chromium sulfate. This combination process water enters the acidic wastewater stream.

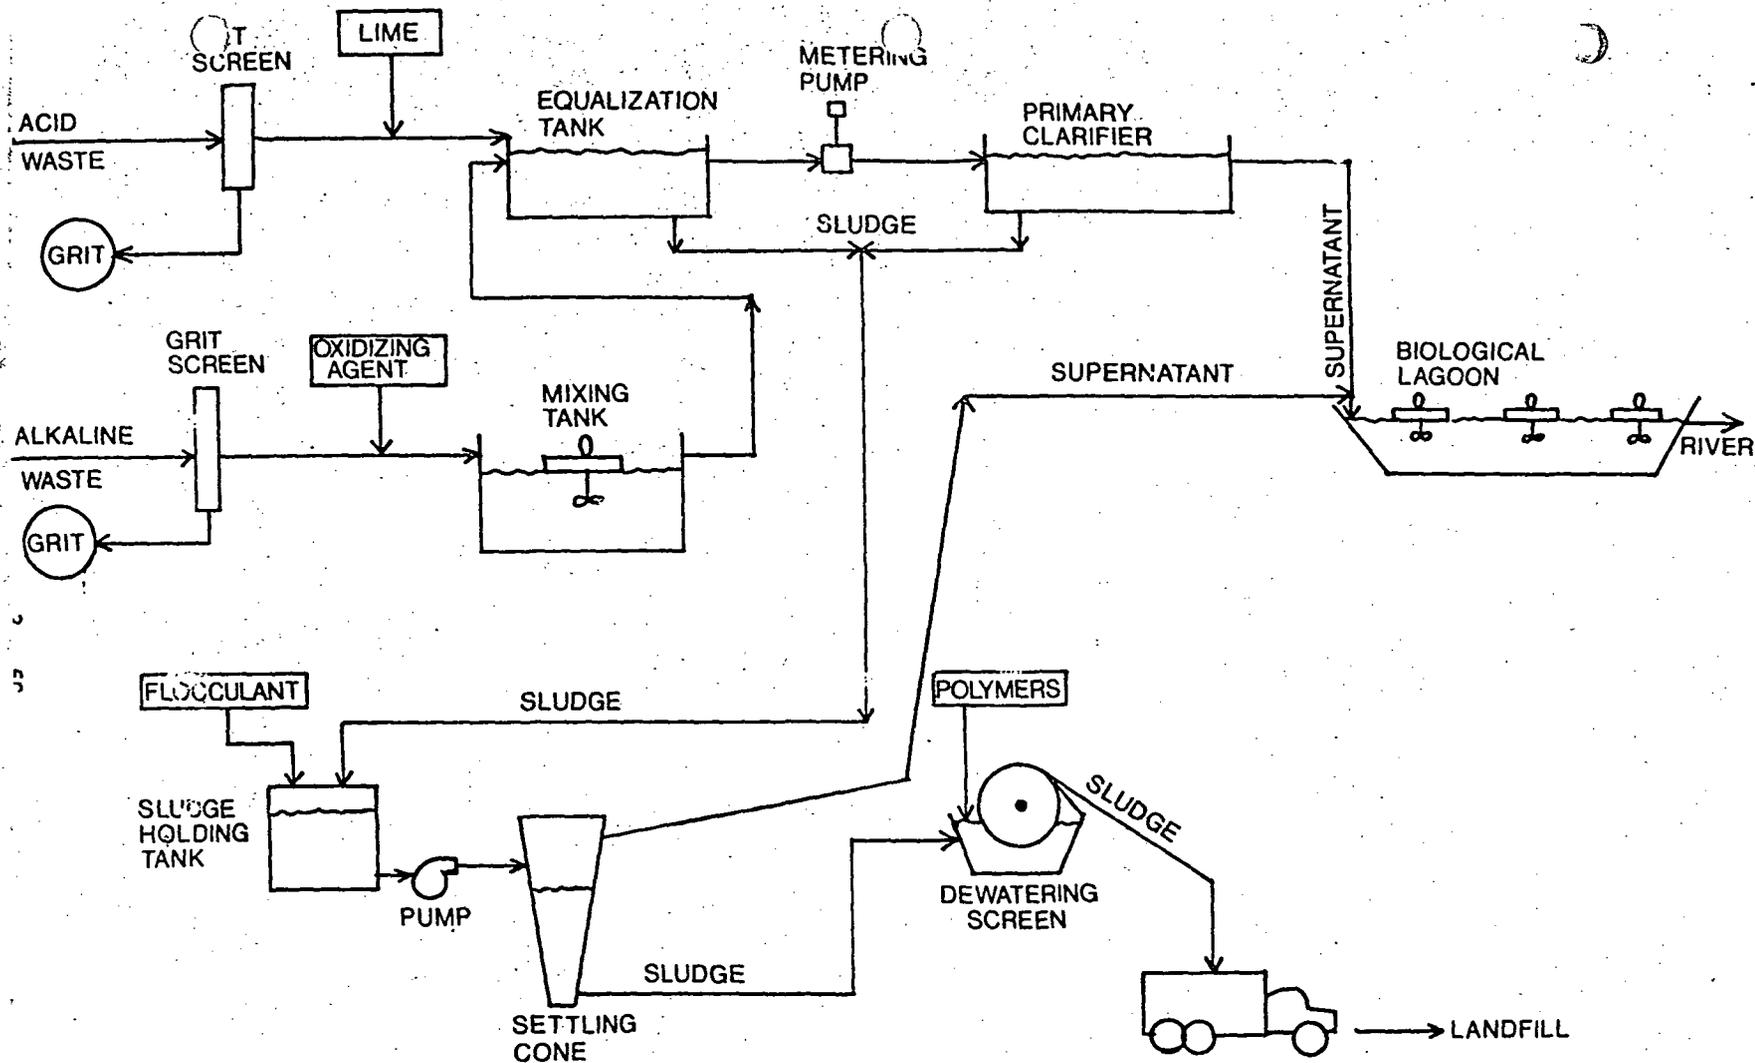
Figure 2A: Wastewater Treatment Process  
 Mohawk Associates  
 Nashua, New Hampshire

The acid waste stream proceeds through a grit screen which removes debris (cans, scraps, etc.) which is subsequently removed by a hauler. The pH of this stream is raised in an equalization tank from 4-5 to 10 by the addition of lime. This causes the chromium to settle to the bottom of the equalization tank.

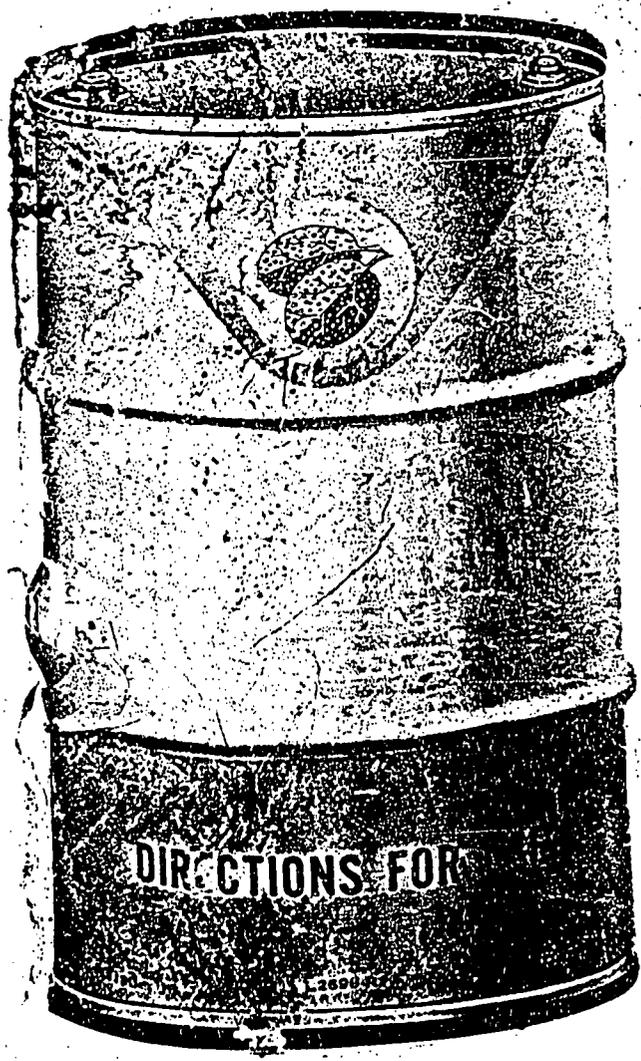
Figure D-1  
Malathion LV  
Concentrate Label  
Found on J. J. Riley  
Company Property

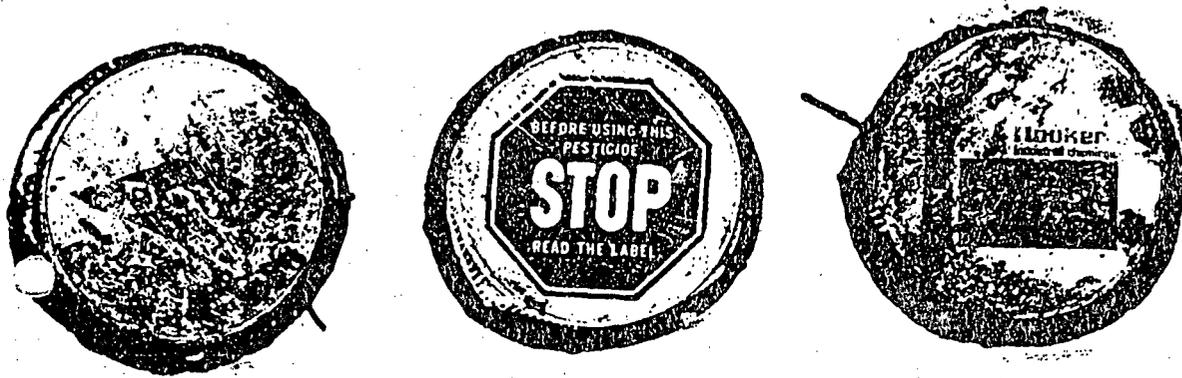
- 1135 - Work party discovers approximately one-hundred pesticide caps (See Appendix D) across the B & M tracks from Dickison Depot. Soil auger used; OVA reading 0 ppm.

Figure D-4  
Pesticide Caps  
found on J. J.  
Riley Property
