[EPA Region 10 Dive Team](http://www.epa.gov/region10/dive)

Investigation of Petroleum Spill, Duwamish East Waterway, April, 2012

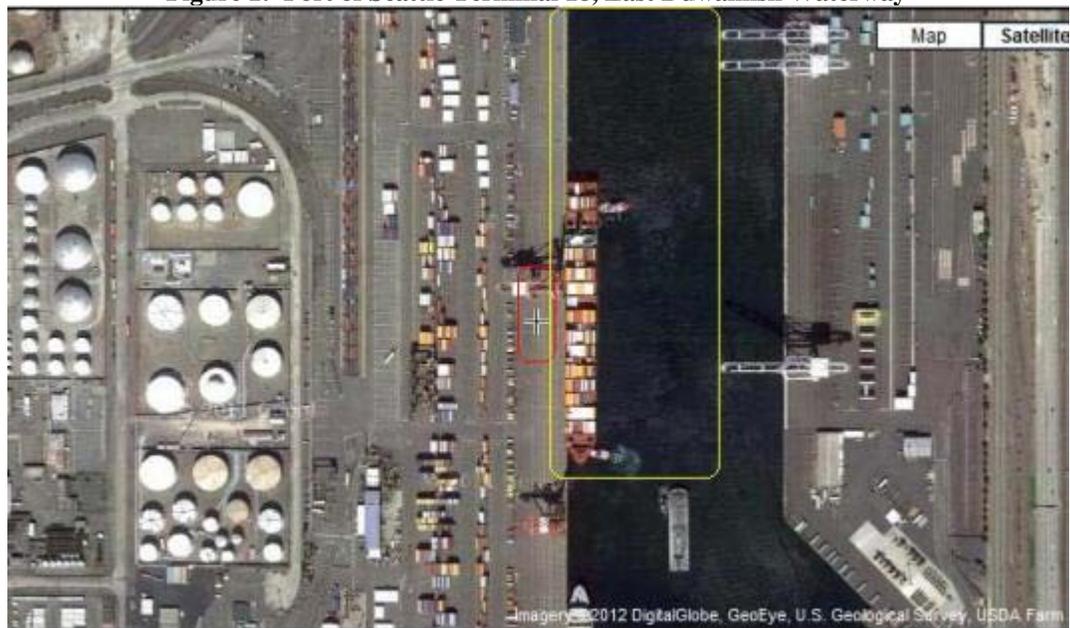
Figure 1: Port of Seattle Terminal 18, East Duwamish Waterway

What: On March 9, 2012, a petroleum spill occurred at the Port of Seattle's Terminal 18 located on the east side of Harbor Island (Figure 1). The material spilled was a substance referred to as "S-7079 Mining Intermediate" which is a light, white colored petroleum distillate with a specific gravity of 1.0. An estimated 3,000 to 4,000 gallons of this liquid was released from a container, and entered the East Duwamish Waterway through a series of six drains located on the dock. Both the U.S. Coast Guard and the Washington Department of Ecology responded to the spill.

How: Execute a visual and photographic survey of the bottom sediments in the vicinity of Terminal 18 to determine if there are obvious residual effects from the March 9 petroleum spill such as staining or free product. The area outlined in yellow on Figure 1 represents the approximate survey area for this dive operation. Water depths in the East Duwamish Waterway adjacent to Terminal 18 are between 55 and 60 feet. In order to determine if gross concentrations of petroleum (i.e., free product or sediment staining) are present that have contaminated the sandy bottom sediments of the marine cap, visual and photographic surveys were conducted along five, north-south transects, each approximately 200 feet in length and separated by about 25 feet. Each transect was centered on the cross-hairs shown on Figure 1 which represents the location of the spill. The western most transect was located immediately adjacent to the Terminal 18 pier (Figure 2), with the eastern most transect approximately 100 feet out into the channel.

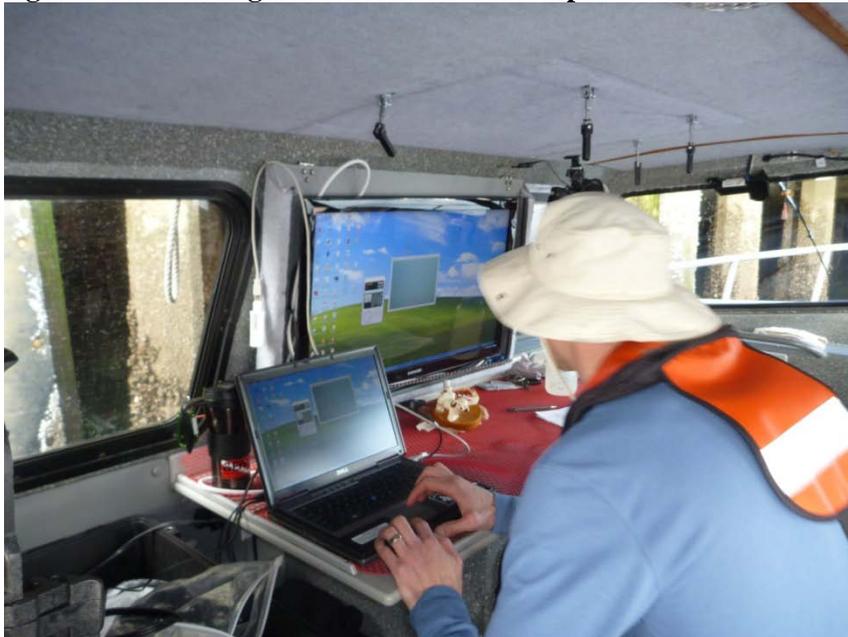
Diver observations of the sediment surface were verbally communicated to the surface through a hard-wired connection between the divers AGA full face mask and the Kirby Morgan KMACS 5 system control box. A live video feed was also obtained and recorded through an arm mounted drop-camera and the *Monitor's* flat panel screen (Figure 3).

Figure 3. Examining live video feed from drop camera aboard the *Monitor*.

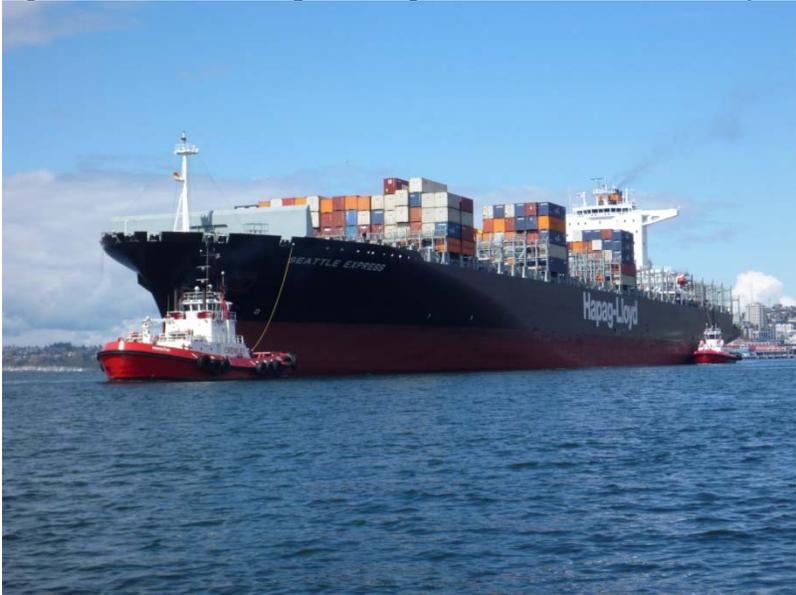
Results: On the morning of April 4, 2012, Terminal 18 was wide open and vacant of vessel traffic permitting easy access to the study area. However, a large container ship pulled into Terminal 18 at 13:20 in the afternoon that terminated dive operations (see Figure 7). The [R10 Dive Unit](#) was aware of this situation in advance from communication with Vessel Traffic Service (VTS) of Sector Seattle, U.S. Coast Guard.

Figure 7. Container ship entering East Duwamish Waterway, Terminal 18.

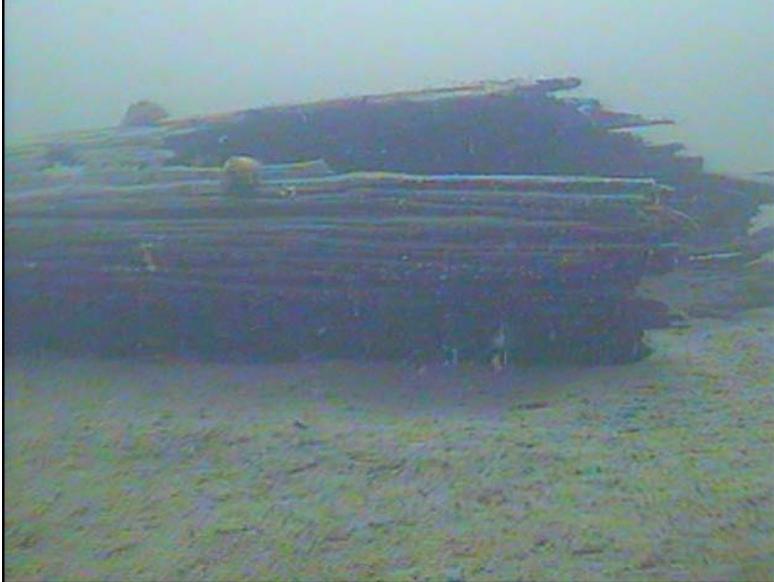
During dive operations, no visual evidence of the petroleum spill such as sediment staining or free product was observed. In general, the bottom of the East Duwamish Waterway in the vicinity of Terminal 18 is a flat to slightly undulating sandy bottom covered with varying amounts of silt from trace

amounts to several inches in thickness. Bottom depths ranged from 56 to 61 feet deep across the surveyed area. While little benthic life was observed on the bottom, scattered invertebrates such as anemones, mollusks (gaper clams), starfish, and sea pens were seen (Figures 7-9) along with a variety of debris including scrap wood and metal, bottles, rope, articles of clothing, and logs. While visibility in the water column was about 5 to 7 feet, on and near the bottom, visibility was in the 15 to 20 foot range. The still photographic images presented in Figures 7-9 were captured from video feeds of both dives which were recorded in near entirety.

Figure 7. Hollowed-out log on bottom.

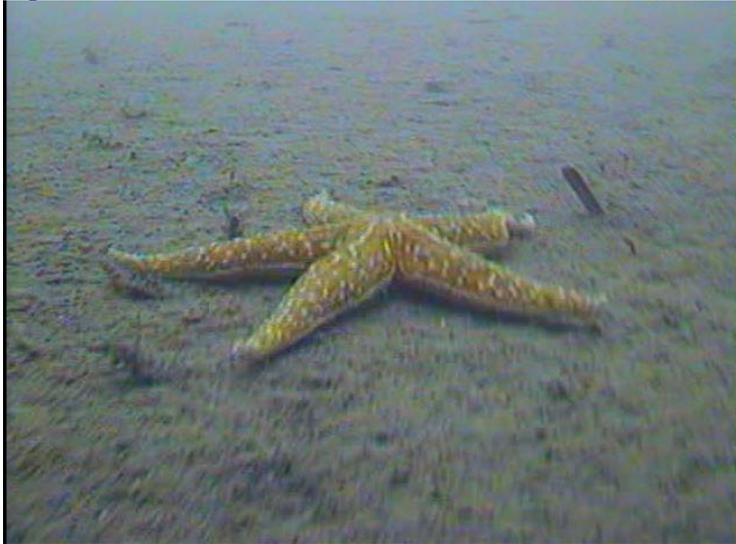
Figure 8. Star fish on bottom.

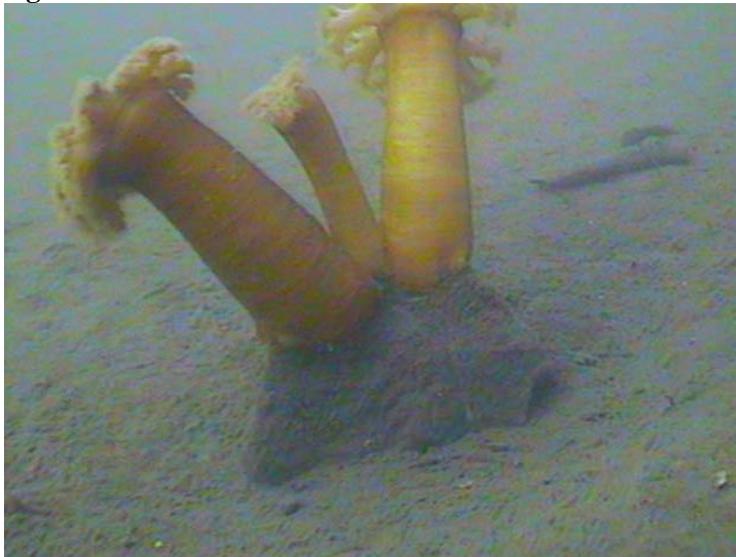
Figure 9. Anemones on bottom.
