FIGURE 3-6  
GEOLOGIC CROSS SECTION C-C', AUG 1996  
REMEDIAL INVESTIGATION REPORT  
NORTH BELMONT PCE SUPERFUND SITE  
NORTH BELMONT, GASTON COUNTY, NC  
SESD PROJECT No. 96S-058, JUNE 1997

**FIGURE 3-7** TOP OF BEDROCK CONTOURS, AUGUST 1996  
 REMEDIAL INVESTIGATION REPORT  
 NORTH BELMONT PCE SUPERFUND SITE  
 NORTH BELMONT, GASTON COUNTY, NC  
 SESD PROJECT No. 96S-058, JUNE 1997

FIGURE 3-8  
SAPROLITE AQUIFER, POTENTIOMETRIC MAP  
OCTOBER 1996  
REMEDIAL INVESTIGATION REPORT  
NORTH BELMONT PCE SUPERFUND SITE  
NORTH BELMONT, GASTON COUNTY, NC  
SESD PROJECT No. 96S-058, JUNE 1997

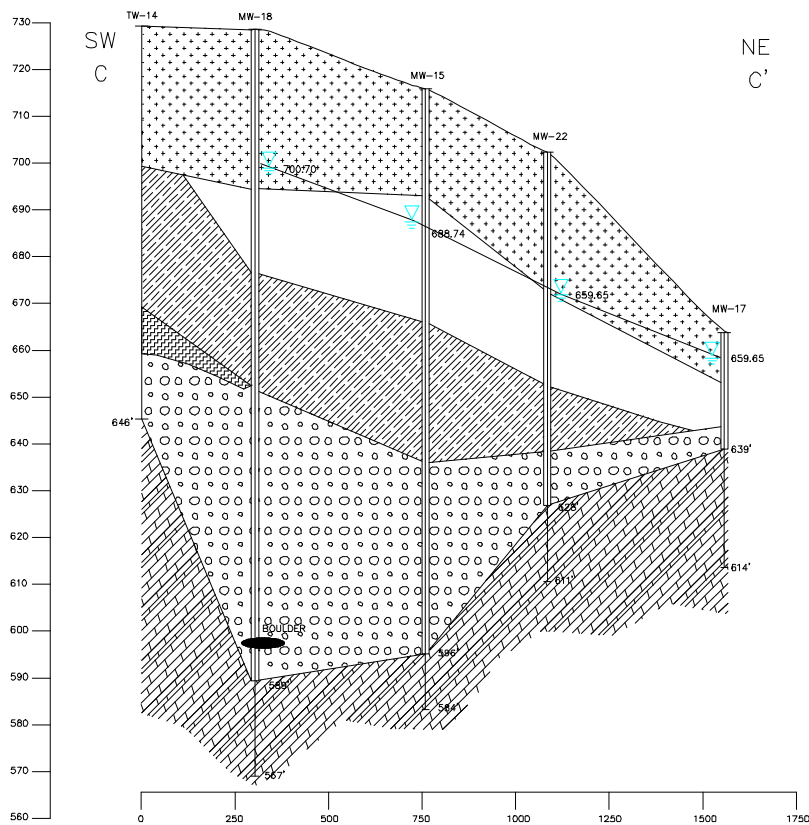
- TOP OF WATER TABLE
- BOTTOM ELEVATION OF SURFACE CASING (FEET ABOVE MEAN SEA LEVEL). 596'
- BOTTOM ELEVATION OF BOREHOLE (FEET ABOVE MEAN SEA LEVEL). 584'
- CONTACT LINE: ALL CONTACT LINES ARE CONSIDERED GRADATIONAL.
- YELLOW BROWN, RED BROWN, BROWN, BLACK, SILTY CLAY WITH APPROXIMATELY 10% FINE GRAINED SAND AND GRAVEL.
- YELLOW BROWN, BLACK, MAROON, SANDY SILTY CLAY WITH APPROXIMATELY 15% FINE GRAINED GRAVEL.
- YELLOW BROWN, WHITE, GREENISH GRAY, MICACEOUS, SANDY CLAY WITH APPROXIMATE 10% MEDIUM GRAINED GRAVEL.
- BROWN, WHITE, GREY, SANDY SILTY CLAY.
- PARTIALLY WEATHERED ROCK, WHITE, GRAY, BLACK, GREEN, SANDY CLAY WITH 20% FINE TO COARSE GRAINED GRAVEL.
- BEDROCK, FRACTURED GRANITIC GNEISS OR QUARTZ RICH DIORITE, WHITE, BLACK, GREEN, QUARTZ, FELDSPAR, MICA, COARSE GRAINED.

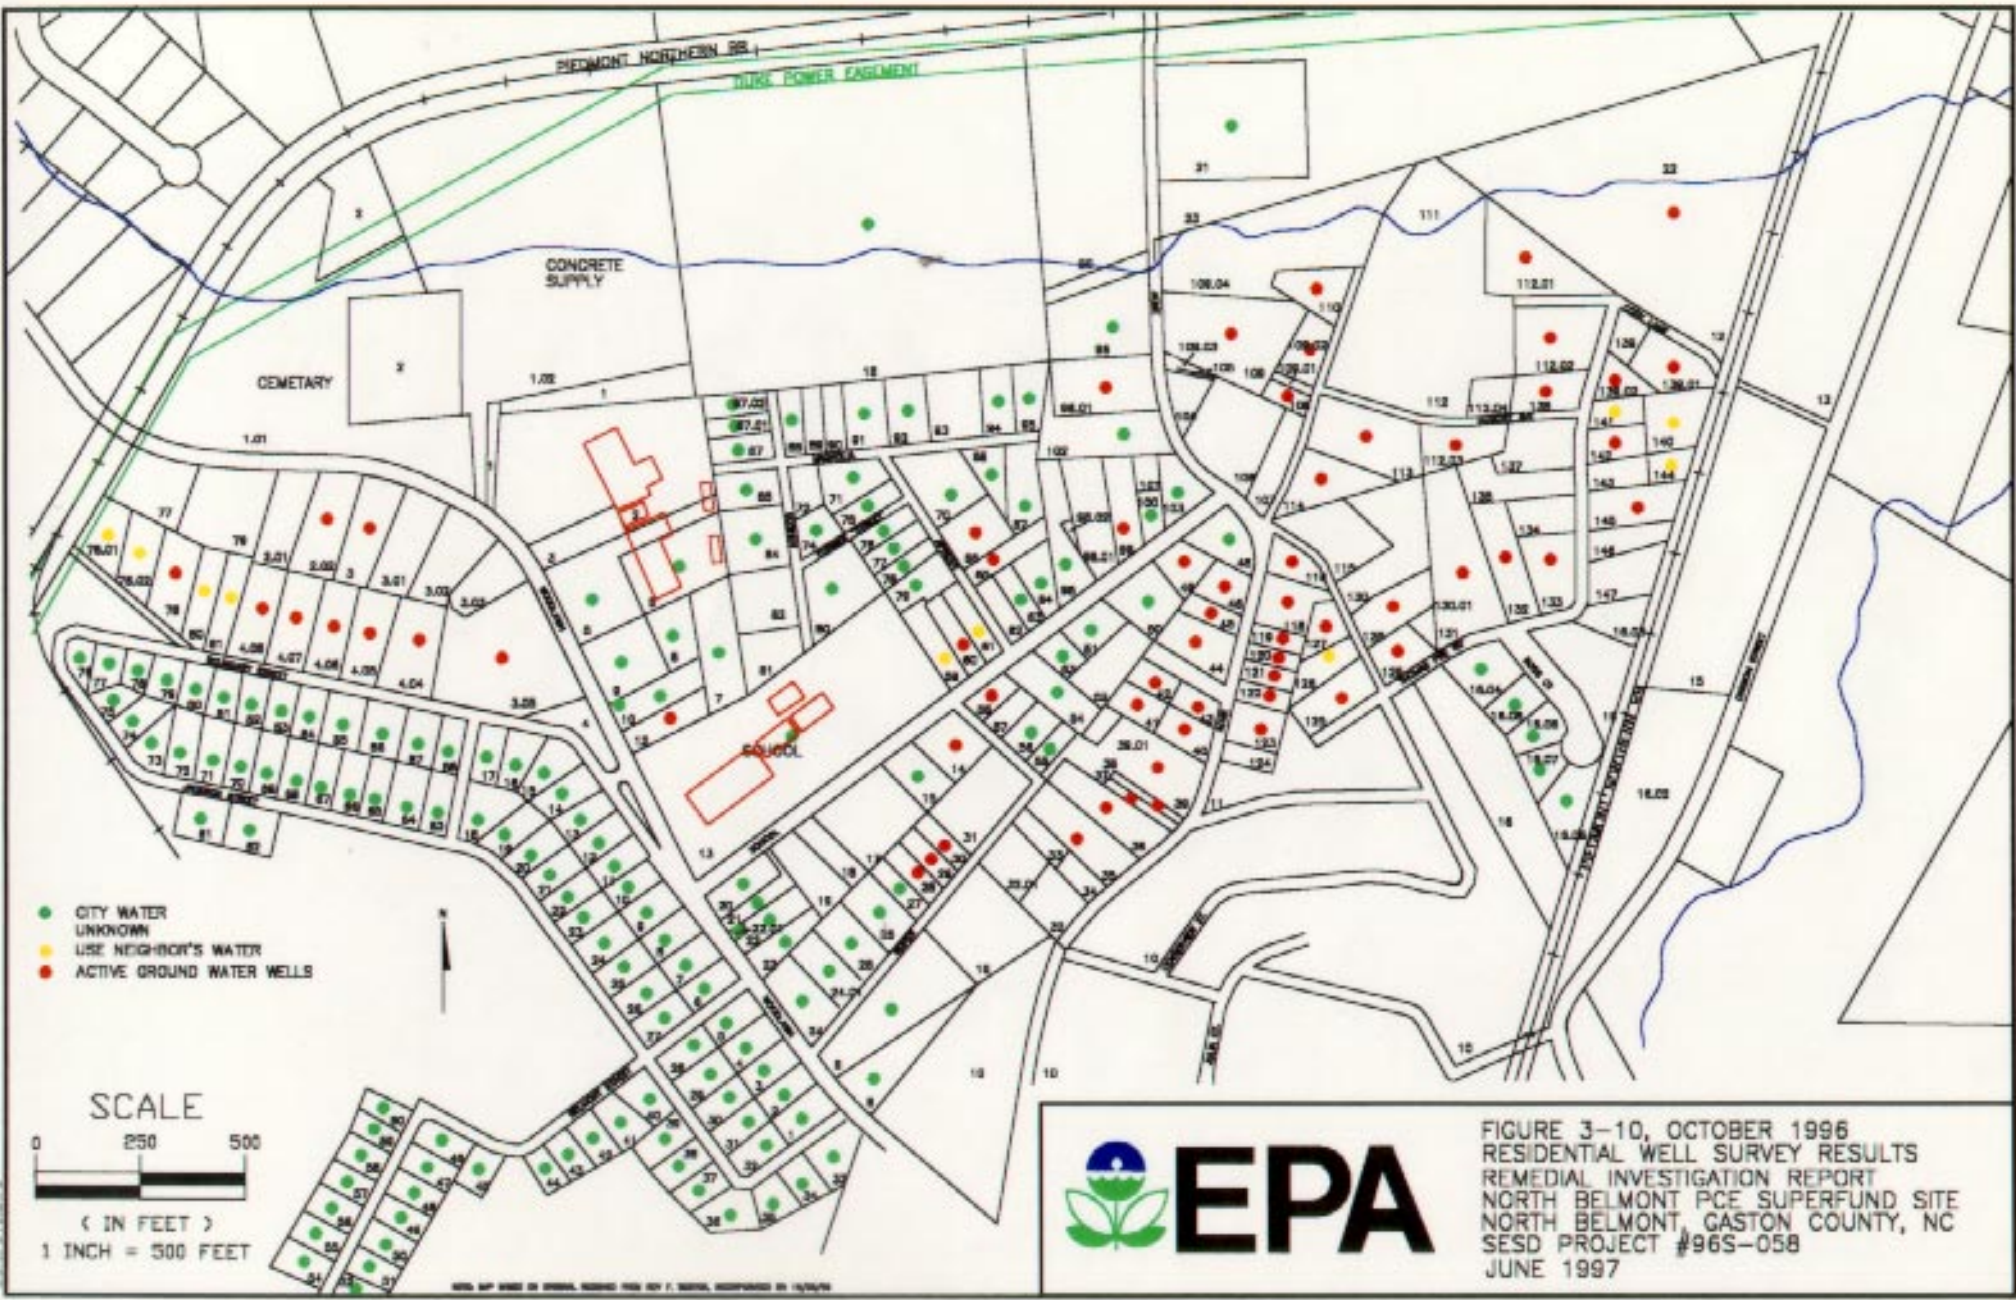
FIGURE 3-10, OCTOBER 1996  
RESIDENTIAL WELL SURVEY RESULTS  
REMEDIAL INVESTIGATION REPORT  
NORTH BELMONT PCE SUPERFUND SITE  
NORTH BELMONT, GASTON COUNTY, NC  
SESD PROJECT #96S-058  
JUNE 1997
