**FIGURE 4-1** PCE GROUNDWATER CONTAMINATION, 1991  
 REMEDIAL INVESTIGATION REPORT  
 NORTH BELMONT PCE SUPERFUND SITE  
 NORTH BELMONT, GASTON COUNTY, NC  
 SESD PROJECT No. 96S-058, JUNE 1997

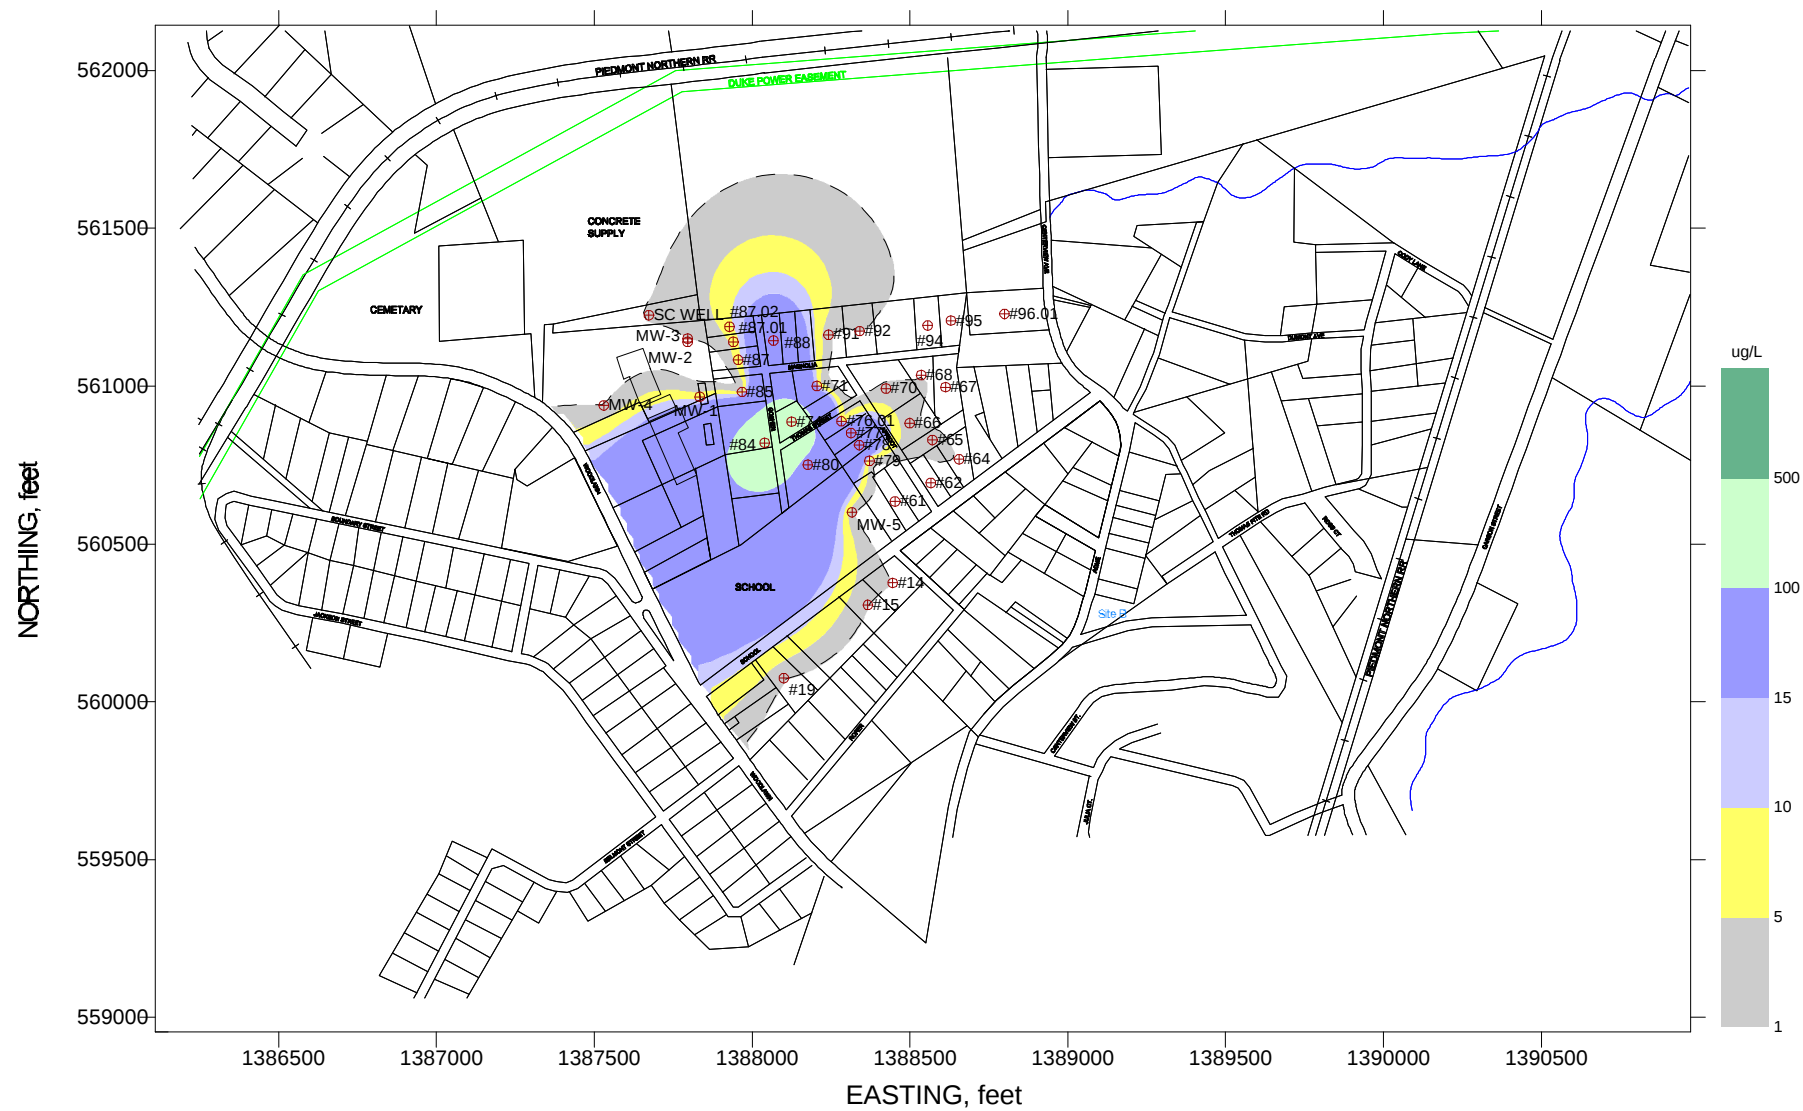
**FIGURE 4-2** TCE GROUNDWATER CONTAMINATION, 1991  
 REMEDIAL INVESTIGATION REPORT  
 NORTH BELMONT PCE SUPERFUND SITE  
 NORTH BELMONT, GASTON COUNTY, NC  
 SESD PROJECT No. 96S-058, JUNE 1997

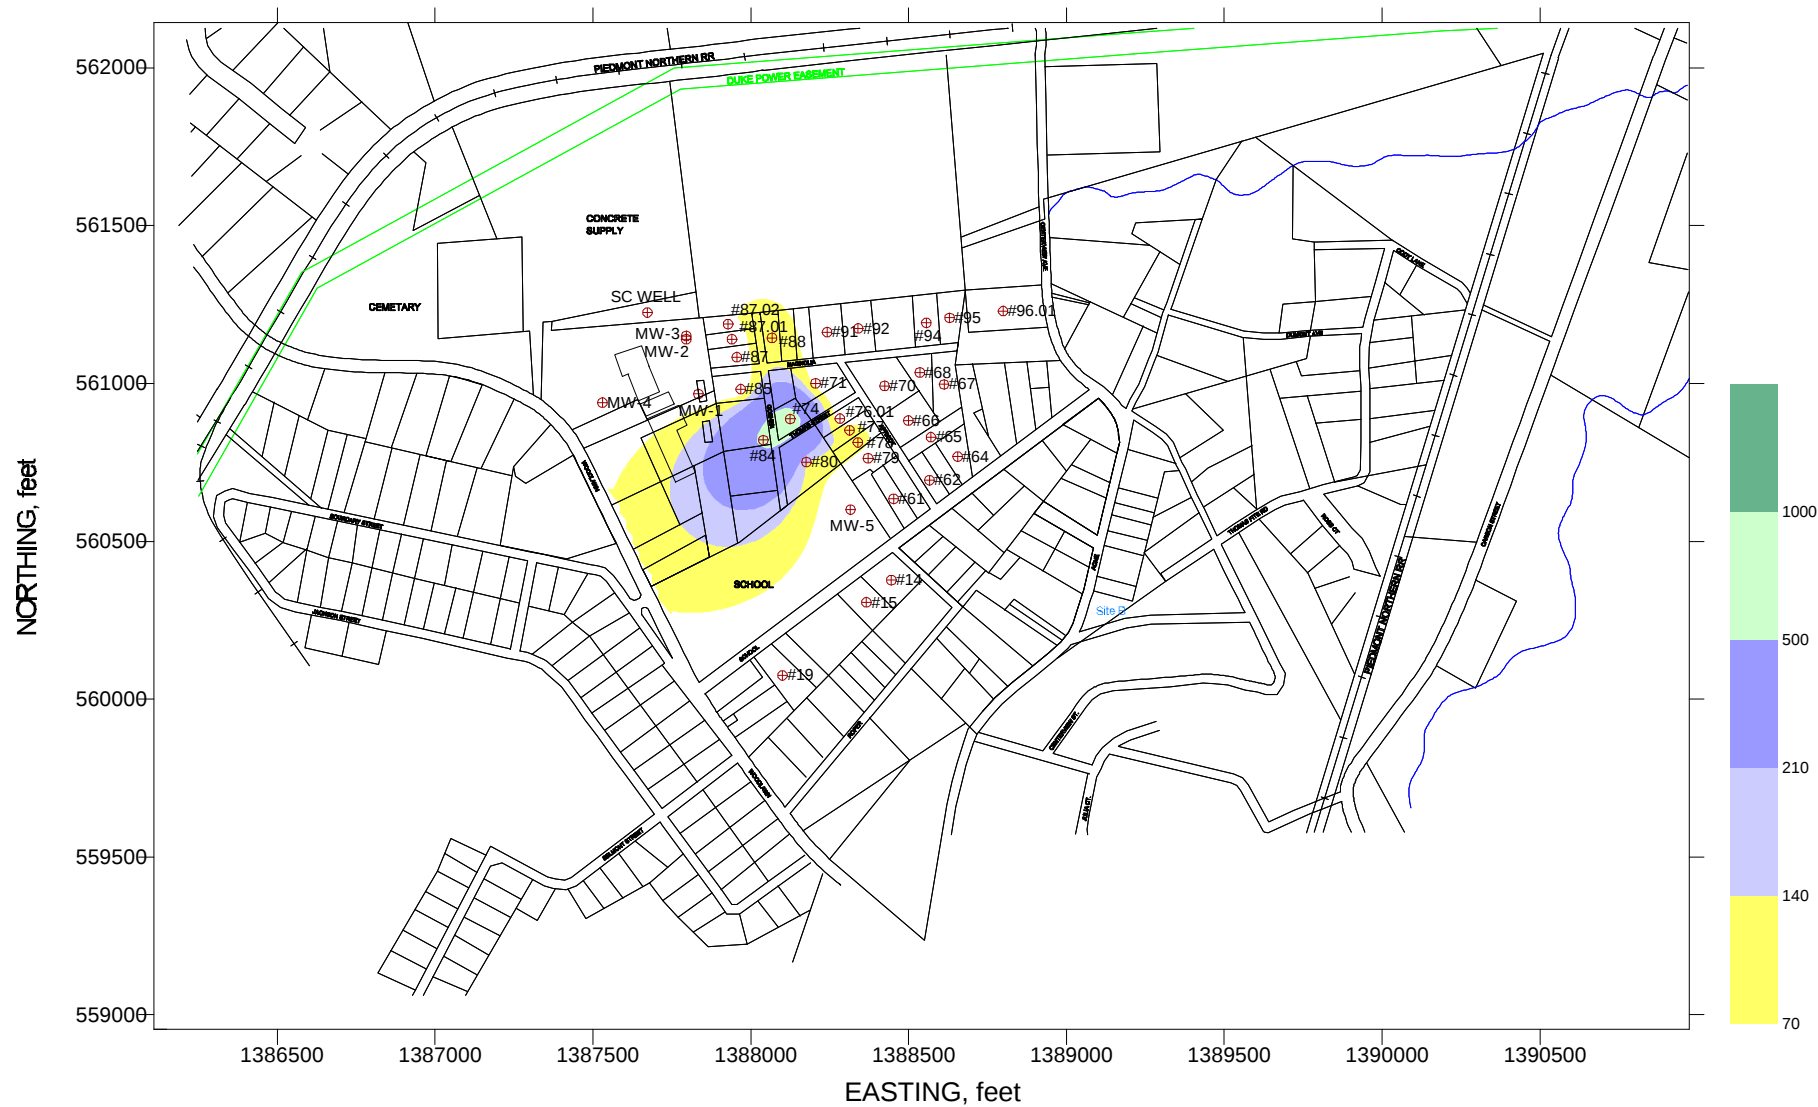
FIGURE 4-3 CIS-1,2, DCE GROUNDWATER CONTAMINATION, 1991  
 REMEDIAL INVESTIGATION REPORT  
 NORTH BELMONT PCE SUPERFUND SITE  
 NORTH BELMONT, GASTON COUNTY, NC  
 SESD PROJECT No. 96S-058, JUNE 1997

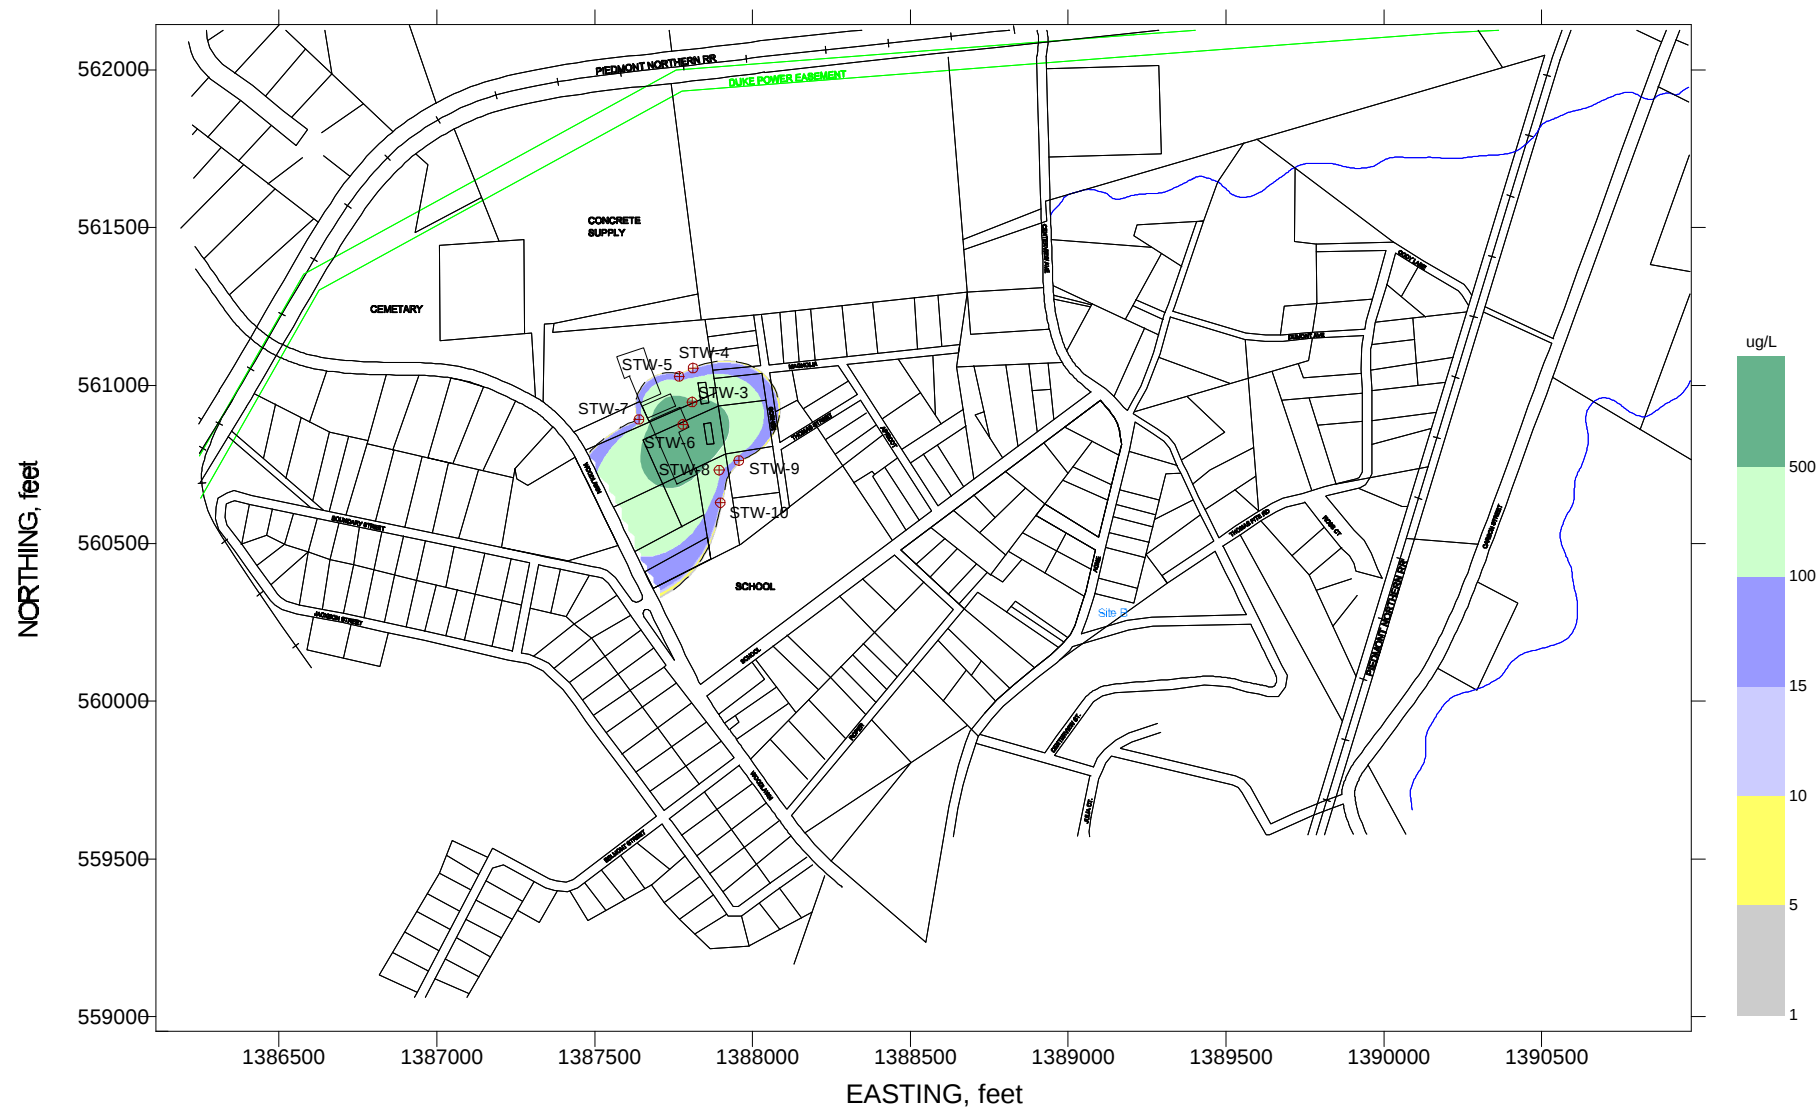
FIGURE 4-5 SHALLOW GROUNDWATER PLUME, PCE CONTAMINATION, JUNE 1996  
 REMEDIAL INVESTIGATION REPORT  
 NORTH BELMONT PCE SUPERFUND SITE  
 NORTH BELMONT, GASTON COUNTY, NC  
 SEDS PROJECT No. 96S-058, JUNE 1997

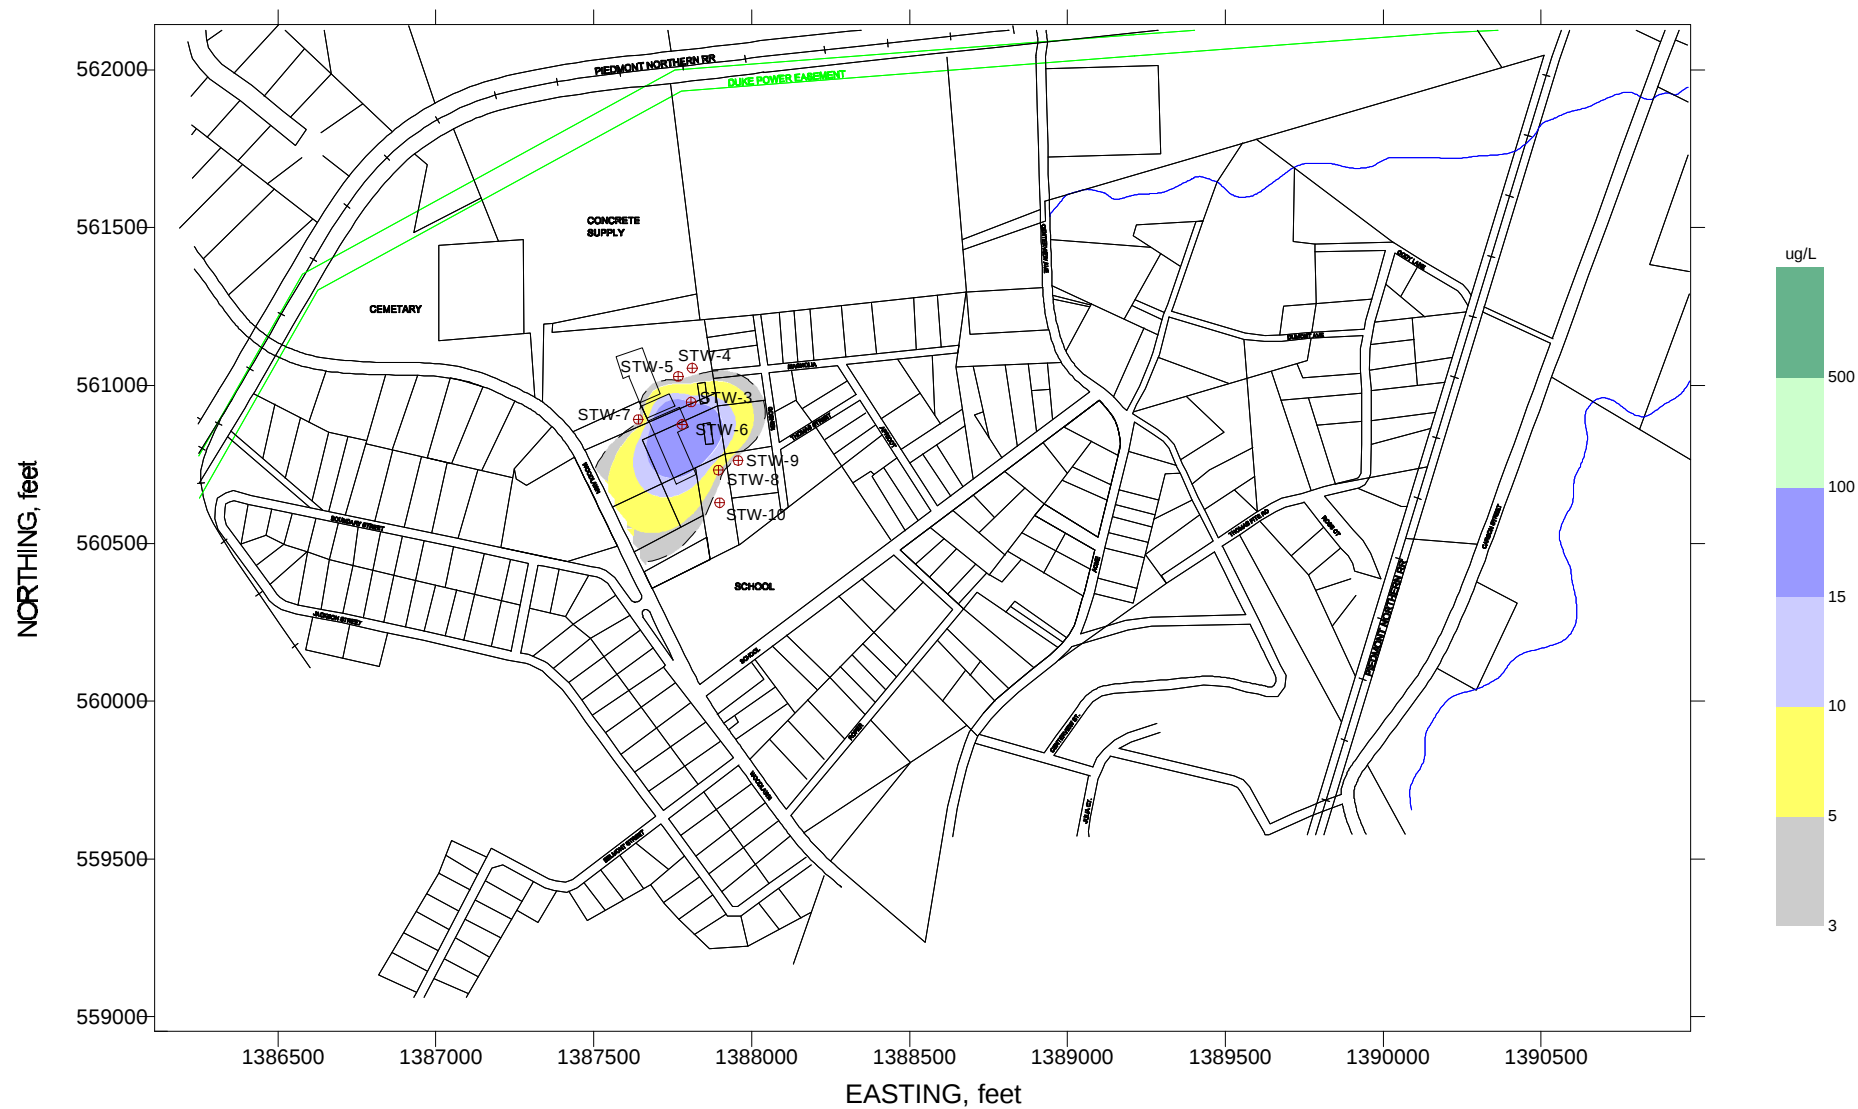
**FIGURE 4-6** SHALLOW GROUNDWATER PLUME, TCE CONTAMINATION, JUNE 1996  
 REMEDIAL INVESTIGATION REPORT  
 NORTH BELMONT PCE SUPERFUND SITE  
 NORTH BELMONT, GASTON COUNTY, NC  
 SEDS PROJECT No. 96S-058, JUNE 1997

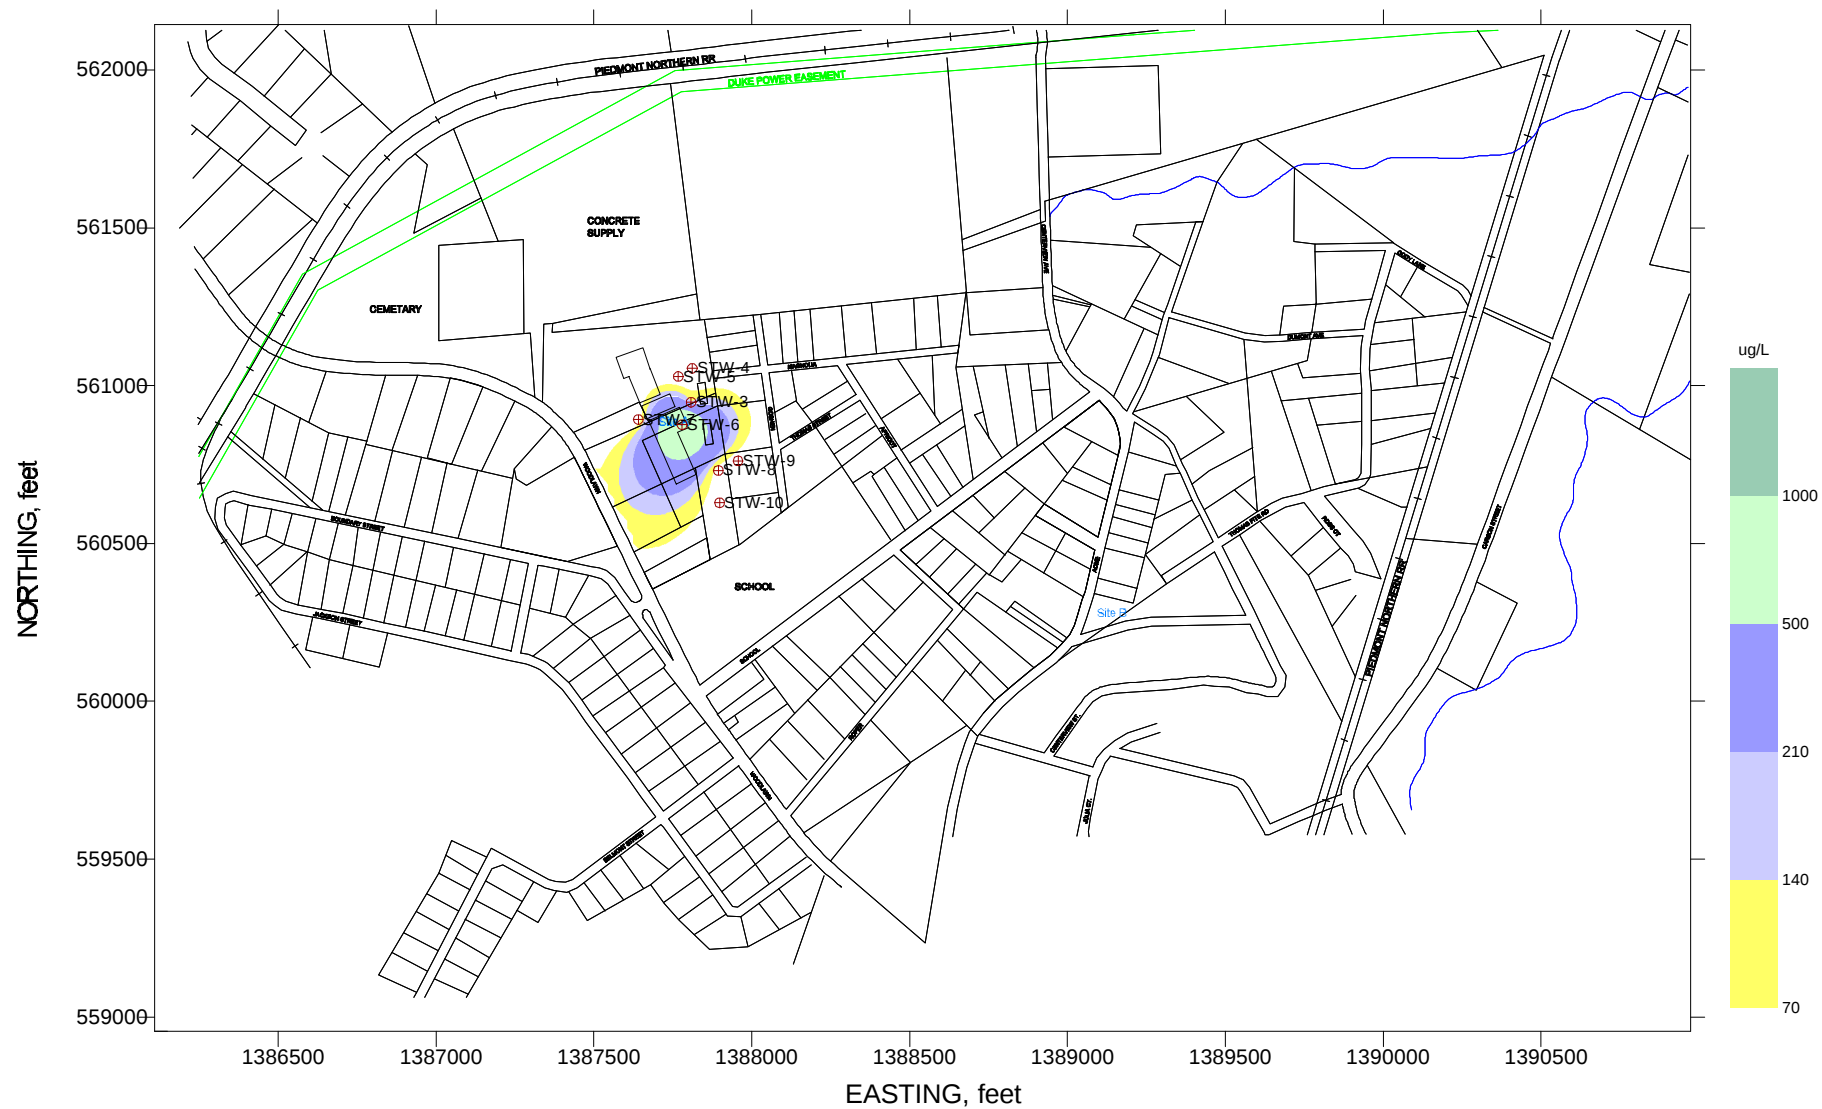
**FIGURE 4-7** SHALLOW GROUNDWATER PLUME, DCE CONTAMINATION, JUNE 1996  
 REMEDIAL INVESTIGATION REPORT  
 NORTH BELMONT PCE SUPERFUND SITE  
 NORTH BELMONT, GASTON COUNTY, NC  
 SEDS PROJECT No. 96S-058, JUNE 1997

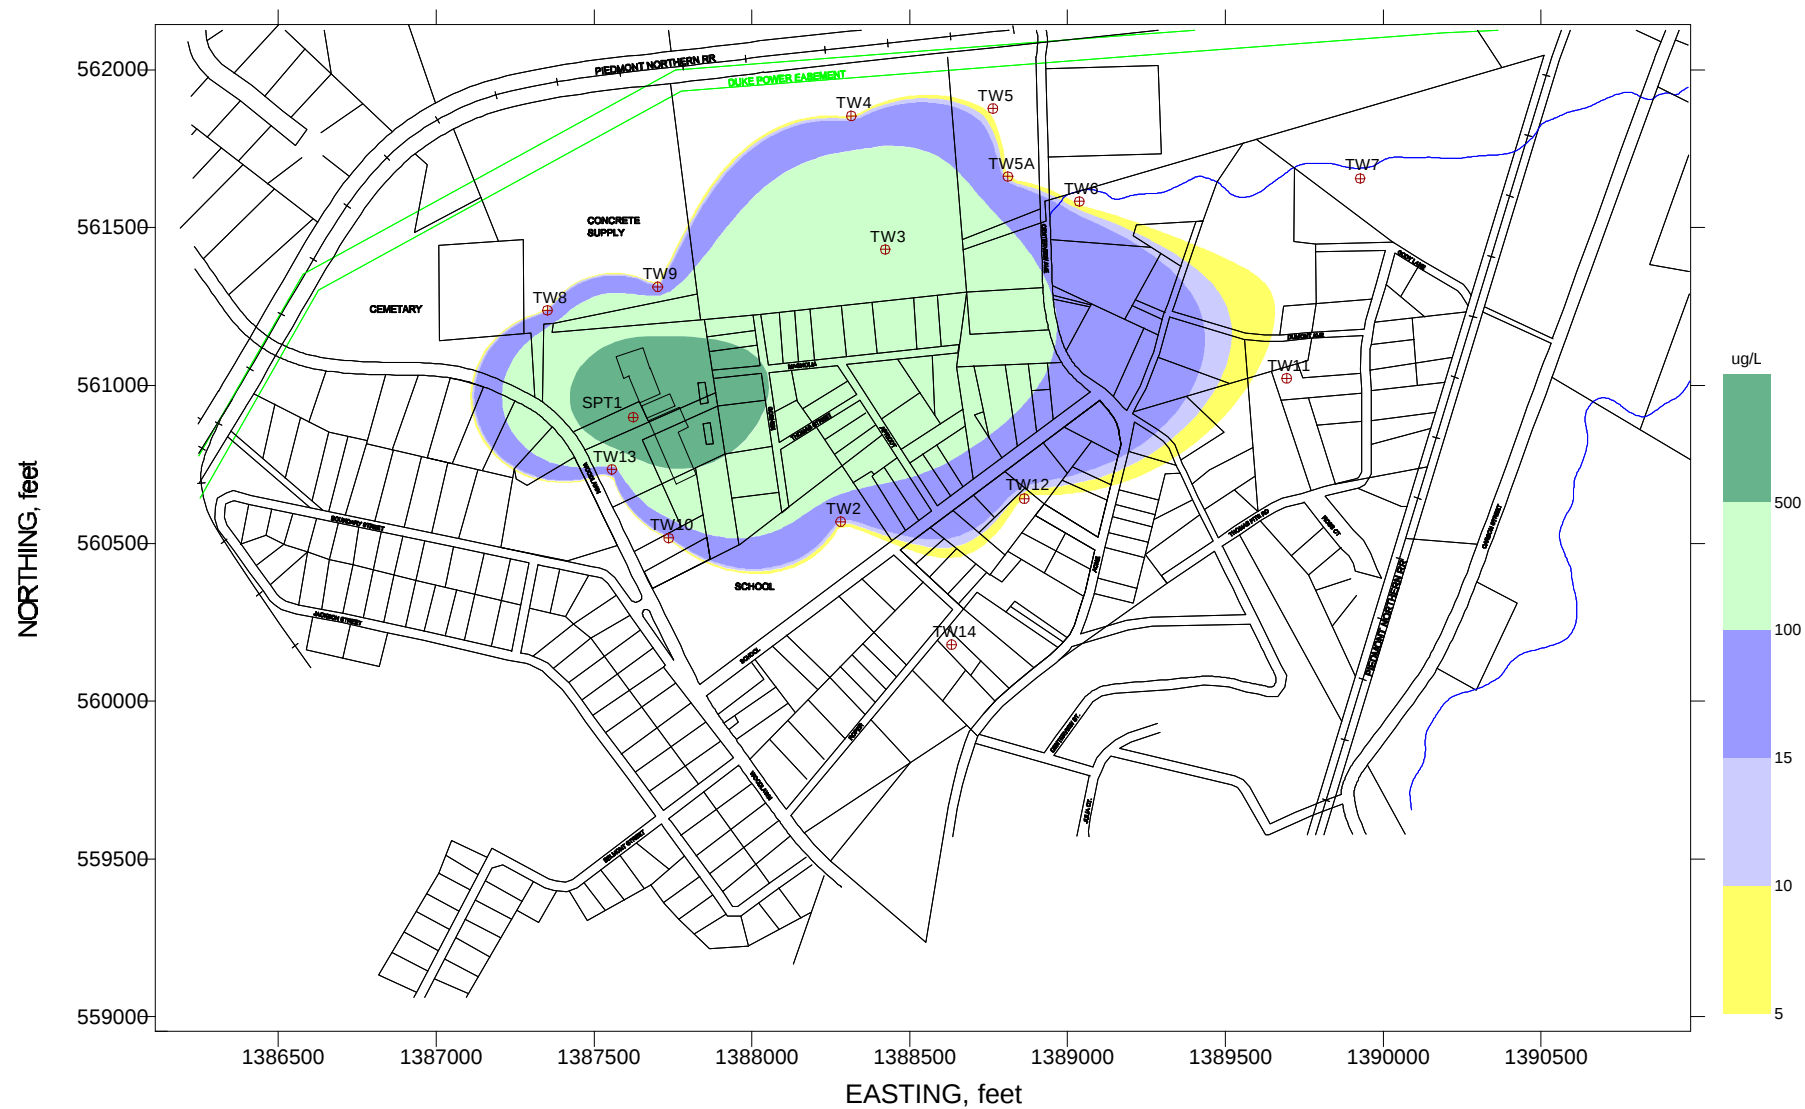
**FIGURE 4-8** TOP OF BEDROCK GROUNDWATER PLUME, TEMPORARY WELLS  
PCE CONTAMINATION, JULY/AUGUST 1996  
REMEDIAL INVESTIGATION REPORT  
NORTH BELMONT PCE SUPERFUND SITE  
NORTH BELMONT, GASTON COUNTY, NC  
SESD PROJECT No. 96S-058, JUNE 1997

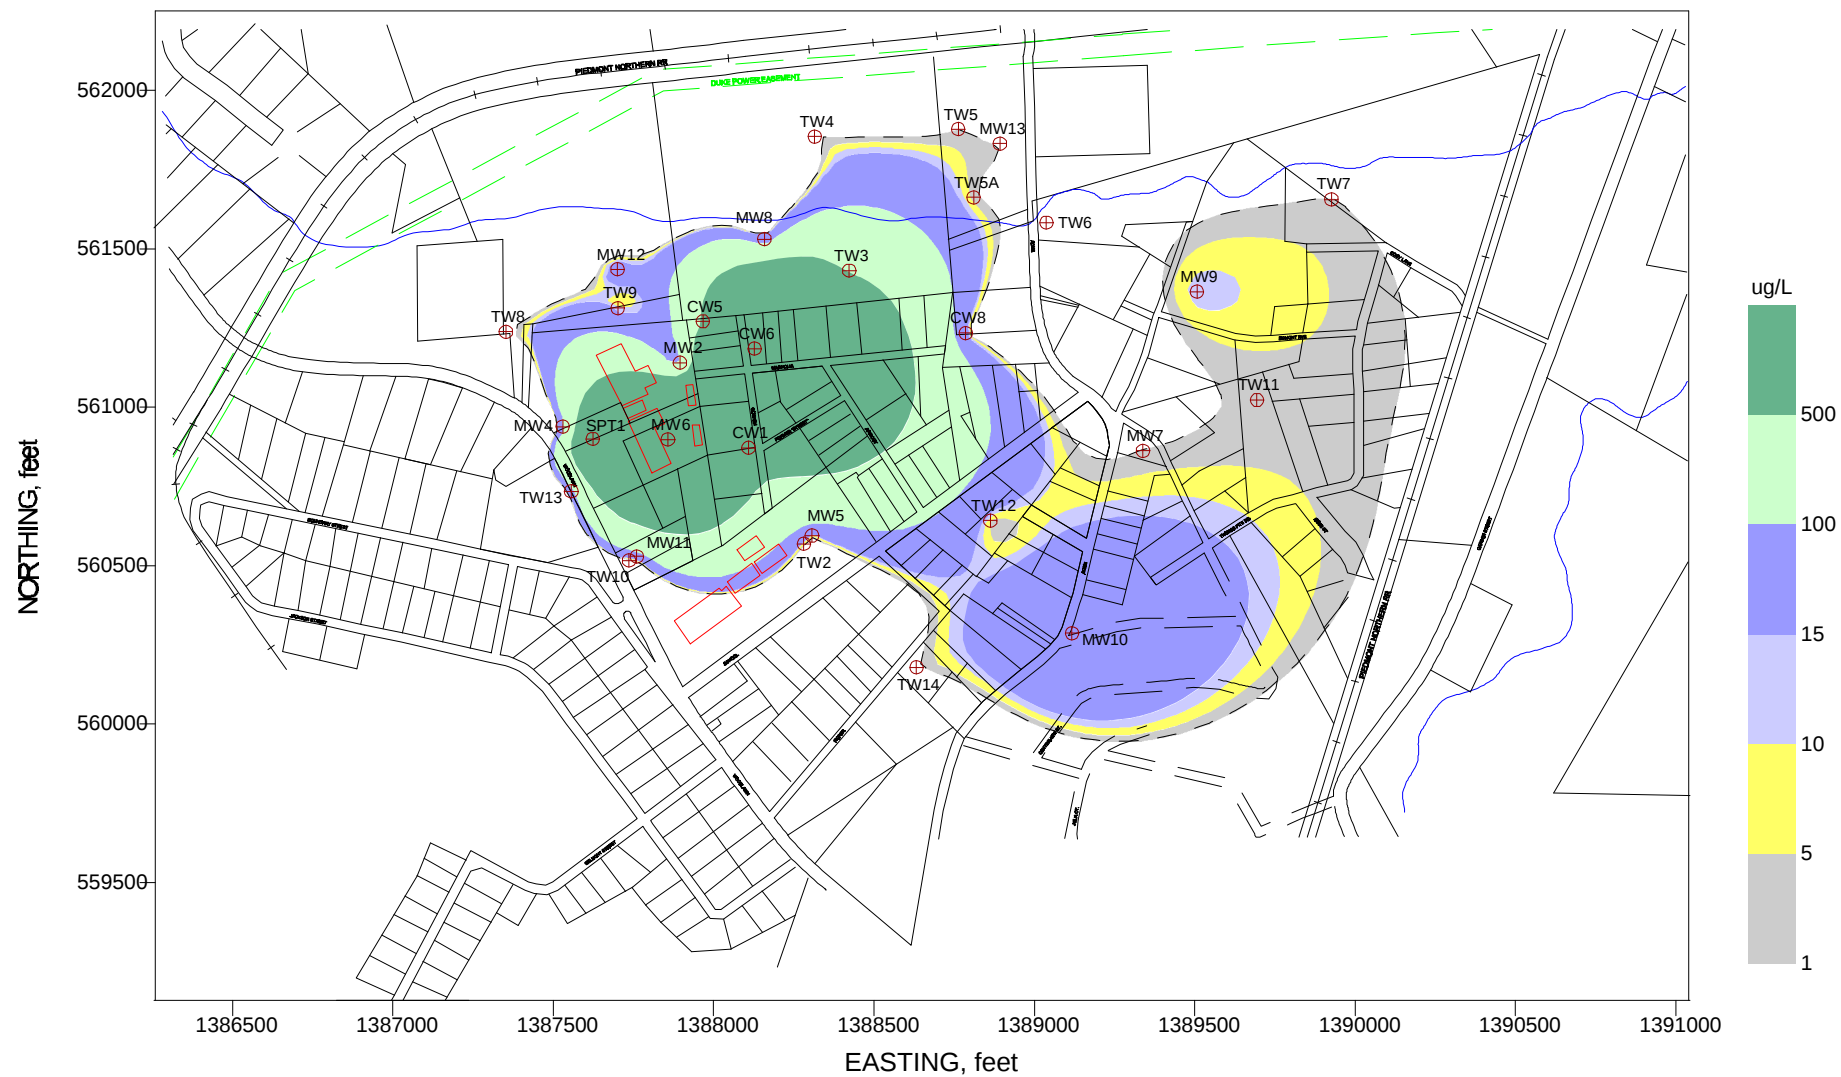
**FIGURE 4-9** TOP OF BEDROCK GROUNDWATER PLUME (TEMPORARY WELLS and PERMANENT WELLS)  
PCE CONTAMINATION, OCTOBER/NOVEMBER 1996  
REMEDIAL INVESTIGATION REPORT  
NORTH BELMONT PCE SUPERFUND SITE  
NORTH BELMONT, GASTON COUNTY, NC  
SESD PROJECT No. 96S-058, JUNE 1997
