**FIGURE 4-10** TOP OF BEDROCK GROUNDWATER PLUME (TEMPORARY WELLS and PERMANENT WELLS)  
TCE CONTAMINATION, OCTOBER/NOVEMBER 1996  
REMEDIAL INVESTIGATION REPORT  
NORTH BELMONT PCE SUPERFUND SITE  
NORTH BELMONT, GASTON COUNTY, NC  
SESD PROJECT No. 96S-058, JUNE 1997

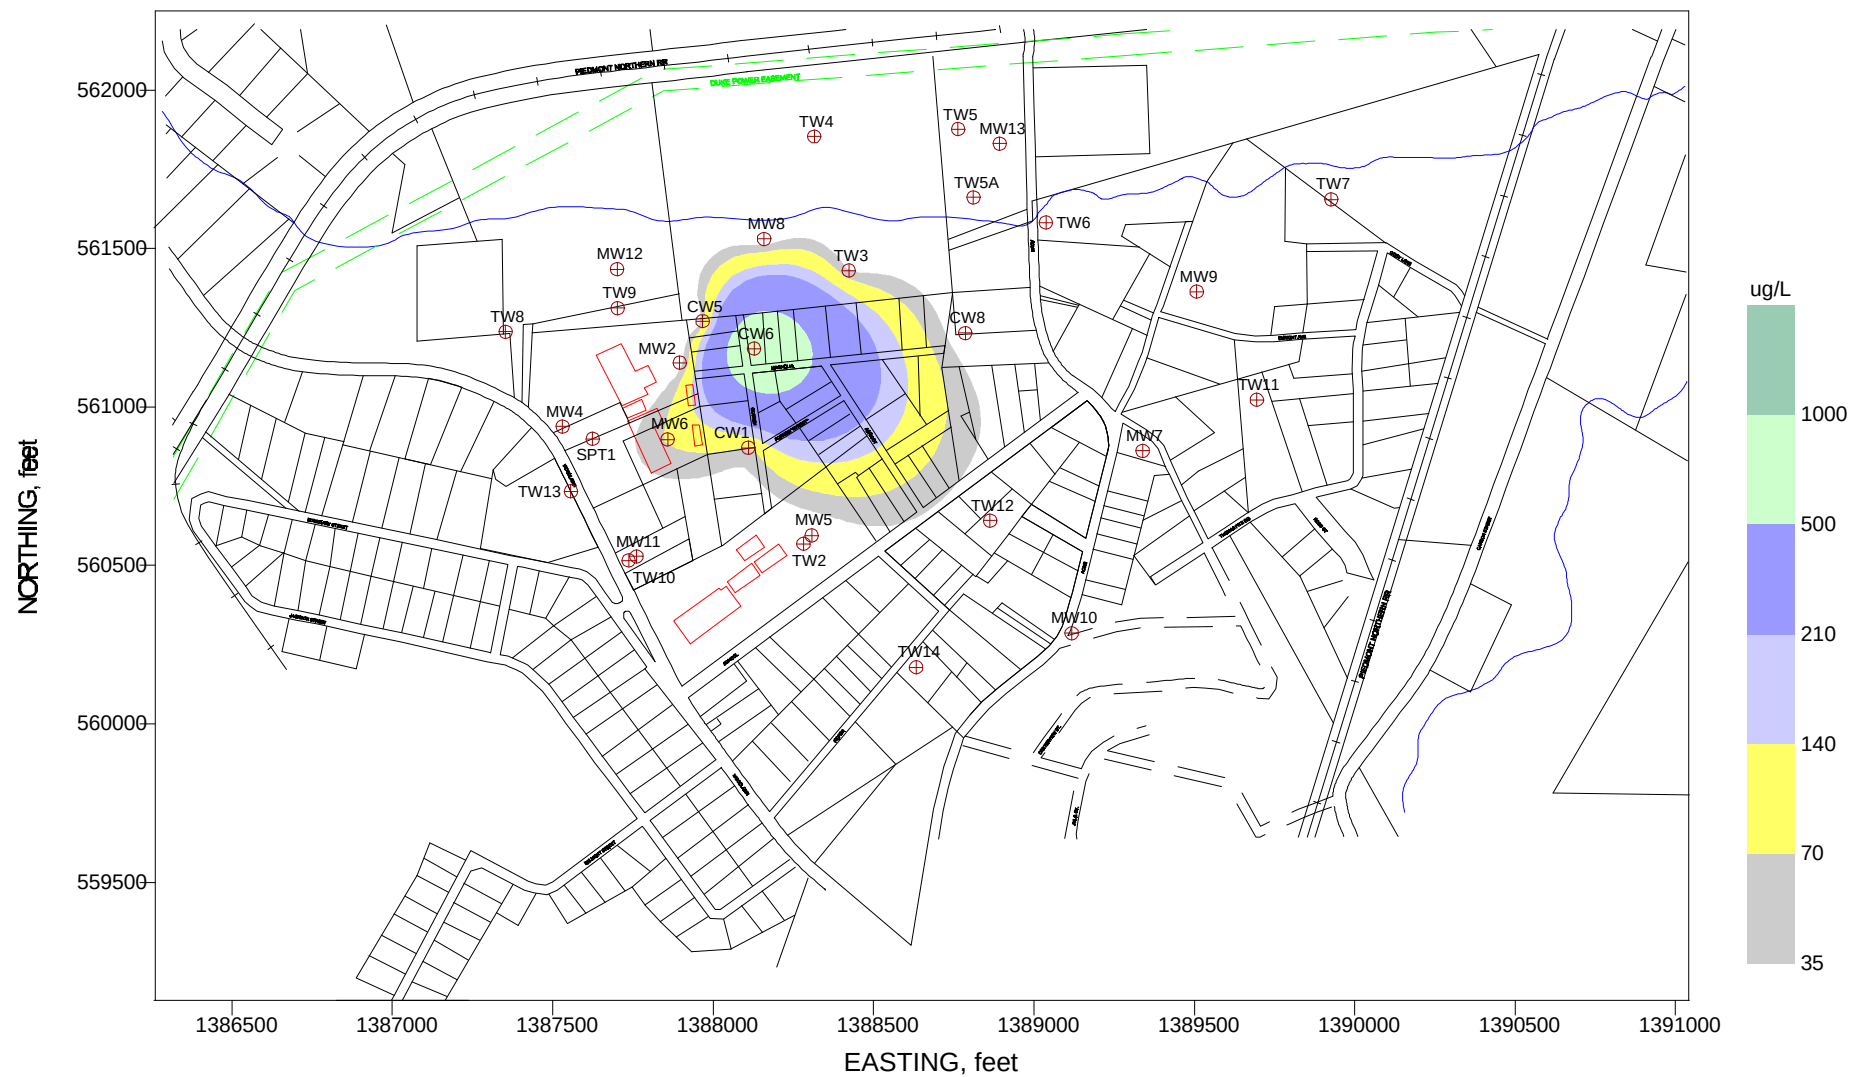
**FIGURE 4-11** TOP OF BEDROCK GROUNDWATER PLUME (TEMPORARY WELLS and PERMANENT WELLS)  
 CIS-1,2 DCE CONTAMINATION, OCTOBER/NOVEMBER 1996  
 REMEDIAL INVESTIGATION REPORT  
 NORTH BELMONT PCE SUPERFUND SITE  
 NORTH BELMONT, GASTON COUNTY, NC  
 SESD PROJECT No. 96S-058, JUNE 1997

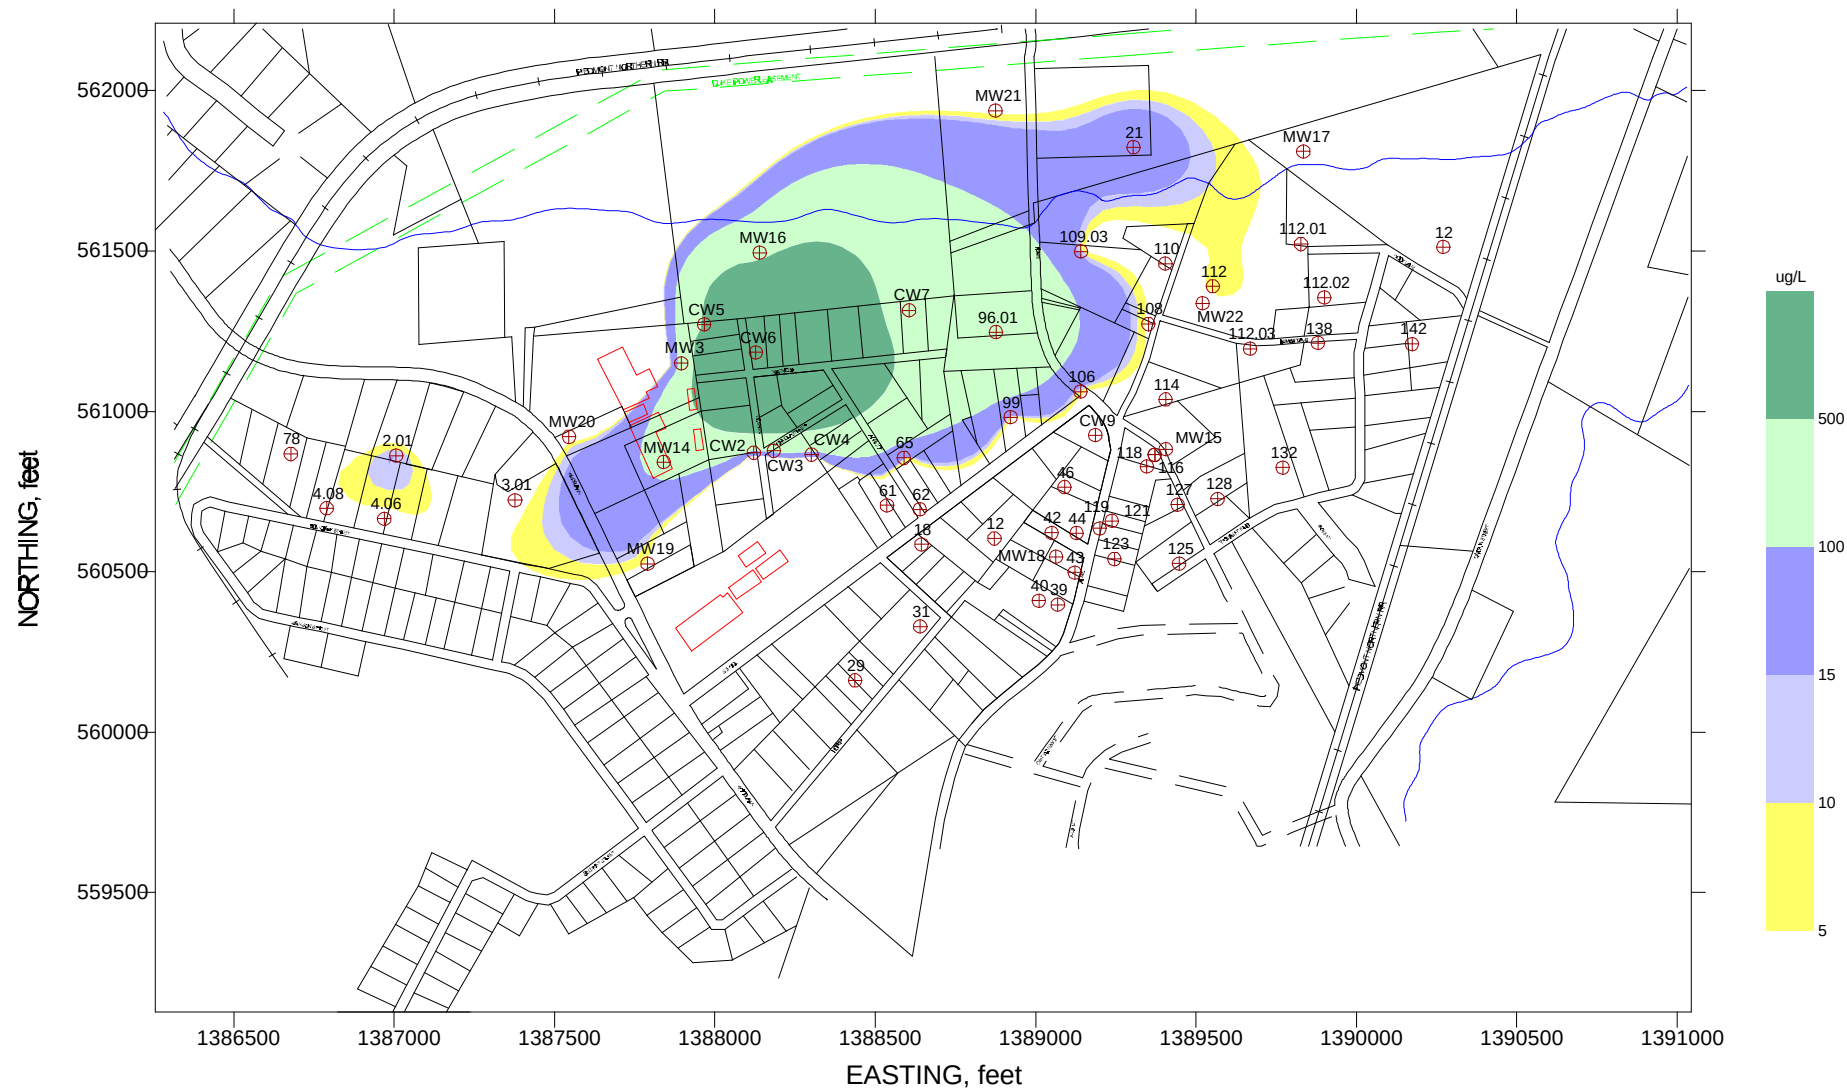
**FIGURE 4-12** BEDROCK GROUNDWATER PLUME (BEDROCK MW and POTABLE WELLS) NOT TO SCALE  
PCE CONTAMINATION, OCTOBER/NOVEMBER 1996  
REMEDIAL INVESTIGATION REPORT  
NORTH BELMONT PCE SUPERFUND SITE  
NORTH BELMONT, GASTON COUNTY, NC  
SESD PROJECT No. 96S-058, JUNE 1997

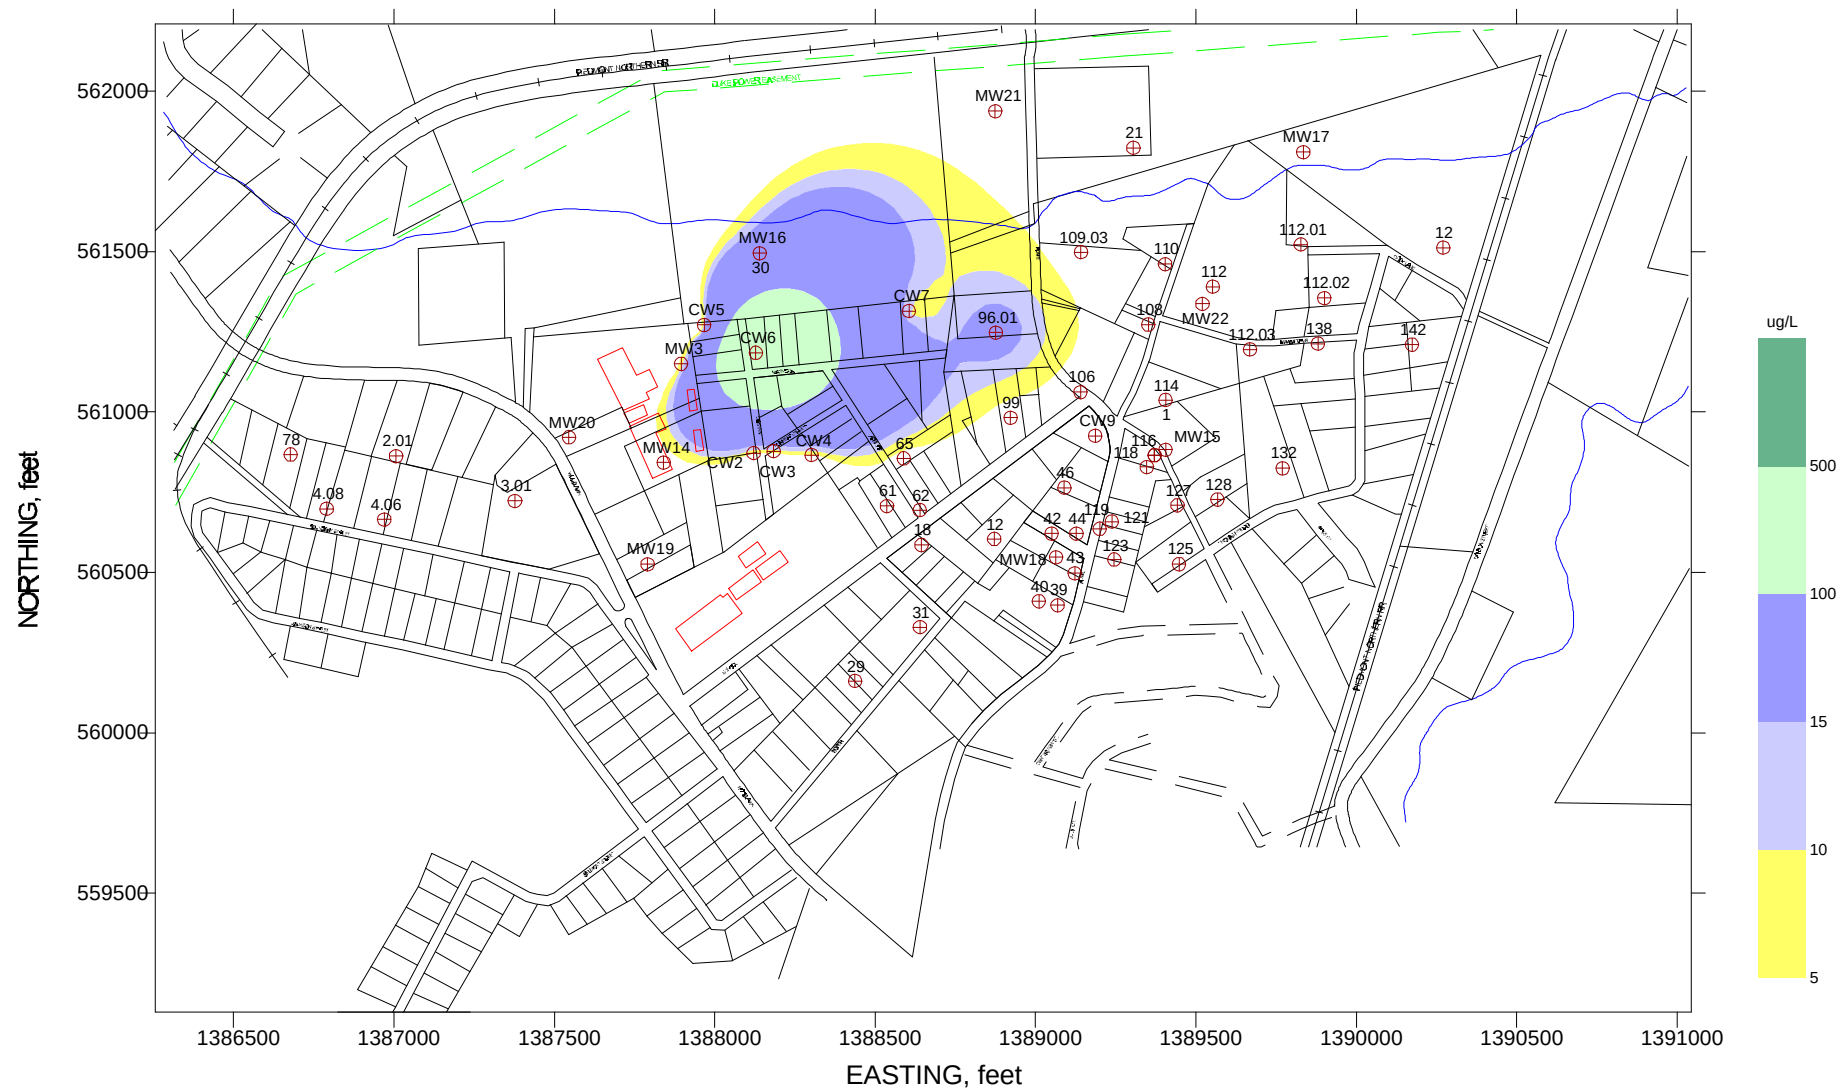
**FIGURE 4-13** BEDROCK GROUNDWATER PLUME (BEDROCK MW and POTABLE WELLS) NOT TO SCALE  
TCE CONTAMINATION, OCTOBER/NOVEMBER 1996  
REMEDIAL INVESTIGATION REPORT  
NORTH BELMONT PCE SUPERFUND SITE  
NORTH BELMONT, GASTON COUNTY, NC  
SESD PROJECT No. 96S-058, JUNE 1997

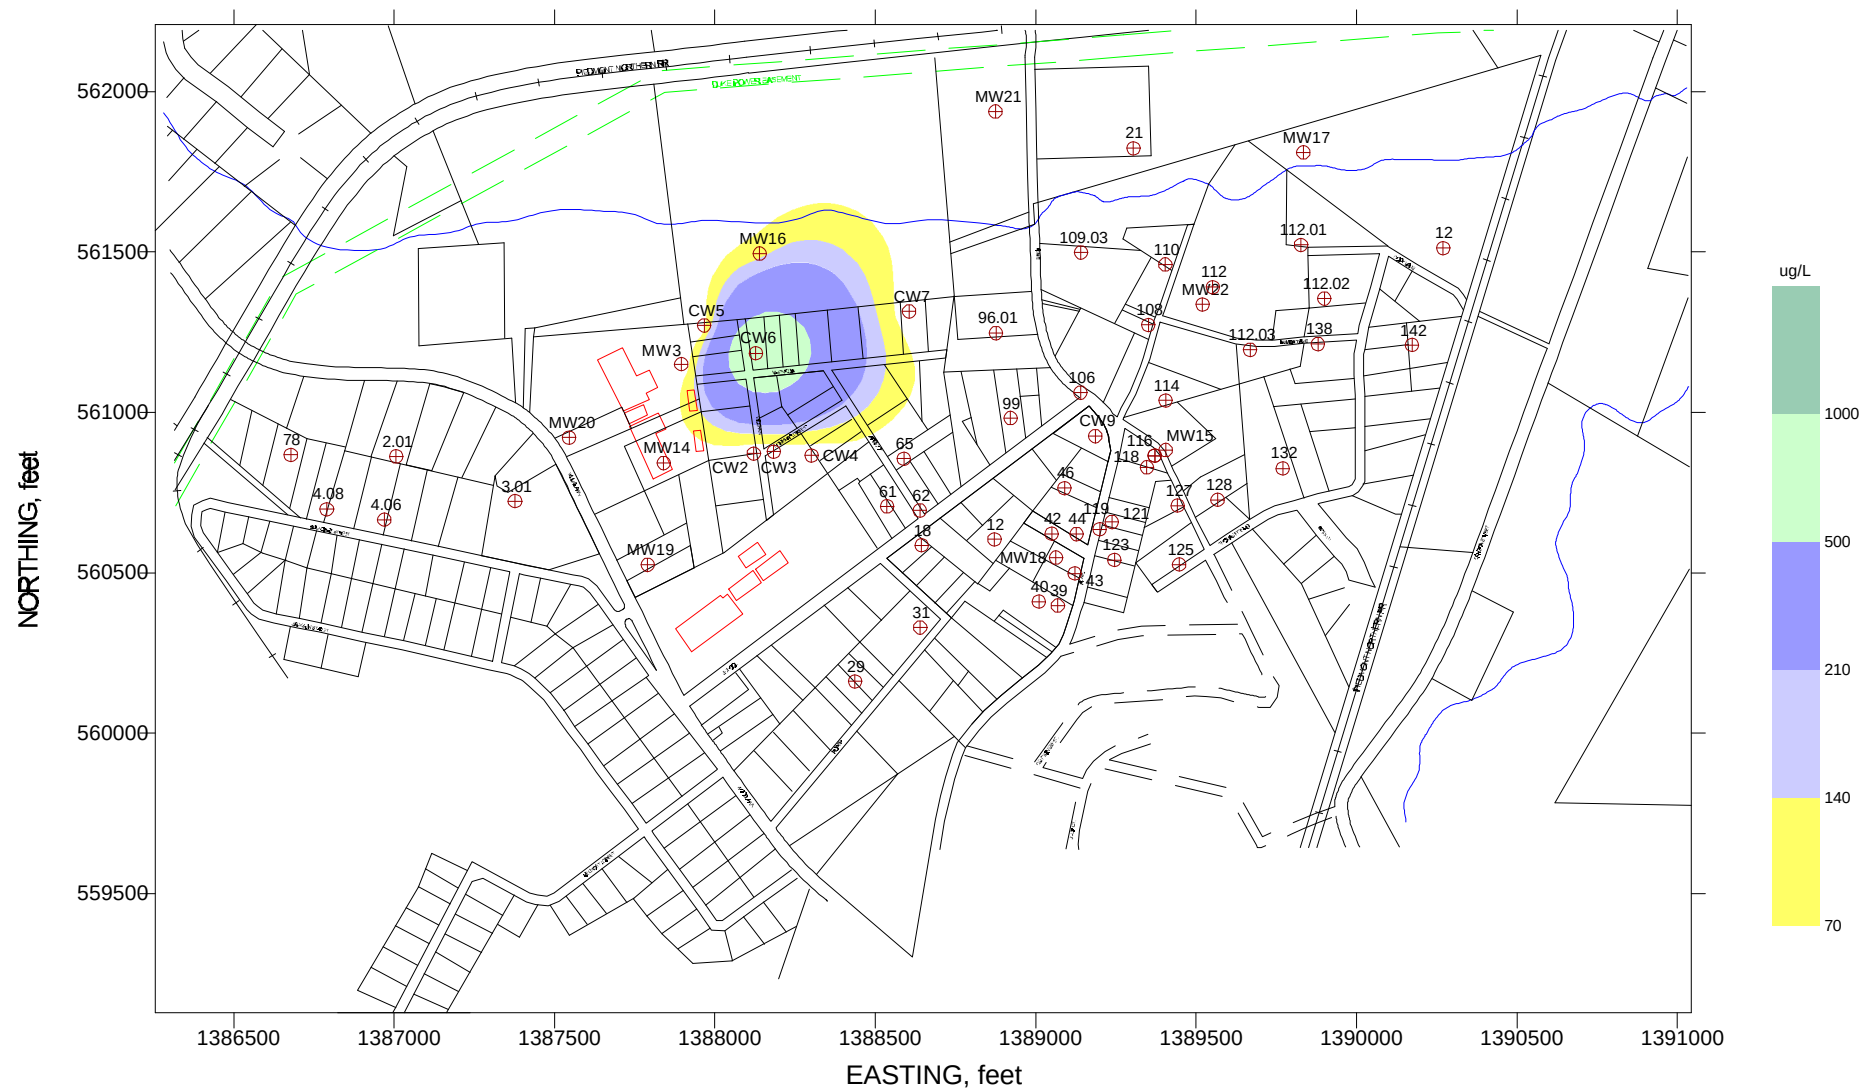
**FIGURE 4-14** BEDROCK GROUNDWATER PLUME (BEDROCK MW and POTABLE WELLS)  
 CIS-1,2 DCE CONTAMINATION, OCTOBER/NOVEMBER 1996  
 REMEDIAL INVESTIGATION REPORT  
 NORTH BELMONT PCE SUPERFUND SITE  
 NORTH BELMONT, GASTON COUNTY, NC  
 SESD PROJECT No. 96S-058, JUNE 1997
