**Enbridge Line 6B MP 608 Pipeline Release  
Marshall, Michigan  
Source Contamination Removal and Verification Summary Report  
Talmadge Creek Section 4  
Stationing 30+00L to 40+00L and 29+00R to 39+00R**

**Enbridge Energy  
September 24, 2010**

# Talmadge Creek Source Contamination Removal and Verification Summary Report

## Section 4 of 10 – Stationing (30+00L to 40+00L) and (29+00R to 39+00R)

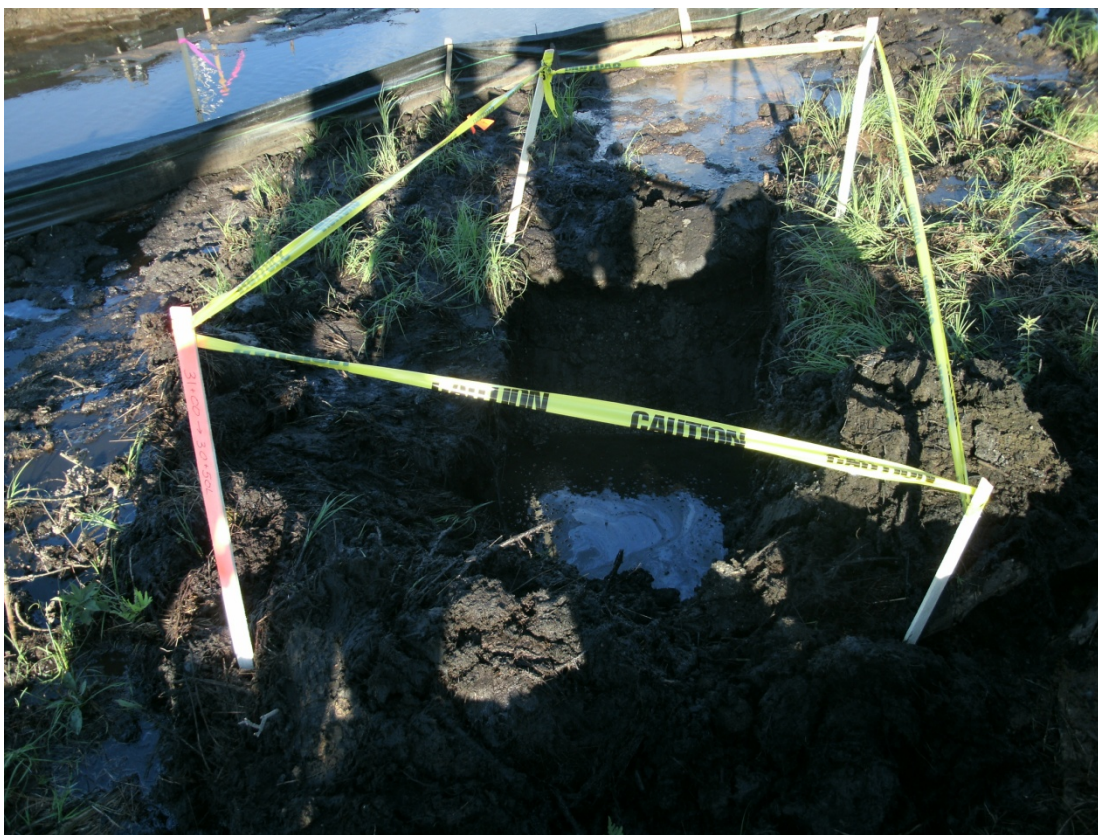
30+50L – 31+00L: Looking upstream at 6-hour test pit (September 14, 2010)

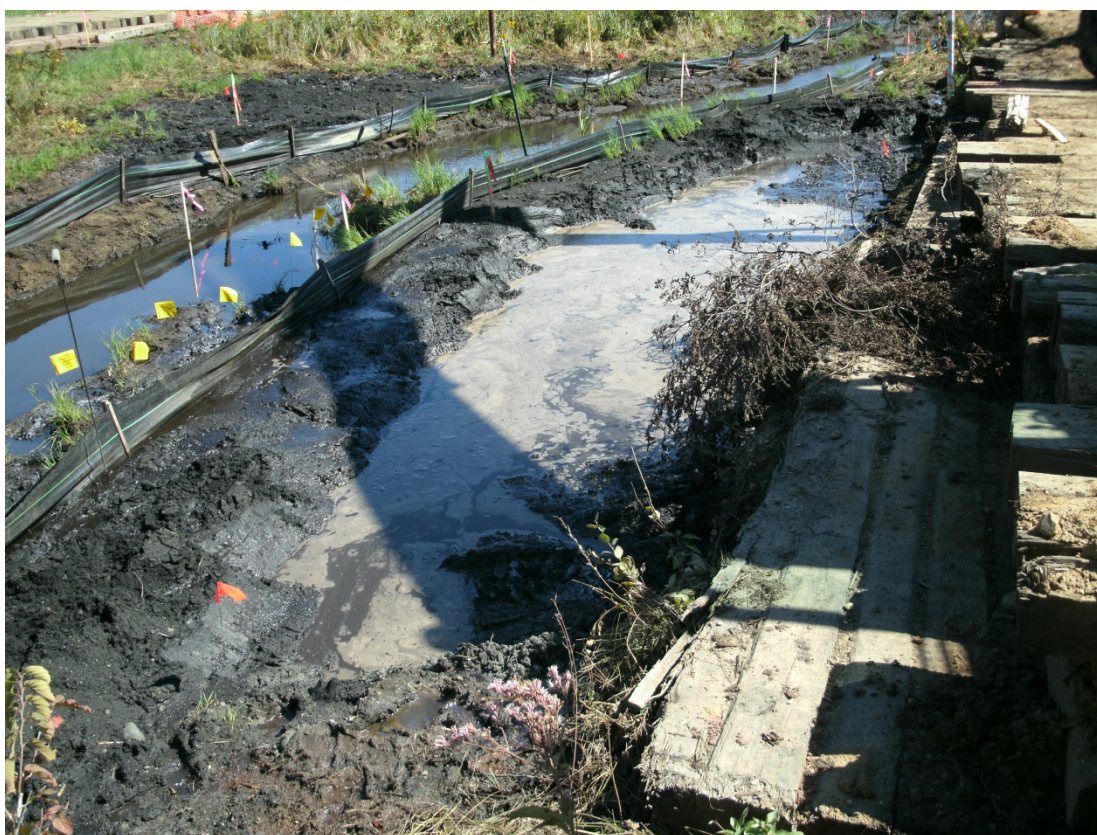
33+50L – 34+00L: Looking upstream (September 13, 2010)

33+50L → 34pool  
Trench 8:15 AM  
11:32 AM X  
Western Rep  
Paul Kyburat

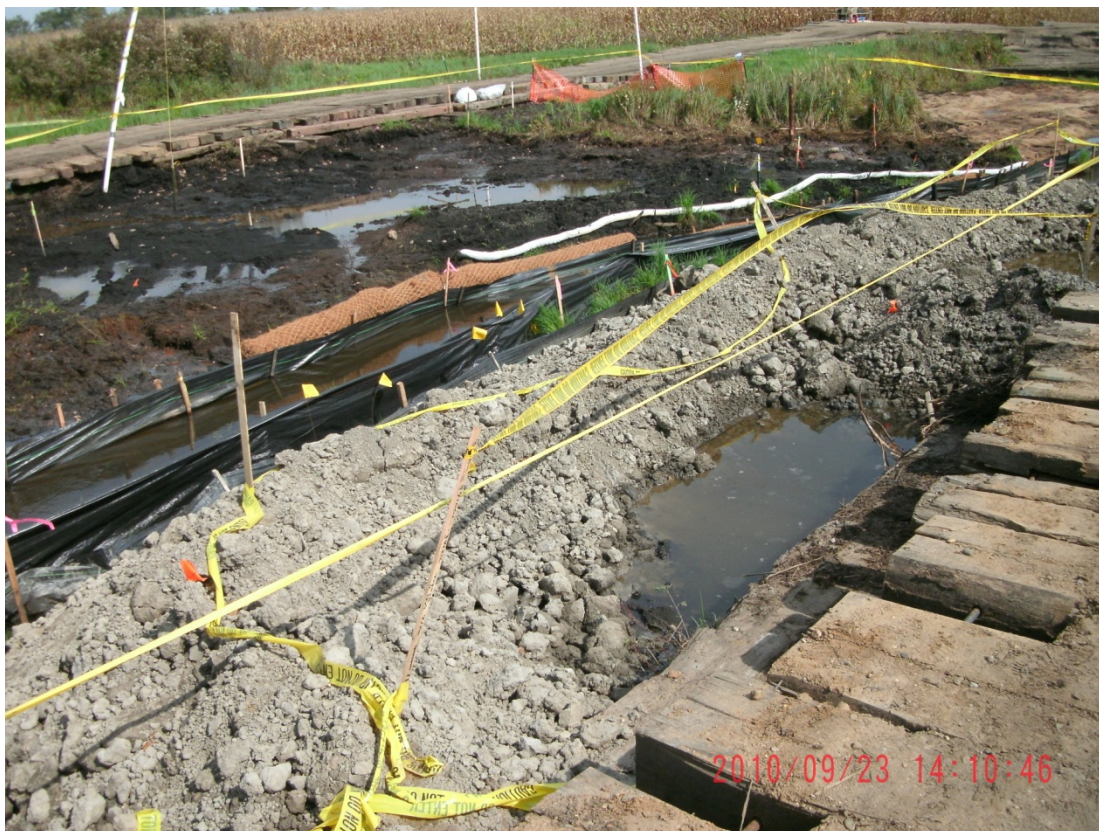
34+00L – 34+50L: Looking upstream (September 23, 2010)

34pool → 34+50L  
Trench 7:00 AM  
11:45 AM

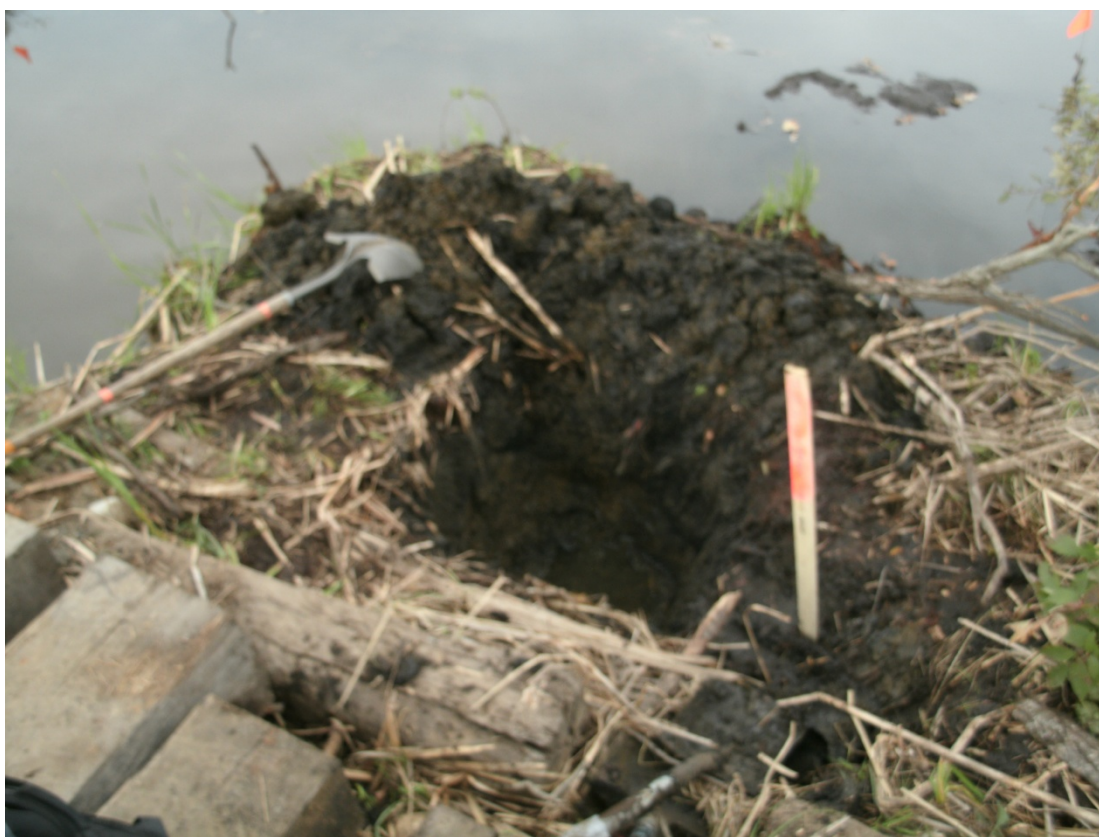
36+50L – 37+00L: Looking toward Talmadge Creek at 6-hour test pit (September 20, 2010)

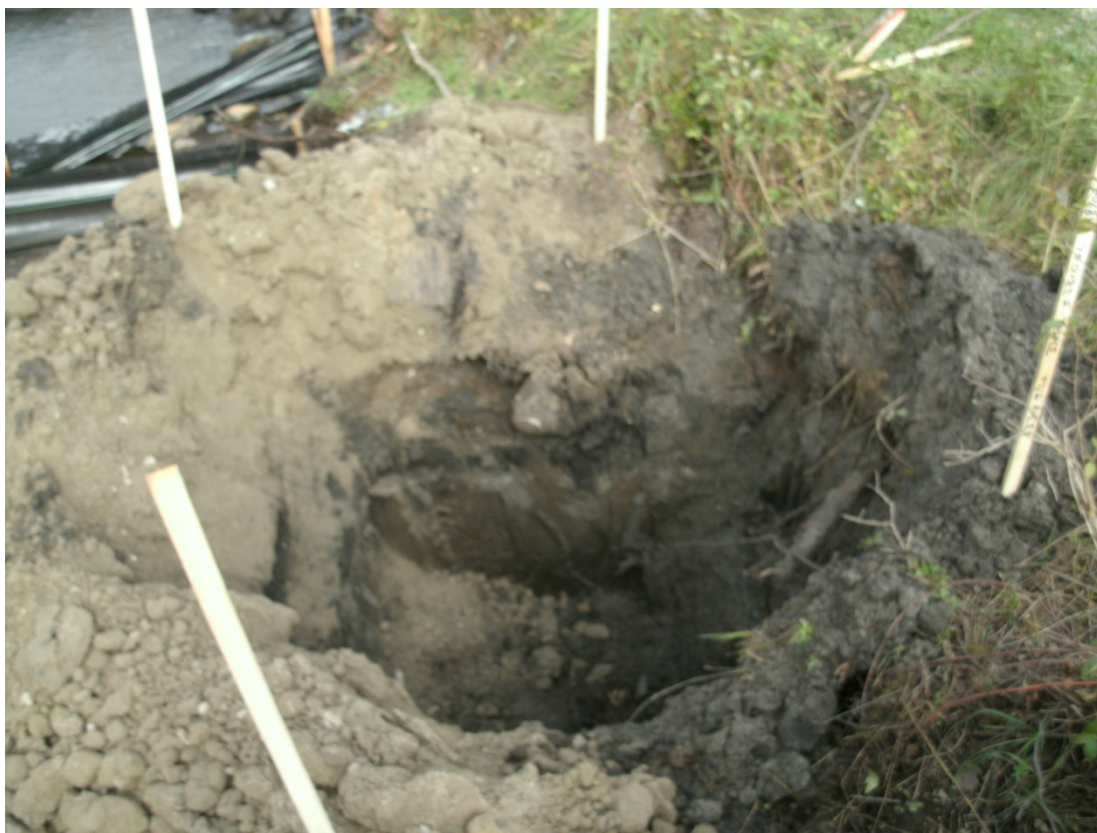
37+50L – 38+00L: Looking toward Talmadge Creek at 6-hour test pit (September 20, 2010)

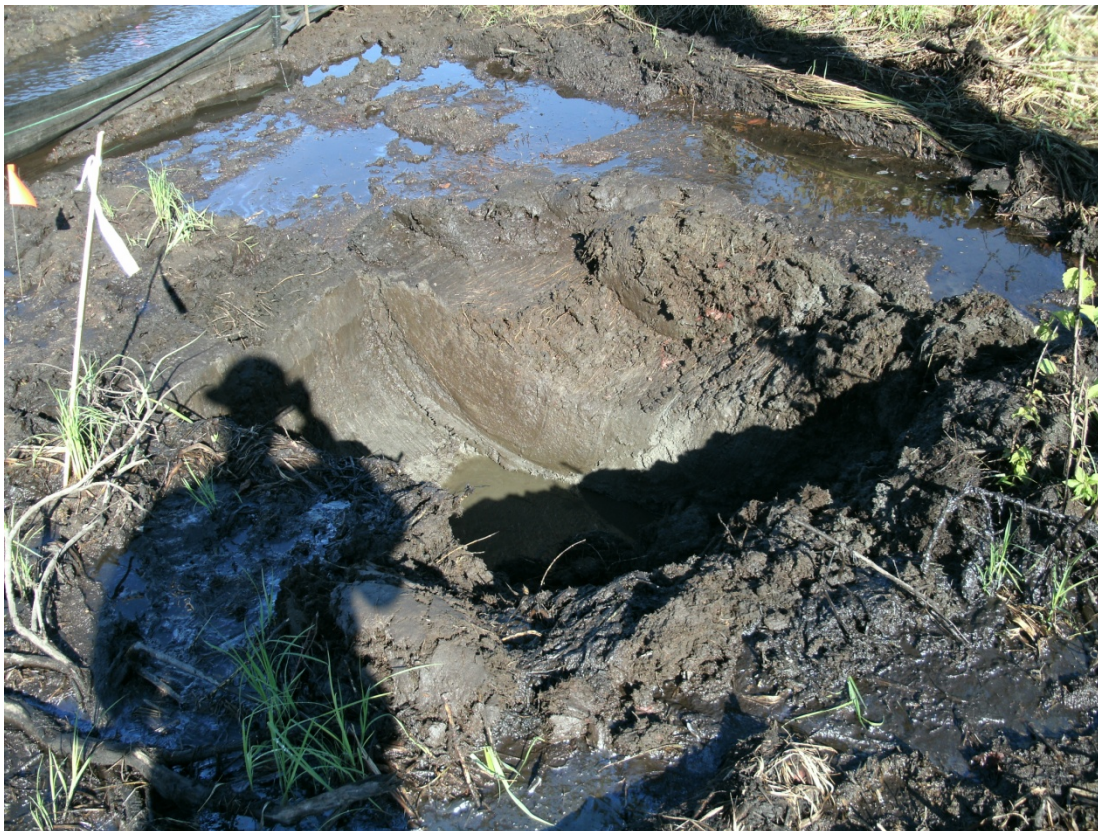
29+00R – 29+50R: Looking toward Talmadge Creek at 6-hour test pit (September 12, 2010)

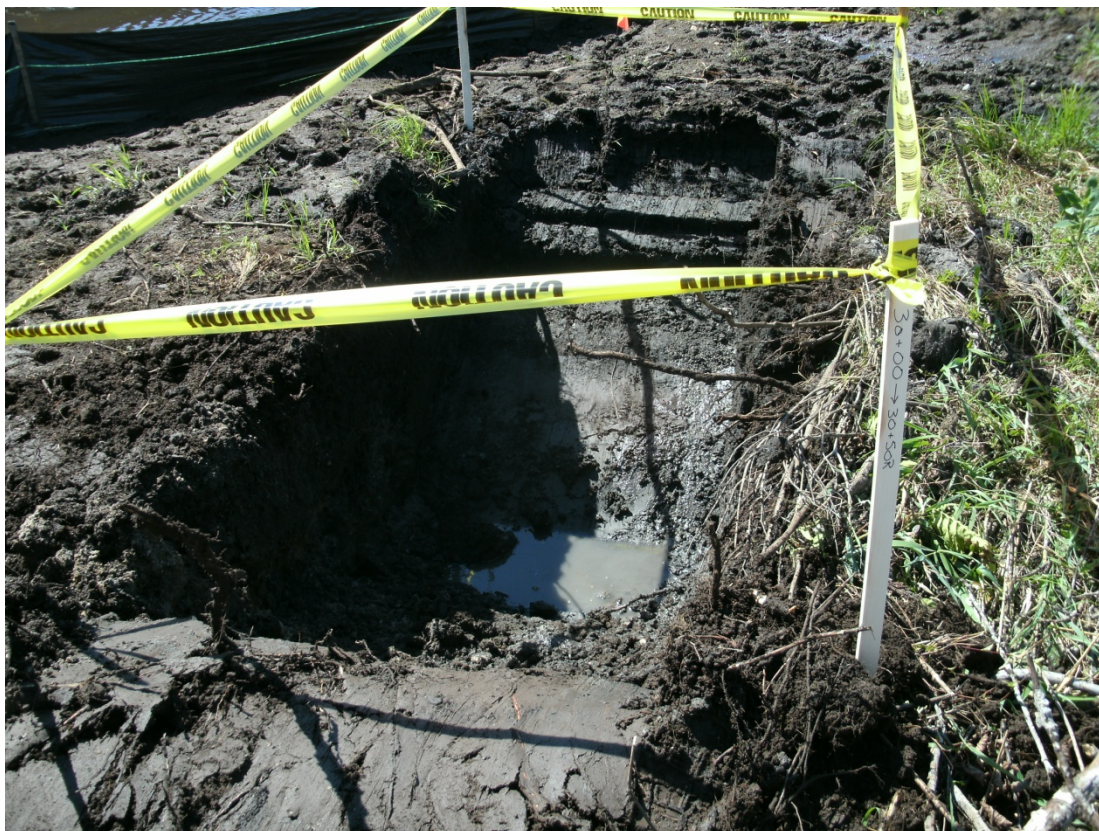
30+00R – 30+50R: Looking at 6-hour test pit (September 14, 2010)

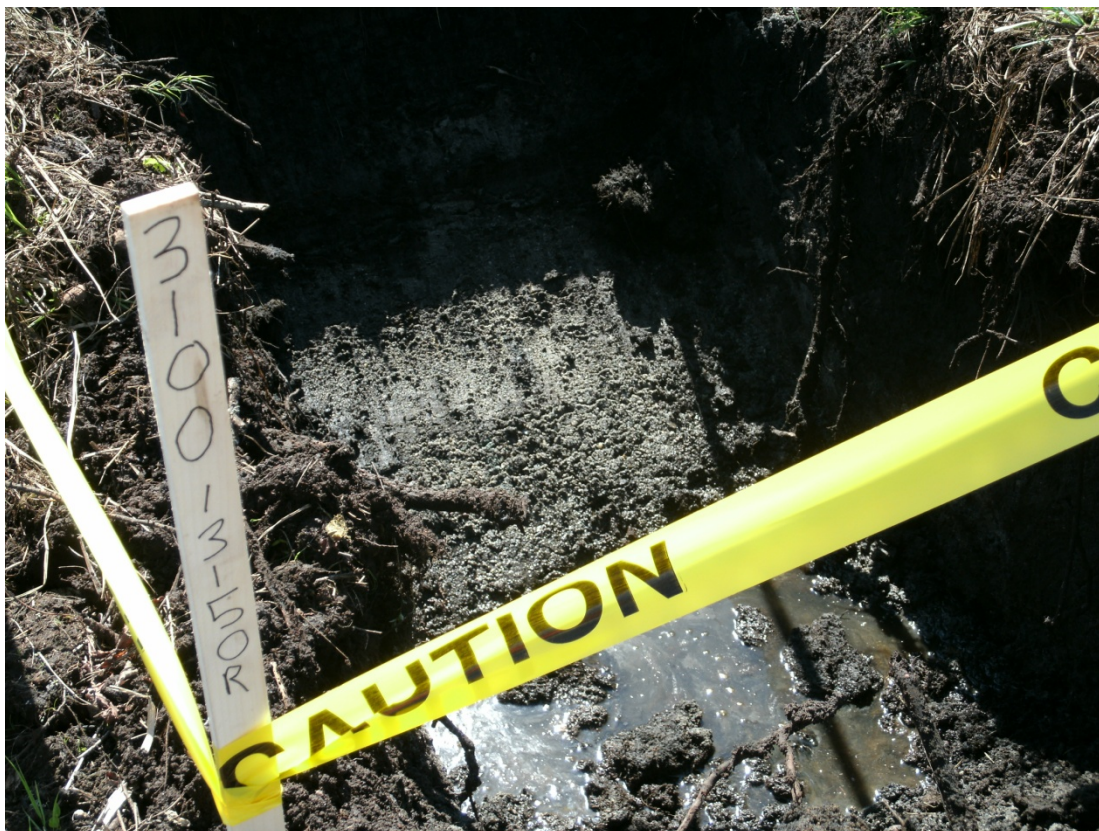
31+00R – 31+50R: Looking at 6-hour test pit (September 13, 2010)

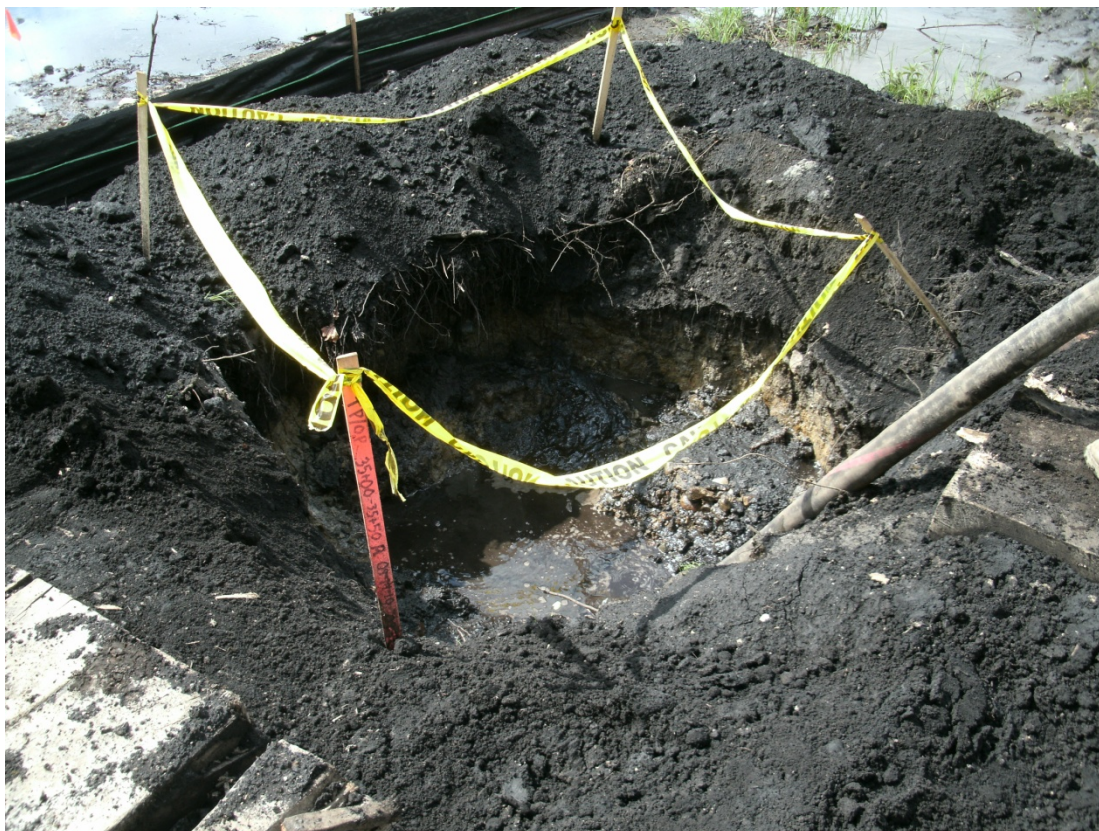
35+00R – 35+50R: Looking toward Talmadge Creek at 6-hour test pit (September 17, 2010)

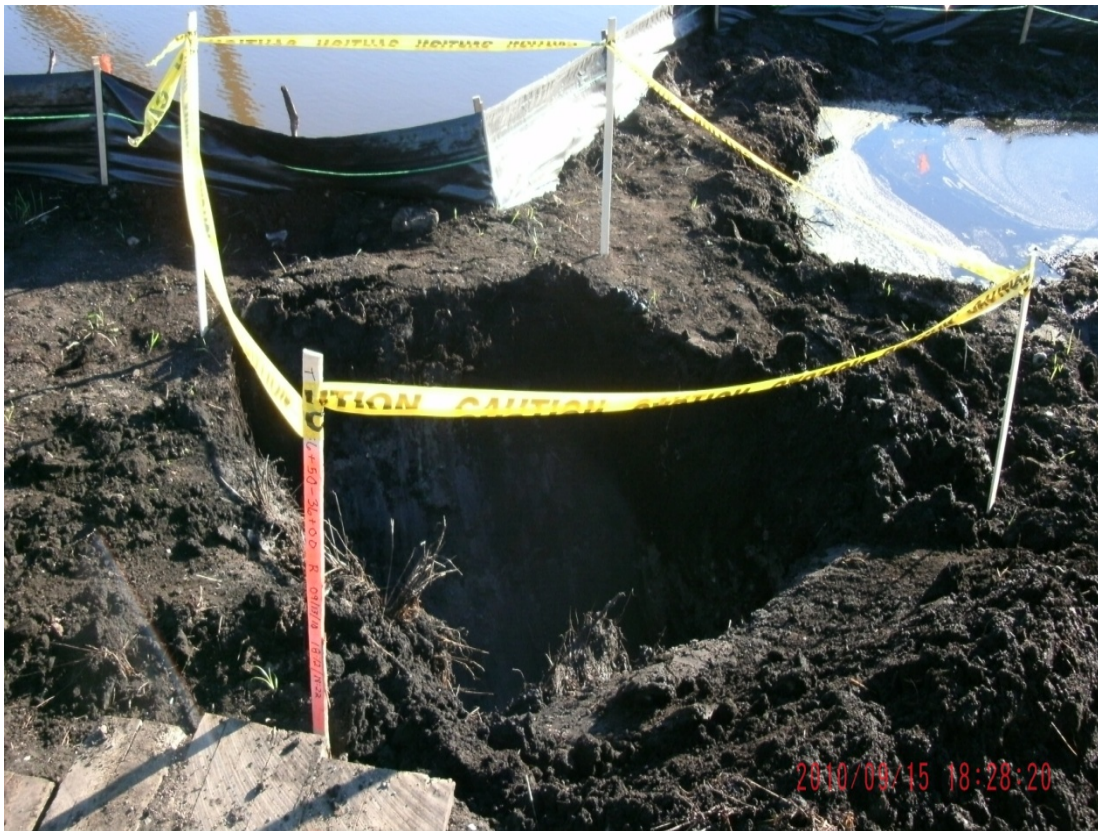
36+00R – 36+50R: Looking toward Talmadge Creek at 6-hour test pit (September 15, 2010)

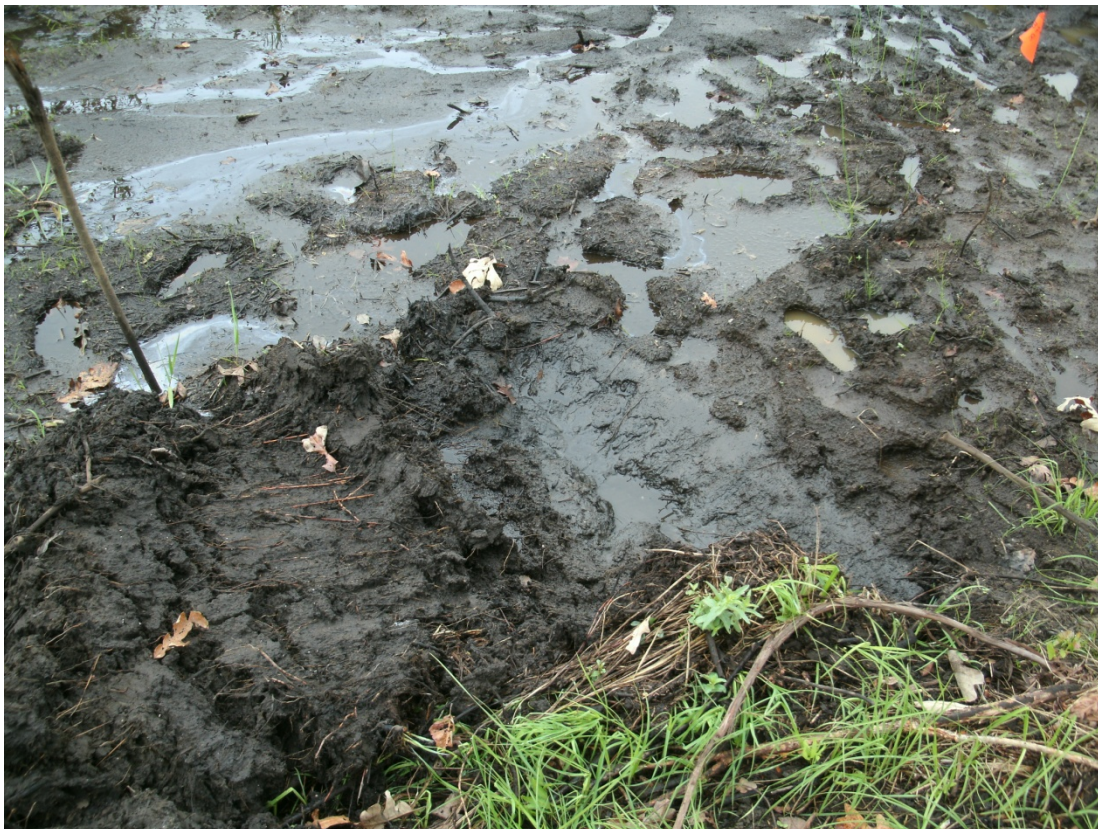
37+00R – 37+50R: Looking at 6-hour test pit (September 16, 2010)

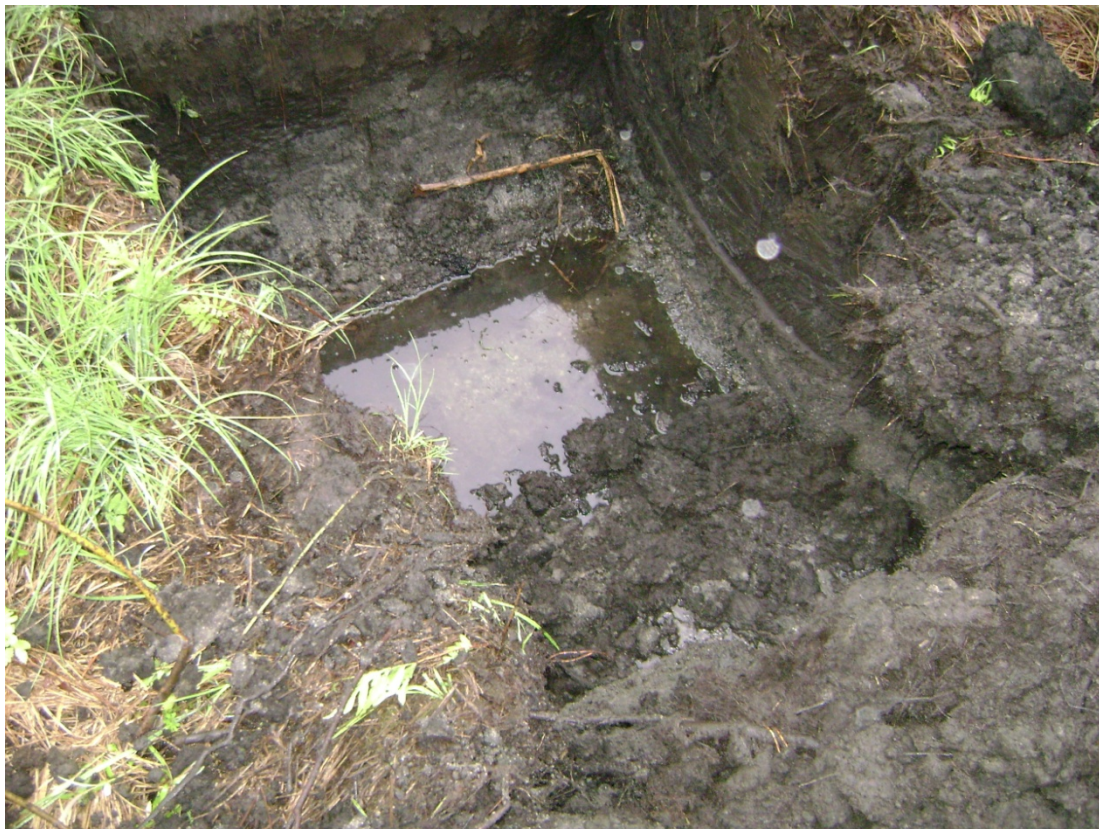
38+00R – 38+50R: Looking at 6-hour test pit (September 11, 2010)

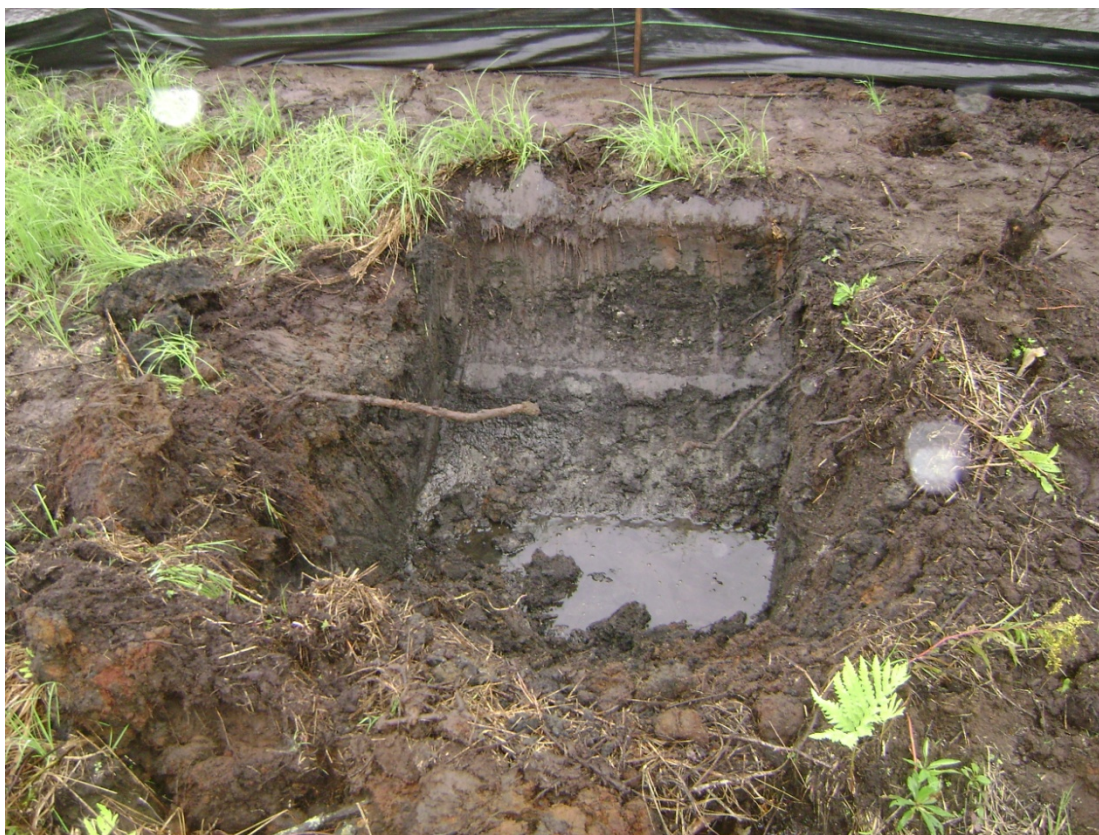
38+50R – 39+00R: Looking toward Talmadge Creek at 6-hour test pit (September 11, 2010)
