Subject: Biological Assessment Report for the Proposed Apex Matagorda Energy Center near
Clemville, Matagorda County, Texas

Biological Assessment Matagorda Energy Center Matagorda County, Texas

Prepared for
APEX Matagorda Energy Center, LLC

April, 2013

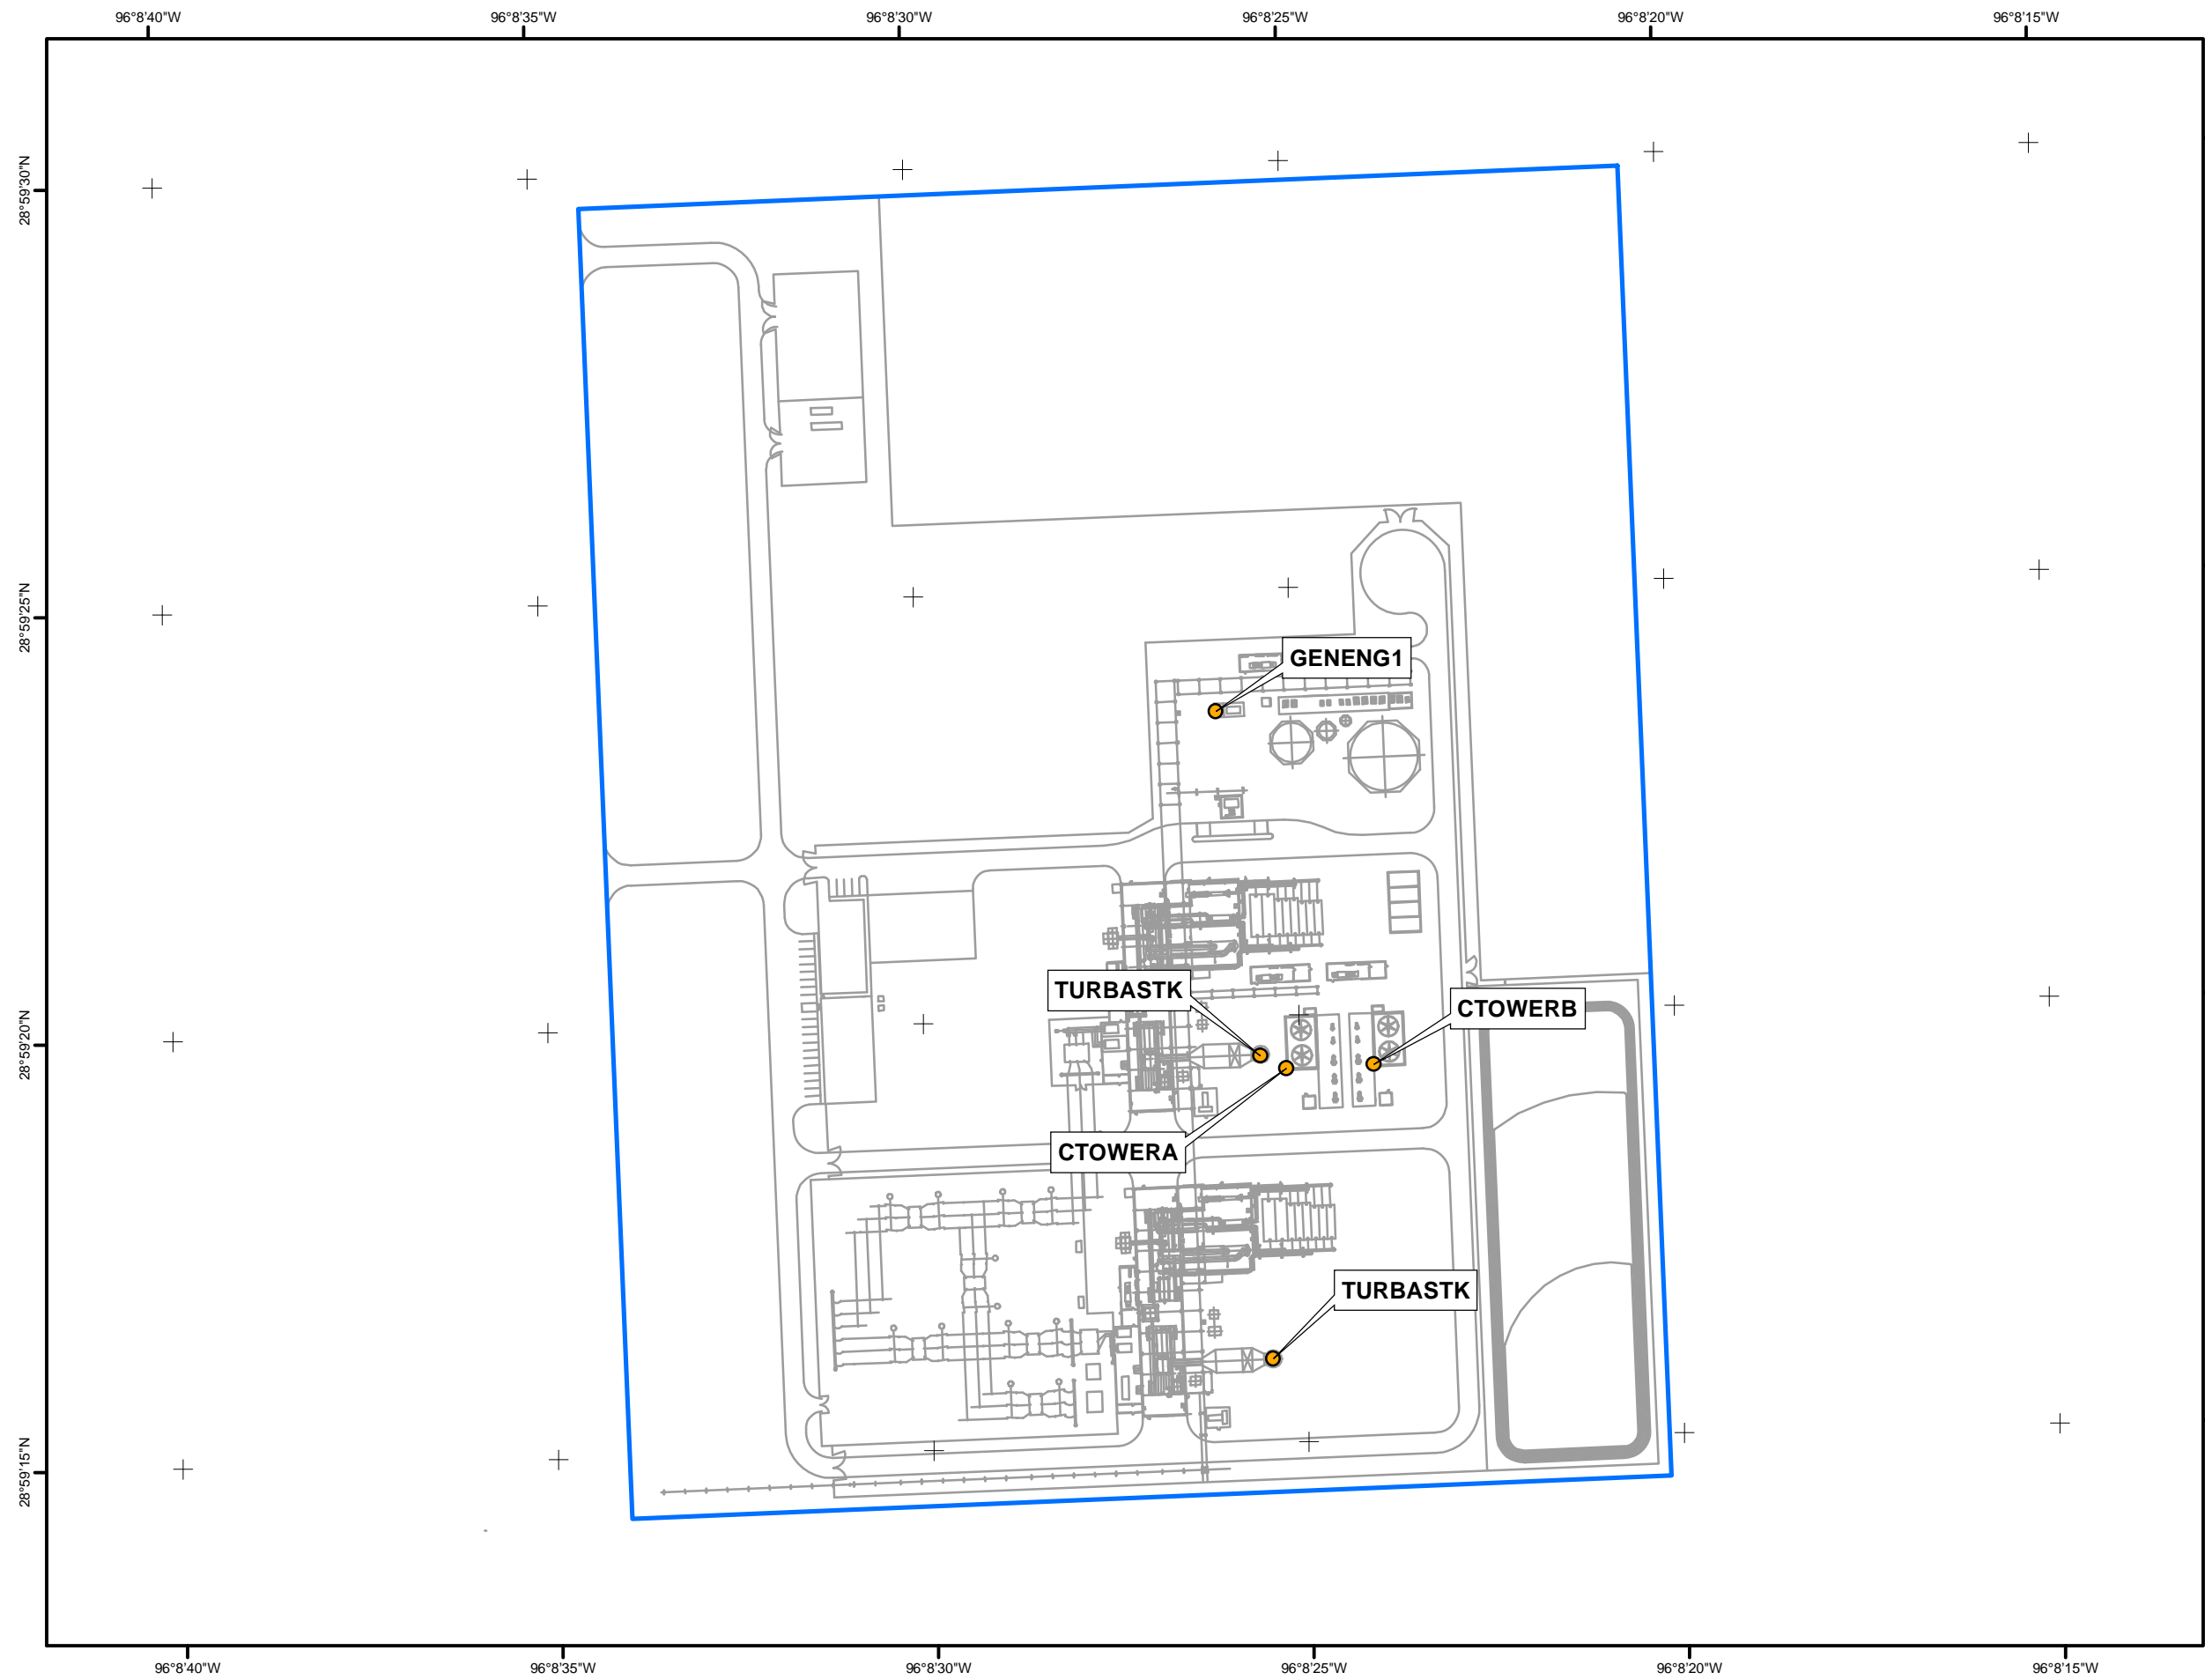
Figure 1-2
Proposed Matagorda Energy Center
Plot Plan
Matagorda County, Texas

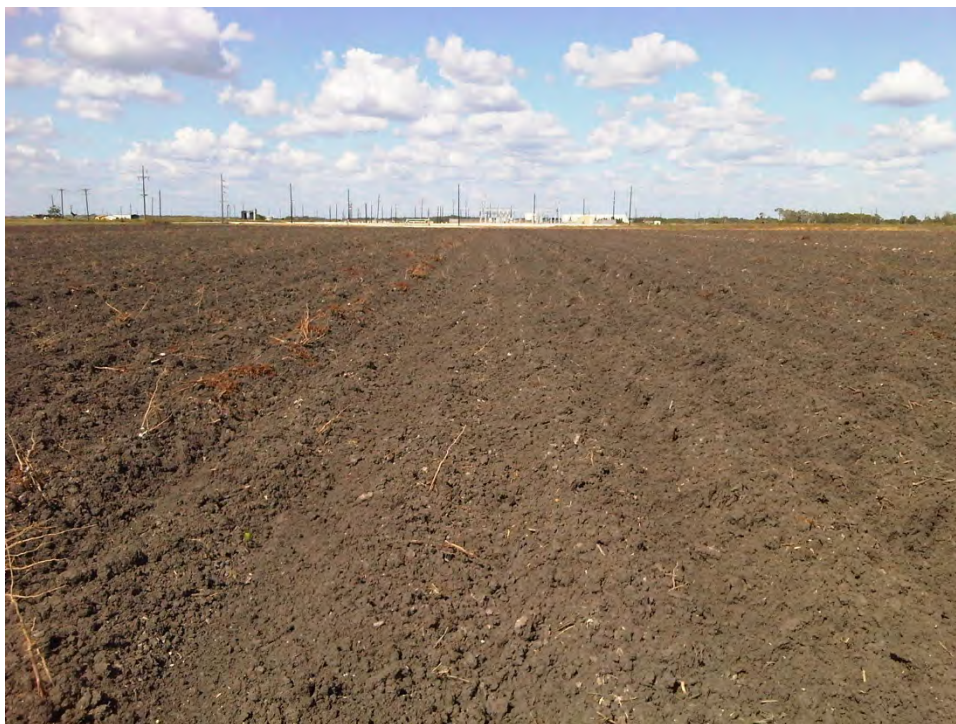
Site: Matagorda County, TX Photo: 1 Date: 11/1/2012 Direction: North
Subject: Representative photo of plowed agricultural field within proposed CAES facility property boundary.

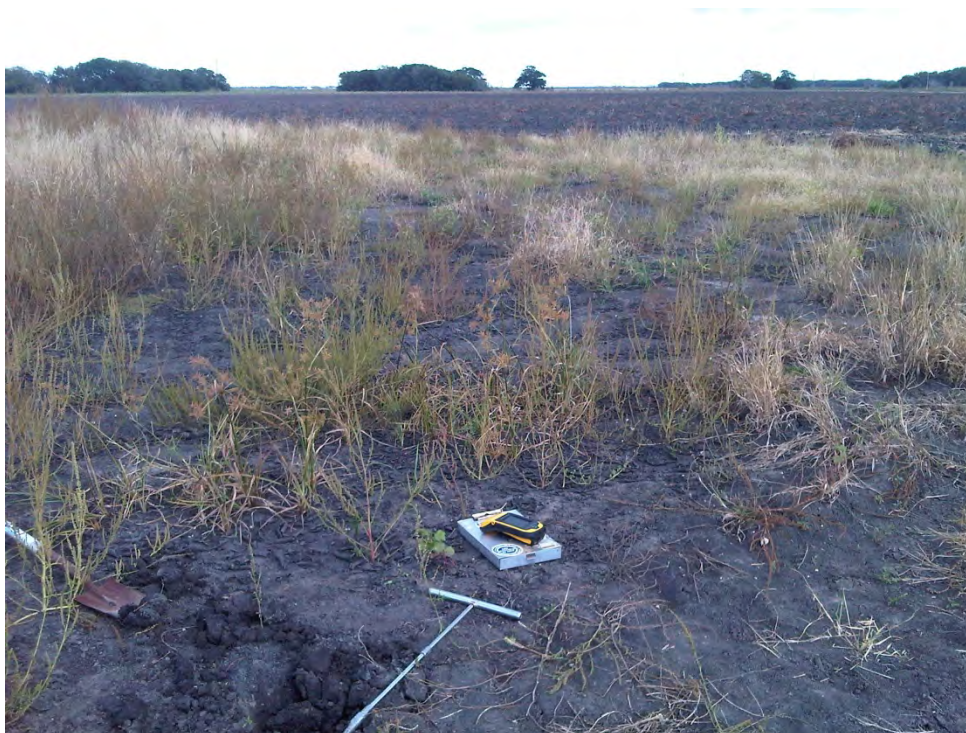
Site: Matagorda County, TX Photo: 2 Date: 11/1/2012 Direction: East
Subject: Representative photo of WL1_PEM, located along the north central boundary of the proposed CAES facility.

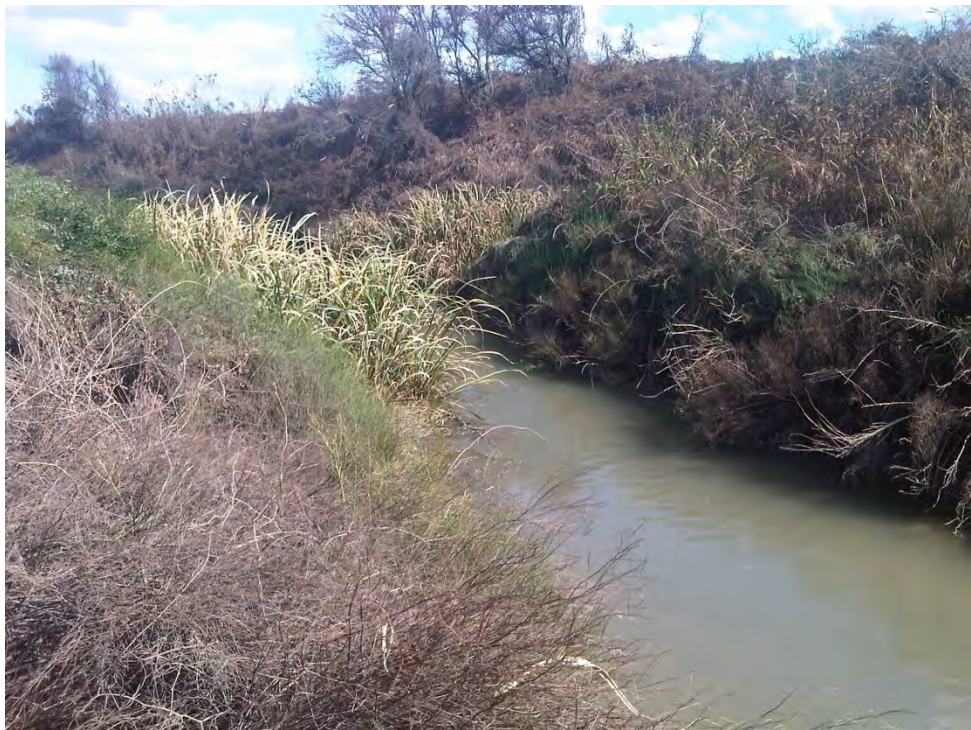
Site: Matagorda County, TX Photo: 3 Date: 11/1/2012 Direction: North
Subject: Tres Palacios River discharge location, facing upstream.

The discharge point for the spent cooling water is located within a relatively sinuous stretch in the upper reach of the Tres Palacios River. The river is deeply incised along this reach with banks approximately 15 feet deep, and a single channel that is approximately 12 feet wide and 1 foot deep. The banks of the river were highly stable with 100% vegetation cover and no evidence of bank erosion within the reach observed. Vegetation along the banks was dominated by Johnson grass, horsetail, and giant cutgrass. However, no fringe wetlands were present due to the bank steepness (approximately 30% slope). No riparian corridor was apparent at the point of discharge, as the tilled farmland abuts the stream bank. Aerial imagery indicates that a riparian corridor consisting of bottomland hardwoods may be present south of the Project, and National Wetland Inventory Database indicates potential palustrine forested wetlands within the riparian corridor (USFWS, 2011).

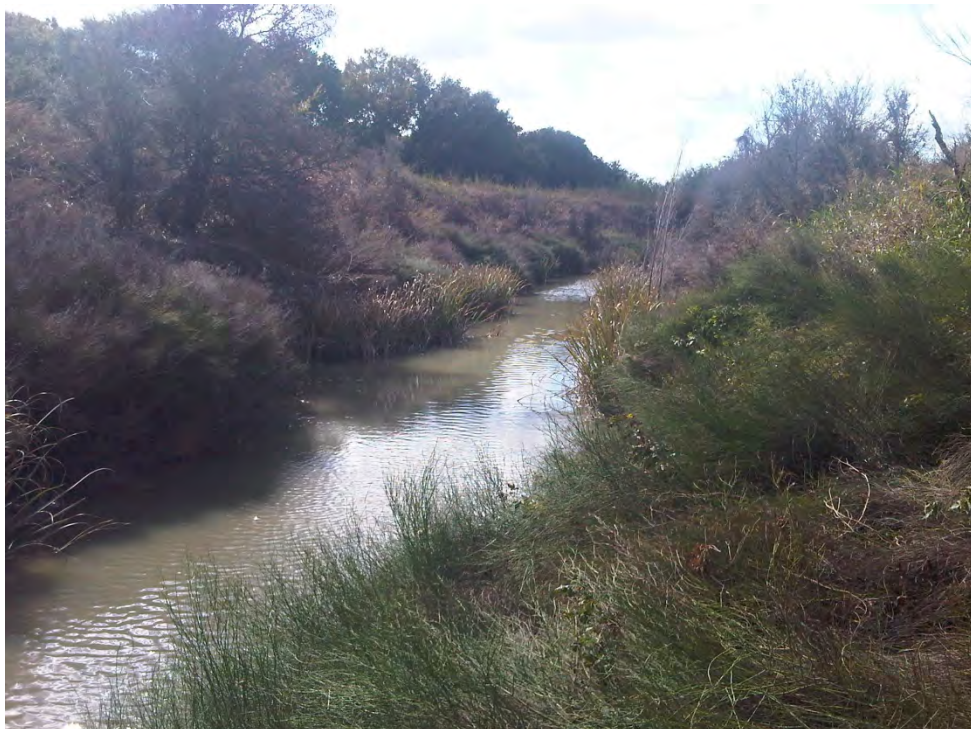
Site: Matagorda County, TX Photo: 4 Date: 11/1/2012 Direction: South
Subject: Tres Palacios River discharge location, facing downstream.

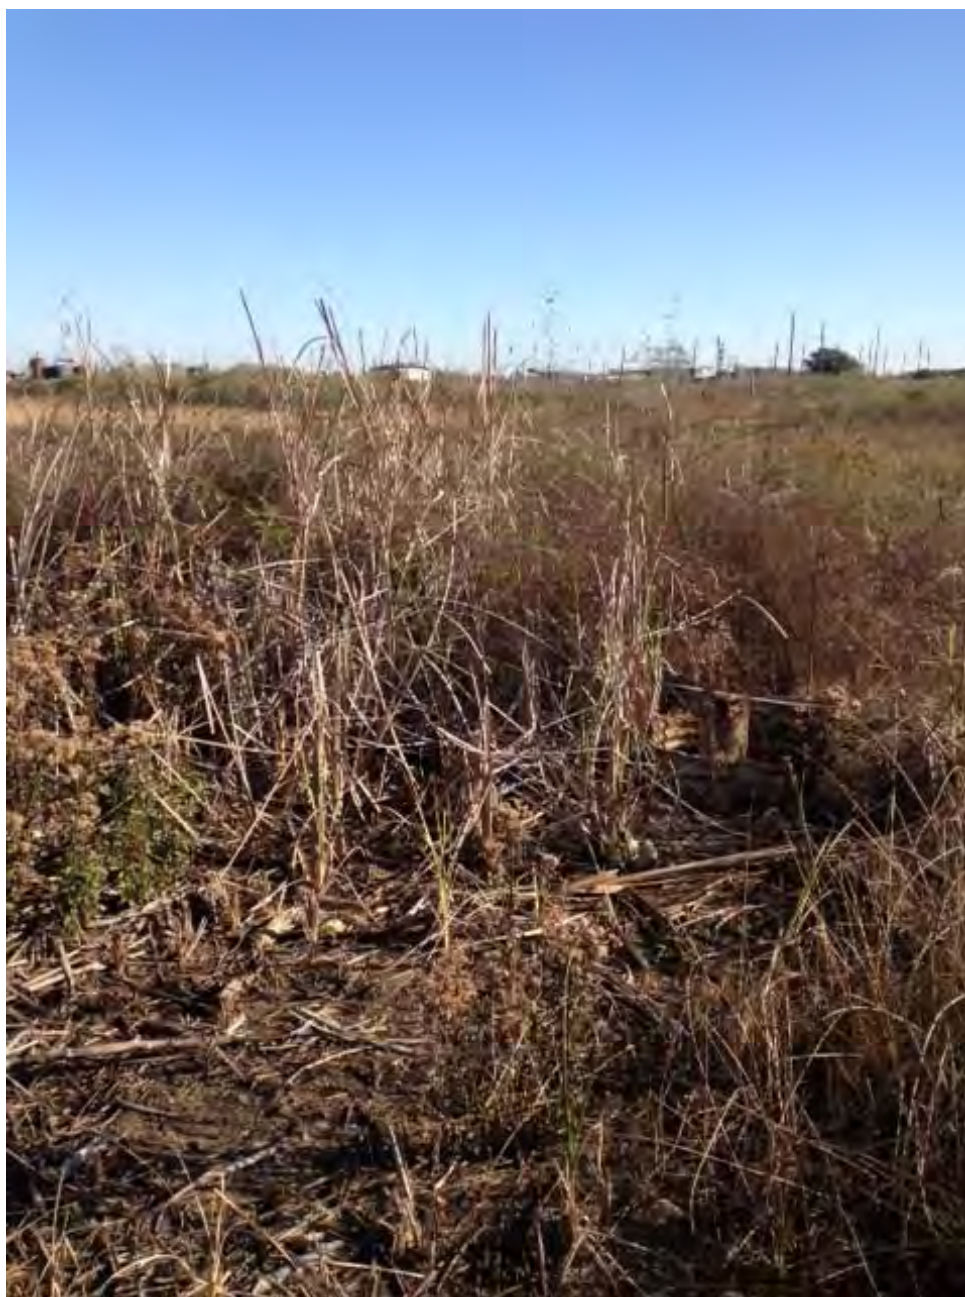
Site: Matagorda County, TX Photo: 5 Date: 12/13/2012 Direction: North
Subject: Representative photo of WL2_PEM, located along the northwestern boundary of the proposed air pipeline corridor.

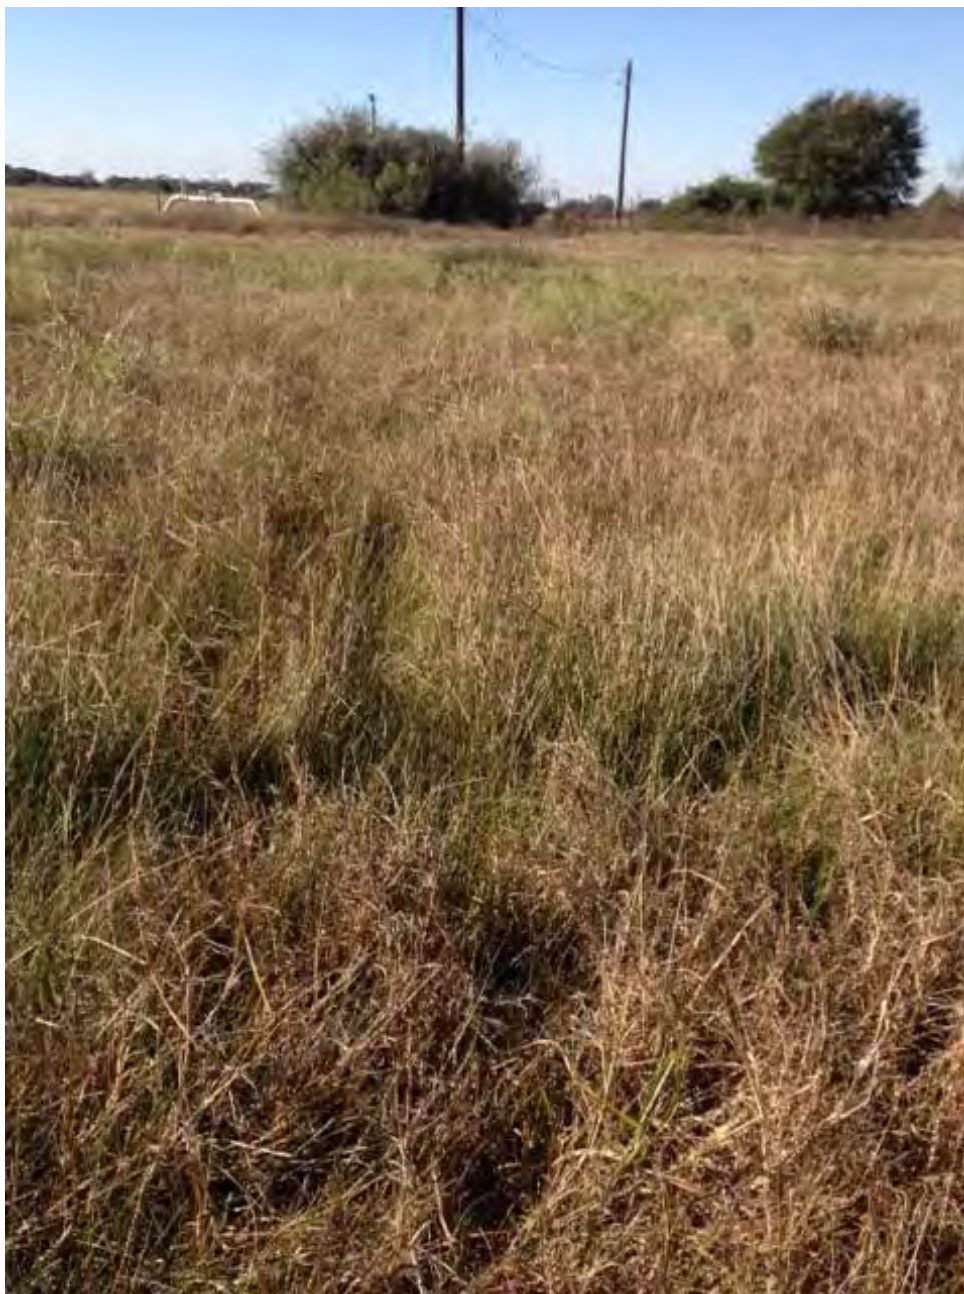
Site: Matagorda County, TX Photo: 6 Date: 12/13/2012 Direction: East
Subject: Representative photo of WL3_PEM, located along the western extent of the proposed air pipeline corridor.

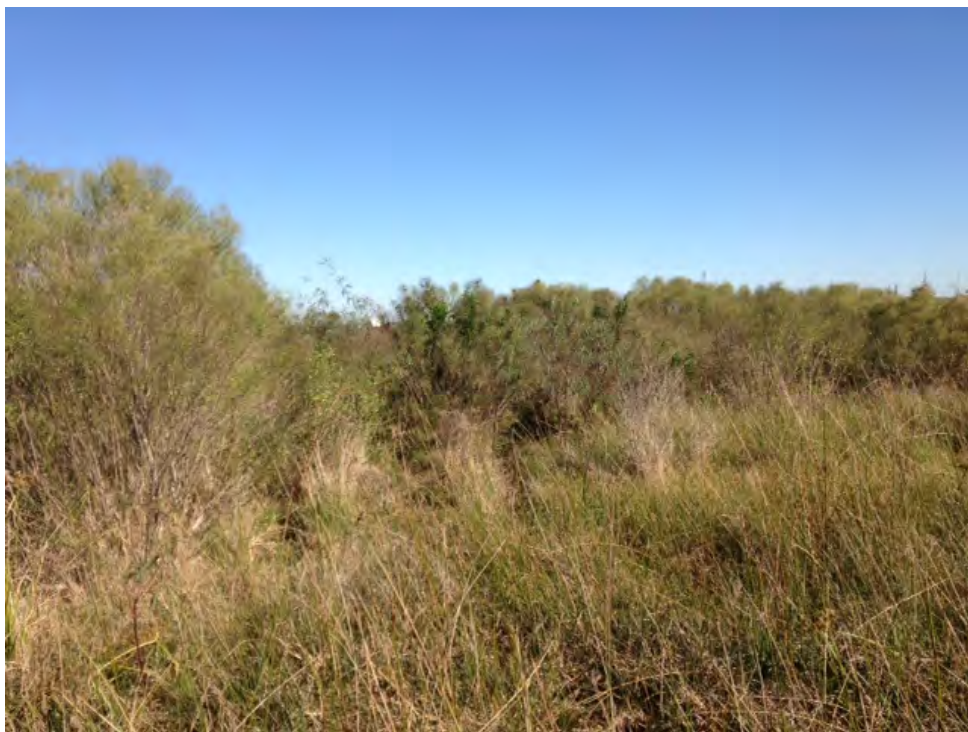
Site: Matagorda County, TX Photo: 7 Date: 12/13/2012 Direction: North
Subject: Representative photo of WL3_PSS, located along the western extent of the proposed air pipeline corridor within the delineated boundary of WL3.

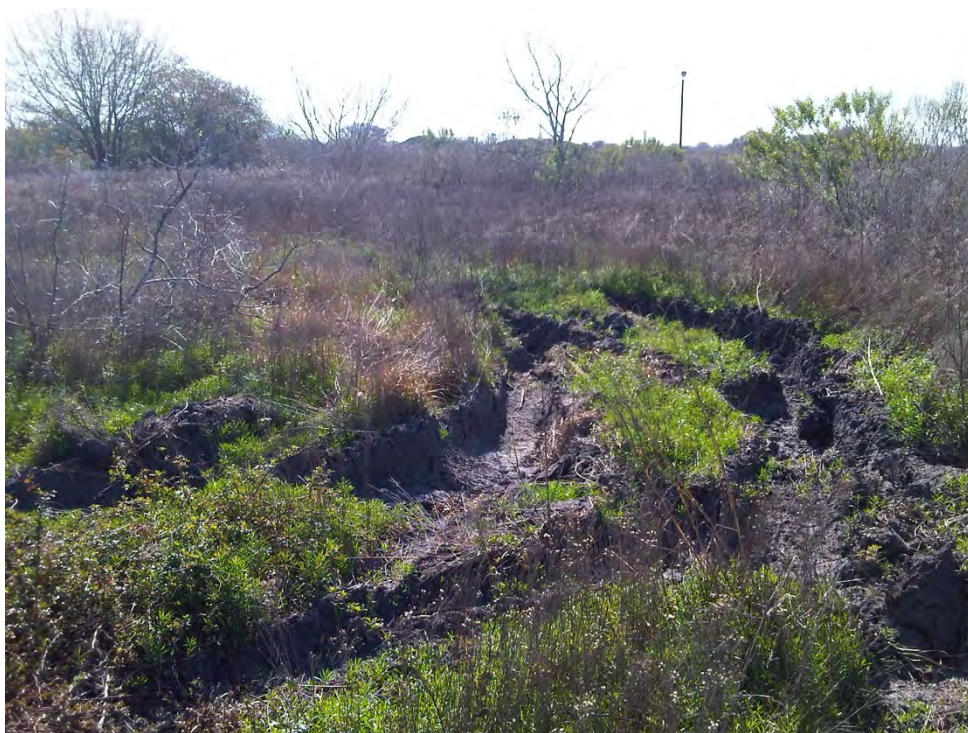
Site: Matagorda County, TX Photo: 8 Date: 3/13/2013 Direction: East
Subject: Representative photo of WL4_PEM.

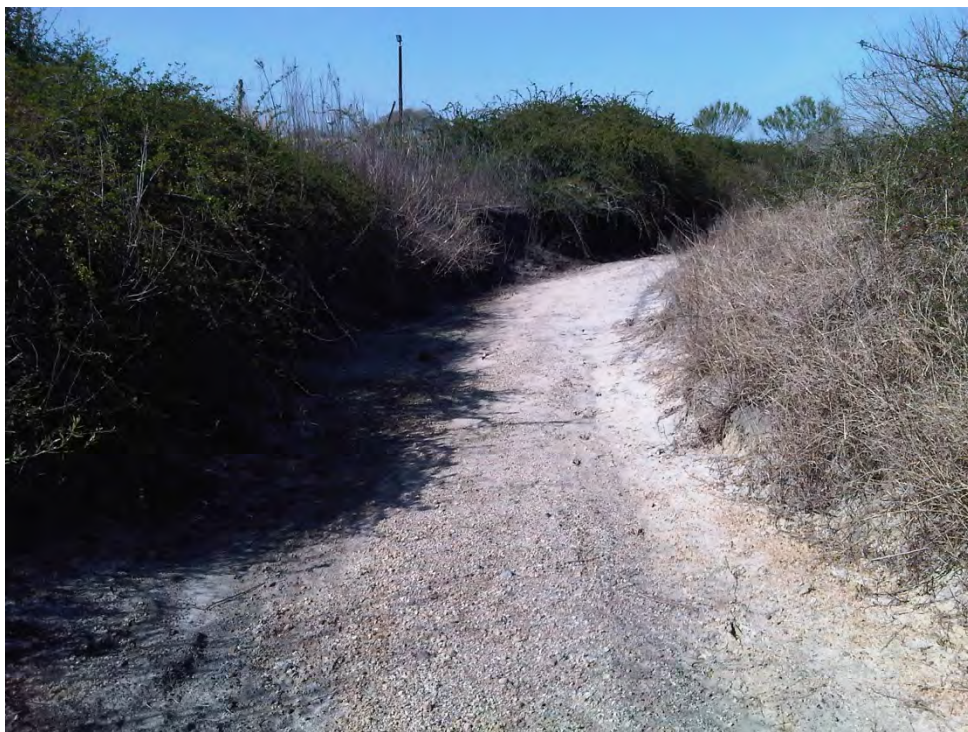
Site: Matagorda County, TX Photo: 9 Date: 3/13/2013 Direction: Southwest
Subject: Representative photo of S2, facing downstream

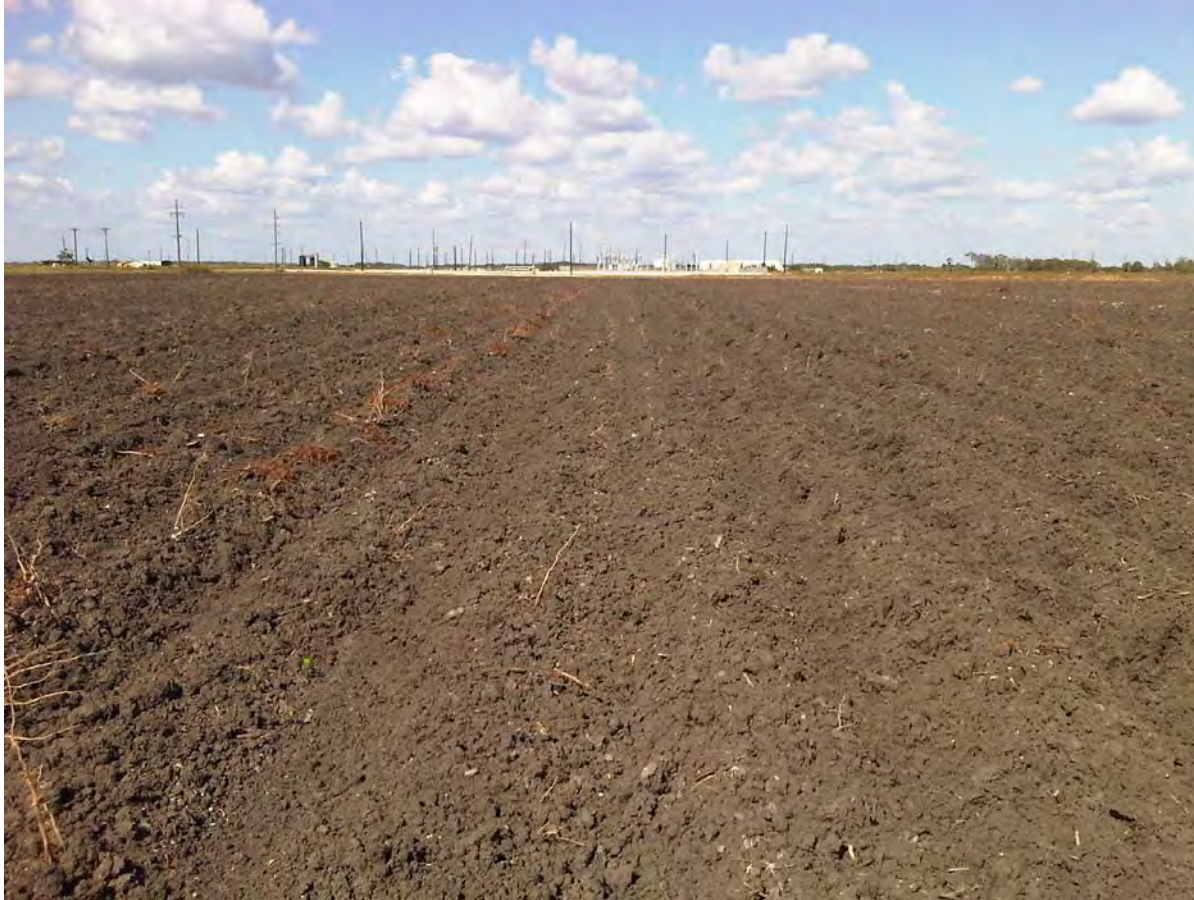
Photo 1: Representative photo of tilled cotton field within the proposed Project site facing north.

The current land use for the site and eastern wastewater pipeline corridor (located east for County Road 417) is predominately agricultural. During an August 15 site visit, this area was planted in cotton but was completely tilled during the November wetland/waterbody and habitat survey. The existing land use along the air pipeline corridor that extends west of the proposed plant site and County Route 417 is abandoned agricultural with adjacent gas pipeline facilities. During the November 1 and 2 and December 13 site wetland/waterbody and habitat survey, the area west of County Road was characterized by low scrub/shrub and grassland habitat with a plant assemblage typical of highly disturbed areas and abandoned pastureland. Site photographs 1 through 5 (attached following this letter) show site conditions at the time of wetland/waterbody and habitat surveys.

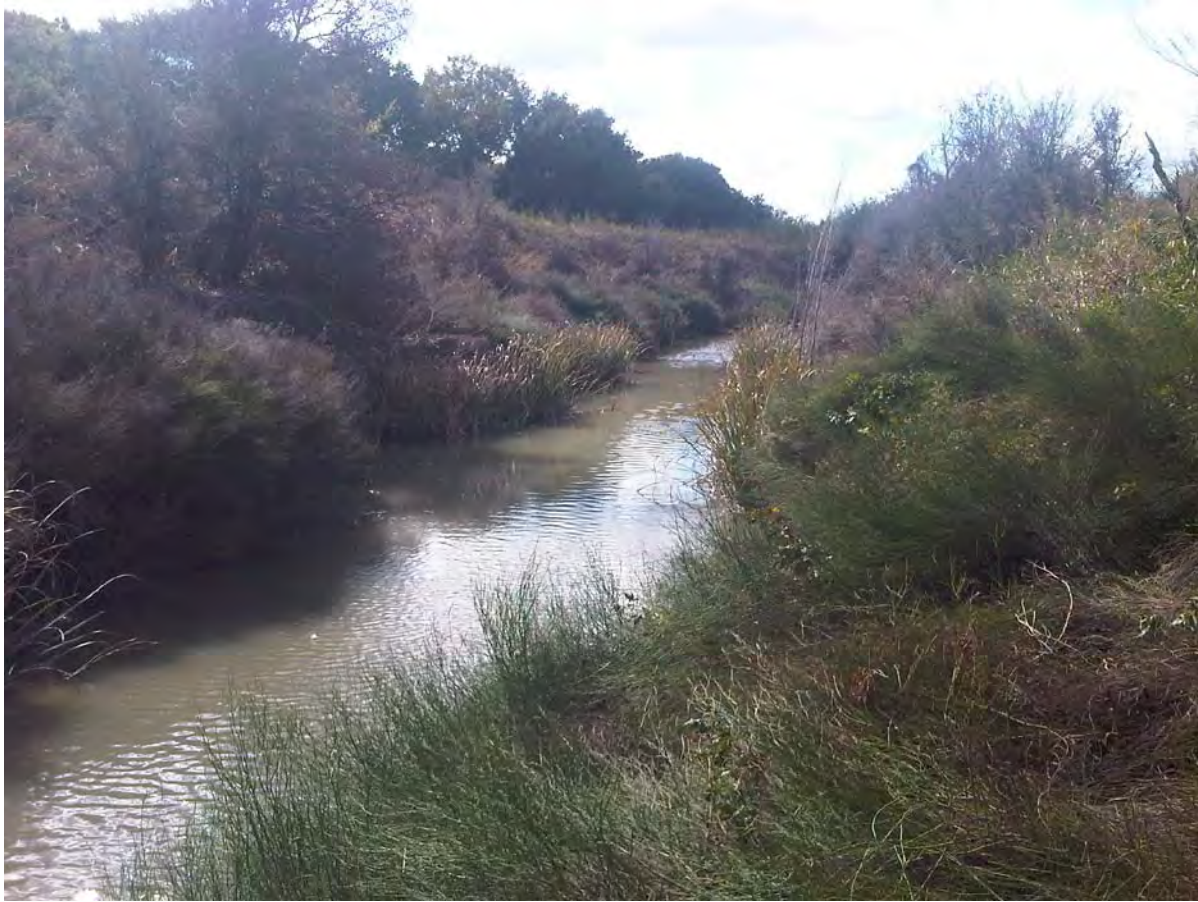
Photo 2. Representative photo of the Tres Palacios River at the eastern terminus of the wastewater pipeline.

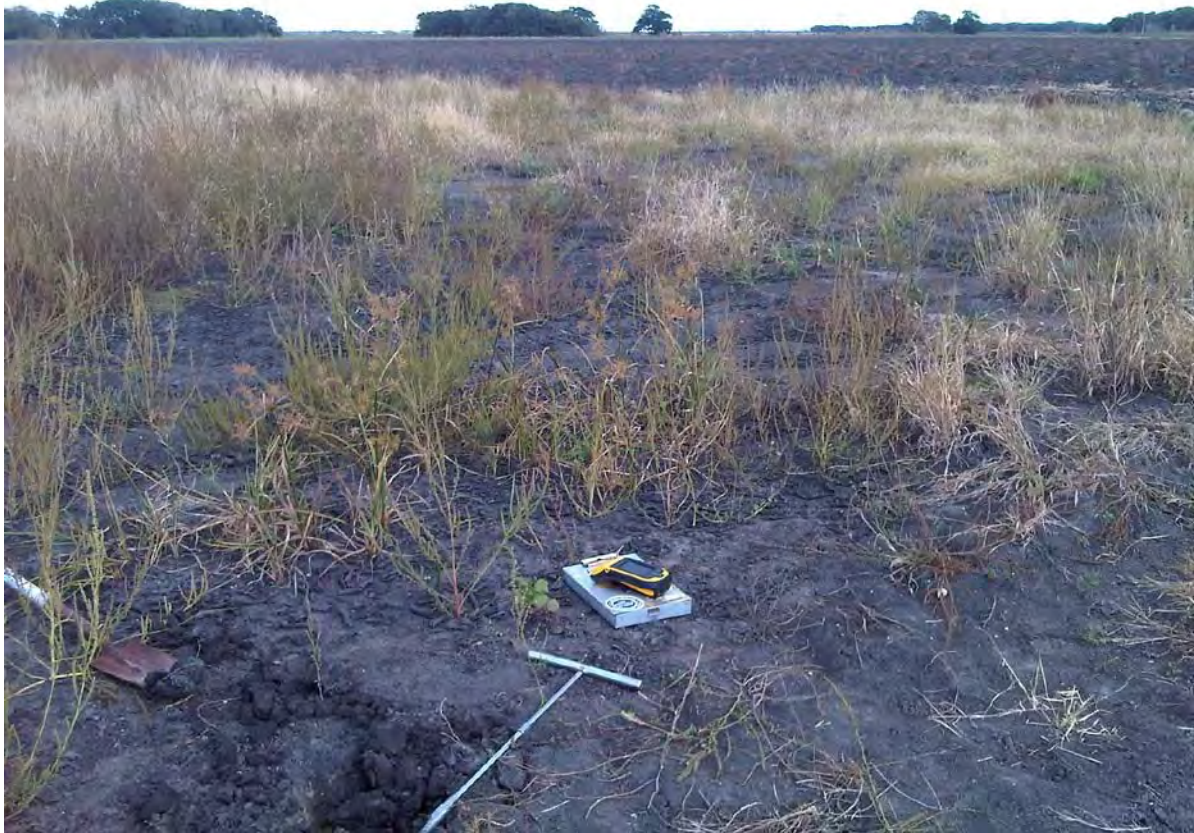
Photo 3. Representative of a small PEM wetland located on the northern boundary of the Project site.

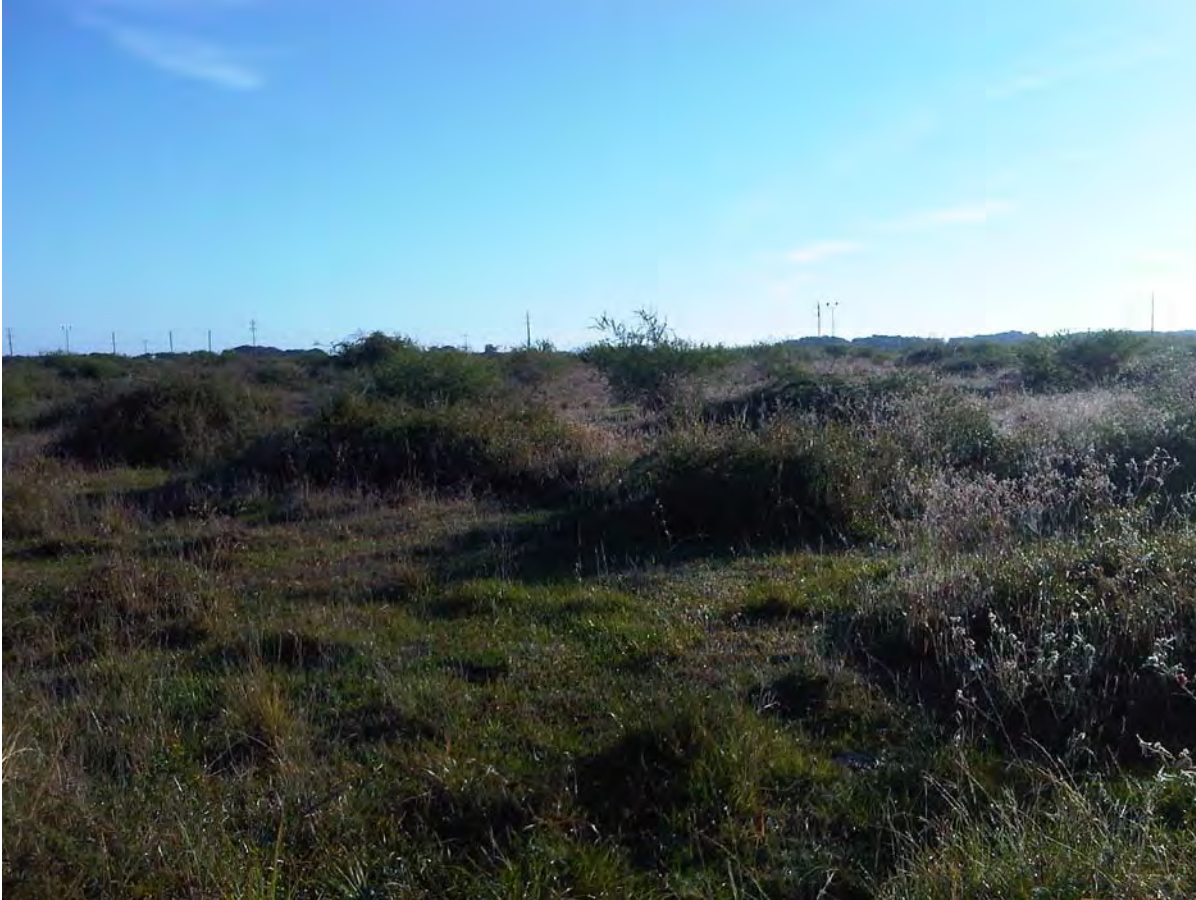
Photo 4. Representative photo of habitat located within the air pipeline corridor. This area is grazed by cattle.

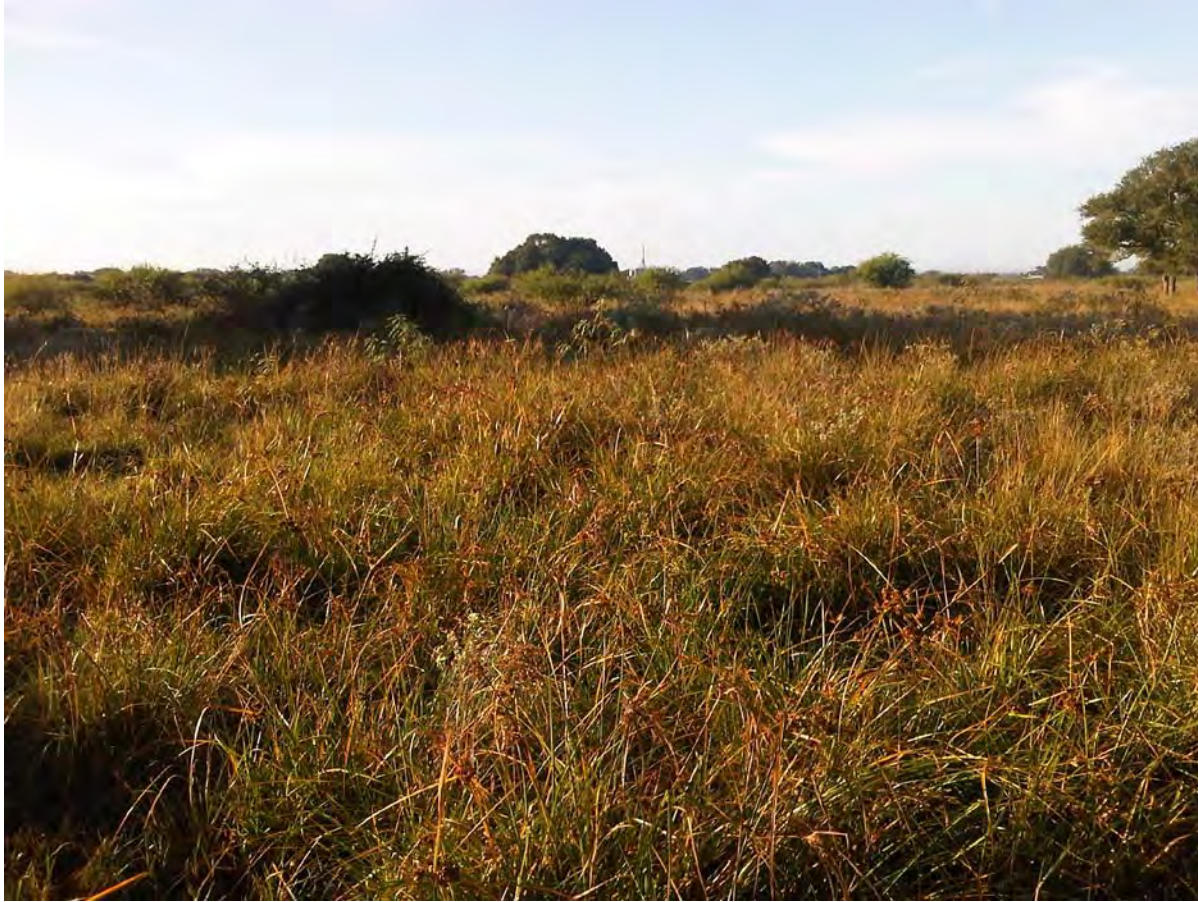
Photo 5. Representative photo of habitat located within the air pipeline corridor. This area is grazed by cattle.
