# Archaeological and Architectural Survey of the Apex Matagorda Energy Center Compressed Air Energy Storage Facility and Associated Infrastructure, Matagorda County, Texas

April 2013  
WSA Technical Report No. 2012-105

Report Title: *Archaeological and Architectural Survey of the Apex Matagorda Energy Center Compressed Air Energy Storage Facility and Associated Infrastructure, Matagorda County, Texas*

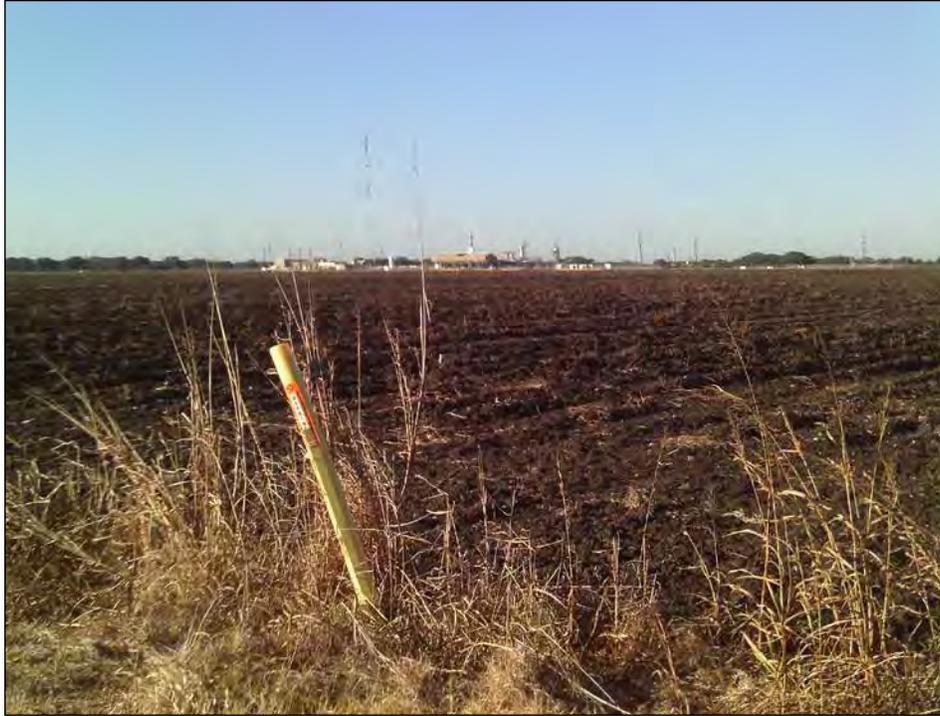
Photo 1. Project area, showing pipeline crossing of proposed wastewater corridor at CR 417, view to the southwest.

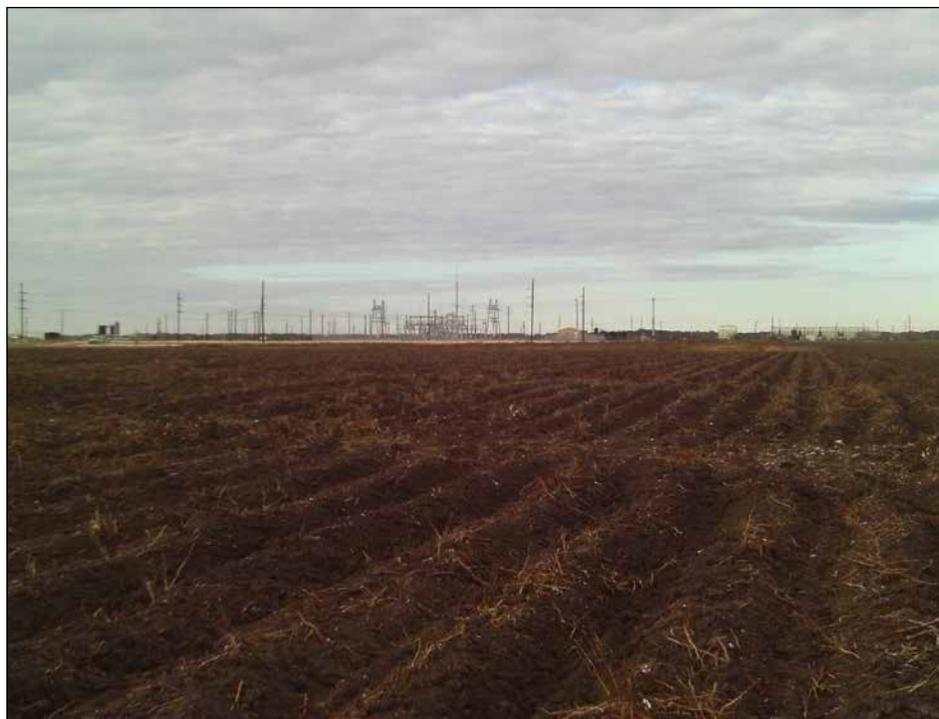
Photo 3. Linear depressions running perpendicular to furrows in the 43-acre proposed plant location, view to the north.

apart that cut across the 30-cm-wide tilled furrows. These lines line up both with the agricultural field and with the oil tank batteries. Because there are historic agricultural earthworks in the area (site 41MG133), these were investigated as potential agricultural earthworks. However, they had no integrity as earthworks and they were minimal depressions, not much lower than the bottom of the plow furrows. In addition, review of historic aerial imagery indicates these depressions show up some time after 1965 and before 1995, putting them out of temporal context of the known historic agricultural earthworks in the area, and more likely associated with modern oil activities (Google Earth 2013). The only other noticeable feature was an emergent wetland identified in the northwest corner of the proposed plant site, just south of an existing, modern oil pad.

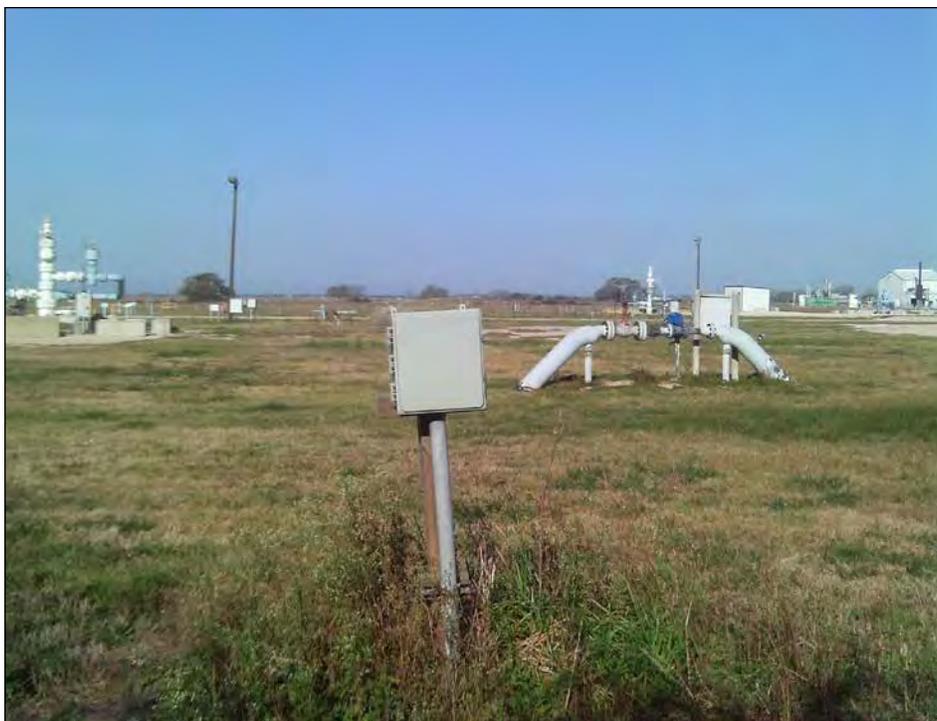
Photo 5. Some of the numerous underground disturbances and facilities of the Texas Brine Facility, view to the west.

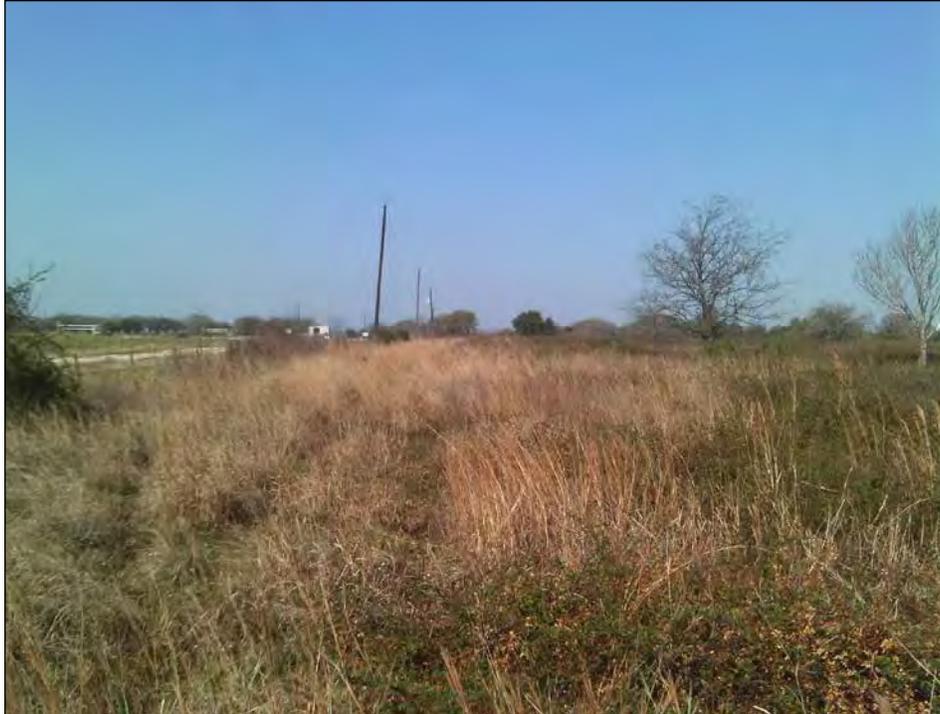
Photo 7. Survey corridor from the east end of the east-to-west portion of the corridor, showing the gravel road and existing pipeline to the south of the survey corridor on the left side of the frame, view to the west.

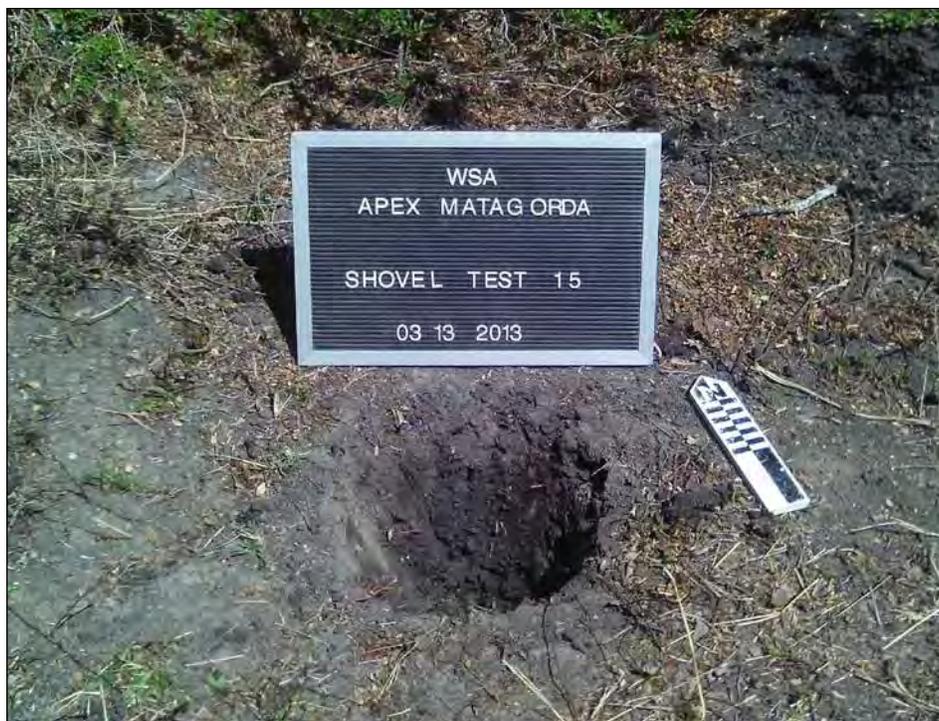
irrigation feature/structure. The shovel tests generally showed 0 to 30 cm of black clay over mottled Beaumont Formation (Photo 8); the shovel tests closer to the historic canal generally showed 10–15 cm of black clay over mottled Beaumont Formation. The tests in the area of the wetland also showed a veneer to 25 cm of sand to sandy clay over the black clay (see Table 2). The majority of the tests are consistent with modest disturbance of the ancient soil mapped in the area; the tests within the wetland suggest a thin veneer of alluvium has been deposited atop the clayey soil, perhaps as part of the surface operation activities or rice field flooding. All tests were negative for cultural materials, and no cultural resources were observed within the proposed freshwater/brine pipeline corridor.

Photo 8. Shovel Test 15, showing the black clay indicative of the ancient soil mapped in the area, view to the north.

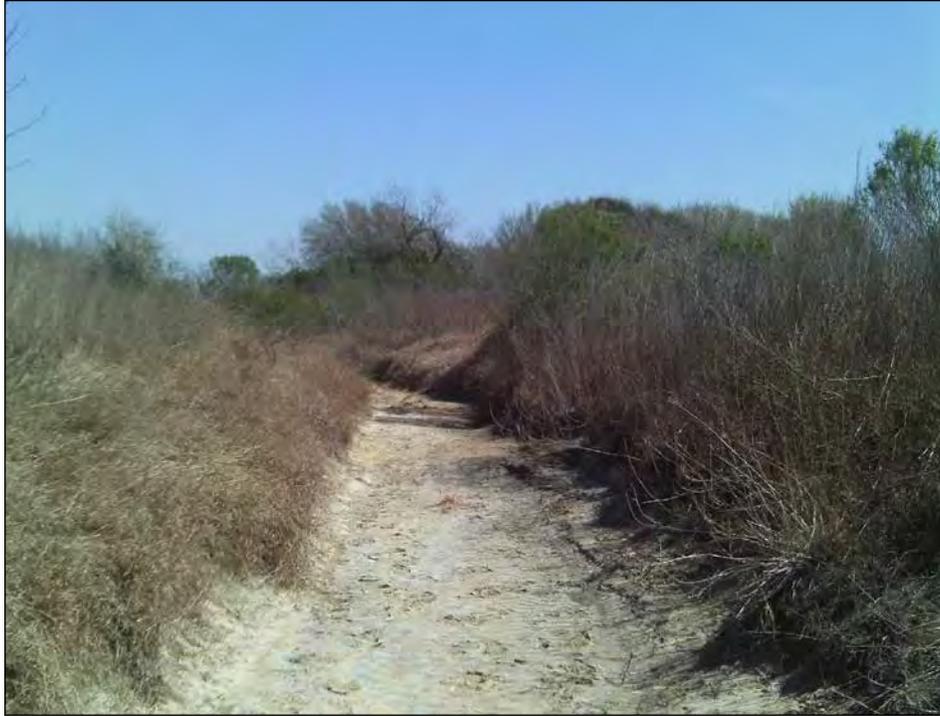
The historic irrigation ditch consists of a canal with deflated berms (Photo 9). No artifacts or features aside from the ditch and associated berms were identified during survey investigations. The ditch is approximately 1–1.5 m deep and is 2 m wide with steep walls. The berms on either side of the ditch are less than 0.5 m tall from the surrounding ground surface and 4–5 m wide. When viewed on aerial images, the ditch originates at Willow Creek, to the west; it travels 1,969 feet (600 m) east, and then turns northeast and runs 2,772 feet (845 m) to FM 1468, where it has been direct-

Photo 9. The historic irrigation canal feature; the sandy bottom is a sandy veneer, likely historic–modern sediments deposited during irrigation episodes, view to the east.

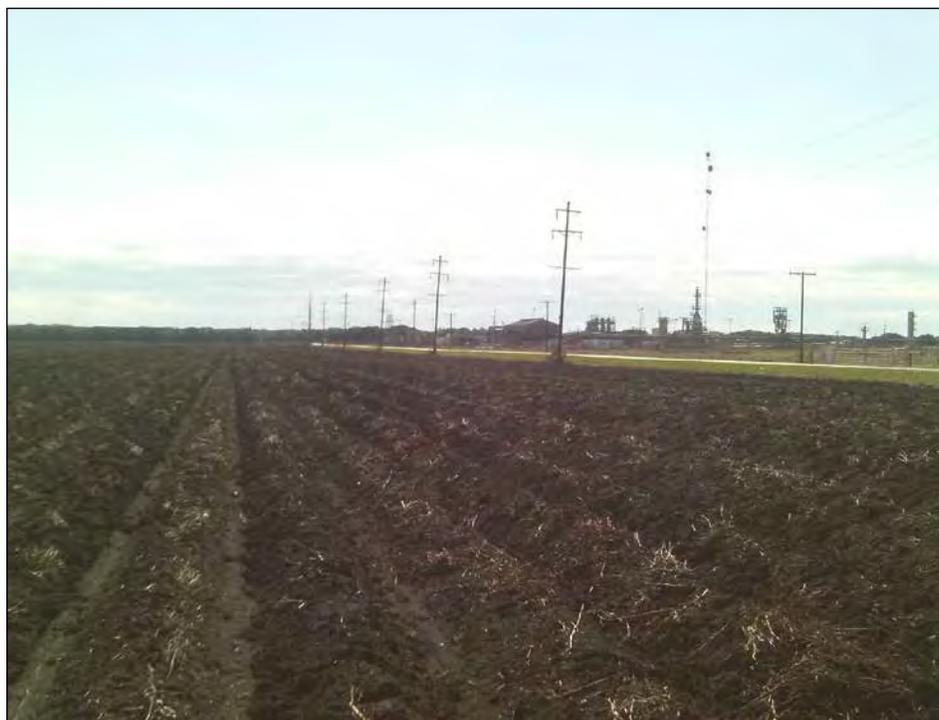
Site 41MG137 is a scatter of historic artifacts that date from the early to mid-twentieth century, and are characteristic of a typical domestic site (Photo 10; see Figure 3). Based on the presence of Depression glass, it appears the site was likely occupied until the 1930s (Photo 11). By the mid-1940s, any structure that had been on the property was gone, as aerial imagery from that time shows no evidence of anything except agricultural fields (Google Earth 2013). The site is located

Photo 10. Overview of 41MG137 site location, view to the south.

within a flat (0–1 percent slope) agricultural field that is currently being used for cotton production (see Figure 2). The Tres Palacios River is the closest water source, and is located approximately 850 m to the east. Soils at the site are a sticky black (10YR 2/1) Laewest clay. The Laewest Series is part of the Beaumont Formation, and typically consists of very deep soils of Pleistocene age (USDA 2012). The site has been extensively plowed and is deflated; it is spread out over a large area spanning approximately 100 m north–south by 70 m east–west (see Figure 3). Ground surface visibility at the time of recording was excellent (approximately 90 percent).

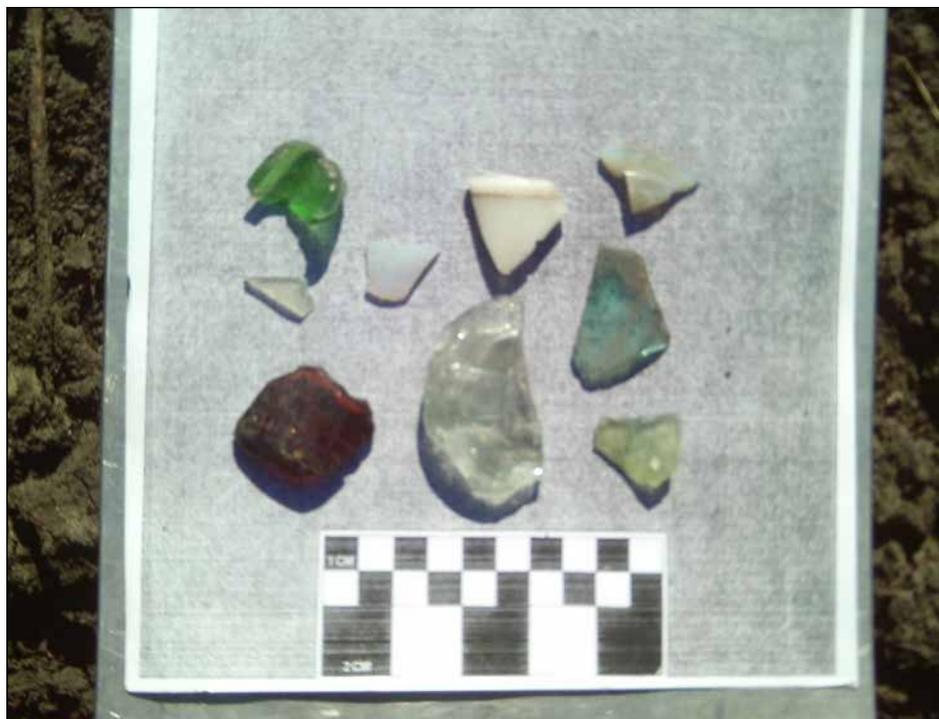
Photo 11. Sample of glass artifacts observed at 41MG137.

Artifacts observed at the site included a variety of glass, ceramics, and metal artifacts that date from the early to mid-twentieth century. Curved (i.e., non-window) glass shards included amber,

aqua, colorless, cobalt blue, light green Depression glass, and milk glass. Aqua window glass was also observed, and is the only architectural element suggestive of a previous structure in the area. Ceramics included undecorated whiteware, undecorated ironstone, undecorated porcelain, Bristol glazed stoneware, and Bristol glazed stoneware with an interior Albany Slip. A few unidentifiable fragments of ferrous metal were also observed, including a threaded pipe collar and a chain.

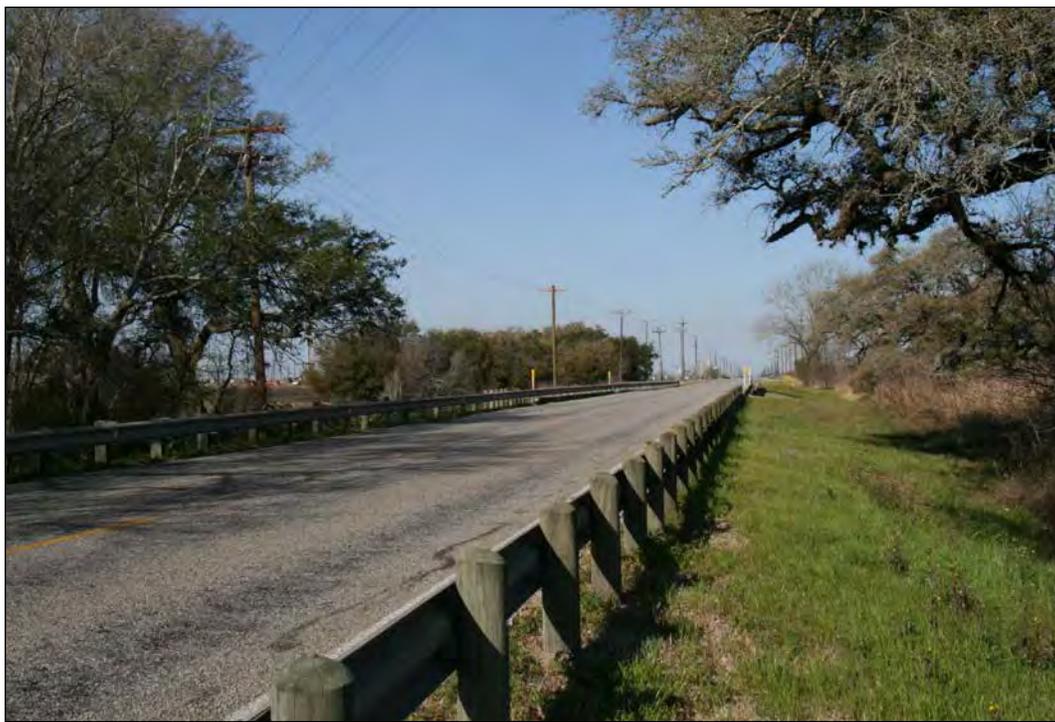
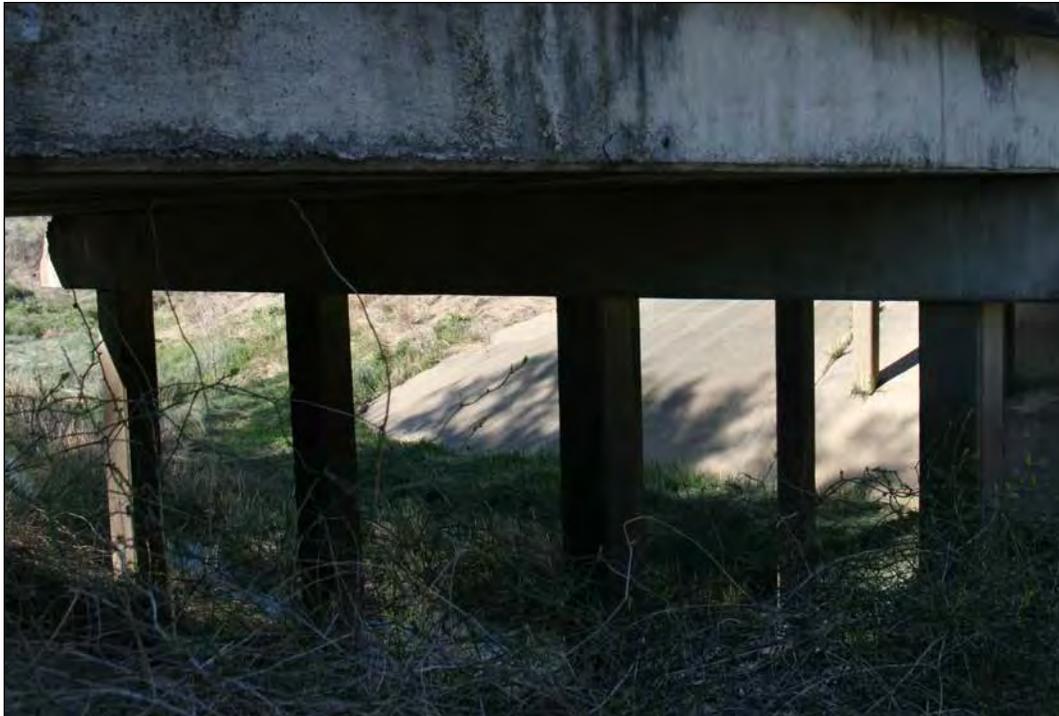
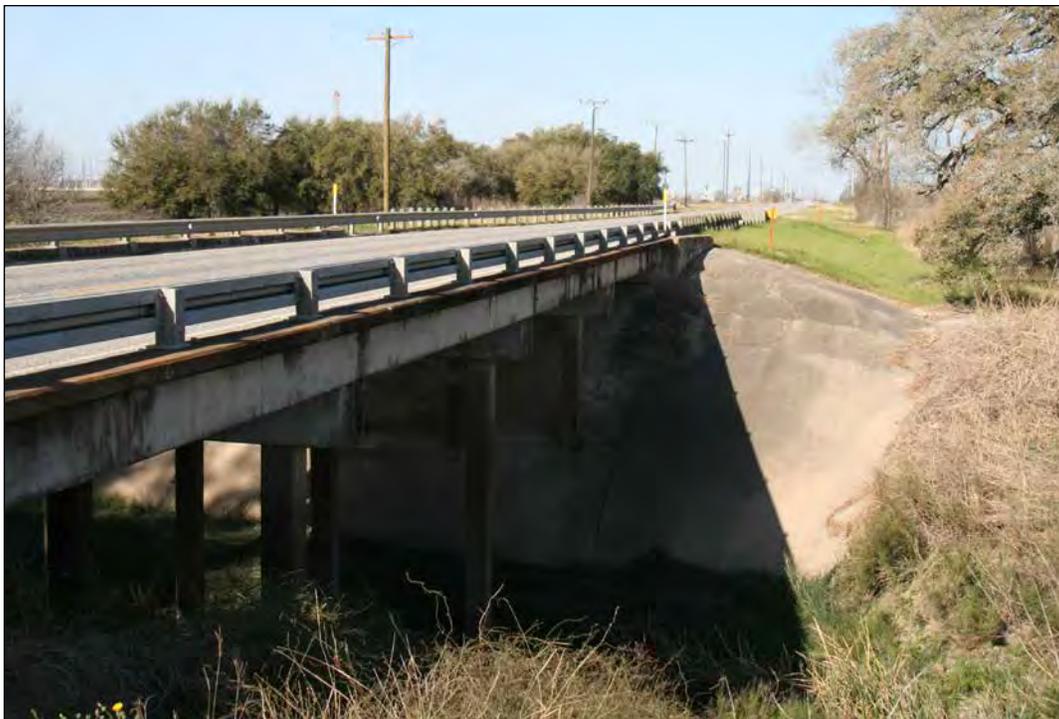
**Description:** The steel and concrete slab bridge consists of six spans across the Tres Palacios River. The pier configuration is composed of concrete pile bents supporting concrete bent caps (Photos 18–20). This substructure supports the concrete slabs that provide the asphalt deck for a roadbed. Full-height concrete abutments slope down toward the Tres Palacios River. The deck is 24 feet wide curb-to-curb. A metal guard rail is mounted into the concrete curb on the bridge and

Photo 18. Resource 1, view to the east.

Photo 19. Resource 1, view to the south.

Photo 20. Resource 1, view to the southwest.

supported with wooden posts along the approach roadway. The bridge is void of a sidewalk or date stamp/plaque.

**Conclusion:** The bridge is not considered historically significant under Criteria A, B, or C. Therefore, it is recommended not eligible for listing in the NHRP.

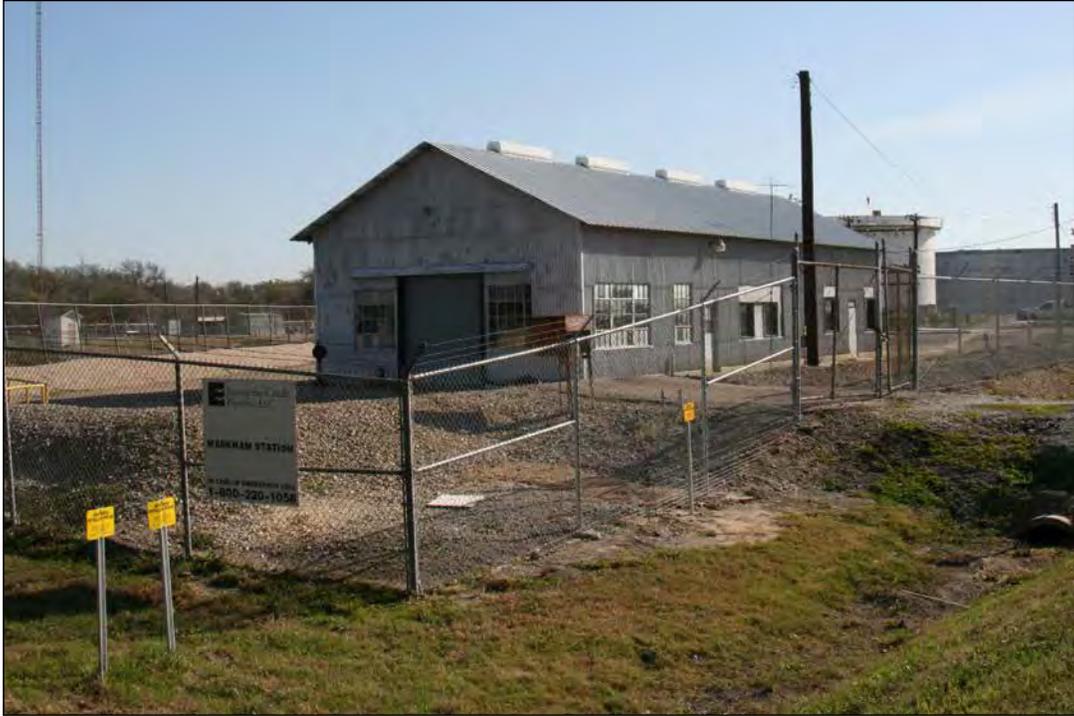
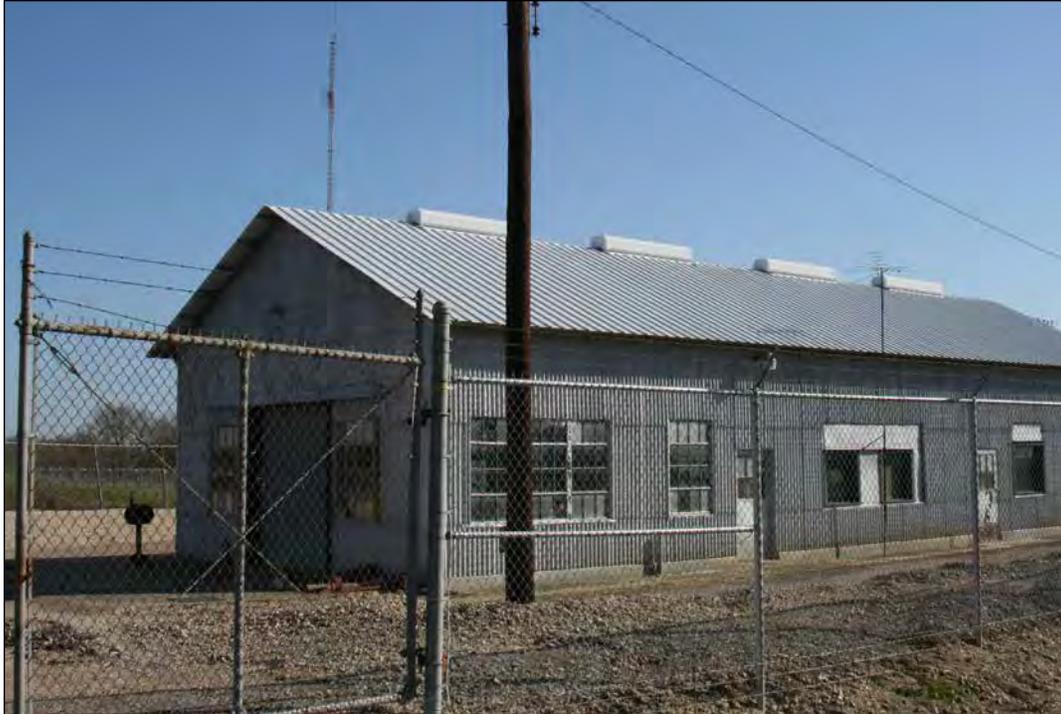
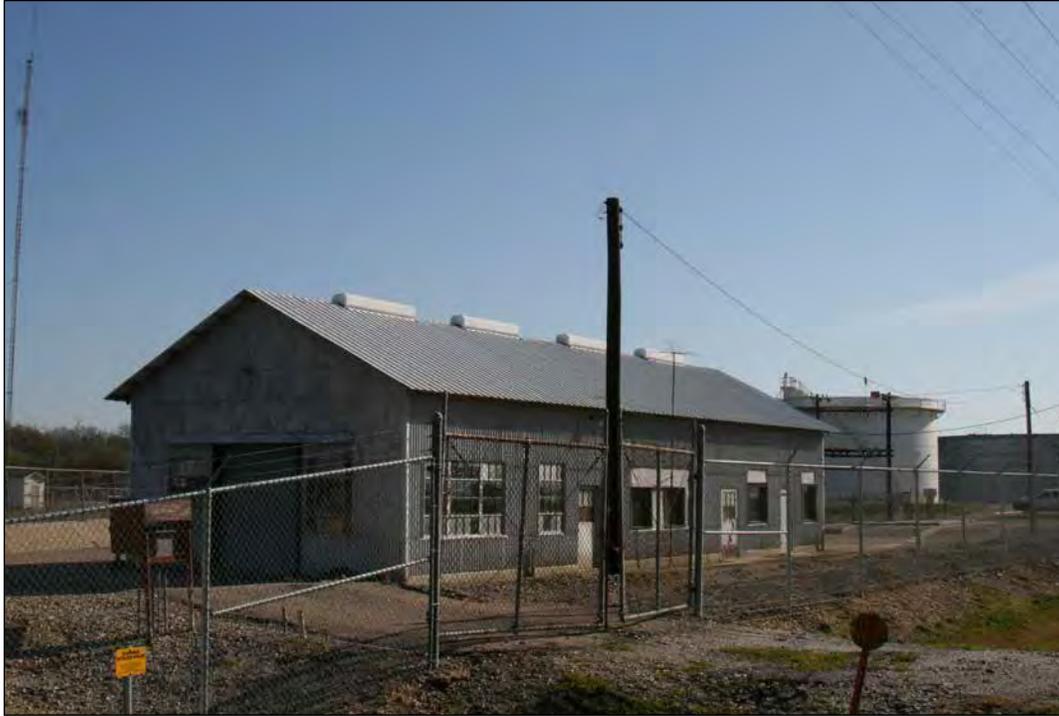
**Description:** Rectangular in footprint, the one-story industrial building is sheltered with an end-gabled, standing-seam metal roof. Also clad in standing-seam metal siding, the building fenestration is composed of multi-light, metal-framed windows and some single-light replacement windows. A large roll-top door provides vehicle or equipment entry into the east elevation. Two single-entrance doors are located on the south elevation. One additional structure is on the property. A round holding tank with numerous pipes attached is located east of the industrial building (Photos 21–23). The function or construction date of the tank is unknown.

Photo 21. Resource 2, view to the northeast.

Photo 22. Resource 2, view to the northeast.

Photo 23. Resource 2, view to the northeast.

**Conclusion:** The industrial building and associated tank are not considered historically significant under Criteria A, B, or C. Therefore, they are recommended not eligible for listing in the NRHP.

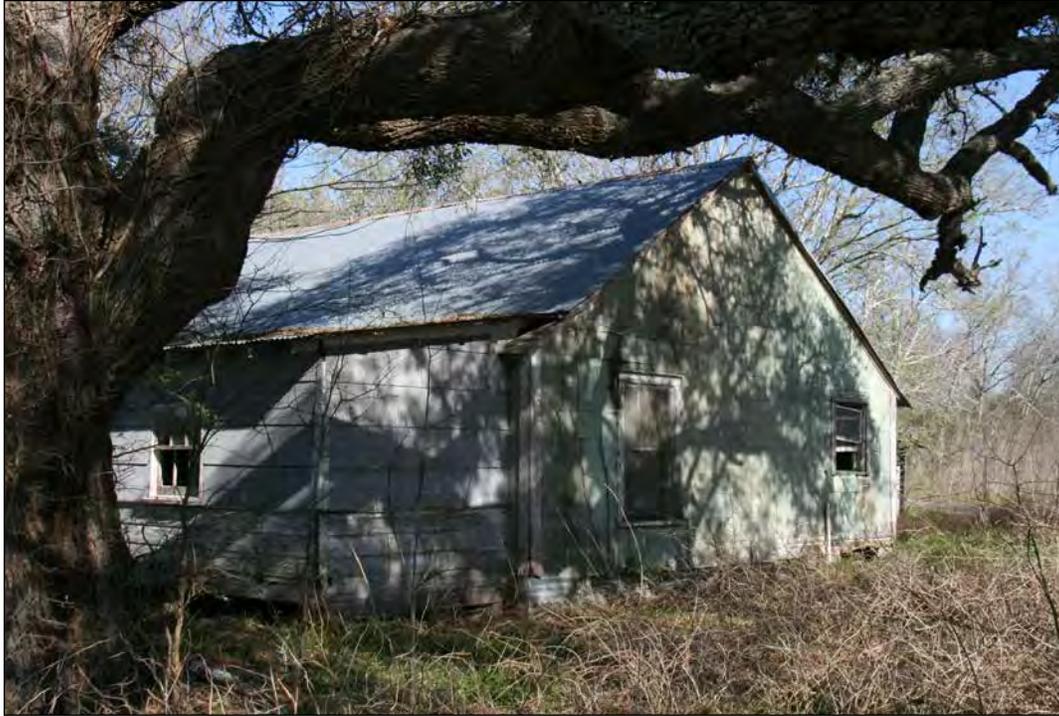
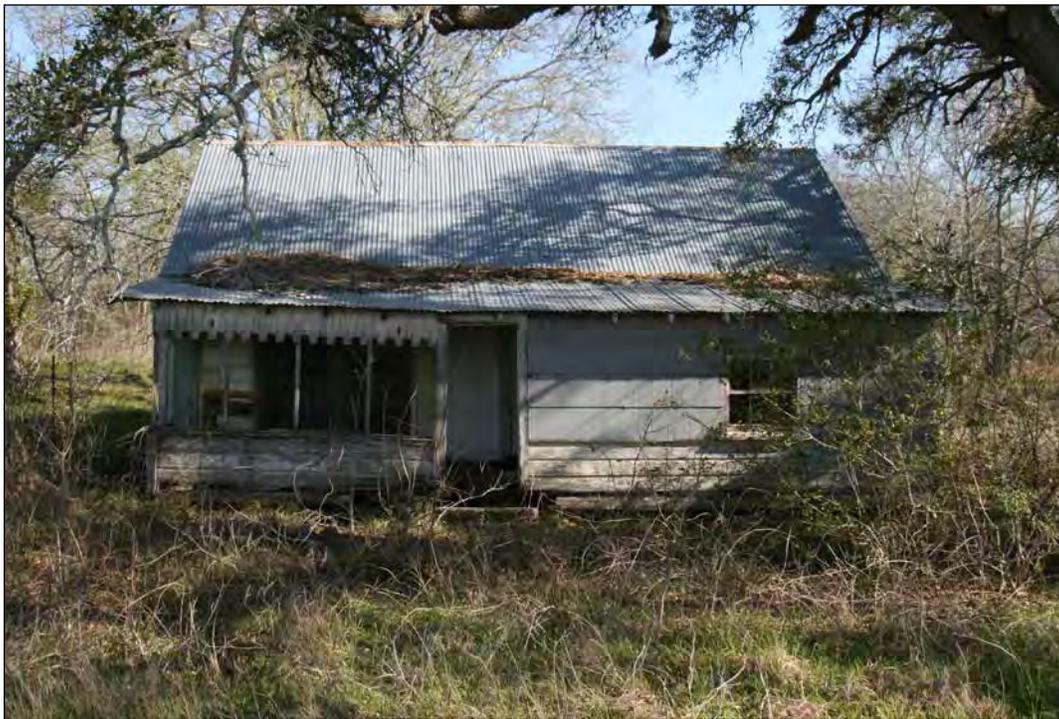
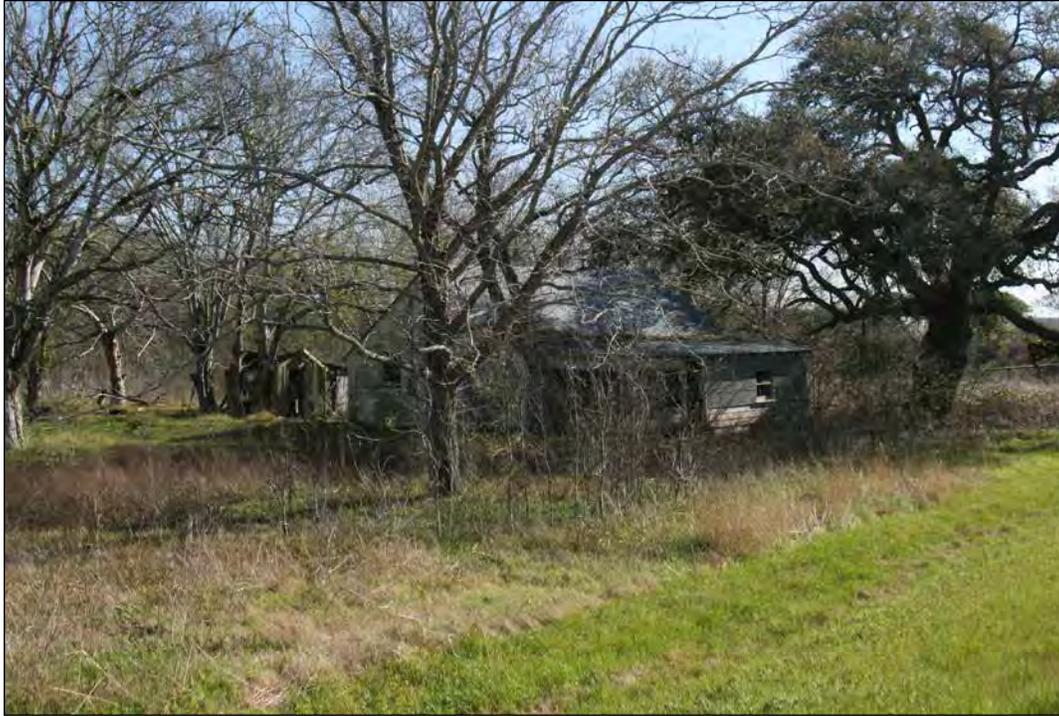
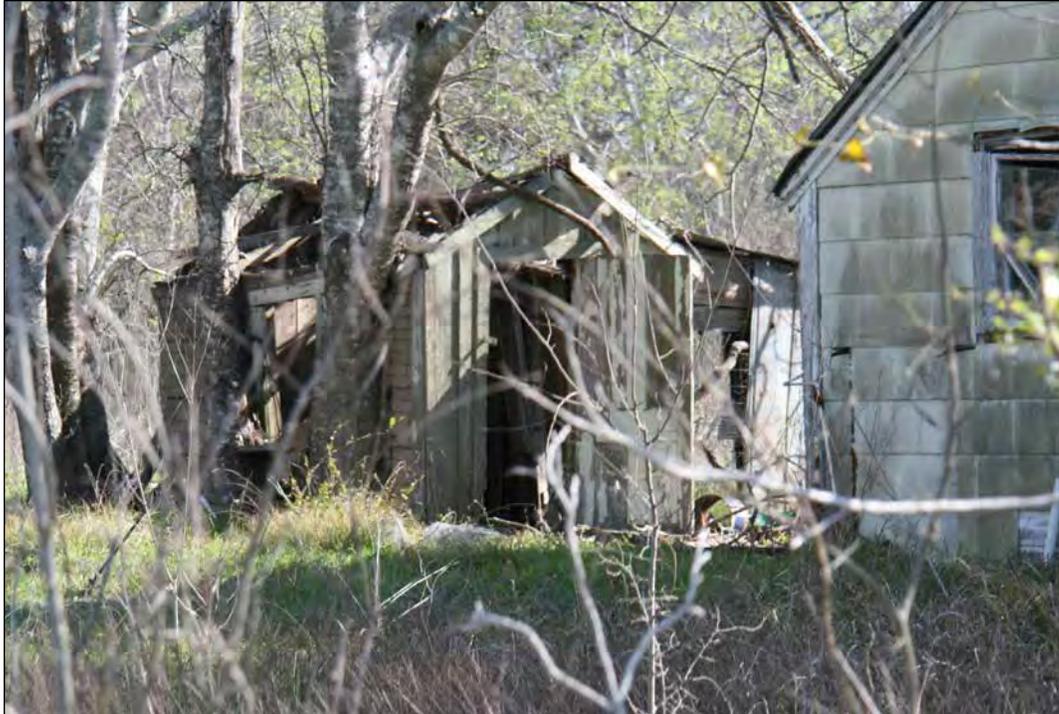
**Description:** The one-story, frame vernacular house is sheltered by an end-gabled, corrugated metal roof. Supported on brick and concrete piers, the house is clad in asbestos shingles over lapped wood siding. A partially enclosed front porch extends the length of the façade. Numerous window types comprise the fenestration, with six-over-six, wood-framed sash windows being the predominant type. A shed-roof addition extends from the rear elevation. This extension may have been an open porch at one time. The house is vacant and in very poor condition (Photos 24–27). A

Photo 24. Resource 3, view to the southeast.

Photo 25. Resource 3, view to the north.

Photo 26. Resource 3, view to the northeast.

Photo 27. Shed behind Resource 3, view to the northeast.

frame shed with a front-gabled roof and shed-roofed addition is located behind the house (the shed was partially visible from the public ROW).

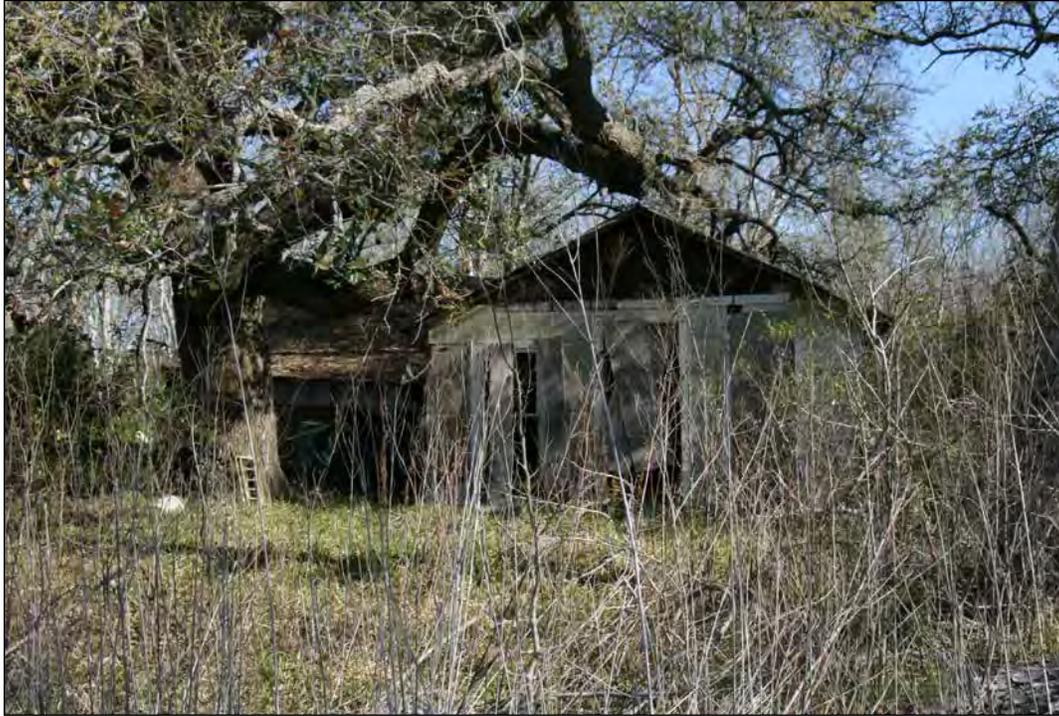
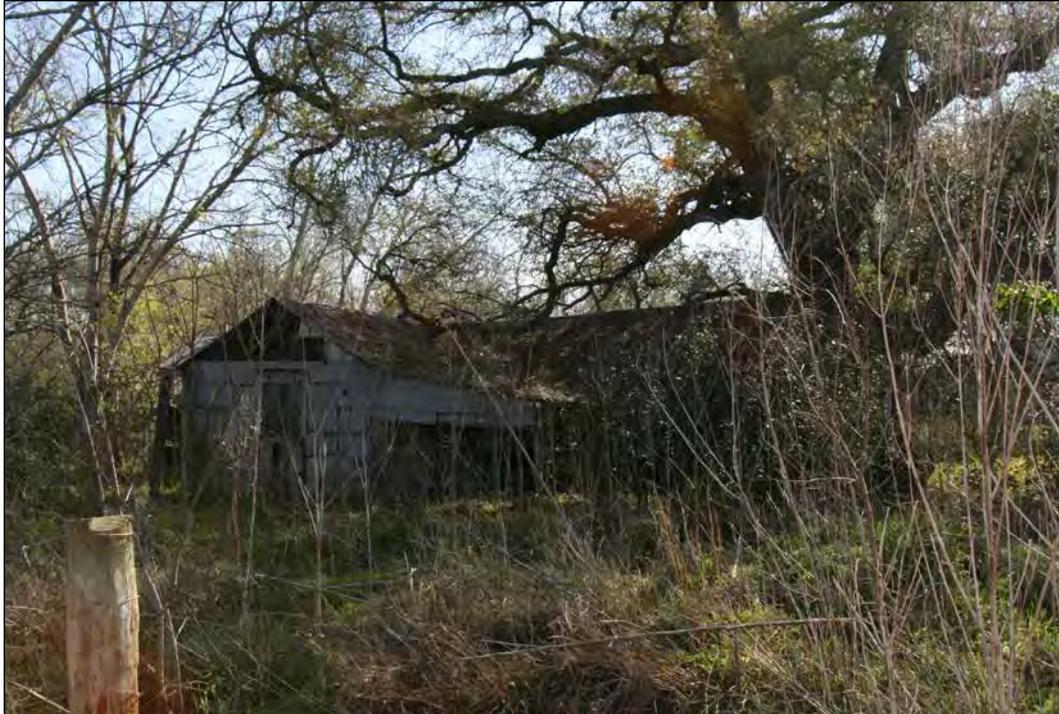
**Description:** The one-story, frame vernacular house is an L-plan with a front-gabled ell. The front door is flanked by two four-over-four, wood sash windows (one is enclosed in plywood). Asbestos shingles over vertical wood planking clads the house. A corrugated metal roof shelters the house. The house is in very poor condition, and further architectural details are indistinguishable (Photos 28–29).

Photo 28. Resource 4, view to the north.

Photo 29. Resource 4, view to the northeast.

**Historical Significance:** Constructed in the 1920s, the house was once located near the center of the Clemville community. The house is not known to be associated with important events in our history. Since integrity is the ability to convey significance, a discussion of integrity is not applicable for this resource. Therefore, it has little to no significance for its association with events or themes in history under Criterion A.

The house is not associated with persons of known historical significance. Since integrity is the ability to convey significance, a discussion of integrity is not applicable for this resource. Therefore, the house is recommended not eligible for listing in the NRHP under Criterion B.

The house is not a particularly unique or distinct architectural style or design. It is not known to be a work of a master. Since integrity is the ability to convey significance, a discussion of integrity is not applicable for this resource. The house is recommended not eligible for listing in the NRHP under Criterion C.

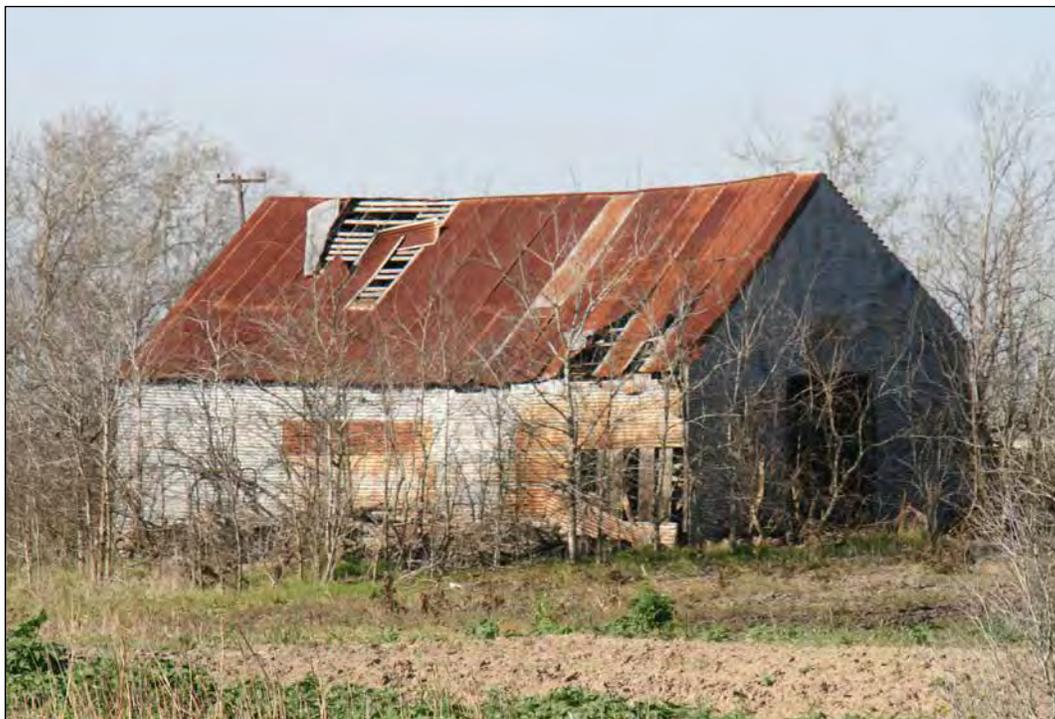
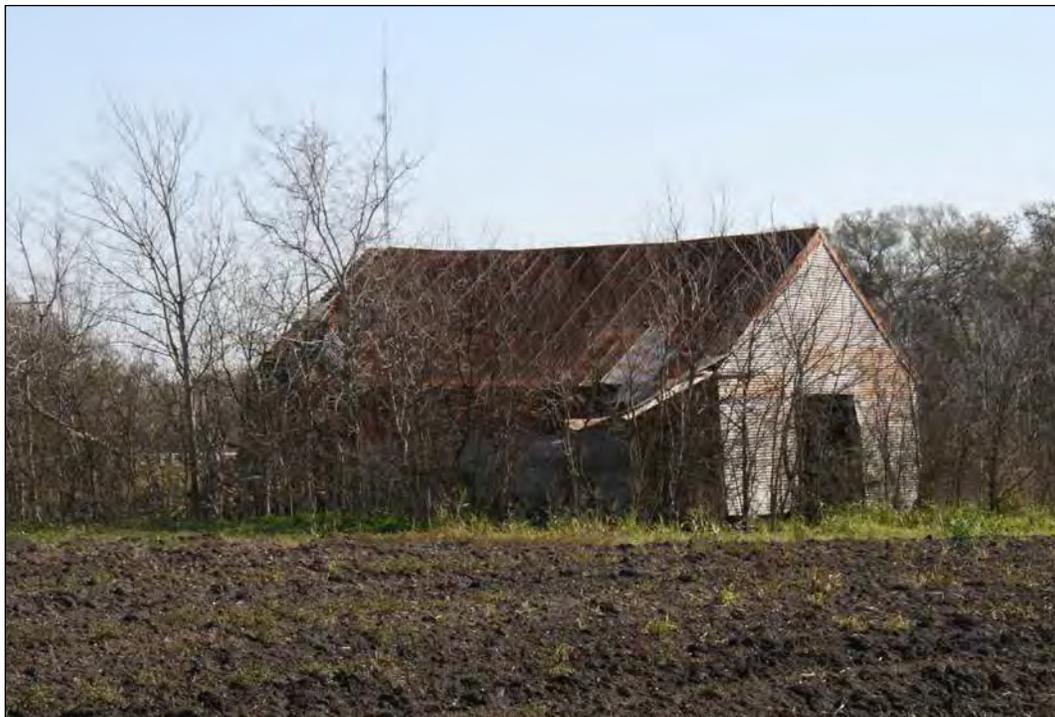
**Description:** Constructed ca. 1930, the frame barn is enclosed in standing-seam metal siding and sheltered with an end-gabled, standing-seam metal roof (Photos 30–31). The barn may have been a hay barn at one time. A large vehicle opening provides access into the southern end.

Photo 30. Resource 5, view to the northeast.

Photo 31. Resource 5, view to the northwest.

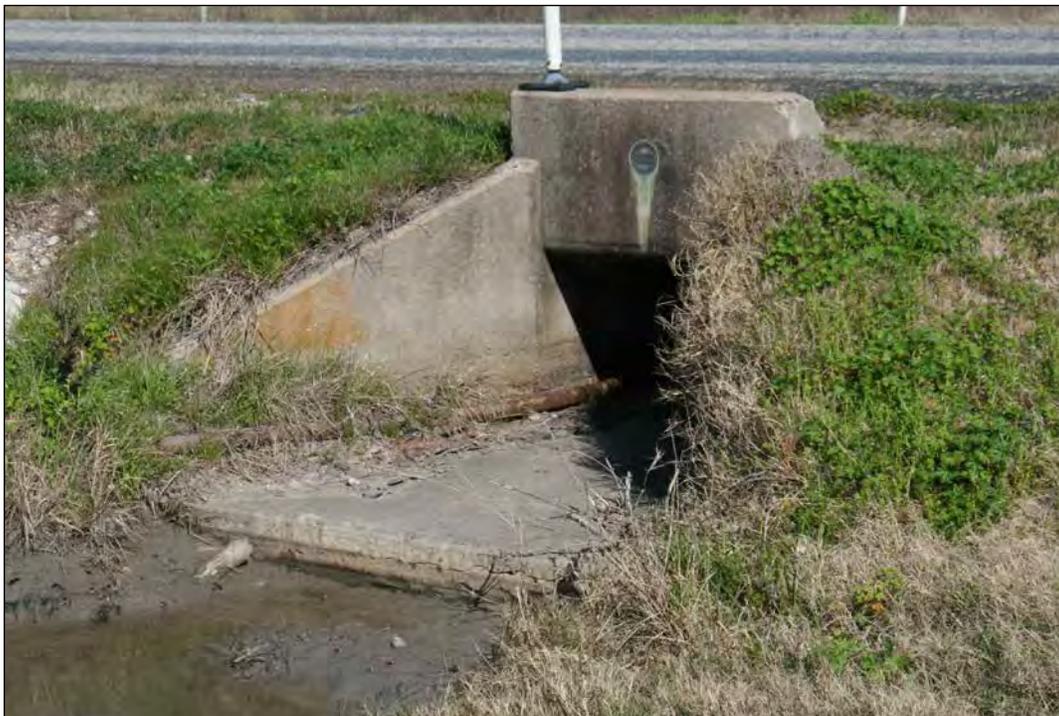
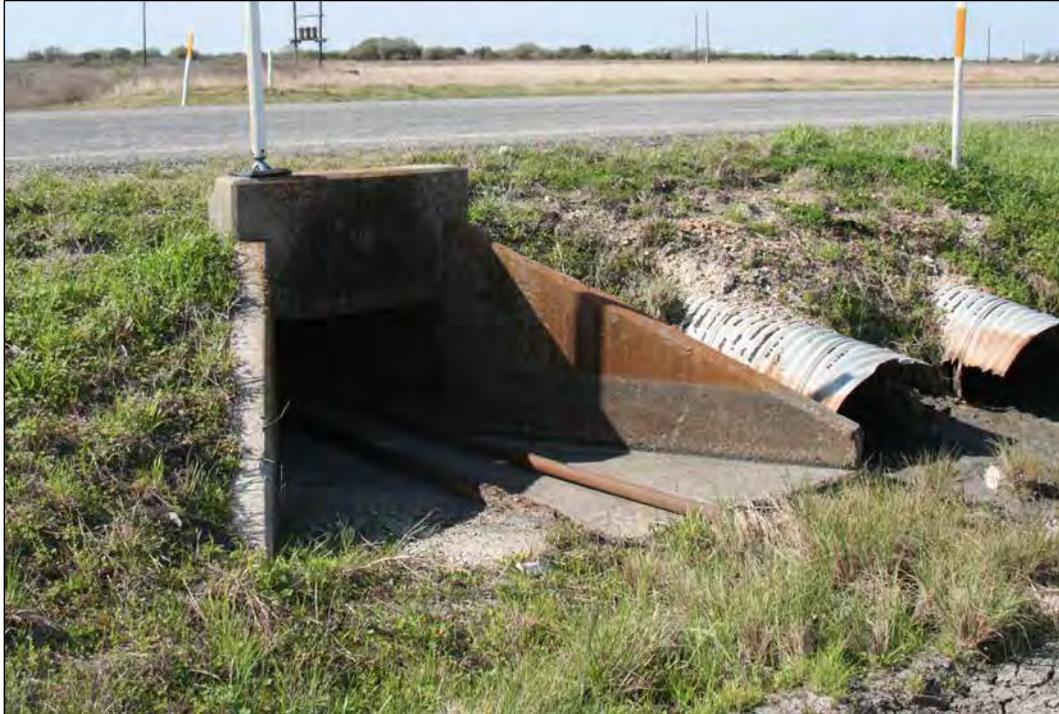
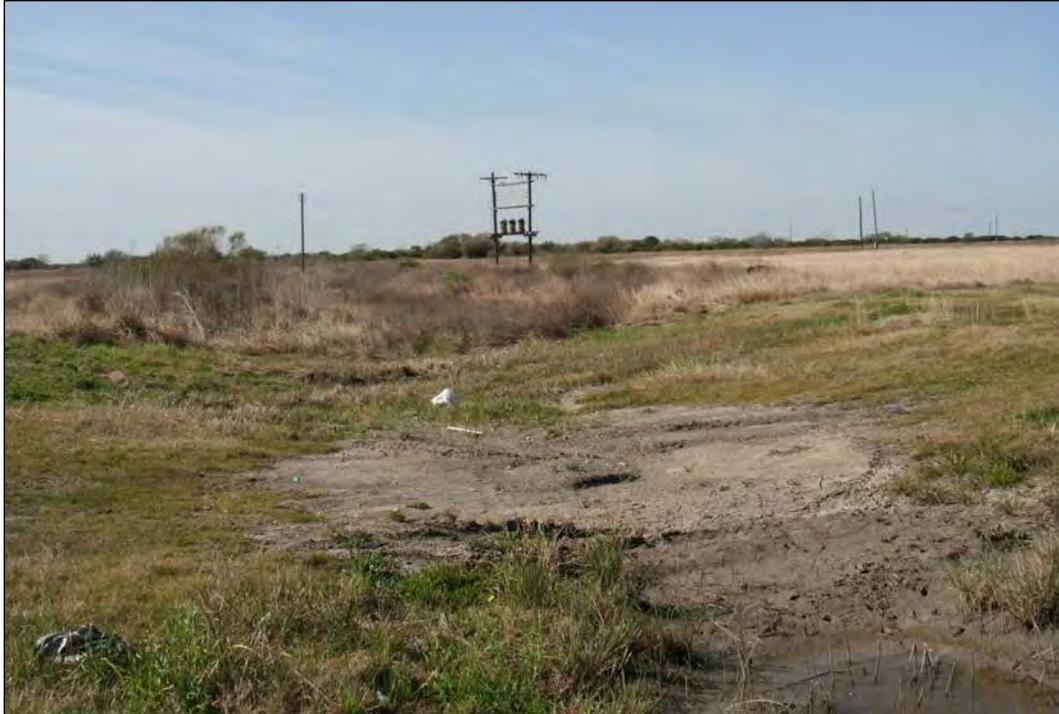
**Description:** The concrete box culvert carries an irrigation ditch under FM 1468. Concrete, flared-wing walls support the embankments of the ditch (Photos 32–34). The culvert is marked with a metal survey plate stating “Texas Highway Department 1941 Contractor.”

Photo 32. Resource 6, view to the northwest.

Photo 33. Resource 6, view to the northeast.

Photo 34. Resource 6, ditch extending from culvert, view to the south.
