# Archaeological and Architectural Survey of the Apex Matagorda Energy Center Compressed Air Energy Storage Facility and Associated Infrastructure, Matagorda County, Texas

April 2013  
WSA Technical Report No. 2012-105

Report Title: *Archaeological and Architectural Survey of the Apex Matagorda Energy Center Compressed Air Energy Storage Facility and Associated Infrastructure, Matagorda County, Texas*

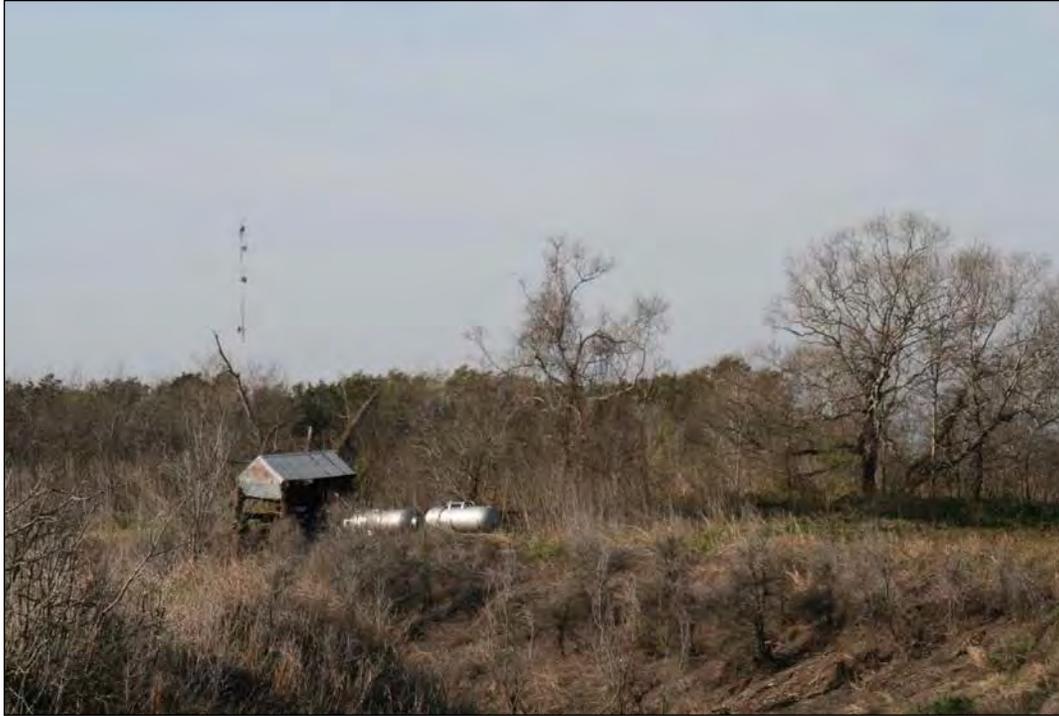
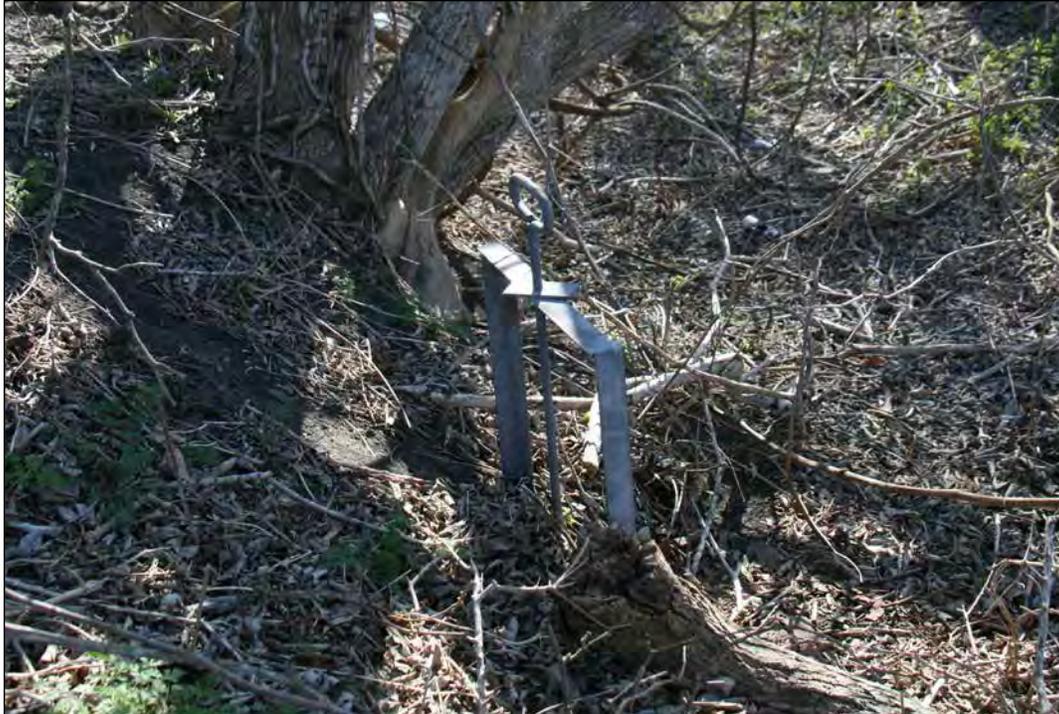
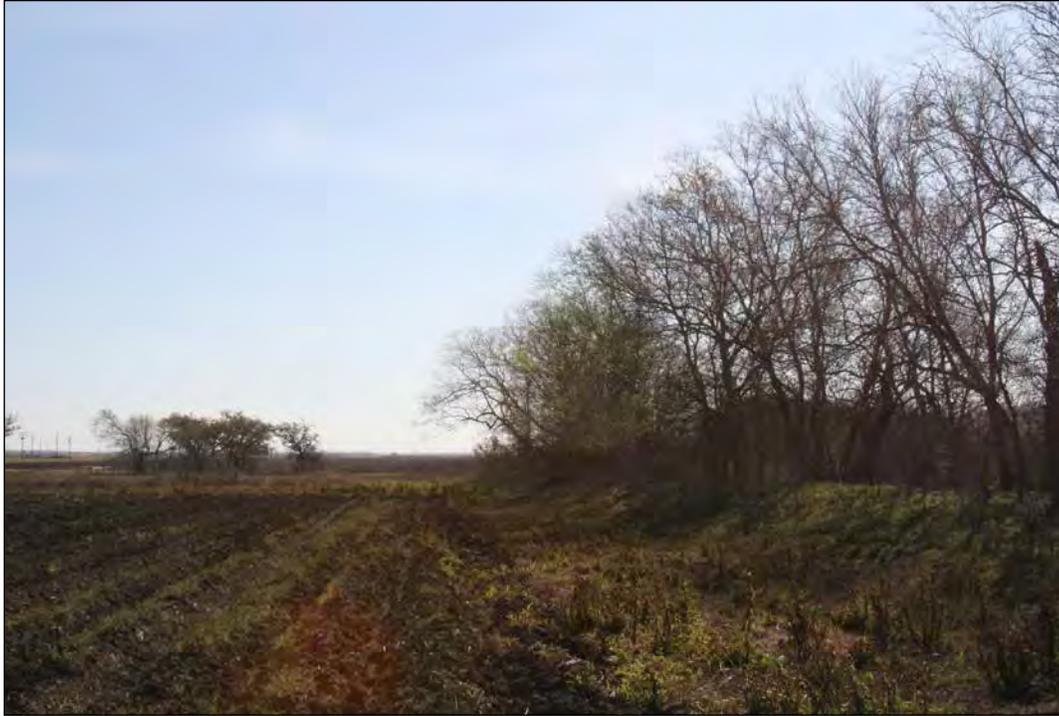
**Description:** The small, frame pump house is perched on the bank of the Tres Palacios River (Photos 39–41). The gabled-roof structure appears to have metal equipment inside; likely a diesel-powered engine based on the presence of a gas tank adjacent to the structure. A bermed, open-cut ditch leads from the pump house to the road (CR 417). Near the road is a small metal check gate. It is unknown whether the water pump is functional. The pump house, attached ditch, and check

Photo 39. Resource 8, view to the northeast.

Photo 40. Resource 8, check gate, view to the east.

Photo 41. Resource 8, bermed ditch, view to the east.

gate are all considered component features of the historic-age irrigation system, and are identified as Resource 8.
