Cultural Resources Survey

Indeck Wharton Energy Center Project Wharton County, Texas

March 2014 (*Final Report*)

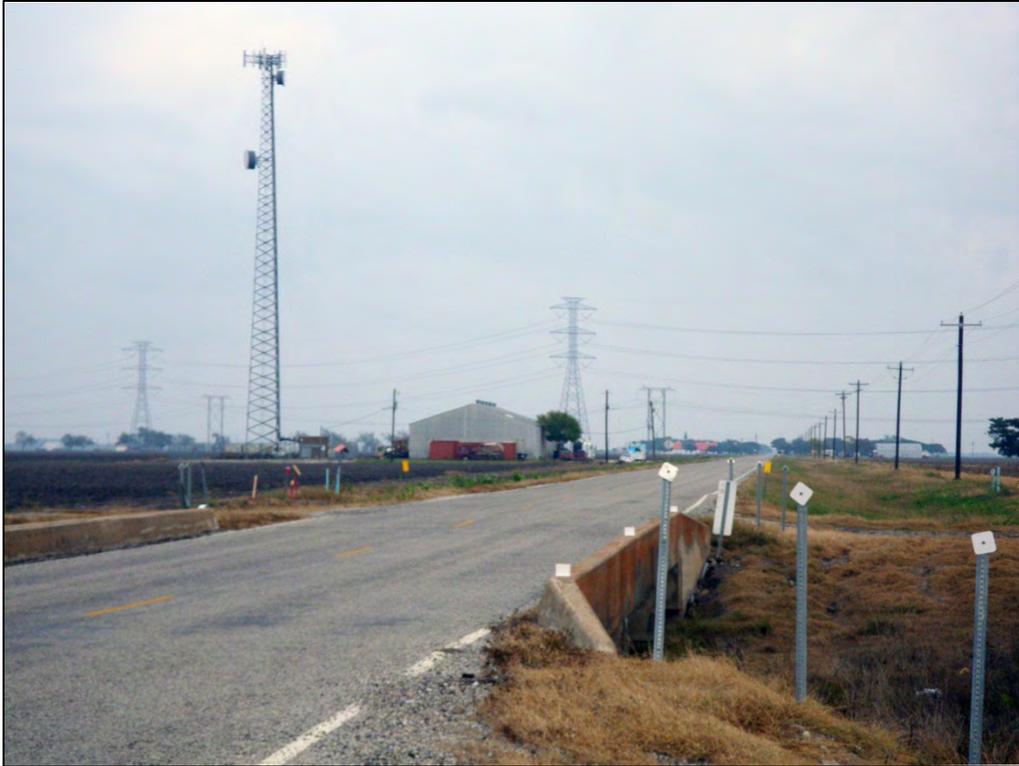
Photo 1: View east along FM 441 toward Archit-1 (at left). (C. Borstel, Tetra Tech, 12/04/2013)

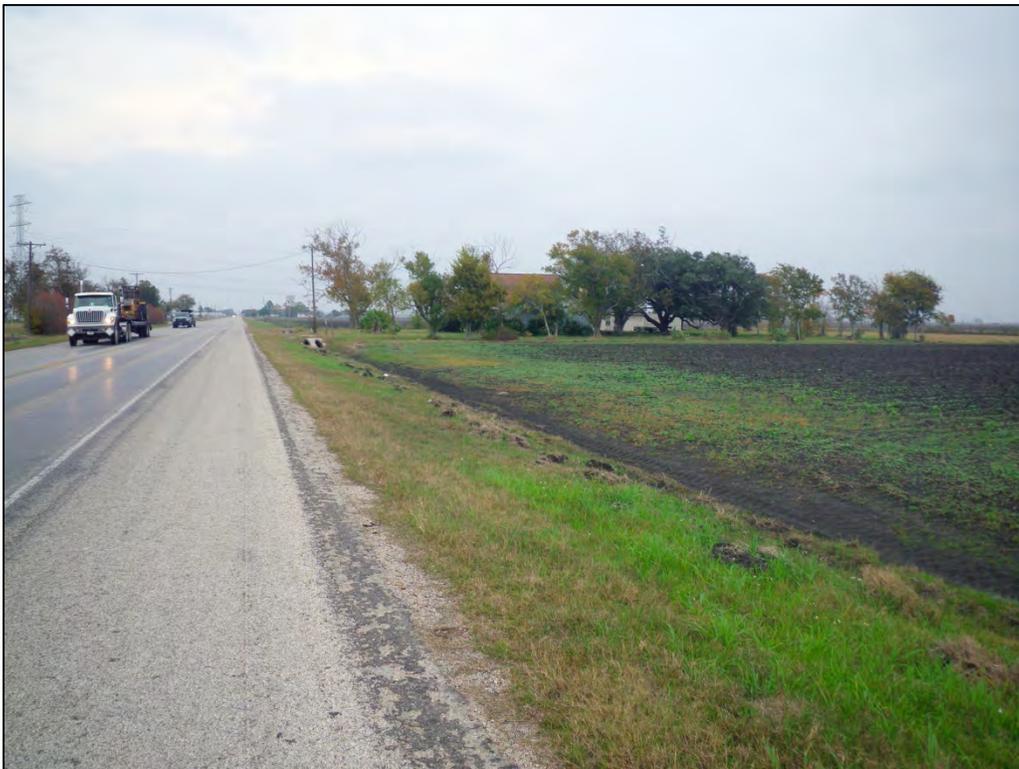
Photo 2: View north along SR 71 toward Archit-3 (at right). (C. Borstel, Tetra Tech, 12/04/2013)

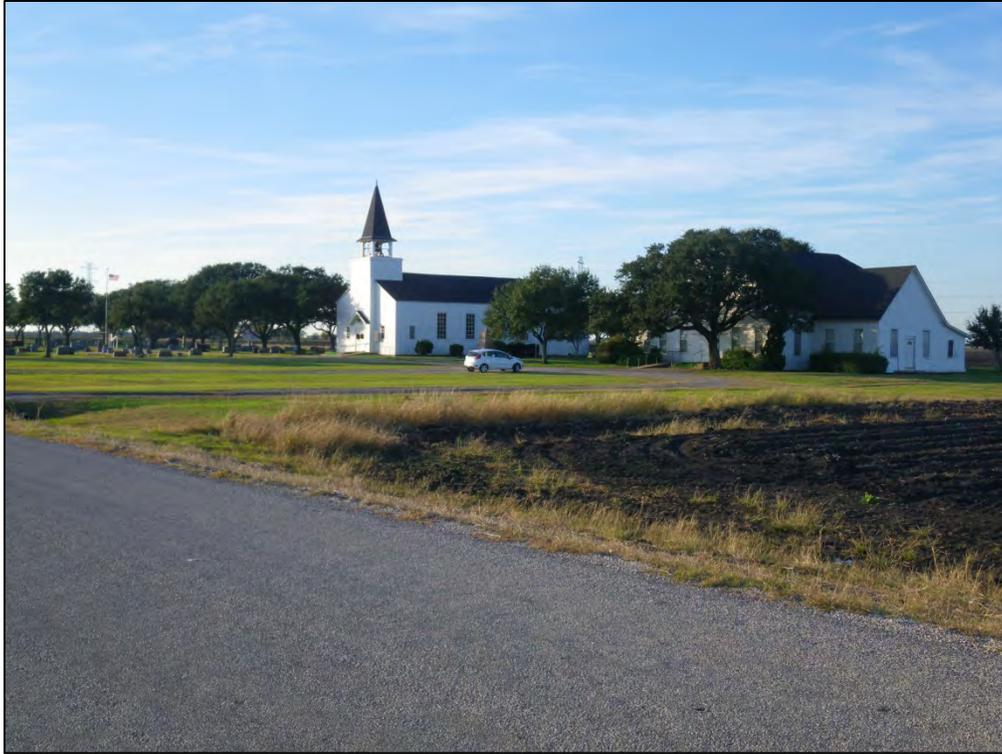
Photo 3: View northwest from CR 426 toward Danevang Lutheran Church at eastern end of surveyed area. (C. Borstel, Tetra Tech, 12/02/2013)

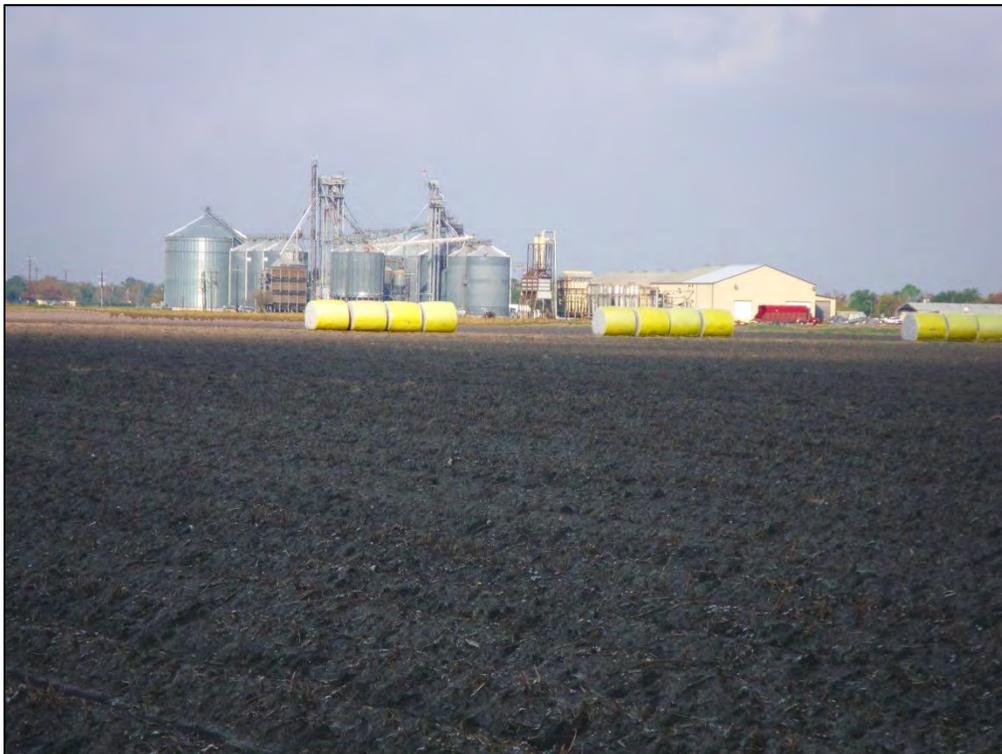
Photo 4: Northern end of Project quarter-section field (marked by cylindrical bales of cotton) looking north toward the cotton gin in Danevang. (C. Borstel, Tetra Tech, 12/04/2013)

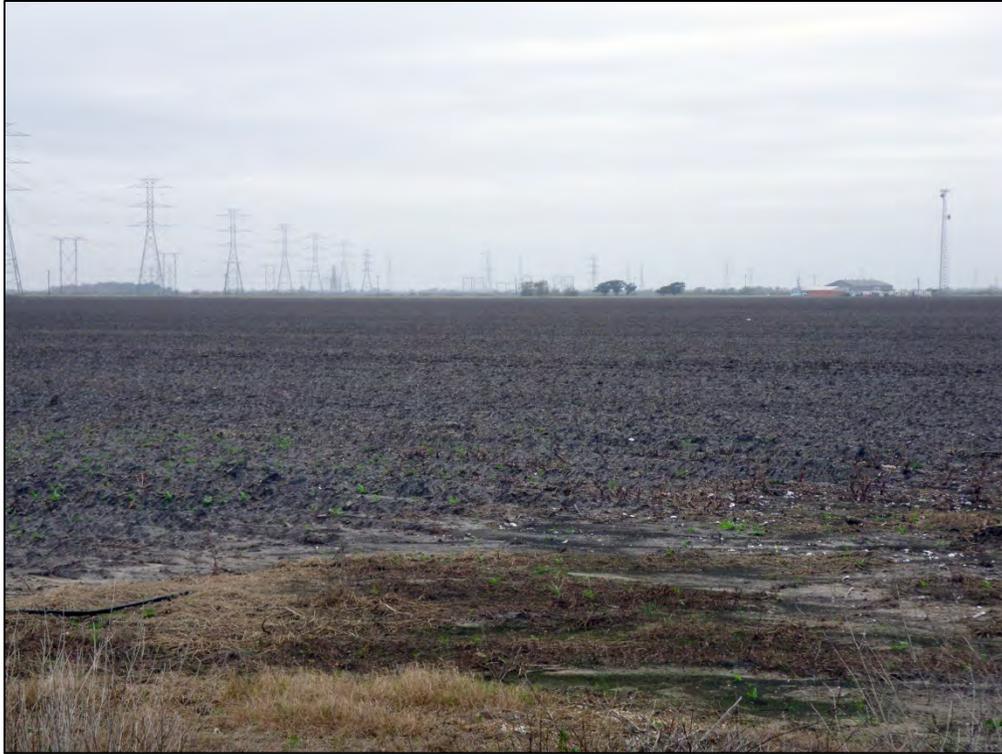
Photo 5: Project area quarter-section field. View southwest from northeastern corner. (C. Borstel, Tetra Tech, 12/05/2013)

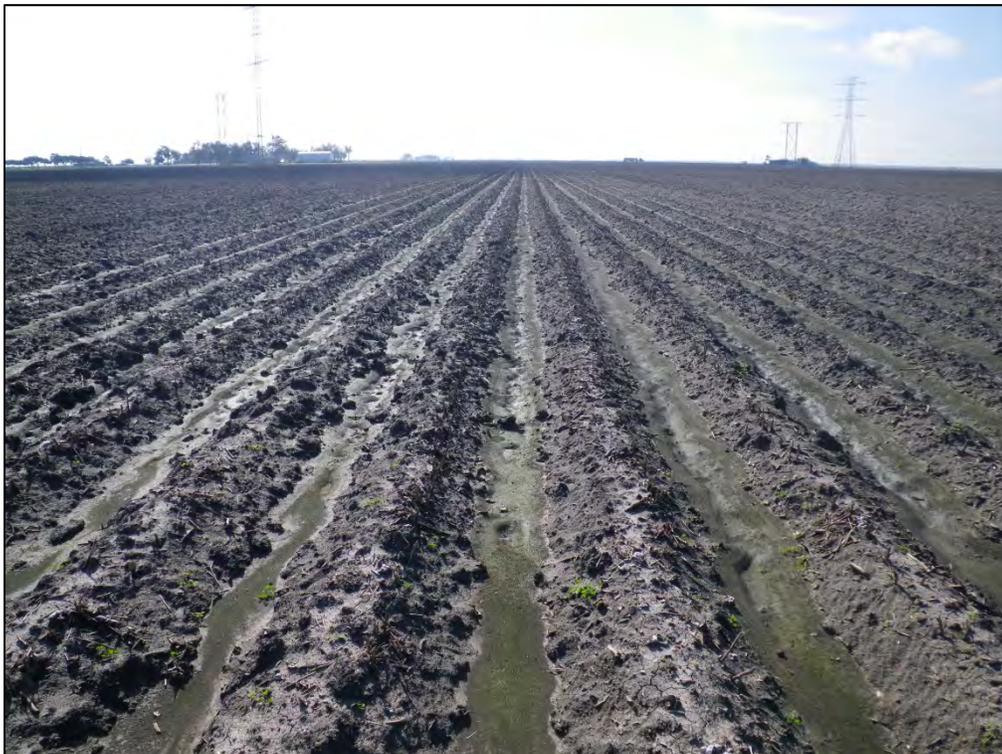
Photo 6: Typical ground visibility in Project area quarter-section field. View south from northern end of Transect 11. (C. Borstel, Tetra Tech, 12/05/2013)

To confirm that systematic surface survey was a sufficient technique for archeological site identification for this study, five soil shovel probes approximately 30 centimeters in diameter were hand-excavated within the footprint of the planned Facility (Figure 2) to depths of 45 to 50 centimeters below surface. Soils were consistently dark gray clays with no visible horizonation. There was no evidence of recent sediment accumulation from small-scale water courses or from wind transport. These observations supported the terrain-based evaluation of the surveyed area as not requiring subsurface archeological testing, given adequate surface visibility.

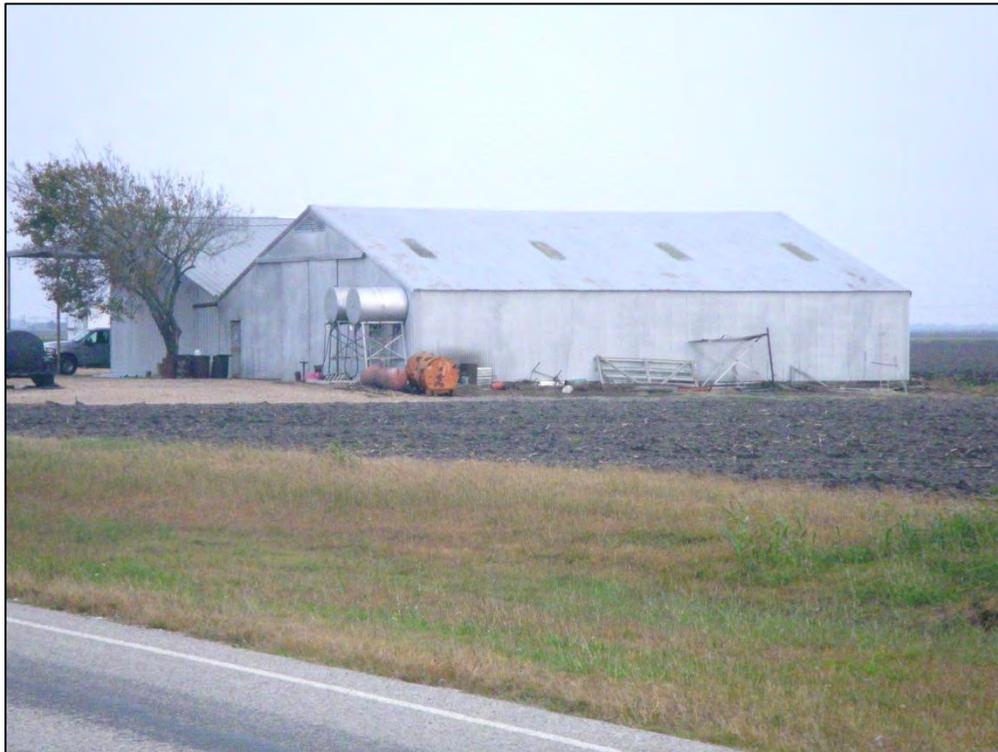
IMG1686: Looking southeast at Archit-2 ([no number] S. FM 441). Ca. 1960 section of metal-clad pole barn is at right (C. Borstel, Tetra Tech, December 4, 2013)

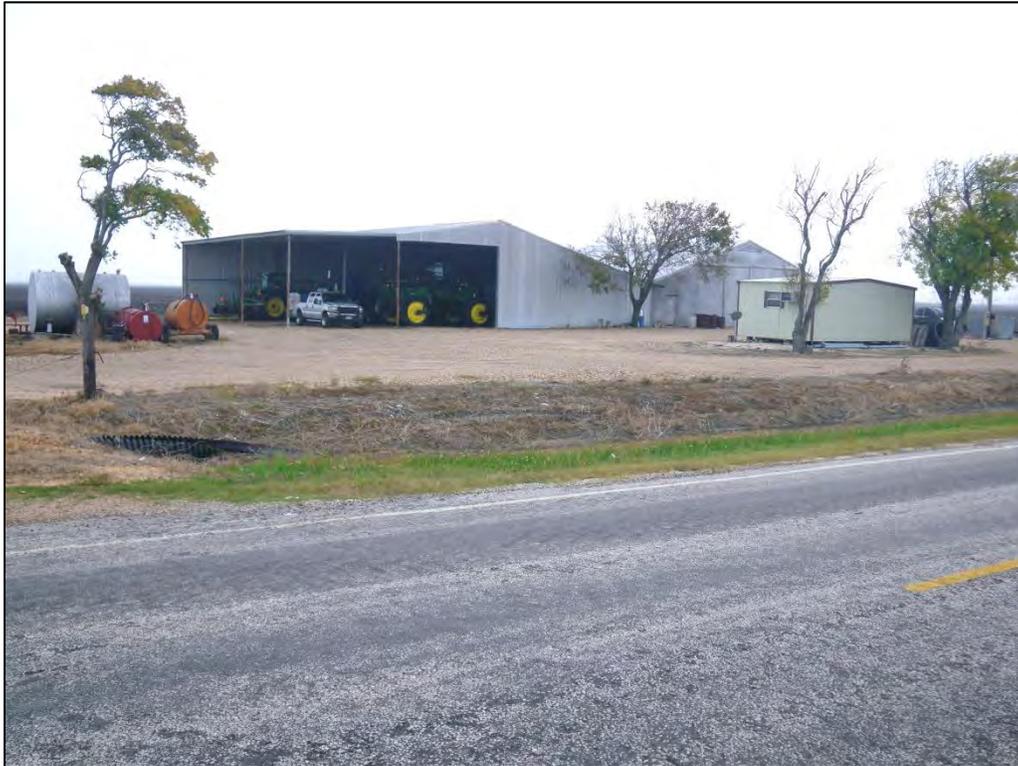
IMGP1709: Looking southwest at Archit-2 ([no number] S. FM 441). Open-bay machine shed at left constructed 1995 to 2005. (C. Borstel, Tetra Tech, December 4, 2013)

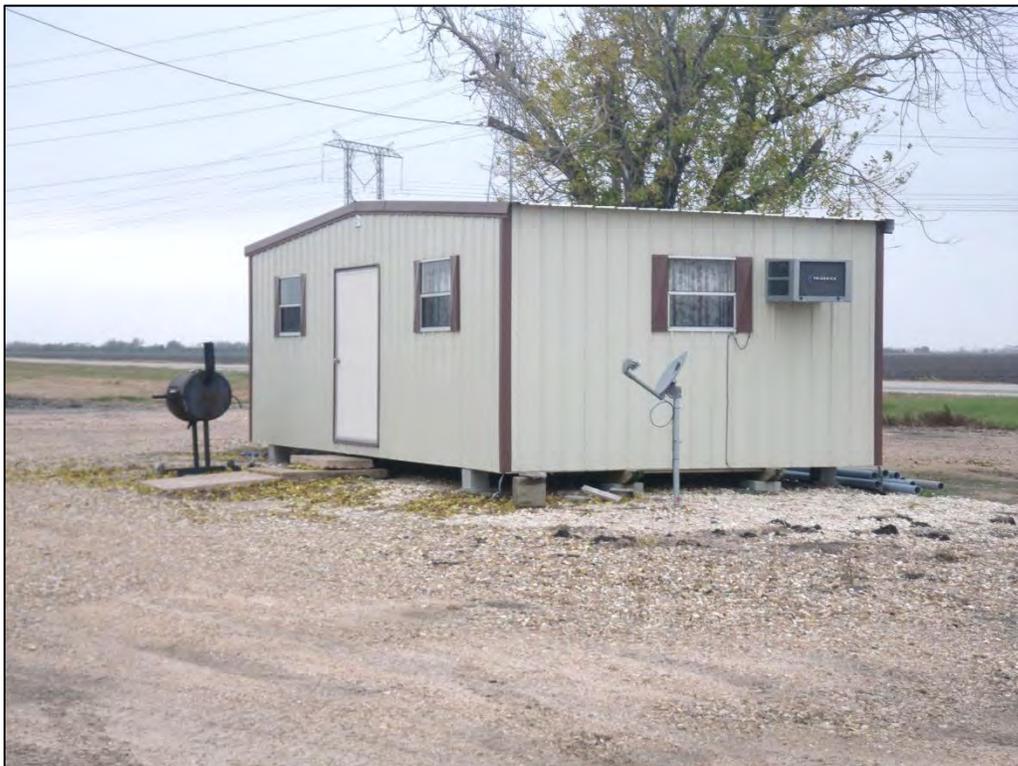
IMGP2039: Looking northwest at at Archit-2 ([no number] S. FM 441)—portable, metal-clad, skid-mounted jobsite office possibly used as field operations building, break room, or seasonal bunkhouse. (C. Borstel, Tetra Tech, December 5, 2013)

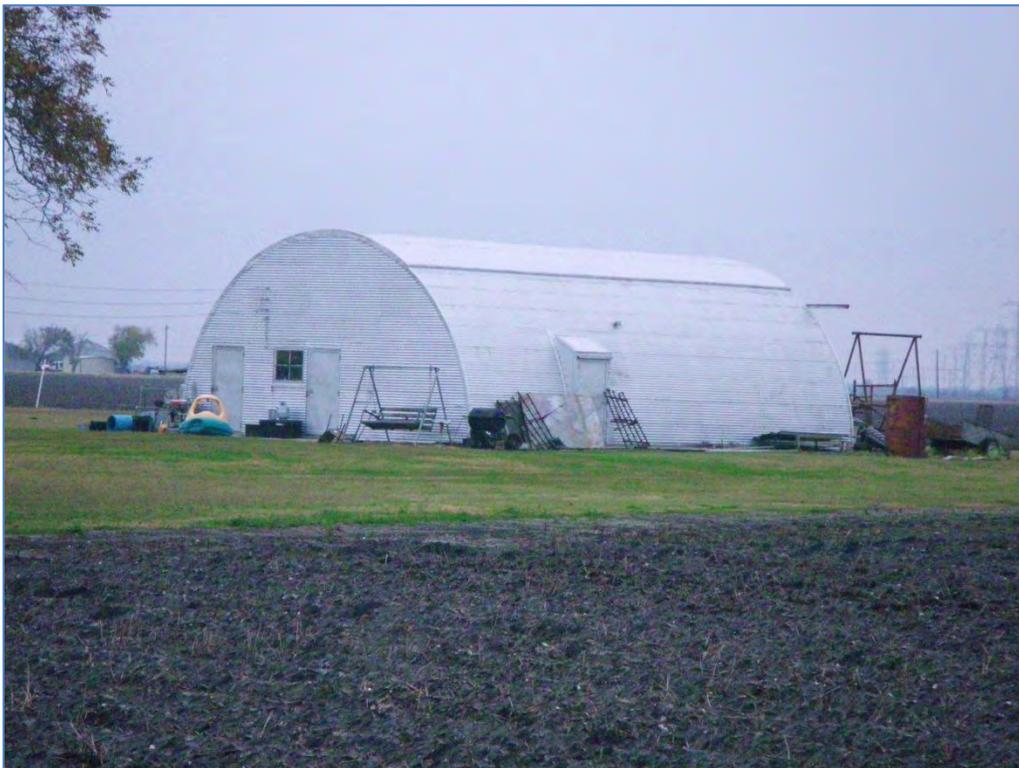
IMG1749: Looking southwest at Quonset shed, Archit-4 (12074 SR 71). (C. Borstel, Tetra Tech, December 4, 2013)

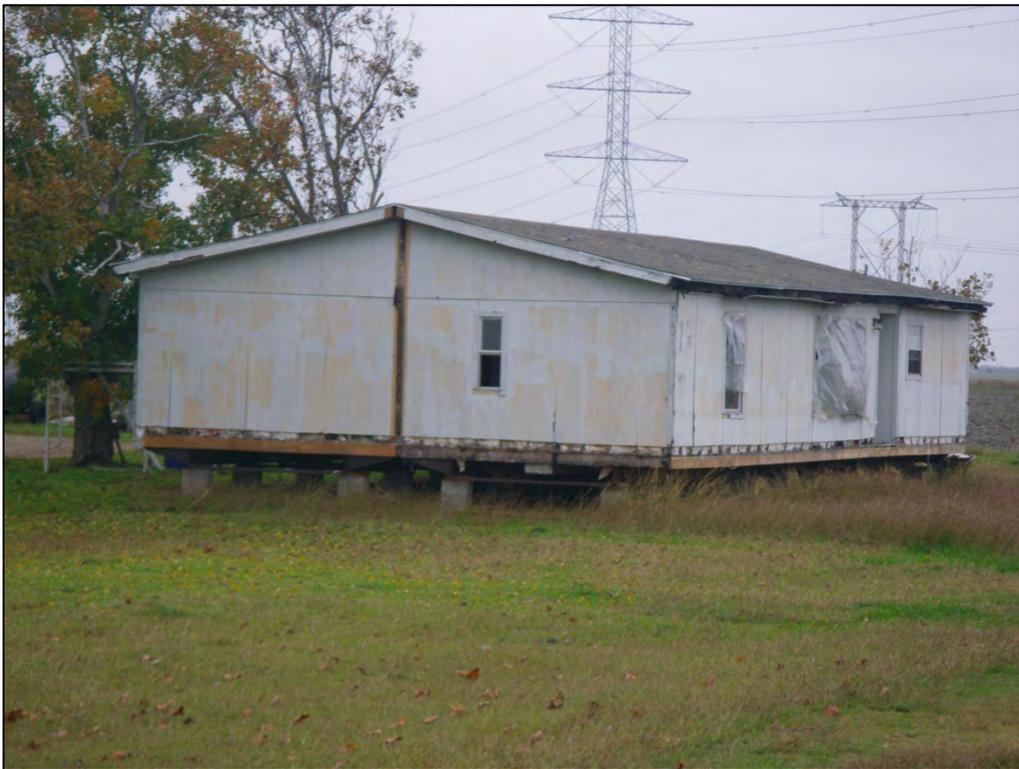
IMG1865: Looking east at dismantled double-wide mobile home in storage south of house at Archit-5 (11795 SR 71). (C. Borstel, Tetra Tech, December 5, 2013)

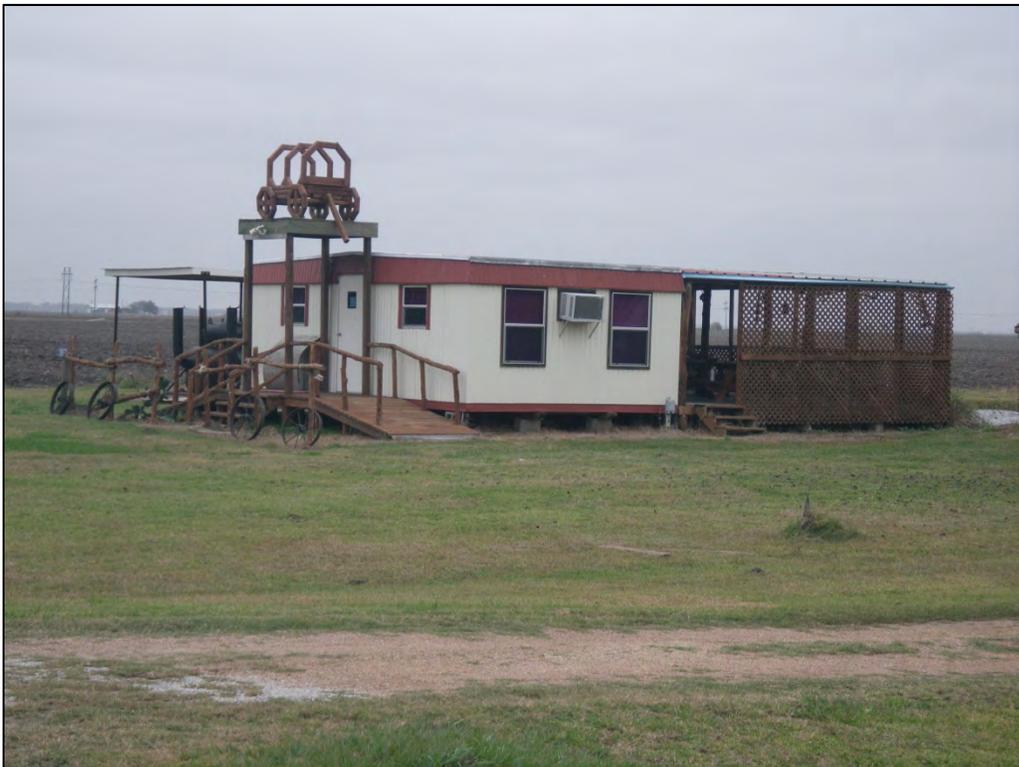
IMGP1916: Looking southeast at Archit-6—portable, metal-clad, skid-mounted building used as “cabana” or office, with street address of 182 CR 426. (C. Borstel, Tetra Tech, December 5, 2013)

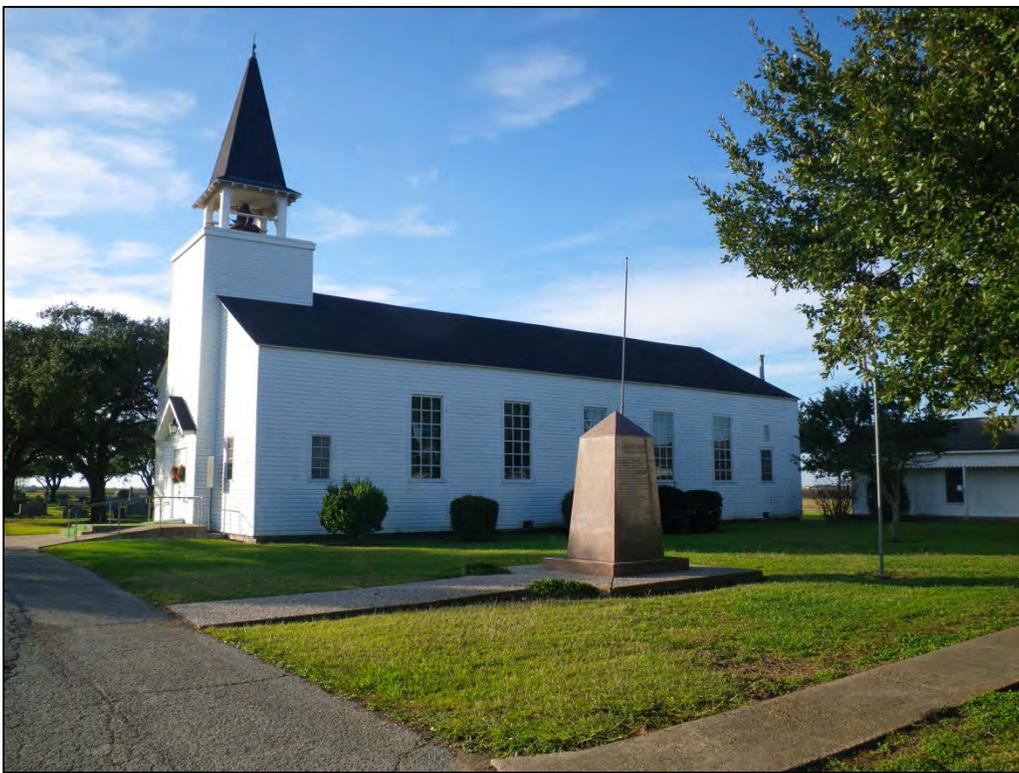
IMGP1332: Looking northwest at Danevang Lutheran Church. Pink granite historical marker is at center; portion of the Sunday School Building is at right. All are elements of Archit-7. (C. Borstel, Tetra Tech, December 2, 2013)

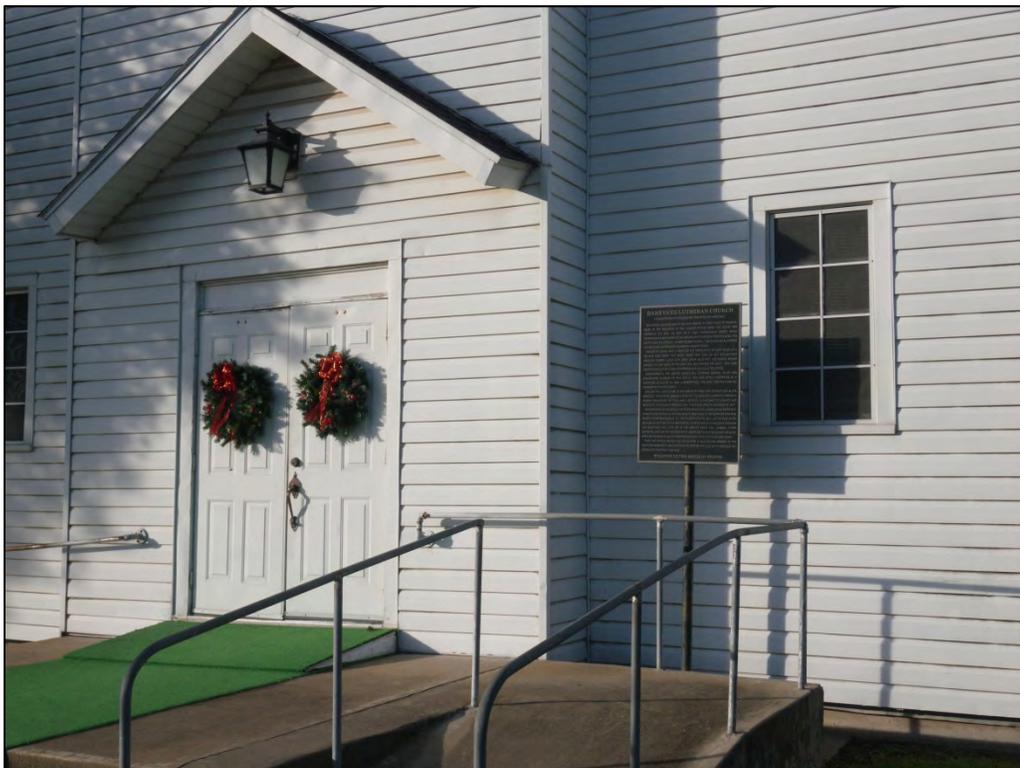
IMG1371: Looking north-northwest at front (south) entrance to Danevang Lutheran Church. Marker recounting history of Lutheran Church in Danevang is to right of door. (C. Borstel, Tetra Tech, December 2, 2013)

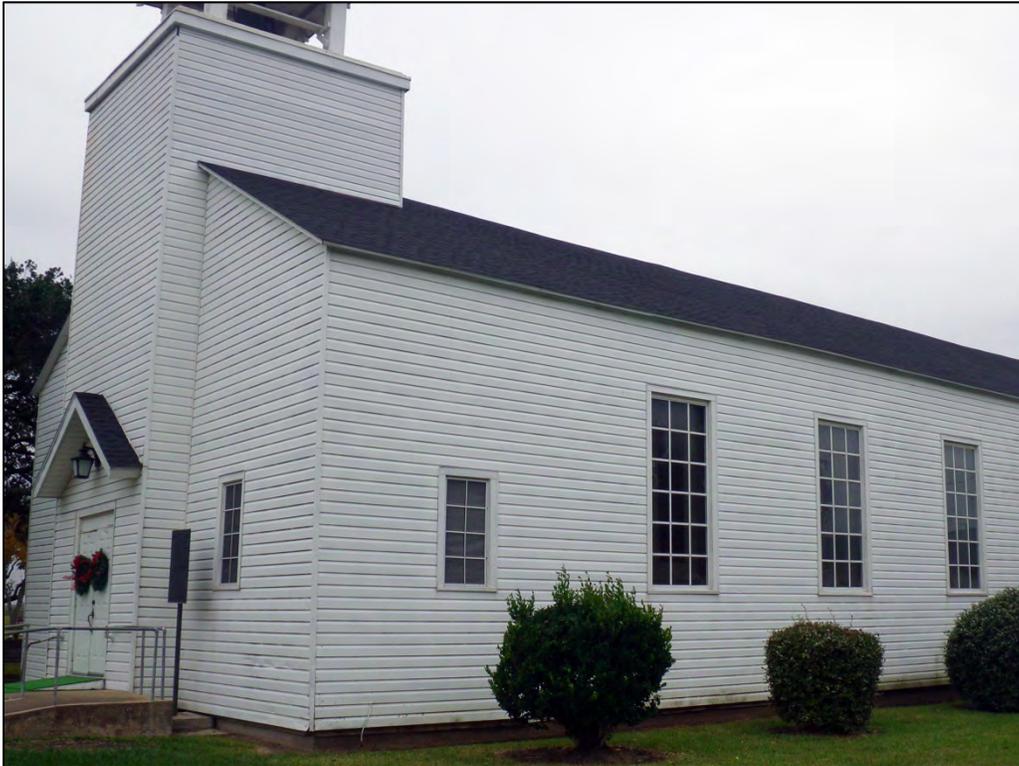
IMGP1963: Looking northwest at front and east side of Danevang Lutheran Church, showing aluminum siding and replacement windows. (C. Borstel, Tetra Tech, December 5, 2013)

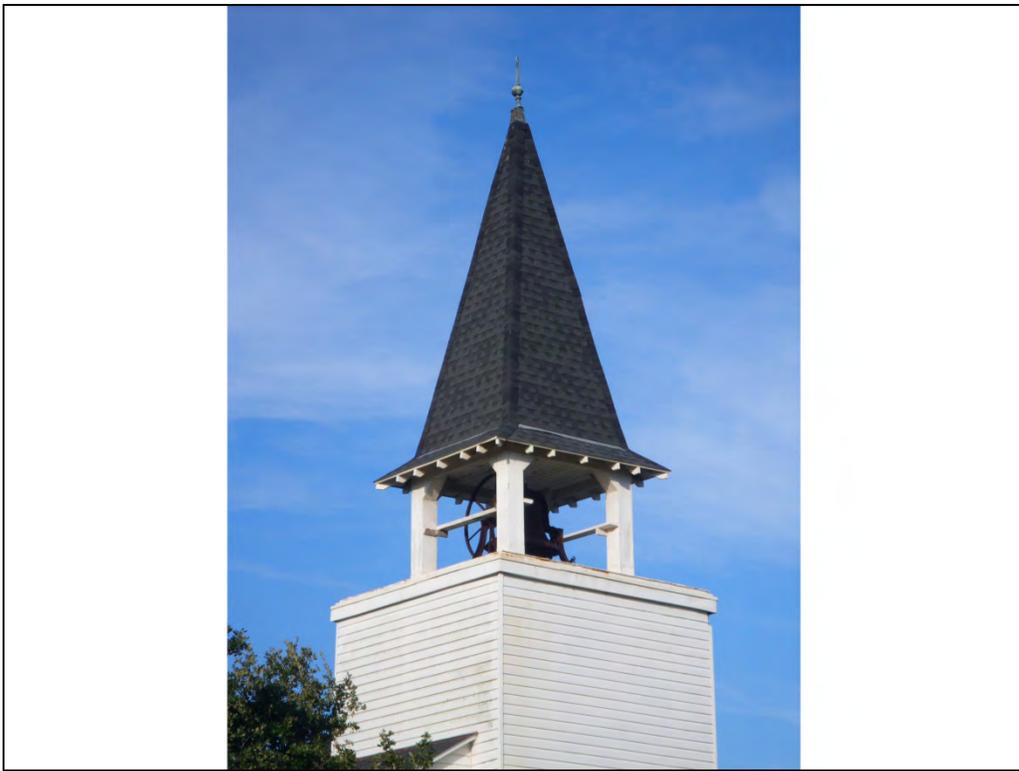
IMGP1389: Looking northeast at bell tower of Danevang Lutheran Church. Church building was relocated to this site in 1947, but tower houses bell of 1909 predecessor church. (C. Borstel, Tetra Tech, December 2, 2013)

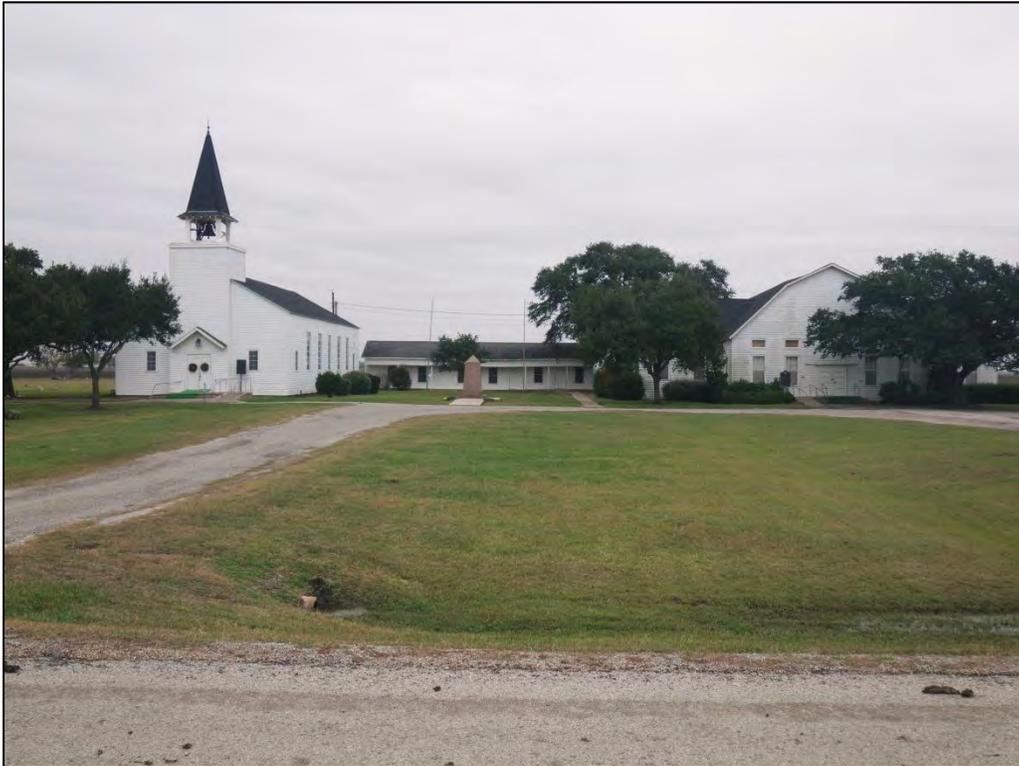
IMGP1956: Looking north from CR 426 at Danevang Lutheran Church (left), Sunday School Building (center), and Danevang Community Hall (right), all elements of Archit-7. (C. Borstel, Tetra Tech, December 5, 2013)

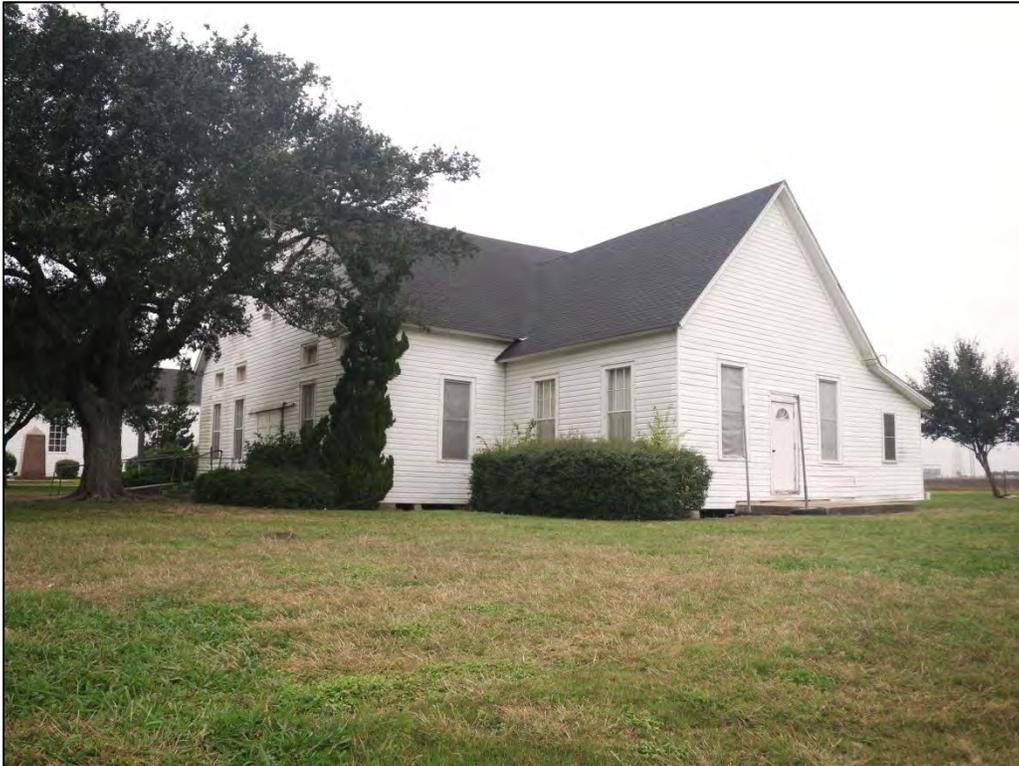
IMG2001: Looking northwest at Danevang Community Hall (Forsamlingshus) showing front (south) and east side. (C. Borstel, Tetra Tech, December 5, 2013)

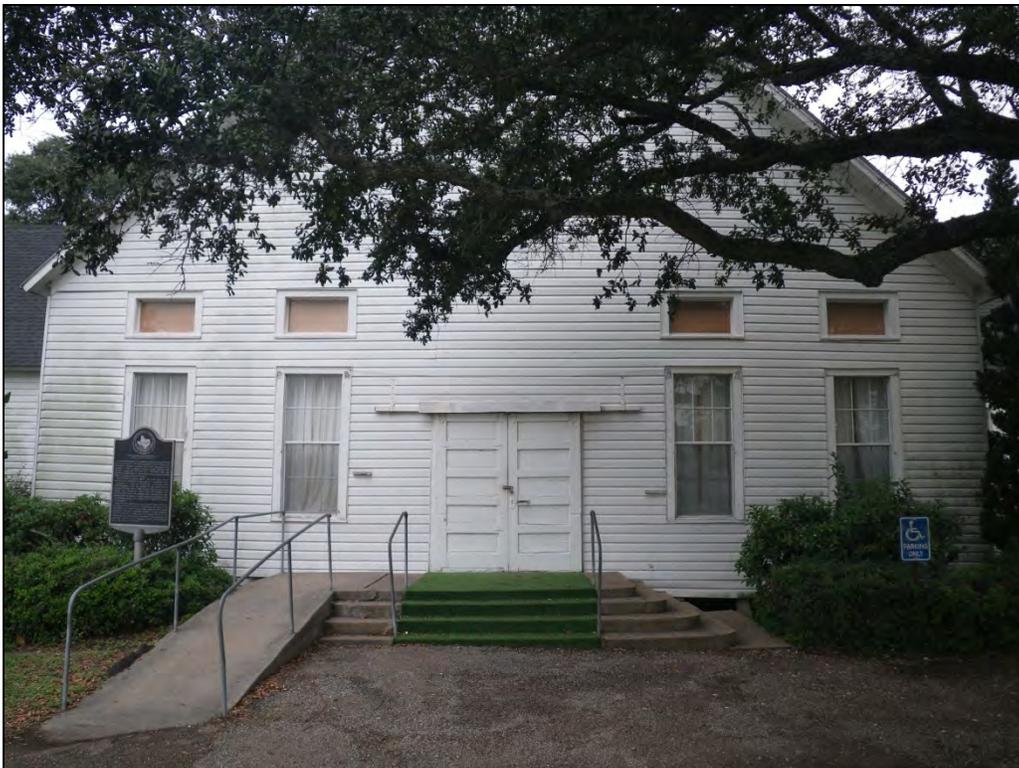
IMG1994: Looking north at front entrance of Danevang Community Hall (Forsamlingshus). Exterior is clad with aluminum siding and some windows appear to be altered. Historical marker is to left of door. (C. Borstel, Tetra Tech, December 5, 2013)

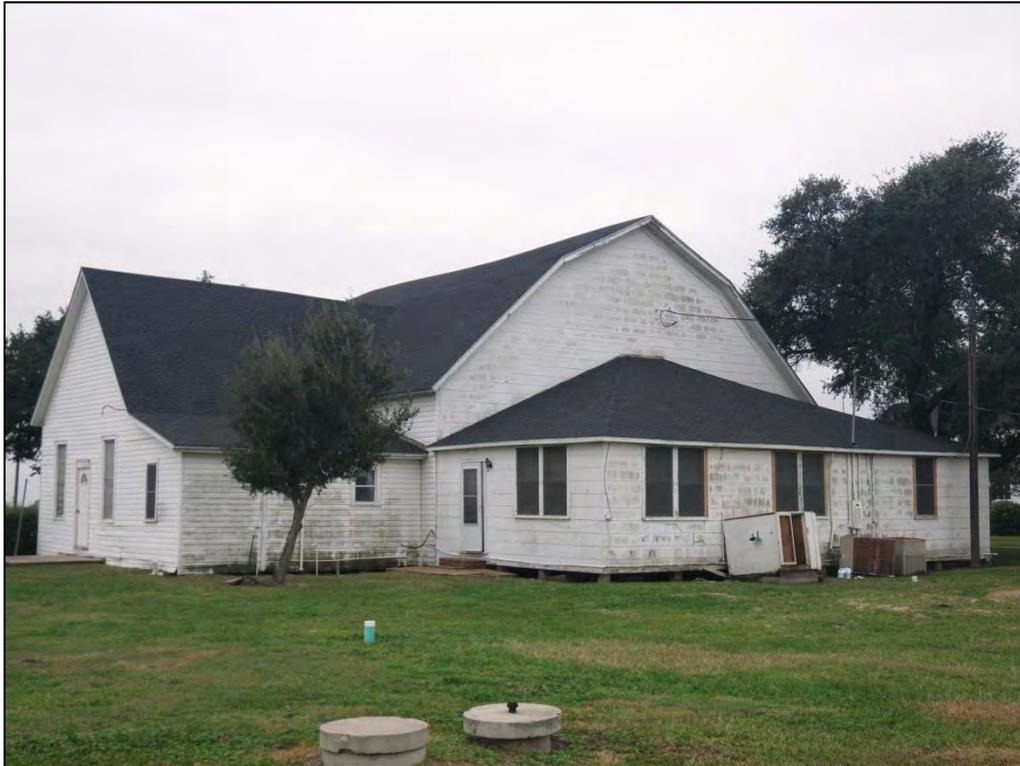
IMG1965: Looking southwest at rear and east side of Danevang Community Hall (Forsamlingshus). (C. Borstel, Tetra Tech, December 5, 2013)

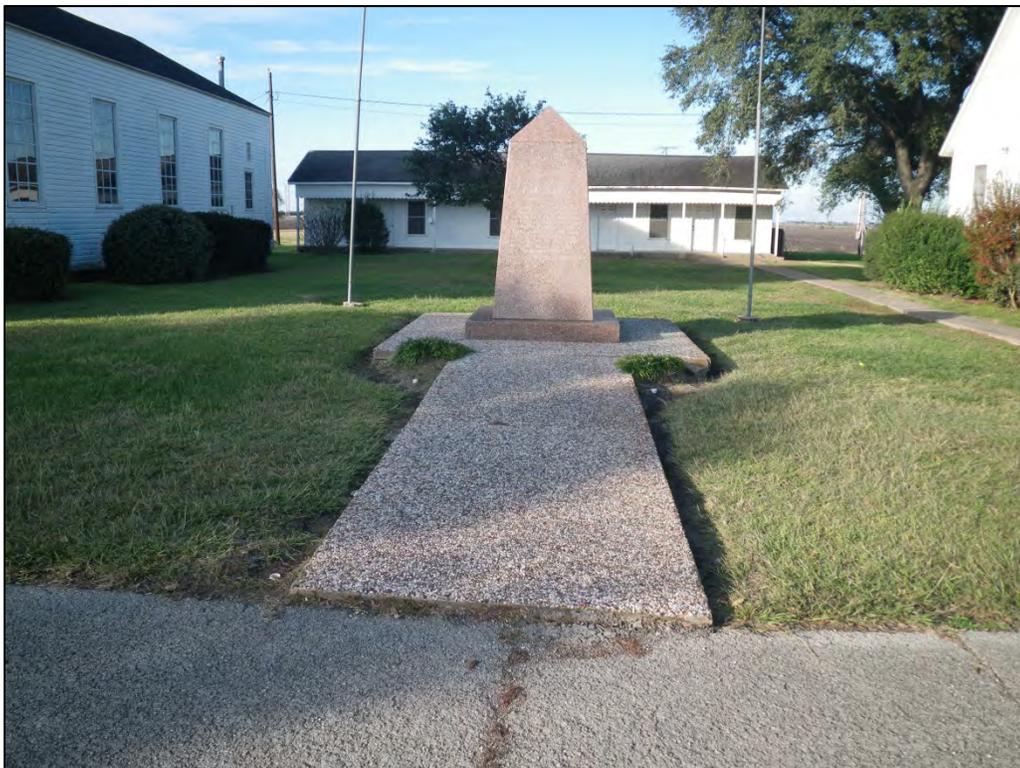
IMG1334: Looking north at the courtyard between the Danvang Lutheran Church (left) and the Community Hall (right). Sunday School Building is in rear, and pink granite historical marker is in foreground. (C. Borstel, Tetra Tech, December 2, 2013)

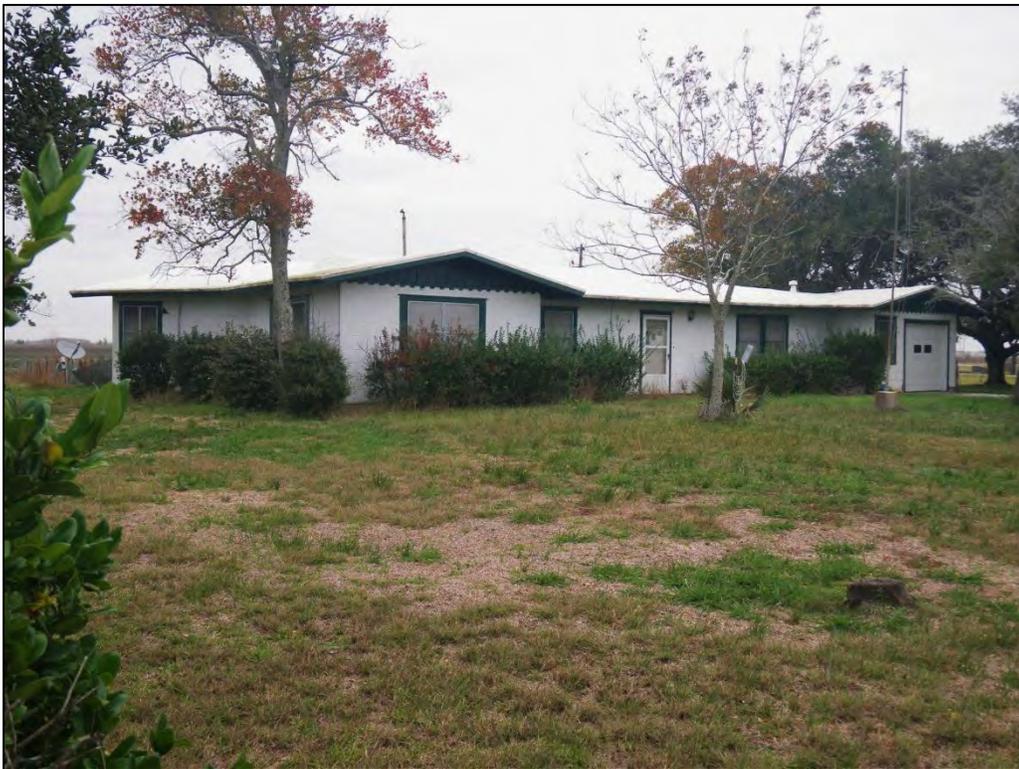
IMG1937: Looking north-northeast at Danevang Lutheran Church house or parsonage. Roof is clad with closed cell polyurethane roofing spray foam. (C. Borstel, Tetra Tech, December 5, 2013)

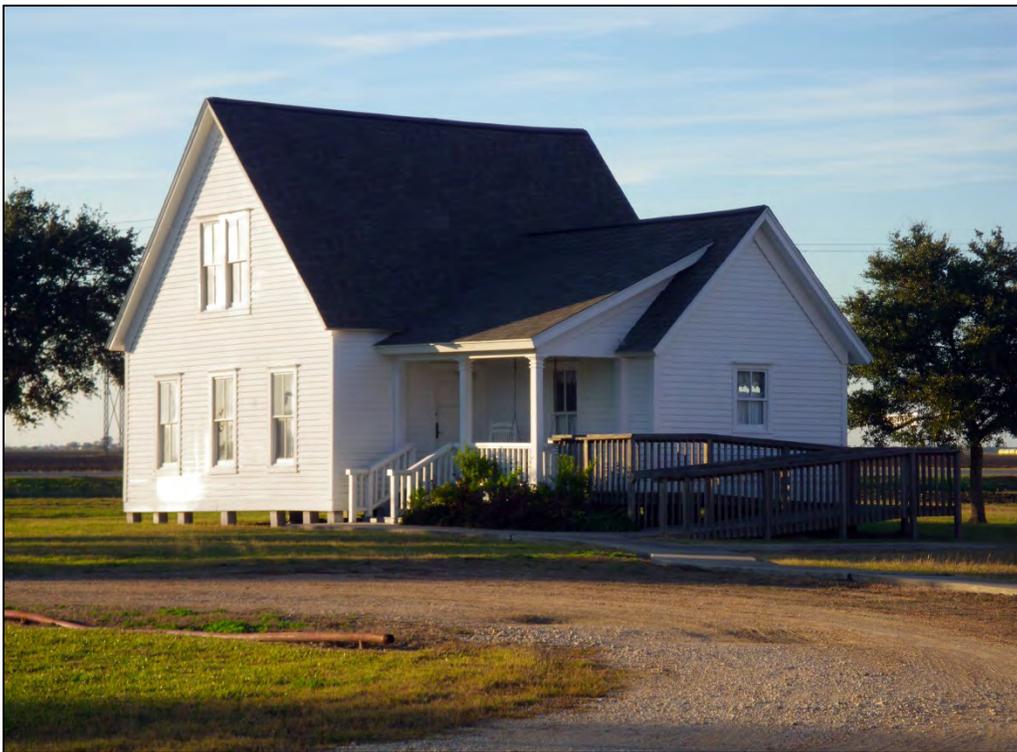
IMG1470: Looking northwest at the Jensen House (Pioneer House), an element of Archit-8A, Danish Heritage Museum, 153 CR 426. The kitchen ell at right is a reconstruction. (C. Borstel, Tetra Tech, December 2, 2013)

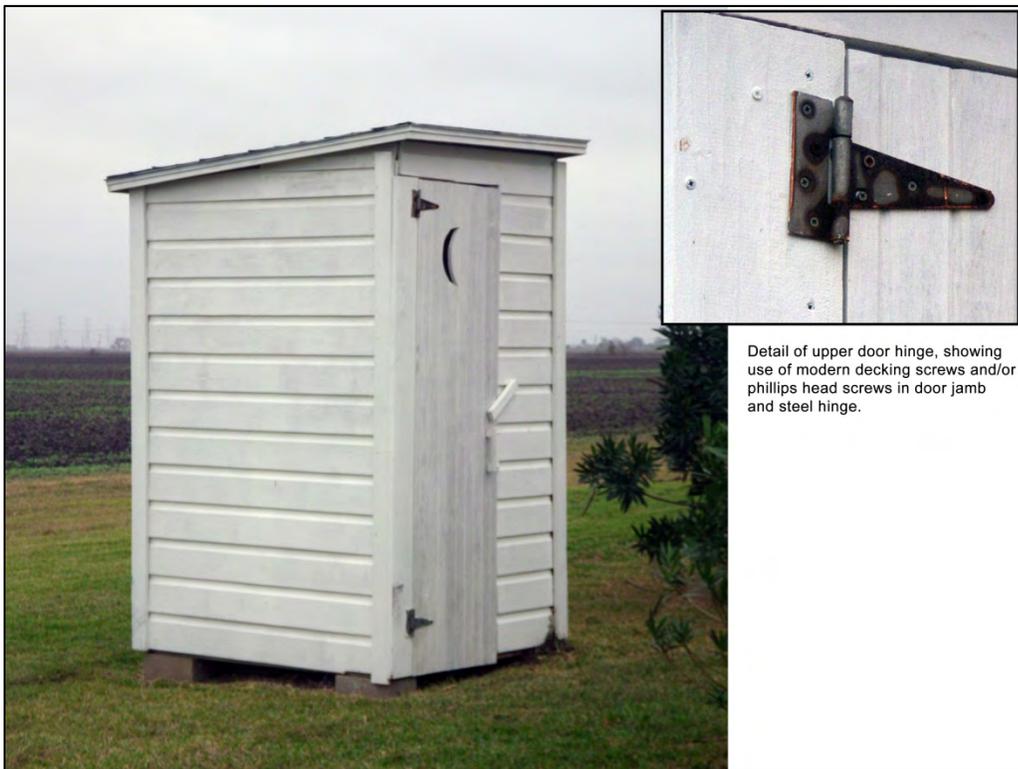
Detail of upper door hinge, showing use of modern decking screws and/or phillips head screws in door jamb and steel hinge.

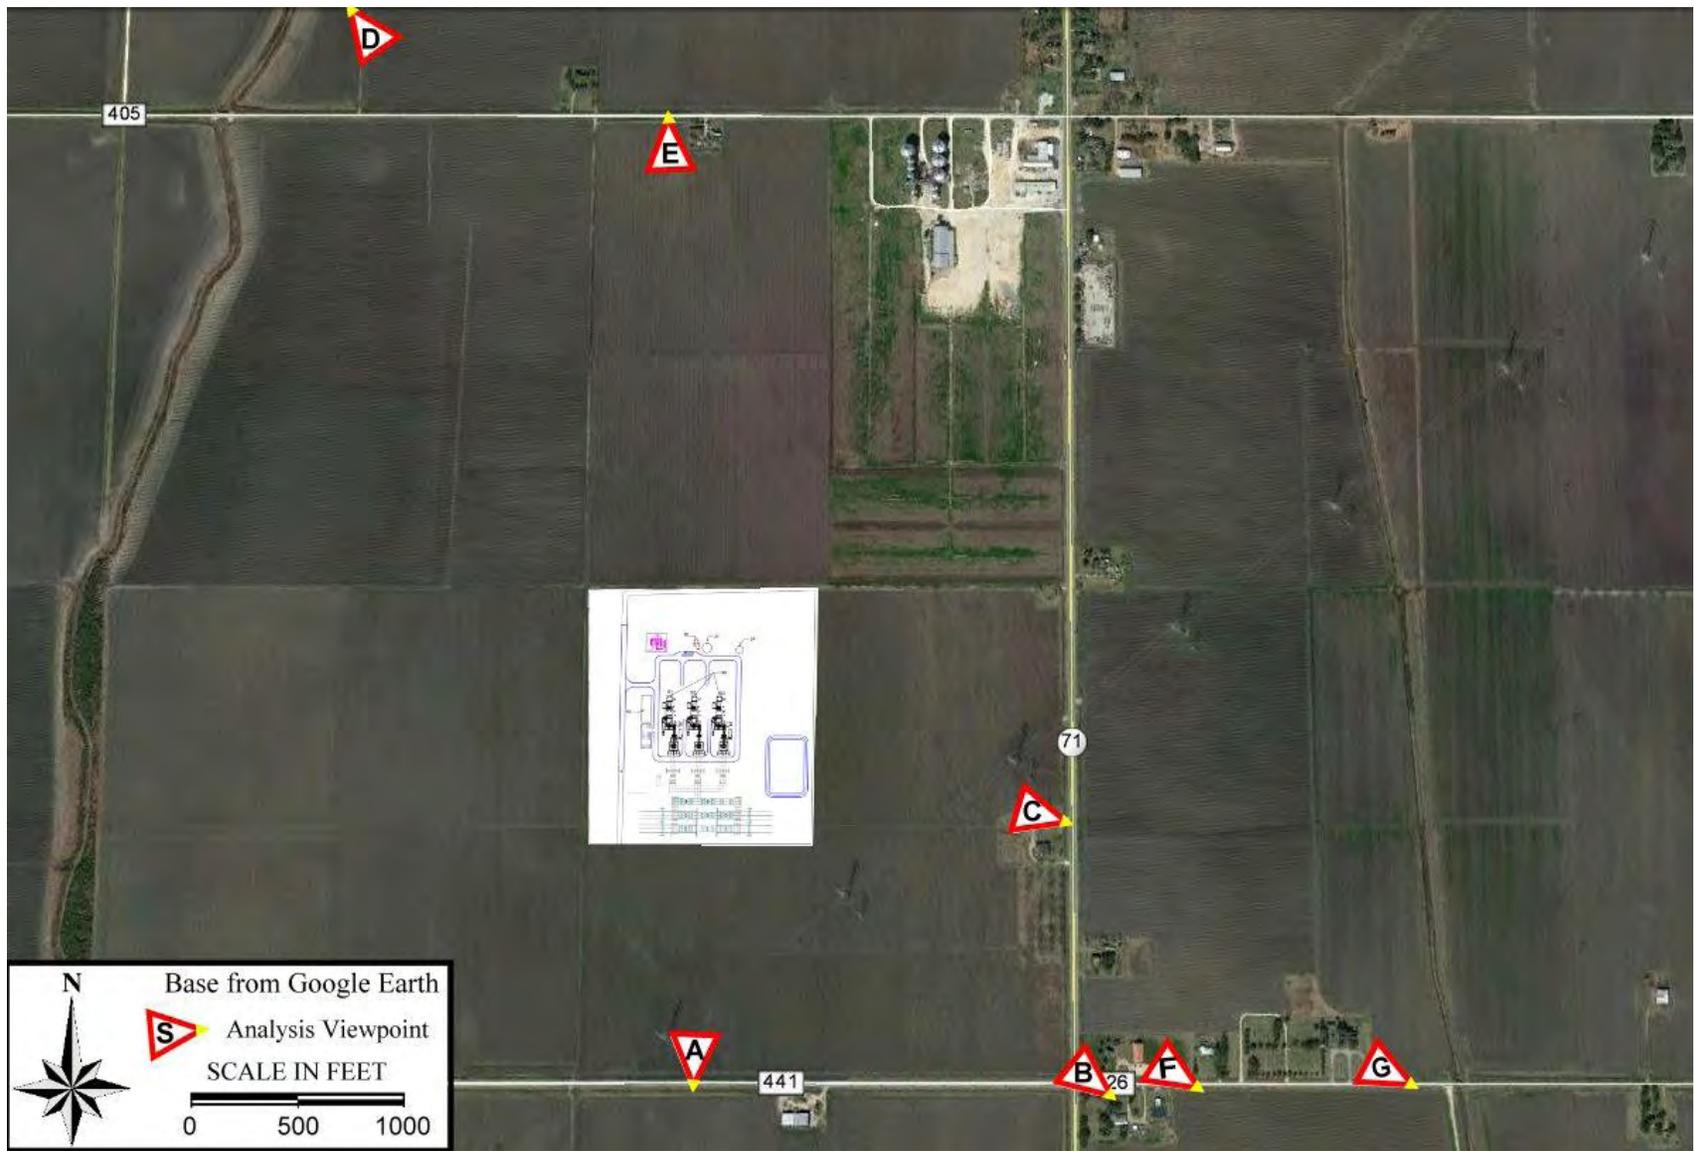
Figure 1: Overview of the Analyzed Viewpoints and Community Land Use in the Site Area

- Viewpoint A: This view is not associated with any sensitivity. It represents the nearest public location from which the Project will be viewed. The image was taken along FM Road 441.

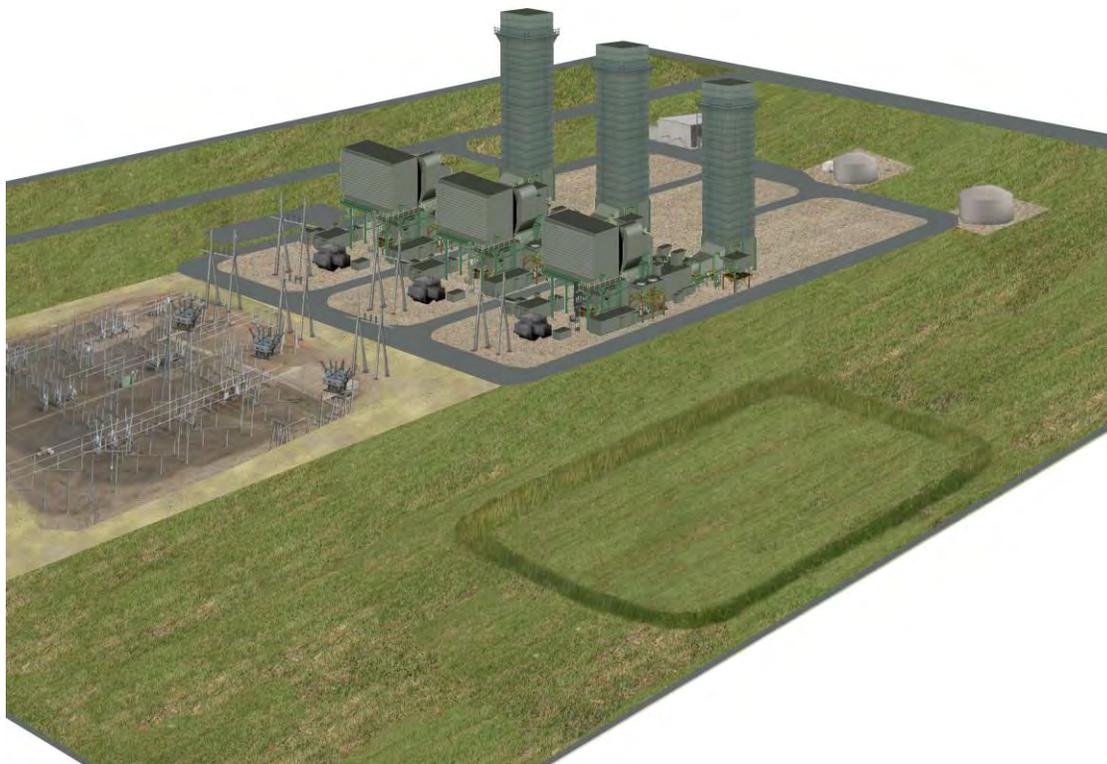
Figure 2: The Visual 3D Concept Model of the Entire Project
