Cultural Resources Survey

Indeck Wharton Energy Center Project Wharton County, Texas

March 2014 (*Final Report*)

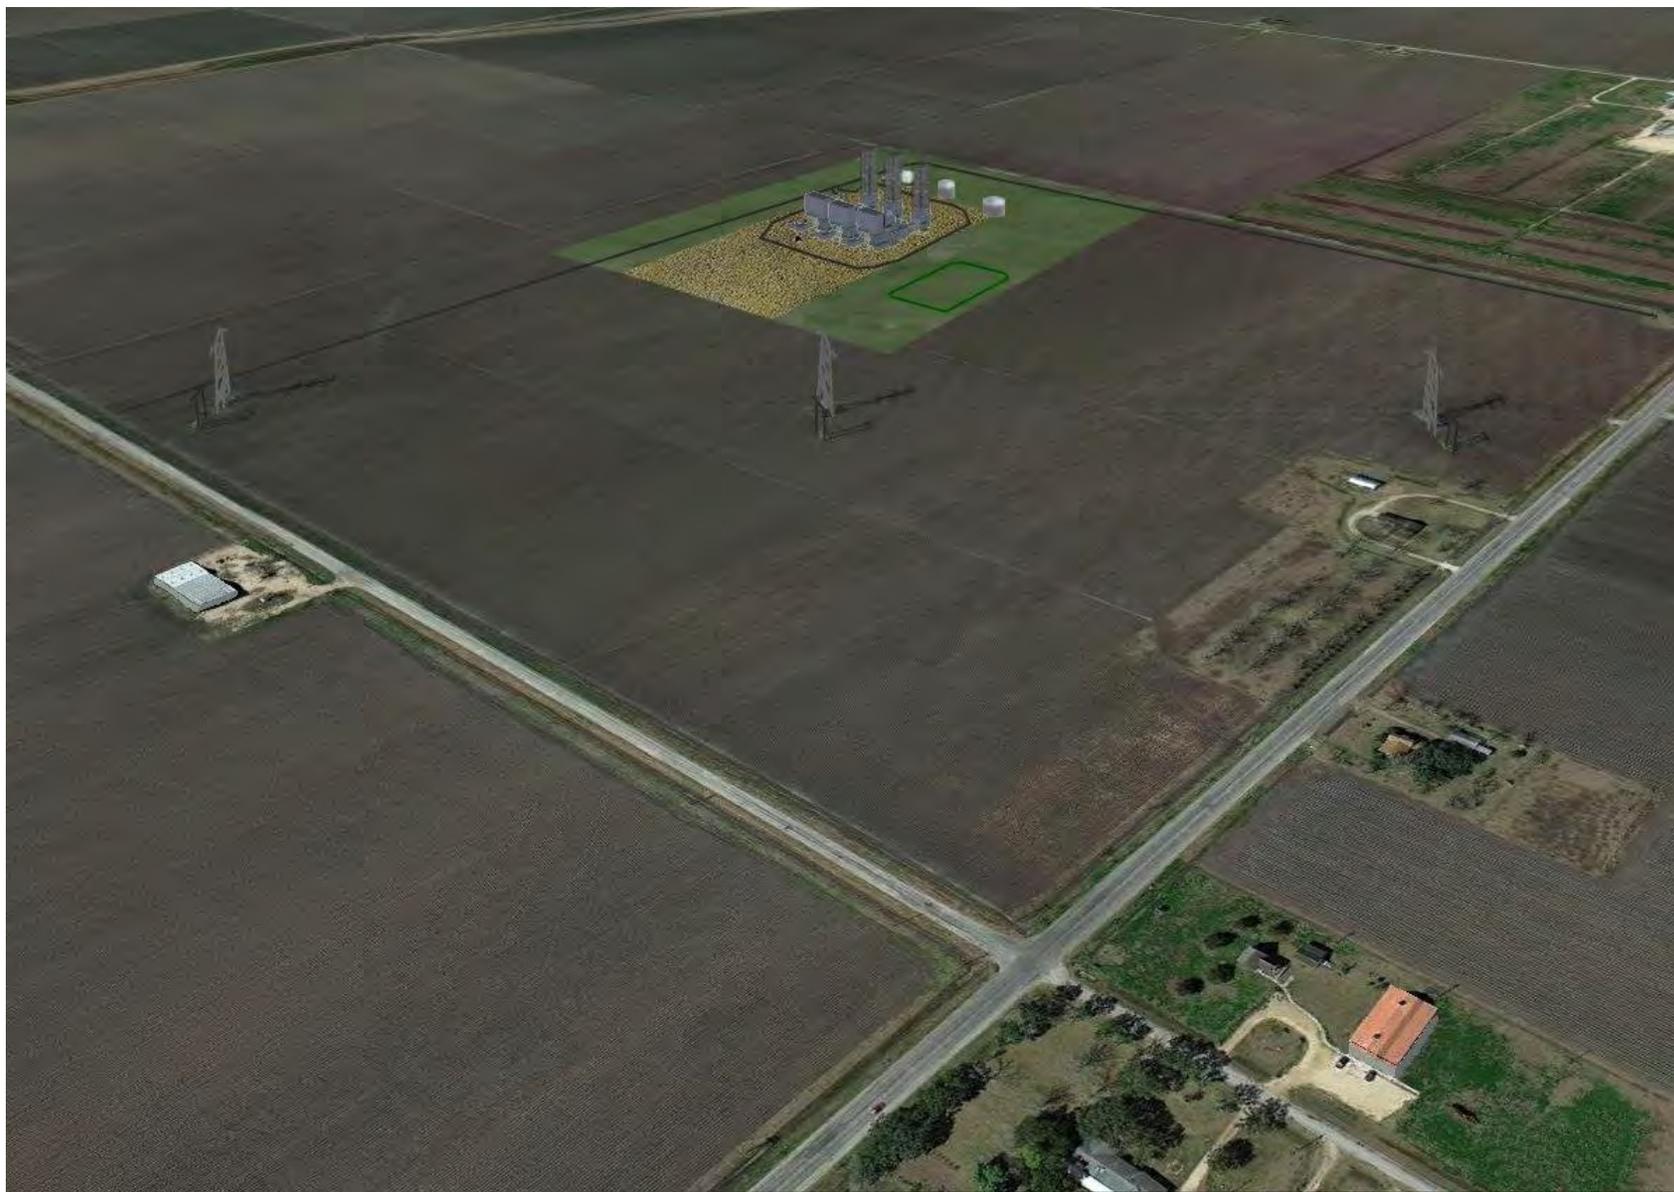
Figure 3: Aerial Overview of the Site Area from an Aerial Location to the Southeast

Once the 3-D model was developed, the model was adapted to each of the analyzed vantage points. The proposed facility model was then overlaid on actual field images to simulate the developed Project. Size and orientation was based on information that was obtained from the field survey, the equipment plan and available aerial images. The simulated plant equipment was overlaid on the photos at the approximate scale and orientation, such that the visual impact of the proposed stacks and structures may be illustrated. The photographs were used in the graphics to show the results of the visual impact analysis. The simulations show various levels of detail depending on the relative distance from the Project equipment. Two overview aerial images are provided in Figure 3 and 4. Also noted in the image are the modeled community viewshed locations.

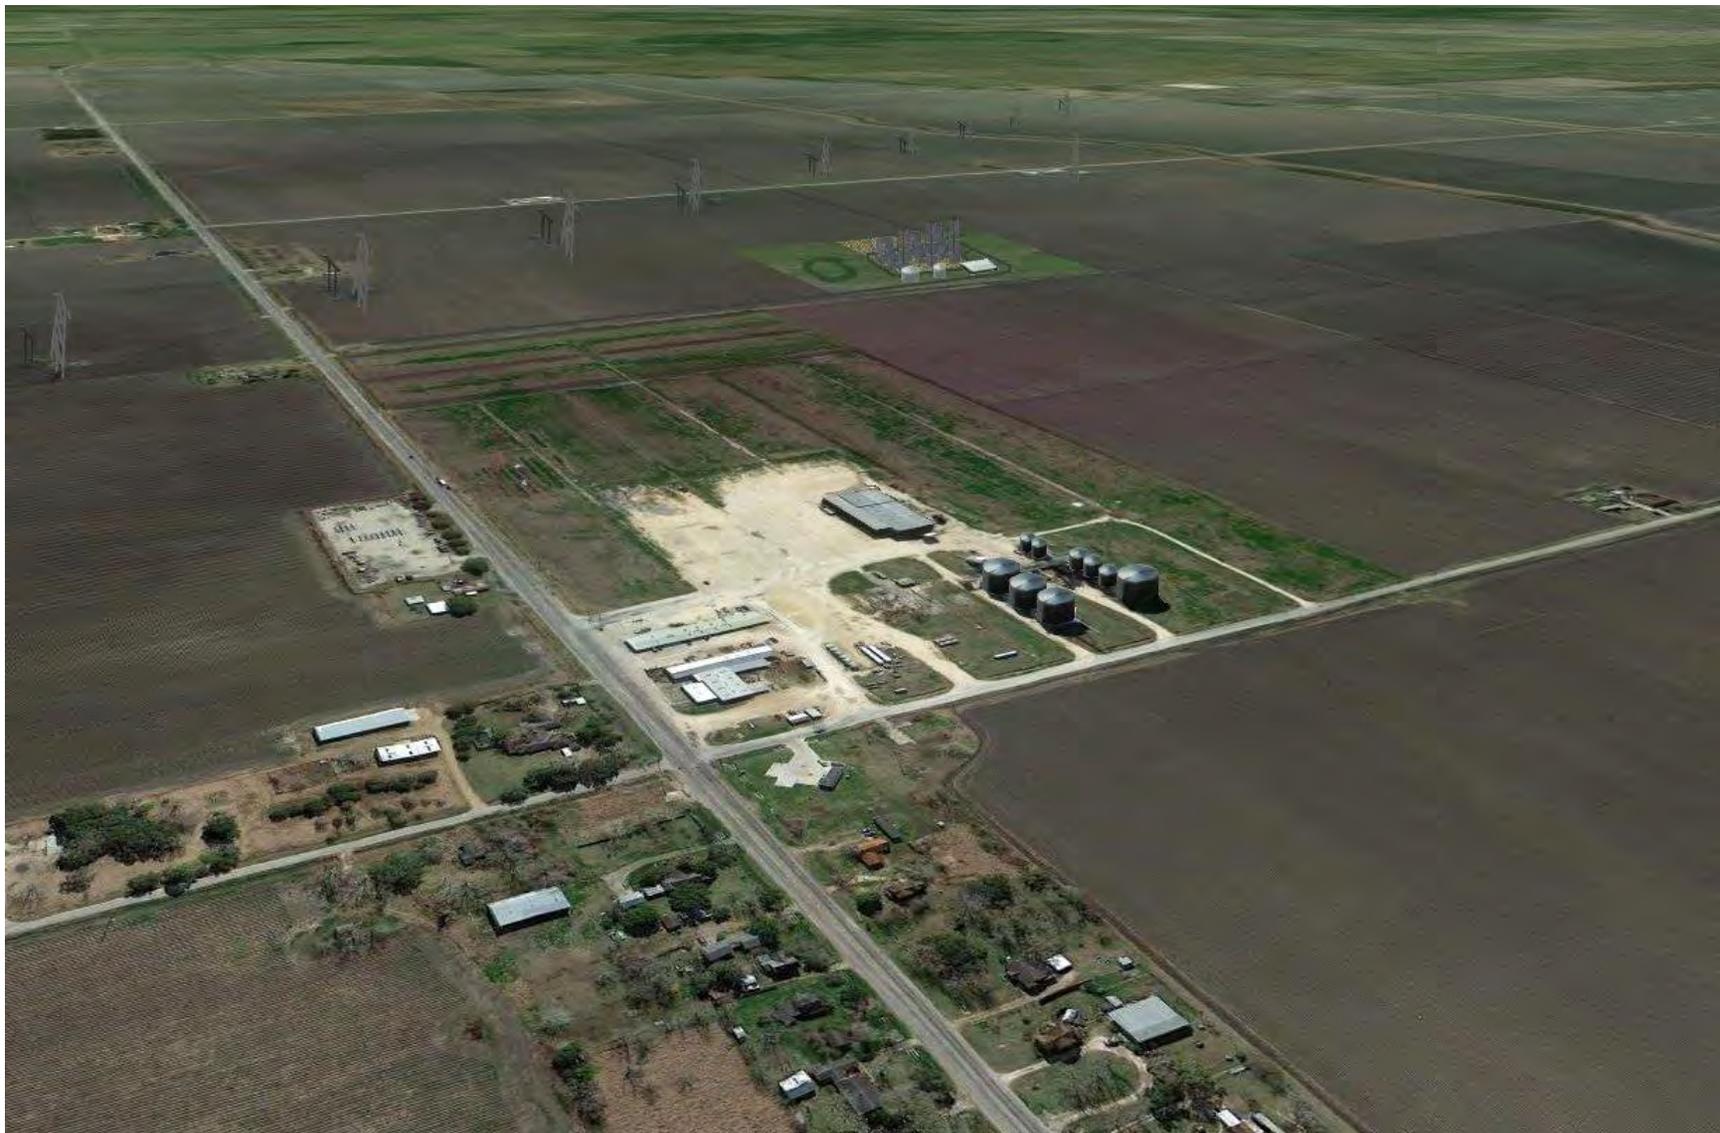
Figure 4: Aerial Overview of the Site Area from an Aerial Location to the Northeast

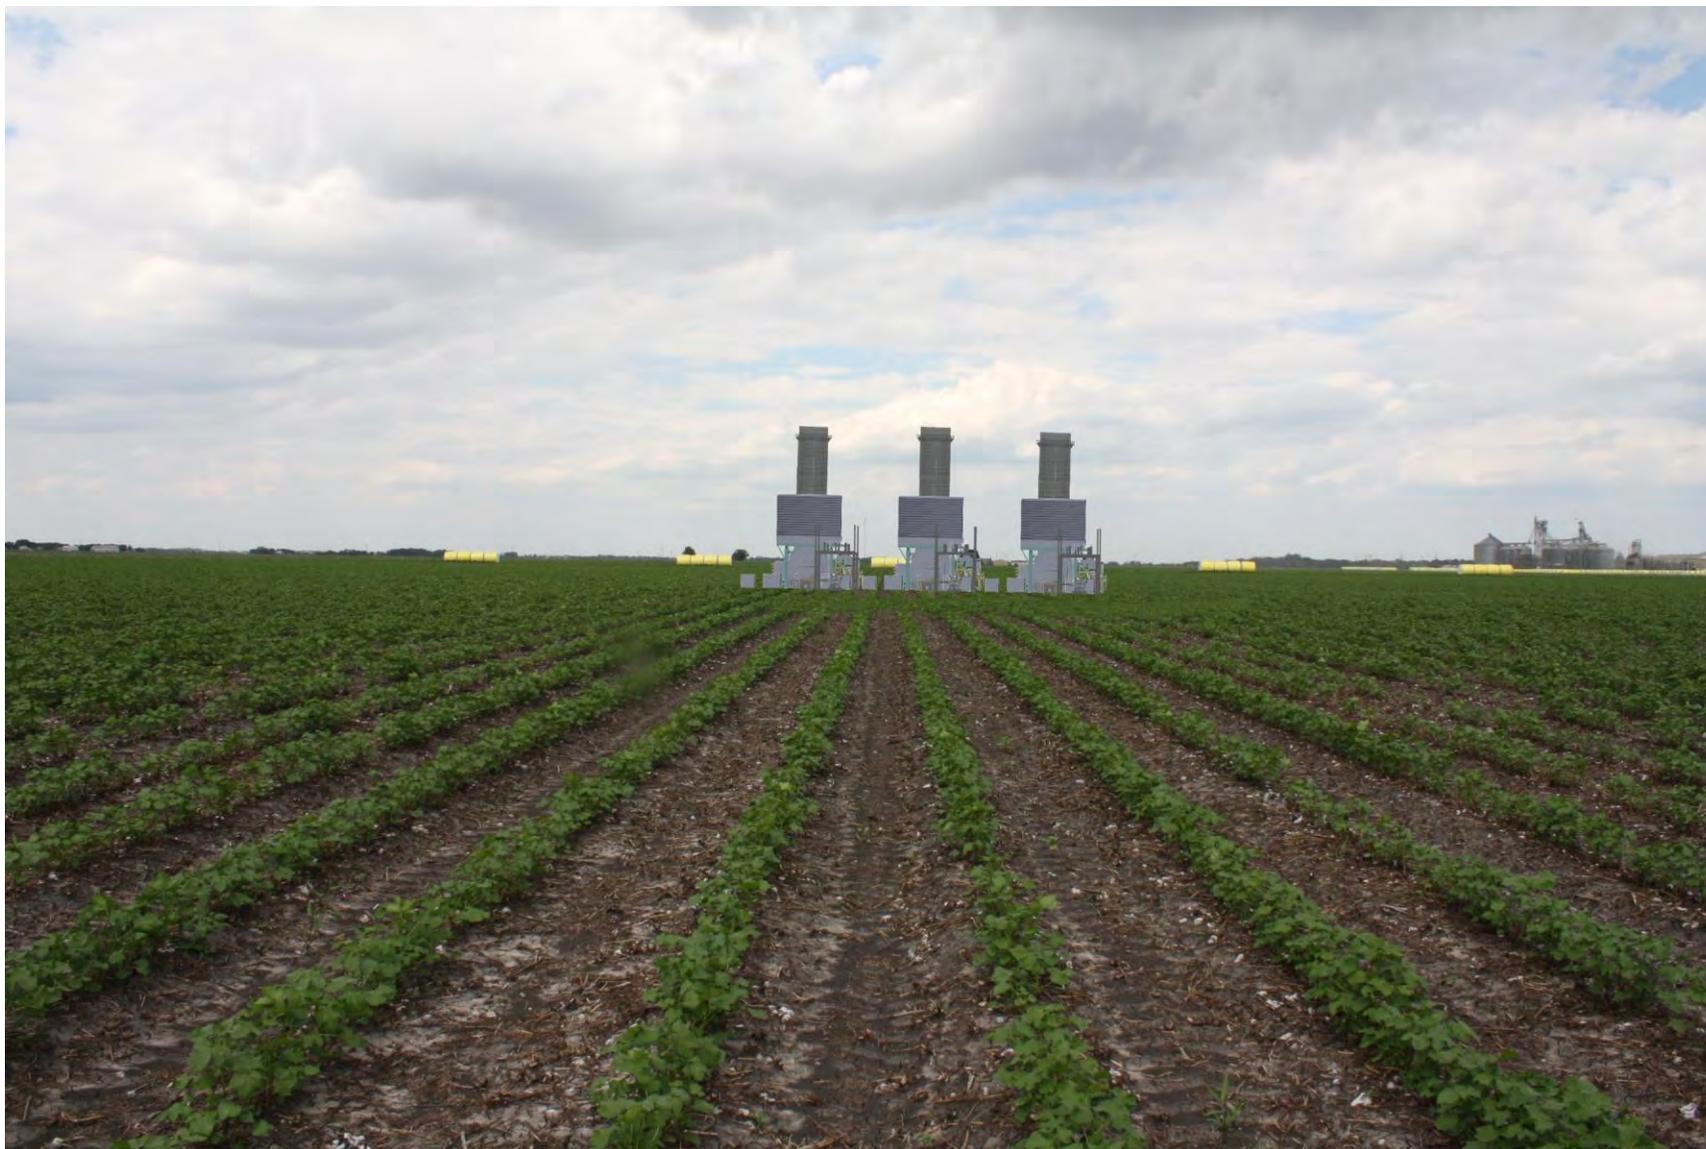
Figure 5 (Loc. A): View of the Proposed Equipment from the Nearest Public Roadway to the South of the Site

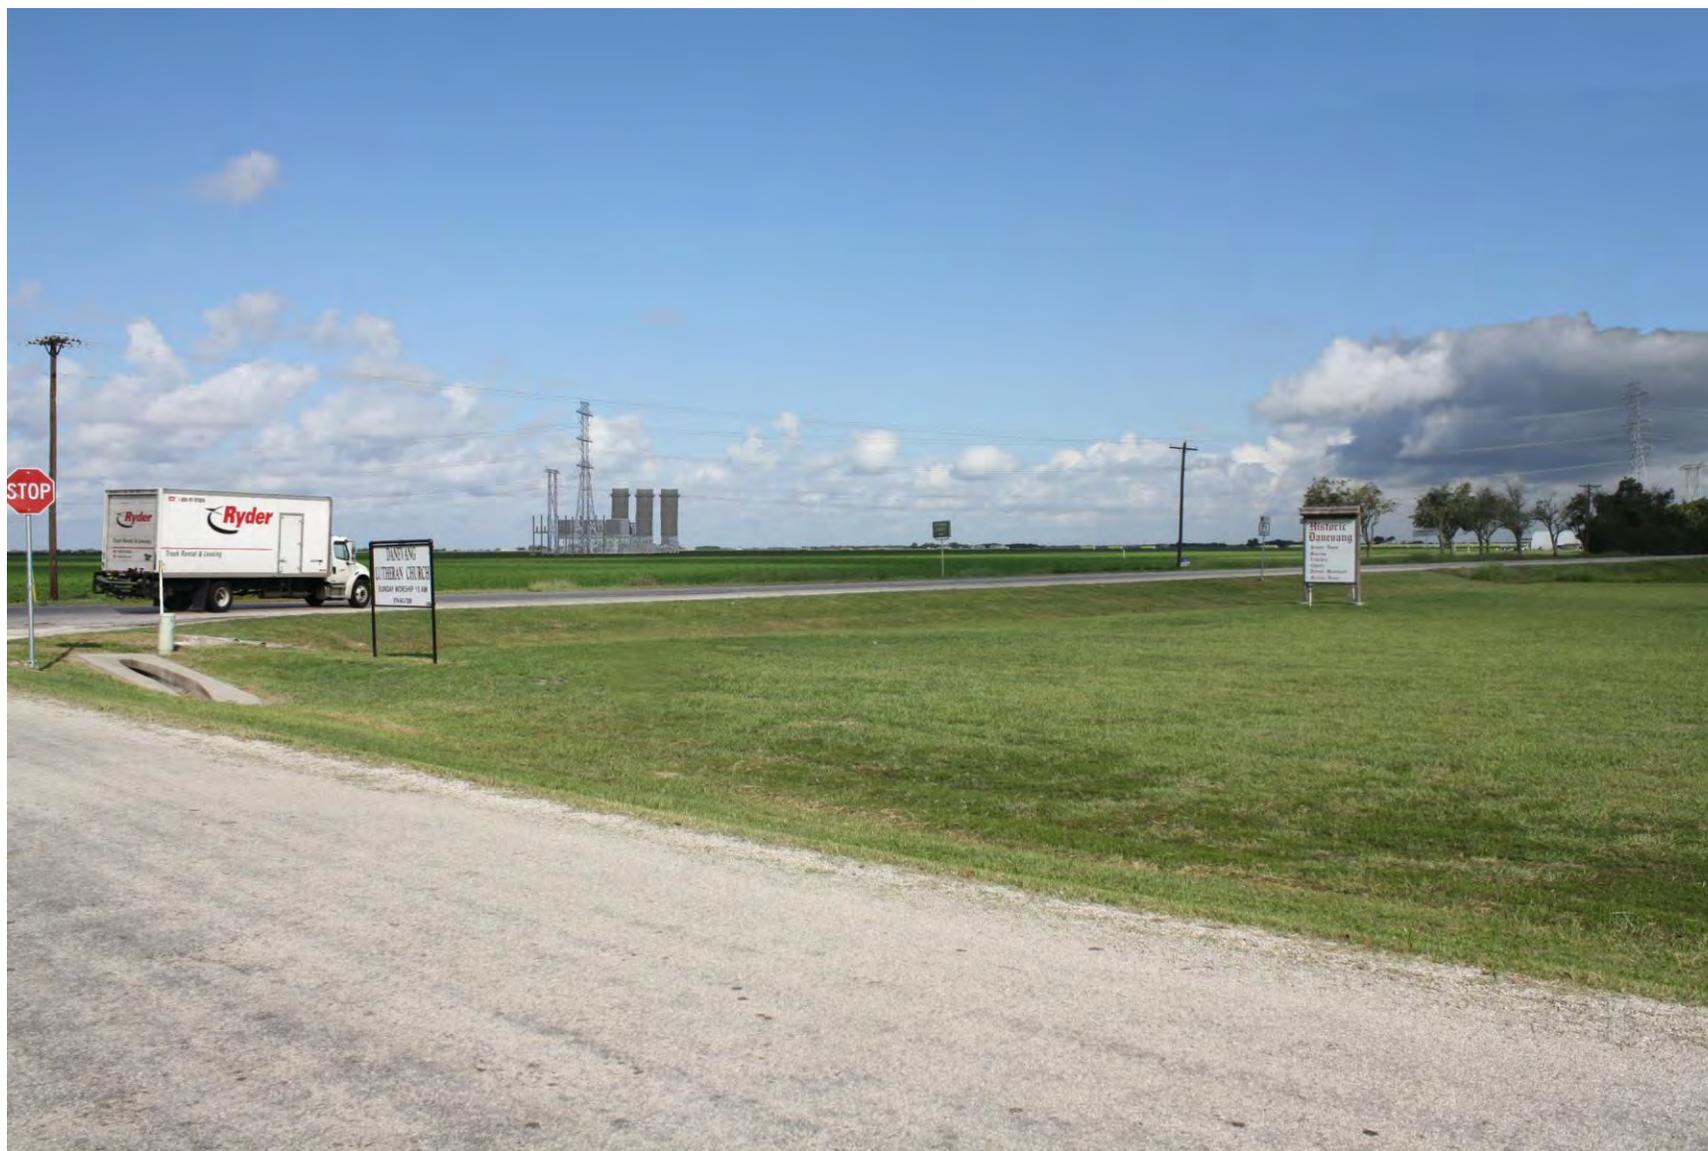
Figure 6 (Loc. B): View of the Proposed Equipment from the Danevang Museum and Residence to the Southeast

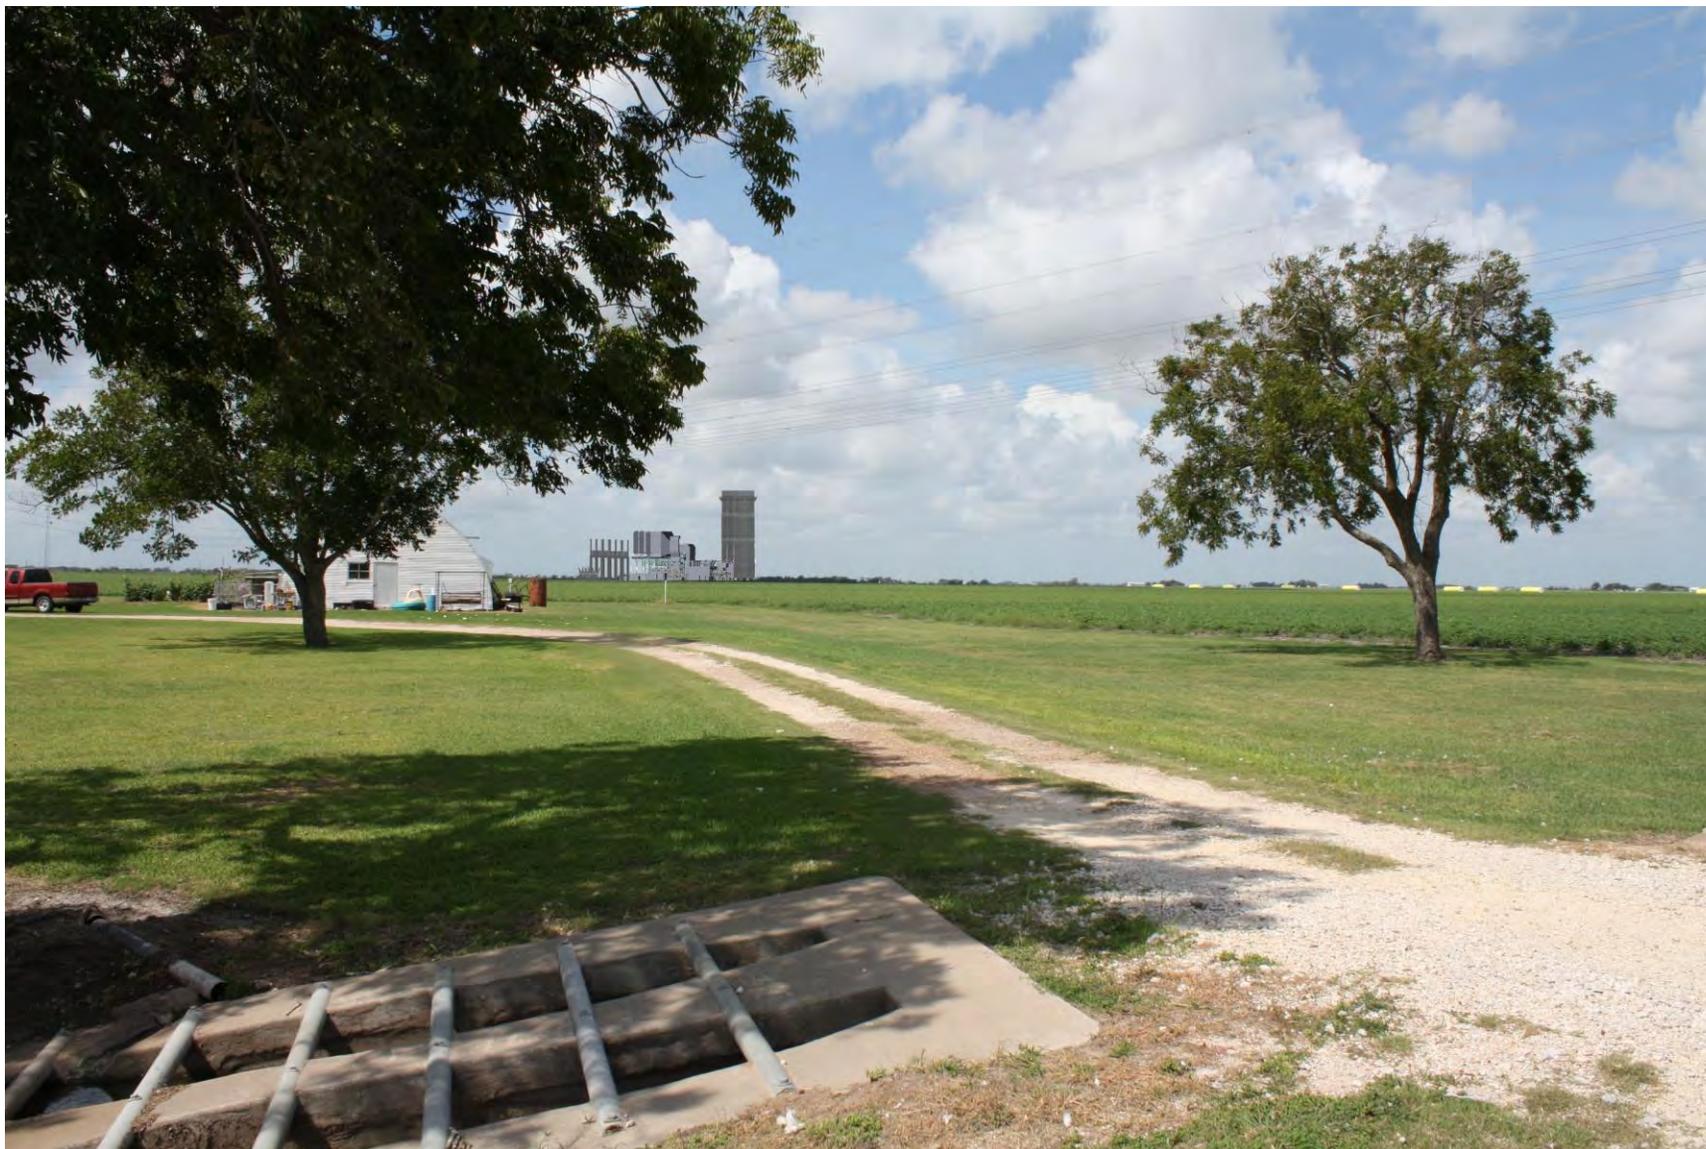
Figure 7 (Loc. C): View of the Proposed Equipment from the Nearest Residence to the East

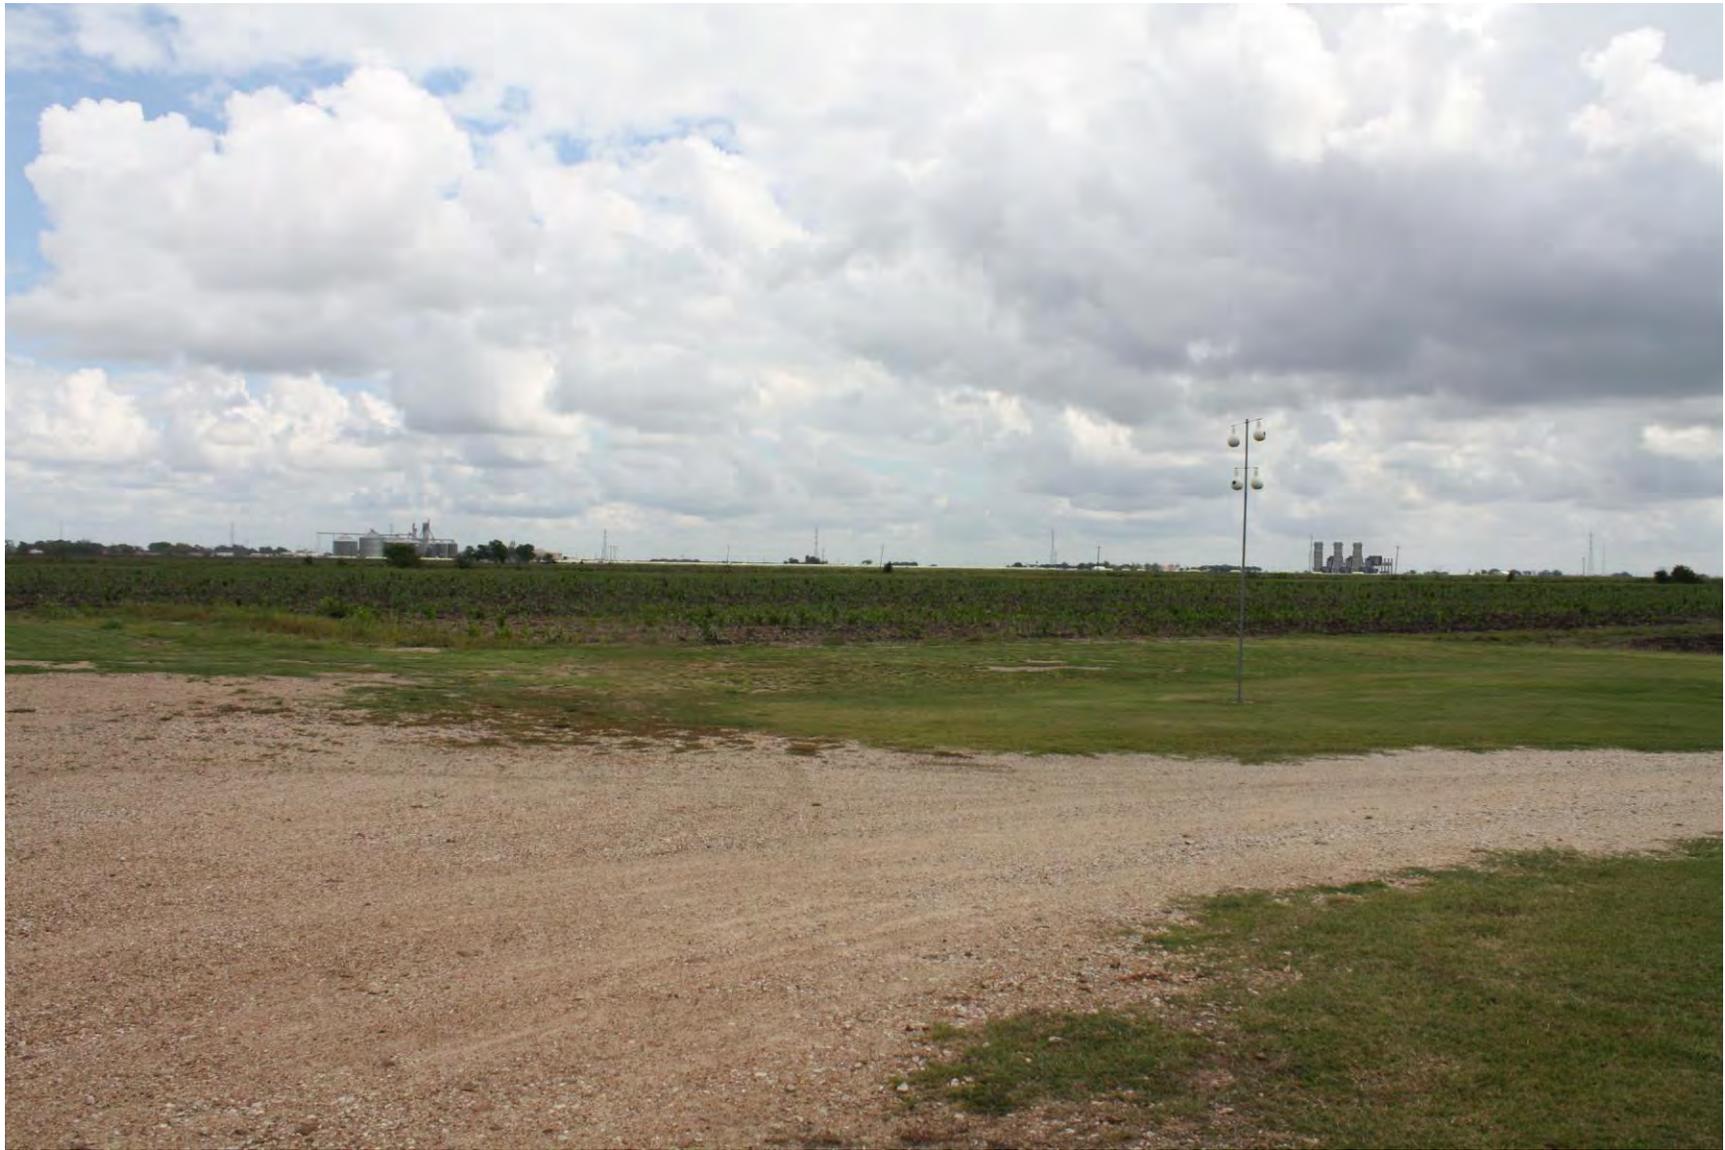
Figure 8 (Loc. D): View of the Proposed Equipment from a Residence to the Northwest

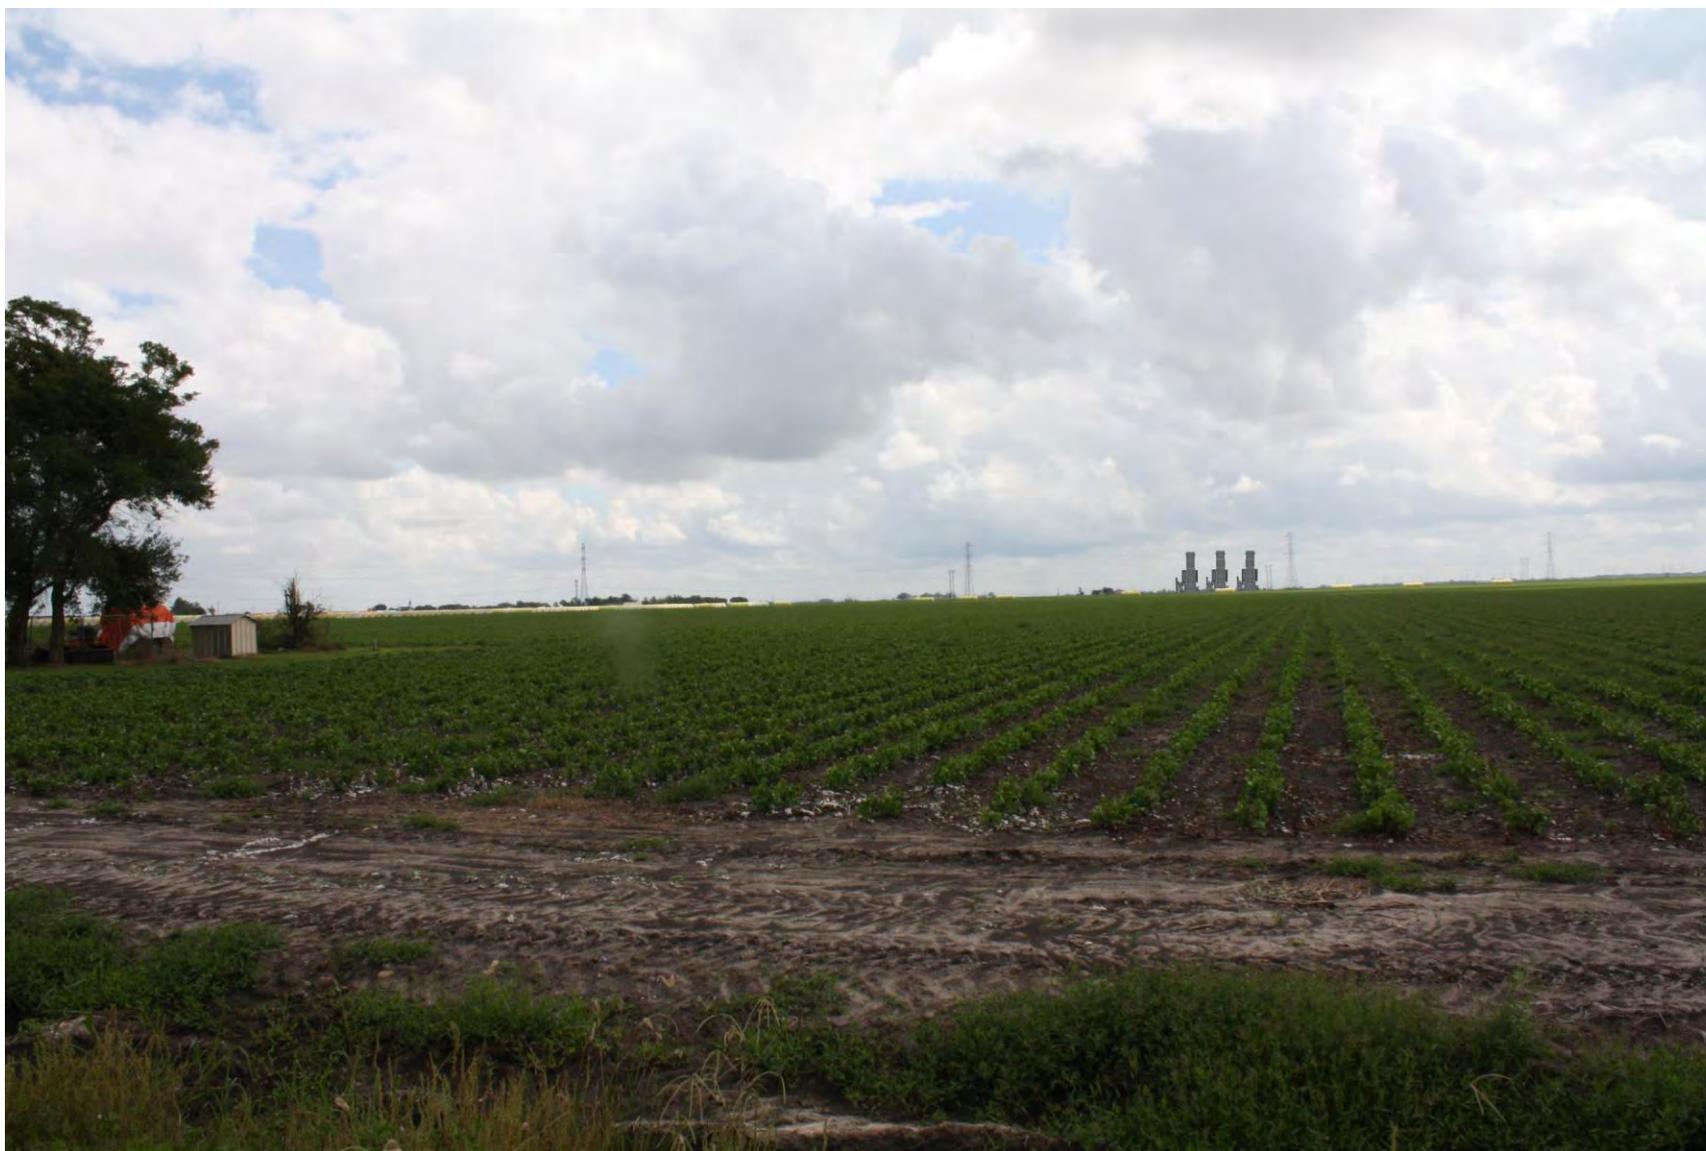
Figure 9 (Loc. E): View of the Proposed Equipment from the Nearest Residence to the North

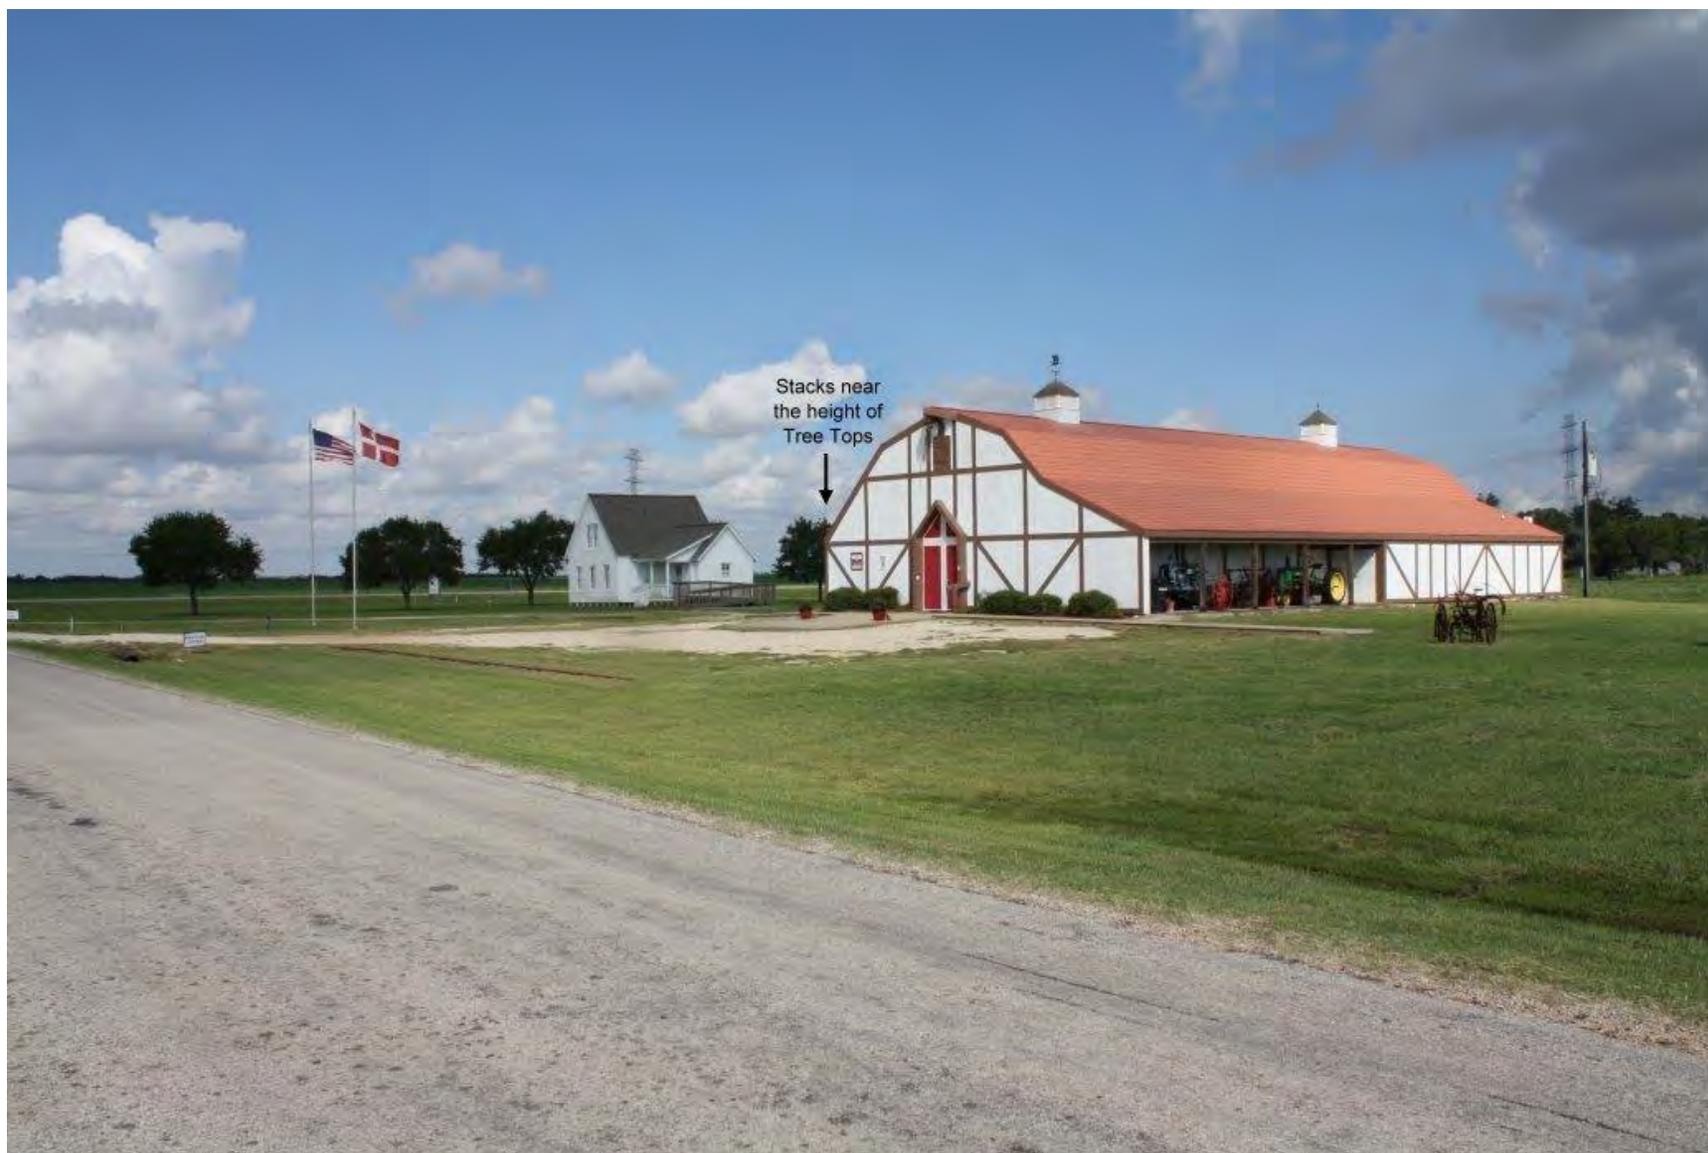
Figure 10 (Loc. F): View of the Danevang Museum Looking in the Direction of the Proposed Project

Finally, the block model was overlaid onto field images from the five community locations. These represent ground level viewing locations. They are shown in Figures 5 through 9. Two additional views are provided at historic locations to the southeast of the site for the Danevang Museum and Church. The field images are shown in Figures 10 and 11. The figures represent the predicted visual effect that the facility will have at each of the viewing locations. Because of the great distances to the receptors, the project, when seen, will be clearly visible from the receptors. For that reason, no "Before" image was compared to the "With Project" image.

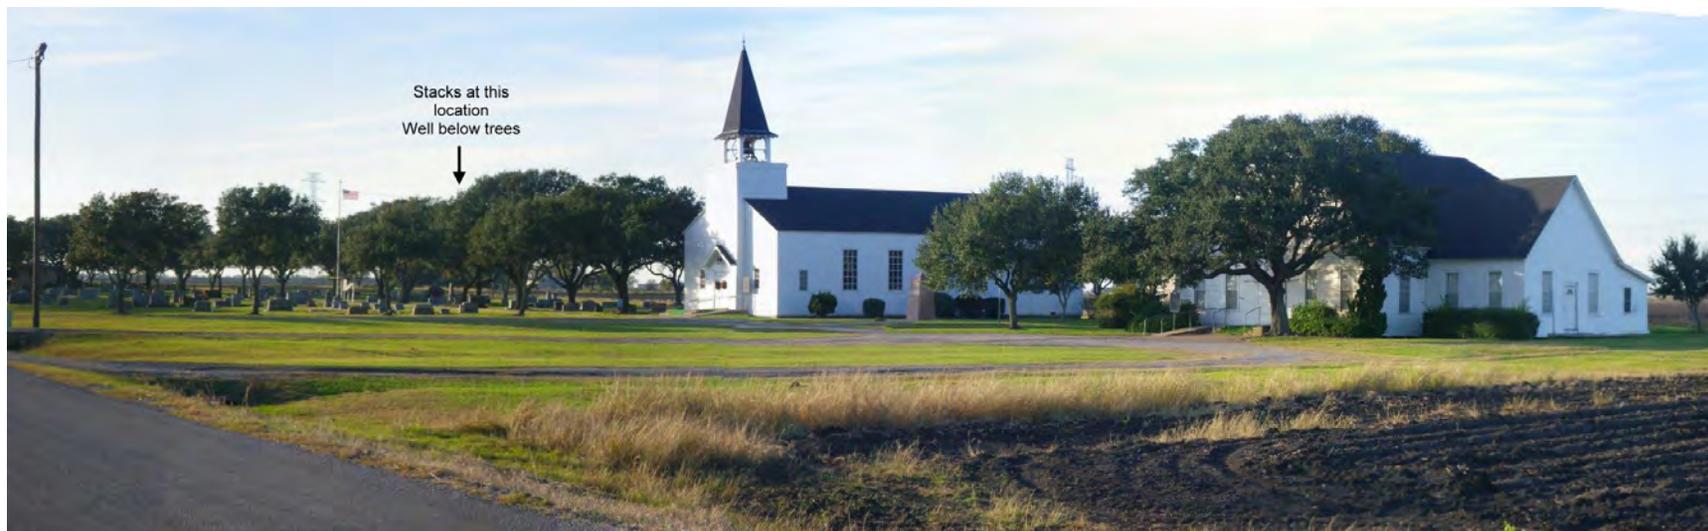
Figure 11 (Loc. G): Panoramic View of the Historic Church Looking in the Direction of the Proposed Project

will not substantively intrude on occupied properties in the surrounding area, including the area which contains the Danevang Lutheran Church and Associated Elements (Appendix E). In particular, a visual simulation looking west from CR 426 toward the community hall, church, and cemetery shows that the proposed Facility will occupy a small area near the visual horizon and, indeed, will be largely hidden by existing landscaping in the cemetery (Figure 11 of Appendix E).
