# Using Compost to Improve Post-fire Water Quality

David Crohn  
University of California, Riverside

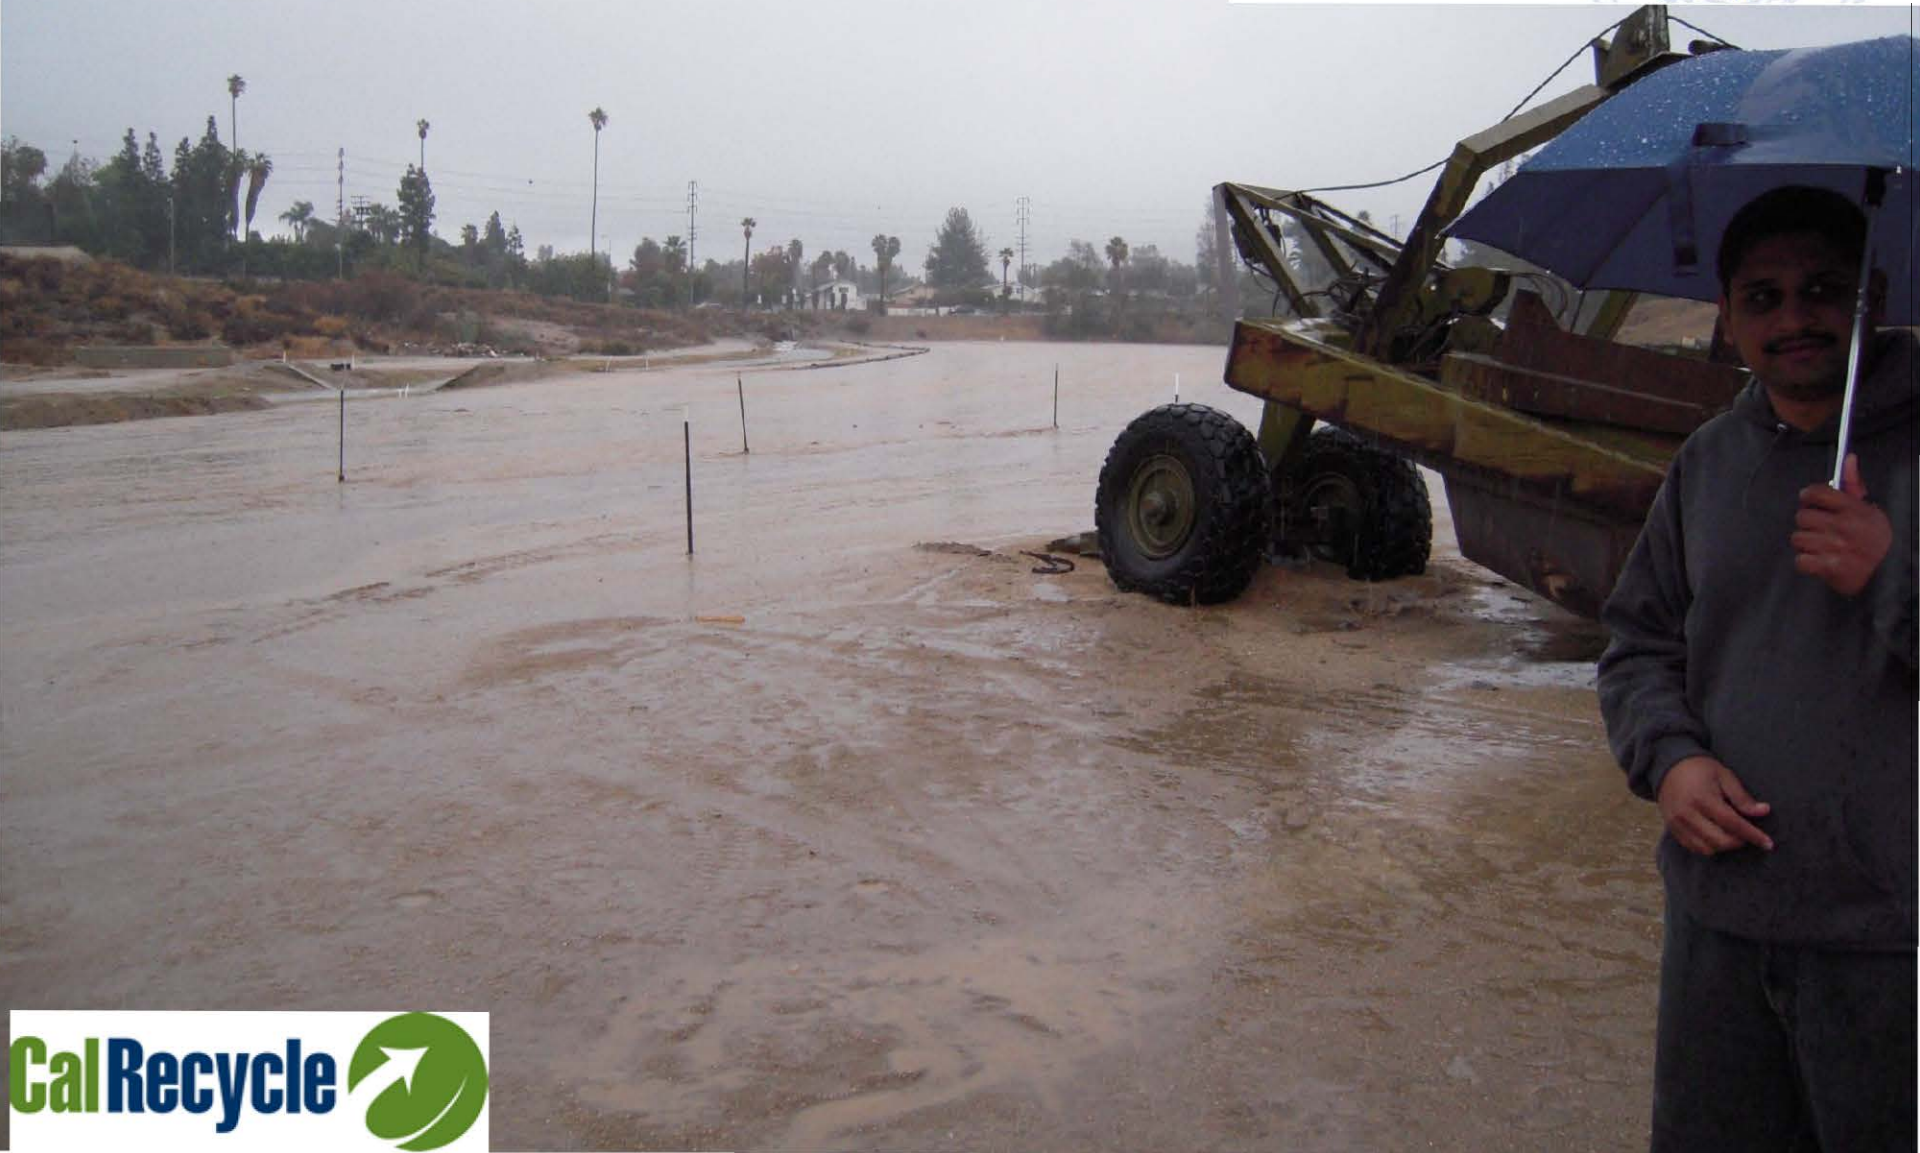
# Randomized Complete Block Plot Design

1" = Compost applied @ 1" depth  
 2" = Compost applied @ 2" depth  
 Inc = compost Incorporated at 2" depth application

#'s 1-30 are plot numbers
