#### Palos Verdes

## Distribution and Fate of Contaminated Seafloor Sediment on the Shelf Offshore Los Angeles

Studies through 1998

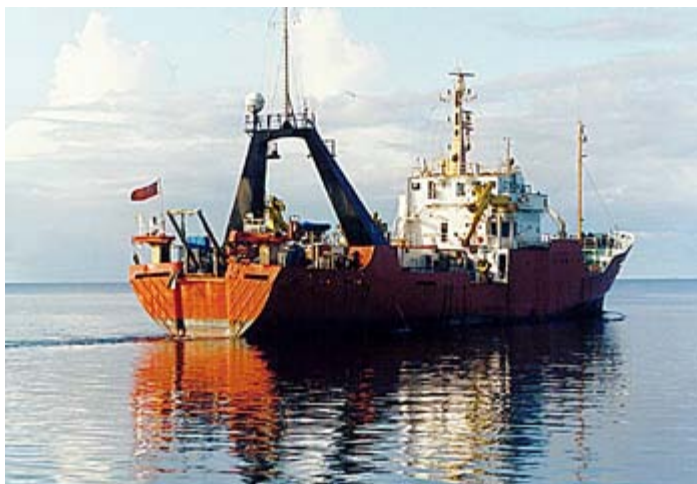
Research Vessel *Farnella* was one of the many vessels used for this project.

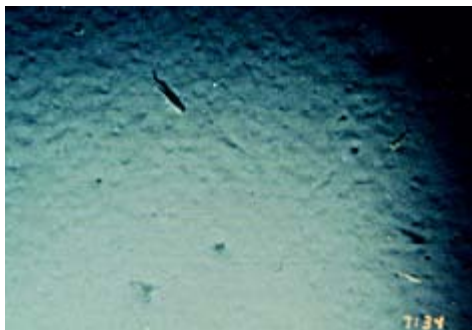
The photo above shows a depression-dominated seafloor.

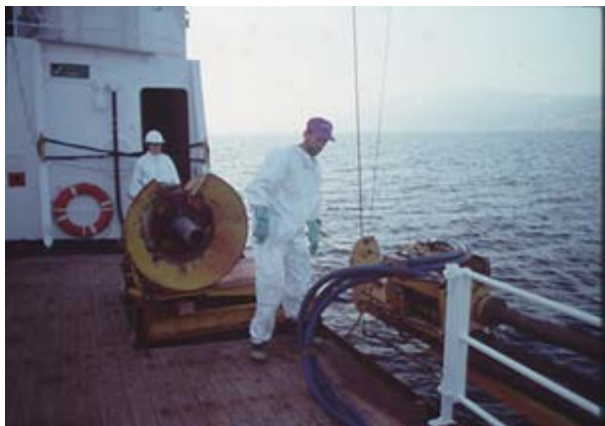
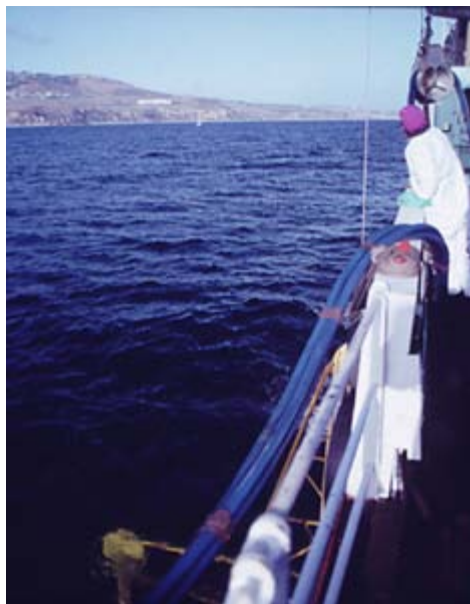
In the photos above the vibracore is being lowered to the sea floor from the deck of the research vessel Farnella. The blue hoses are providing compressed air to the pneumatic motor on top of the corer. The photo below shows the vibracore on the bottom.

An Alpine vibracore was used to collect cores on the shelf (shelf here is defined as no deeper than 70-90 meters). An Alpine vibracore is used to collect long cores (approximately 6 meters in length) from a sandy and/or gravelly sea floor. A longer core might provide information on sediment conditions before human occupation. The vibracore is lowered to the sea floor and the core is "vibrated" into the sea floor by an air driven pneumatic motor on top of the corer. The compressed air is provided by an air compressor on deck.

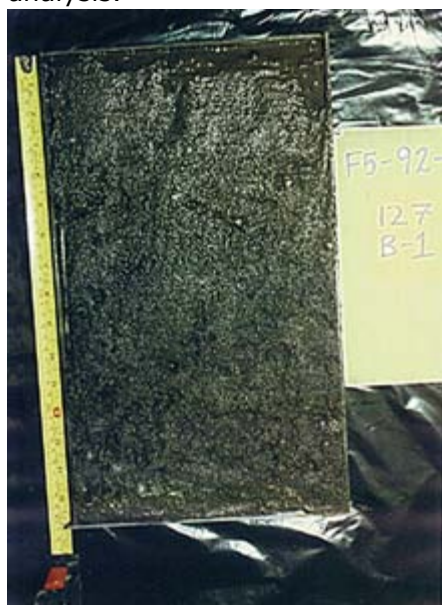
The photo below shows a plexi-glass tray with a "slab" of the boxcore. The "slab" is basically just a thin slice of the boxcore and is kept for later use in analysis back onshore, one of the uses for this kind of sample is for x-ray analysis.

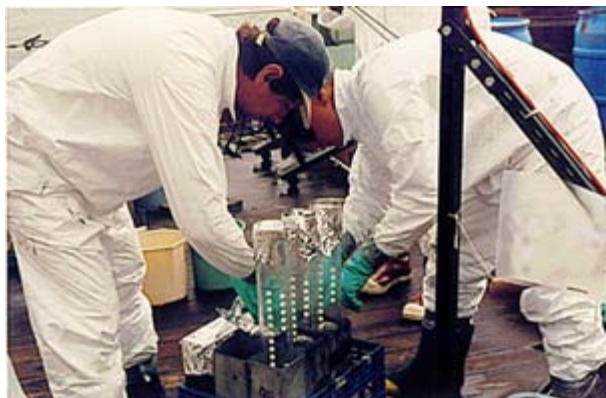
The photo above shows subsamples (tubes with white spots) for geochemical analysis being taken from the boxcore. The photo below shows biologists organizing samples taken for biologic analysis.

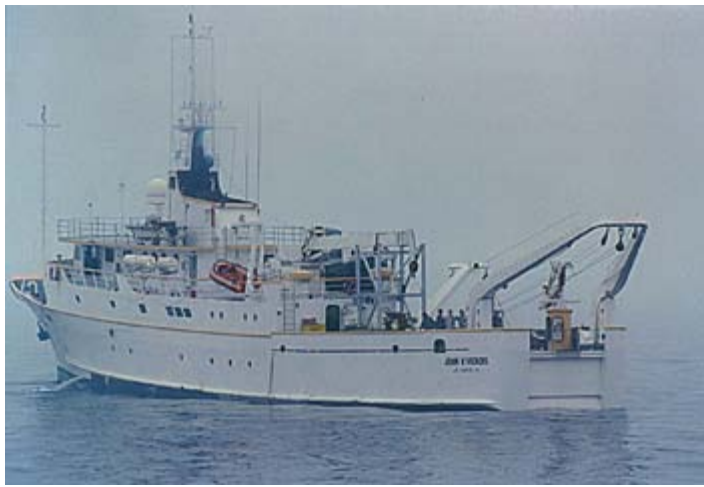
The NOAA research vessel *Vickers* was one of the vessels used for deployment/recovery of the moorings.

All the moorings for this study were designed and prepared by the [Sediment Transport Support Team](#) at the [Woods Hole Field Center](#), a part of the USGS Marine and Coastal Geology Program.
