Contaminated Structures

Stakeholders Conference

April 2013

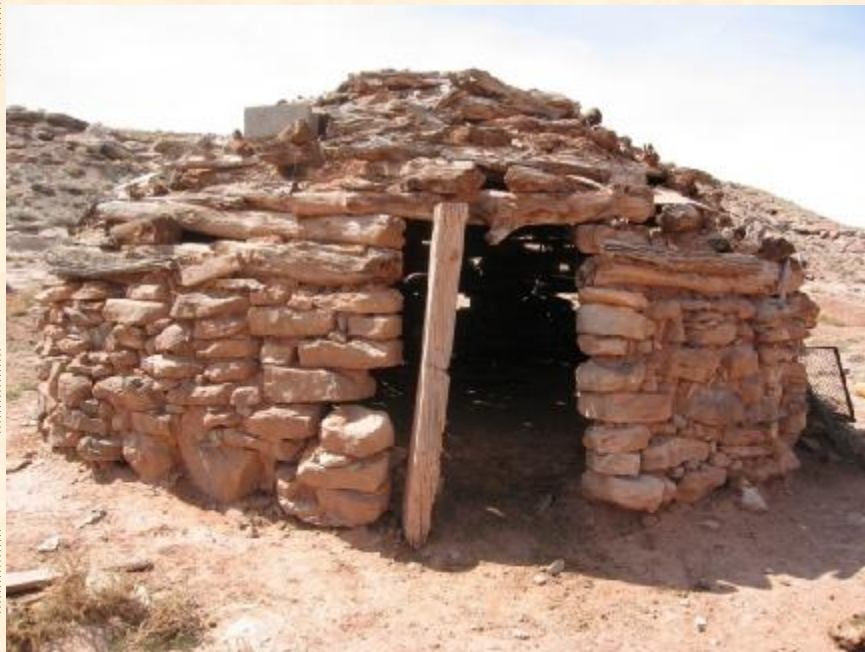
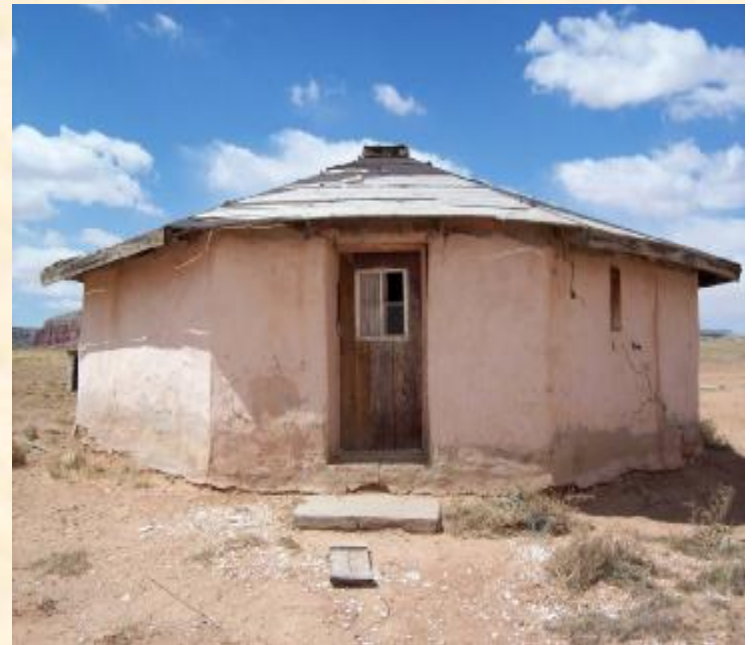
Example Structures

- ◆ Residential structures may have been constructed using abandoned mine materials or built on or near abandoned mines
- ◆ Materials include:
 - ❖ Chunks of ore and waste rock used for foundation, walls, or fireplaces
 - ❖ tailings mixed into cement used for foundations/floors
 - ❖ cinder blocks contaminated by tailings
- ◆ Radioactive materials used in the construction of homes and hogans as well as contamination in surface soil can result in exposure of current and future residents to elevated levels of radiation

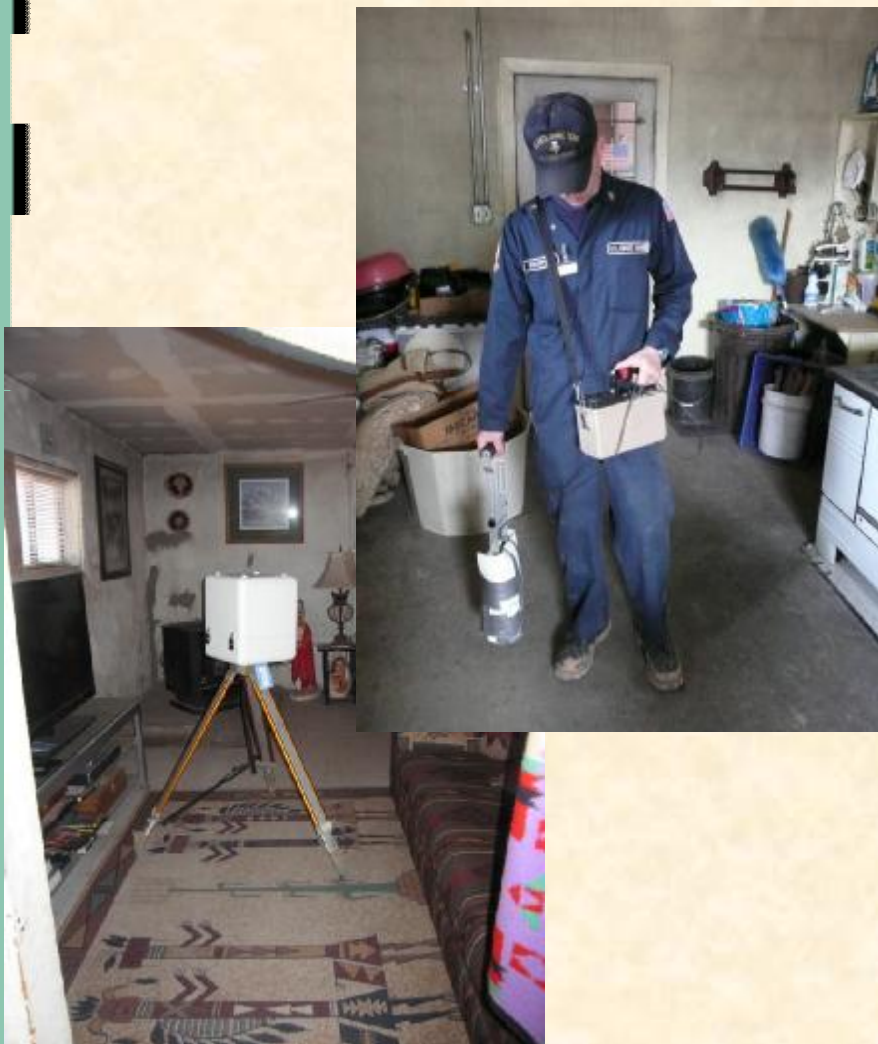
Indoor Radiation Assessment

- ◆ Interior radiation surveys were performed for all structures by an assessment team.
- ◆ Radiological survey data and structure characteristics were documented.
- ◆ Use Pressurized Ion Chamber (exposure - microR/hr) & 3"x3" NaI scintillating detector with ratemeter (contamination - cpm)

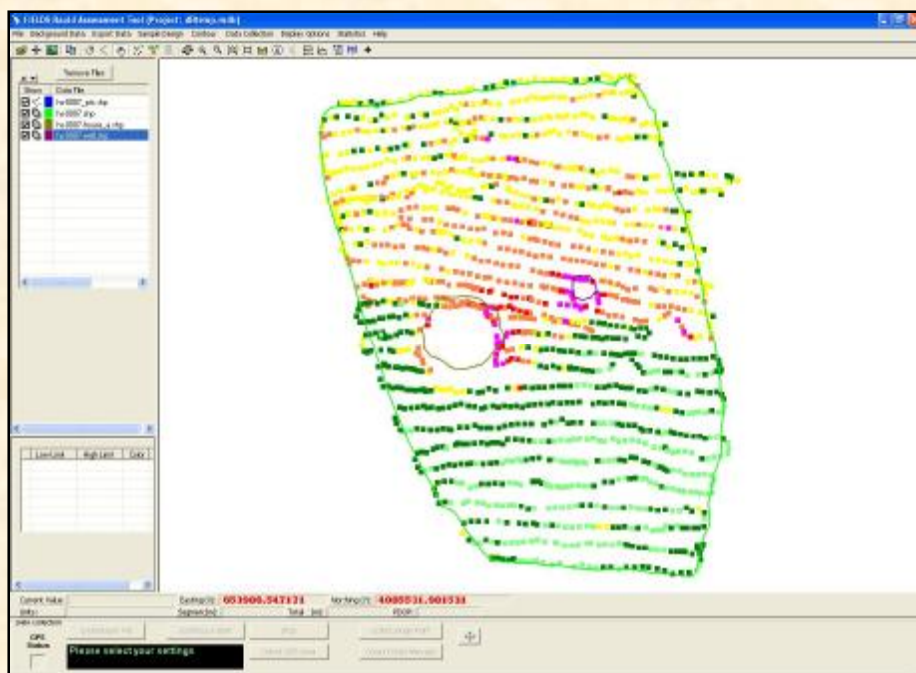
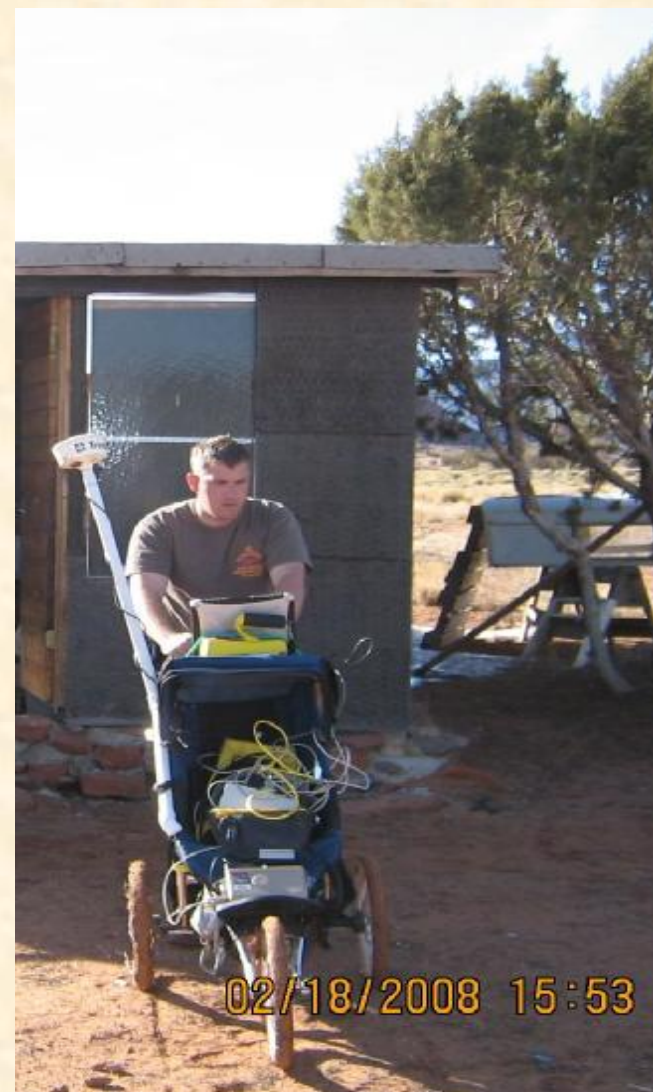
Outdoor Scanning

- ◆ Teams synchronize the gamma count rate and dose rate data with GPS point location simultaneously, as well as visualize the data being collected in a 2 dimensional field.

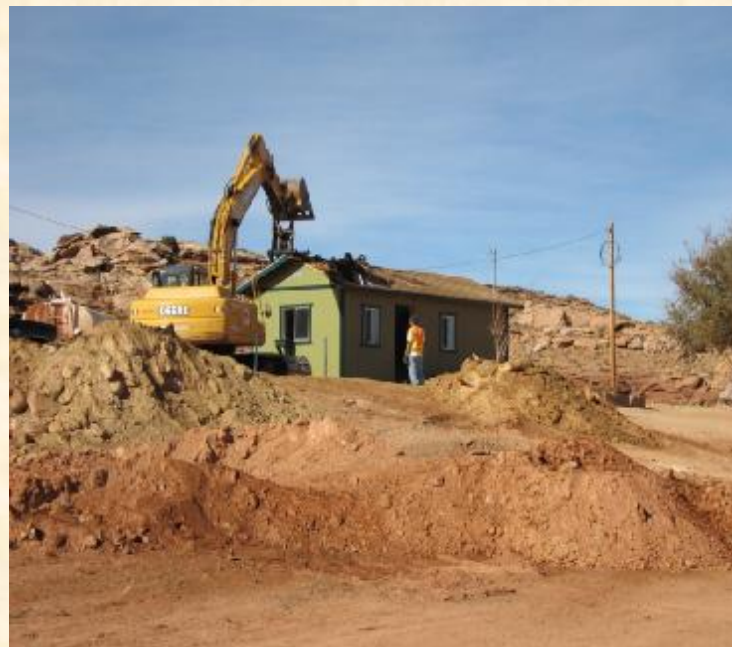
Contour map anomalies

House built on mill tailings

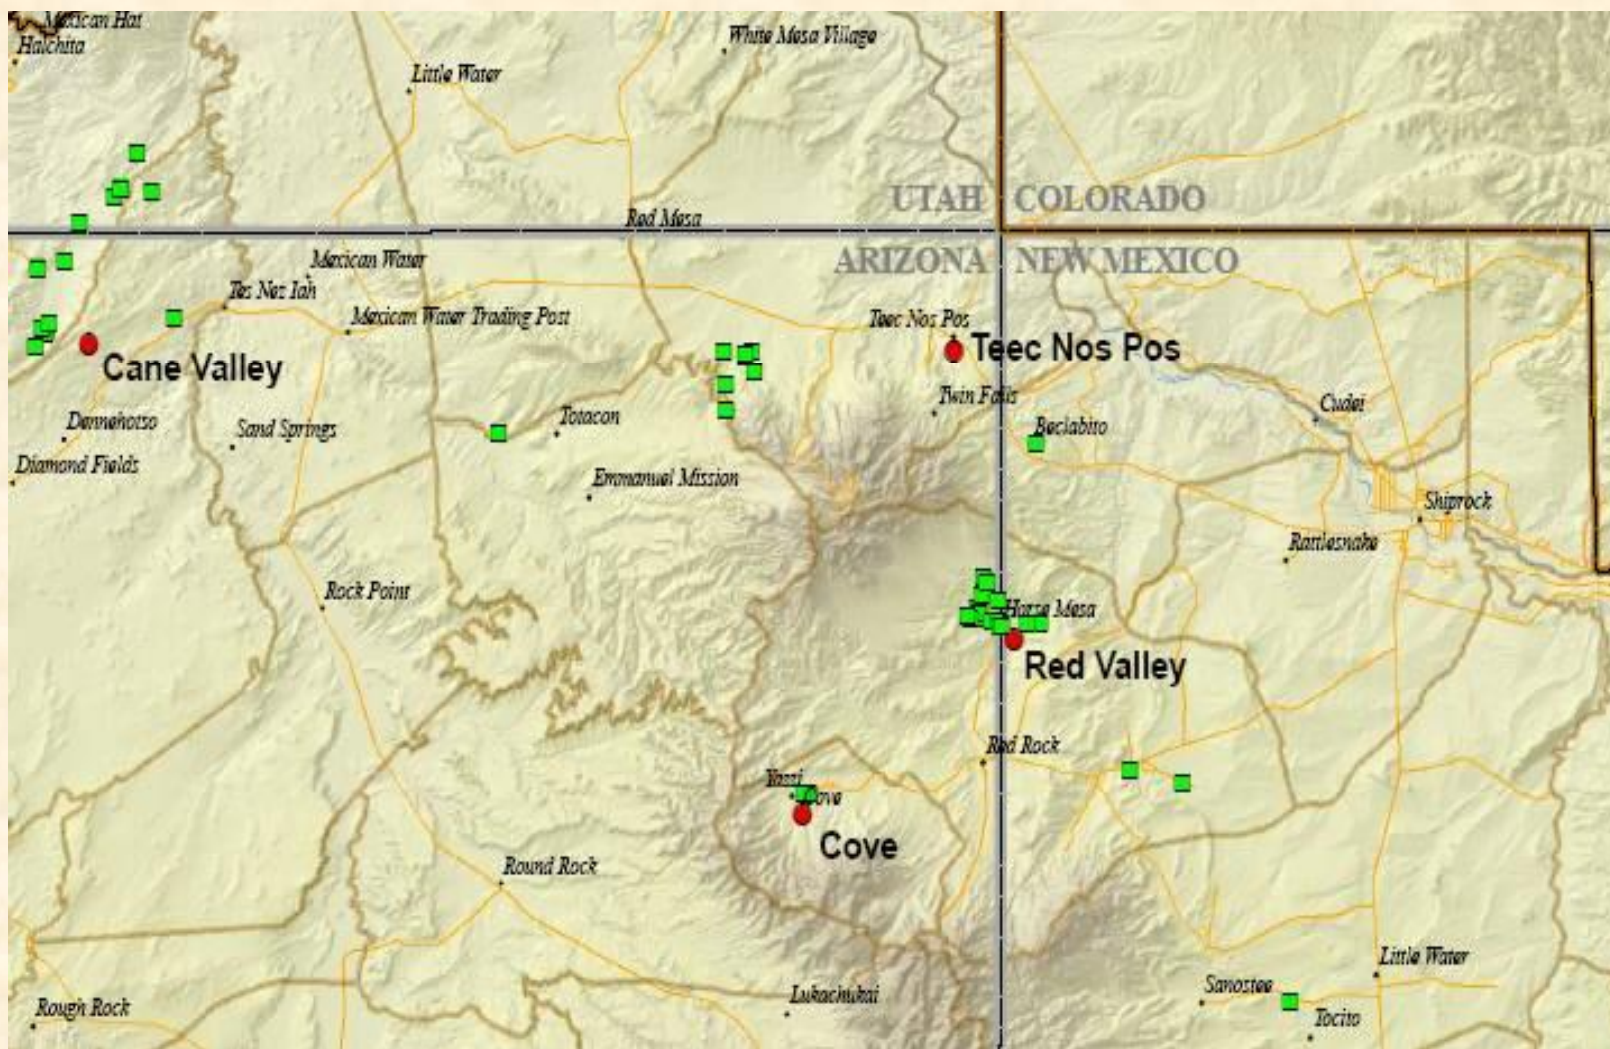
The homesites were located in four geographic areas of the Navajo Nation: Teec Nos Pos, Cane Valley, Red Valley, and Tuba City.
