Gila River Indian Community Enforcement Case Study

Will Antone III, Air Quality Specialist

Overview of CEMEX Enforcement Action

United Metro d.b.a CEMEX Asphalt Plant
Sacaton Plant

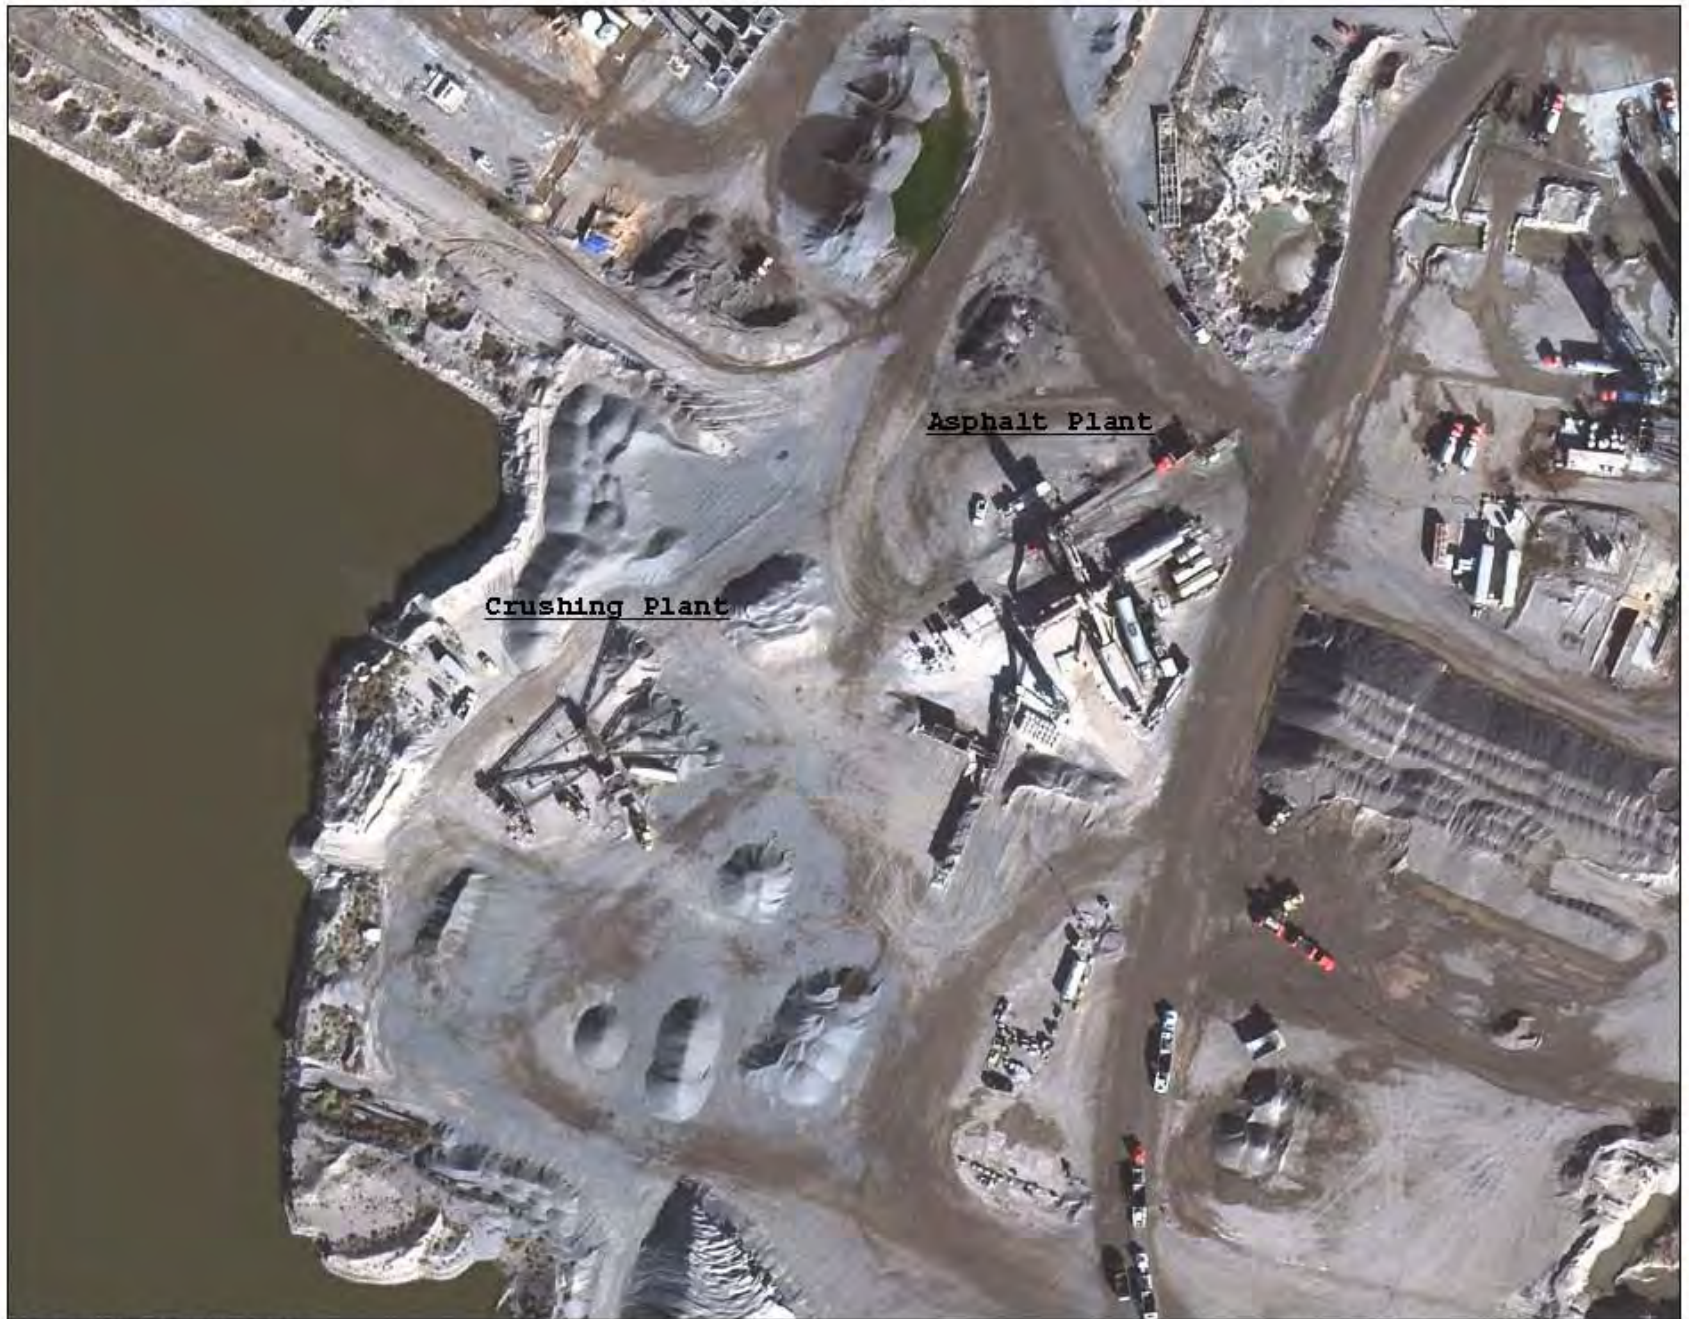
- AQP received a complaint
- Conducted an inspection on both facilities
 - San Tan Plant, Maricopa Plant
- Observed visible emissions
- Conducted visible emissions readings on baghouse, passive baghouses and asphalt silo
- Emission Limitations
 - 7% Opacity Limitations for storage silo
 - 20% Opacity Limitations for baghouse

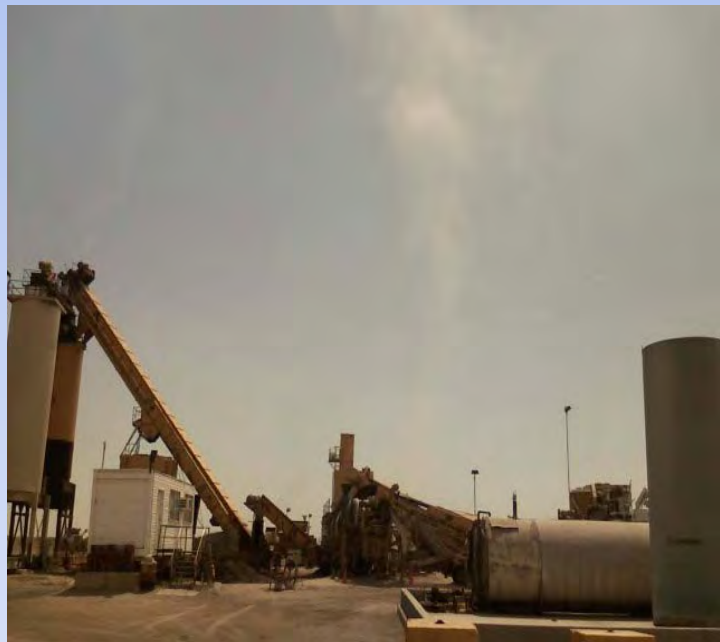
USEPA Method 9 Visible Emissions Observations

VISIBLE EMISSION OBSERVATION FORM									
Company Name <u>United Metro dba Cemex</u>					Observation Date <u>2/25/08</u>		Start Time <u>10:25</u>		End Time <u>10:47</u>
Location <u>2126 Tanner Rd</u>					Sec		Min		Comments
City <u>Sacaton</u> State <u>AZ</u> Zip <u>85247</u>					0 15 30 45				
Process Equipment <u>Hot Mix Asphalt Plant</u>					Operating Mode <u>Continuous</u>				
Control Equipment <u>Baghouse</u>					Operating Mode <u>Continuous</u>				
Describe Emission Point <u>Exhaust Stack of Baghouse (Square)</u>									
Height of Emission Point <u>Approx 25 ft</u>					Height Relative to Observer <u>Start 25 ft End 25 ft</u>				
Distance to Emission Point <u>Approx 100 ft</u>					Direction to Emission Point <u>Start NW End NW</u>				
Vertical Angle to Observation Pt. <u>Start</u> <u>End</u>					Direction to Observation Point <u>Start</u> <u>End</u>				
Describe Emissions									
Start <u>Lofting</u> End <u>Lofting</u>

Emission Color <u>Black/gray</u>					If Water Droplet Plume (Circle) <u>Attached</u> <u>Detached</u> <u>N/A</u>				
Point In The Plume At Which Opacity Was Determined <u>Approx 35 ft above stack</u> <u>End 25 ft above stack</u>									
Describe Plume Background									
Start <u>Blue sky w/ white clouds</u> End <u>Blue sky w/ white clouds</u>					Sky Condition <u>Overcast</u> <u>Overcast</u>				
Background Color <u>Blue/white</u>					Wind Speed <u>Approx 5 mph</u> <u>End 5 mph</u>				
Wind Direction <u>Toward the SE</u>					RH Percent				
Ambient Temp <u>Start</u> <u>End</u>					Wet Bulb Temp				
<p>SOURCE LAYOUT SKETCH</p>									
Additional Information									
<p>Observer's Name (Print) <u>Daniel C. Blair</u></p> <p>Observer's Signature <u>Daniel C. Blair</u> Date <u>2/29/08</u></p> <p>Organization <u>GRIC DEQ</u></p> <p>Certified by <u>Mr. Ryan Brown</u> Date <u>10-25-07</u></p> <p>Continue on reverse side</p>

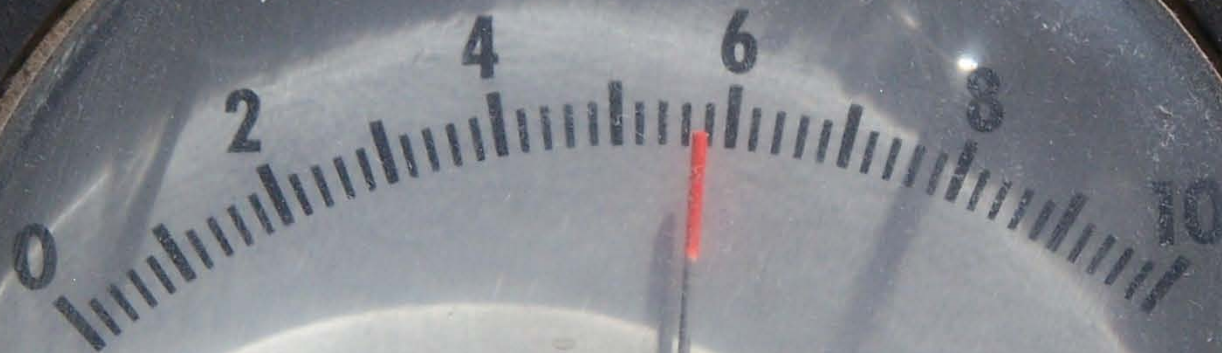
INCHES OF WATER

MAGNEHELIC®

MAX. PRESSURE 15 PSIG

SACATON OPERATIONS			
Issue	Corrective Action	Status	Comment
ASPHALT PLANT			
Dryer Emissions NOV 08-001	Connected magnehelic gauge on the baghouse and will properly maintain.	Completed	
	Replaced defective baghouse bags .	Completed April 2008	Improved preventative maintenance program.
Asphalt Storage Silo NOV 08-003	Enclosed slat conveyors transporting asphalt into storage silos to prevent visible emissions from escaping out of the open elevator.	Completed March/April 2008	
	Closed observation hatches on top of asphalt storage silo to prevent visible emissions from escaping out of the top of the storage silo.	Completed March/April 2008	
	Repaired hole in the side of the asphalt silo to prevent visible emissions from escaping out of the open hole.	Completed March/April 2008	
	Cleaned excessive amounts of baghouse fines and lime that have collected underneath and around the asphalt plant equipment to prevent excess emissions.	Completed/ Ongoing 2 times/week	Procedures to clean plant areas have been improved.
