WASTE MANAGEMENT DIVISION
RCRA ENFORCEMENT OFFICE

Purpose: TSCA Section 6(e), PCB Inspection

Facility: Veolia Environmental Services

Date of Investigation: July 15, 2009

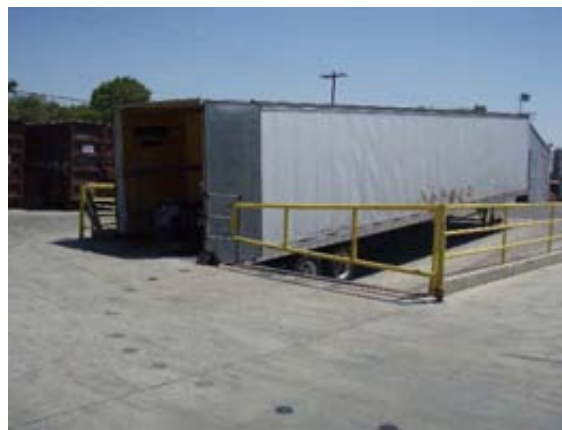
During the facility inspection, the inspectors identified the PCB storage shed and the truck loading area as potential locations for sampling. General photographs of these two areas are shown below, from left to right, respectively.

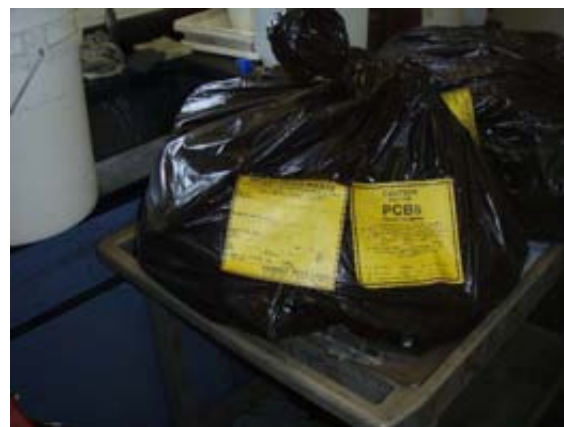
After collecting samples, the inspectors were shown the facility’s laboratory and were given an overview of the laboratory’s sampling procedures by Dev Maheshwari, the laboratory supervisor. All waste associated with PCB sampling is assumed to be PCB waste. This waste includes personal protective equipment (PPE), acids, solvents, and vials. The laboratory PPE is removed once per week. At the time of the inspection, a cart with two garbage bags of PPE were ready to be taken out to the PCB shed. One of the bags did not have a PCB label on it. The facility corrected this potential violation during the inspection (see before and after photographs below).

- In the on-site laboratory, two garbage bags of PPE were ready to be taken out to the PCB shed and one of the bags did not have a PCB label on it.

- During the inspection, the bag of PPE was labeled as PCB waste.
