FINAL
Commonwealth of the Northern Mariana Islands
Integrated 305(b) and 303(d)
Water Quality Assessment Report

Bureau of Environmental and Coastal Quality
September, 2014

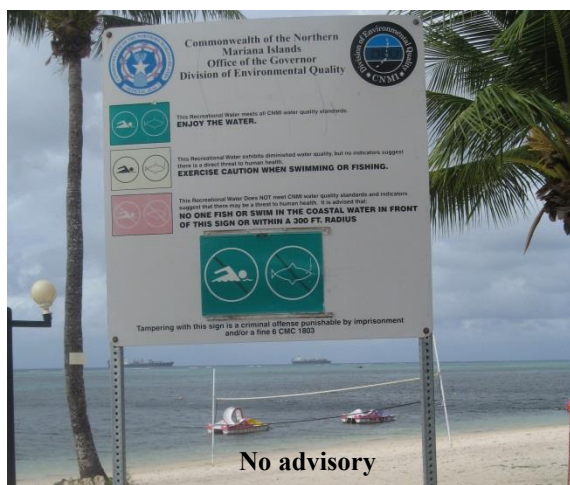
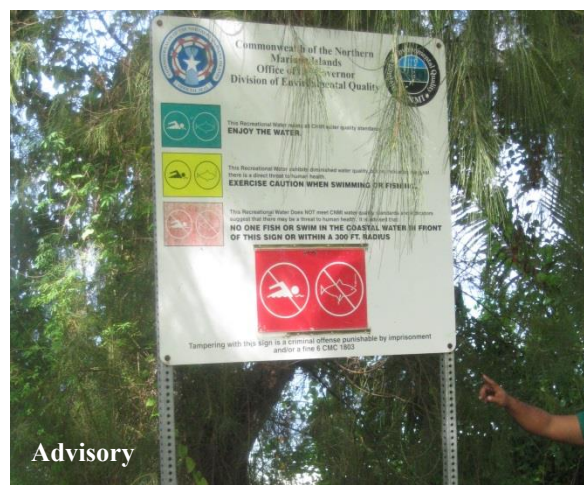
Beach advisory signboards are posted at 10 sites on Saipan shoreline with internationally recognizable symbols for “no swimming” or “no fishing”. Red Placards are posted at these locations whenever results call for a Public Advisory.
