Re: City of Oxnard Municipal Separate Storm Sewer System (MS4) Compliance
Audit Report

**MUNICIPAL SEPARATE STORM
SEWER SYSTEM (MS4)
COMPLIANCE INSPECTION**

**CITY OF OXNARD,
CALIFORNIA**

INSPECTION REPORT

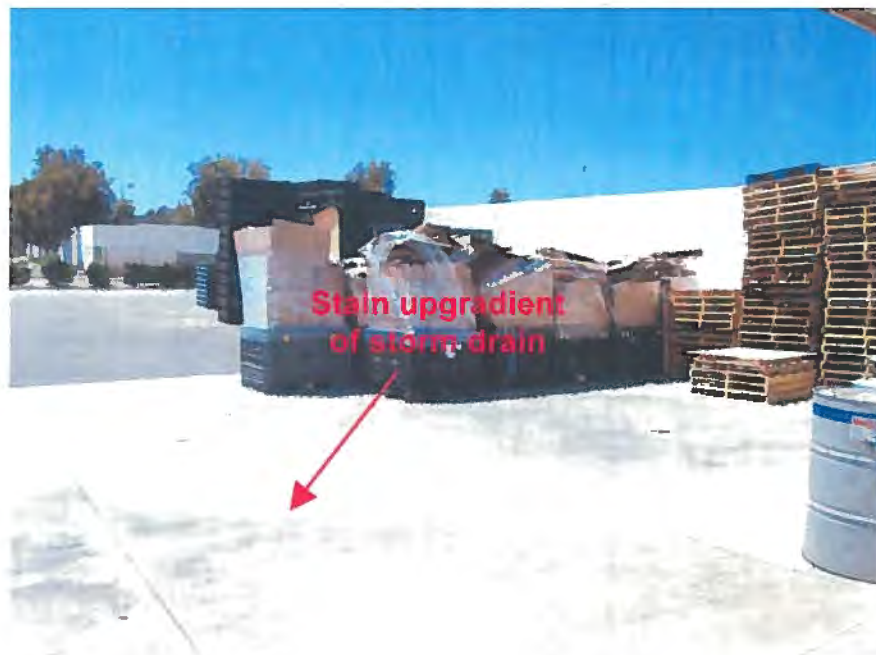
- A stain from what appeared to be a petroleum product was present on the impervious surface to the southwest of the hazardous materials shed and upgradient of a storm drain inlet (Photographs 1 and 2). The petroleum stain appeared to the EPA Inspection Team to not have recently occurred. The City inspector stated that he would typically discuss stains and evidence of spills with facility representatives during an inspection.

Photograph 2. PTI Facility I/C Site Visit – Additional view of the paved yard located on the west side of the building. Note the additional view of the stain shown in Photograph 1.

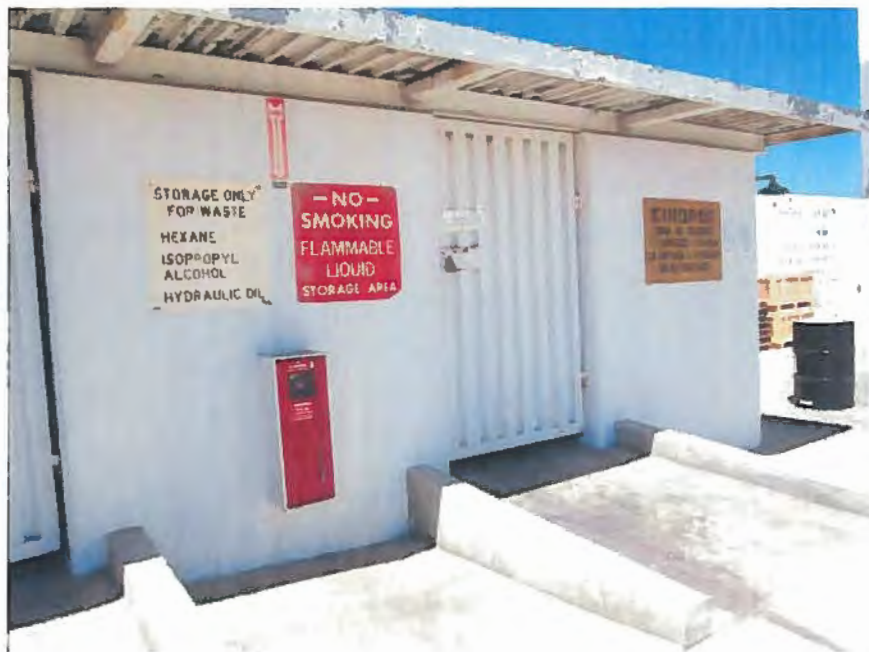
- The City Inspector had the facility Environmental Health and Safety Manager open the hazardous material/hazardous waste storage shed (Photographs 3 and 4).
- The City Inspector also asked to see the “stormceptor” stormwater management structure located near the northern end of the facility (Photograph 5). The stormceptor was an underground permanent stormwater management structure which received flow from the parking area in the central portion of the facility. The stormceptor was intended to remove floatables, solids, hydrocarbons, and metals from stormwater discharges prior to discharge to the MS4. The City inspector explained that during a typical inspection he

Photograph 3. PTI Facility I/C Site Visit – View of hazardous materials shed located on the northern side of the paved yard.

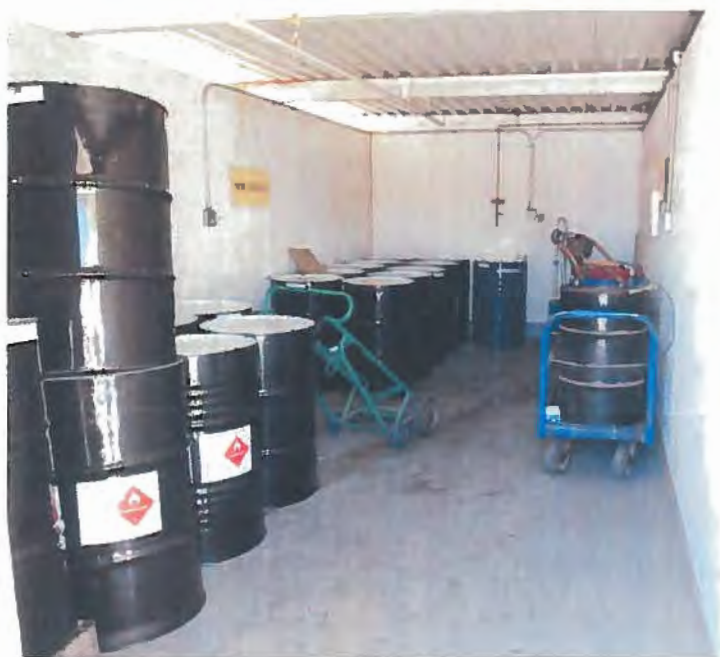
Photograph 4. PTI Facility I/C Site Visit – View of a room in the hazardous materials shed shown in Photograph 3 located on the northern side of the paved yard.

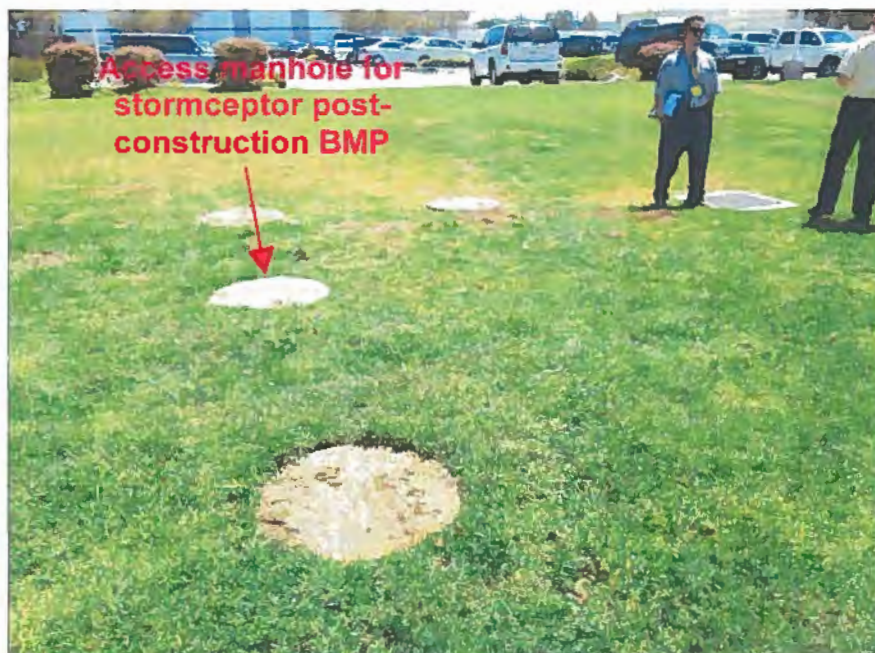
would require PTI staff to open the manhole on the stormceptor to observe the condition of the structure.

Photograph 5. PTI Facility I/C Site Visit – View of access manhole for stormceptor located on the north end of the facility.

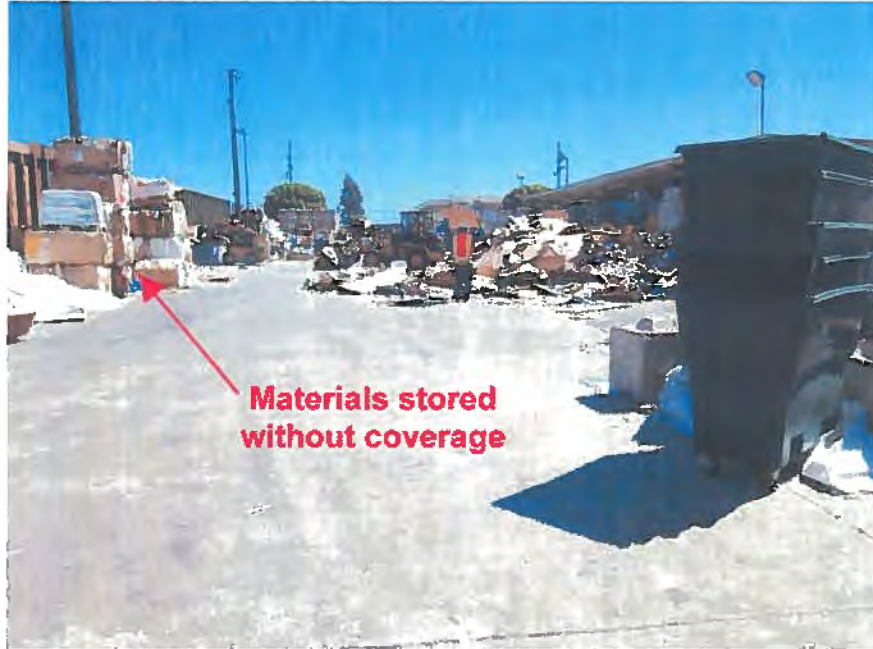
- Piles of materials were stored uncovered throughout the site (Photographs 1 and 2).
- A petroleum stain was observed outdoors on an impervious surface along the north side of the facility (Photographs 3 and 4).
- Loose cardboard and paper were located in multiple areas of the site (Photographs 5 and 6).

Photograph 1. Rincon Facility I/C Site Visit – View looking south of materials stored at the facility without coverage.

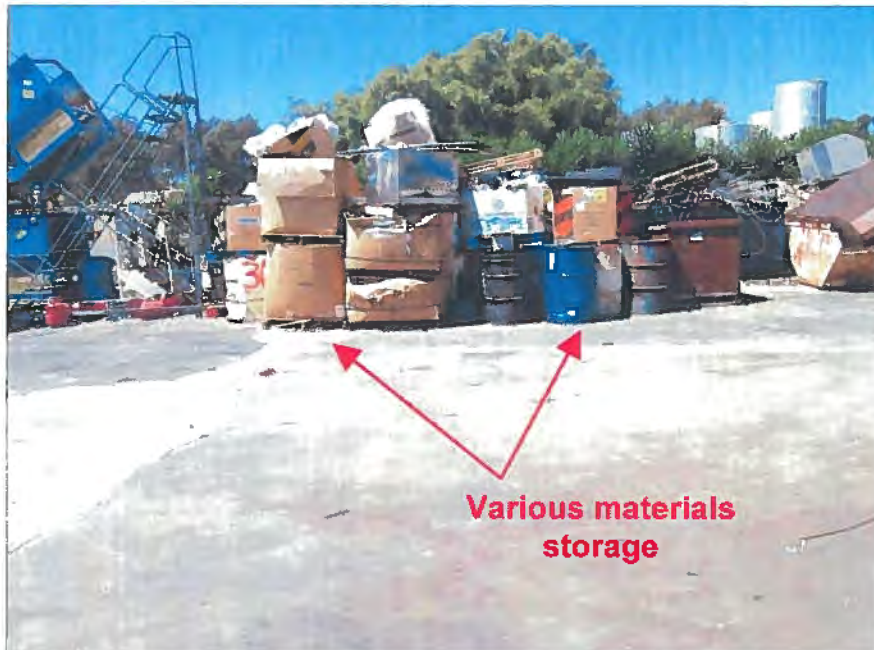
Photograph 2. Rincon Facility I/C Site Visit – Additional example of materials stored without coverage on the north side of the facility.

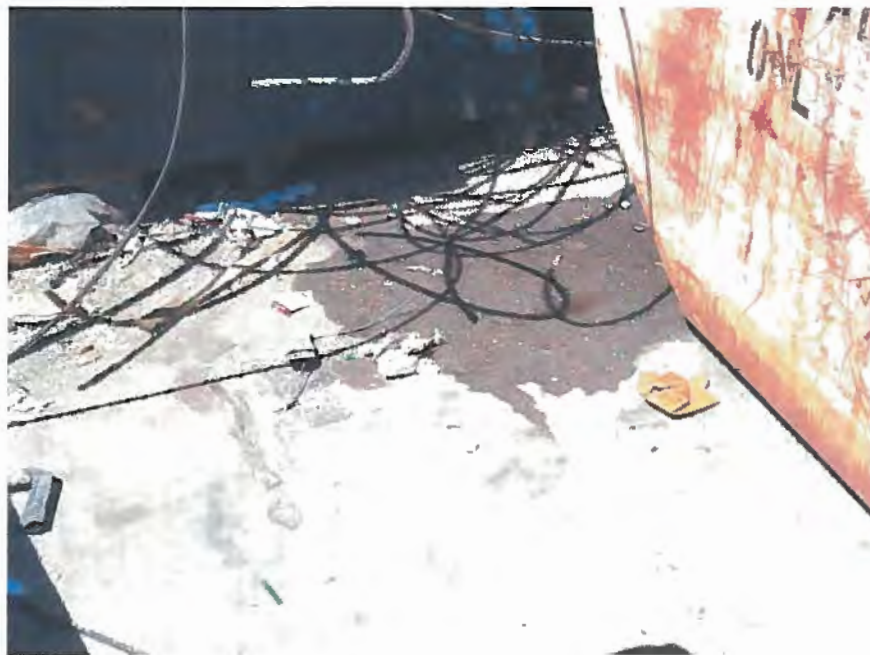
Photograph 4. Rincon Facility I/C Site Visit – Close-up view of the petroleum stain shown in Photograph 3.

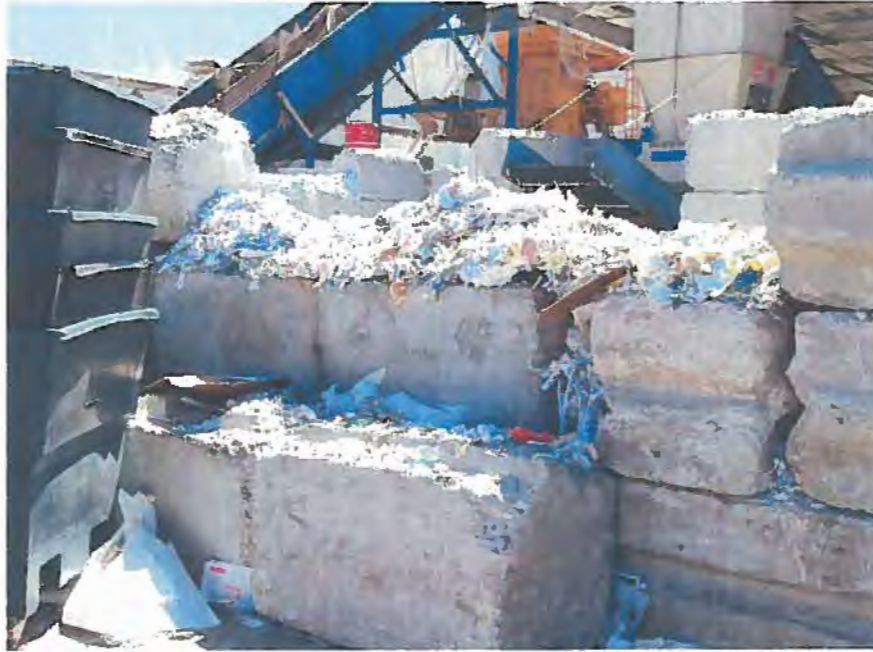
Photograph 5. Rincon Facility I/C Site Visit – View of loose cardboard and paper located in the central area of the facility.

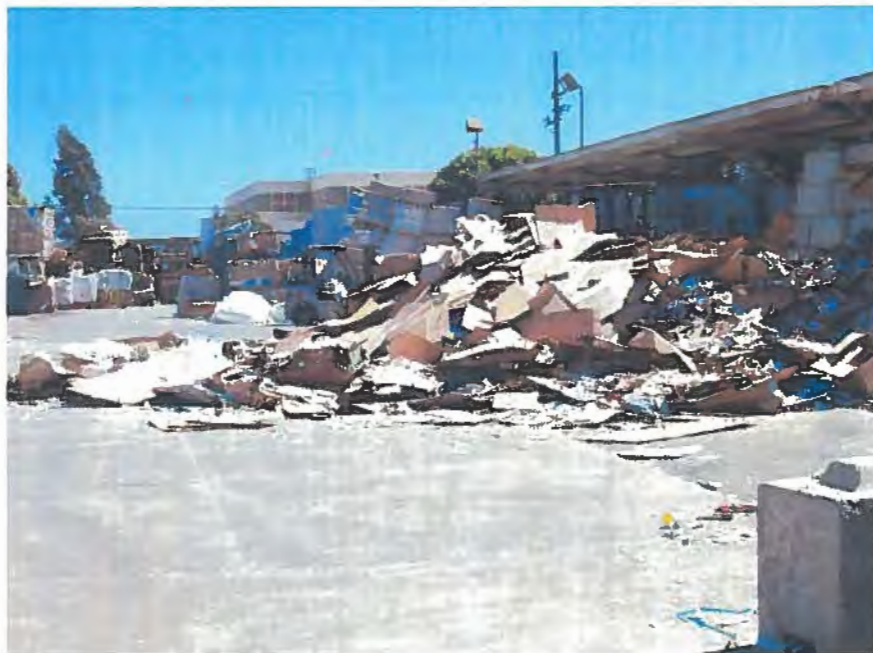
Photograph 6. Rincon Facility I/C Site Visit – Additional view of loose cardboard and paper located in the central area of the facility.

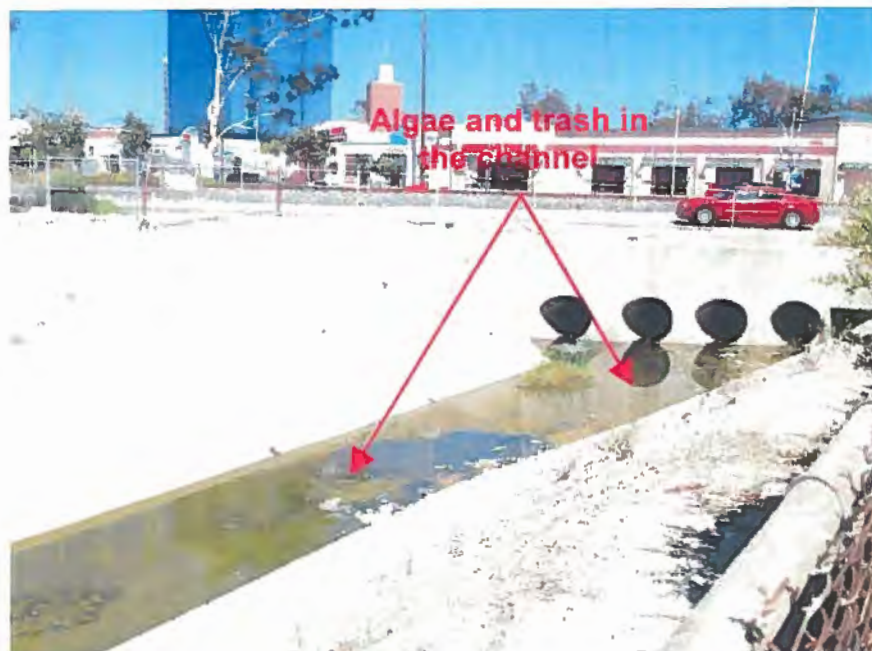
- A small amount of water was observed flowing from each of the 36-inch pipes into the VCWPD channel. City staff stated that the flow was from residential irrigation.
- Algal growth and some trash were present in the VCWPD channel (Photographs 1 and 2).

Photograph 1. City MS4 Outfall – El Rio Drain Outfall – View of the outfall from the City MS4 to the VCWPD. Note the algal growth and trash in the channel.

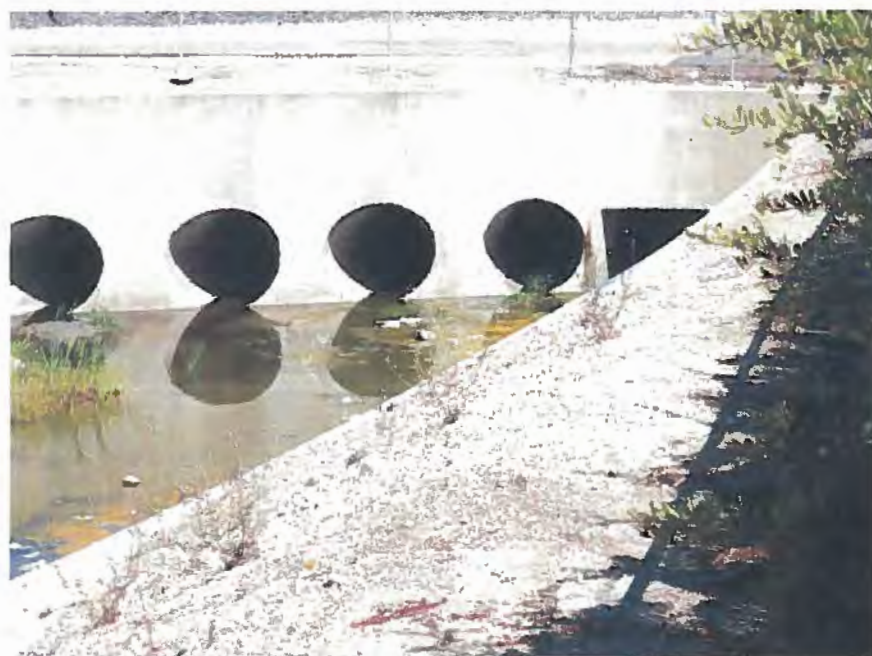
Photograph 2. City MS4 Outfall – El Rio Drain Outfall – Close-up view of the outfall from the City MS4 to the VCWPD.
