Re: City of Simi Valley Municipal Separate Storm Sewer System (MS4) Compliance
Audit Report

**MUNICIPAL SEPARATE STORM
SEWER SYSTEM (MS4)
COMPLIANCE INSPECTION**

**CITY OF SIMI VALLEY,
CALIFORNIA**

INSPECTION REPORT

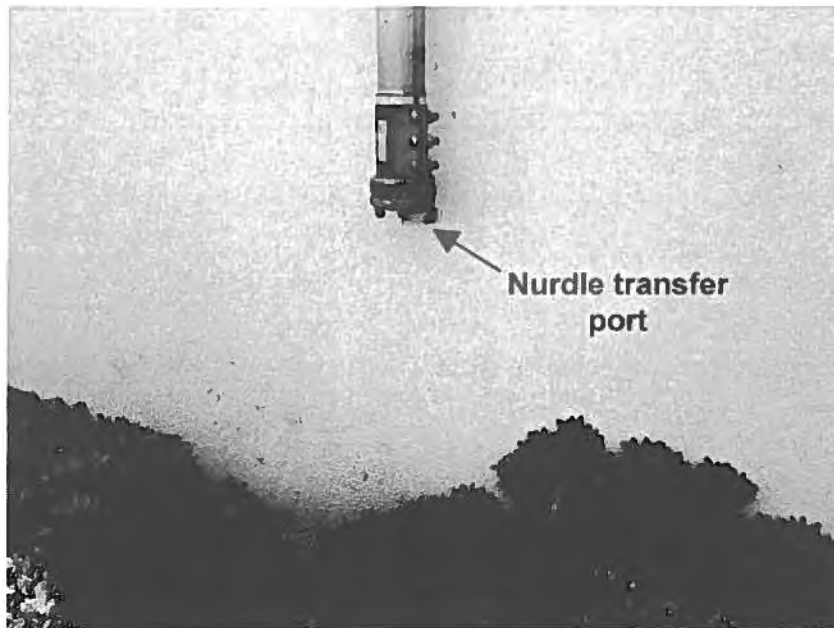
Photograph 1. Poly-Tainer, Inc. – View of the nurdle transfer port located on the east side of the facility building.

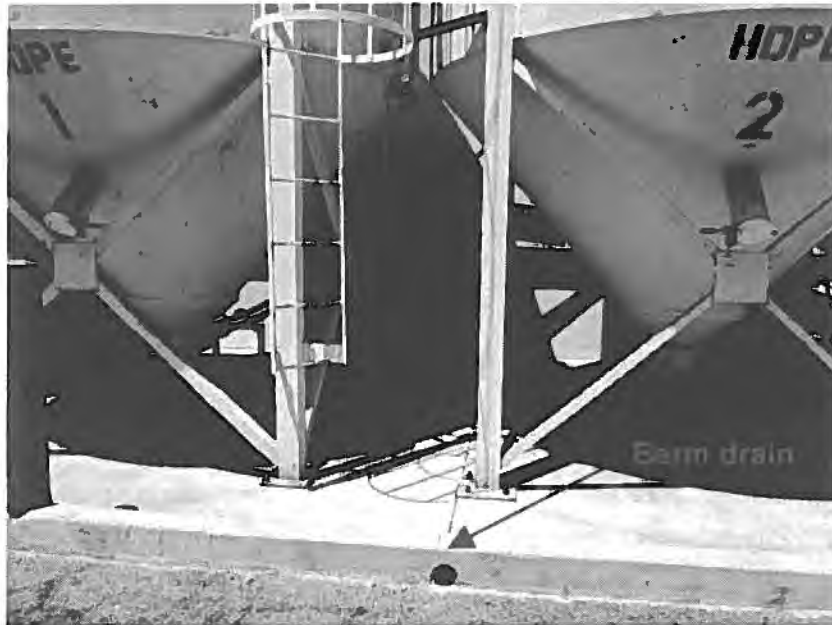
Photograph 3. Poly-Tainer, Inc. – View of the nurdle silos located on the southern side of the facility building. Note the drain in the berm was equipped with a mesh screen smaller than nurdle diameter.

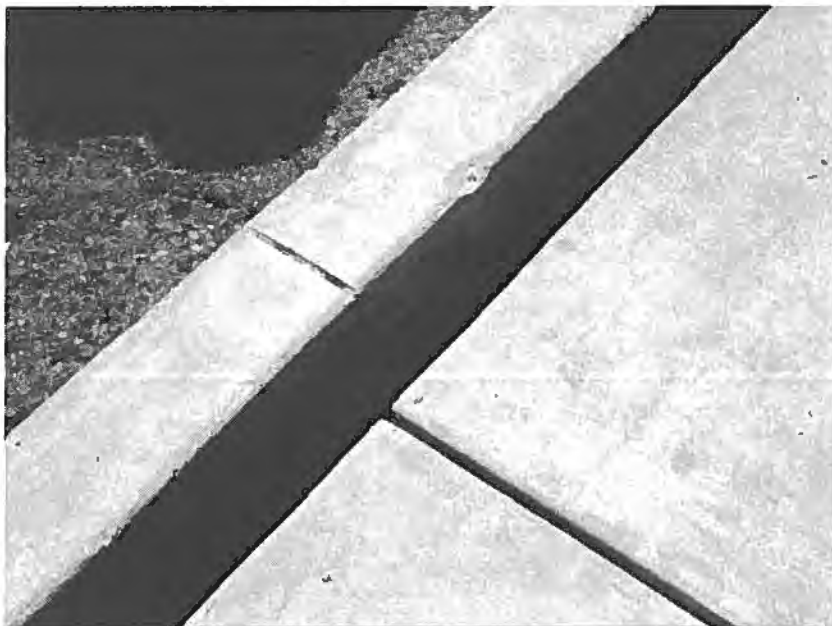
Photograph 4. Poly-Tainer, Inc. – Closer view of drain in the berm around the nurdle silos equipped with a mesh screen.

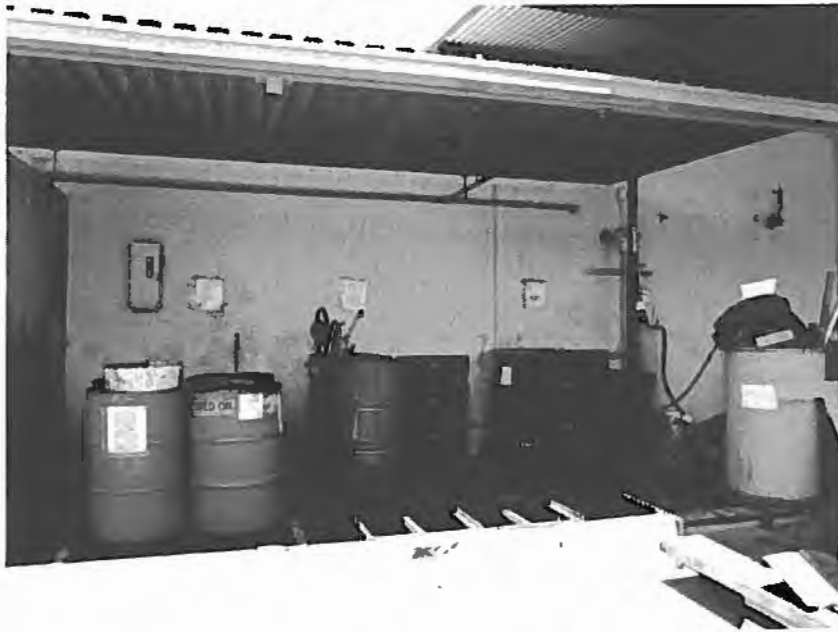
Photograph 5. Poly-Tainer, Inc. – View of the hazardous materials and hazardous waste covered storage area located on the south side of the facility building.

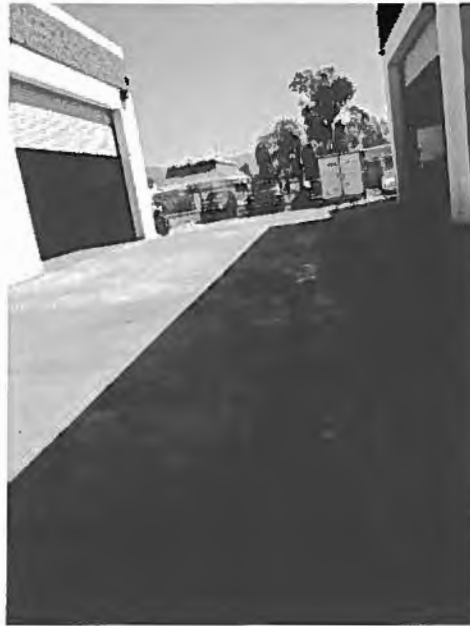
Photograph 1. Bill's Quality Auto Care – View of the impervious area located on the east side of the facility garage.

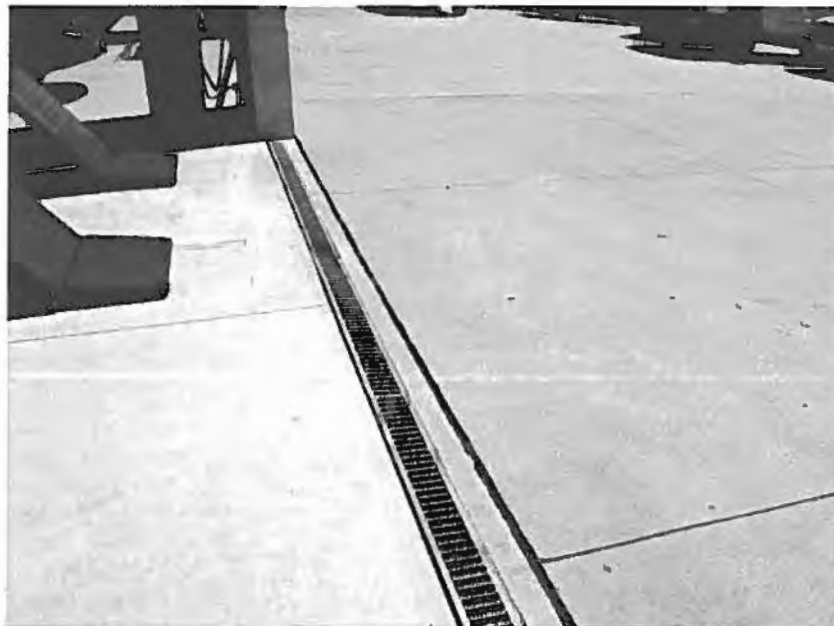
- The City inspector performed an inspection of the garage and surrounding outdoor areas (see Photographs 2 and 3). No deficiencies related to the garage were observed while onsite.
- The City Inspector inquired if radiators were promptly drained upon removal from vehicles. Facility staff stated that the radiators were drained prior to being stored inside the garage (see Photograph 4).

Photograph 2. Bill's Quality Auto Care – View of a trench grate located indoors adjacent to the impervious outdoors facility area.

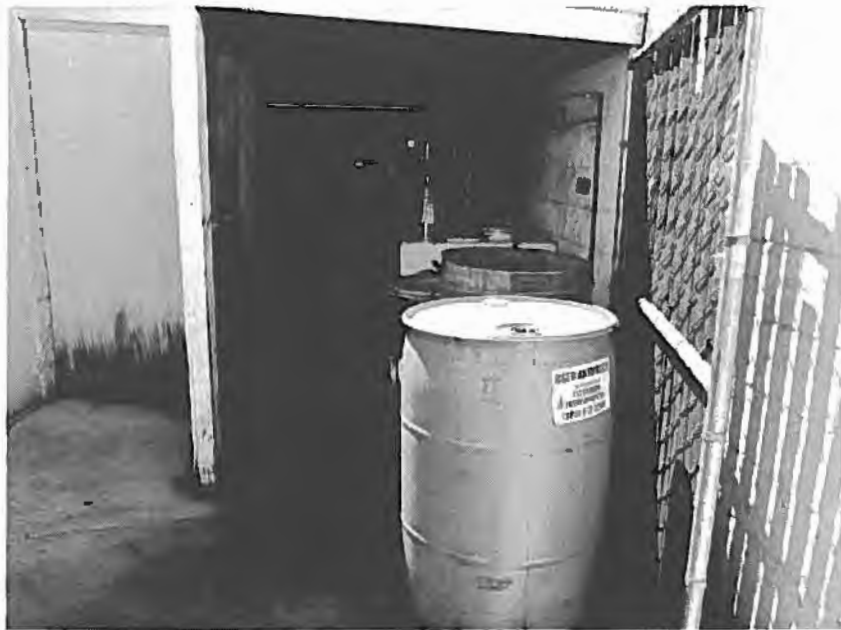
Photograph 3. Bill's Quality Auto Care – View of the hazardous materials shed located on the northeast side of the facility.

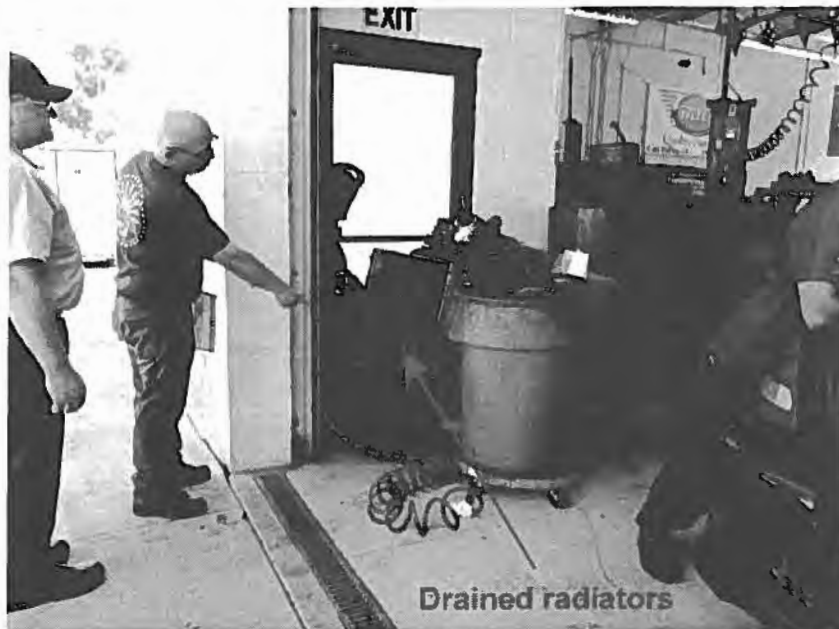
Photograph 4. Bill's Quality Auto Care – View of radiators drained of fluid located inside the facility garage.

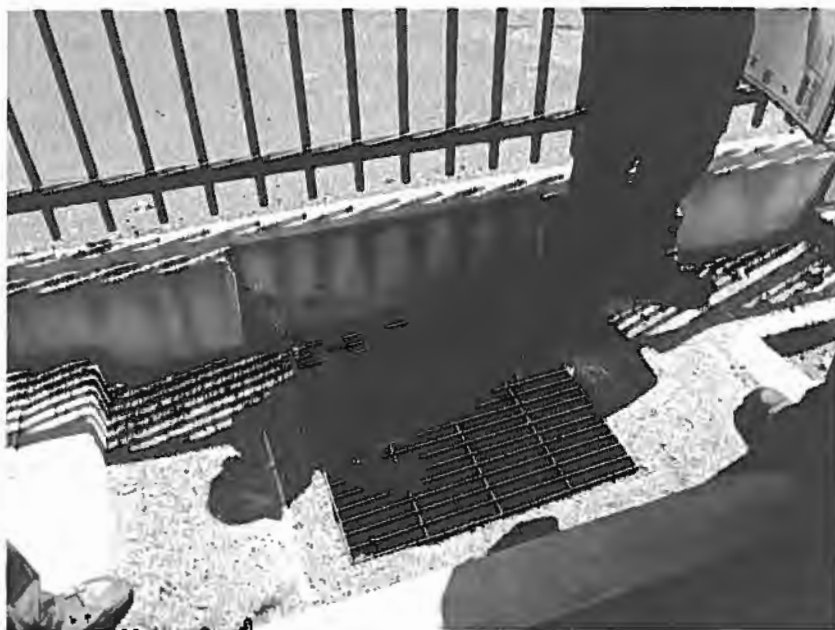
- The City Inspector inspected a storm drain inlet located on the south side of the facility yard (see Photographs 5 and 6) that led to an outlet from the facility (see Photograph 7). He explained that an absorbent fiber roll BMP had been placed in the storm drain to prevent further conveyance of petroleum to the site outfall in the event of a spill.

Photograph 5. Bill's Quality Auto Care – View of a storm drain inlet located on the south side of the facility yard.

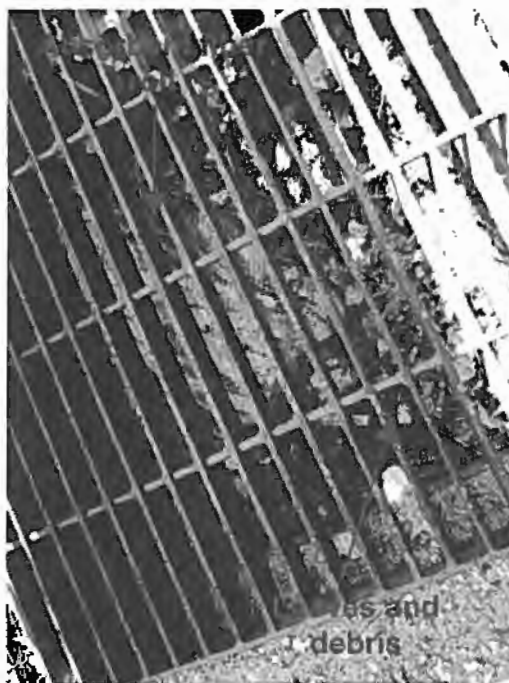
Photograph 6. Bill's Quality Auto Care – Close-up view inside the storm drain inlet shown in Photograph 5. Note that an absorbent fiber roll BMP had been placed in a drain to prevent further conveyance of petroleum to the site outfall. In addition there were leaves and debris within the catch basin.

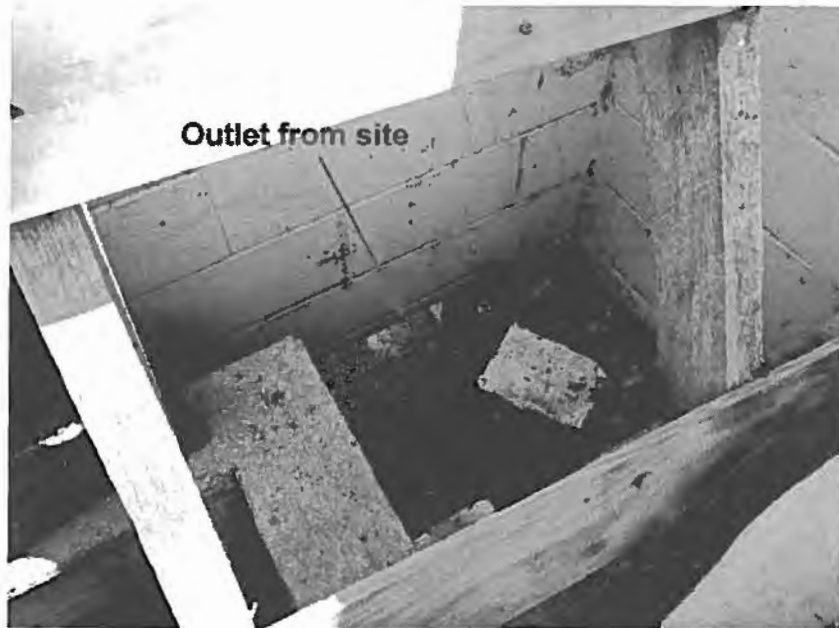
Photograph 7. Bill's Quality Auto Care – View of an outlet from the site located in the southeast corner of the facility.
