2013 HAWAII OCEAN DISPOSAL SITE MONITORING SYNTHESIS REPORT

Prepared by:
Dredging and Sediment Management Team
USEPA Region 9
San Francisco, CA

April 27, 2015

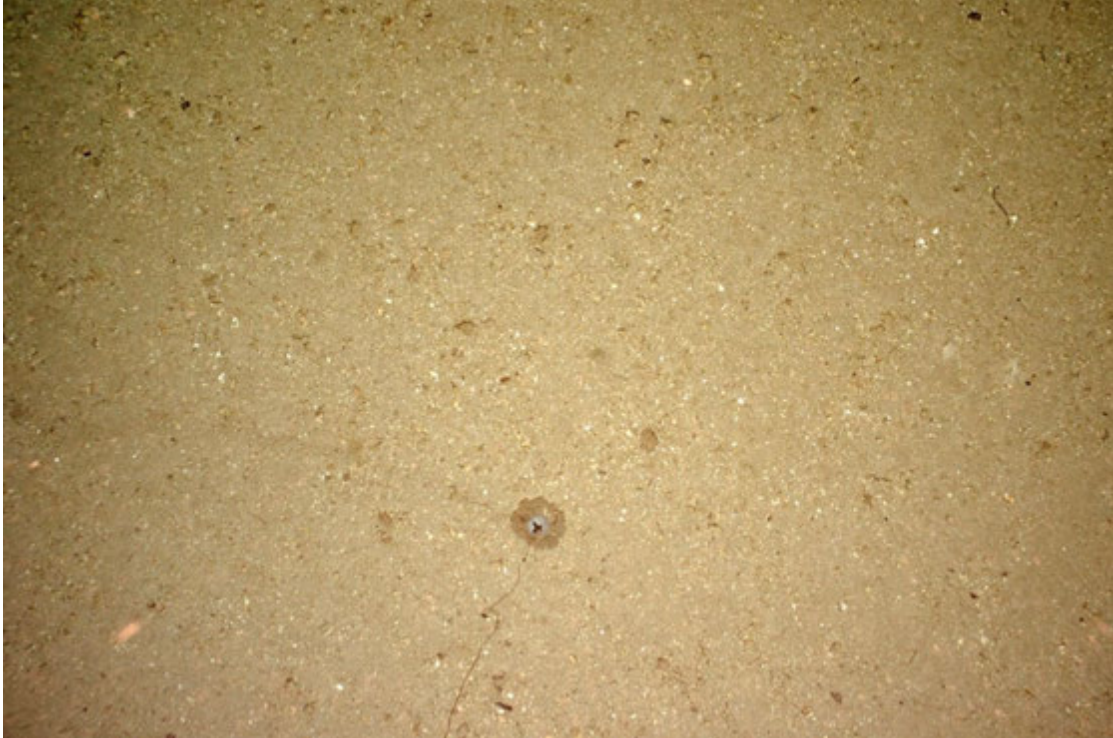
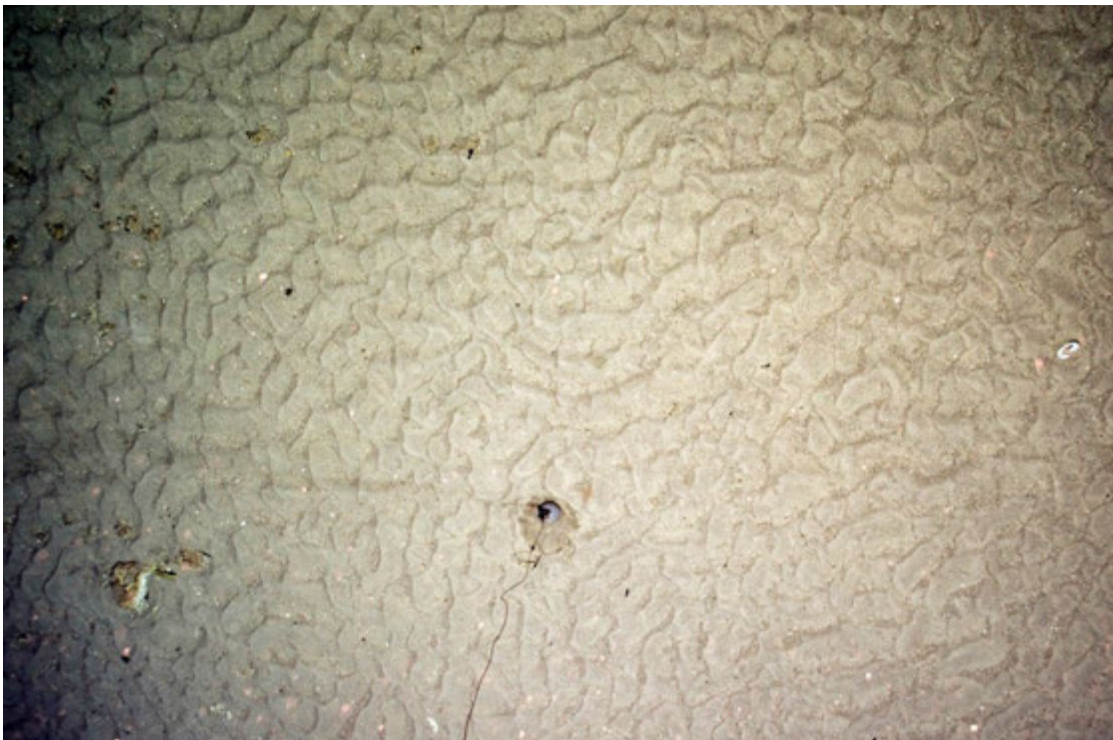
Figure 16. Plan view images of the dredged material deposit compared to the native seafloor at South Oahu. Station C1 on dredged material (top) shows the visual difference in both sediment color and surface texture/features of dredged material compared to the ambient bottom at Station NW6 (bottom). Scale: width of each PV image is approximately 4 m. (Germano & Assoc., 2013)

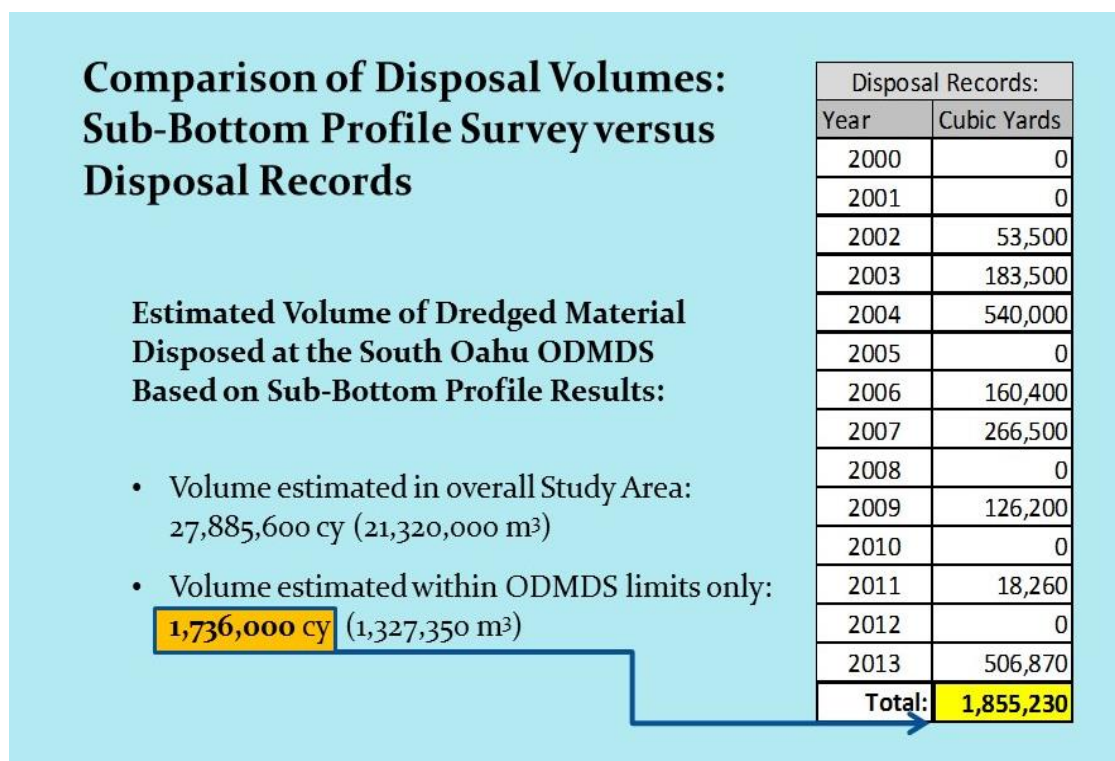
Figure 30. Comparison of South Oahu site dredged material volume estimates: from sub-bottom mapping versus recorded disposal volumes for 2000-2013 (see Table 1).

Although the volume of dredged material estimated by the sub-bottom profiling survey to be within the South Oahu disposal site boundary (1.74 million cy) compares well with the actual disposal records since 2000 (1.85 million cy), Table 1 shows that a total of 6.3 million cy has actually been disposed since the site was designated in 1980. It is likely that some substantial portion of the total 6.3 million cy disposed at the South Oahu site since 1980 is actually represented within the approximately 26 million cy of historic material estimated to be *outside* the site boundaries. Prior to the early 2000s, automatic satellite-based tracking and recording of disposal scow position was not required², and “short-dumping” (resulting in material depositing outside site boundaries) probably occurred fairly frequently. Still, it is highly likely that much of the material disposed between 1980 and 2000 was nevertheless deposited on-site, so more than 1.8 million cy should be present. It is to be expected that physical consolidation of any dredged material deposit would occur over time, reducing its apparent volume compared to disposal records. For all these reasons, the sub-bottom profiling survey’s rough estimate is certainly low. However, it is also certainly within an order of magnitude, and is an interesting cross-check on other disposal site monitoring results.

The analysis of the full sub-bottom data set (Sea Engineering, Inc., 2014) suggests that the dredged material deposits in and around the South Oahu site generally vary between 3 and 12 feet (1- 4 m) in thickness. An order of magnitude approximation of the total amount of dredged material within the study area was calculated using an average thickness of 6 feet (2 meters). The total volume of dredged material mapped throughout the entire study area, including historic disposal outside the current site boundaries, was thus calculated to be 27,885,600 cubic yards (21,320,000 cubic meters). However, the total volume of dredged material mapped within the current South Oahu site boundary was calculated to be 1,736,000 cubic yards (1,327,350 cubic meters). This compares quite favorably with the recorded volume of 1,855,230 cubic yards of material known to have been disposed from 2000 through 2013 (Table 1, and Figure 30).
