**MUNICIPAL SEPARATE STORM  
SEWER SYSTEM (MS4)  
COMPLIANCE INSPECTION**

**SACRAMENTO COUNTY,  
CALIFORNIA**

**INSPECTION REPORT**

**Inspection Date:  
August 15-16, 2012**

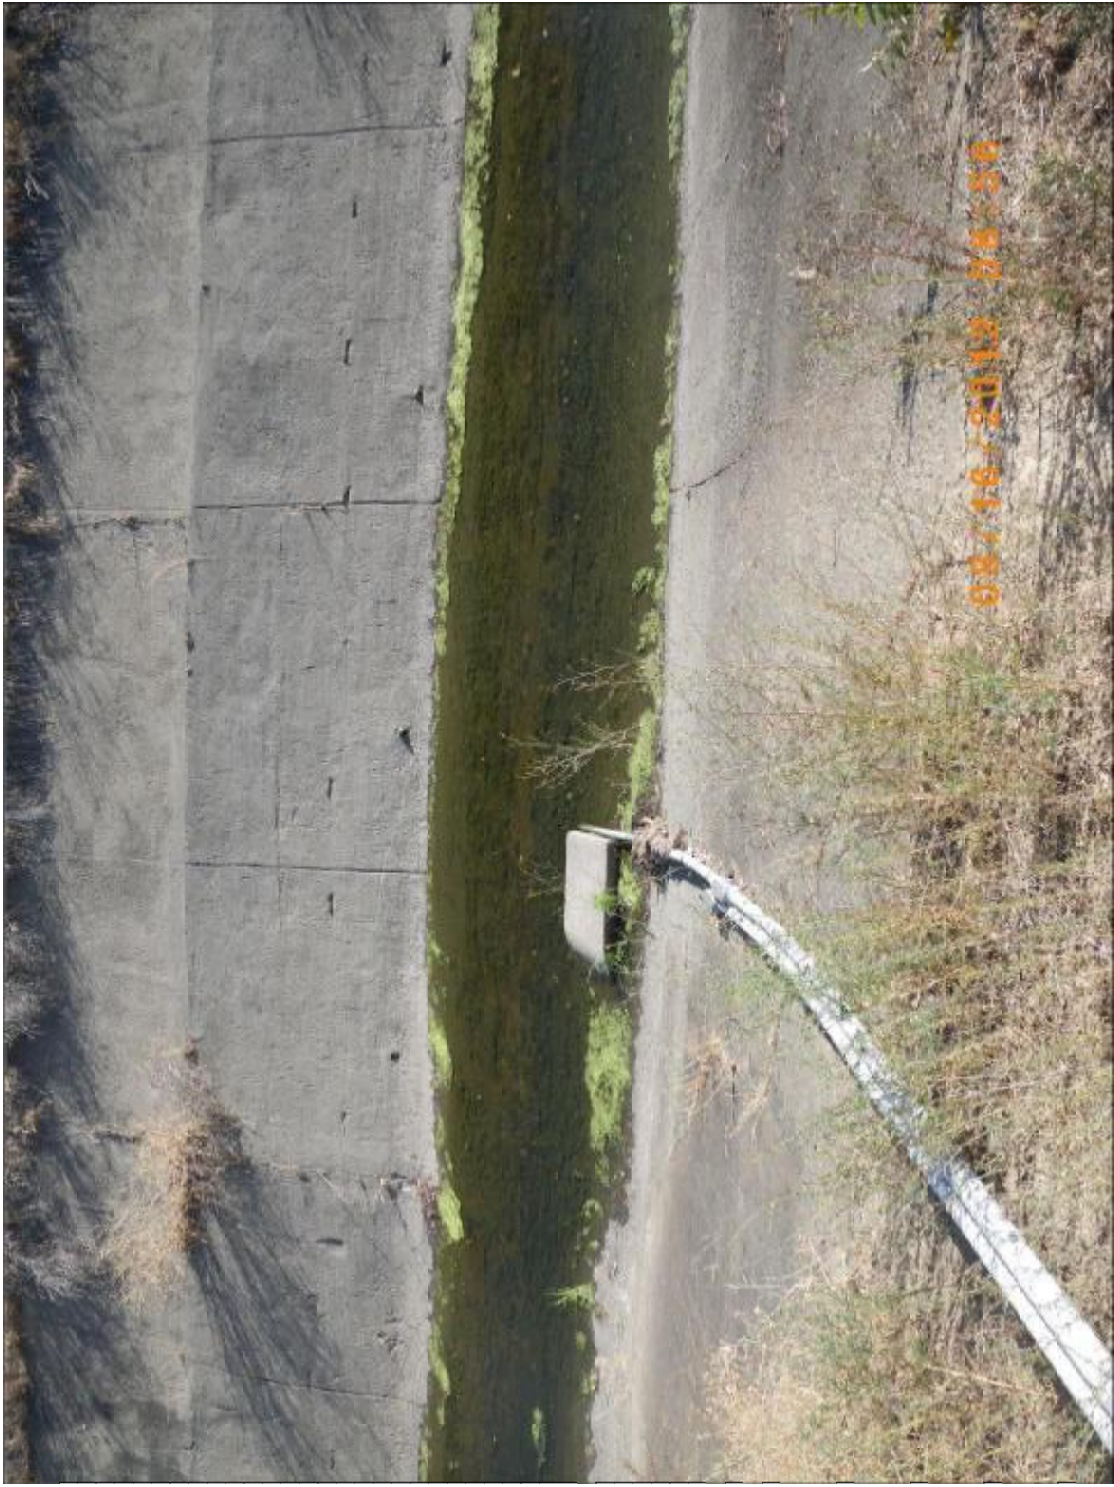
IMGP0919

A steady flow of water was observed without any recent precipitation. The water was generally clear with algae and other aquatic vegetation observed. Minimal debris consisting of terrestrial plant detritus was entrained within the flow.

**IMGP0919:** Water quality sampling location within Strong Ranch Slough.

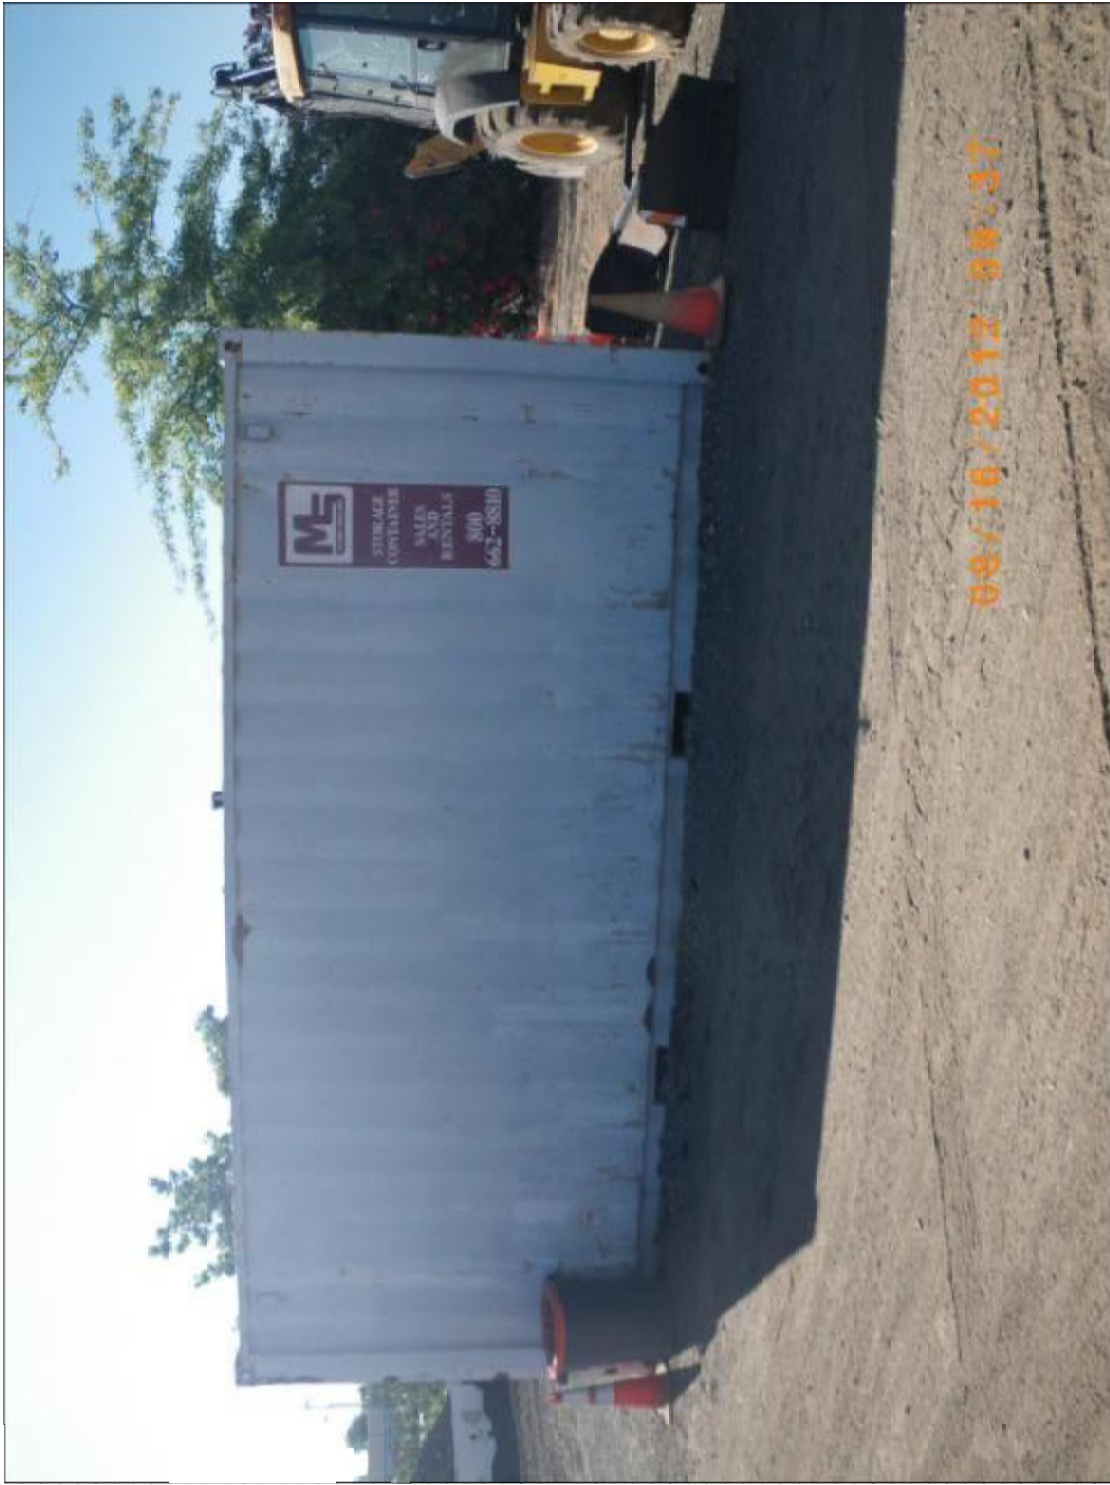
IMGP0924

**IMGP0924:** Hazardous materials storage container.

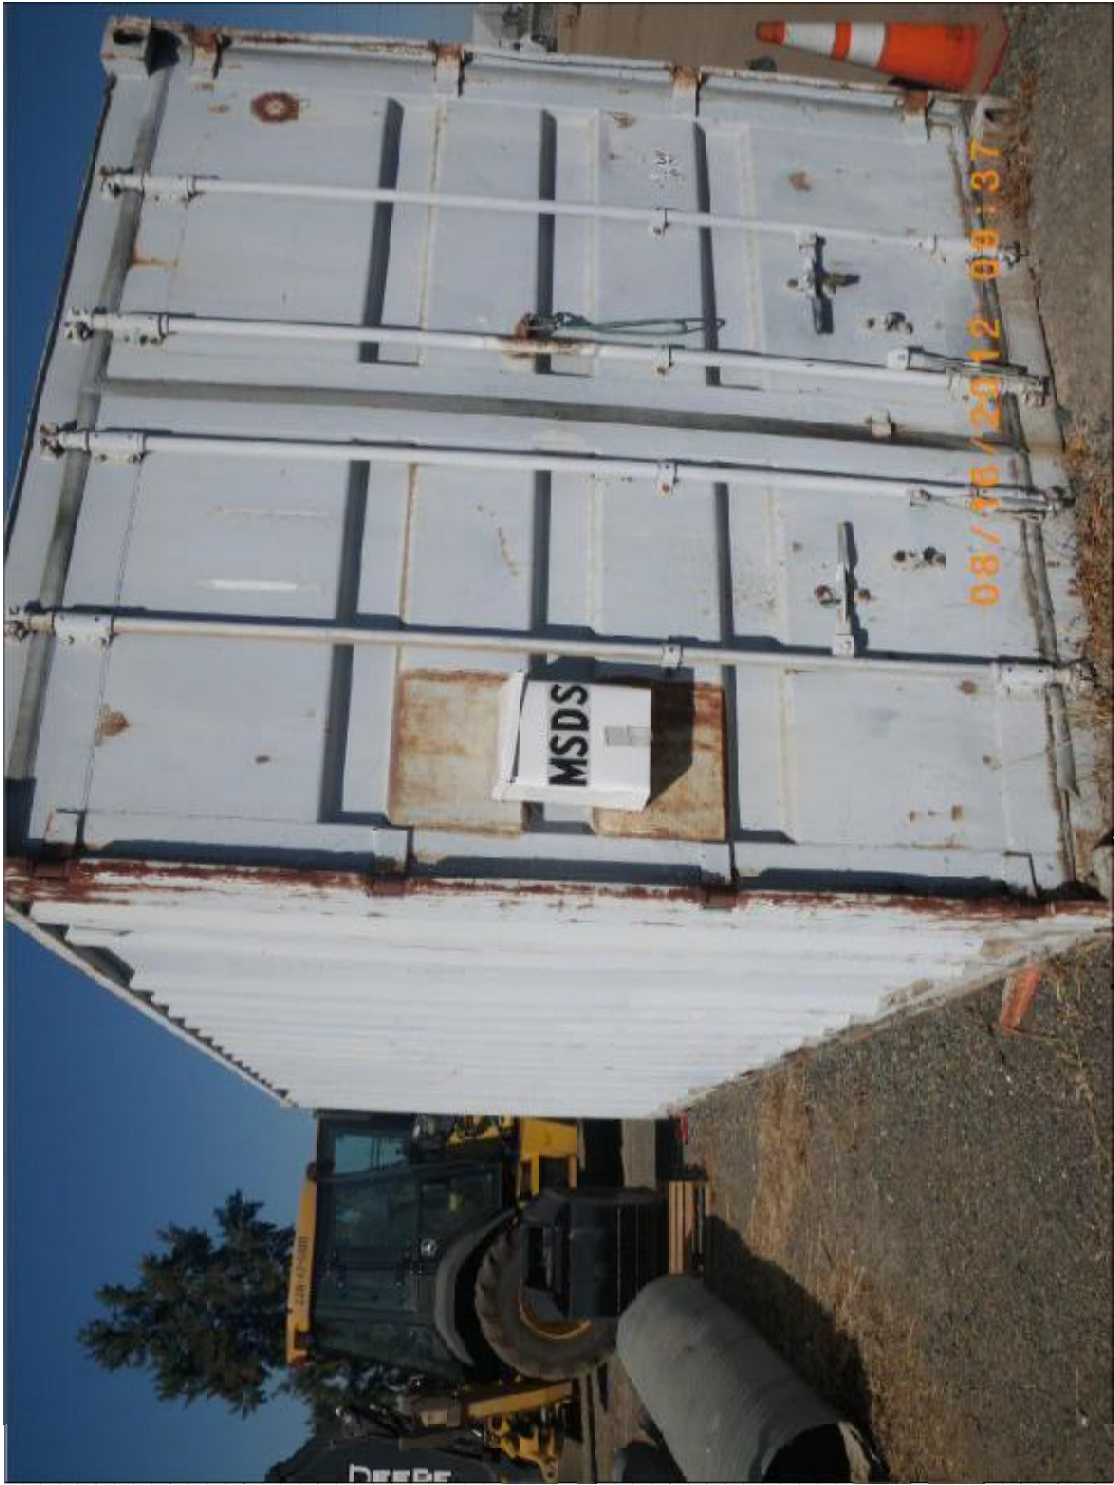
IMGP0925

**IMGP0925:** Material safety data sheets for hazardous materials stored within container.

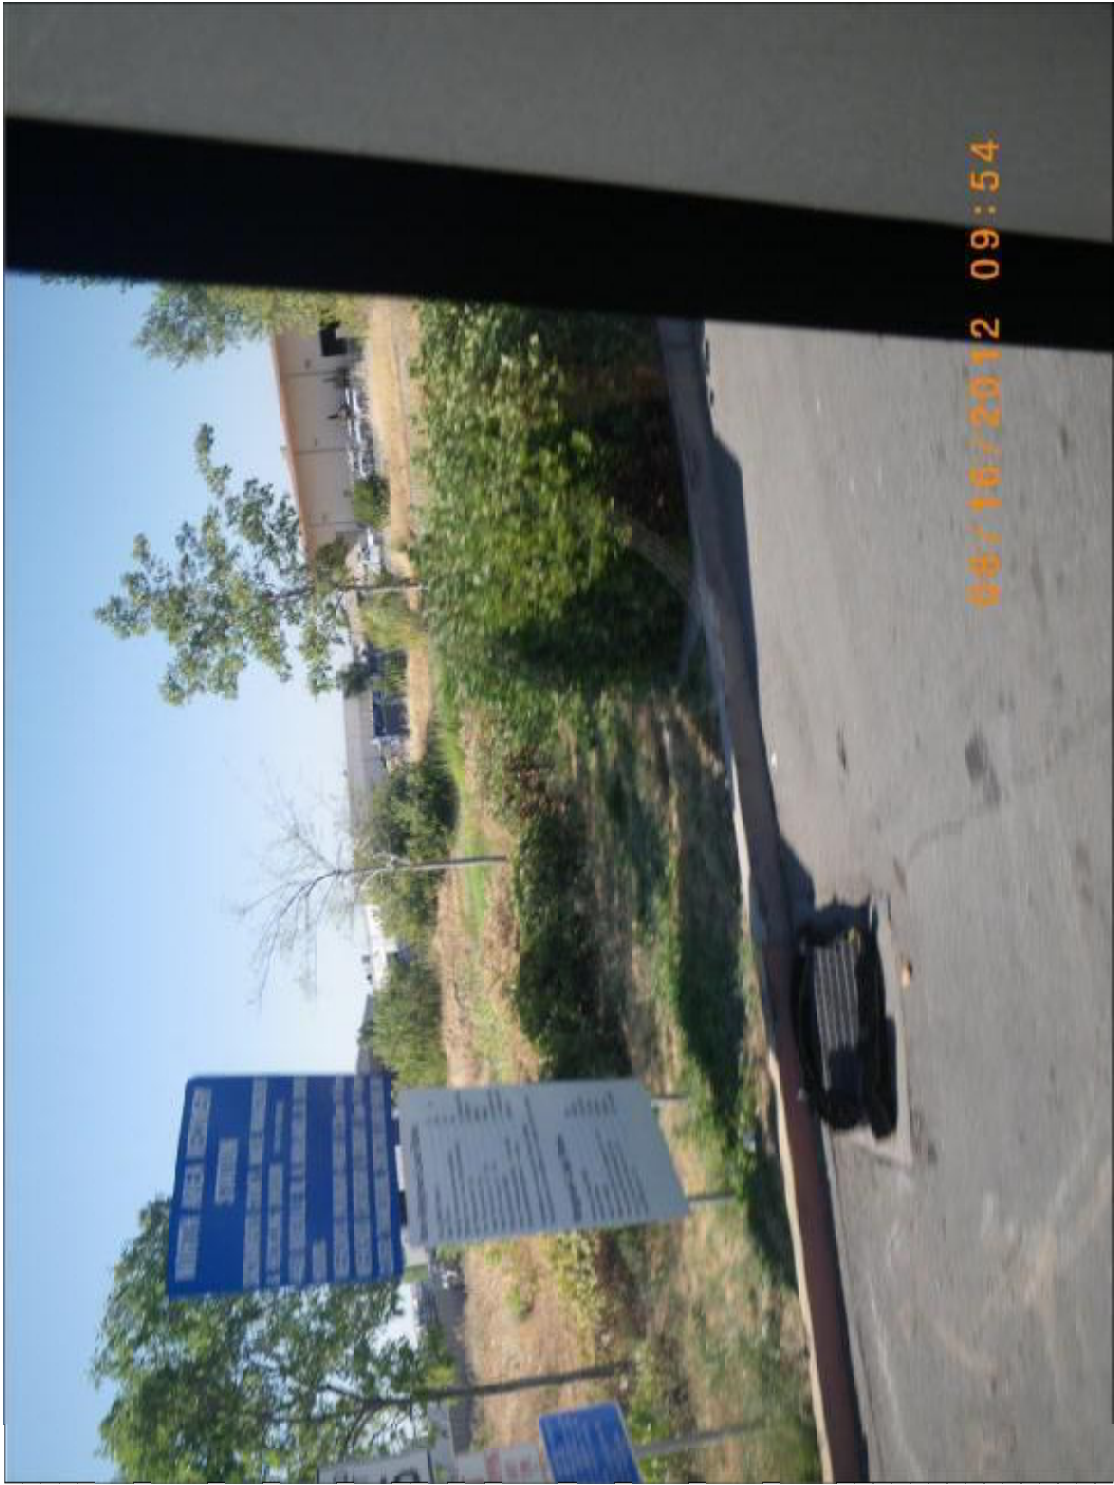
IMGP0931

**IMGP0931:** Main entrance to the facility with a vegetated and storm water detention basin which treats most of the facility's storm water prior to discharge to the MS4. Filter fabric was also observed in the drop inlet.

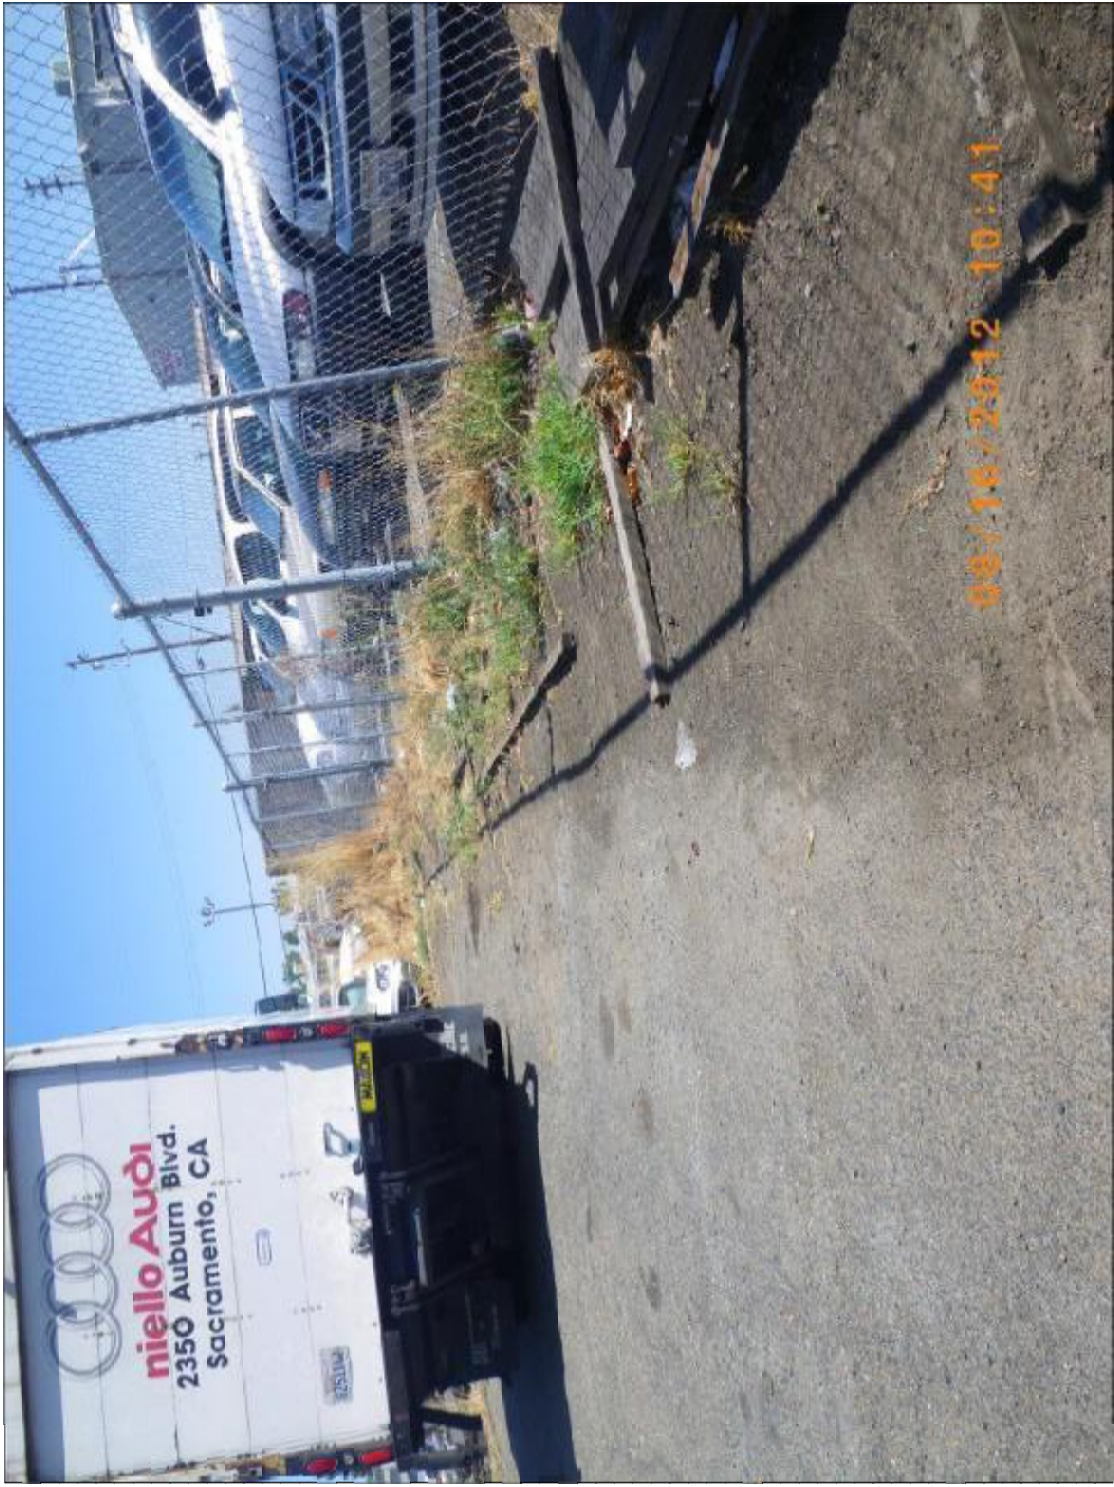
IMGP0945

- Coverage for scrap equipment and parts was marginal and there was not a regular schedule for pick up.
- The Inspector raised concerns about the northeast corner of the facility due to oil staining, accumulation of sediment and trash, and being the storm water discharge point from the facility.

**IMGP0945:** Low point in the yard, where storm water discharges, accumulations of dirt, roof gravels, weeds and trash. Oil staining was also observed in the soils.

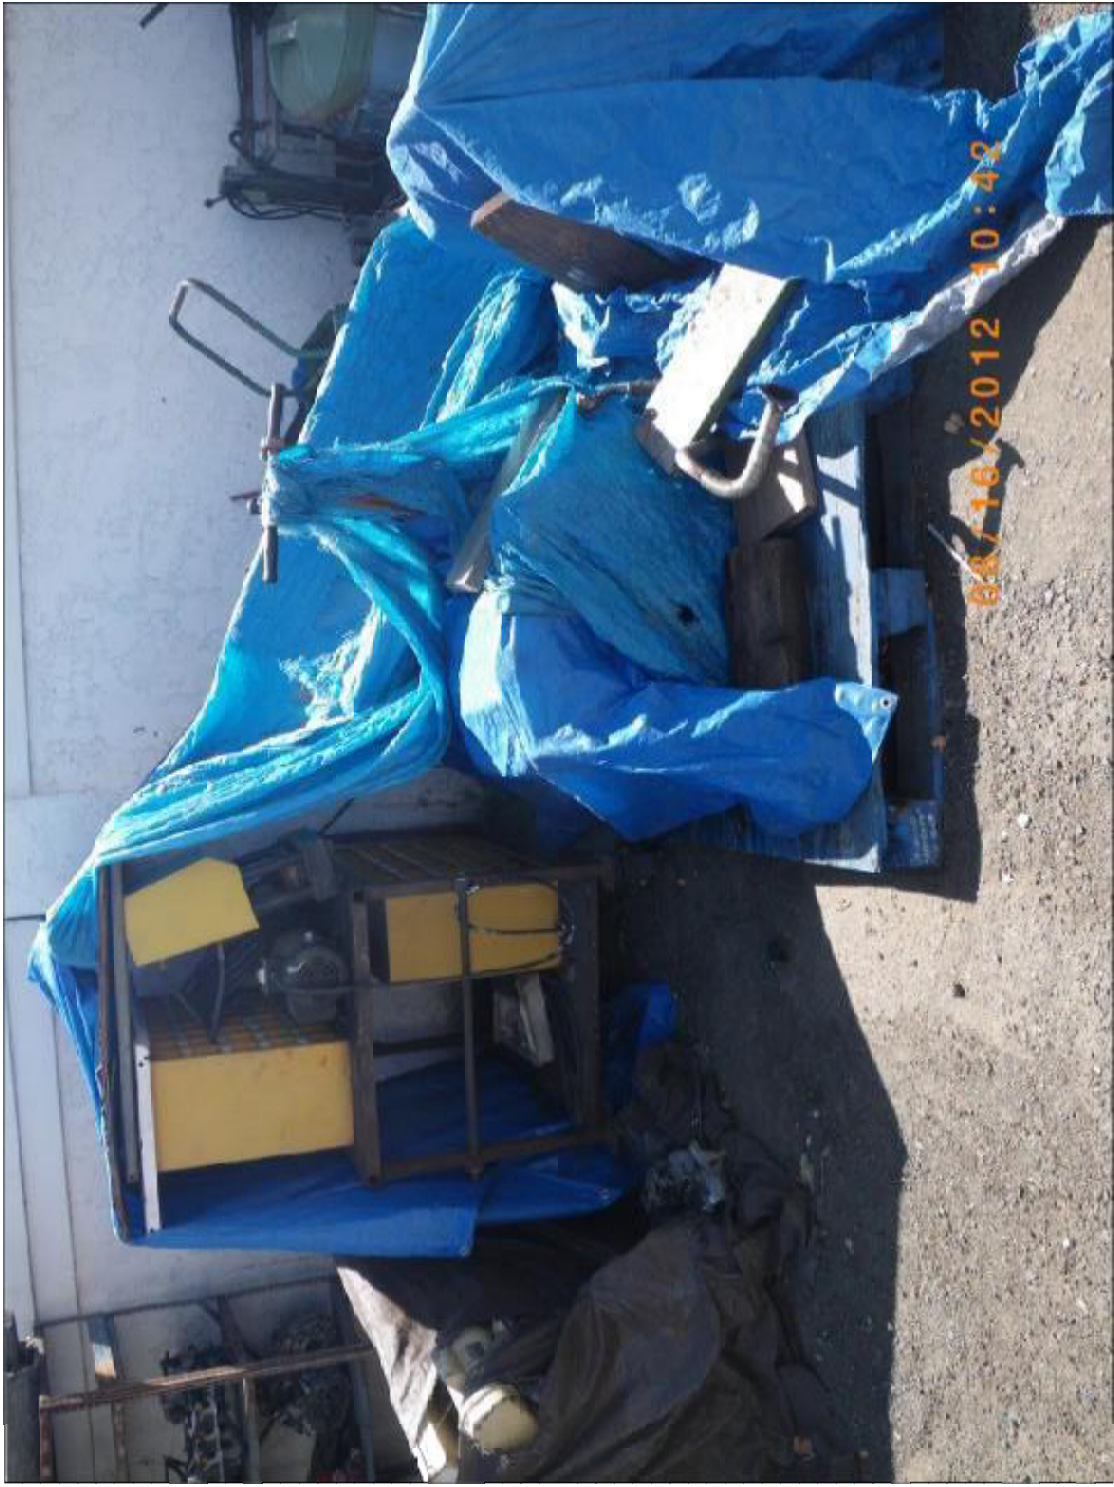
IMGP0947

**IMGP0947:** Palletized scrap metals partially covered by a tattered tarp.

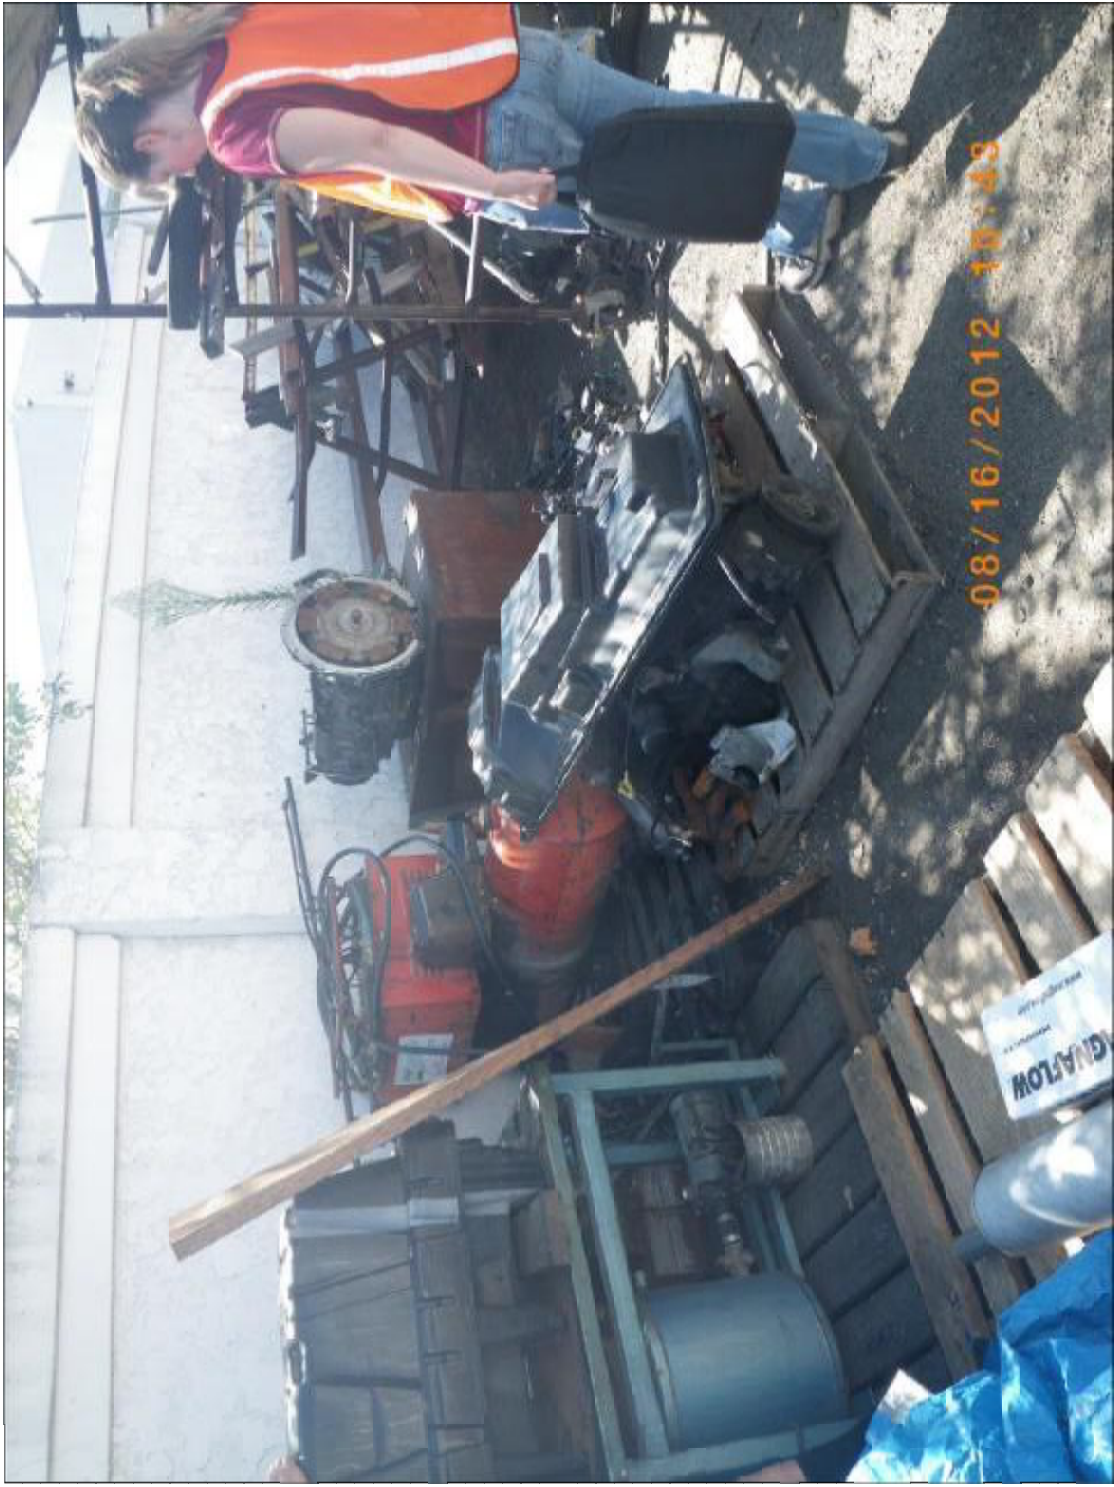
IMGP0948

**IMGP0948:** Other palletized scrap metals with minimal coverage.

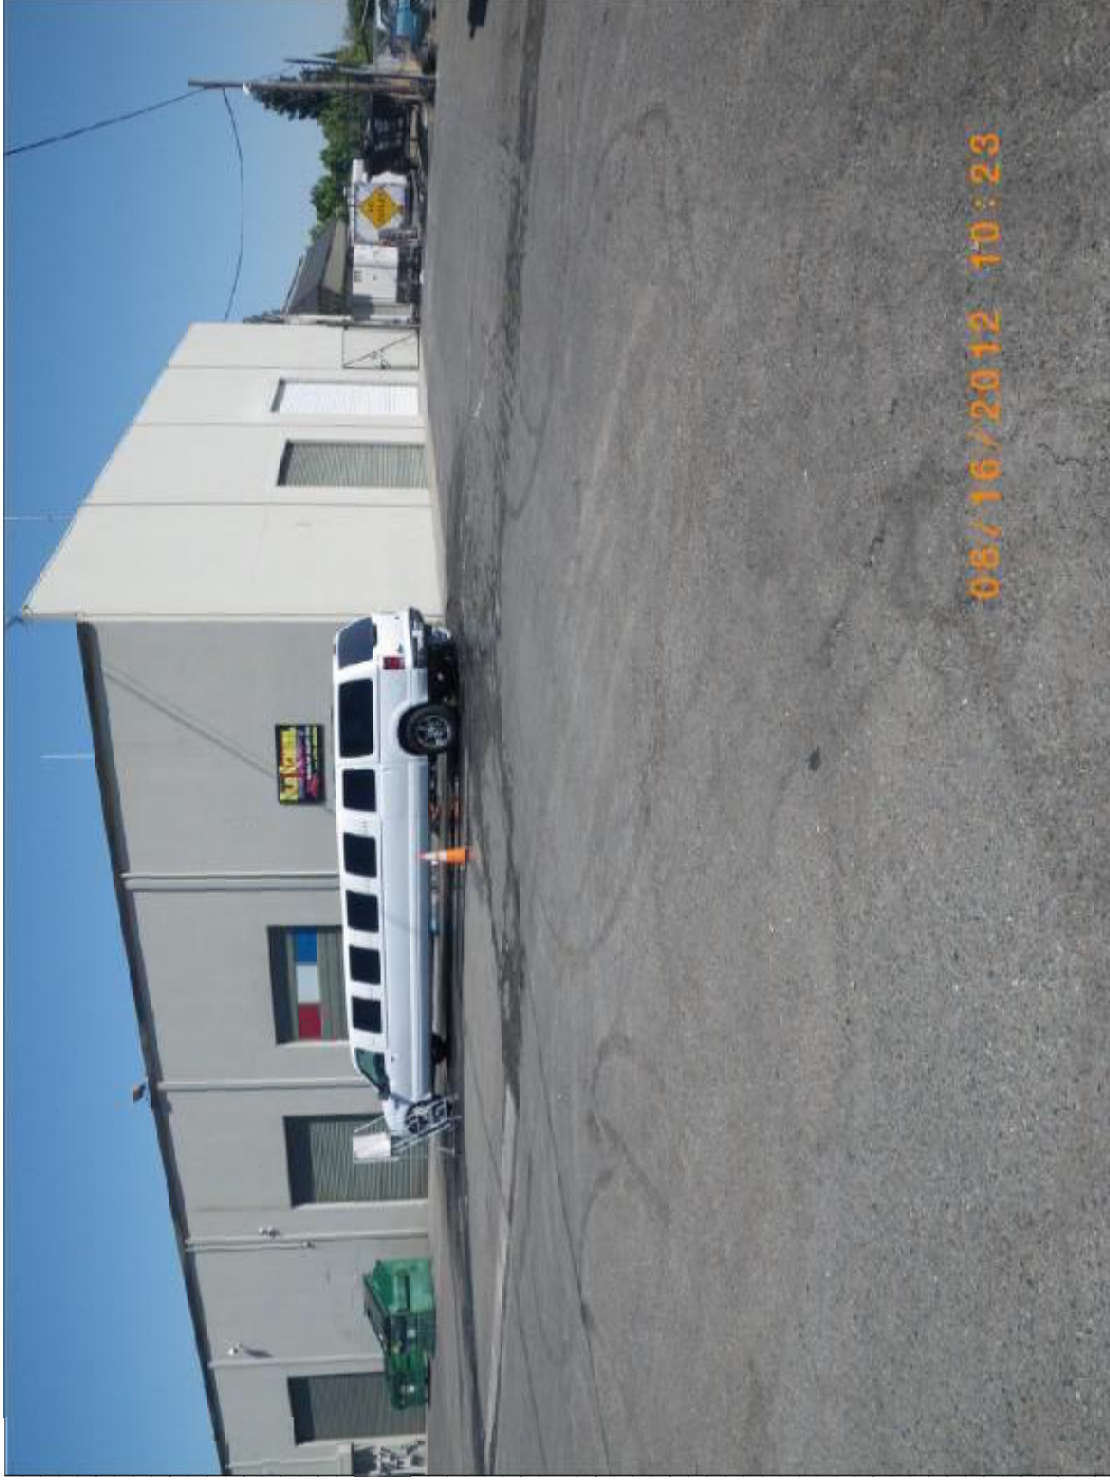
IMGP0941

While en-route to a planned inspection at O'Donnell Truck and Engine Repair, the inspection party encountered Old School Auto Detailing discharging prohibited wash water rinsate to the County MS4. The wash water was observed to be flowing directly to the storm drain and soap suds were observed within the drop inlet. A County Official and an EPA representative contacted the operator and provided storm water compliance information. County staff informed the business of county code that prohibited discharges of washwater to the storm drain system. The operator was aware of the stormwater ordinance prohibiting the discharge of wash water; however, no BMPs to prevent the discharge were observed by the EPA. County staff worked with the operator, who offered to install a barrier and pump system to collect the washwater. County staff stated they will write a follow-up letter to the operator, and will perform random drive-by inspections in the future to verify compliance.

**IMGP0941:** Stretched luxury vehicle in the process of being washed and detailed, rinsate discharging to MS4. This photo was take while en-route to O'Donnell Truck and Engine Repair inspection. All following photos were taken approximately 50 minutes later.

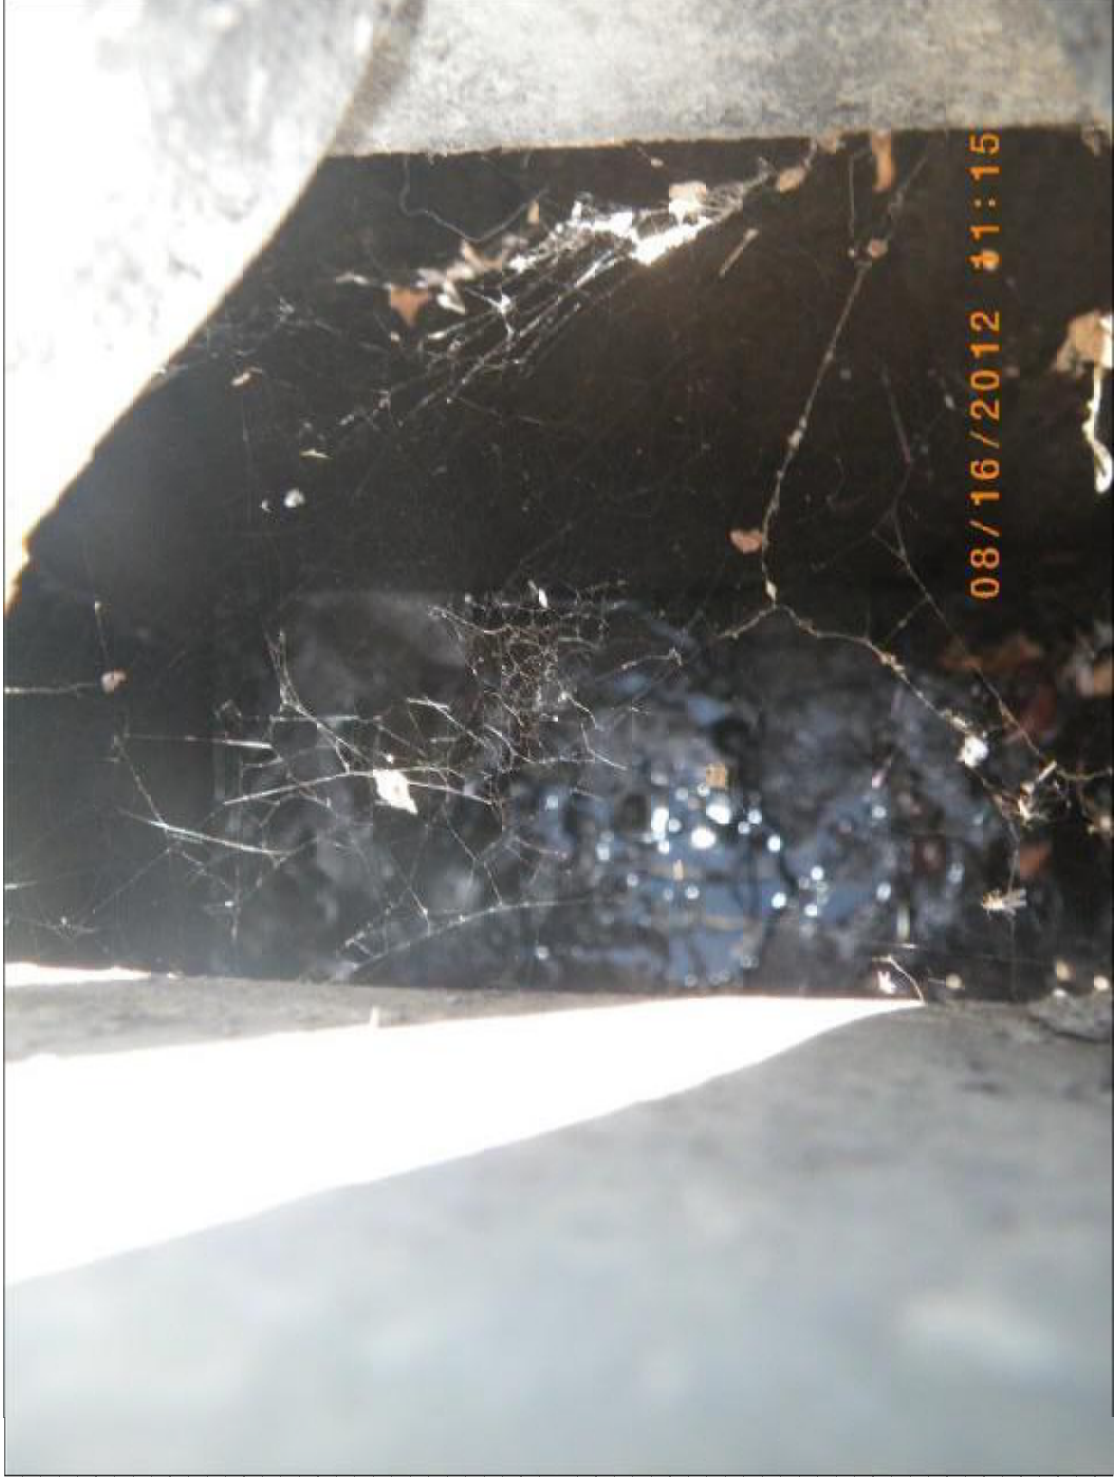
IMGP0955

**IMGP0955:** Vehicle rinsate accumulated within the drop inlet.

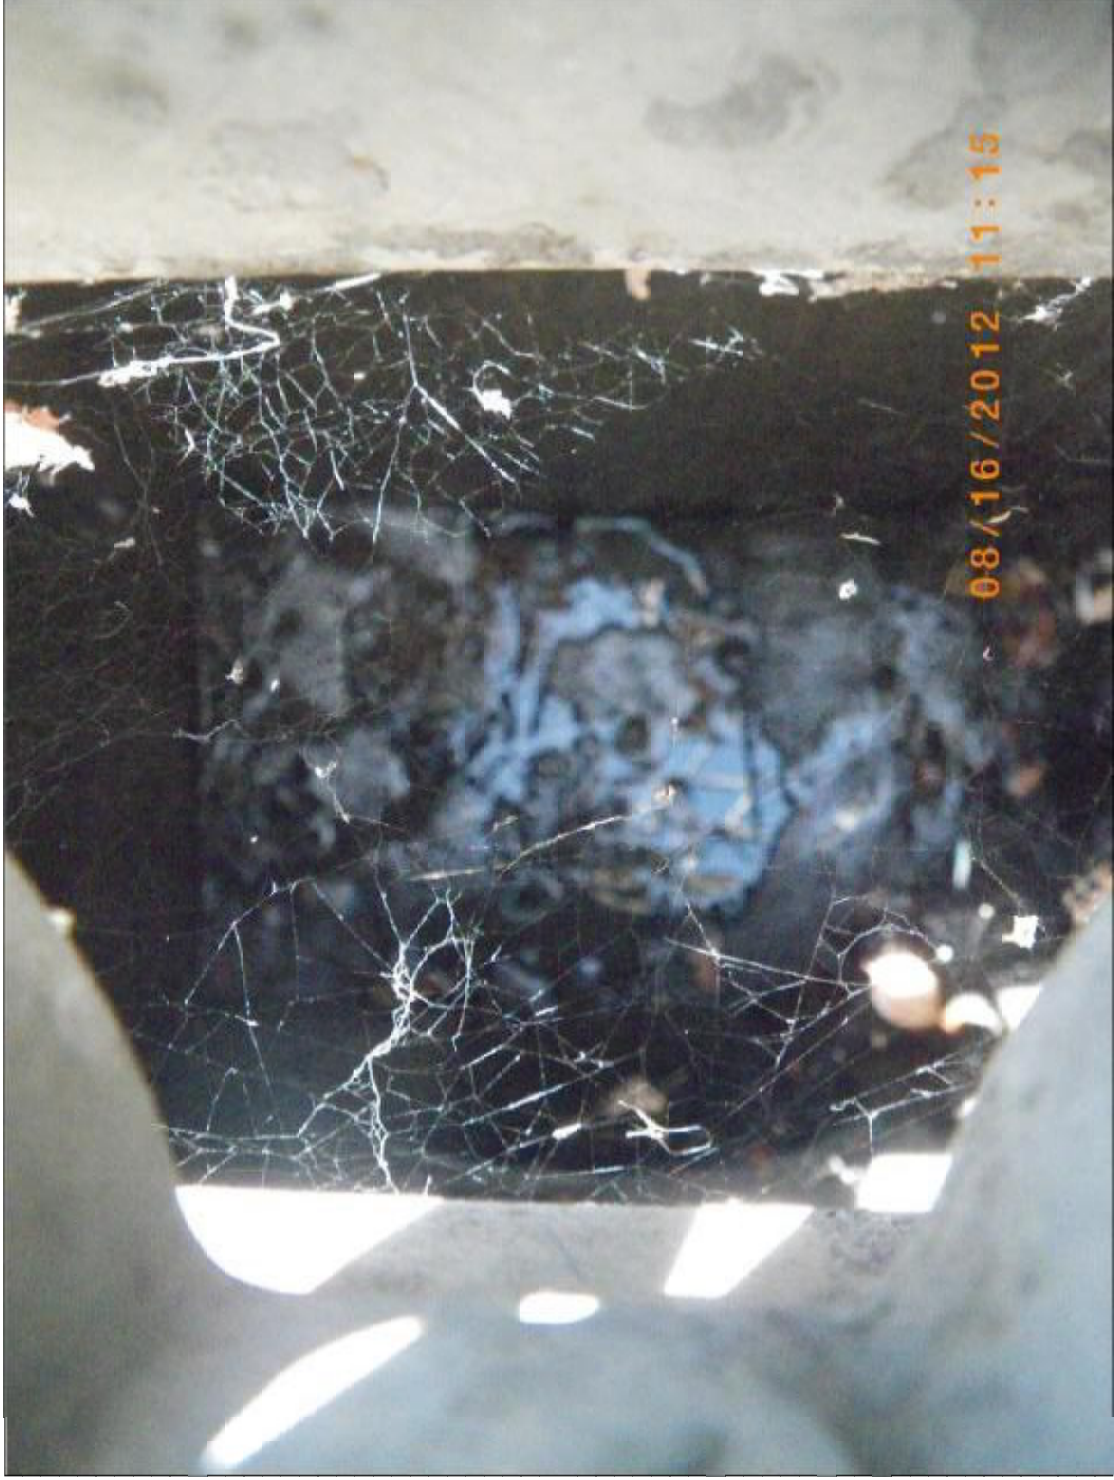
**IMGP0956:** Same as IMGP0956 however; depicting soap bubbles.

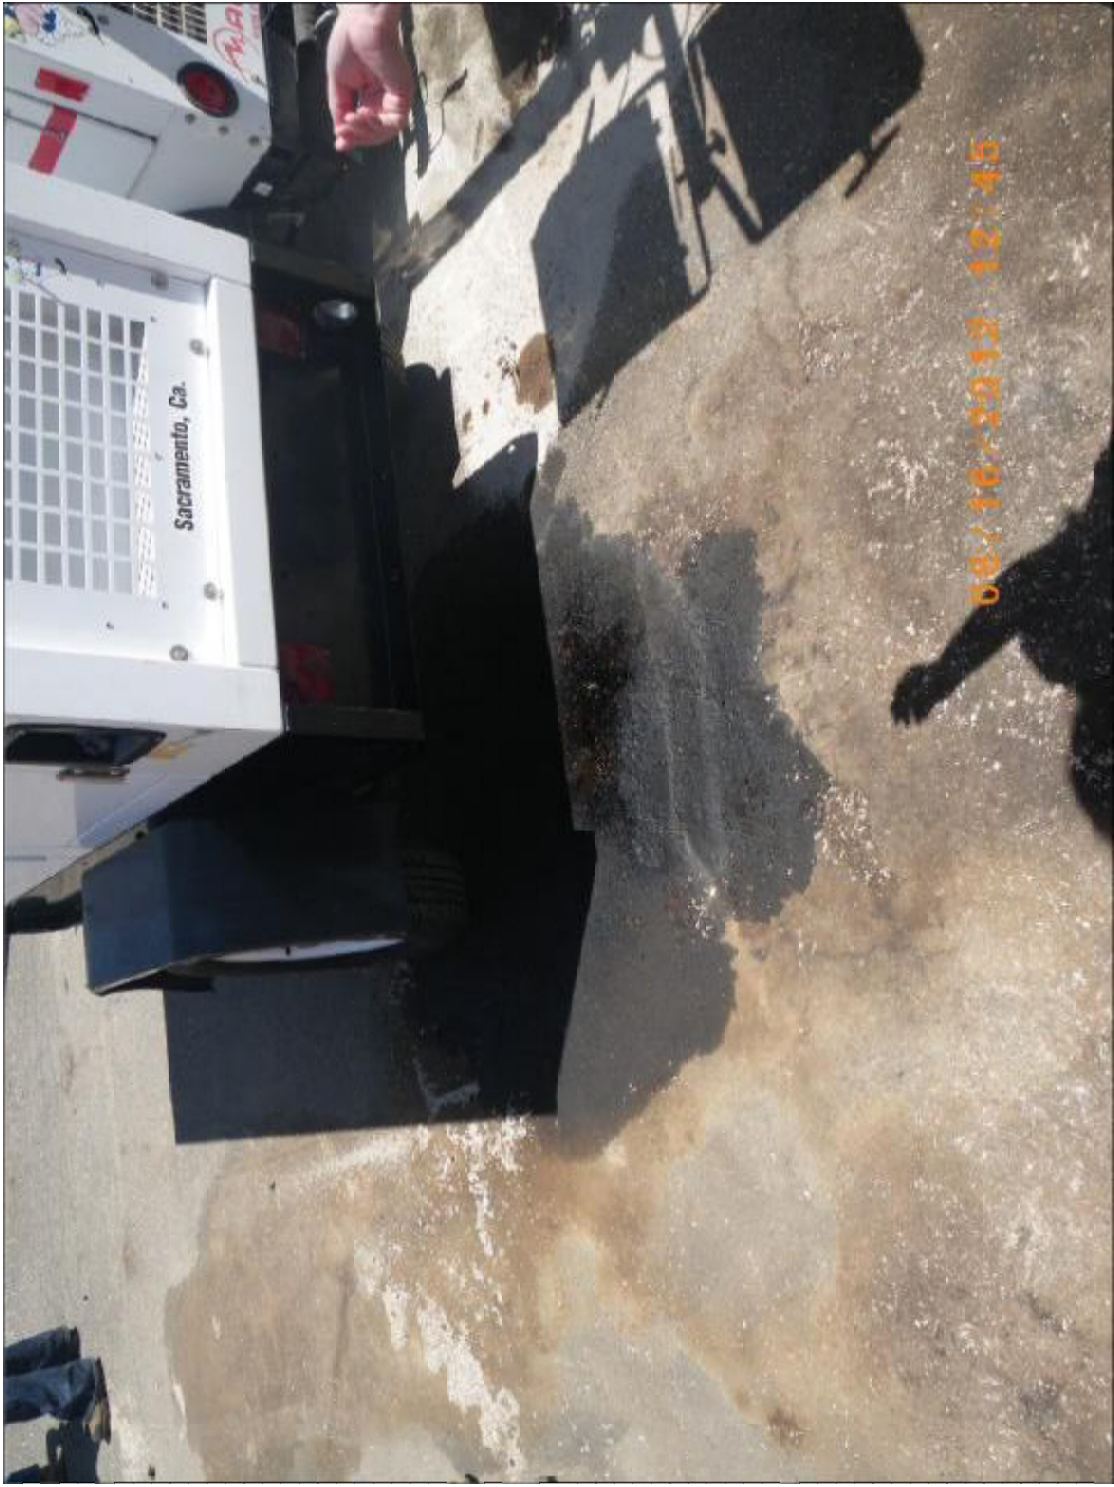
IMGP0961

**IMGP0961:** Spilled diesel fuel from over-filled fuel tank on a portable generator. Staining from past spills and evidence of cleanup with absorbent.

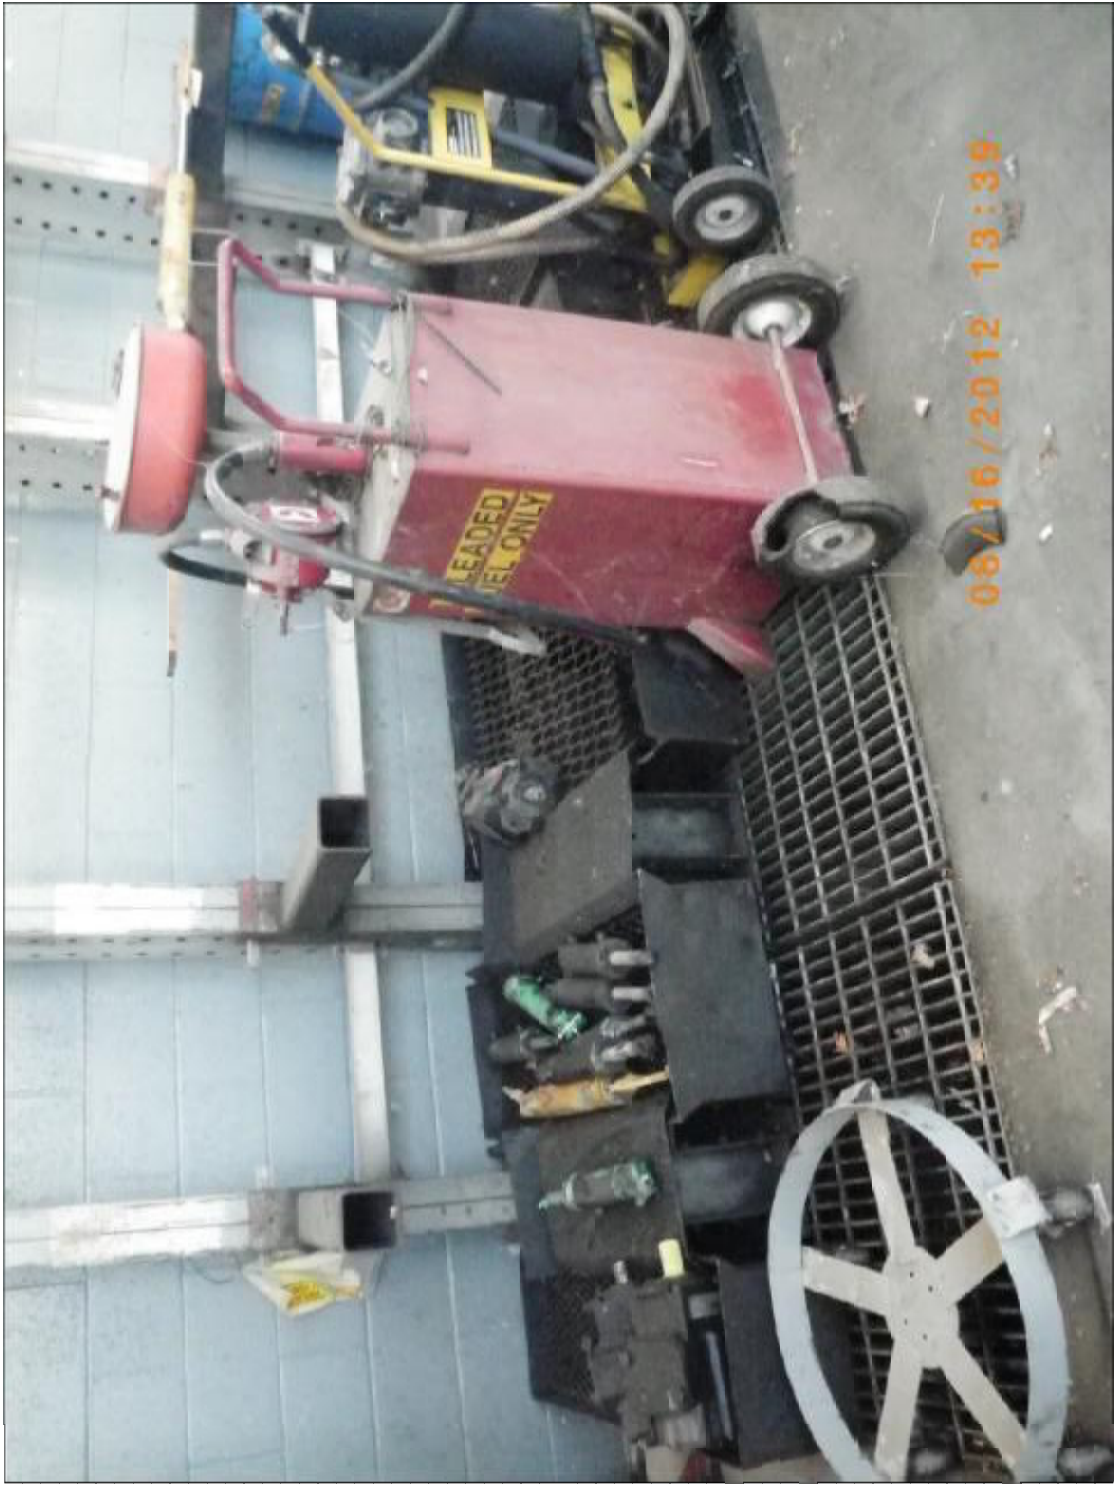
IMGP0966

**IMGP0966:** Ancillary, covered staging/storage bay with secondary containment for hazardous fluids such as fuel and hydraulic fluids.

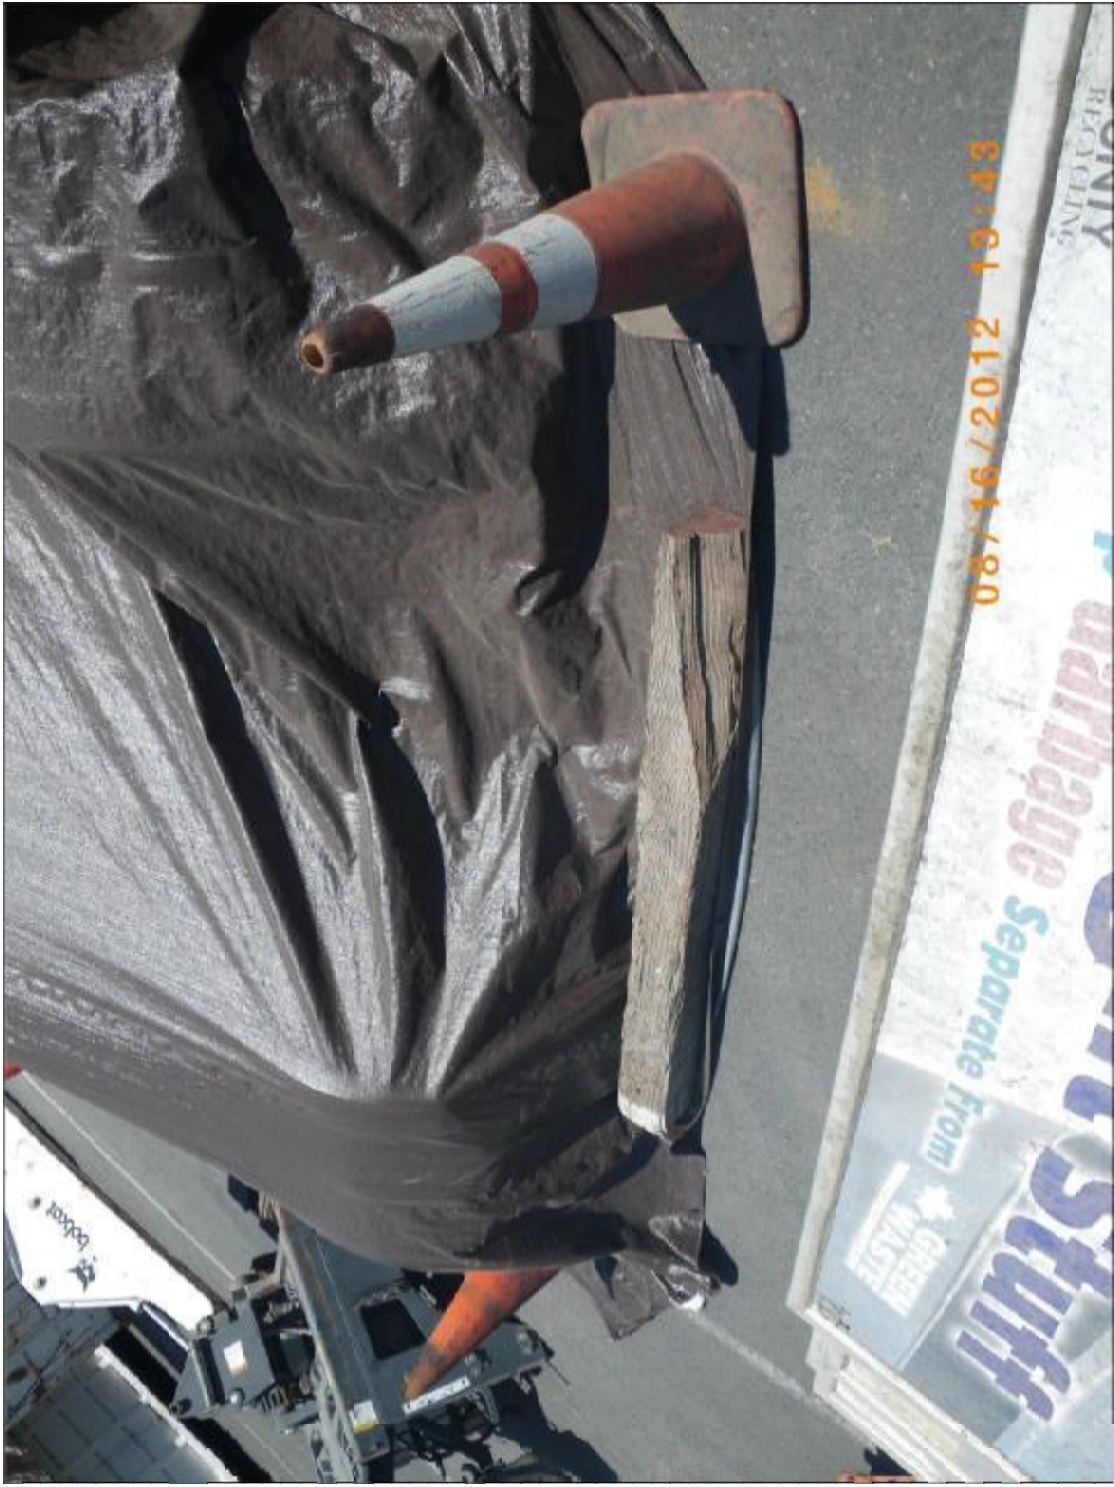
IMGP0971

**IMGP0971:** Brown tarp described in previous image was in good condition, weighted down, and also bungee-corded (not depicted).
