**MUNICIPAL SEPARATE STORM  
SEWER SYSTEM (MS4)  
COMPLIANCE INSPECTION**

**SACRAMENTO COUNTY,  
CALIFORNIA**

**INSPECTION REPORT**

**Inspection Date:  
August 15-16, 2012**

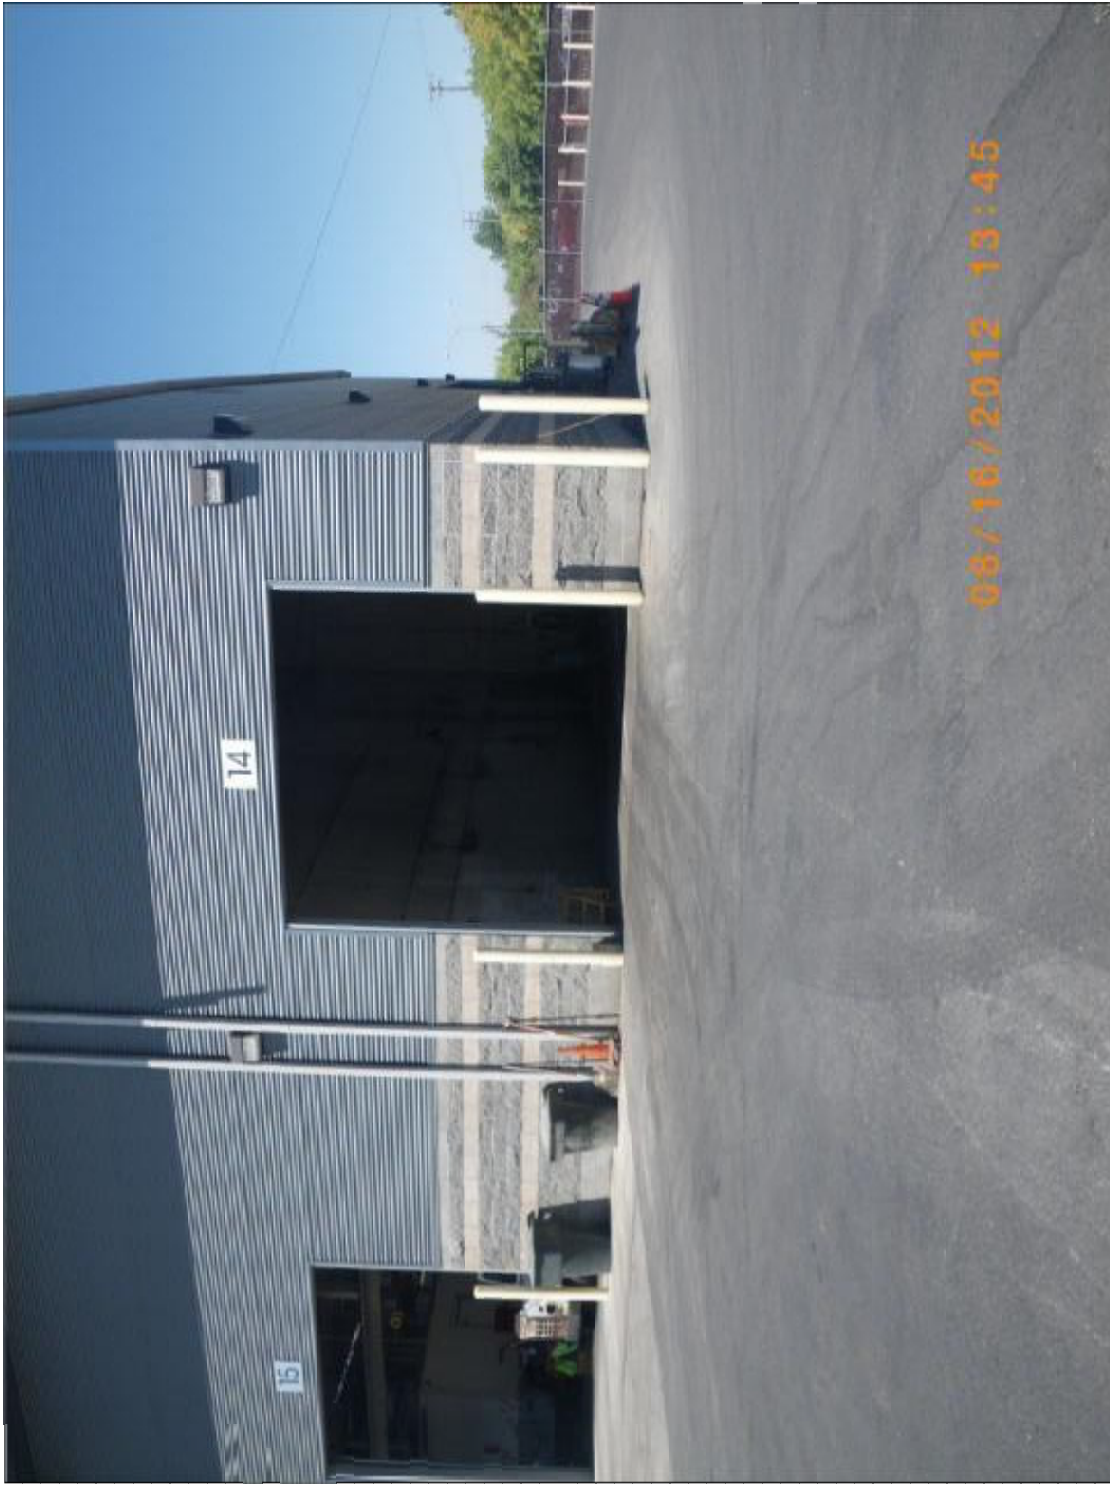
IMGP0972

**IMGP0972:** Bay 14: Vehicle wash bay. Some staining was observed trailing from the proximity of the bay entrance however; no active non-storm water discharges were observed. Facility personnel reported that vehicle rinsate drains into a sand/oil separator prior to discharging to the sanitary sewer.

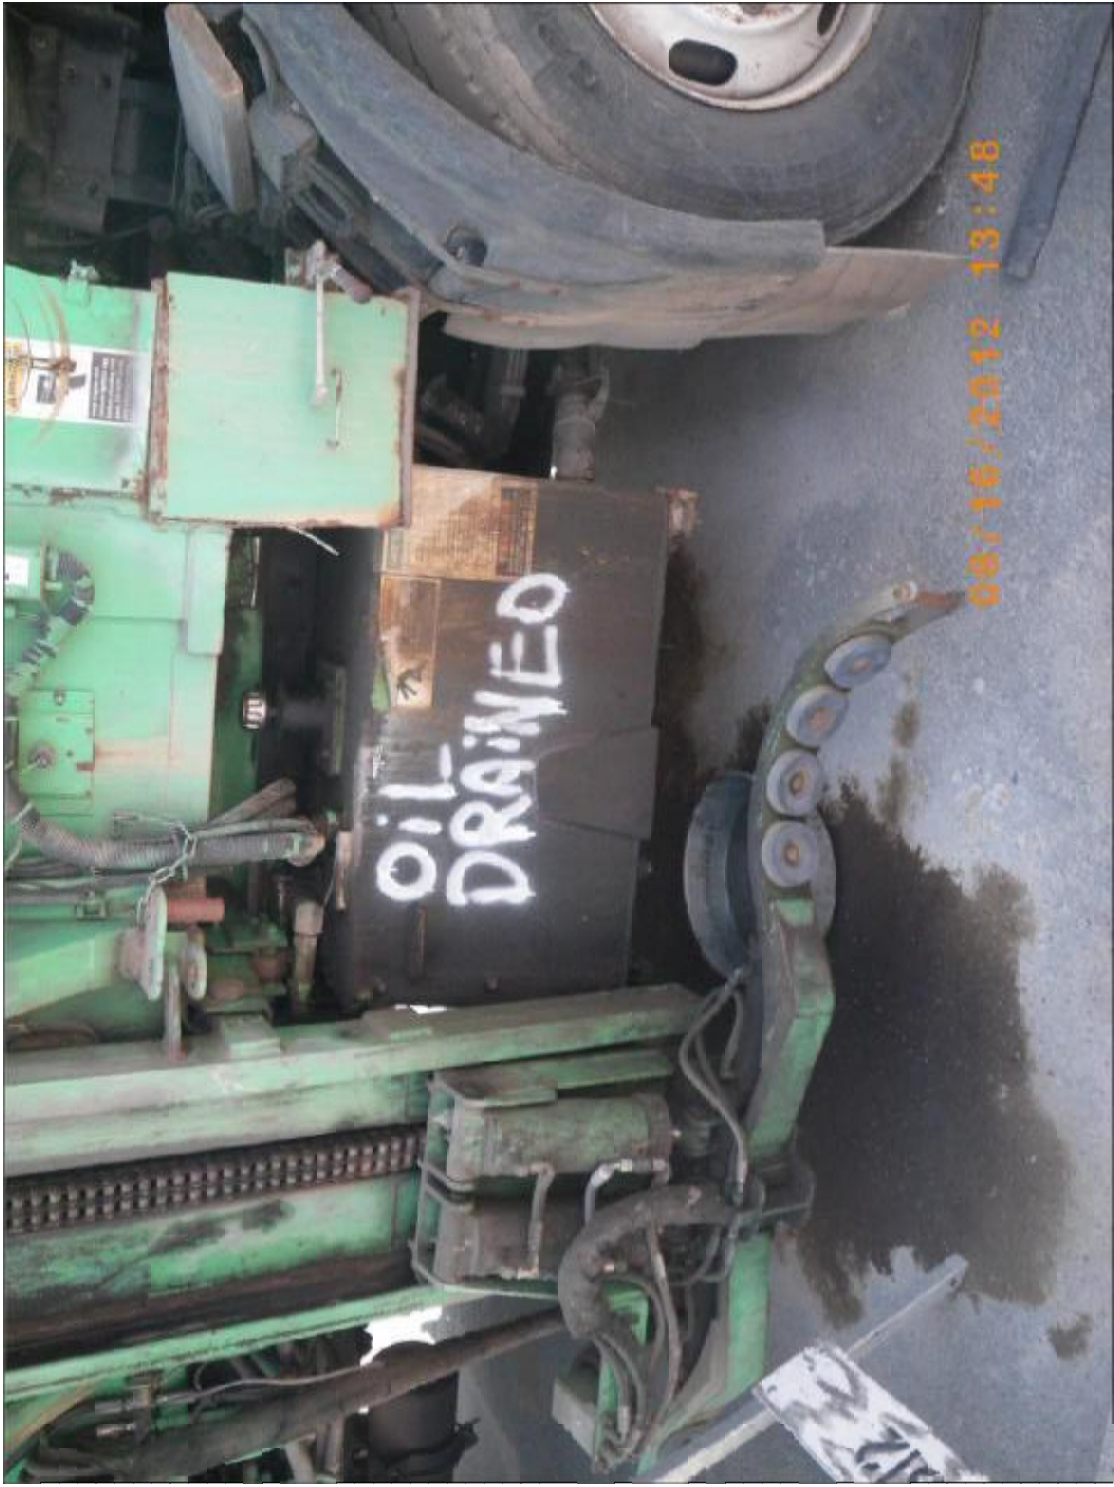
IMGP0973

**IMGP0973:** Garbage truck that had been in an accident and was sequestered to the yard as evidence had been drained of hazardous fluids. Some staining was evident from the fluid removal as was absorbent material used in response to the spill. A drip pan was staged under the oil pan to collect any residual dripping.

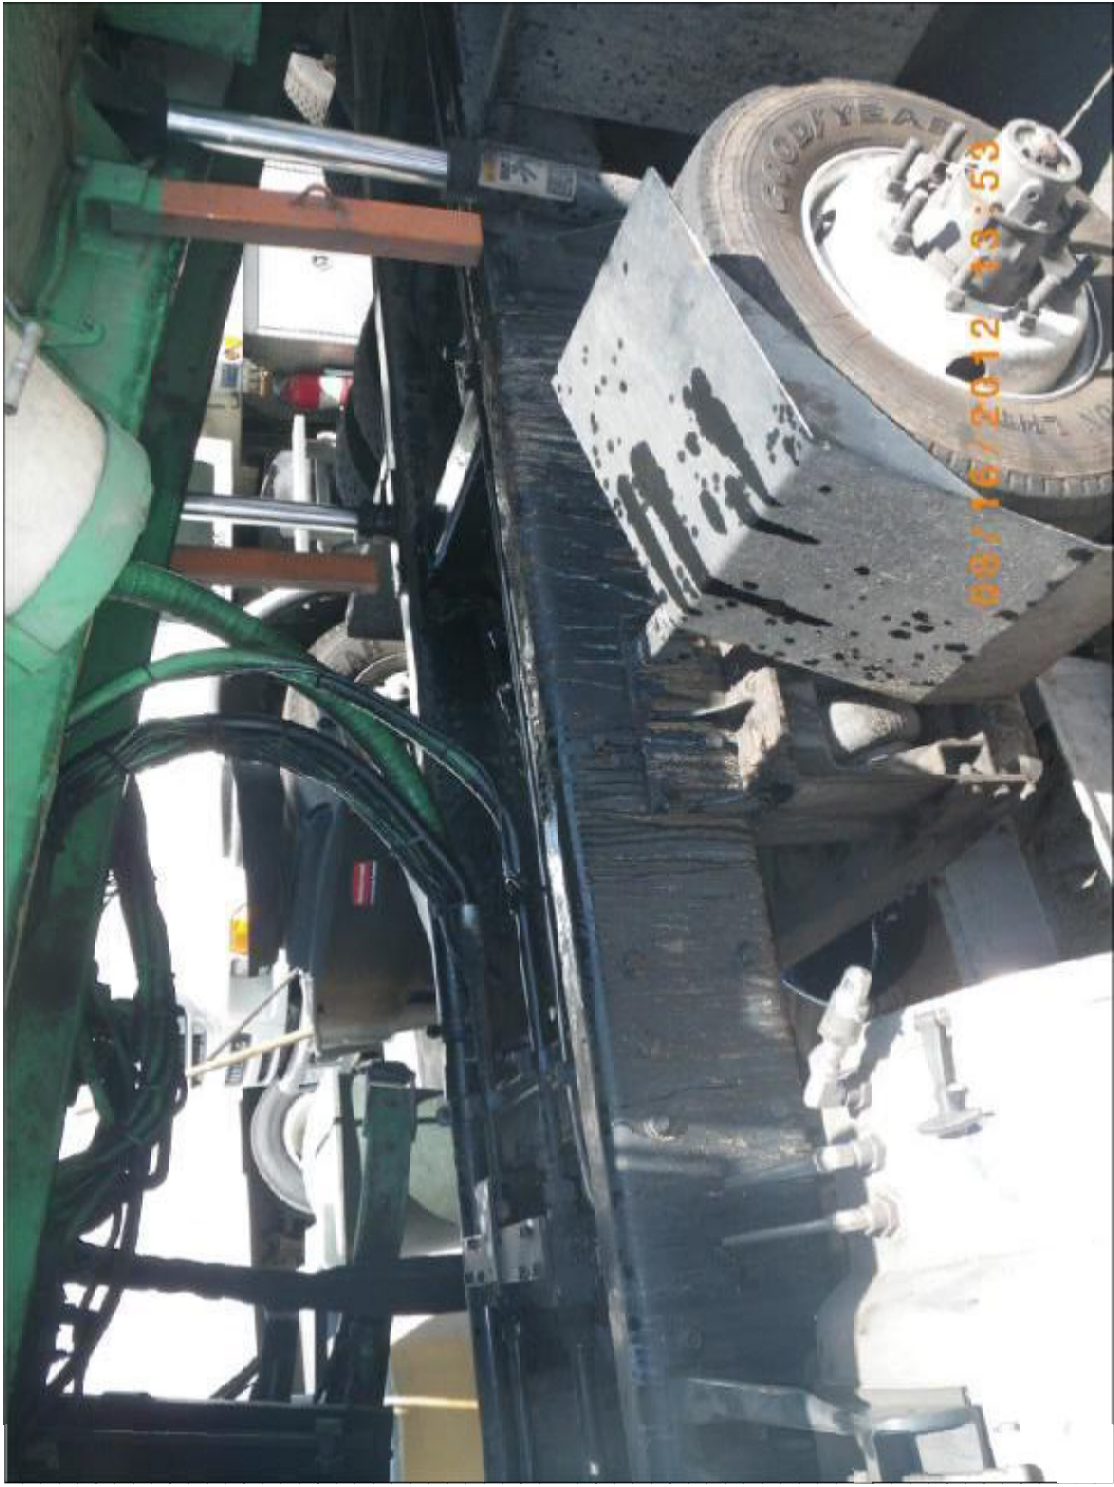
IMGP0974

**IMGP0974:** Garbage (different than the one depicted in IMGP0973) truck with a ruptured hydraulic line during a maintenance inspection. Yard staff responded to the spill with absorbent and drip pans.

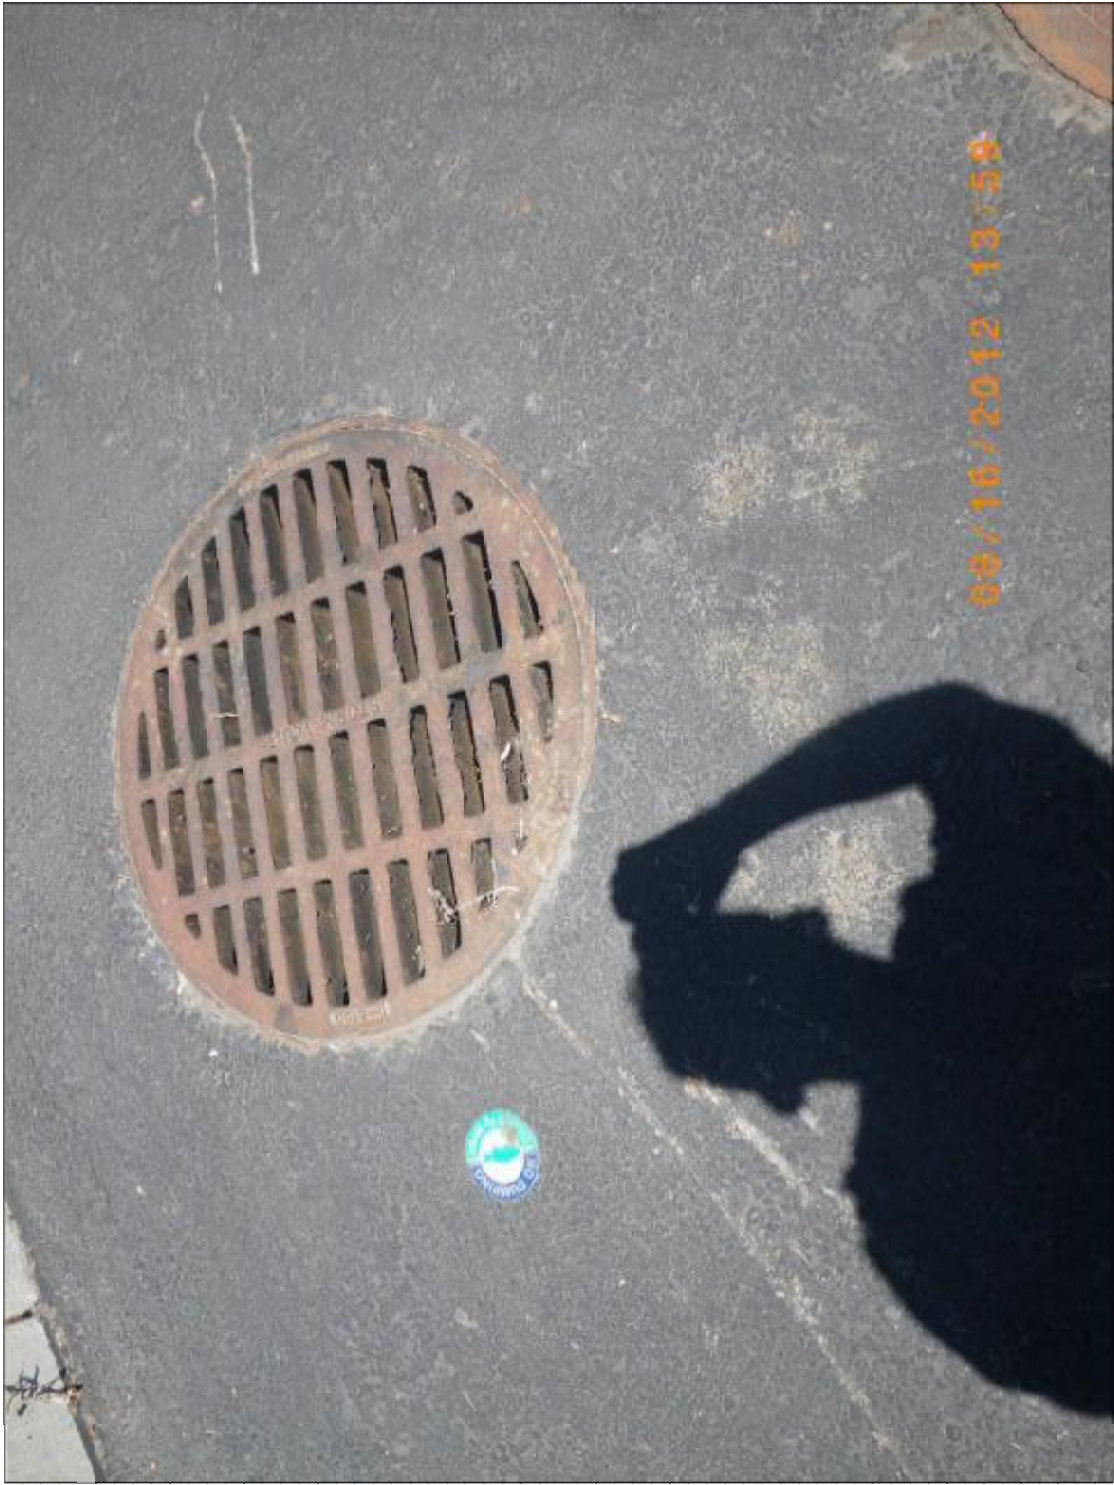
- The SWPPP describes catch basin filter inserts as a BMP used throughout the yard and the facility maps show which catch basins should have filters installed. During the site tour, EPA observed that some catch basins identified on the facility maps lacked such inserts (see photos IMGP0980 and IMGP0982).
