Tribal Case Study: Wrapping Mountains

Jacquelyn Gonzales
San Manuel Band of Mission
Indians

Winter 2010 Storm Aftermath

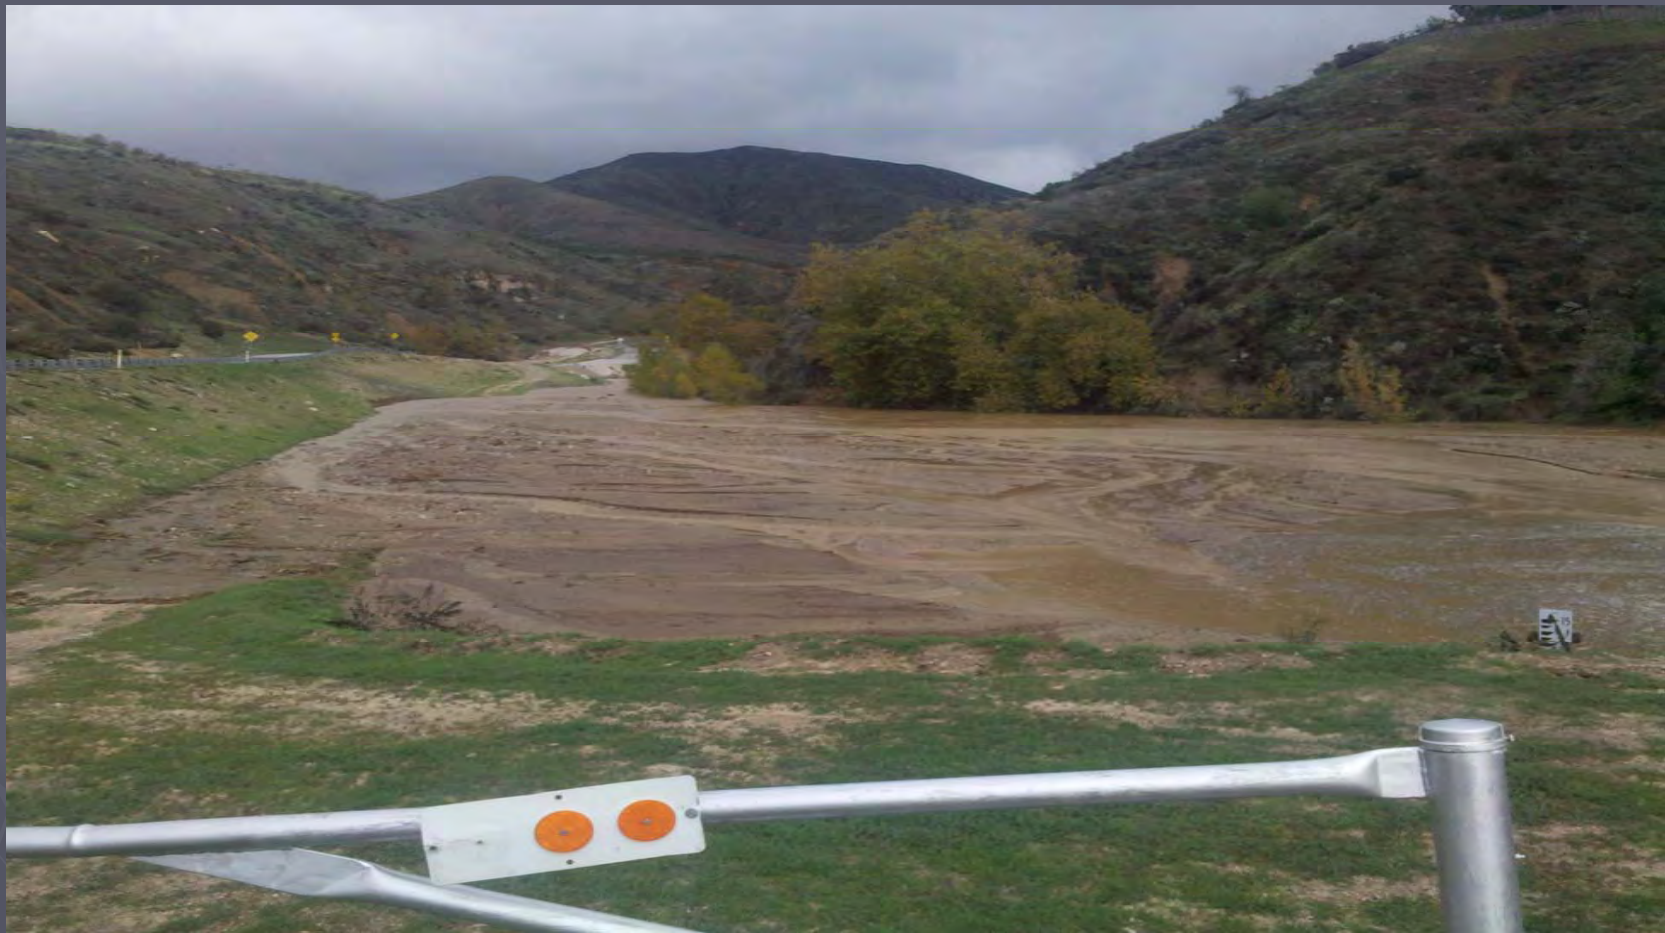
Sand Canyon Sedimentation basin – Flood Control District
(15ft of material deposited)

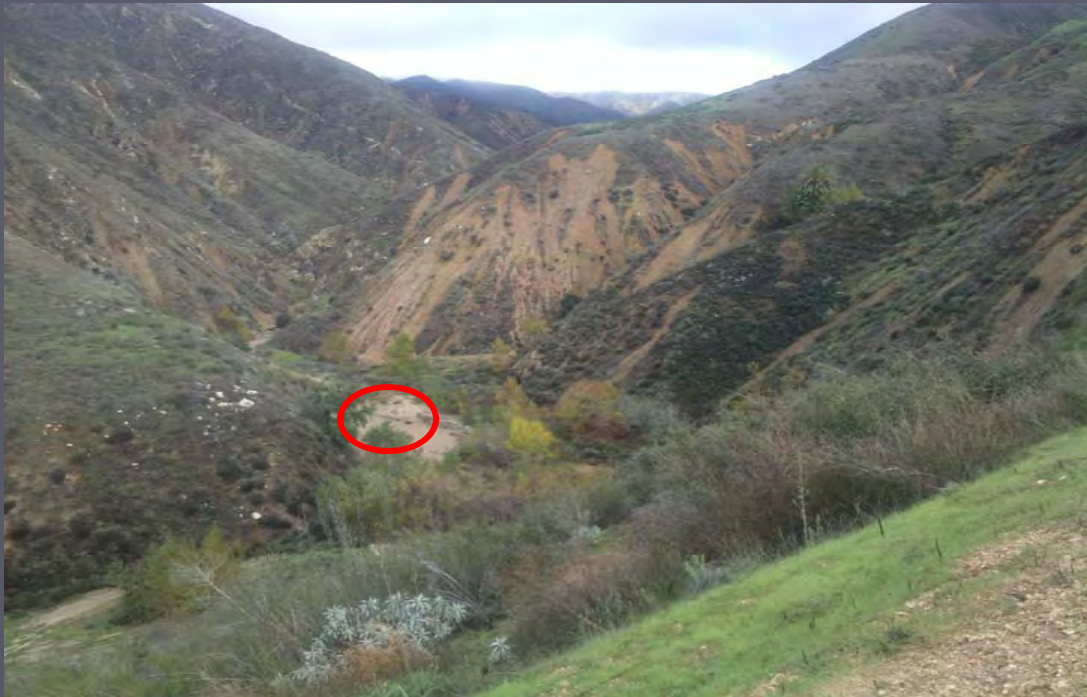
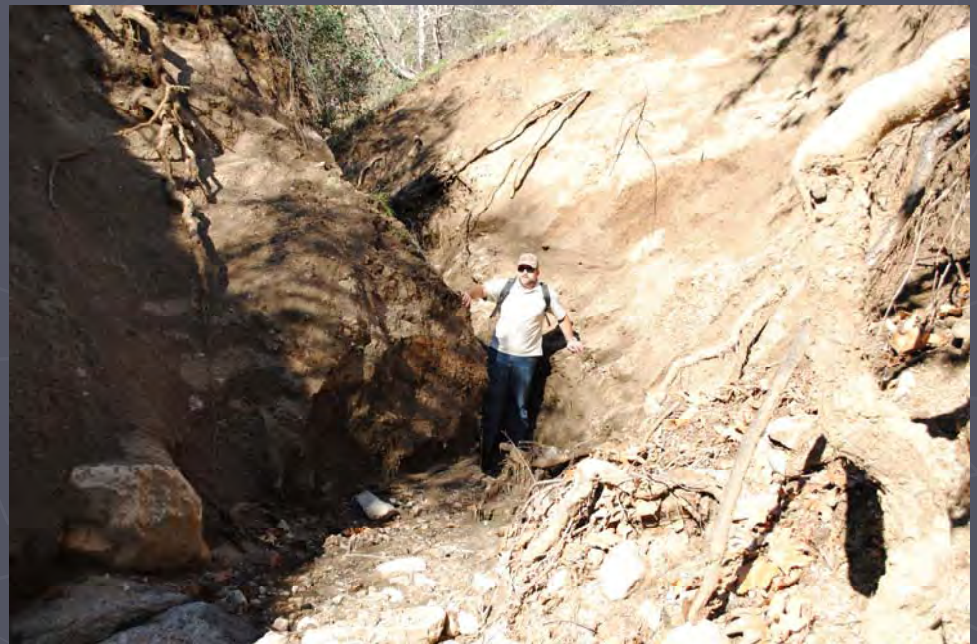
Result of no BMPs used at this site

Day after storm, major slope failures
And severe bank cutting
