**MUNICIPAL SEPARATE STORM
SEWER SYSTEM (MS4)
COMPLIANCE INSPECTION**

**CITY OF ELK GROVE,
CALIFORNIA**

INSPECTION REPORT

Inspection Date:
August 7–8, 2012

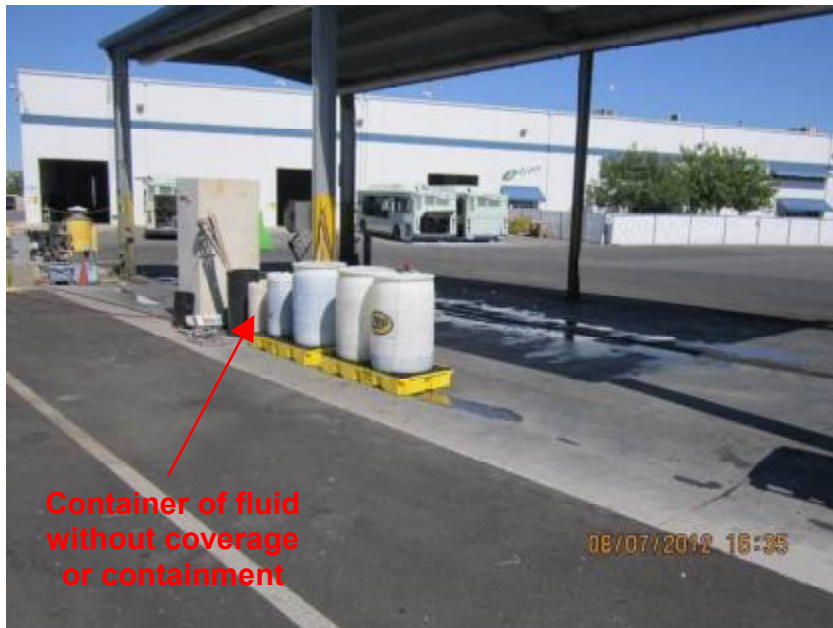
Photograph 4. View of covered vehicle wash bay at the facility.

- An unlabeled container of fluid was stored in an uncovered area without secondary containment along the northwest side of the vehicle wash bay (see [Photographs 4 and 5](#)).
- A bus was parked directly over a storm drain inlet in the area of pervious pavement near the western edge of the facility (see [Photographs 6 and 7](#)). Staining was present on the

Container of fluid
without coverage
or containment

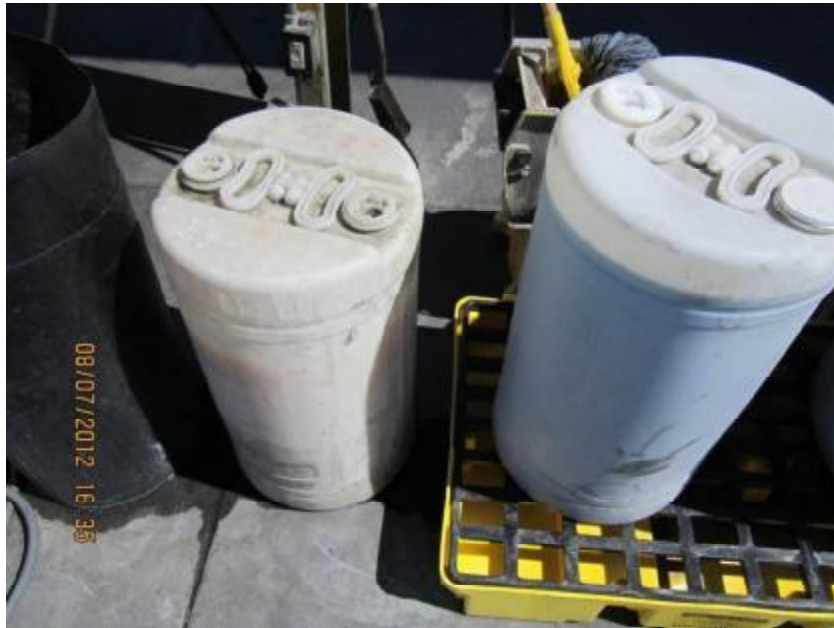
Photograph 5. View of drum of unlabeled container of fluid stored in an uncovered area without secondary containment adjacent to the vehicle wash bay shown in Photograph 4.

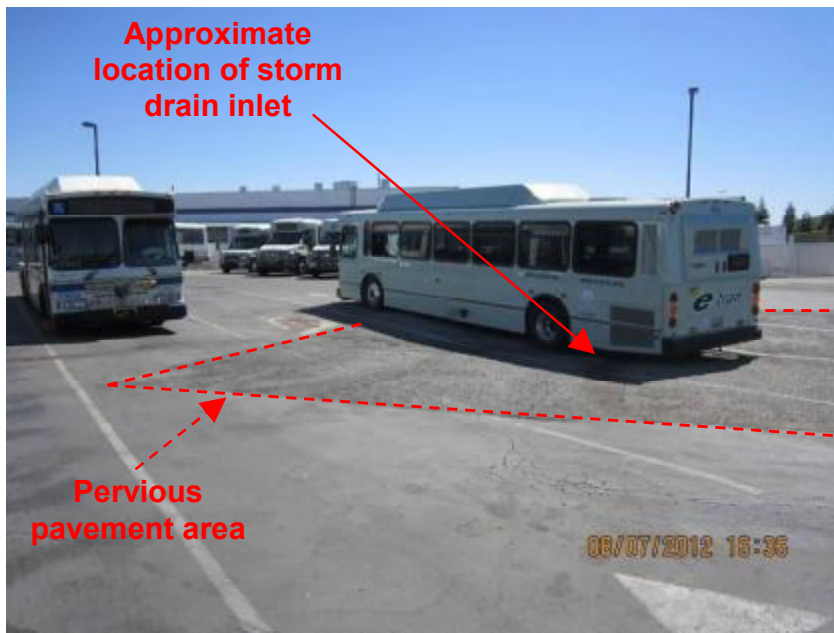
Photograph 6. View of bus parked over a storm drain inlet in an area of pervious pavement.

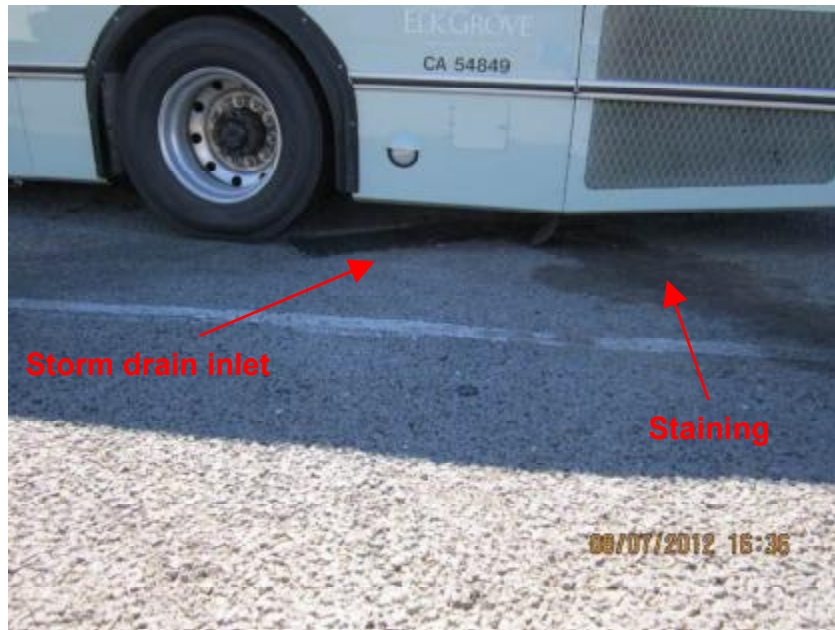
pervious and impervious ground surface adjacent and upgradient of the storm drain inlet (see Photographs 7 and 8).

Photograph 7. Closer view of storm drain inlet referenced in Photograph 6.

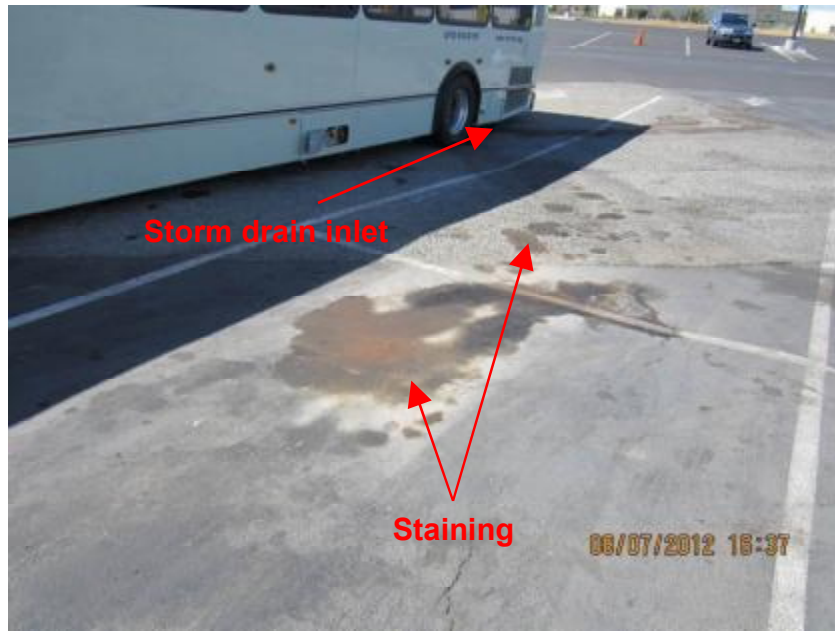
Photograph 8. View of staining on pervious and impervious ground surface upgradient of storm drain inlet shown in Photographs 6 and 7.

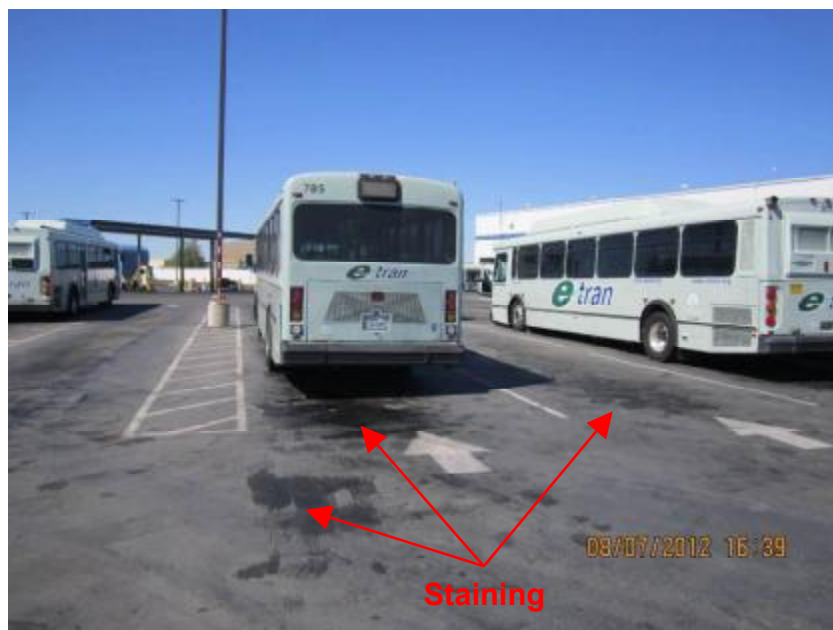
- Staining on the impervious ground surface was observed in multiple locations throughout the bus storage and parking area at the facility (see Photographs 7 through 10).
- Storm drain inlet protection had not been provided for a storm drain inlet on the west side of the warehouse building between the personal vehicle parking area and the building itself (see Photograph 11).

Photograph 9. Example of staining on impervious ground surface in bus storage and parking area.

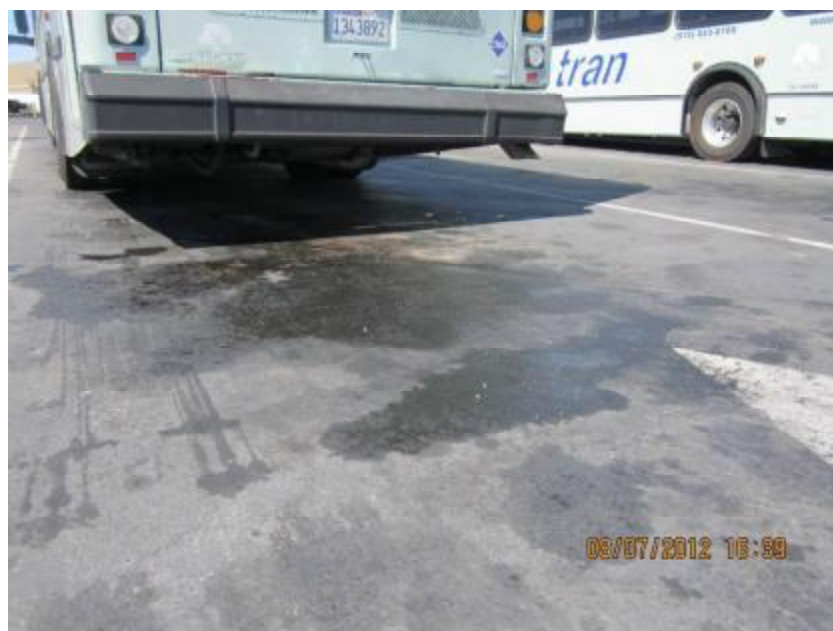
Photograph 10. Closer view of staining shown in Photograph 9.

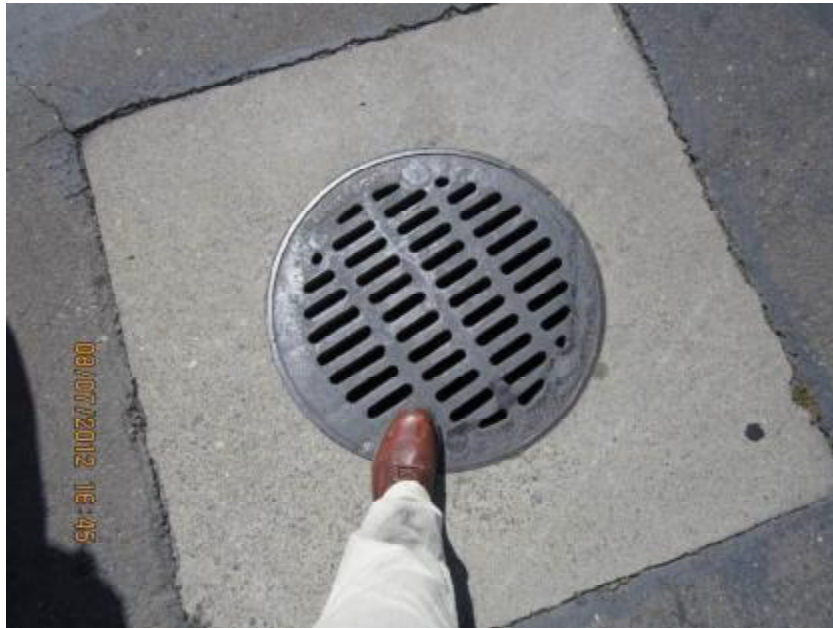
Photograph 11. View of storm drain inlet without BMPs for inlet protection.

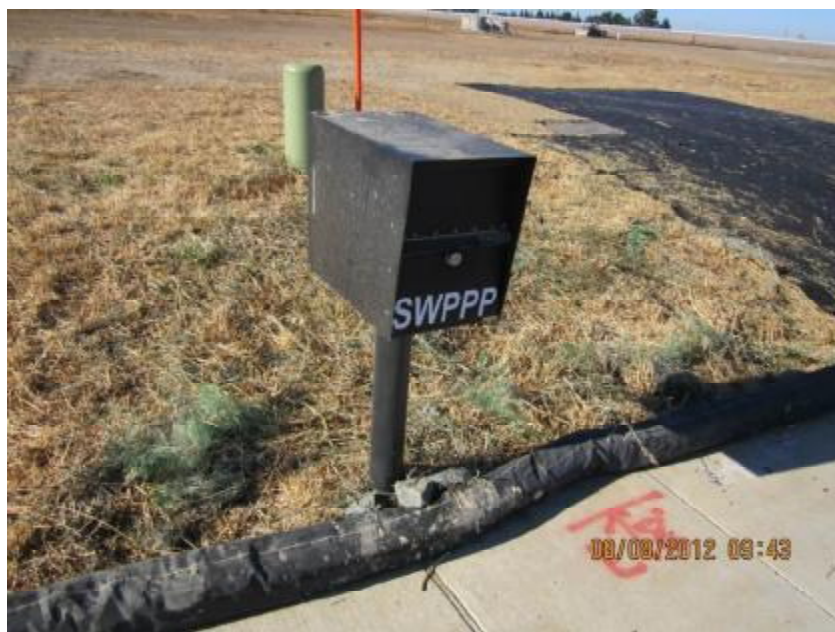
- There was a container on site labeled “SWPPP” ([see Photograph 1](#)); however, the storm water pollution prevention plan (SWPPP) for the project was not located in the container at the time of the inspection. During the site visit, an on-site representative retrieved it from a nearby location.
- A “heavy weight wattle” sediment control BMP was not properly entrenched into the ground near the center of the active construction area ([see Photograph 2](#)).
- Two portable toilets observed on site were not staked into the ground or otherwise secured ([see Photographs 3 and 4](#)).
- Concrete was present on the ground adjacent to the concrete washout containment structure at the project site ([see Photograph 5](#)).

Photograph 1. View of container at construction site for the project's SWPPP.

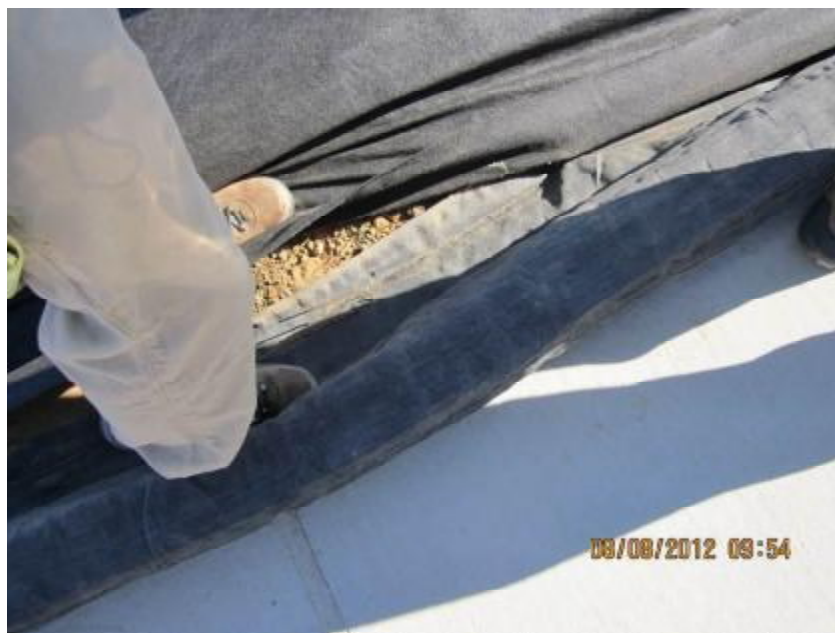
Photograph 2. View of “heavy weight wattle” sediment control BMP which was not entrenched into the ground.

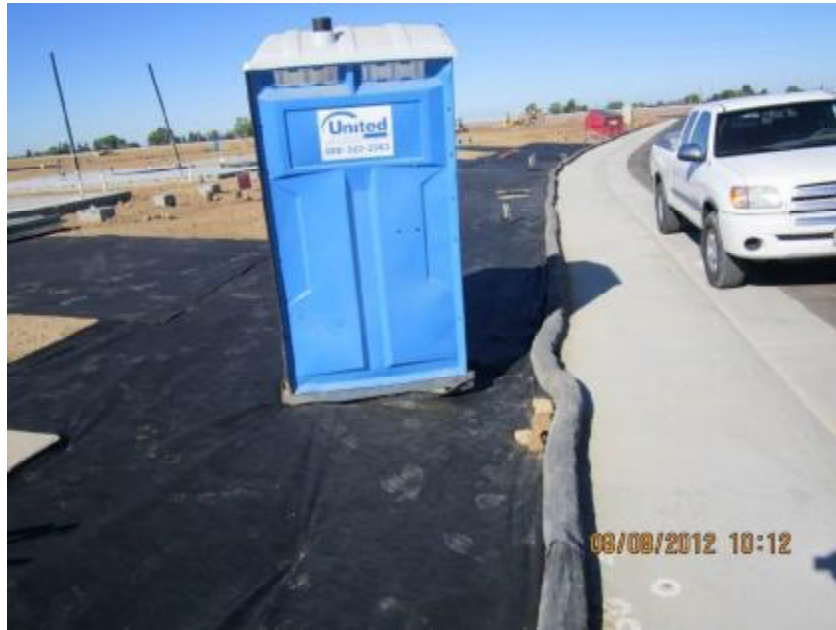
Photograph 3. View of portable toilet at the site which was not staked into the ground or otherwise secured.

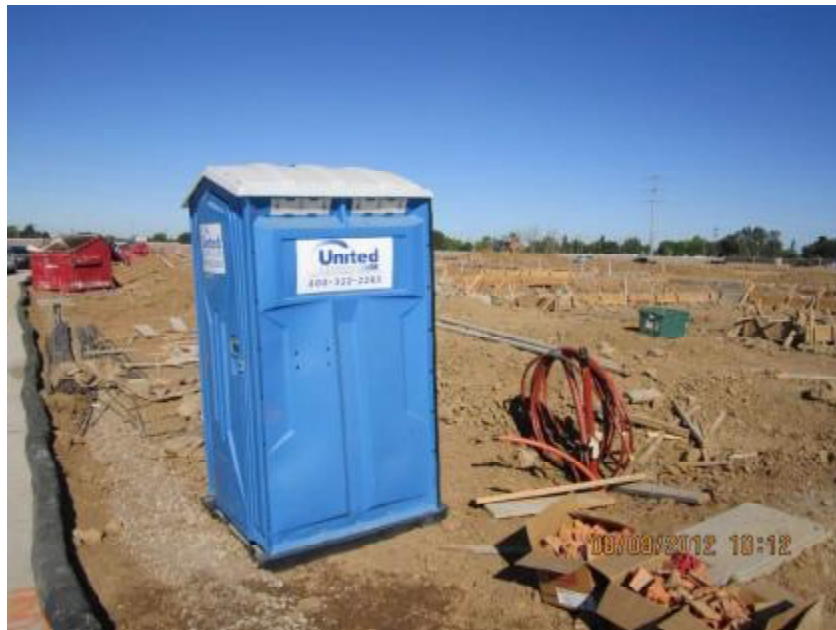
Photograph 4. View of an additional portable toilet at the site which was not staked into the ground or otherwise secured.

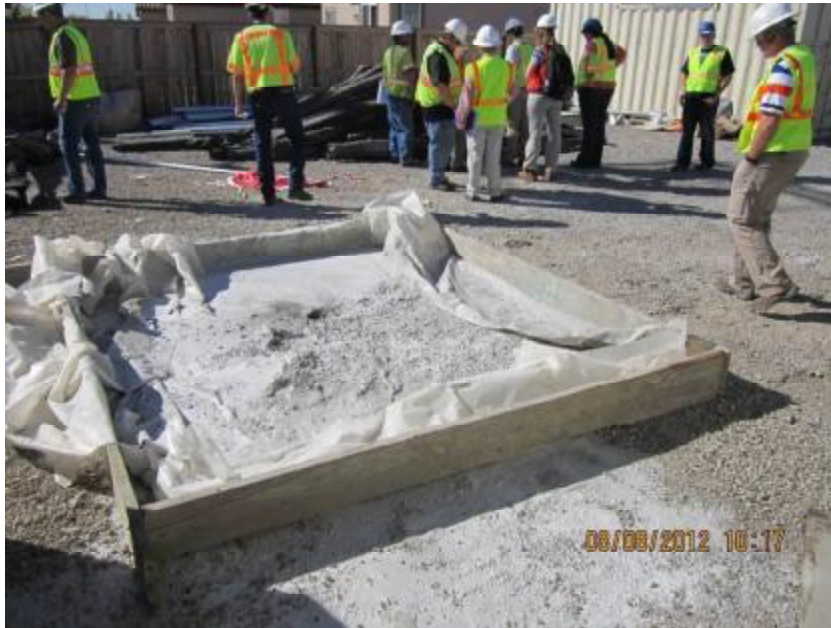
Photograph 5. View of concrete washout area at the site. Note concrete waste material located adjacent to the washout containment structure.

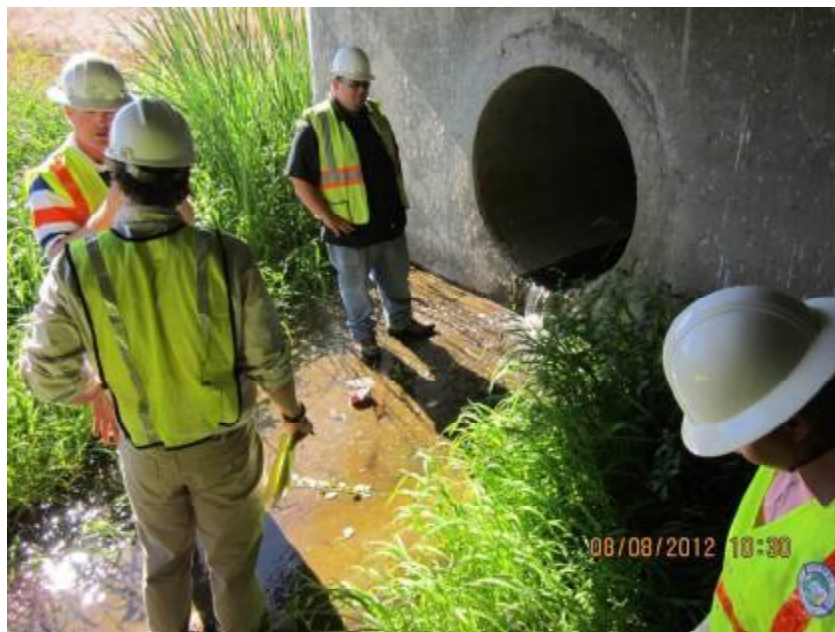
During the field component of the inspection, the EPA Inspection Team, along with City and Willdan staff, observed an outfall from the MS4 to the Shed B Channel. A site visit write-up and photograph log is included as Appendix A.6. The site visit occurred during dry weather conditions and flow was observed discharging from the outfall to the Shed B Channel. The EPA Inspection Team asked if this outfall would be one that the maintenance contractor would inspect as a component of its maintenance duties. In contrast to what he said earlier, the Willdan Construction and Maintenance Operations Manager stated that the maintenance crew might not observe this outfall since it was not visible from the roadway.

- Flow was observed discharging from the outfall, though dry weather conditions were experienced the day prior to and the day of the site visit (see [Photographs 3 and 4](#)).
- Evidence of irrigation flow from upstream turf areas along the roadway was present at the time of the site visit (see [Photographs 5 and 6](#)). City staff stated that they believed the flow from the outfall was from this irrigation water.

Photograph 3. View of outfall to Shed B Channel. Note dry weather flow from outfall.

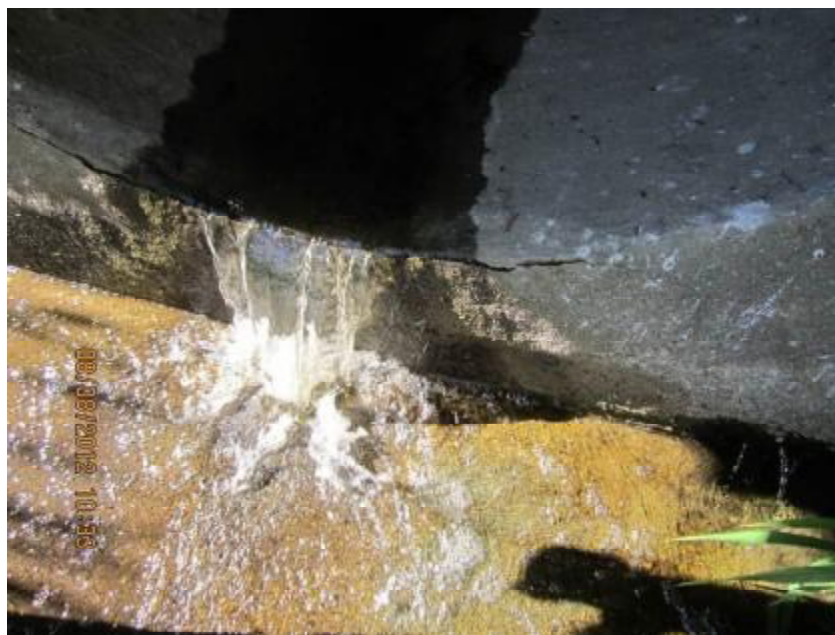
Photograph 4. Close-up view of dry weather flow from outfall.

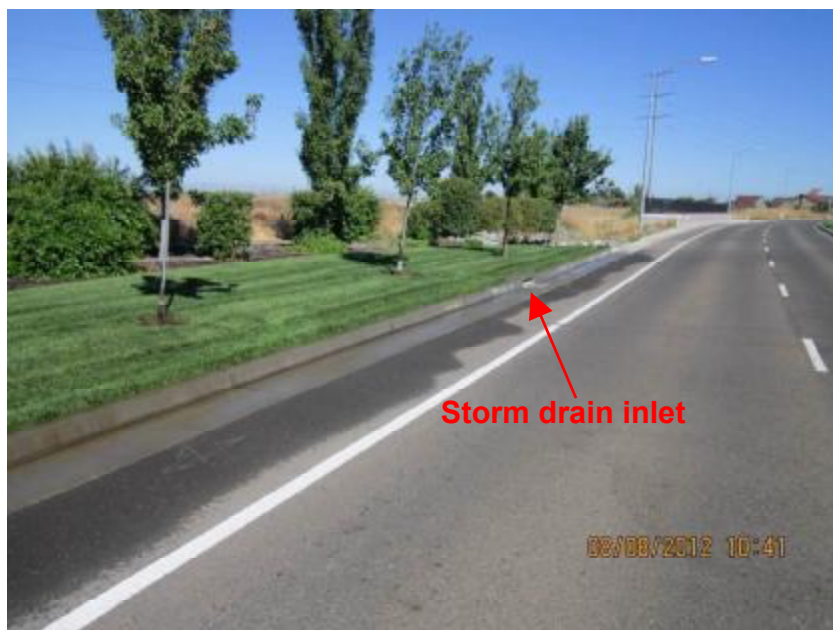
Photograph 5. View of turf area along roadway upgradient of outfall. Note evidence of irrigation flows to the curb and gutter.

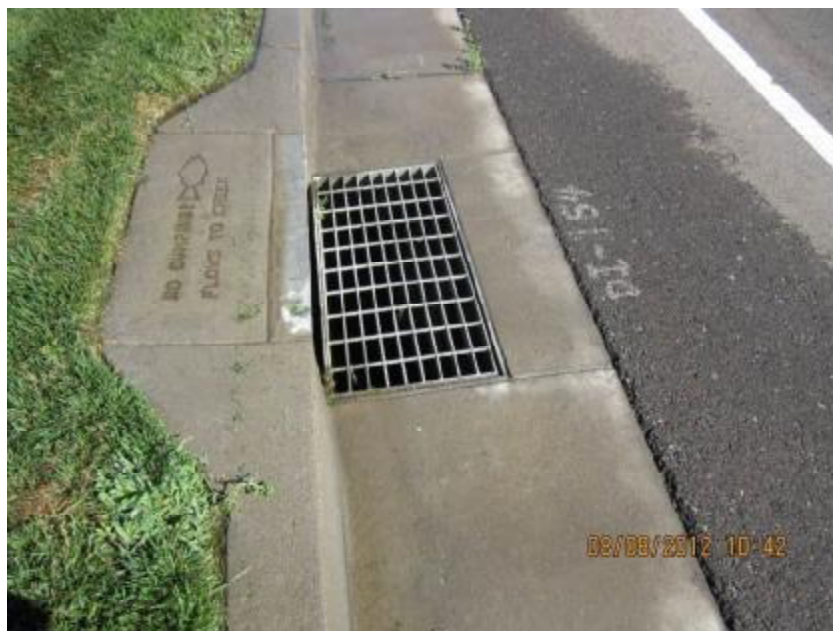
Photograph 6. Close-up view of storm drain inlet noted in Photograph 5. Note wetted area surrounding inlet.

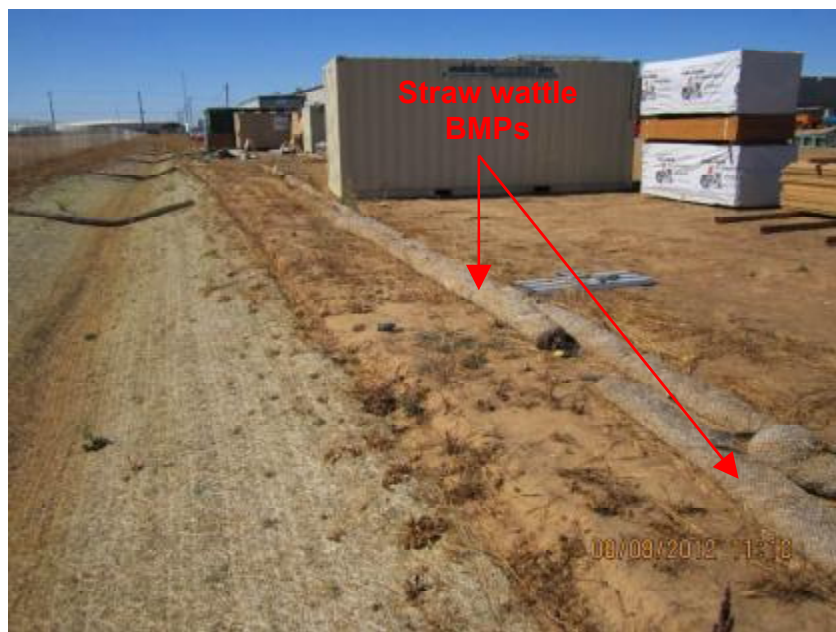
Photograph 3. View of straw wattle BMPs installed along the eastern edge of the site. Note that the straw wattles were not entrenched into the ground.

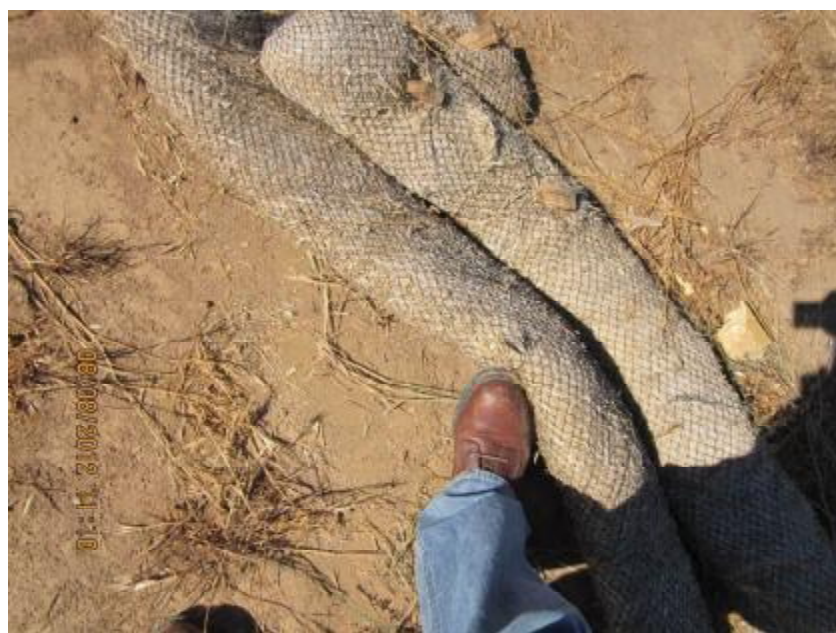
Photograph 4. Close-up view of straw wattles along the eastern edge of the site which were not entrenched into the ground.

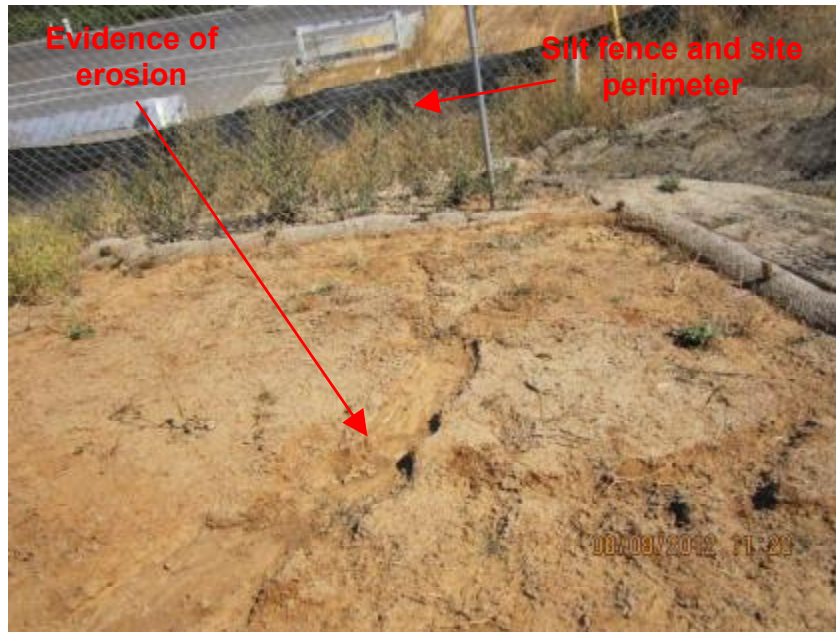
- There was a concrete washout area with secondary containment at the site (see Photograph 1).
- A temporary sediment basin had been installed near the northwest corner of the site (see Photograph 2).
- Straw wattle BMPs installed for sediment control along the eastern edge of the site were not entrenched into the ground to retain sediment and prevent failure (see Photographs 3 and 4).
- A section of straw wattle BMPs installed near the northeast corner of the site had accumulated sediment to its full height and sediment had been transported beyond the straw wattle (see Photographs 5 and 6). Silt fence had been installed downgradient of the straw wattle BMPs along the site perimeter and it did not appear that sediment was transported beyond the site perimeter (see Photographs 5, 6, and 7).

Photograph 5. View of straw wattle BMPs and silt fence BMP installed near the northeast corner of the site. Note evidence of erosion in foreground of the photograph.

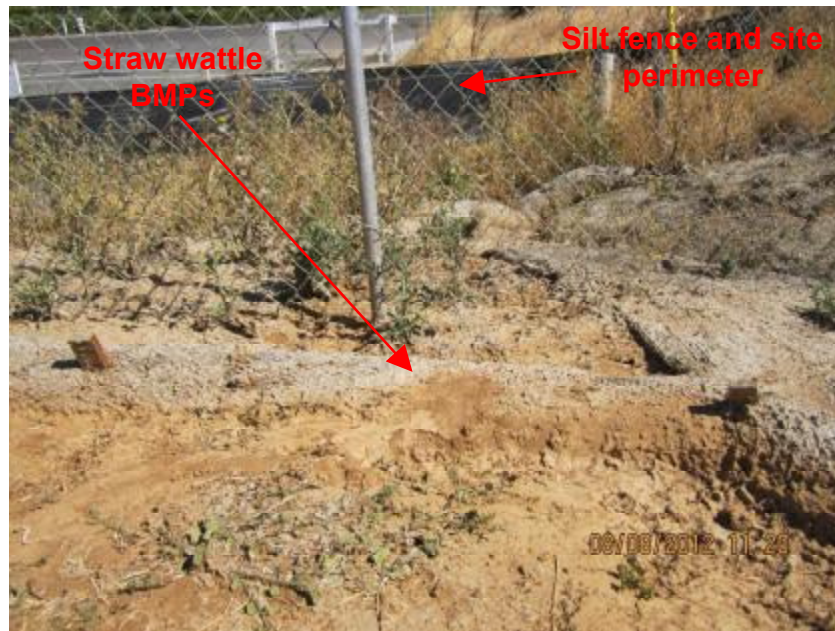
Photograph 6. Close-up view of straw wattle which had accumulated sediment to its full height.

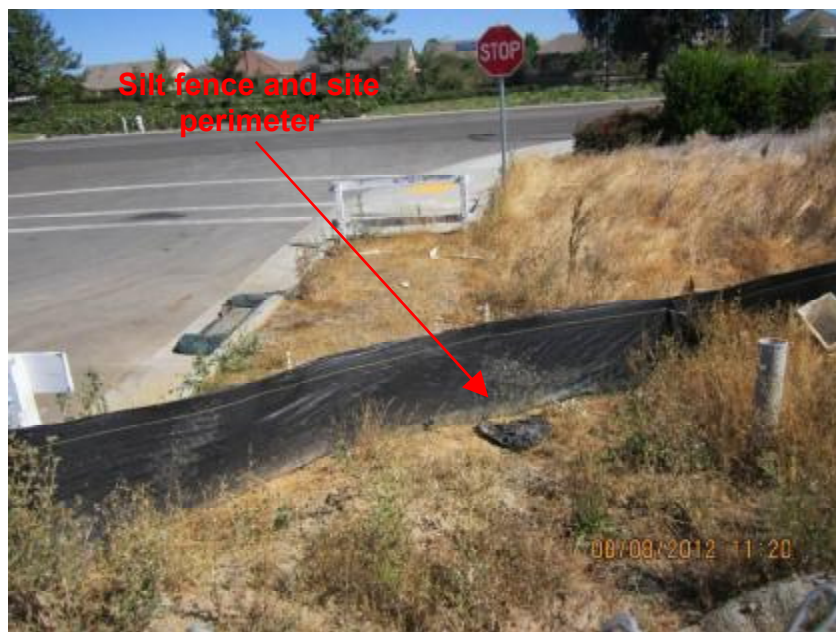
Photograph 7. View of silt fence BMP installed downgradient of the straw wattles shown in Photographs 5 and 6.

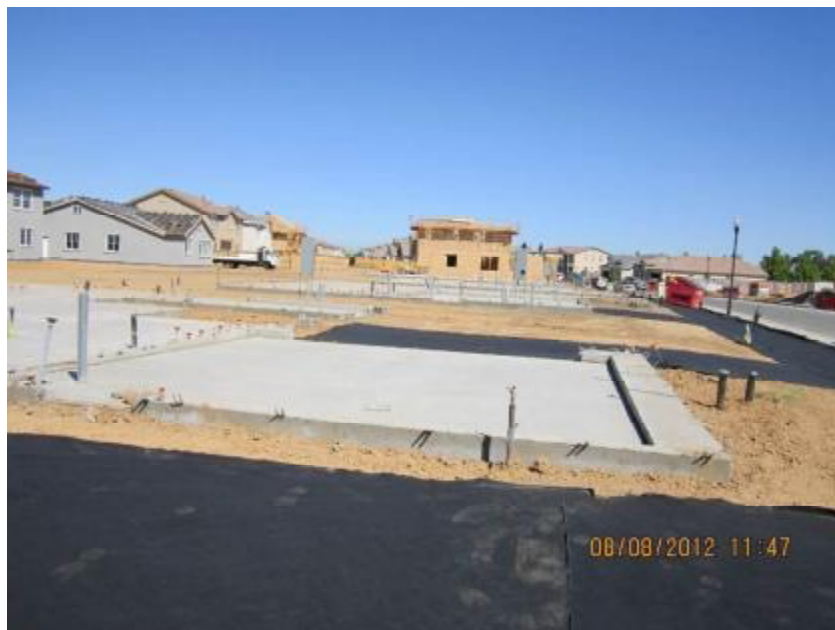
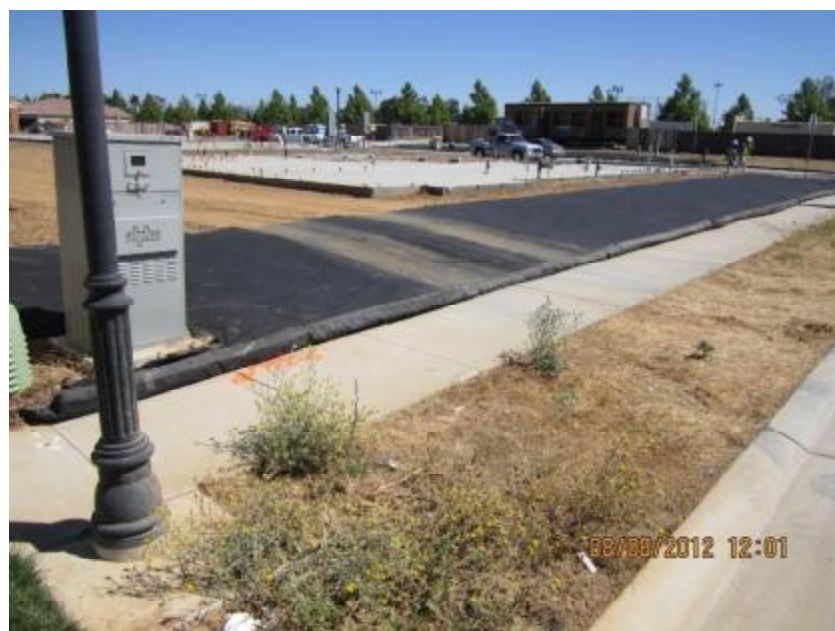
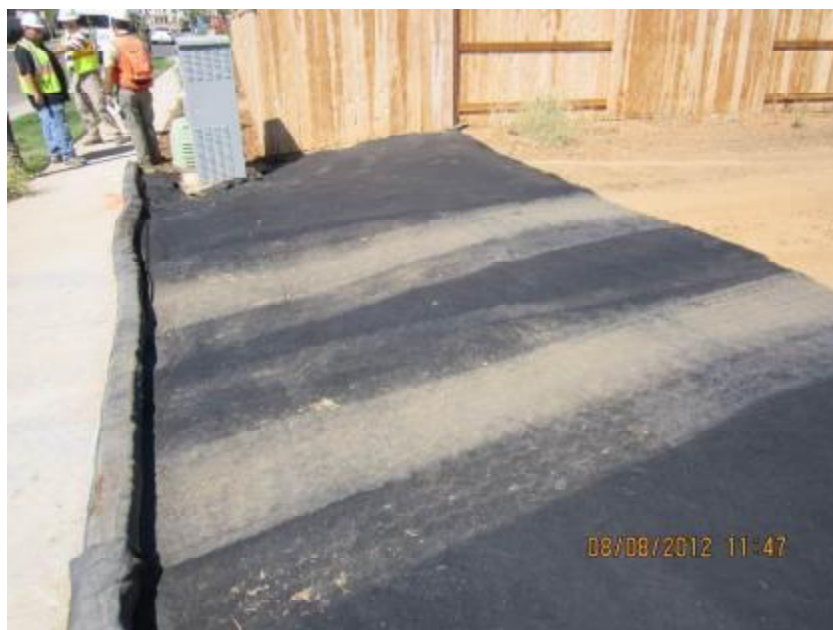
- A black geotextile fabric had been applied to cover the perimeter of lots within the development and used as vehicle access areas (see [Photographs 1, 2, and 3](#)). The City Construction Site Inspector stated that he would prefer to see rock-lined construction site entrances rather than the geotextile fabric used to stabilize entrances.
- Multiple gravel bags implemented on site for storm drain inlet protection were deteriorated (see [Photograph 4](#)).
- During the site visit, an on-site contractor demonstrated a “self-contained” cleaning procedure for a concrete truck chute (see [Photograph 5](#)).

Photograph 1. View of lots with geotextile fabric applied around the perimeter of an active lot.

Photograph 2. View of area with geotextile coverage that was used for vehicle access.

Photograph 3. Close-up view of area used for vehicle access shown in Photograph 2.

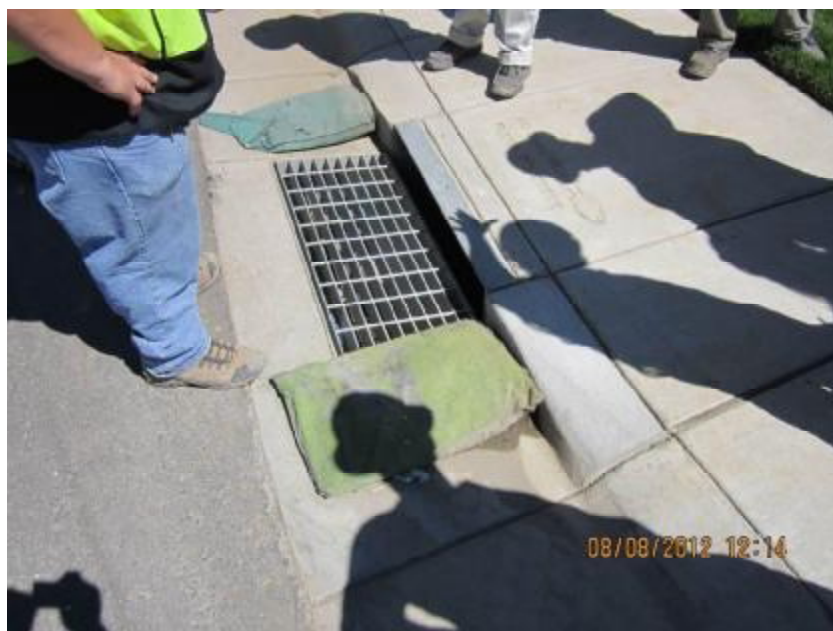
Photograph 4. View of deteriorated gravel bags used for storm drain inlet protection.

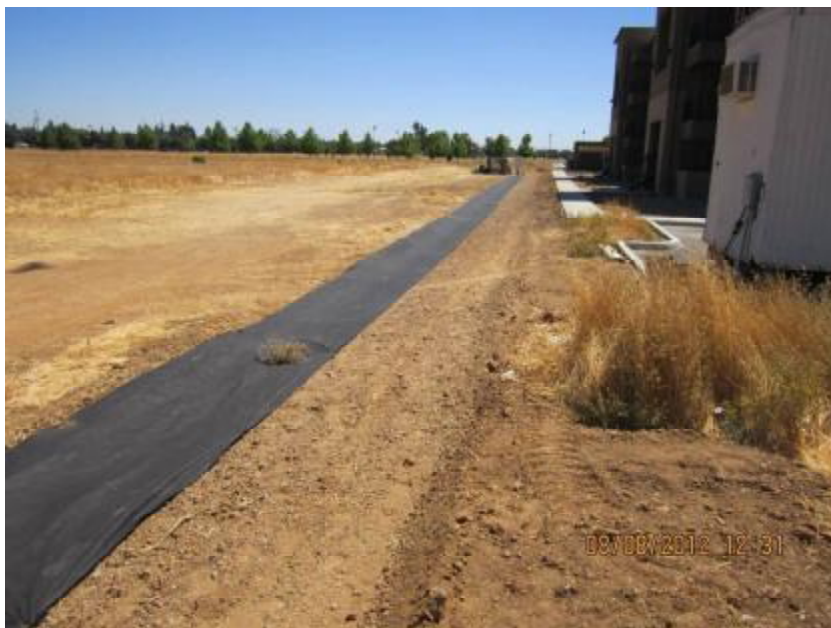
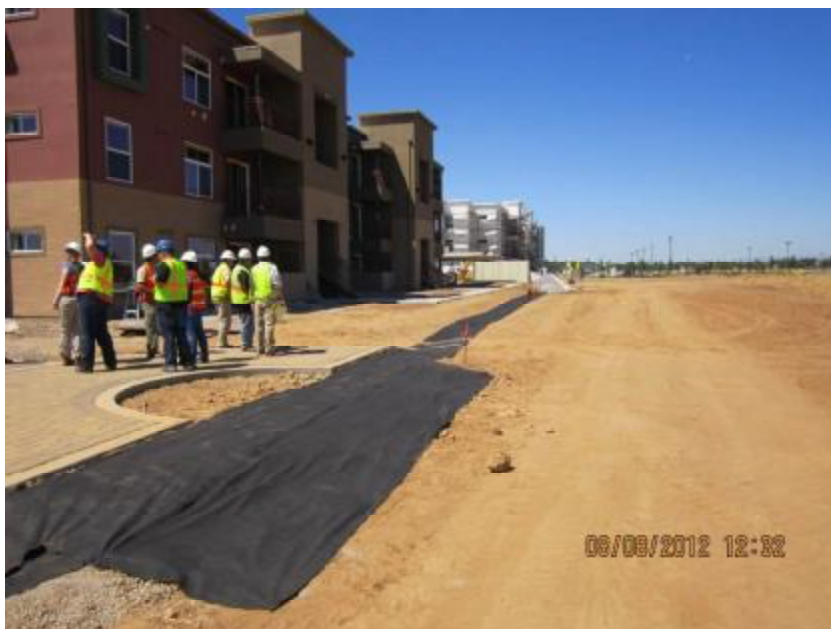
During an inspection of the Laguna Ridge Apartments Construction Project, the EPA Inspection Team observed that appropriate perimeter control BMPs had not been implemented (see [Appendix A.9](#)). The Willdan Construction and Maintenance Manager and Willdan Construction Stormwater Inspector stated that the lack of BMPs was an ongoing problem with this specific construction site. The City representative stated that the City had issued multiple Notices of Correction, but had not issued a Notice of Non-Compliance and/or Cease and Desist Order, and had not referred the site to the Regional Water Board. While onsite, the Willdan Construction and Maintenance Manager agreed that this case should have been escalated to a Notice of Non-Compliance. Subsequent to the inspection, the EPA Inspection Team received documentation of a Notice of Non-Compliance issued to the Laguna Ridge Apartments Construction Project on August 9, 2012 (see [Appendix B.104](#)).

- Perimeter control BMPs had not been implemented along the northern perimeter of the construction site (see [Photographs 1 and 2](#)).
- Straw wattle BMPs placed around multiple stockpiles at the site were not entrenched into the ground (see [Photographs 3 and 4](#)).

Photograph 1. View looking east of northern perimeter of the construction site. Note that BMPs had not been installed for perimeter control.

Photograph 2. View looking west of northern perimeter of the construction site. Note that BMPs had not been installed for perimeter control.

As described above, the City identified a construction project (Laguna Ridge Apartments) with on-going violations, had issued multiple Notices of Correction, but had not referred the site to the Regional Board. The City must develop a clear mechanism for referring sites with chronic violations to the Regional Water Board. The procedure should be shared with construction project managers at the pre-construction meeting so it is clear how enforcement activities, including referring cases to the Regional Board, will be conducted.

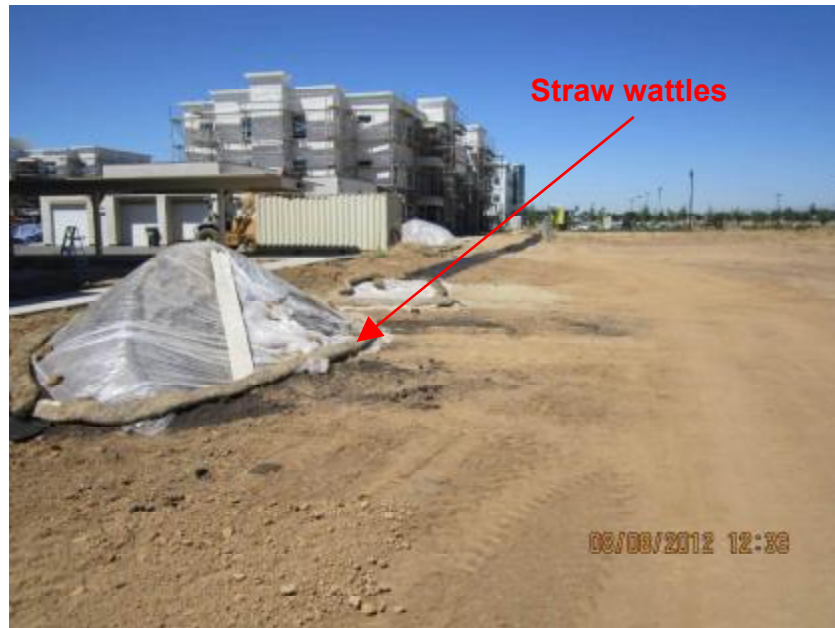
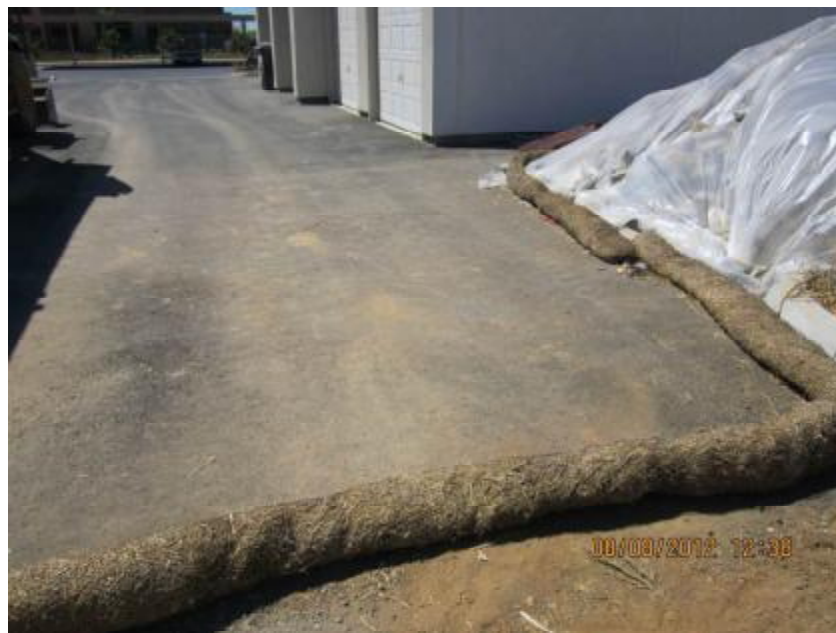
Photograph 3. View of stockpile along northern perimeter of the construction site. Note that the straw wattles placed around the stockpile were not entrenched into the ground.

Photograph 4. Additional example of stockpile surrounded by straw wattles which were not entrenched into the ground.

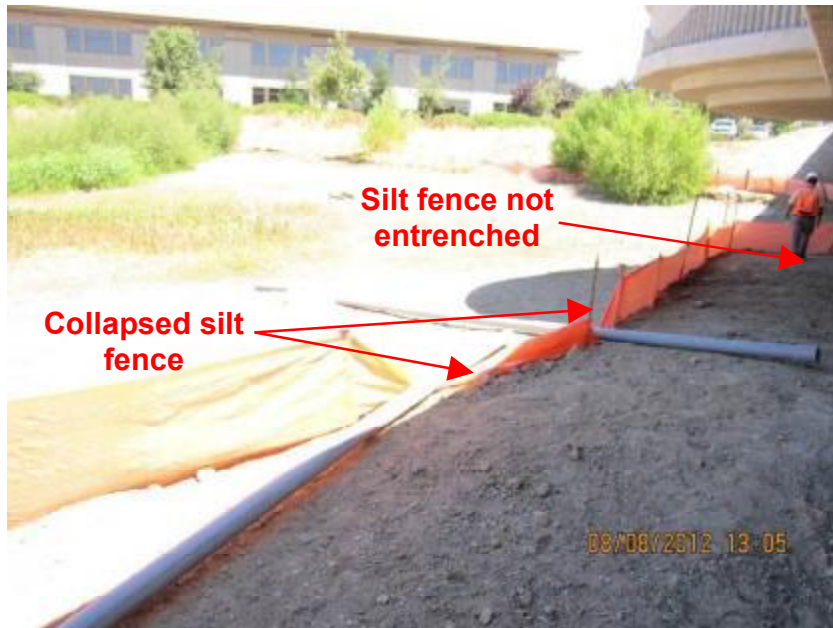
The EPA Inspection Team visited a City-sponsored capital improvement construction project—the Longleaf Drive Bridge Construction Project—and multiple site deficiencies were observed during the site visit. A site visit write-up and photograph log is included in Appendix A.10. During the site visit, the Willdan Construction and Maintenance Manager explained that this City-sponsored project had not received stormwater inspections by City or Willdan staff. In fact, City and Willdan staff explained that the City had not conducted stormwater-specific inspections for any City-sponsored construction sites.

- A section of silt fence installed below the bridge near the center of the Elk Grove Creek channel was collapsed due to pipes on the silt fence ([see Photograph 1](#)).
- A section of silt fence installed below the bridge along the eastern side of the Elk Grove Creek channel was not entrenched into the ground to retain sediment and prevent failure ([see Photographs 1, 2 and 3](#)).
- BMPs for erosion and sediment control had not been implemented for the abutments on the west end of the bridge ([see Photographs 4 and 5](#)).
- Inlet protection had not been installed for a storm drain inlet in a disturbed area along the south side of the roadway extension from the bridge ([see Photographs 6 and 7](#)).

Photograph 1. Longleaf Drive Bridge Construction Project – View of area below the bridge where there was a section of collapsed silt fence and a section of silt fence that was not entrenched into the ground.

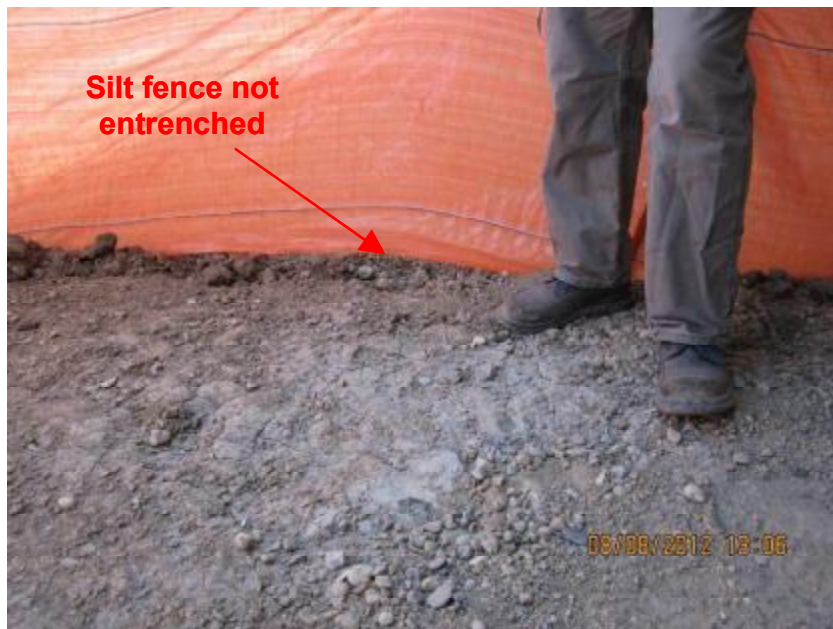
Photograph 2. Longleaf Drive Bridge Construction Project – Closer view of section of silt fence that was not entrenched into the ground noted in Photograph 1.

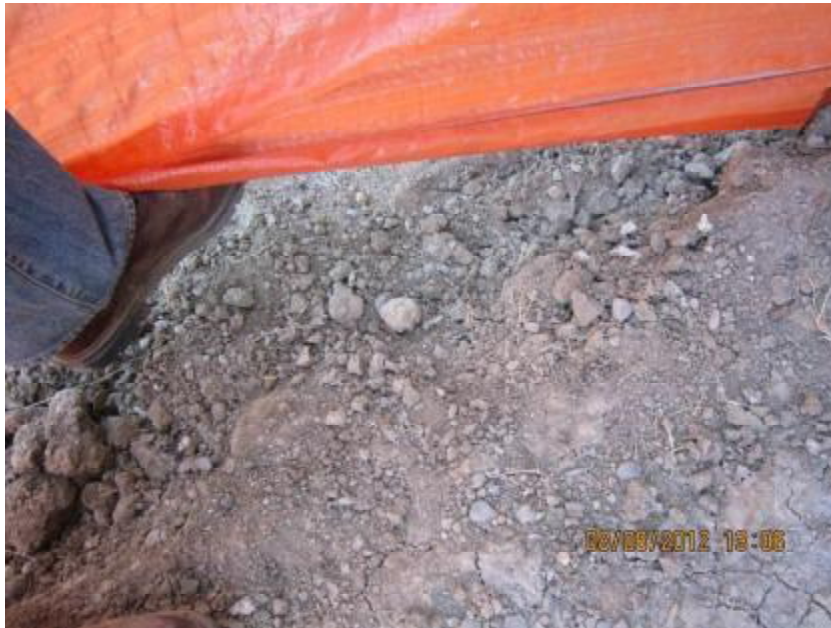
Photograph 3. Longleaf Drive Bridge Construction Project – Additional view of silt fence shown in Photographs 1 and 2 that was not entrenched into the ground.

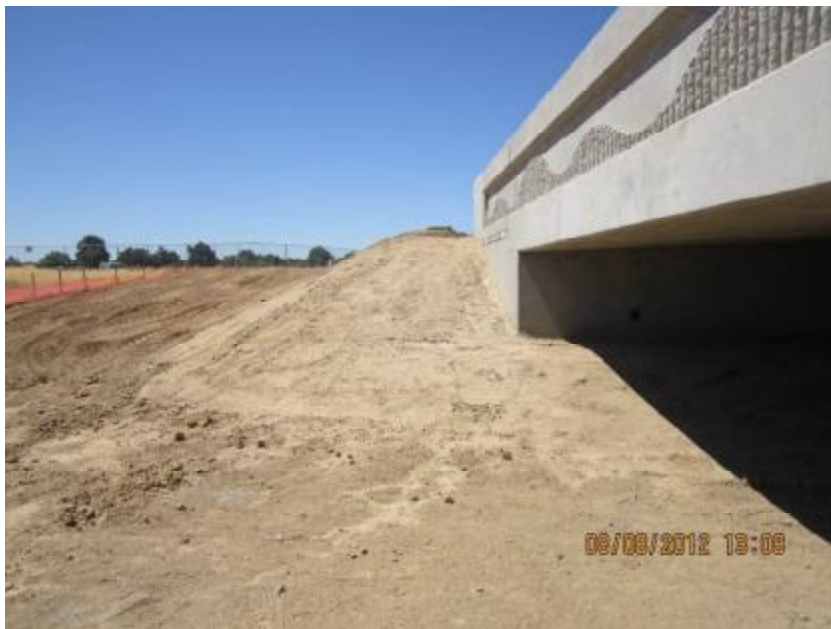
Photograph 4. Longleaf Drive Bridge Construction Project – View of south abutment on west side of the bridge. Note lack of erosion and sediment control BMPs.

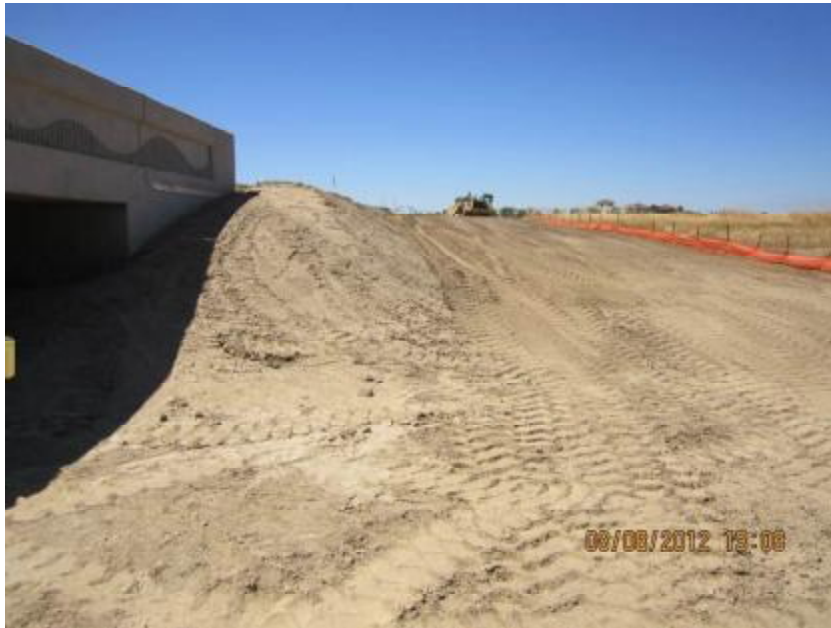
Photograph 5. Longleaf Drive Bridge Construction Project – View of north abutment on west side of the bridge. Note lack of erosion and sediment control BMPs.

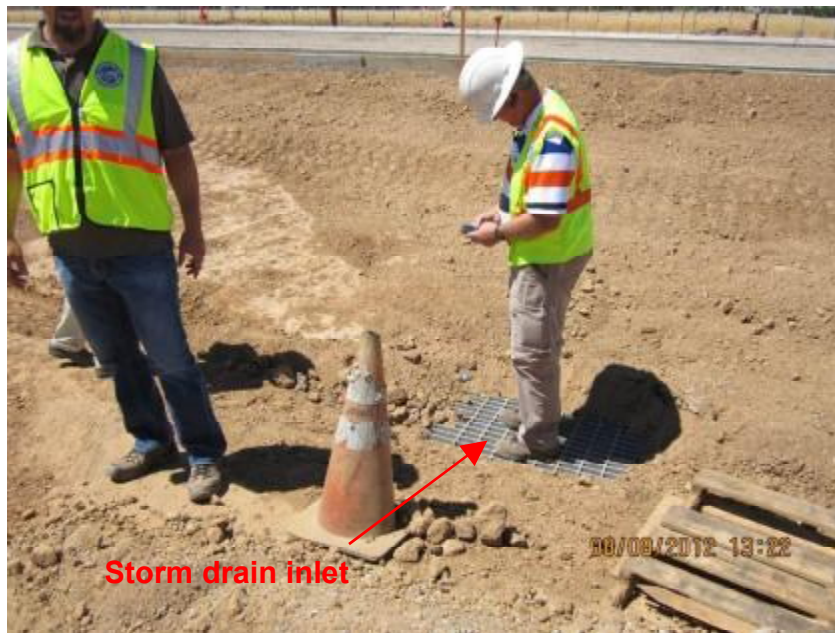
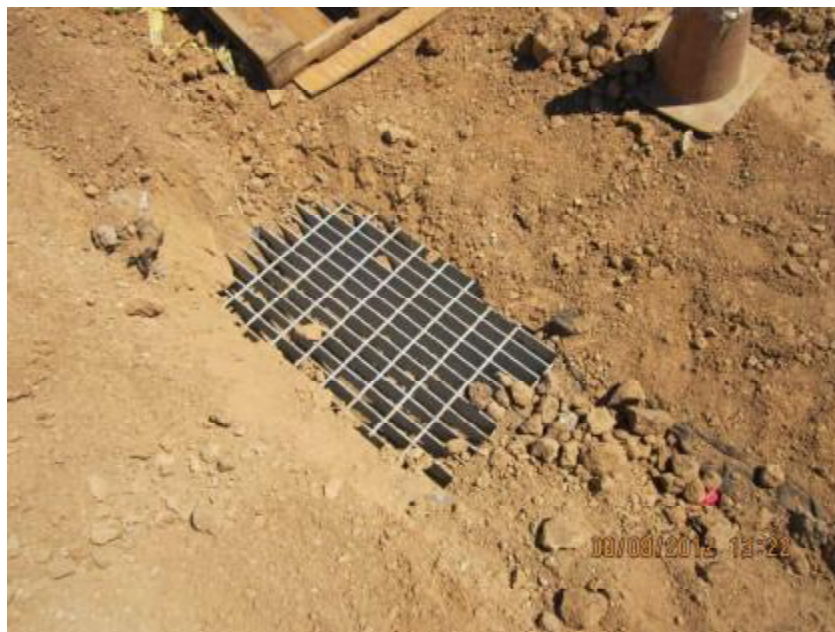
Photograph 6. Laguna Corporate Center Construction Project – View of storm drain inlet without inlet protection along south side of the roadway extension construction from the bridge.

Photograph 7. Laguna Corporate Center Construction Project – Close-up view of storm drain inlet shown in Photograph 6.
