**MUNICIPAL SEPARATE STORM
SEWER SYSTEM (MS4)
COMPLIANCE INSPECTION**

**CITY OF ELK GROVE,
CALIFORNIA**

INSPECTION REPORT

Inspection Date:
August 7–8, 2012

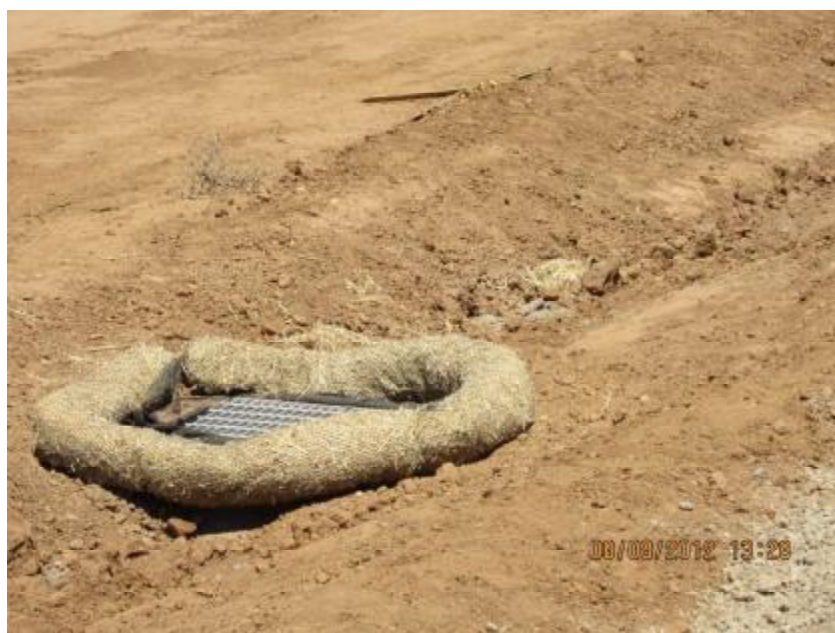
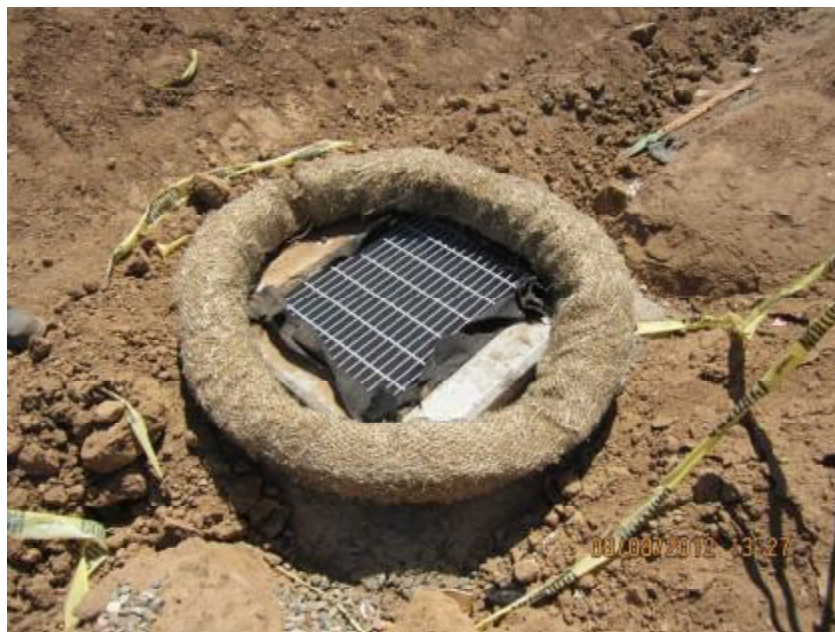
- Straw wattles installed around multiple storm drain inlets in the area parking lot area toward the southern end of the project were not entrenched into the ground ([see Photographs 8 and 9](#)).

Photograph 8. Laguna Corporate Center Construction Project – View of storm drain inlet in parking lot area surrounded by straw wattles which were not entrenched into the ground.

Photograph 9. Laguna Corporate Center Construction Project – Additional example of storm drain inlet in parking lot area surrounded by straw wattles which were not entrenched into the ground.
