NPDES COMPLIANCE EVALUATION INSPECTION

NPDES Permittee: American Samoa Power Authority

Facility: Satala Power Plant
P.O. Box PPB, Pago Pago, Tutuila Island, American Samoa
(NPDES Permit No. AS0020044)

Date of Inspection: April 30, 2009

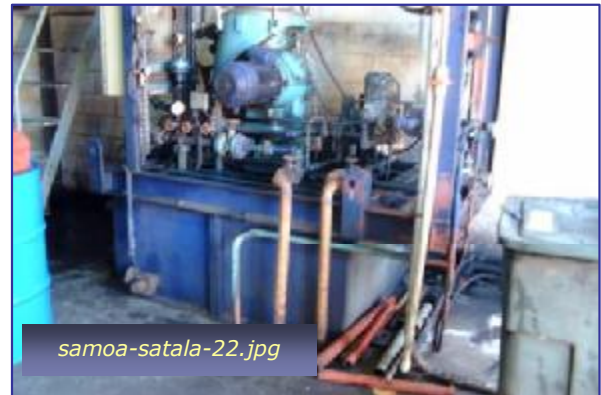
Engine Room Drainage – Oil spills, oily wastewaters, lube oil centrifuge sludges, and slop captured within the power plant are conveyed through floor drains to four blind pit sumps in the engine room. These wastewaters used to be pumped to the waste oil tanks located near NPDES Sump #1 for off-site hauling to the Tafuna Power Plant for reprocessing. However, ASPA now indicates that these oily wastewaters are pumped directly from the pit sumps to a 2000-gallon truck for off-site disposal. See Photos #1 and #2 in Section 1.5 on page 6.

Photo #2: One of Four Lube Oil Centrifuges
Taken By: Greg V. Arthur
Date: 04/30/09

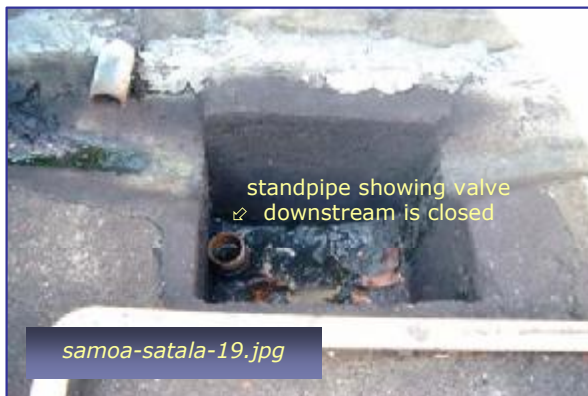
Fuel Farm Tank Wash – The diesel tanks are power washed every three weeks. Run-off captured within the tank farm secondary containment drains to a small sump located inside, in the center, and against the front wall. This sump drains by buried line to a central sump drain located at the edge of the truck unloading area outside of the fuel farm. The central sump drain discharges by gravity through underground pipe to NPDES Sump #1. The buried drain line from the sump inside of the fuel tank farm containment is valved, and was found in the closed position during this inspection. This tank wash water would be expected to entrain diesel, grime, and organic material. See Photos #3 and #4 in Section 1.5 on page 6.

Photo #3: Drainage Sump within Fuel Tank Farm
Taken By: Greg V. Arthur
Date: 04/30/09

- The valved drain lines from the fuel tank farm containment sump, waste oil storage containment, and transformer platform should be operated in the normally closed position.
- Groundwater seepage should be off-hauled for disposal or treated in a package oil water separator for NPDES discharge. See U.S. Army Corp of Engineers design publication, “Designing Coalescing Oil/Water Separators for US Army Washracks, ERDC/CERL TR-00-40, Dec 2000. (<http://aec.army.mil/usaec/technology/ows-designing.pdf>)
- Outdoor truck and equipment washing should be prohibited on-site.
- Perimeter curbing should be installed in order to prevent the off-site run-off from the adjacent properties from draining through the NPDES sumps.
- Additional best management practices should be instituted to ensure that only non-contact storm water run-off discharges to the harbor through the NPDES sumps.

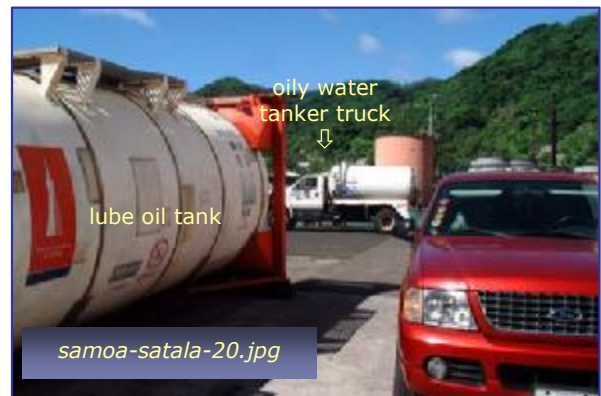
Off-Site Disposal – Collected oily wastewaters from the engine room pit sumps and the NPDES sumps are now pumped to a 2,000 gallon tanker truck for off-site disposal at the Tafuna Power Plant. ASPA estimates six loads are collected per month. The disposal involves enclosed batch settling tanks, an oil skimming pit, settling basins, evaporation and percolation of the water fraction, and the off-site waste oil reclaim in the boilers at Chicken of the Sea. See Photos #4, #13, #14, #15, #16 in Section 1.5 on pages 6 and 8.

Photo #4: Lube Oil Tank - ASPA Tanker Truck
Taken By: Greg V. Arthur
Date: 04/30/09

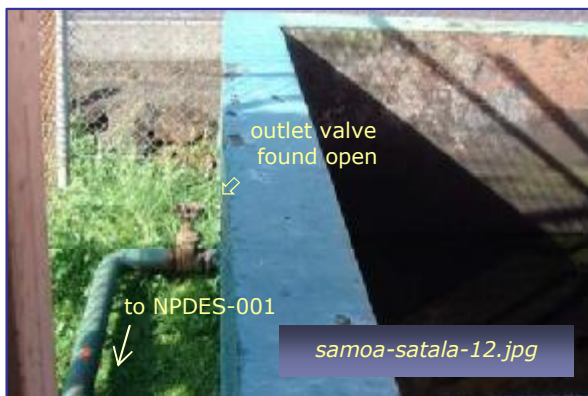
Waste Oil Storage Decant – Oily wastewaters collected into the two waste oil storage tanks are now pumped directly to a 2,000 gallon tanker truck. The waste oil storage tanks had decant return lines to NPDES Sump #1 although it is not certain that these are still in use. The waste oil storage secondary containment is outfitted with a valved drain line to NPDES Sump #1. The drain line valve was once again found in the open position during this inspection. See Photo #5 in Section 1.5 on page 6.

Photo #5: Waste Oil Tanks 2° Containment
Taken By: Greg V. Arthur
Date: 04/30/09

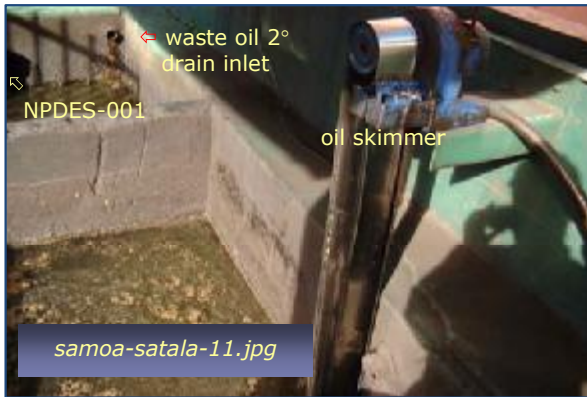
NPDES Sump #1 – Storm water and process wastewater drainage are by design directed through the eastern oil water separator for discharge to the harbor. The eastern oil water separator provides solids settling and oil skimming in two chambers as well as trace free oil removal through a small contact oil film skimmer. Captured oils are pumped to the adjacent waste oil tanks for off-hauling by tanker truck to the Tafuna Power Plant for disposal. NPDES Sump #1 discharges into a storm drainage ditch along the highway that empties through a culvert under the highway to the harbor. See Photos #6, #7, #9, #10 in Section 1.5 on pages 6 and 7.

Photo #7: NPDES Sump #1 - Eastern Oil Water Sep
Taken By: Greg V. Arthur
Date: 04/30/09

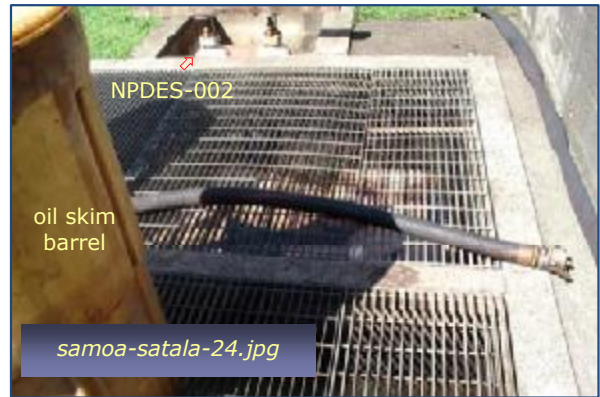
NPDES Sump #2 – Storm water drainage and vault seepage are discharged to the harbor through the western oil water separator. It is equivalent in design to the eastern oil water separator except it does not have a small contact oil film skimmer to remove trace sheen. Captured oils are pumped to a small barrel also for off-hauling by tanker truck. NPDES Sump #2 also discharges into the storm drainage ditch along the highway. See Photos #6, #8, #9, #10 in Section 1.5 on pages 6 and 7.

Photo #8: NPDES Sump #2 - Western Oil Water Sep
Taken By: Greg V. Arthur
Date: 04/30/09

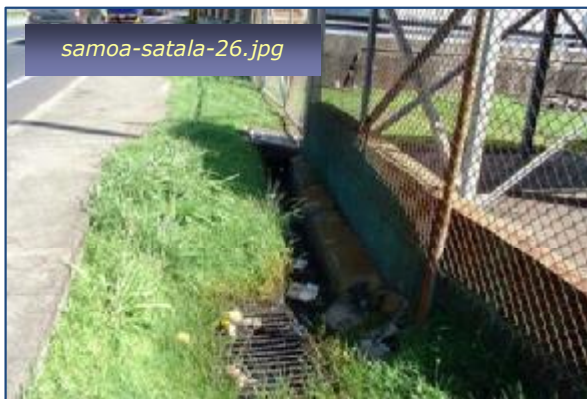
Photo #9: Storm Drainage Ditch - Culvert Inlet
Taken By: Greg V. Arthur
Date: 04/30/09

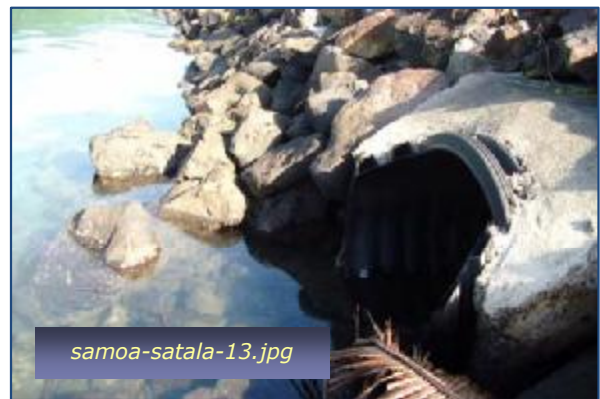
Photo #10: Culvert Outlet to the Harbor
Taken By: Greg V. Arthur
Date: 04/30/09

The NPDES permit establishes a number of narrative prohibitions as the receiving water limits for Pago Pago Harbor. The drainages observed to discharge through the NPDES sumps would be expected to be substantially free of color, odor, taste, visible floating materials, oils, turbidity, toxicity, or solid wastes. On this day of inspection, no apparent sheen was observed in the harbor at the culvert outlet.

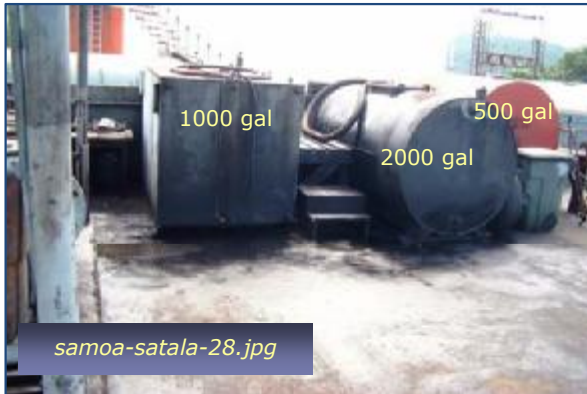
Photo #13: Waste Oil Step 1 - Batch Settling Tanks
Taken By: Greg V. Arthur
Date: 04/30/09

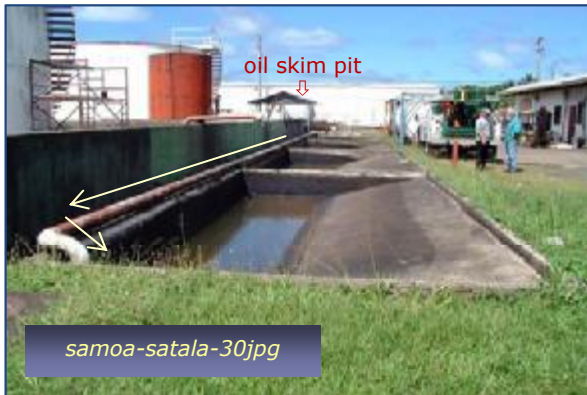
Photo #15: Waste Oil Step 3 - Settling Basins
Taken By: Greg V. Arthur
Date: 04/30/09

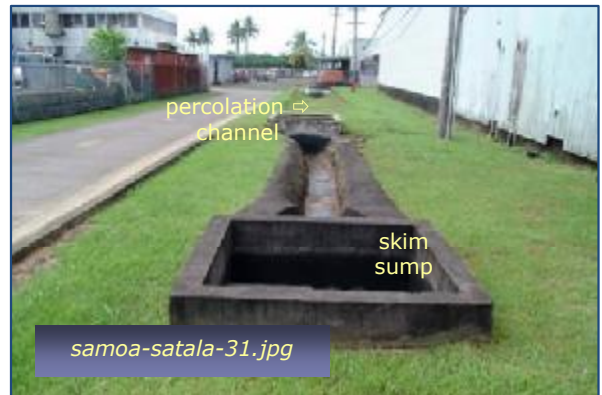
Photo #16: Waste Oil Step 4 - Percolation
Taken By: Greg V. Arthur
Date: 04/30/09
